殊像寺 建筑表面装饰、 塑像、陈设物 状况评估

Condition Assessment
of
Painted Architectural
Surfaces, Sculpture,
Furnishings and Objects

会乘殿 状况评估

Huicheng Hall Condition Assessment

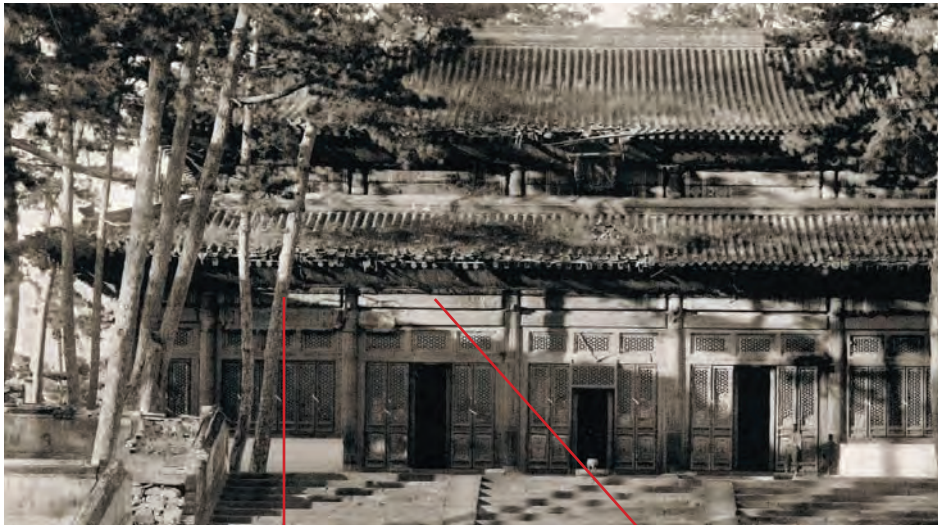
1933年关野贞摄请注意屋顶的残损状况及下檐可见的残存彩画。其中大额枋上彩绘整体留存，而小额枋西端有部分彩画留存。

1933 Sekino photograph. Note the poor condition of the roof and the surviving areas of painting visible on the lower level. The painting on the greater architrave survives in entirety. On the lesser architrave, the painting survives on the west end.

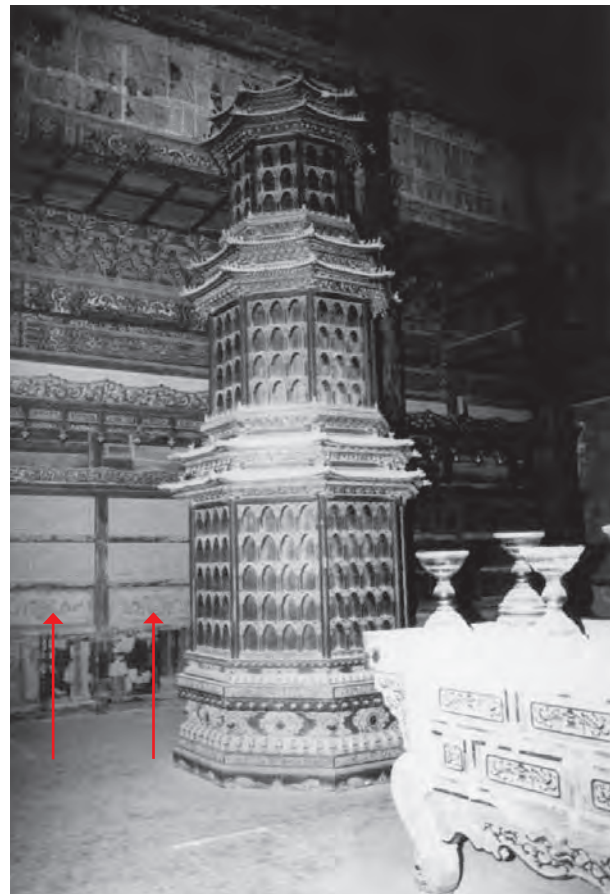
与2002年的照片相比，两尊塑像已不存在（从殊像寺消失）。但是多了经格的门。在1933年关野贞的照片中经格没有门。

Comparison photograph taken in 2002 which no longer shows the sculptures (now missing from Shuxiang Temple) but does include replacement sutra shelf doors noticeably absent in the 1933 Sekino photograph.

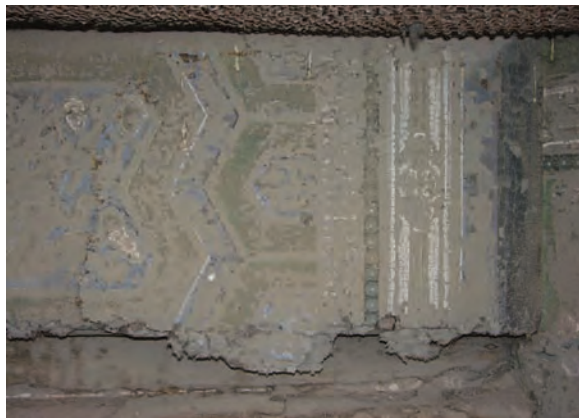
彩画表面总体来说残损严重。不同种类的画层起甲、细小裂缝及缺失，以及总体风化和灰尘堆积导致这一残损外观。这一局部取自东立面下檐南尽间。

The surface of the painting is generally very deteriorated. Different types of paint flaking, fine cracking and loss in addition to weathering and dirt deposition leads to this deteriorated appearance. This area is from the lower level of the east wall, southernmost bay.

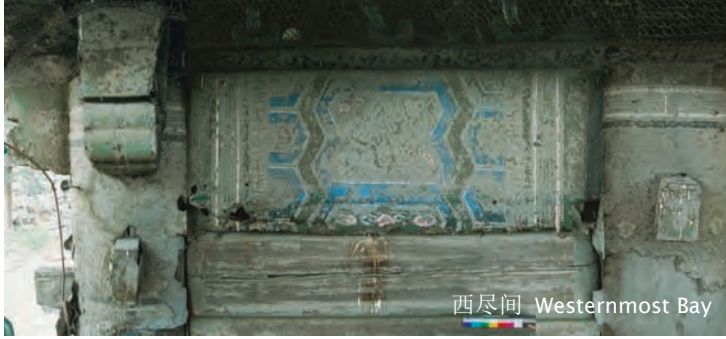
西尽间：大额枋上彩画保存状况较好，但其底部剥离且呈悬挂状态。这片彩画背面有一个鸟巢，在其下小额枋暴露的木材表面有鸟粪痕迹。小额枋彩画全部脱落。

Westernmost Bay: greater architrave painting survives in good condition though the bottom part is detached and hanging down. There is a bird nest behind the painting and evidence of bird droppings on the exposed wood. The lesser architrave decoration is completely lost.

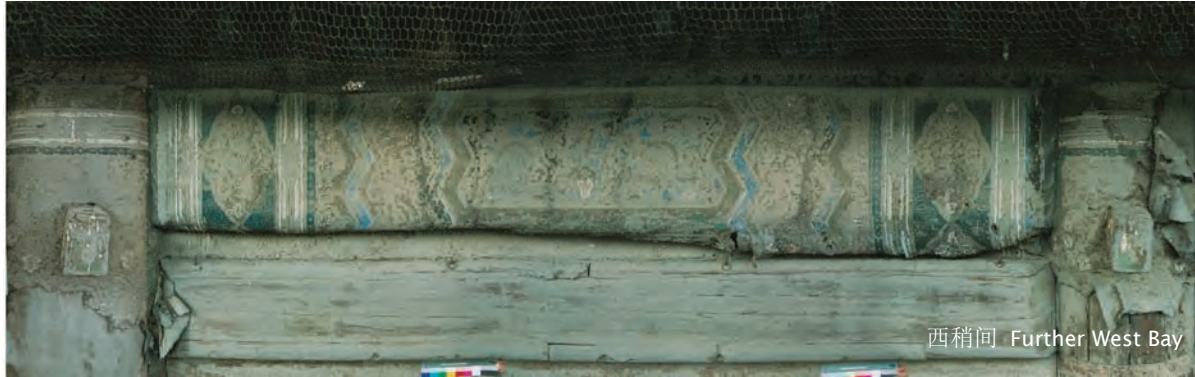
西稍间：大额枋彩画状况良好，但是东半部底部空鼓且下垂。一个斗拱构件脱落于防鸟网中。小额枋彩画完全缺失。

Further West Bay: greater architrave painting is in good condition but the right half is detached at bottom and hanging down. There is a piece of bracket which has fallen and is caught in the bird netting. The lesser architrave decoration is completely gone.

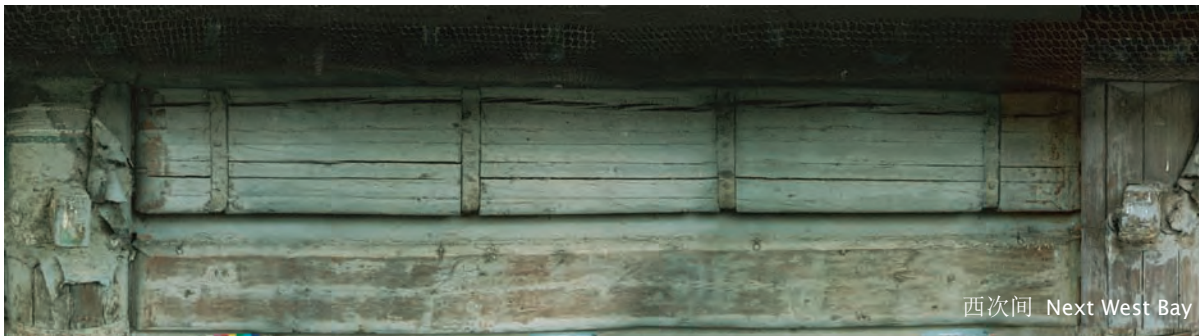
西次间：彩画几乎全部缺失，木质表面完全暴露。大额枋上出现线状开裂。

Next West Bay: the painting is almost entirely lost and the wooden beams completely exposed. The greater architrave beam is cracked and splitting.

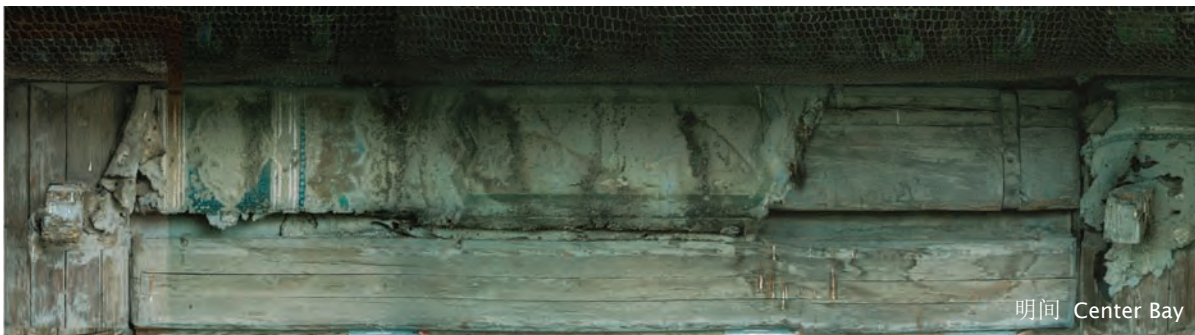
明间：部分大额枋彩画尚存，但某些地方出现空鼓及污迹。东端1/3部分的彩画脱落。小额枋彩画全部脱落，暴露的木材表面可见污迹以及鸟粪。

Center Bay: greater architrave painting survives but is detached in places shows staining. The eastern third of the painting is lost. The lesser architrave decoration is entirely lost with staining and bird droppings on the exposed wood.

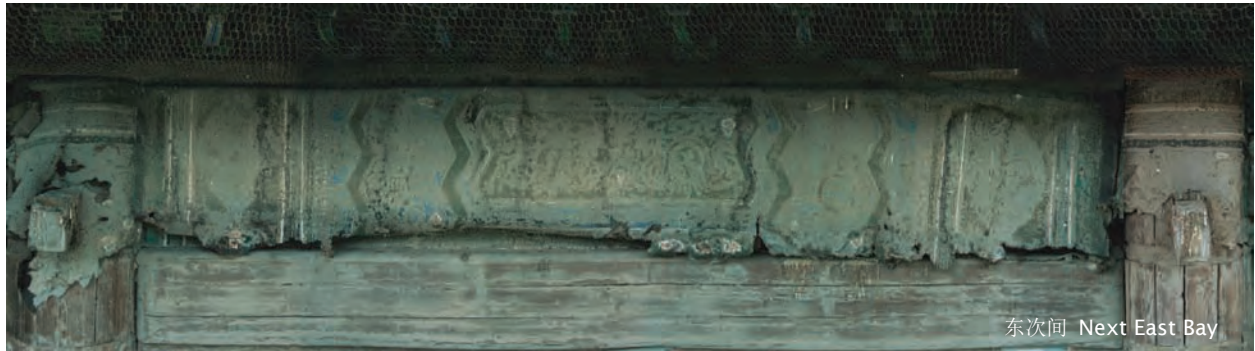
东次间：大额枋上彩画尚存，但东1/3端部分空鼓并剥离。这部分彩画在2004年5月初次记录与2004年7月进一步观察之间脱落。小额枋上彩画全部脱落。

Next East Bay: greater architrave painting survives, but the eastern third is bulging and detached. This area of painting was lost between the initial condition recording in May 2004 and a following inspection in July 2004. The lesser architrave painting is completely lost.

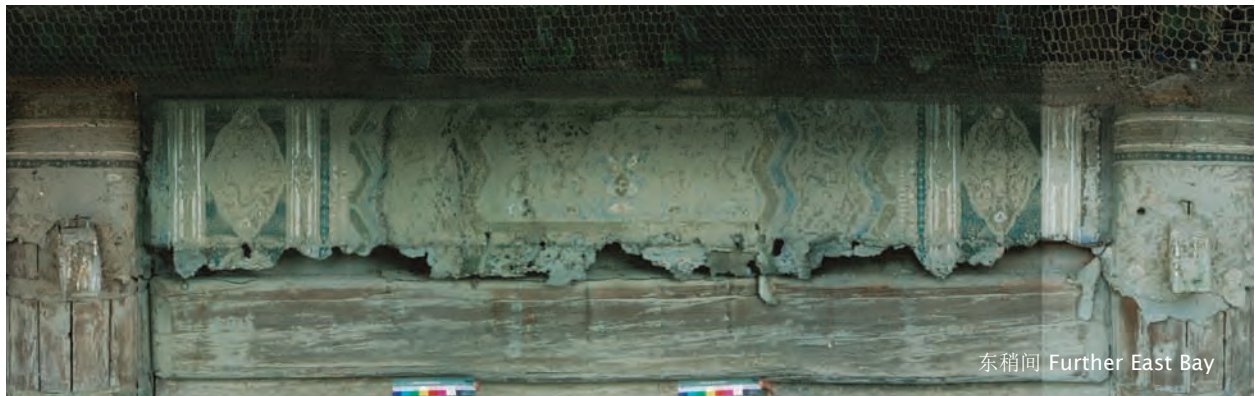
东稍间：大额枋彩画保存了下来，但下半部空鼓且呈悬挂下垂状态。小额枋彩画脱落。

Further East Bay: greater architrave painting survives but the bottom half is detached and hanging down. The lesser architrave decoration is lost.

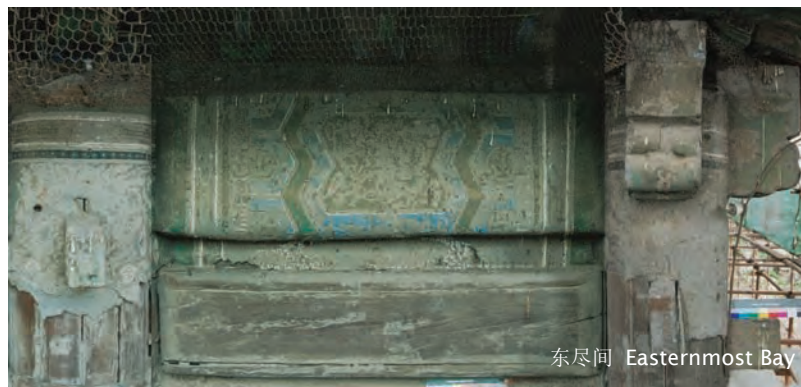
东尽间：大额枋保存状况较好，垫板上的彩画与木材结合良好。有一些鸟粪痕迹在大额枋上。小额枋彩画完全脱落。

Easternmost Bay: greater architrave painting is in good condition and is well attached to the cushion board between the architraves. There are bird droppings on the greater architrave painting. The lesser architrave decoration is completely lost.

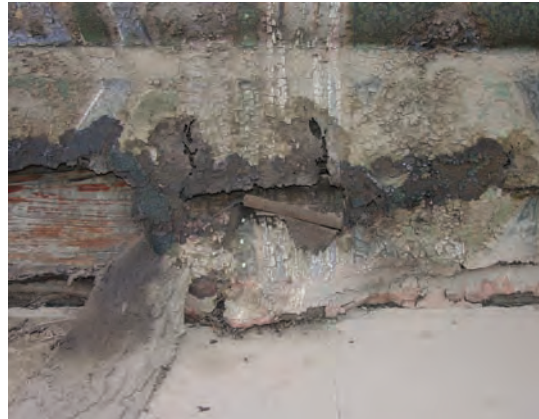
由于动物活动造成的彩画黑化及残损状态。

Blackening and deteriorated state of the paintings due to animal activity.

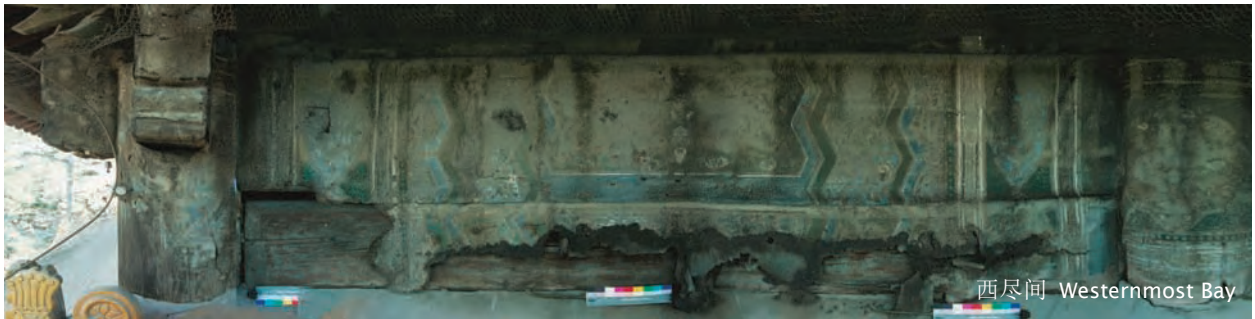
西尽间：大额枋上有严重的污迹。小额枋彩画底部脱落，空鼓，严重的动物活动带来黑色污迹。彩画风化严重。斗拱与挑檐檁上大量彩画脱落，仅小面积遗存（照片上看不到）。

Westernmost Bay: the greater architrave painting has severe staining. The lesser architrave painting is lost along the bottom edge, detached, and severely stained black with animal activity. The painting is very weathered. Painting on the purlin and brackets only survive in small areas (not visible in photograph).

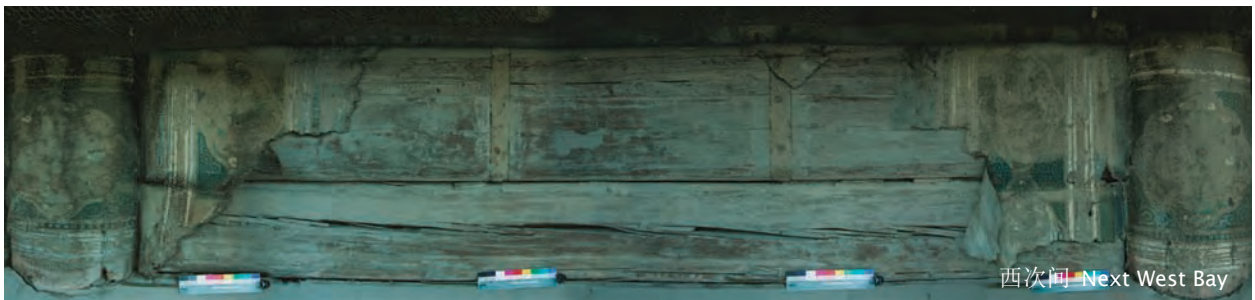
西次间：大、小额枋彩画几乎全部脱落（本间中部）。残存区域留有污迹，磨损并空鼓。挑檐檁被更换。几乎所有斗拱上的彩画都脱落了（照片上看不到）。

Next West Bay: both greater and lesser architrave painting is mostly lost (in the center of the bay). The surviving areas are stained, abraded, and detached. The purlin is replaced and almost all painting on brackets is gone (not visible in photograph).

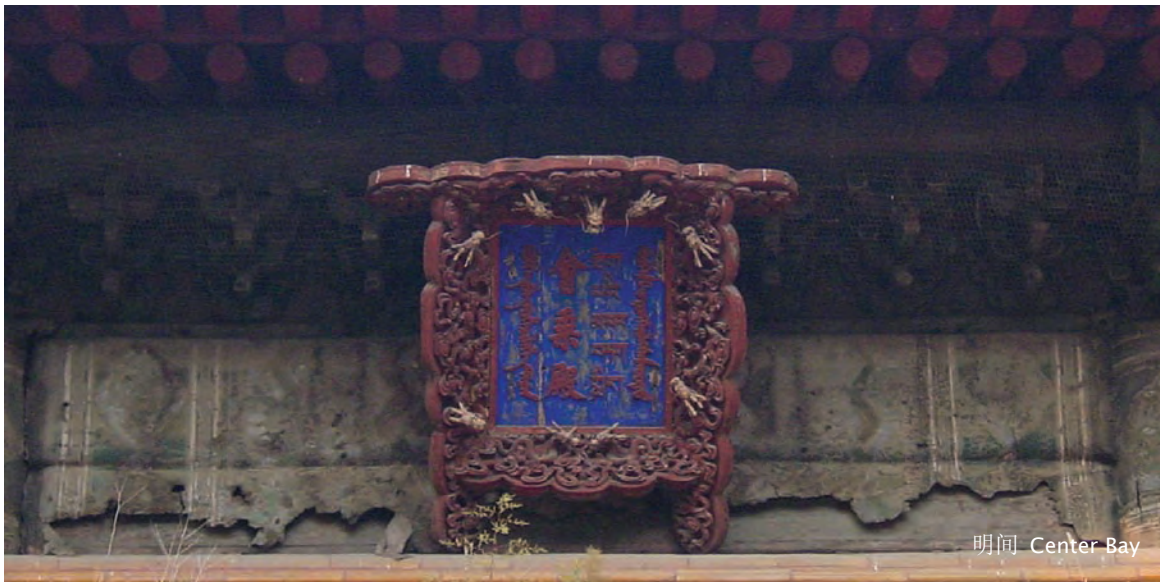
明间：大额枋彩画上有污迹及脏物。小额枋下半部彩画脱落，其余部分有空鼓。几乎所有在斗拱及檩上的彩画都脱落了（照片上看不到）。
Center Bay: greater architrave painting is stained and dirty. The lesser architrave painting is detached and the lower half is lost. Almost all painting is gone on the purlin and brackets (not visible in photograph).

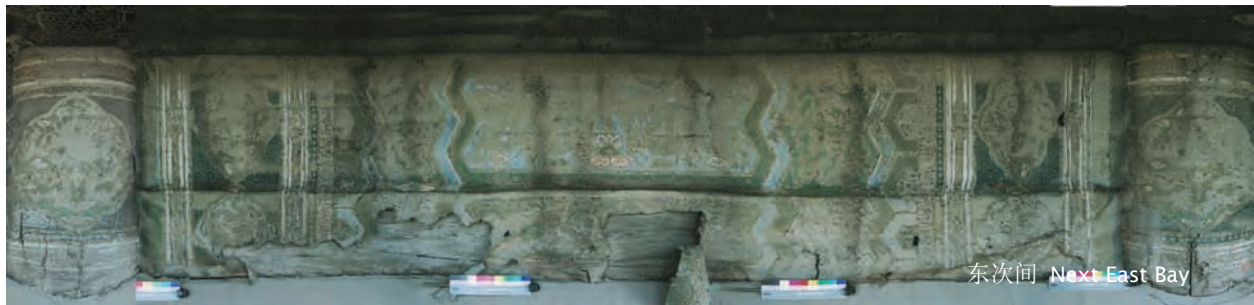
东次间：大额枋彩画除污迹及表面风化外，以稳定状态完整的保存了下来。小额枋彩画部分脱落，风化，空鼓，并且凸出来。东侧挑尖梁头彩画空鼓，呈悬挂下垂状态（照片上看不到）。

Next East Bay: greater architrave painting, despite staining and surface weathering, survives intact with areas of stable condition. The lesser architrave painting has losses, is weathered, and is detached and bulging in areas. The eastern *tiaojianliang tou* painting is detached and hanging off (not visible in photograph).

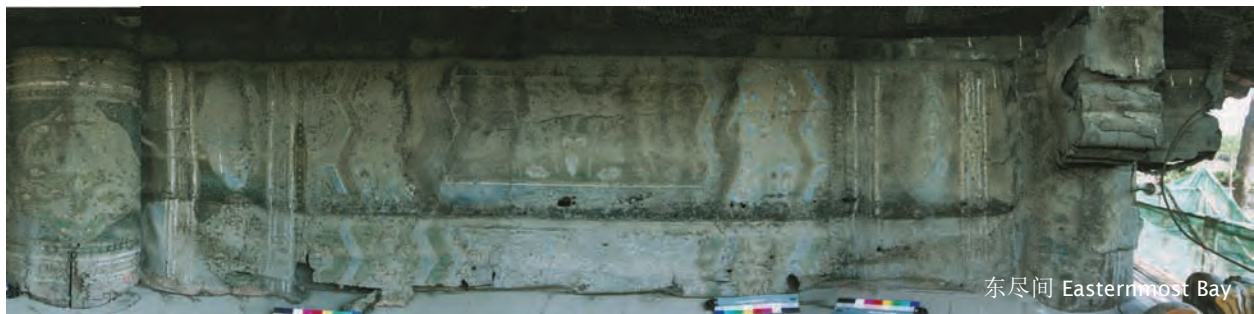
东尽间：大额枋上彩画有污迹一较大水平裂缝，底部空鼓。小额枋彩画完全空鼓，底部局部脱落并凸出来。

Easternmost Bay: the greater architrave painting has staining, a big horizontal crack, and is detached at the bottom. The lesser architrave painting is completely detached and bulging with some small losses at the base.

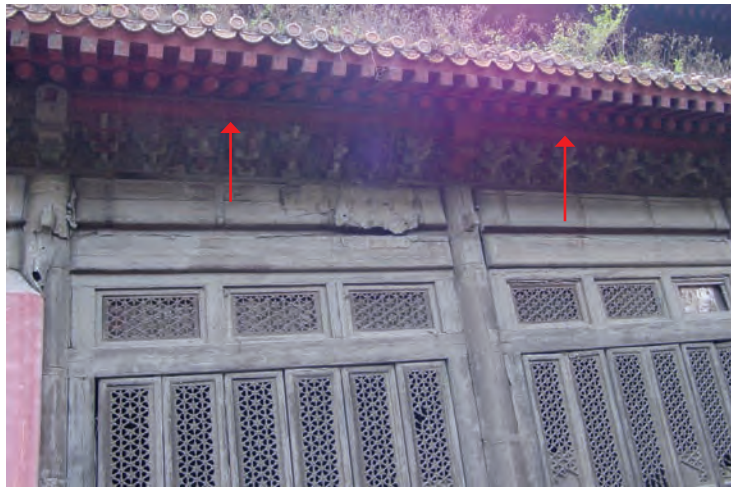
东次间与明间上已经更换过的檩子与斗拱。经过替换的挑檐檩。

Replaced purlins and bracket pieces on next east and center bays.

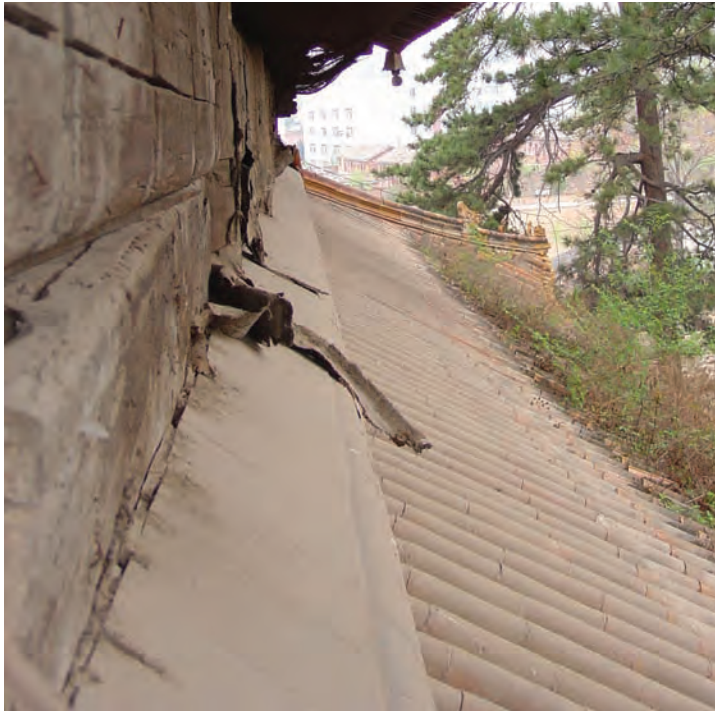
掉在下檐屋顶上的一大片脱落的彩画。
Large pieces of fallen painting on lower eave.

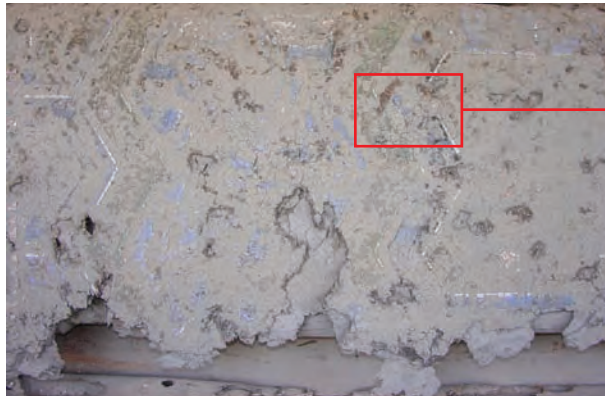
风化程度较严重的彩画区域。请注意表层地仗的小面积缺失暴露出了下部地仗层。

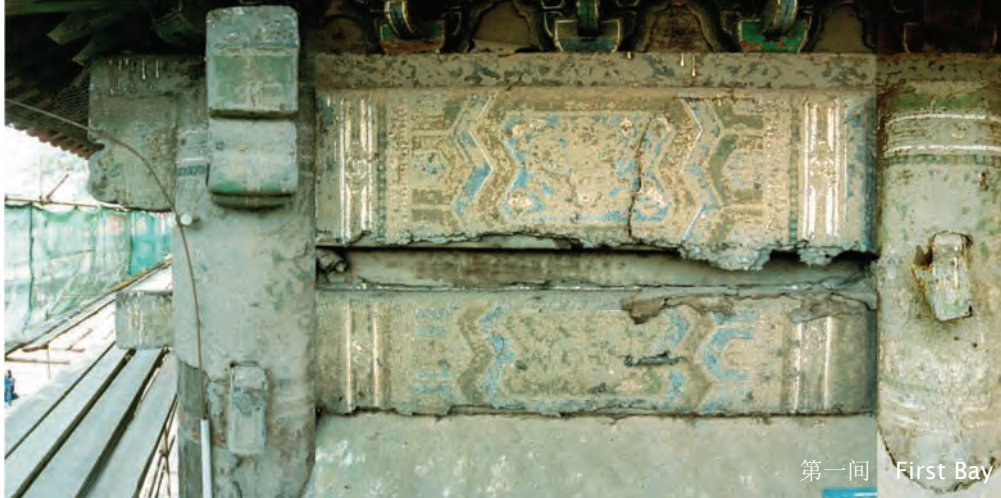
第一间：大额枋上彩画裂开且翘起，垫拱板上彩画已脱落。

First Bay: the greater architrave painting is split and lifting. The painting on the cushion board is lost.

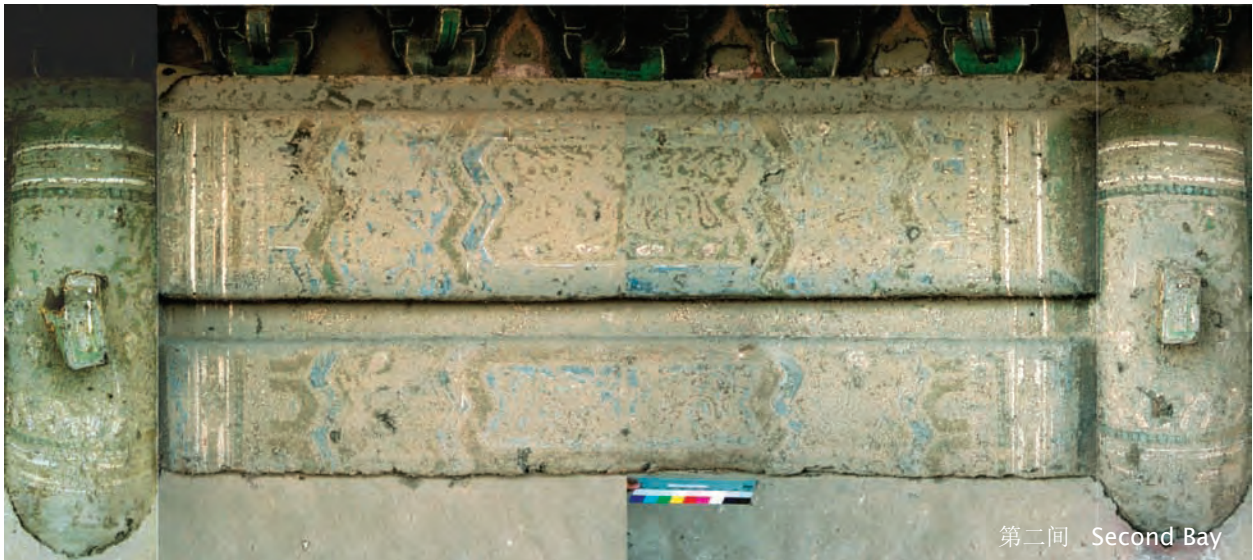
第二间：大、小额枋上彩画保存状况较好。斗拱的垫拱板有两处三宝珠的装饰脱落。

Second Bay: the painting on the architraves survive in good condition. Two areas of the fire and three pearl decoration on the bracket-arm cushion board are lost.

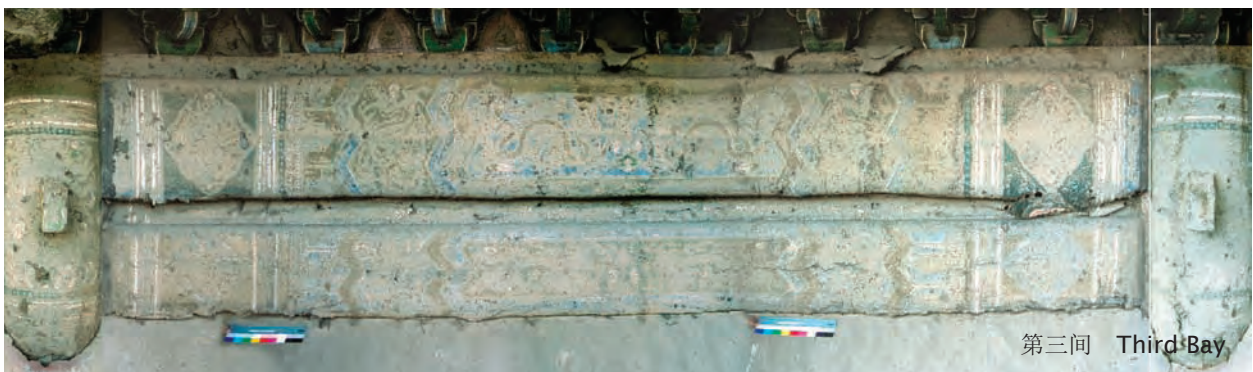
第三间：除北端一小部分外整体彩画贴附状况好，6块垫拱板上的三宝珠彩画装饰已脱落或脱落中。

Third Bay: the painting remains well attached in all areas except for a small area on the northern end. Six areas of the fire and three pearl decoration on the bracket-arm cushion board are lost or falling off.

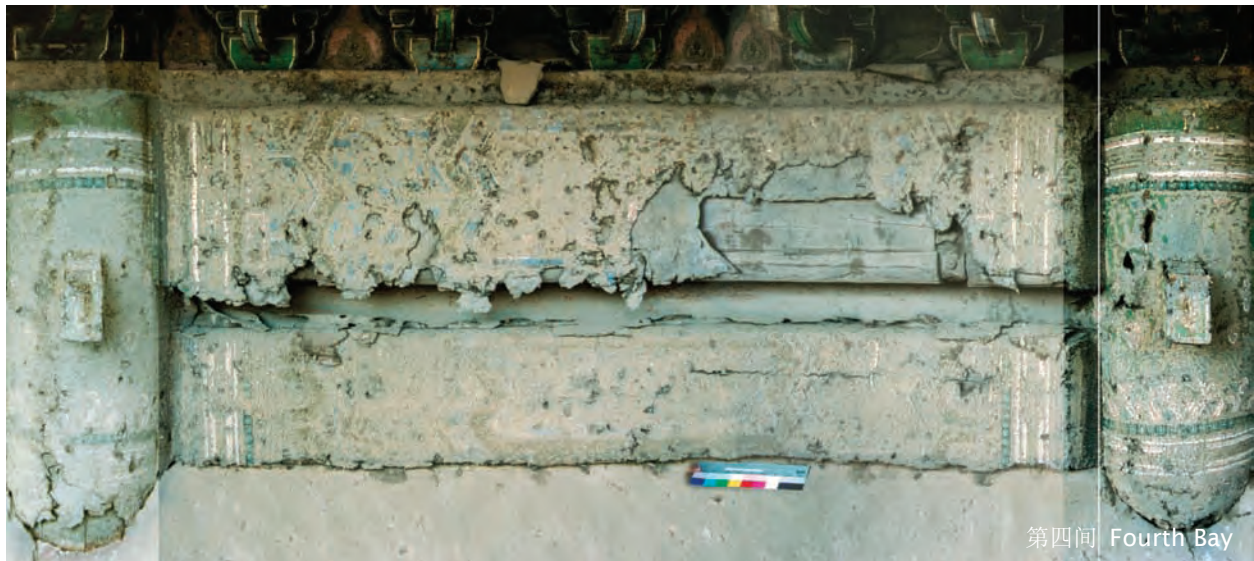
第四间：大额枋上有部分彩画完全脱落，并有部分上层地仗缺失。遗存彩画残损严重。垫板彩画脱落，掉在小额枋上面。小额枋彩画上存在水平裂缝。部分挑檐檩及3处垫拱板上的三宝珠装饰彩画脱落。

Fourth Bay: there is an area of complete loss in the greater architrave painting and also areas of loss of the upper plaster layer. Surviving painting is very deteriorated. Painting on the cushion board between the architraves has detached and now rests on the lesser architrave. The lesser architrave painting has a horizontal crack, Part of the purlin (not visible in photograph) and three areas of the fire and three pearl decoration on the bracket-arm cushion board are lost.

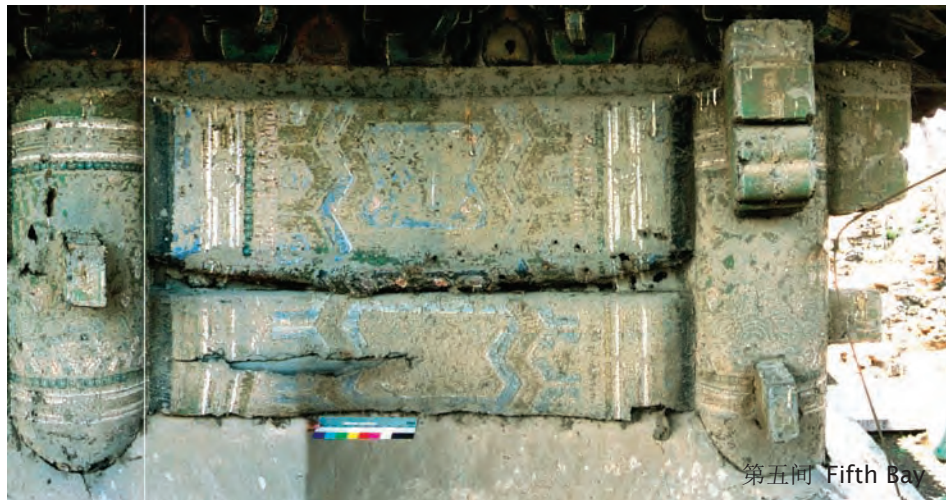
第五间：大额枋下部彩画空鼓。小额枋彩画水平开裂且伴有空鼓。

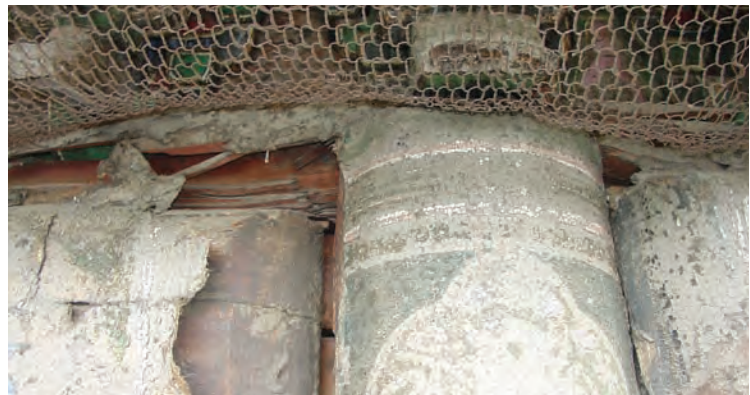
平板枋的开裂导致了第二间及第三间之间的彩画脱落。

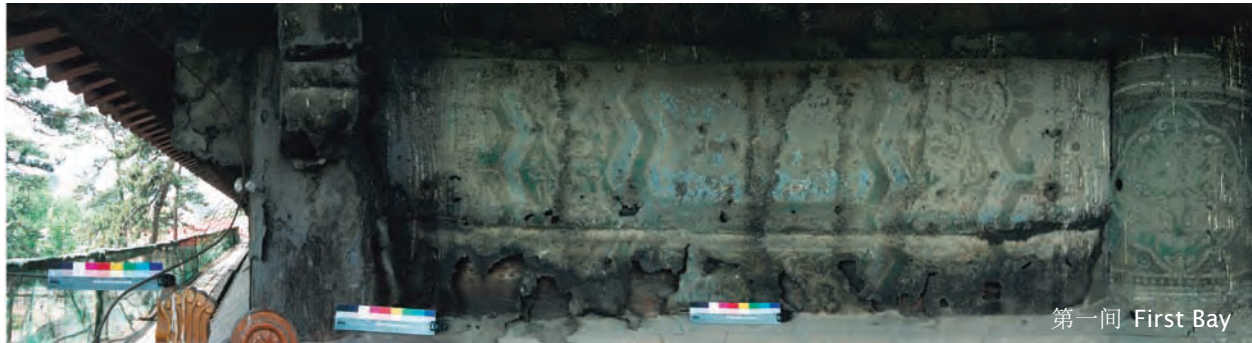
第一间：大额枋彩画有深色污迹且磨损。彩画空鼓，凸起，脏，且有动物活动痕迹。小额枋残损严重，有脱落并由于动物活动造成黑化。

First Bay: the greater architrave painting has dark staining and is abraded. The painting is detached, bulging, and dirty, and there is evidence of animal activity. The lesser architrave is extremely deteriorated with losses and blackening due to animal activity.

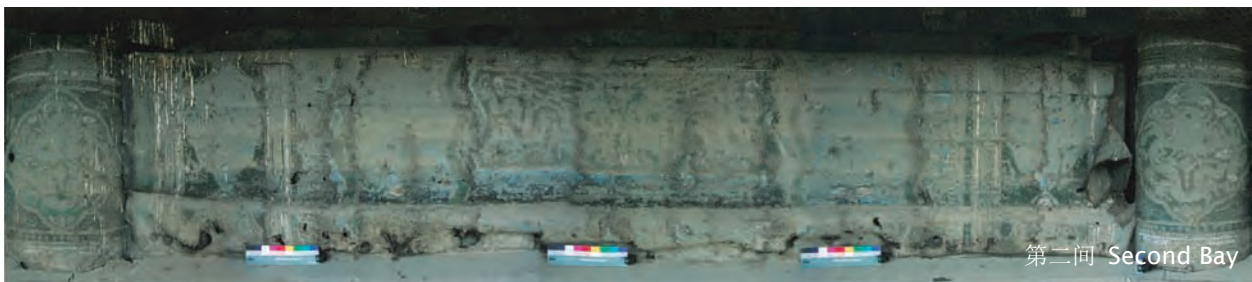
第二间：大额枋彩画南端有大量的鸟类排泄物；可以看见一些裂缝且彩画脏，风化，底部空鼓；北尽端局部彩画剥离且下垂。小额枋彩画底部空鼓残损，有动物活动的痕迹。

Second Bay: greater architrave painting has significant amounts of bird droppings on the southern end. Some cracks are visible and the painting is dirty, weathered and the bottom half is detached. Pieces of painting at the far northern end are detached and falling off. The lesser architrave painting shows signs of animal activity at the base where the painting is detached and deteriorated.

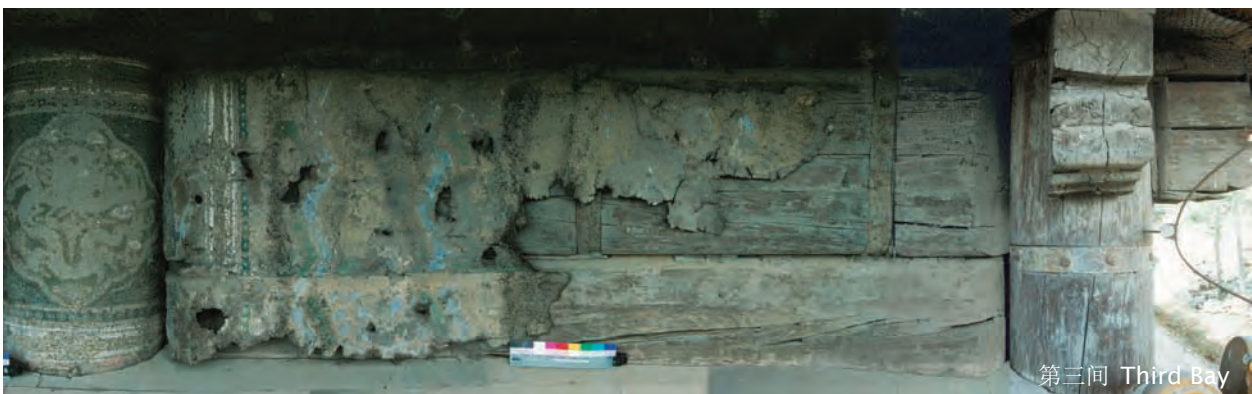
第三间：大额枋彩画北半部严重风化并有大面积脱落。残存的彩画很脏并用钉子固定在额枋上。小额枋彩画完全空鼓。挑檐檩及5个斗拱构件经过更换并漆成红色（照片中看不到）。

Third Bay: greater architrave painting is very weathered with large losses on the northernmost half. Surviving areas of painting are dirty and fastened to the wood beam with nails. The lesser architrave painting is completely detached. The purlin and five bracket pieces in this bay have been replaced (not visible in photograph).

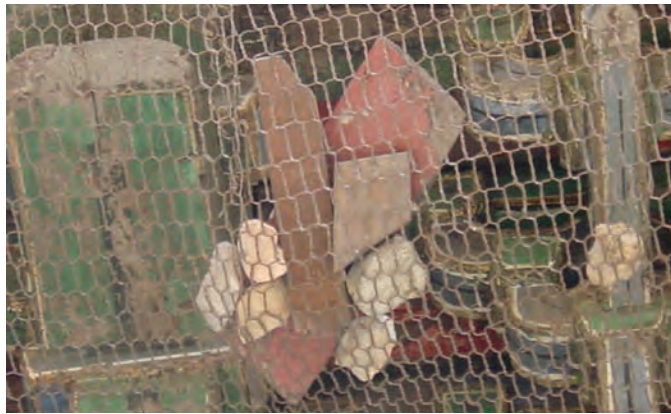
在鸟网中经常可见斗拱构件，（包括脱落的彩画）及从垫拱板与檩子脱落的彩画。

Pieces of bracket sets and fallen pieces of painting from the purlin and cushion board between the brackets are often found caught in the bird netting.

It is recommended that this netting be replaced with netting that does not obscure the paintings and which prevents birds from nesting in the roof.

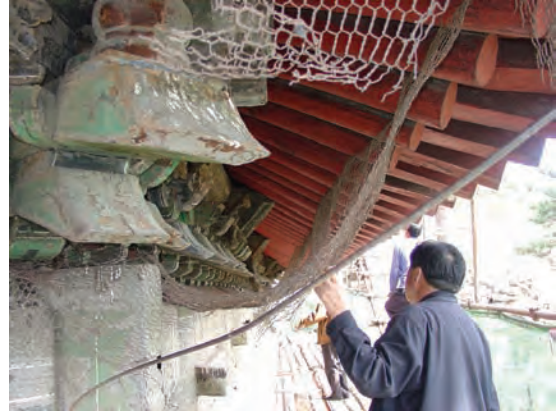
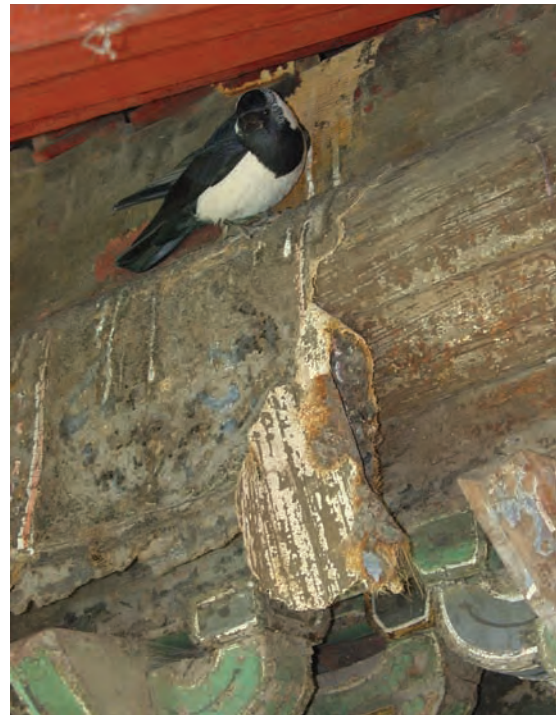
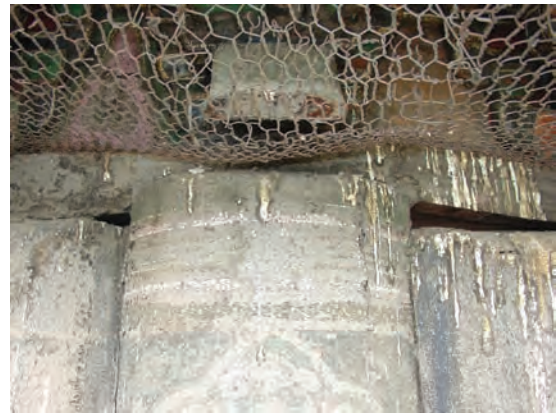
东立面上檐第二间有大量的鸟粪。

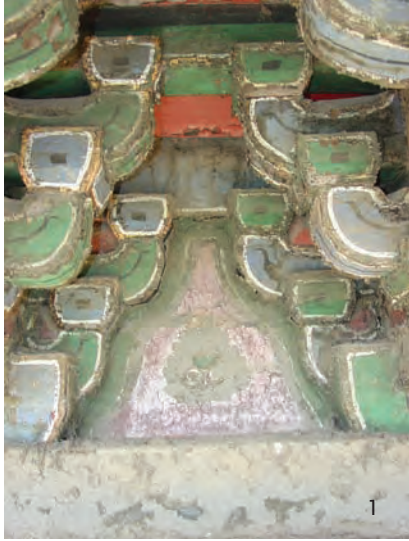
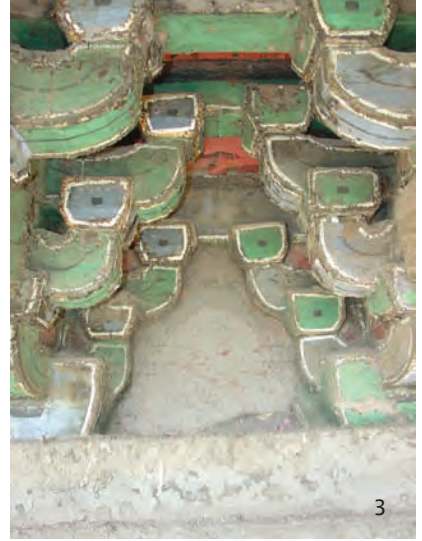
斗拱之间（垫拱板上）的三宝珠装饰，图中可见其彩画(1) 遗存(2)，剥落及(3) 完全缺失的状况。

The "fire and three pearl motif" decoration on the area between the brackets, known as the bracket-arm cushion board shown with surviving painting (1), painting detached (2) and complete loss (3).

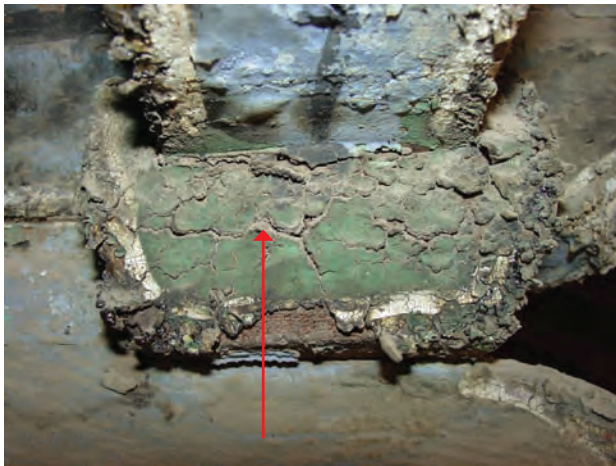
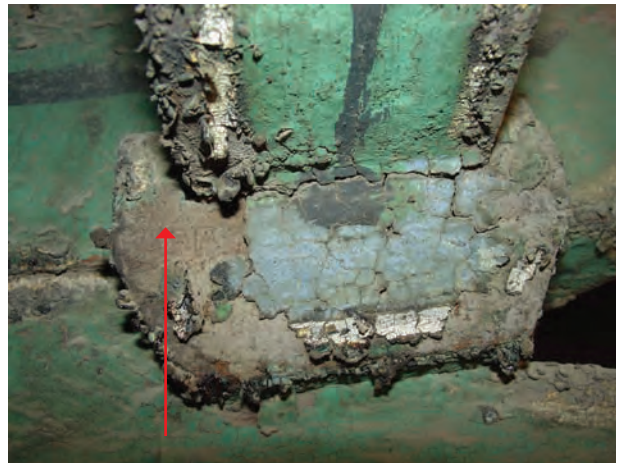
彩绘层裂缝和起泡，导致彩绘层的脱落。

Cracking and blistering of the paint layer leading to losses.

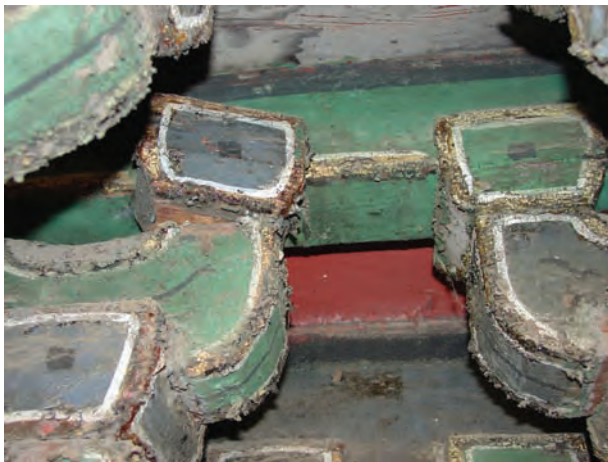
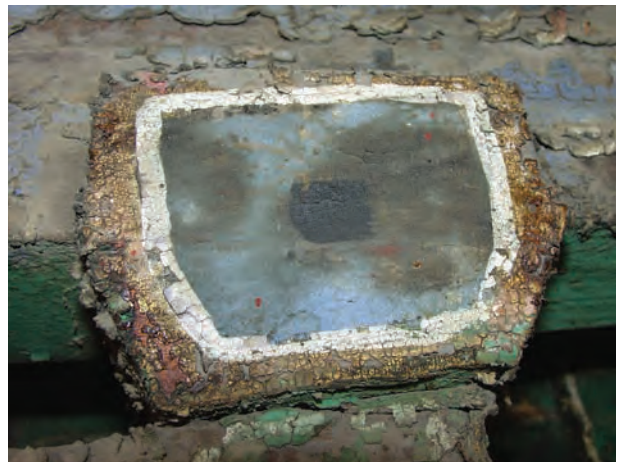
斗拱金边残损。

The gilded borders on the brackets are deteriorating.

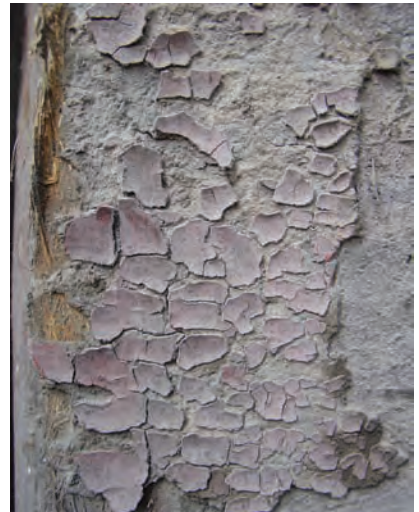
保留下来的油饰普遍有开裂和起甲的现象。

The surviving areas of paint are often cracked and flaking.

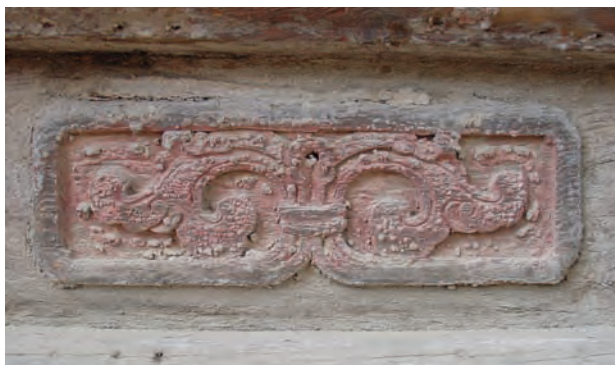
室外门板上的装饰。注意红漆凹凸不平的表面，而造成这种现象的成因不知。

Decoration on an exterior door panel. Note the bumpy surface of the red paint. The cause of this surface phenomenon is unknown.

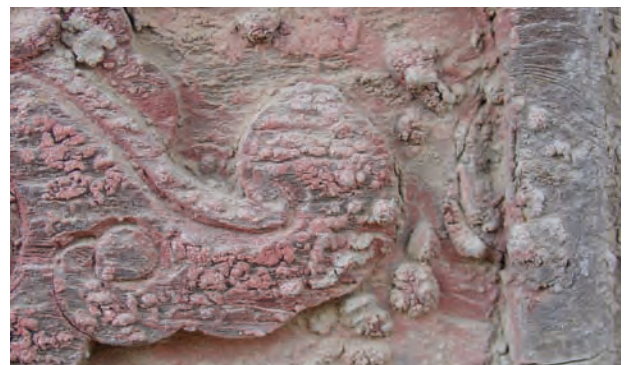
门板装饰细节和近看红漆不平滑表面。
