研究与测试 Research and Testing

实施保护措施 Treatment Implementation

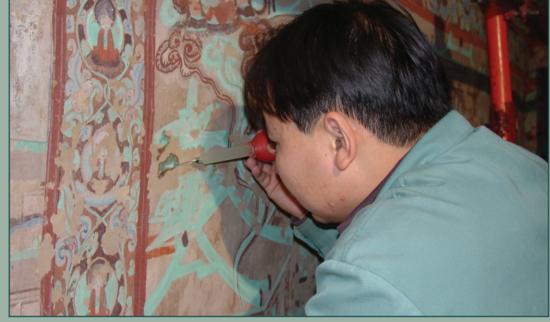
用注射器将浓度1-2%的明胶溶液注入起甲的壁画层,使之重新粘结。 Flaking paint was readhered with a 1-2% gelatin solution injected

with a syringe.

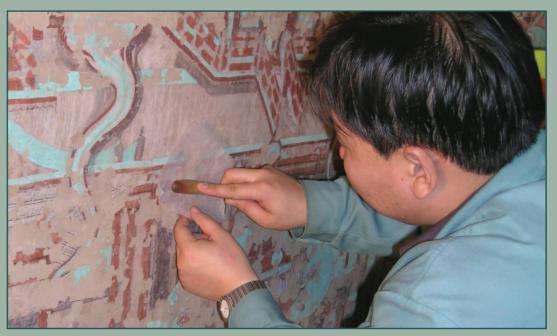
使用木质工具(图示)或丝绸包裹的软球体轻柔地将起甲的壁画压回原位。

The paint flakes were then gently pressed back into place using a wooden tool (shown) or a soft silk covered ball.

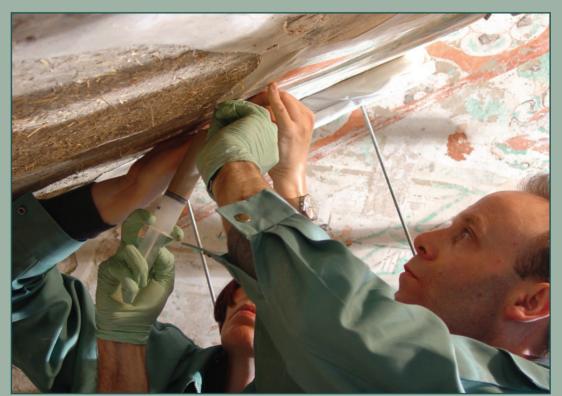
对整窟大面积的壁画层进行了灌浆处理。 Large areas of painted plaster were injected with the grout mixture throughout the cave.

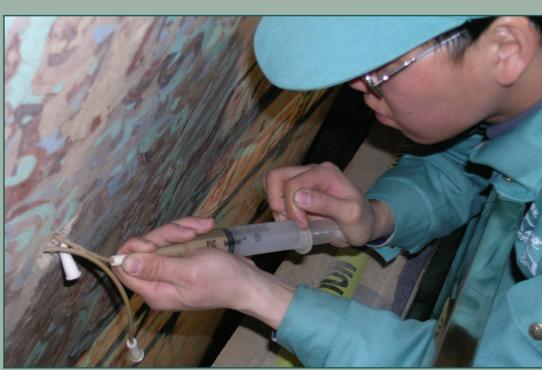
使用注射器和导管在壁画层后进行灌浆处理。 Injection of the grout mixture behind the painted plaster was done using syringes and catheter tubes.

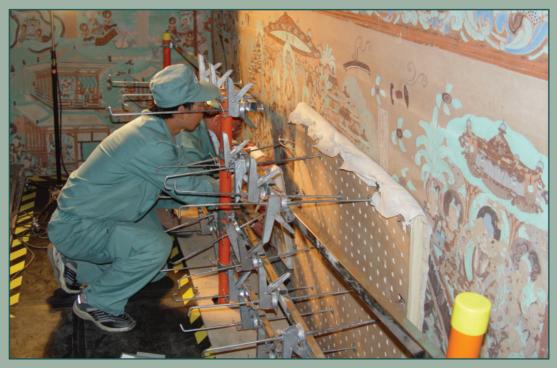
在灌浆之后,立即用有吸水能力的顶板顶住壁画一直到灌浆材 料干燥为止。这一关键步骤减低了含水灌浆材料所造成的可溶 盐运移并且避免盐分在壁画表面结晶。

Immediately after grouting an absorbent press was applied and kept in place as the grout dried. This key step reduced soluble salts mobilized by water in the grout which would crystallize on the surface of the wall painting.

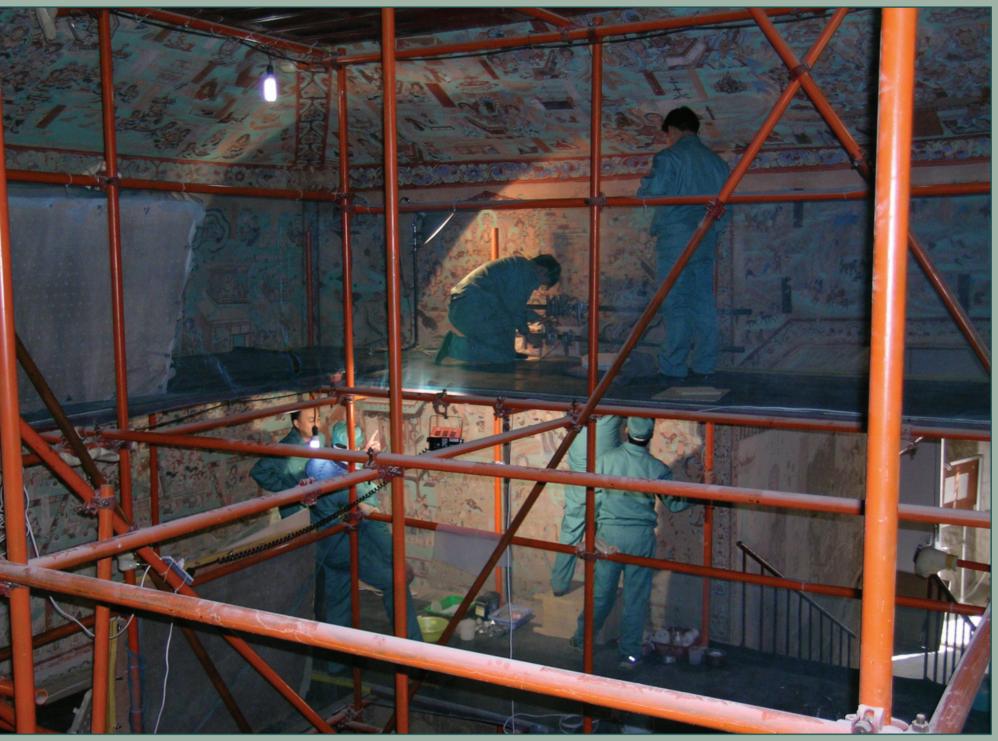
正在主室东壁进行保护工作。 Conservation work in progress on the east wall of the main chamber.

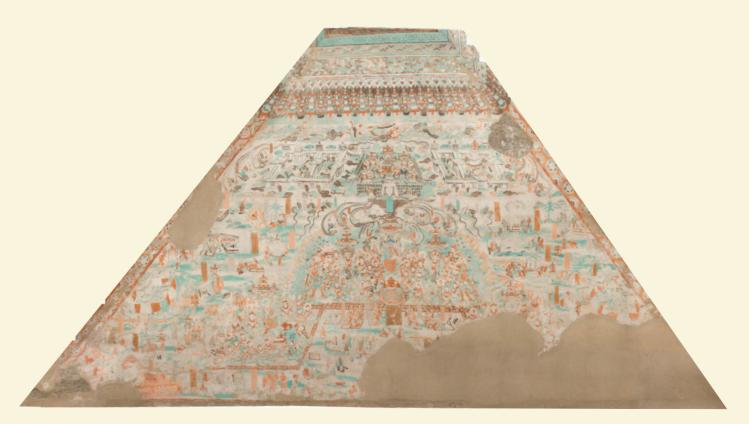
治理后的窟顶西披。没有对脱落的区域重绘,最小限度地添加新的地仗泥层,以避免人为增加水分 (来自潮湿的地 仗层),因为水分会造成可溶盐在壁画层内运移。保留了早期保护工作中对地仗层的修复区域以及近年来因壁画脱落 使砾岩裸露的区域(如1996年脱落的区域)。

The west ceiling slope after conservation treatment. Areas of loss were not repainted and new plastering was kept to a minimum in order to avoid the addition of water (from the wet plaster) which could redistribute soluble salts within the painted plaster. Instead, plaster repairs from earlier conservation work were left in place and recent areas of loss (such as the area of collapse from 1996) were left unfilled with the conglomerate exposed.
