Survey of Damage to Historic Adobe Buildings After the January 1994 Northridge Earthquake

E. Leroy Tolles
Frederick A. Webster
Anthony Crosby
Edna E. Kimbro

GCI Scientific Program Report 1996

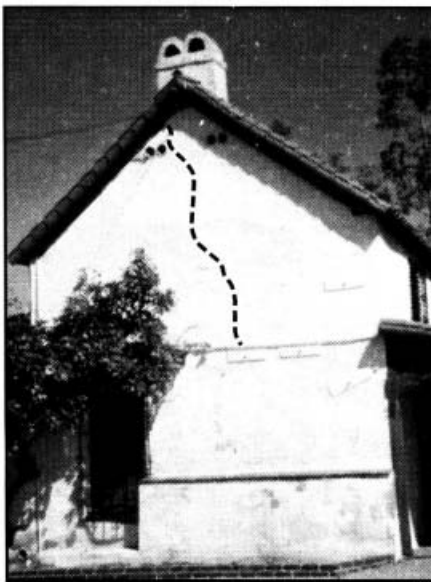
Figure 3.4. *Andres Pico Adobe. Gable-end wall in 1991 before the Northridge earthquake. Preexisting cracks are indicated by dotted line.*

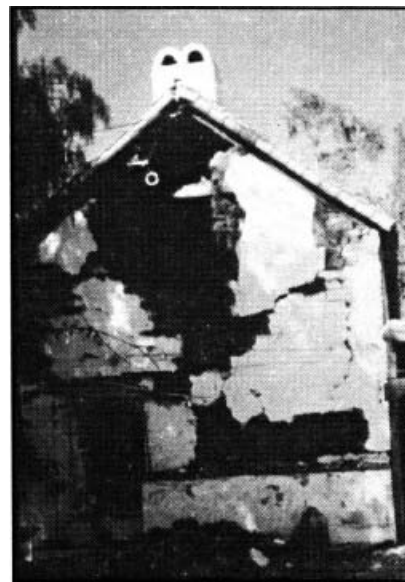
Figure 3.5. *Andres Pico Adobe. Gable-end wall after the Northridge earthquake.*

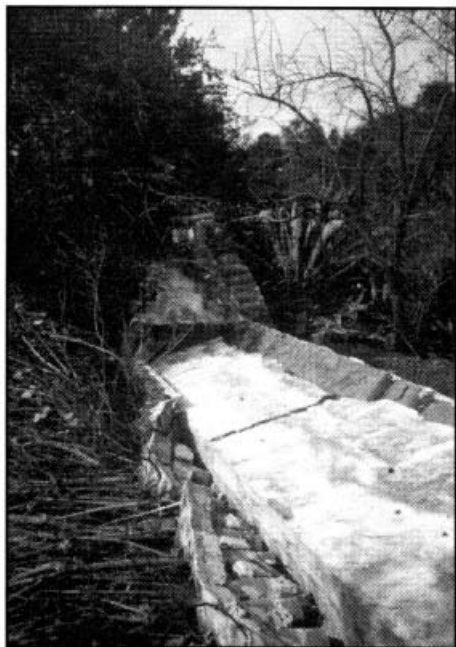
Freestanding walls are the most vulnerable to overturning. Freestanding walls have no horizontal support along their length such as that provided by cross walls or roof or floor systems. Garden walls are examples of freestanding walls susceptible to overturning. Intersecting walls will improve the stability of freestanding walls. A garden wall on the north side of the convento at the San Fernando Mission collapsed (Figure 3.7). This wall was made with stabilized adobe bricks and had a slenderness ratio of 5.

Figure 3.7. Overturning collapse of garden wall outside of the convento at Mission San Fernando ($S_L=5$).

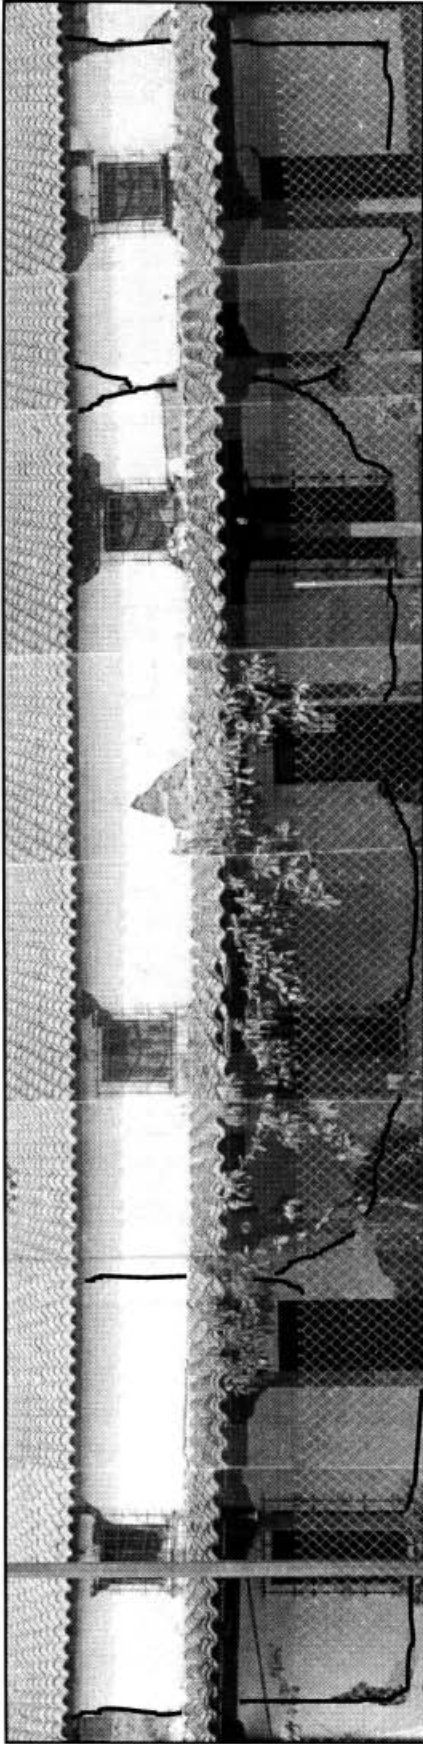
Figure 3.8. Andres Pico Adobe. Cracks caused by out-of-plane flexure are highlighted by darkened lines.

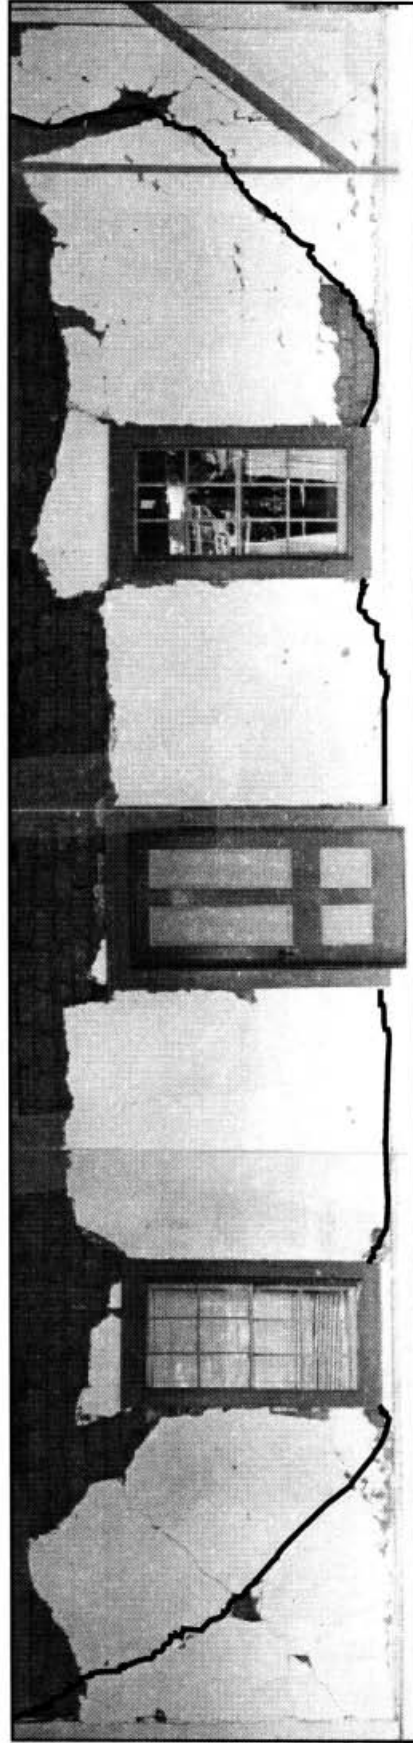
Figure 3.9. Leonis Adobe. Cracks caused by out-of-plane flexure are highlighted by darkened lines.

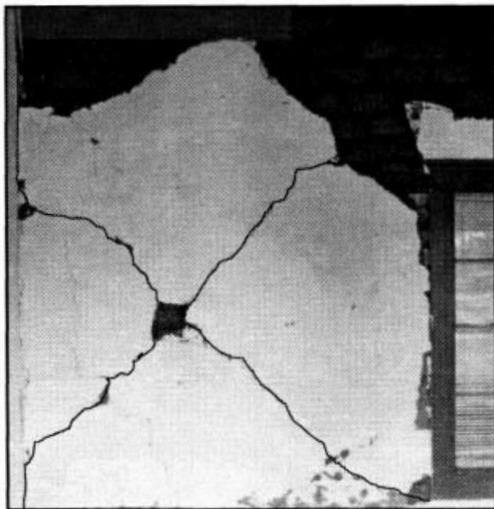
Figure 3.12. *Leonis Adobe. Shear cracking in typical X-pattern (cracks highlighted).*

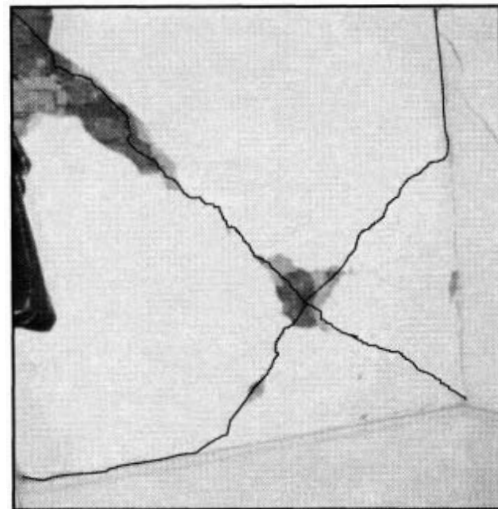
Figure 3.13. *De la Osa Adobe. Shear cracking in typical X-pattern (cracks highlighted).*

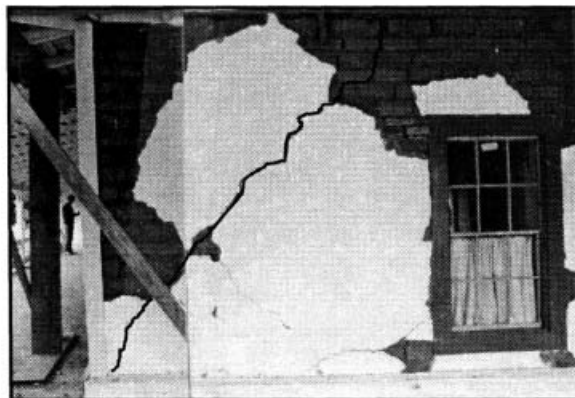
Figure 3.16. Leonis Adobe. Diagonal crack at the southeast corner on the second floor (crack highlighted).

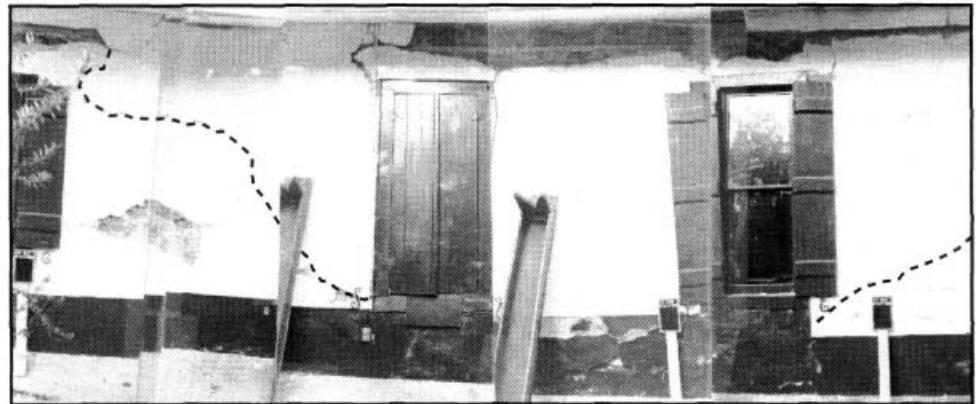
At the south end of this long west wall is a stone-masonry bathroom addition that extends out toward the west. There is a separation gap at the intersection of the stone wall with the long adobe wall. Little damage was observed in the stone-masonry walls. However, an old vertical crack does exist at the interface between the west-facing stone wall and the adjacent west-facing adobe wall of the southwest corner bedroom.

Figure 4.3. West wall of west wing. Flexural crack extends from upper left diagonally to the base of the wall and along base (dotted line along crack).

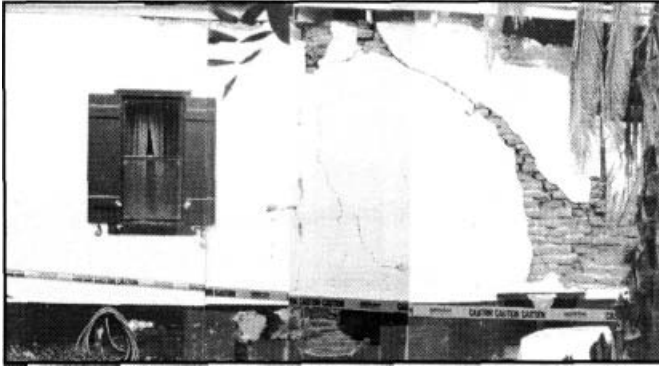
The west wall of the bedroom has a severe diagonal crack that runs from the rafter level at the northwest corner of the room down and across to the southwest corner, through the window at the sill level (Figure 4.5). The in-plane horizontal offset of this crack is approximately 2 inches. This wall also had out-of-plane flexural damage as evidenced by a vertical crack at the northwest corner that transitions into a horizontal crack at the base.

Figure 4.5. *Exterior elevation of the west wall of the bedroom at the southwest corner of the residence. The diagonal crack is a shear crack with a permanent offset of approximately 2 inches.*

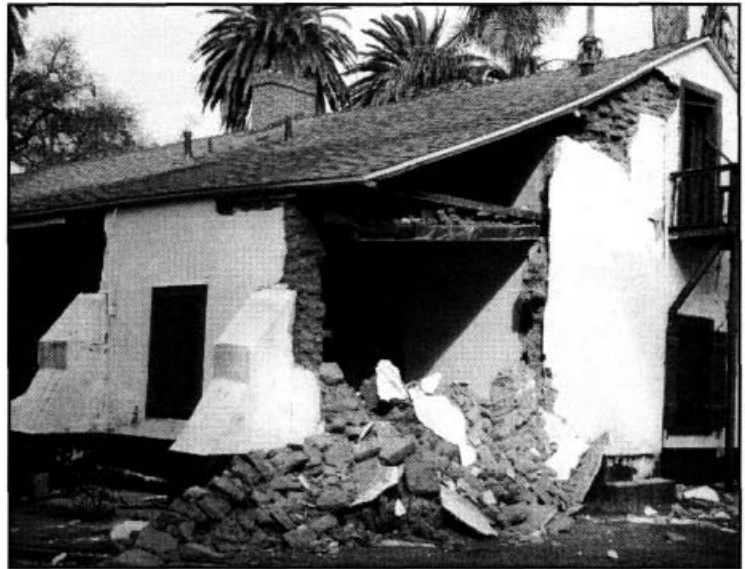
Figure 4.9. *Southeast corner of Ramona's room. The buttresses on the south wall prevented collapse of that wall. The east wall of Ramona's room collapsed during the earthquake. The gable-end wall did not collapse but suffered serious damage (more details are shown in Figure 4.10).*

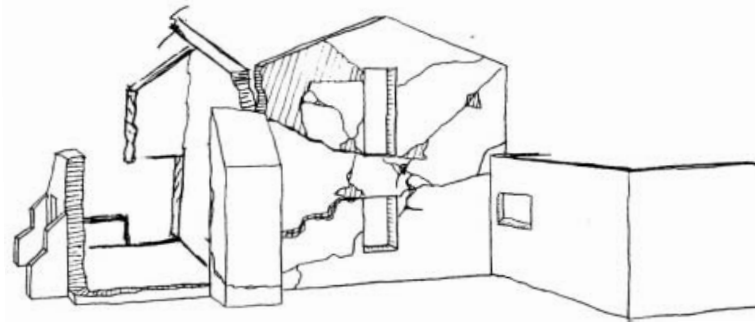
Figure 4.11. Drawing of damaged gable-end wall on the east end of the south wing.

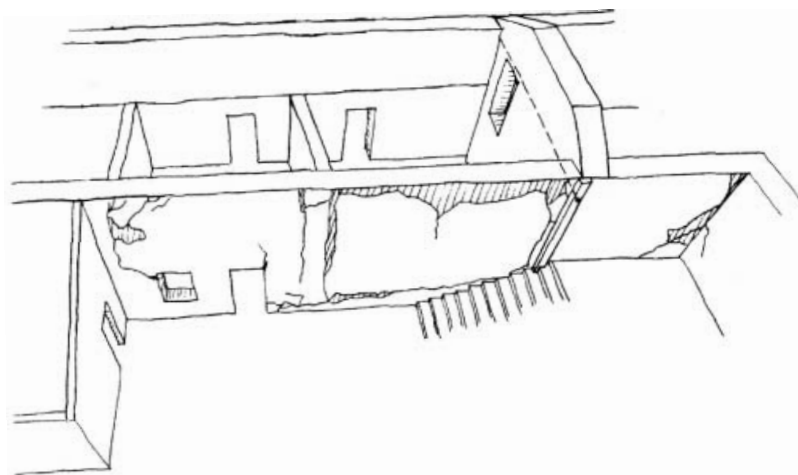
Figure 4.12. Drawing of damage to the north wall of the south wing, similar to that shown in Figure 4.13.

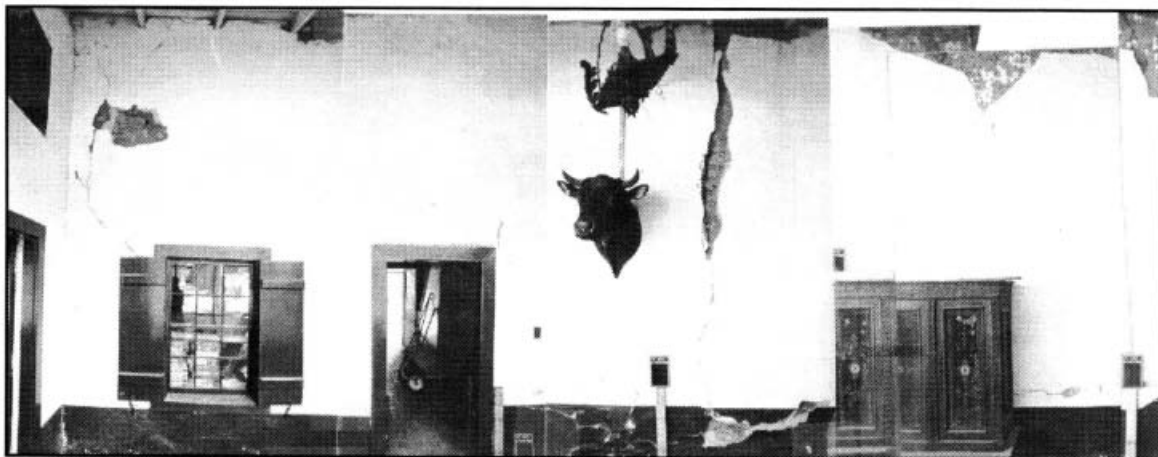
Figure 4.13. *North wall of the south wing. This photograph shows the flexural cracking that has developed vertically at perpendicular walls and along the base of the wall between perpendicular walls. Despite the cracking, the wall is only slightly out of plumb.*

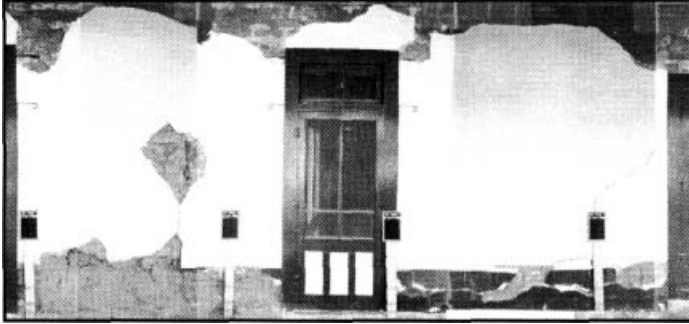
Figure 4.16. *East wall of west wing. Flexural crack extends from upper left diagonally to the base of the wall and along the base.*

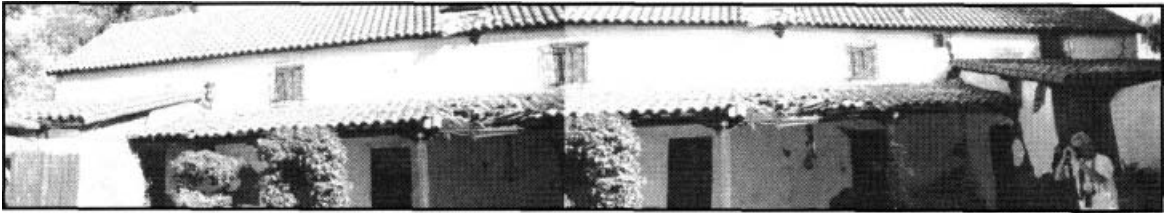
Figure 5.4. West elevation. The chimney collapsed and fell through the porch roof. There is damage to the west wall at the reentrant corners where the lower roofs intersect the west wall.

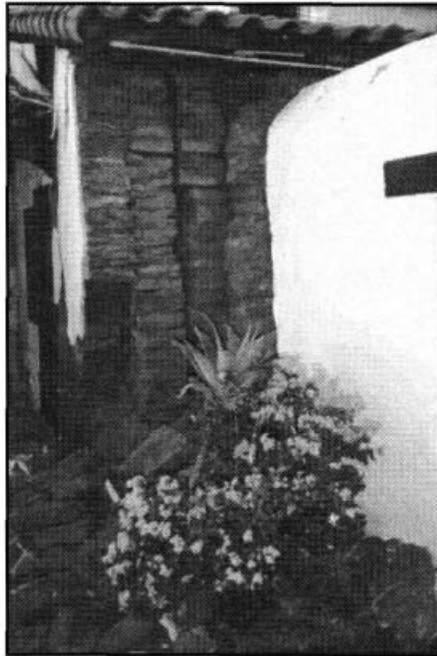
Figure 5.5. Northwest corner of the kitchen. The layout of the bricks in this area was partially responsible for the collapse at this location. At first glance, it appears that the wall is 3 wythes wide, but the wall on the left of the photograph is only 2 wythes wide. The third wythe is a connecting section between the two walls.

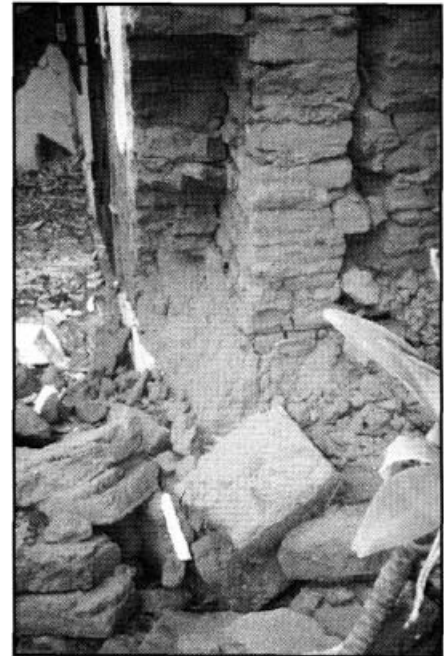
Figure 5.6. Detail at the base of the northwest corner of the kitchen shown in Figure 5.5. Previous moisture intrusion reduced the strength of the adobe, which developed a slip plane along which the outer section of the wall collapsed.

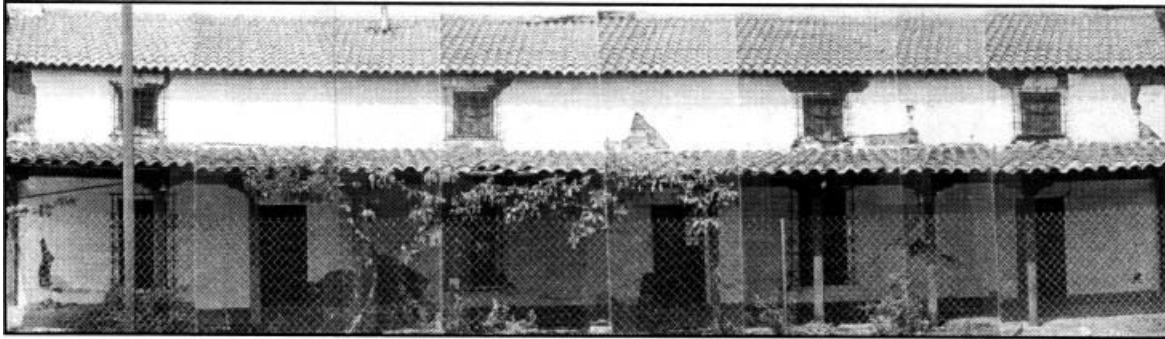
Figure 5.7. East elevation. The damage to the east wall was largely defined by out-of-plane flexure of the walls. Cracks developed vertically at the end walls at the two interior cross walls (cracks highlighted in Figure 3.8).

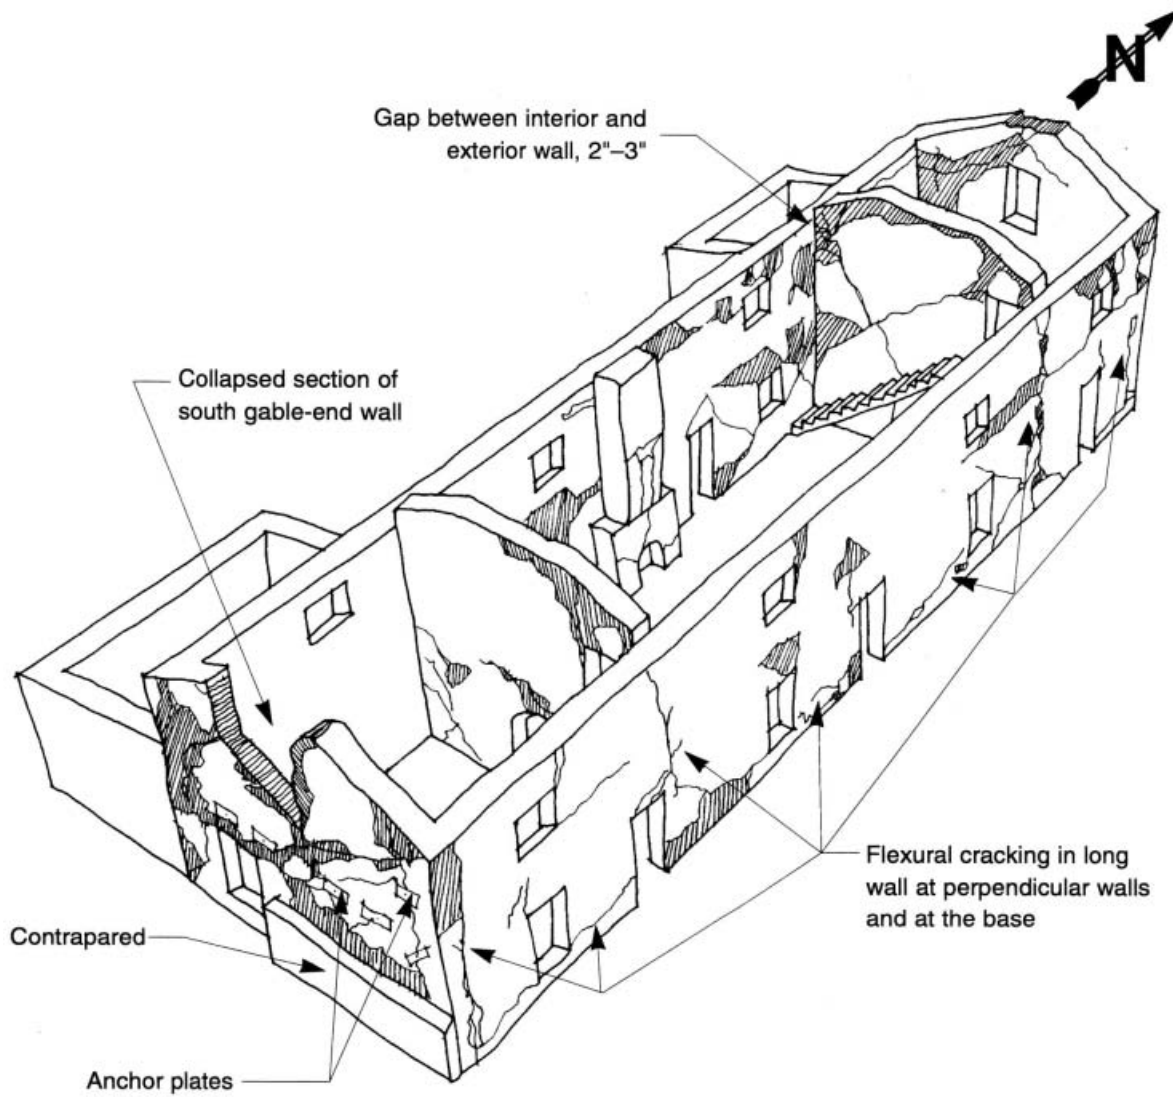
Figure 5.8. Drawing of damage to the Andres Pico Adobe from the southwest corner after the 1994 Northridge earthquake.

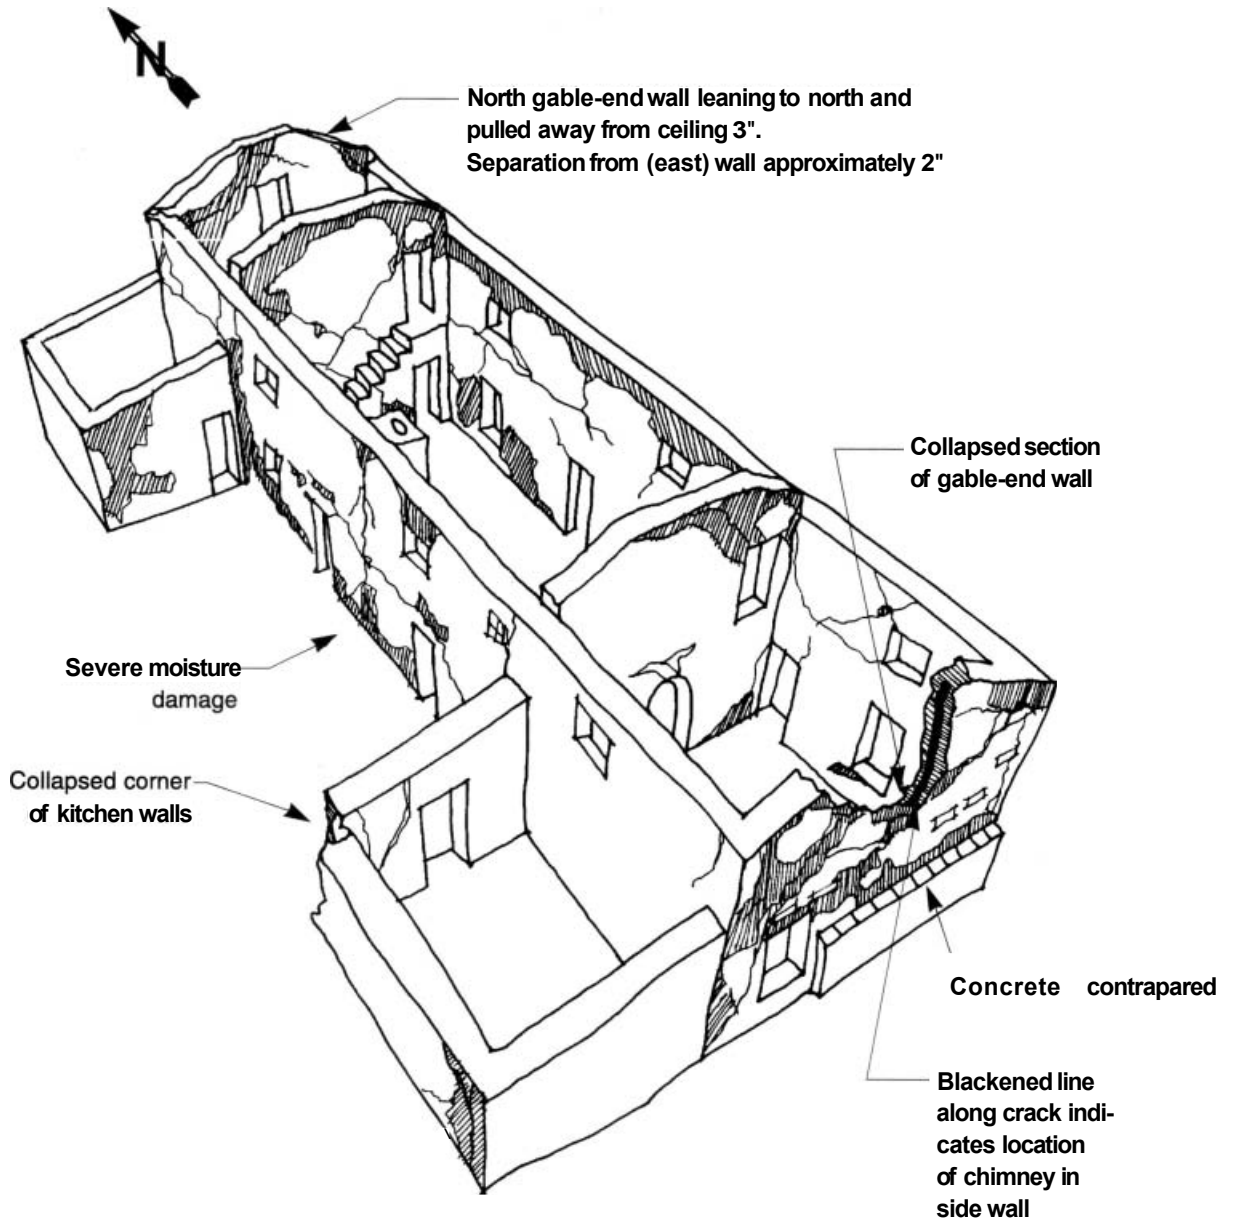
Figure 5.9. Drawing of damage to the Andres Pico Adobe from the southeast corner after the 1994 Northridge earthquake.

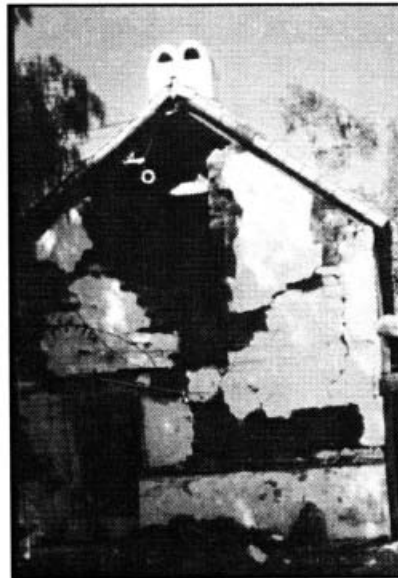
Figure 5.11. *Andres Pico Adobe. Gable-end wall after the Northridge earthquake.*

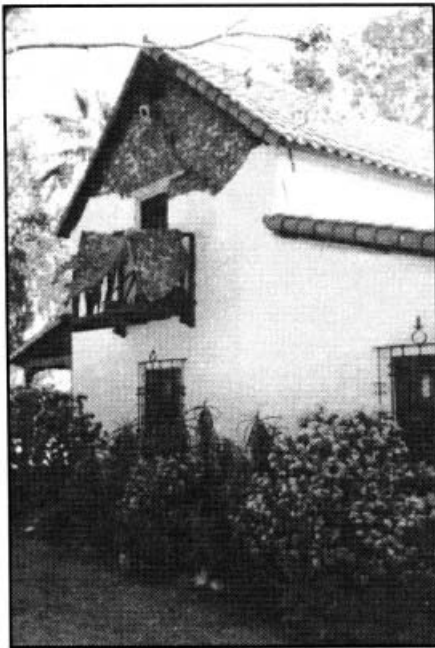
Figure 5.12. *North gable-end wall. The north gable wall suffered some damage but not as severe as the south end. A large diagonal crack extends from the peak of the gable down to the intersection with the lower roof on the right in the photograph. A large section of the plaster fell and damaged the balcony*

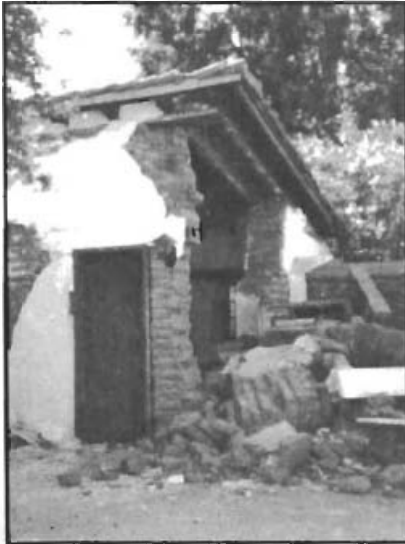
Figure 5.13. *Collapsed section of garage in the southwest corner of the courtyard.*

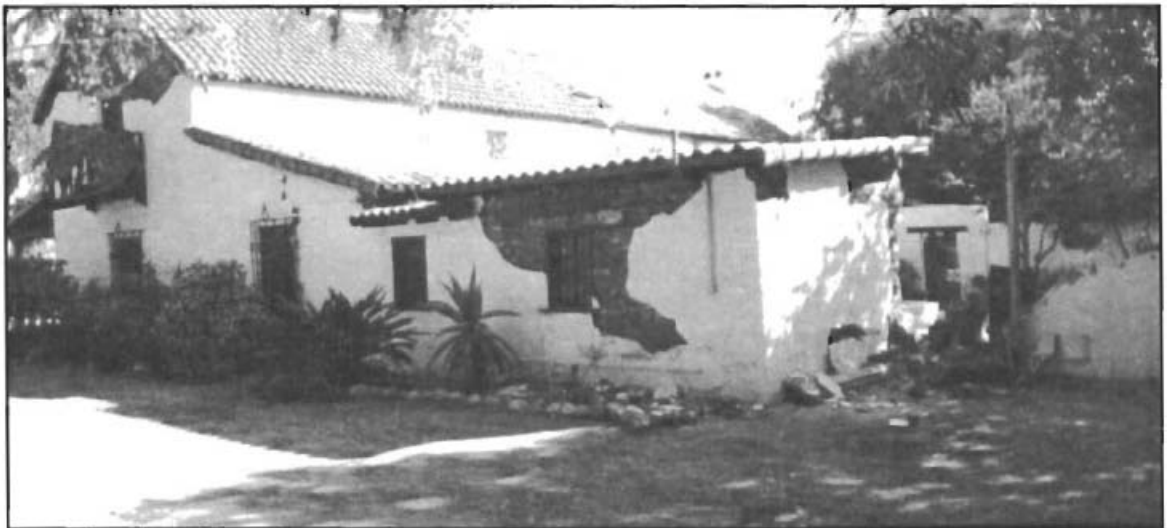
Figure 5.14. *Collapsed garden wall on the north side of the courtyard, plaster damage along the north wall, and damage to the north gable-end wall.*

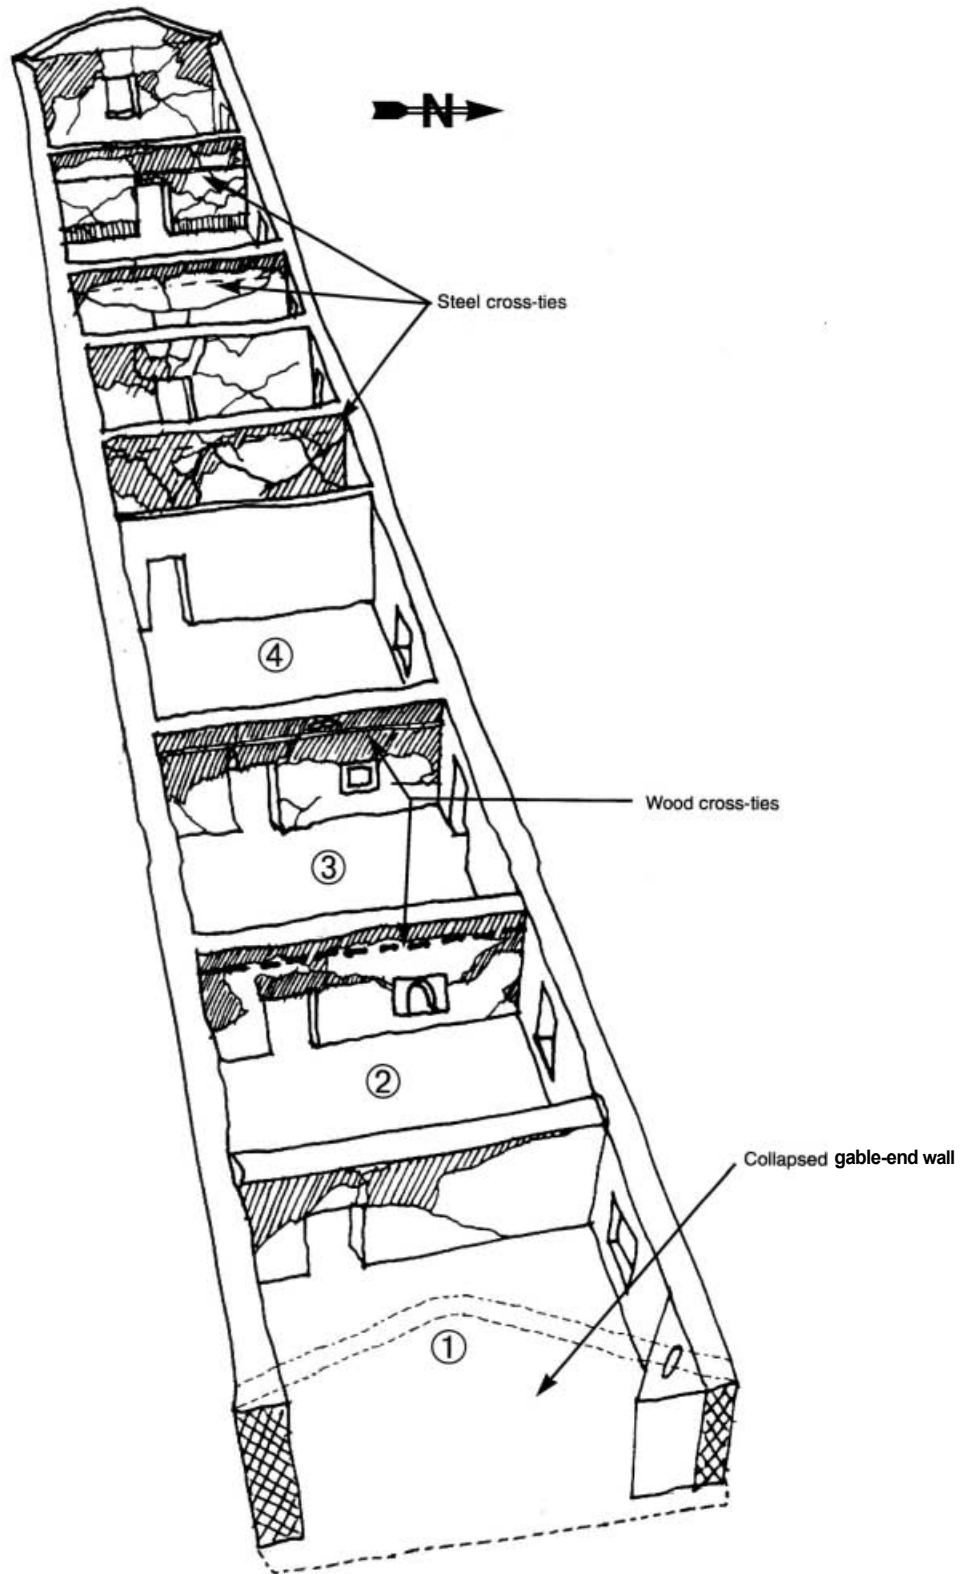
Figure 6.2. *De la Osa Adobe*. Drawing of earthquake-damaged building from the east end.

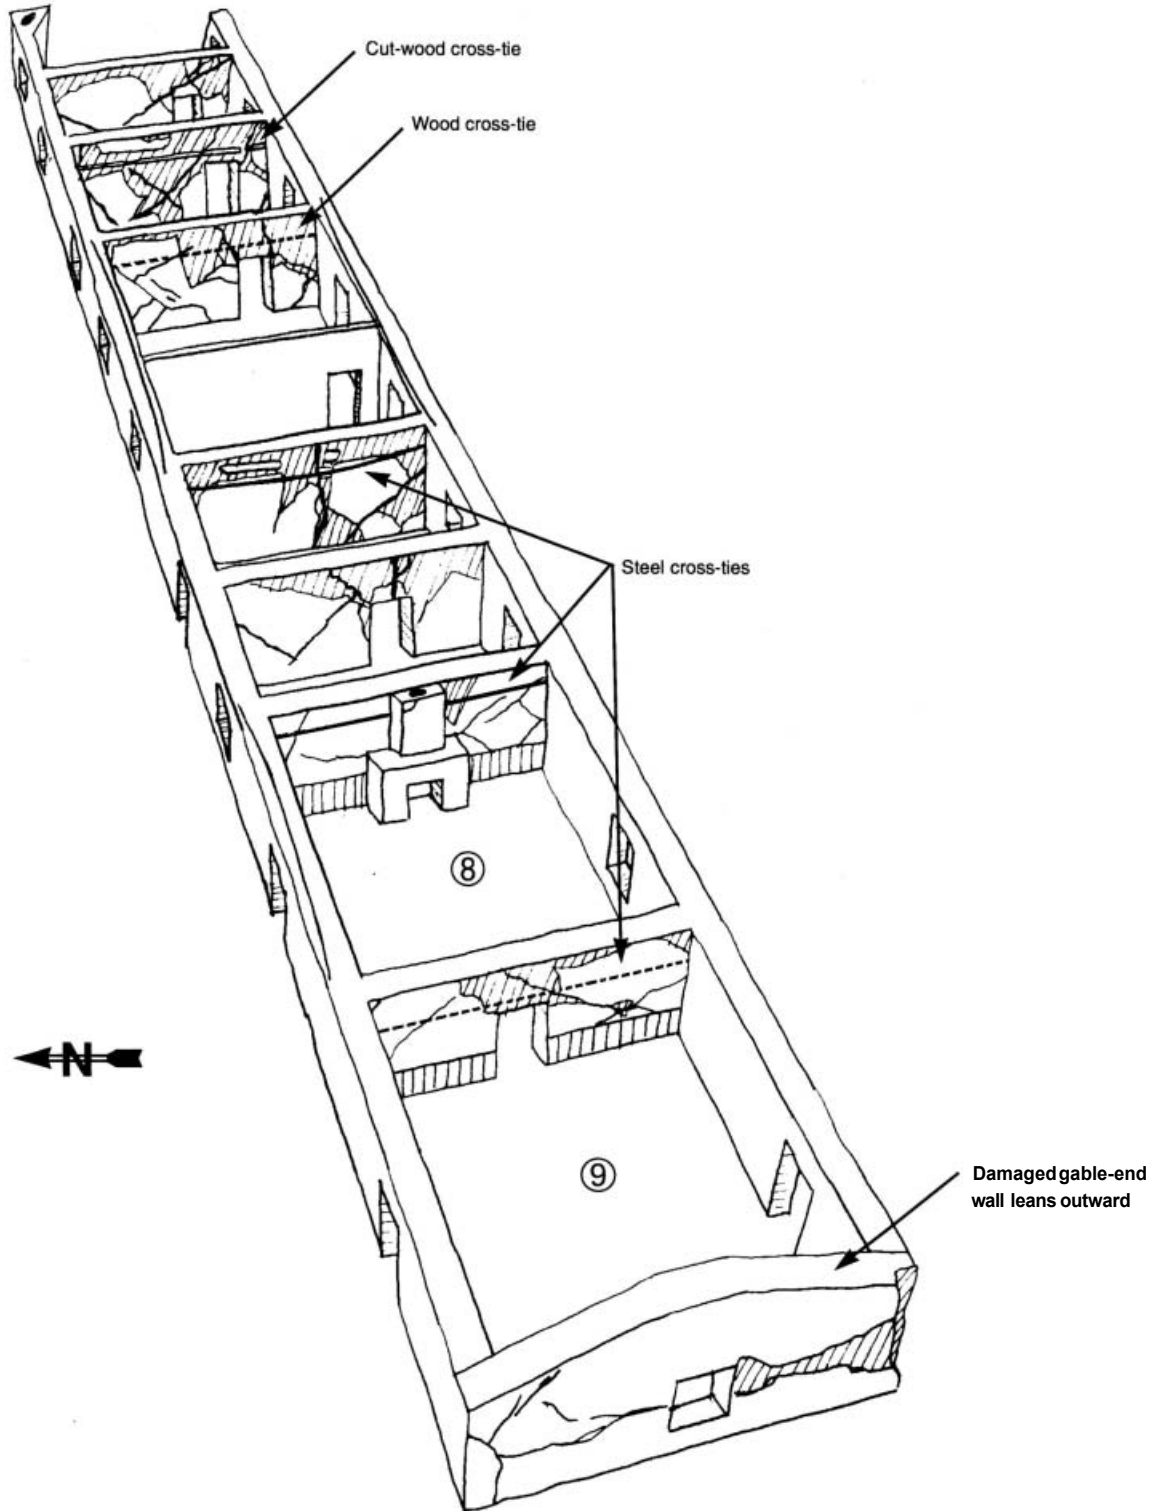
Figure 6.3. De la Osa Adobe. Drawing of earthquake-damaged building from the west end.

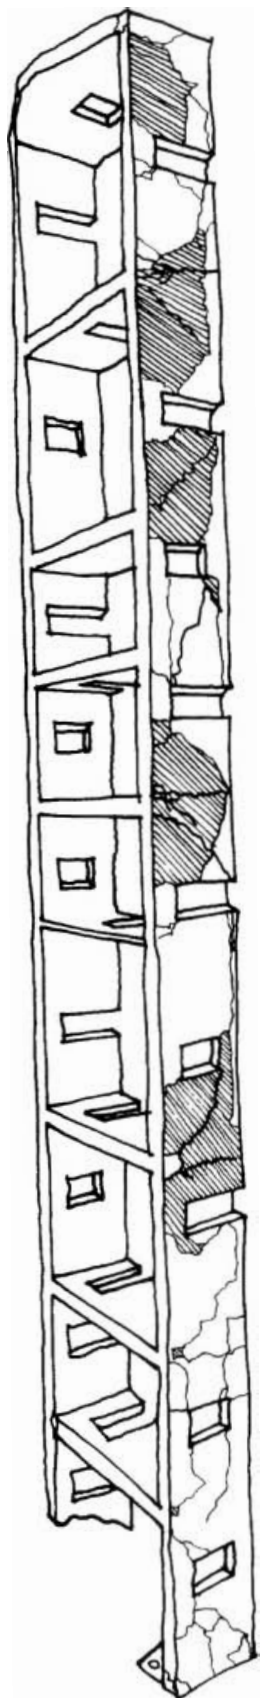
Figure 6.4. De la Osa Adobe. North elevation showing earthquake crack pattern and plaster damage.

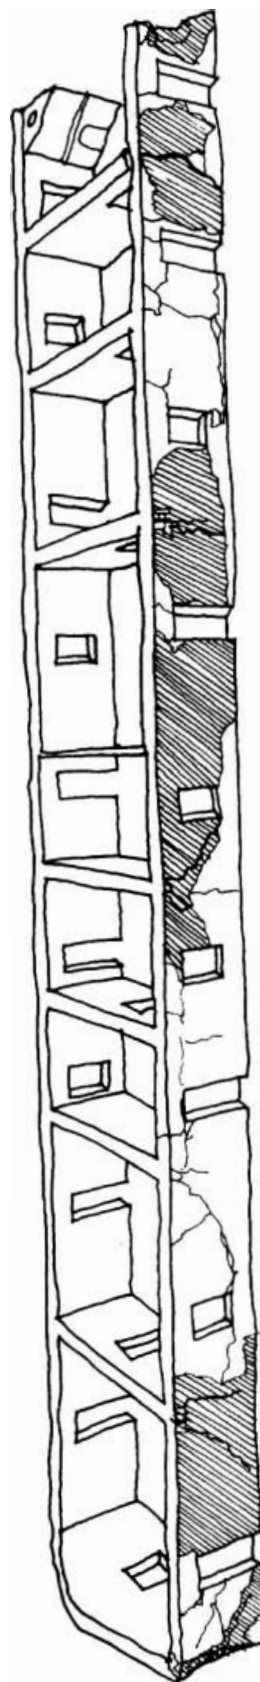
Figure 6.5. De la Osa Adobe. South elevation showing earthquake crack pattern and plaster damage.

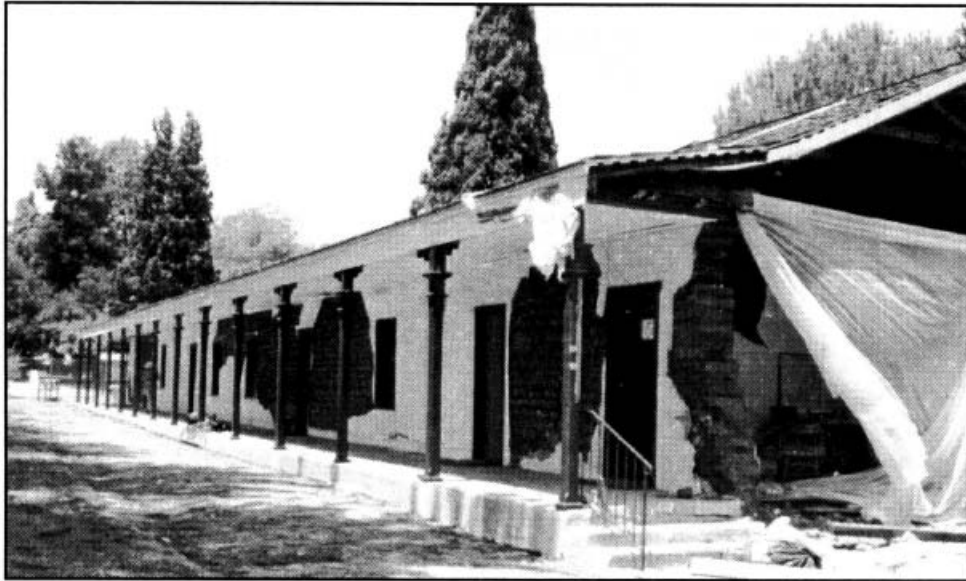
Figure 6.6. Southeast corner of the De la Osa Adobe. Collapsed gable-end wall is visible on the right.

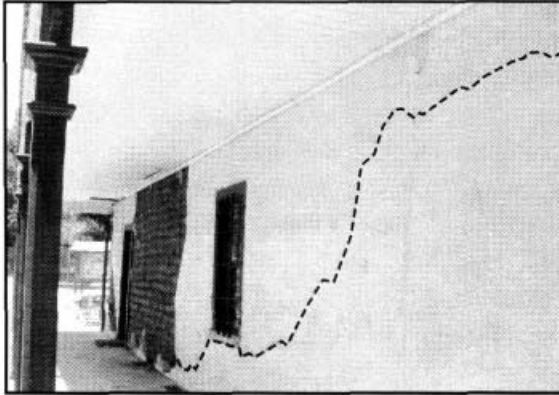
Figure 6.8. Exterior of south wall outside Rooms 8 and 9. A flexural crack starts at the anchorage at the upper right of the photo (anchorage not visible except for plaster cracking) and extends to the base of the window and then to the lower part of the wall (dotted line along crack).

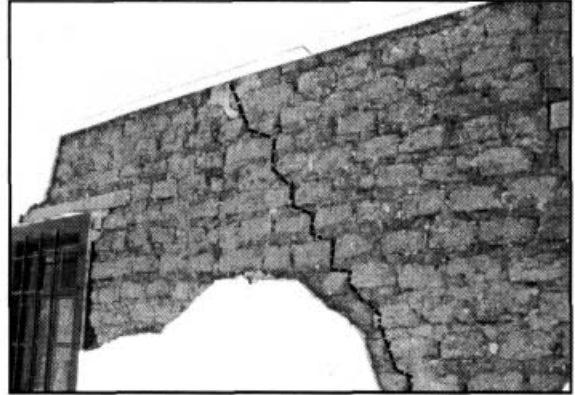
Figure 6.9. Shear crack in exterior wall starting at the interior wall between Rooms 5 and 6. Wood anchorage with S-shaped steel end plate shown at the soffit line. This anchorage is provided for a steel tie rod that spans the building in the transverse direction (dotted line along crack).

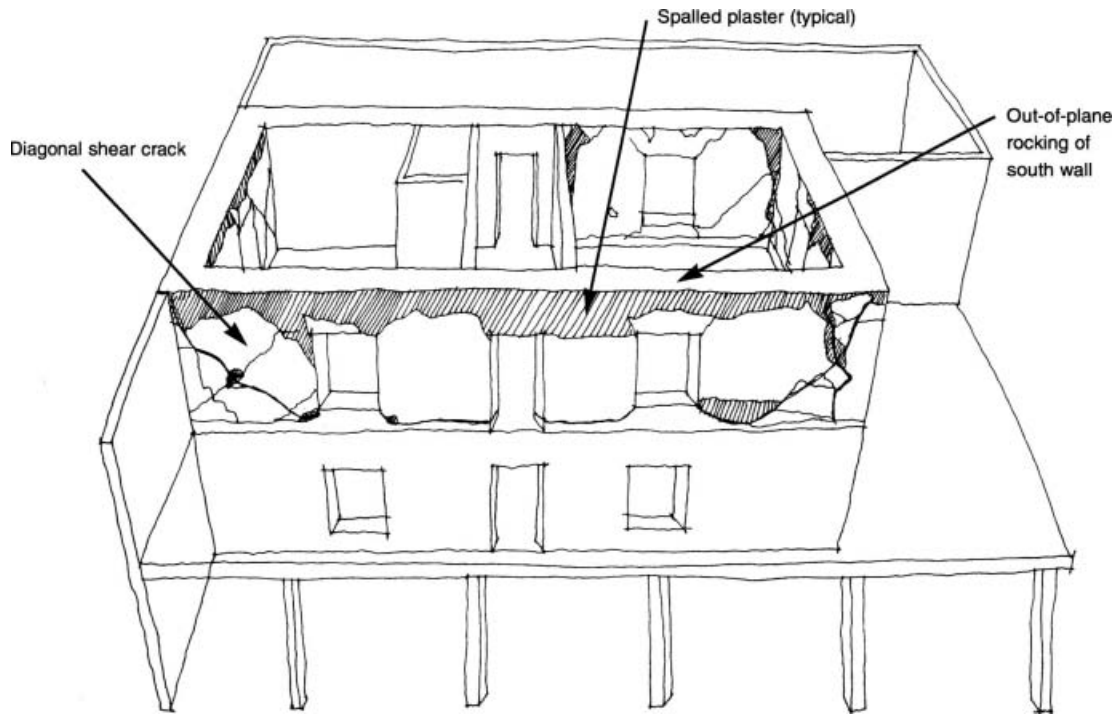
Figure 7.5. South side of the Leonis Adobe showing crack and spall damage.

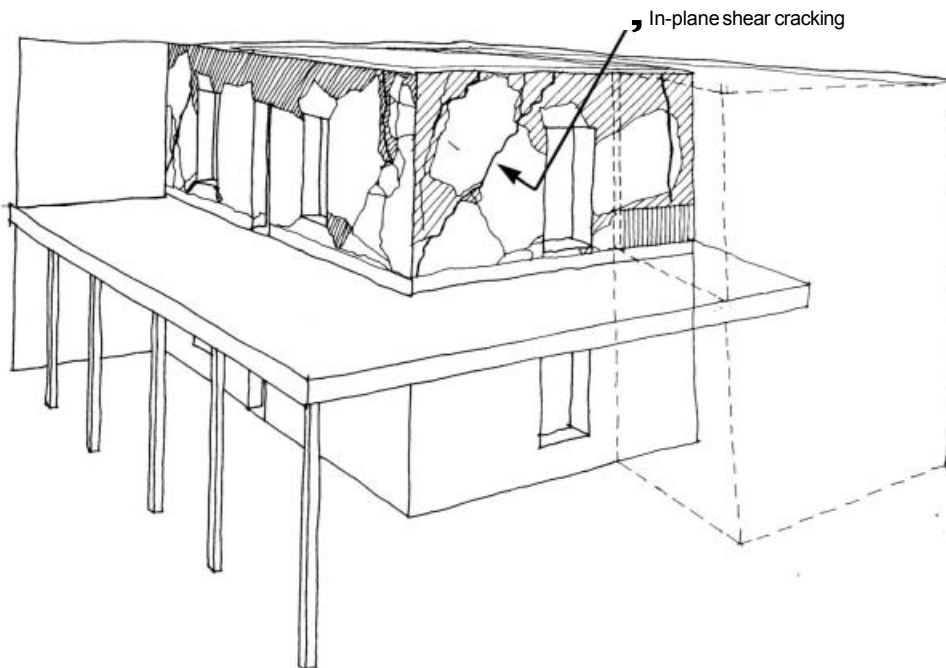
Figure 7.6. Southeast corner of the Leonis Adobe showing crack and spall damage.

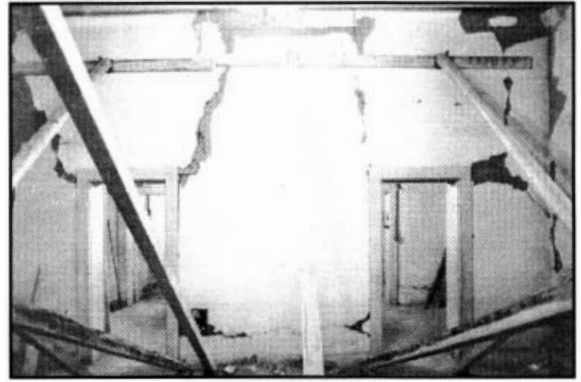
Figure 9.5. South side of the transverse wall between Rooms 9 and 10. Out-of-plane motion is the principal reason for damage to this wall.

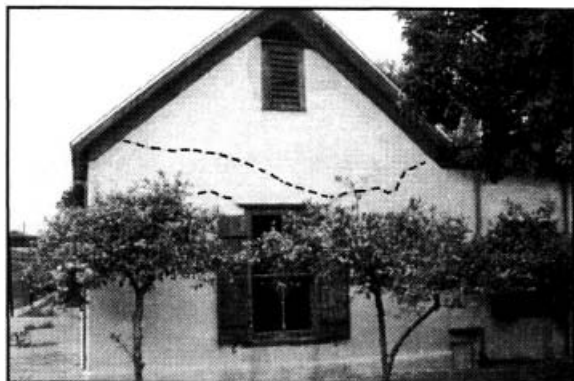
Figure 10.3. South gable-end wall. Horizontal cracks above window lintel and above ceiling height may define the location of a wood Plate, similar to that seen on the north end.

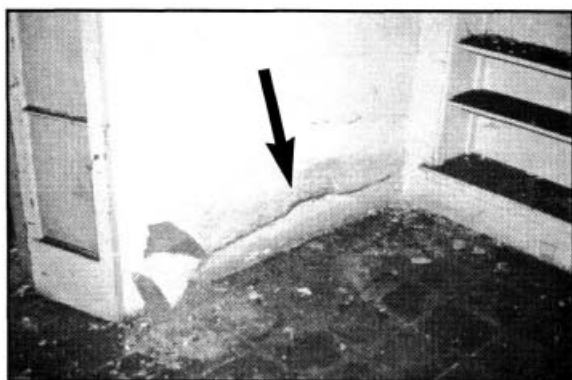
Figure 10.4. Spalling of adobe and plaster at the base of the east wall. The adobe has been severely weakened by previous wet/dry cycles.

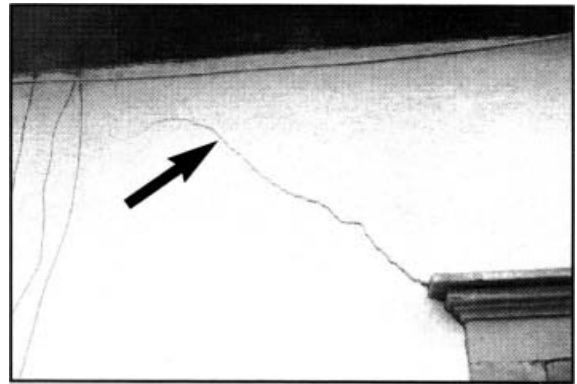
Figure 10.7. Crack at a window opening on the west wall above the area shown in Figure 10.9. The window is just north of the central doorway. The crack tapers in width indicating slumping of the wall below.

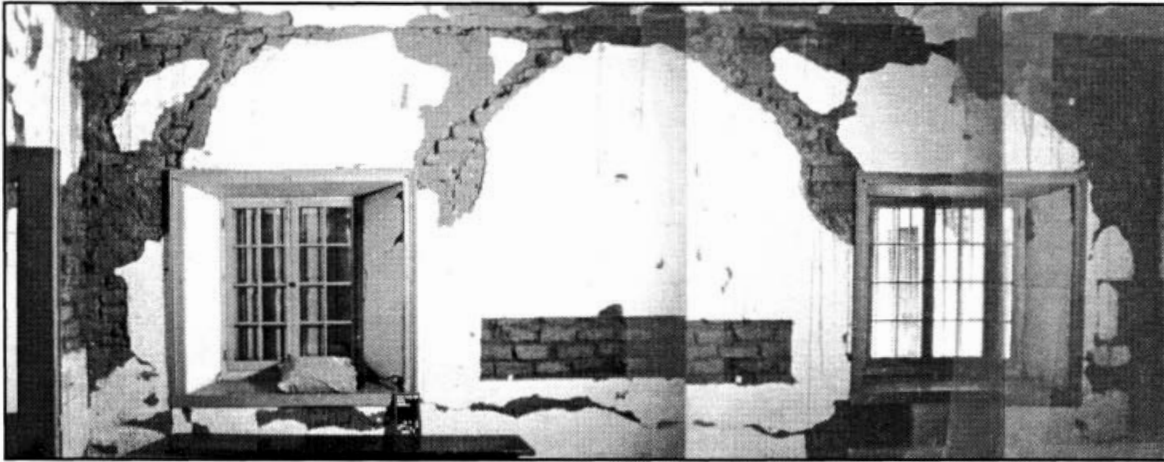
Figure 11.8. Interior elevation of the east wall of Room 8. This wall was repaired in 1991 with an adobe-flyash grout and appears to have suffered little additional damage in the Northridge earthquake.

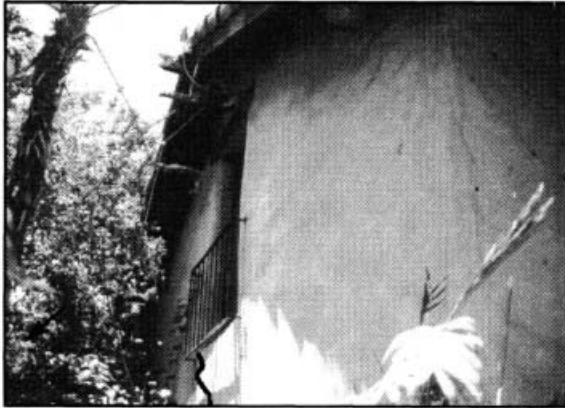
Figure 12.14. Rocha Adobe. Minor cracking in the south gable-end wall visible below the balcony railing.

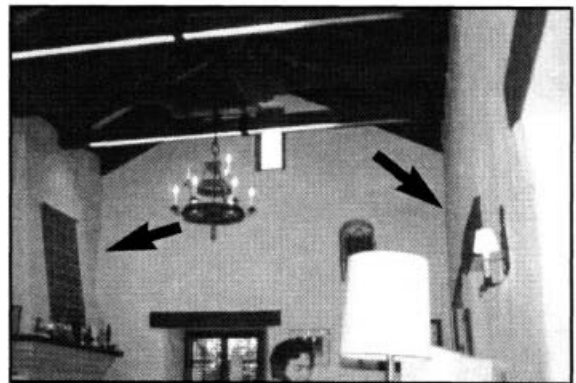
Figure 12.16. Rocha Adobe. Interior elevation of the north gable-end wall. The floor framing in this area has been removed. There are cracks that show beginning separation between the gable-end wall and the perpendicular walls.

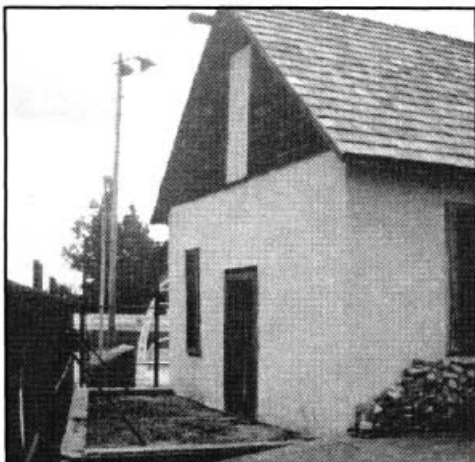
Figure 12.27. Miguel Blanco Adobe. No visible damage from exterior inspection.
