Seismic Retrofitting Project: Assessment of Prototype Buildings

Volume 1

Research Report

Claudia Cancino and Sara Lardinois

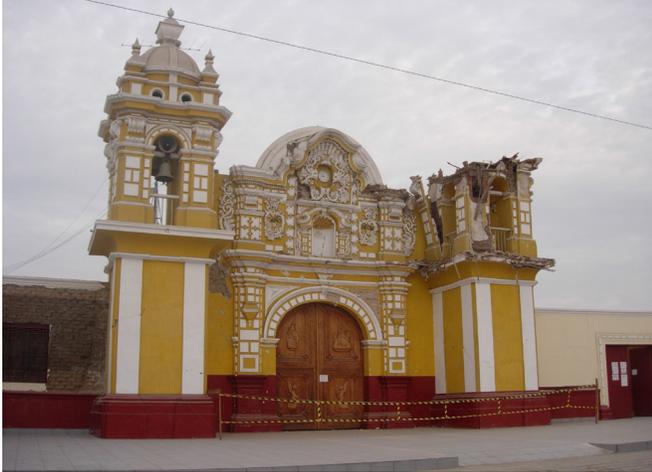
FIGURE 1.3
The earthen Church of El Carmen, Chíncha, Peru. The bell tower collapsed during the 2007 Pisco earthquake.
Image: Philippe Garnier, for the GCI.

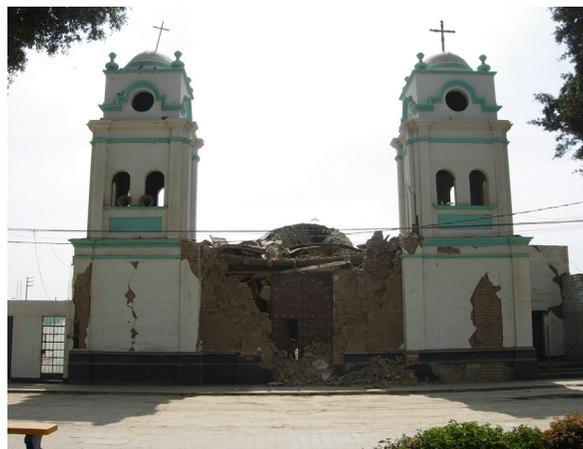
FIGURE 2.1 (LEFT)

Church of Guadalupe, damaged by the 2007 Pisco earthquake, 2007.
Image: Claudia Cancino.

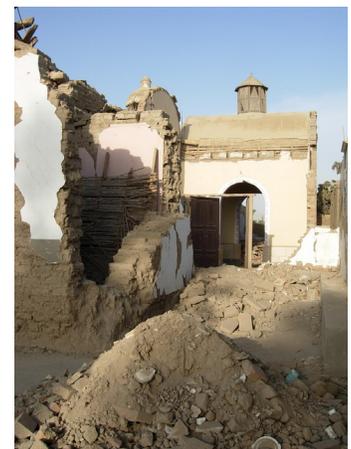
FIGURE 2.2 (RIGHT)

Church of Humay, damaged by the 2007 Pisco earthquake, 2007.
Image: Claudia Cancino.

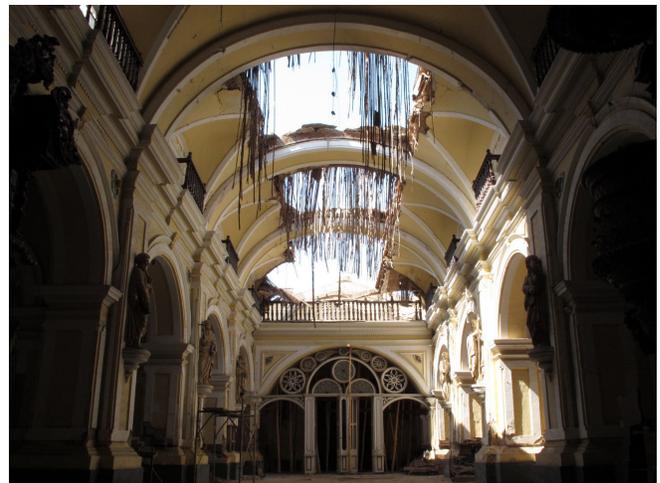
FIGURE 2.7

- It is representative of churches along the coast of Peru constructed with mud brick lateral walls, a fired brick façade, and *quincha* pillars and roofs. Although it is structurally more complex than some of the other churches, any proposed seismic retrofitting measures may be adapted for the less complex churches.
- The cathedral was damaged during the 2007 Pisco earthquake, and thus presents an opportunity to study existing earthquake damage and provide badly-needed solutions for its retrofit (Fig. 2.7).

Interior view of the Cathedral of Ica, showing damage to the vault after the 2007 earthquake.

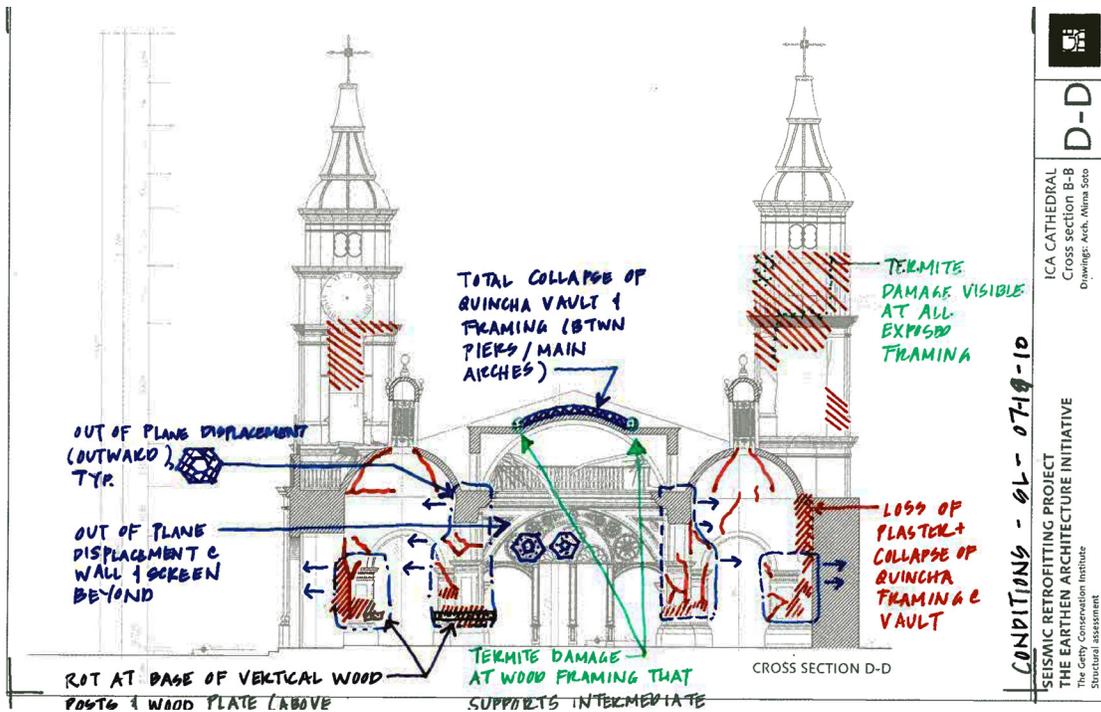
FIGURE 2.15
Example of detailed drawing accompanying survey form, graphically indicating location of observed conditions.
Drawing: Sara Lardinois.
