CHAPTER 3

Hotel El Comercio

3.1 Summary

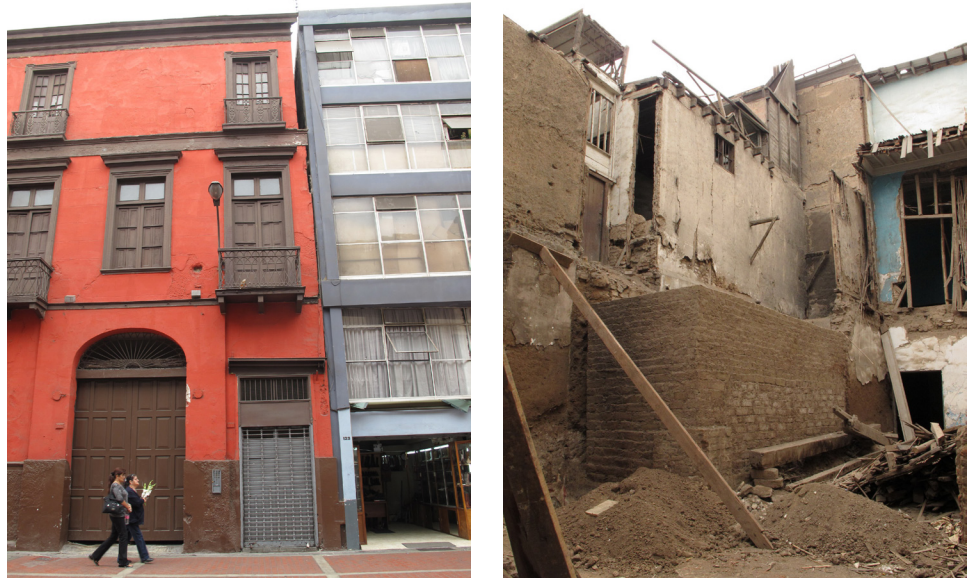
FIGURE 3.11 (RIGHT)
Collapsed bay between the two patios.
Image: Sara Lardinois.
