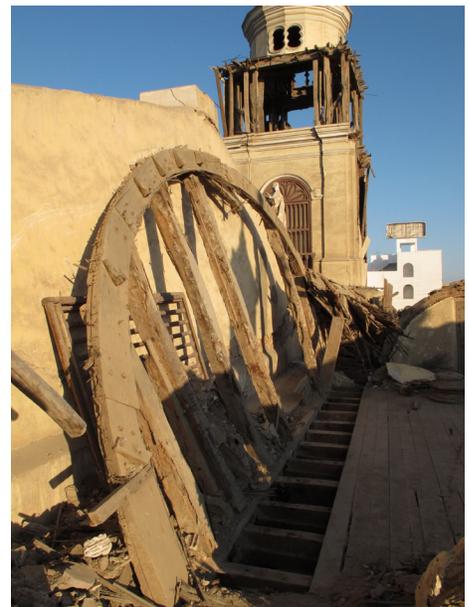
FIGURE 4.34
View of semicircular end panel that once formed the end of the barrel vault above the choir loft, which collapsed during the 2007 earthquake.
Image: Sara Lardinois.

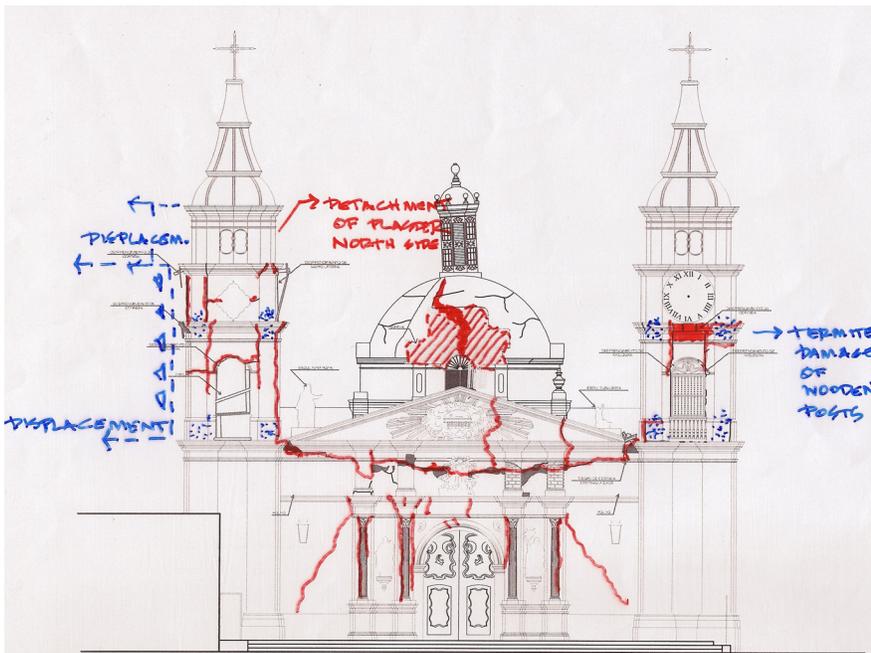
FIGURE 4.40

- The principal façade is in fair to poor condition. There are horizontal cracks between the lower façade and the pediment. Diagonal cracks were observed between the upper cornice and the base of the bell towers. This diagonal cracking suggests pounding of the towers during the earthquake (Fig. 4.40).
- The wood-framed portions of the towers are in poor condition and thus present a threat to the cathedral's roof system to the west. Damages include the failure of some connections, displacement of the wood elements at the south tower from their original positions, and loss of plaster. Thus, the wood posts are exposed and show signs of severe termite damage. (Fig. 4.41).

Front façade, graphic condition survey indicating cracks and areas of plaster loss in red and displacement and termite damage in blue.

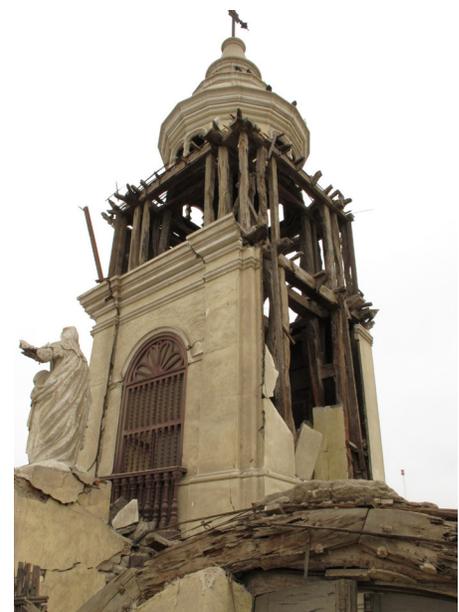
FIGURE 4.41

Loss of plaster at the south bell tower.

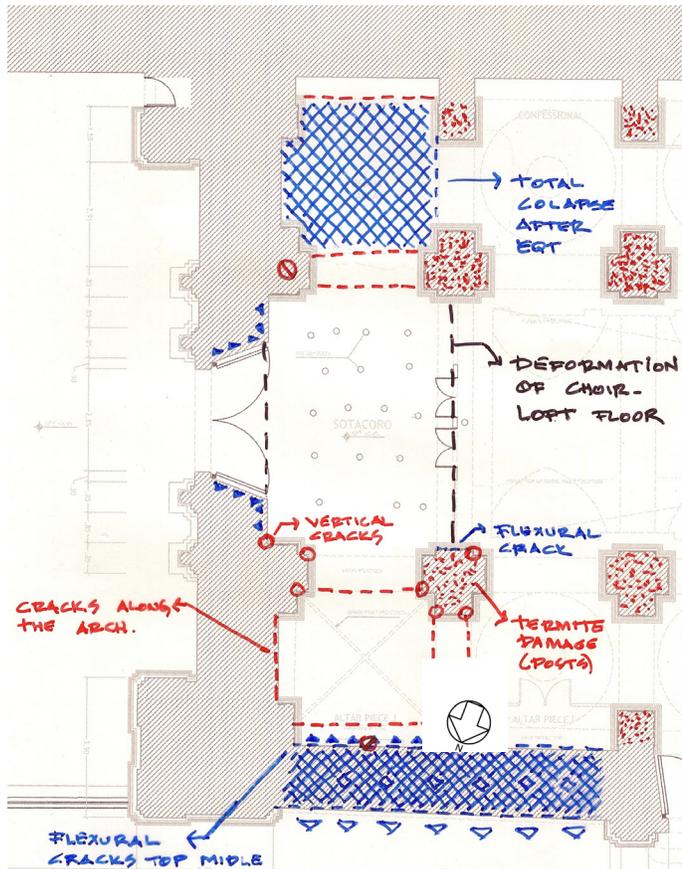
- Horizontal and vertical cracking along the perimeter of all arches and piers at the north lateral wall, in the altarpiece J (Saint Rose of Lima) space.
- Disconnection between the rib vault at the northeast corner and the north lateral wall.
- Deformation of the choir loft floor and the choir screen below.
- Vertical cracking along the pillars separating the sotacoro from the nave and structural disconnection between the pillars and adjacent choir screen.
- Total collapse of the rib-vaulted ceiling and flat roof above the altarpiece K space (southeast corner), occurring after the 2007 earthquake sometime between November 2007 and May 2009 (Figs. 4.43, 4.44).
- Collapse of the barrel vault that originally covered the choir loft.

FIGURE 4.42
Sotacoro: Graphic condition survey.
Drawing: Claudia Cancino.

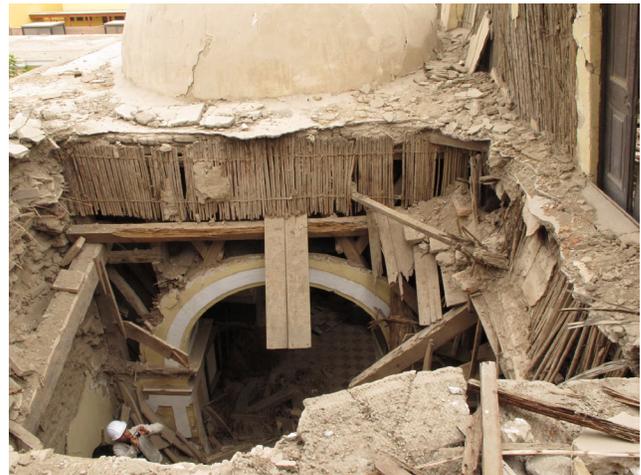
FIGURE 4.44 (BOTTOM)
View of roof and ceiling above altarpiece K, after collapse, 2010.
Image: Sara Lardinois.

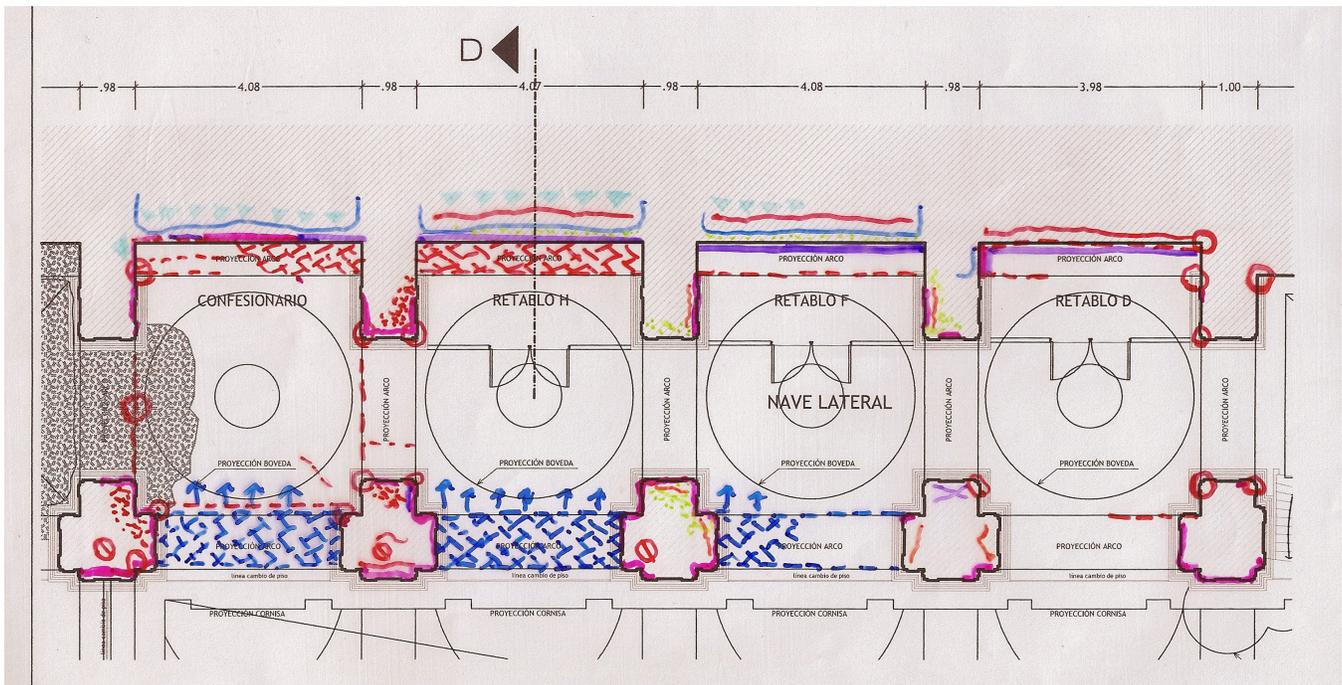
FIGURE 4.45

- Humidity in the soil and in the remains of the fired brick catacombs below the church floor (as observed in propection IS-2). This humidity may be the result of improper site drainage in the cloister of the adjacent former Jesuit college. This moisture has led to plaster detachment and disintegration of the masonry in the wall and base course—most noticeably in lower east end of the south lateral wall. This humidity has also resulted in disaggregation of the mortar in the stone foundations, but not to the degree that stones are loose.

- Bricks at the pier bases do not interlock with the brick base course along the lateral wall. The lack of connection is thought to explain the vertical cracking that was observed between the pilasters and lateral walls.

- Out-of-plane displacement of the arches at the pillar wall between the side aisle and nave.
- Partial collapse of the arches attached to the south mud brick wall in the confessional and altarpiece H spaces (Figs. 4.46–4.48).

- Horizontal cracking along the south mud brick wall.
- Minor out-of-plane displacement of the pillar wall, towards the south side aisle.
- Structural disconnection between the pillars and their bases and between the pillars and the arches above.

- Vertical cracking at the west pillar in altarpiece D space.

Sector B: South side aisle graphic condition survey. The dark blue hatch pattern and small dark blue arrows show the out-of-plane displacement at the arches between the side aisle and nave; the large, light blue arrows show areas of moisture damage; the red lines show areas of horizontal cracking; and the red circles show areas of vertical cracking.

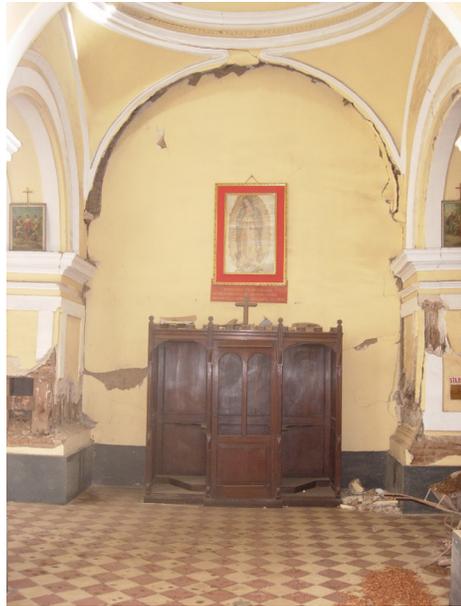
FIGURE 4.47 (RIGHT)
Sector B: Cracking and partial collapse at arches at the top of the wall, altarpiece H space, 2007.
Image: Philippe Garnier.

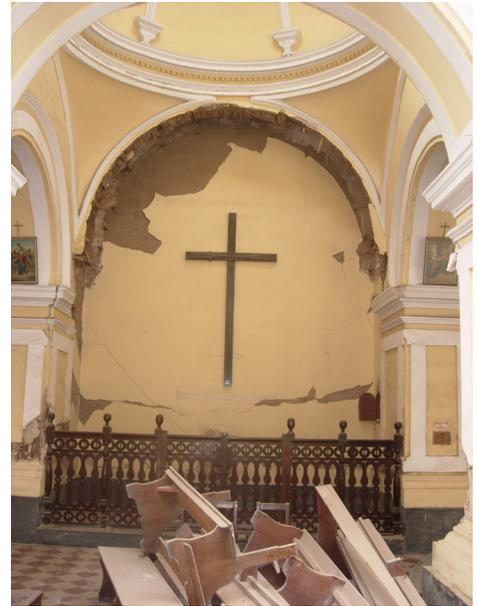
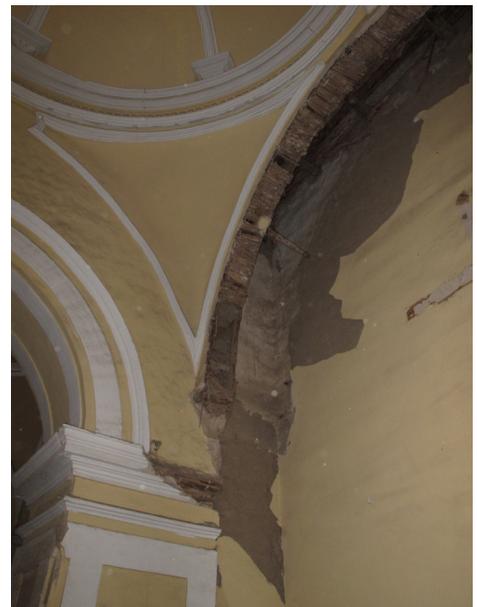
FIGURE 4.48
Sector B: Detail of cracking and partial collapse at arches along the south lateral wall.
Image: Sara Lardinois.

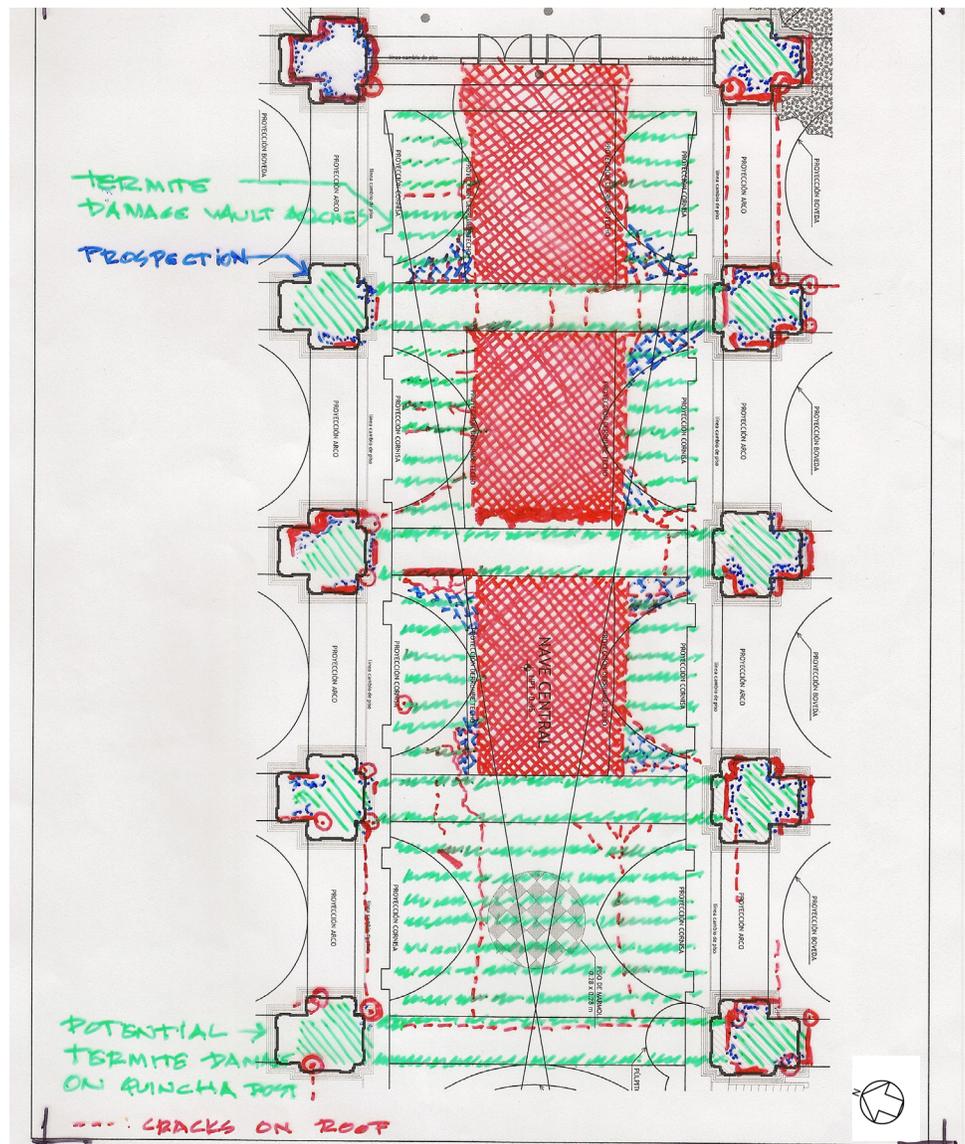
FIGURE 4.49

- Partial collapse of the central portion of the barrel vault, between the 3" × 10" (0.08 × 0.25 m) wood beams at the tops of the lunettes, in the three bays at the east end of the nave (Fig. 4.50). Based upon the GCI's photographic records from November 2007, the central portion of eastern-most nave vault collapsed several months after the August 2007 earthquake, as photos taken in November 2007 show the vault intact but with cracking in the area that would later collapse. Heavy termite damage to the wood members and corrosion of the connecting nails is thought to have contributed to this collapse (Fig. 4.51). During the 2007 earthquake, the rocking of the pillars added tension to the already deteriorated wood vault arches, breaking them into pieces and leading to failure of the mortise-and-tenon joints. The lateral wood beam at the tops of the lunettes that runs perpendicular to the principal arches may have prevented total collapse of the barrel vault in these bays (Fig. 4.52).

Sector C: Graphic condition survey. Collapsed portions of the barrel vault are shown in the red hatch pattern.

- All of the pillars are in poor condition, showing signs of structural deterioration. The wood posts, diagonal reinforcements, and sill plate exhibit heavy termite damage and rot from rising damp in the brick bases below (Fig. 4.53). The connections between the posts and the wood arches in the upper part appear to be in fair condition, but some termite damage is present. Most of the plaster exhibits vertical cracking and detachment; and, in areas where the plaster has been lost, the wood elements are exposed to further deterioration. The only element of the pillars that remains in good condition is the huarango tree trunk, which probably helped to prevent collapse of the structure during the 2007 earthquake.
- Minor outward out-of-plane displacement of pillar walls.
- Vertical cracking along the lunettes in all bays.

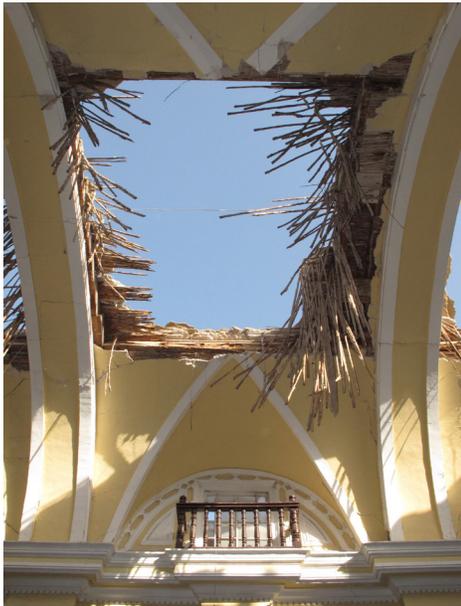
FIGURE 4.50
Sector C: View of a collapsed bay of the nave barrel vault.
Image: Sara Lardinois.

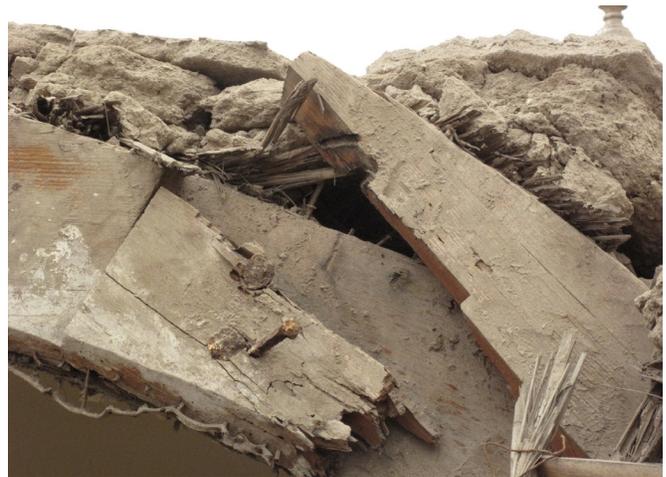
FIGURE 4.51 (TOP)
Sector C: Damage to wood arches forming the nave barrel vault, with corrosion at the nails connecting the arch segments.
Image: Claudia Cancino.

- The main cause of collapse of the roof structure appears to be the heavy deterioration of the timber elements, especially at the connections.
- Horizontal cracks in the mud brick walls were caused by lateral vibrations during the earthquake, but they do not reduce the walls' stability and resistance.

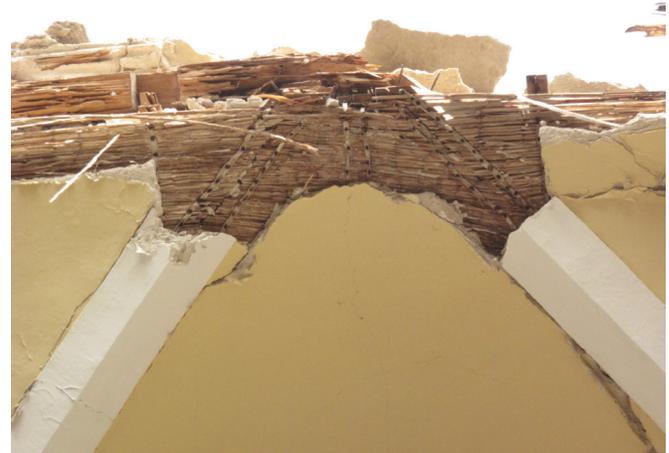
FIGURE 4.52 (BOTTOM)
Sector C: Top of nave lunette, where the wood beam spanning between the nave arches may have prevented total collapse of the vault.
Image: Claudia Cancino.

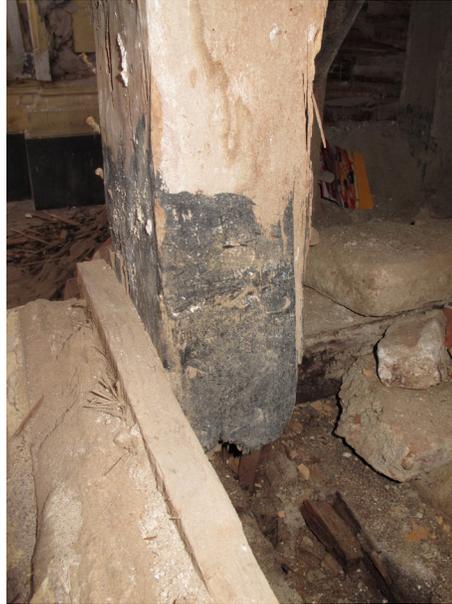
FIGURE 4.53 (NEAR RIGHT)
Sector C: View of pillar base, showing deterioration of the wood post and sill.
Image: Sara Lardinois.

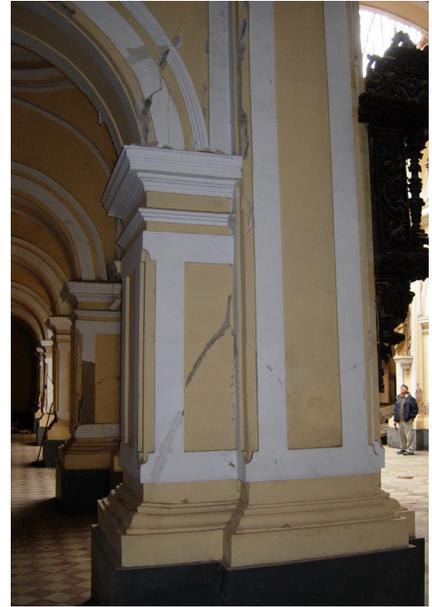
FIGURE 4.54 (FAR RIGHT)
Sector D: Cracking in west pillar at the north side aisle.
Image: Claudia Cancino

- Partial collapse of the arch adjacent to the north lateral wall in the altarpiece I space.
- Horizontal cracking at the upper and lower levels of the north lateral wall in all altarpiece spaces.
- Minor inward out-of-plane displacement of the pillar wall.
- Vertical cracks at the west piers of altarpiece E space (Fig. 4.54).

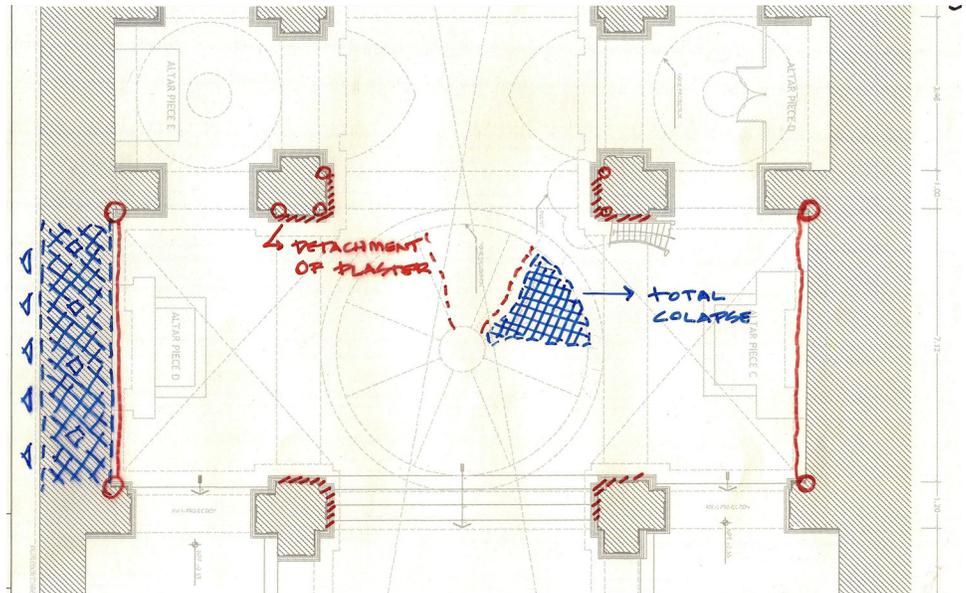
FIGURE 4.55

- Partial collapse of the southeast section of the umbrella dome over the crossing (Figs. 4.56, 4.57). Termite damage to the wood elements is thought to have contributed to this collapse; however, the circular rings running parallel to the base of the dome and interwoven with the wood ribs, as well as the strong connection between the collar ring and wood frame at the base of the dome, provided strength for the dome structure which ultimately kept it in place.
- Cracking parallel to the dome ribs in the remaining portions of the dome.
- Vertical cracking at the dome pendentives (Fig. 4.58).
- Cracking and disconnection between the transept and the two altarpiece spaces.
- Horizontal cracking at the lower portions of the north and south end walls in the transept.

Sector E: Graphic condition survey. The combination of the dark blue hatch pattern and small dark blue arrows show out-of-plane displacement; the smaller dark blue hatch pattern alone shows areas of collapse at the main dome; the red lines show areas of horizontal cracking; and the red circles show areas of vertical cracking. Drawing: Claudia Cancino.

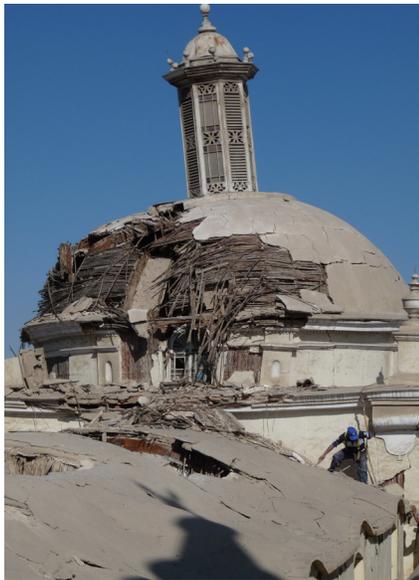
FIGURE 4.56

Sector E: View of partial collapse of quincha dome.
Image: Mirna Soto, for the GCI.

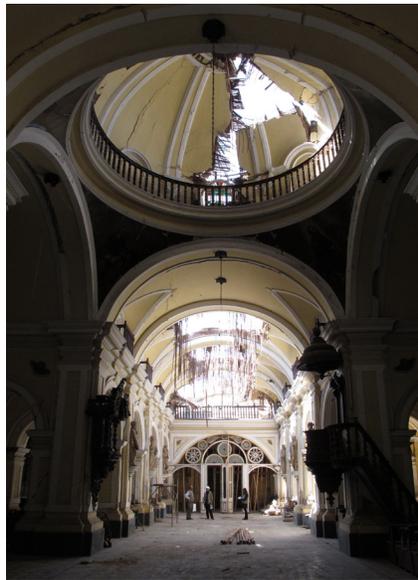
FIGURE 4.57

Sector E: Interior view, looking east, showing the partial collapse of the dome and barrel vault.
Image: Sara Lardinois.

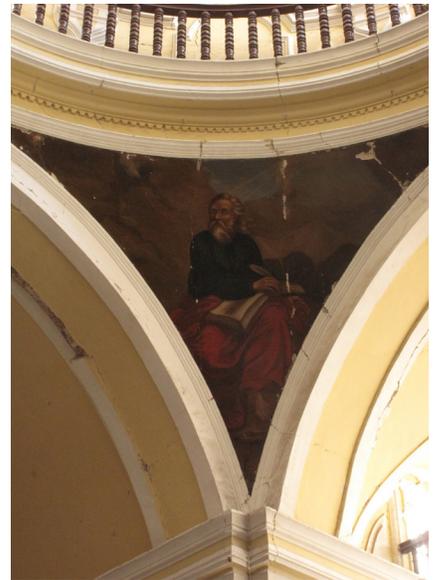
FIGURE 4.58

Sector E: View of the vertical cracks in a pendentive at the main dome.
Image: Claudia Cancino.

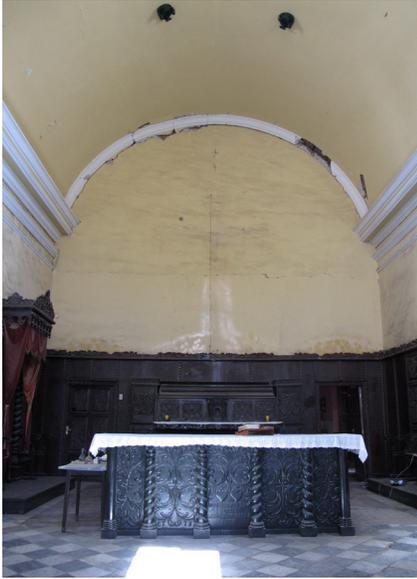
FIGURE 4.59
Sector F: The upper west wall behind the altar exhibits out-of-plane displacement and cracking.
Image: Sara Lardinois.

- Outward out-of-plane displacement, disconnection, and cracking at the upper levels of the west end of the altar and the south side chapel, altarpiece A space (Fig. 4.59).
- Cracking parallel to the direction of the vaults in the vaults covering the altar and the side chapel spaces.
- Vertical cracking at the corners of both side chapels (altarpiece A and B spaces) and at the west wall of the altar (Figs. 4.60, 4.61).
- Horizontal cracking at the upper levels of the north and south walls of the altar, as well as at the south and west walls of the altarpiece A space.

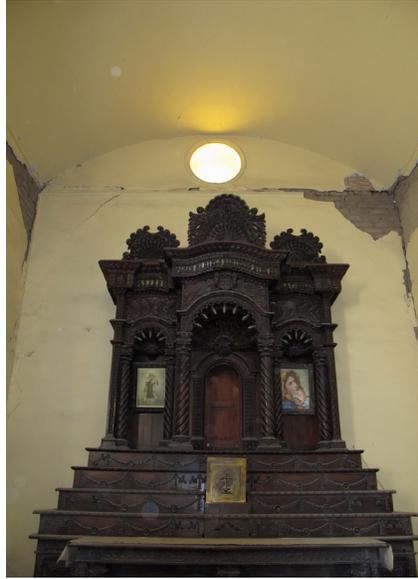
FIGURE 4.60
Sector F: View of vertical cracking in either corner at west wall of the north side chapel, behind altarpiece B.
Image: Sara Lardinois.

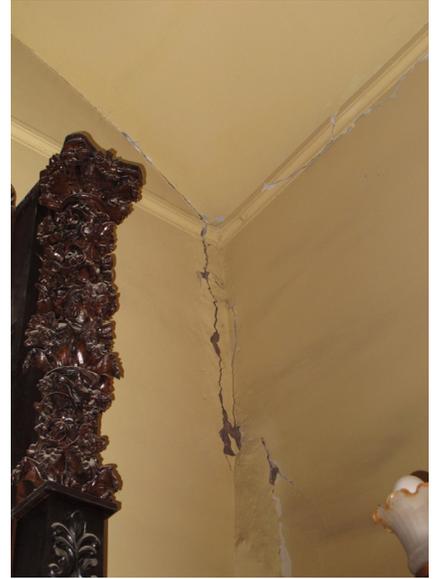
FIGURE 4.61
Sector F: Detail of vertical crack at north-west corner of the cathedral.
Image: Sara Lardinois.
