## CHAPTER 6

# Casa Arones

### 6.1 Summary

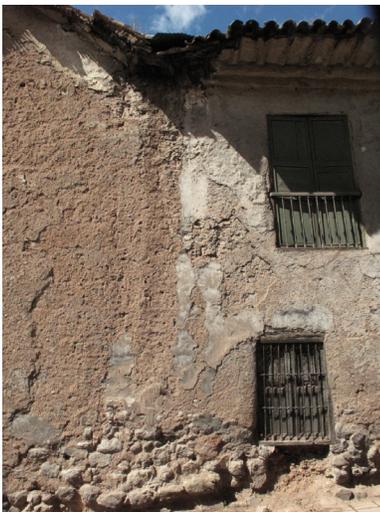
Overall, the foundation and base course are in fair condition and generally cohesive. Humidity in the soil and foundations and rising damp have led to moisture damage, detachment and loss of plasters, and basal erosion at some of the mud brick walls above. At the north façade (sector A2) there has been severe erosion and loss of the base course stones in an area corresponding to room C-109. The damage is most severe below the window in that room (Figs. 6.40, 6.41). This damage may be the result of falling water from the roof above, as the location corresponds to the valley at the intersection of the two main gable roofs. Surface water runoff along the adjacent sloping sidewalk, which is finished with smooth impermeable stone paving, may also contribute to the problem; however, this is an unlikely source as the damage is localized and is not as severe in other parts of the north elevation.

**FIGURE 6.40**  
Erosion and loss of base course stones outside room C-109, north façade.  
Image: Claudia Cancino.

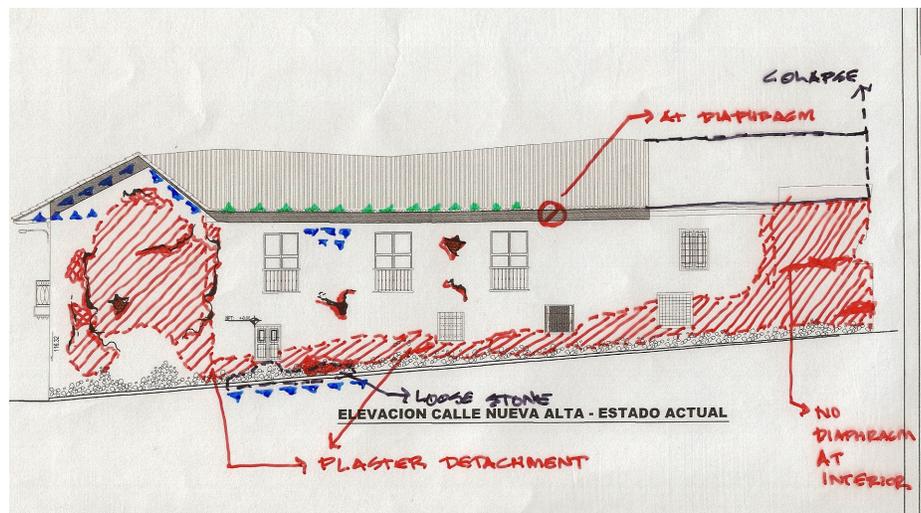
**FIGURE 6.41**  
Graphic condition survey of north façade, indicating areas of loose and lost base course stones (in black) and plaster detachment (in red). Areas of moisture damage are indicated with the blue triangles, and green triangles mark areas where vegetation is present.  
Drawing: Claudia Cancino.

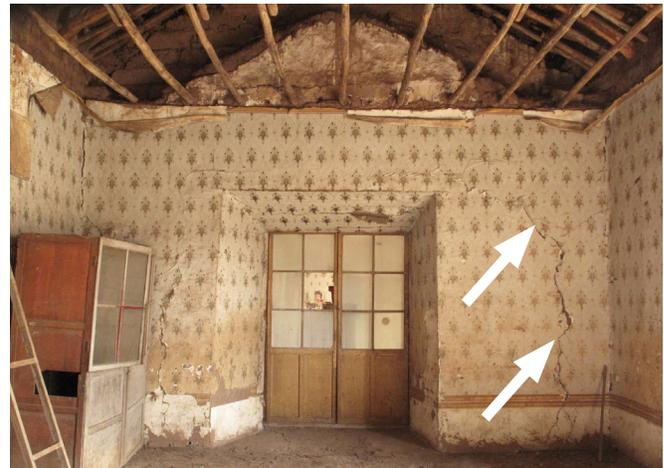
were observed in the transverse walls, suggesting some out-of-plane displacement in the lateral perimeter walls in both sectors B1 and B2 (Fig. 6.42). In room 204 of sector B1, a significant diagonal crack was observed through prospection IIW-2, indicating some disconnection between the façade at Calle Arones and the south perimeter wall (Fig. 6.43). In sector B5, At the south wall, five 5/8" (16 mm) diameter threaded steel rods with steel plates and wood blocking have been installed at the second floor, tying the south wall to the adjacent building wall; however, this is not a good solution because stress concentrations produce cracking around the rod (Fig. 6.44).

**FIGURE 6.42**  
Vertical crack in transverse wall between rooms A-203 and A-204, adjacent to the east façade.  
Image: Claudia Cancino.

- Basal erosion in the walls is the result of a leaking roof, the lack of an efficient drainage system, and humidity in the soil.
- There are relatively few transverse walls at the second floor; and, where present, there is often a disconnection between transverse and lateral walls. This has led to outward displacement and vertical cracking.

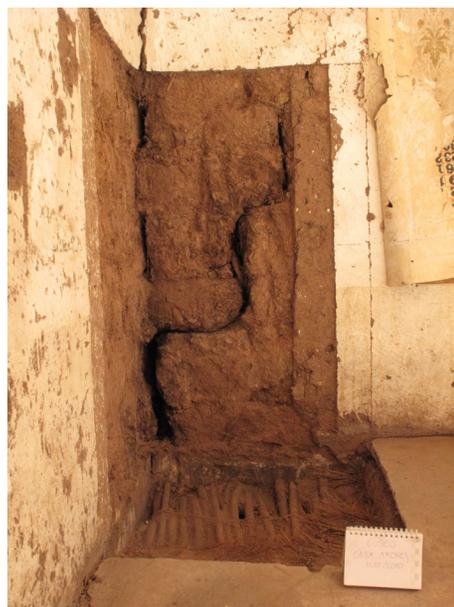
**FIGURE 6.43 (LEFT)**  
Crack in second floor mud brick wall at southeast corner of building, indicating a disconnection between the façade at Calle Arones and the south perimeter wall.  
Image: Claudia Cancino.

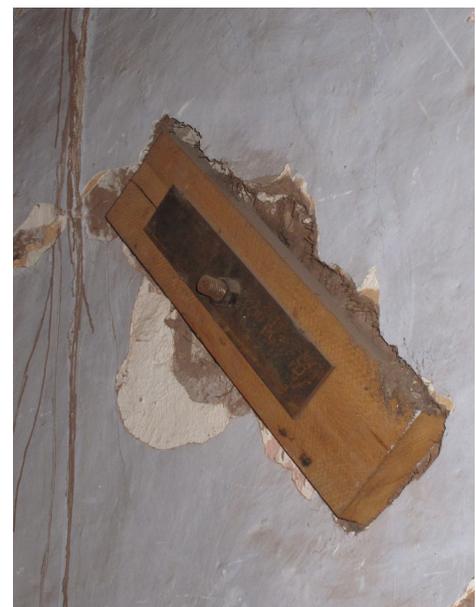
**FIGURE 6.44 (RIGHT)**  
Threaded steel rod, plate, and wood blocking at south perimeter wall (room B-206).  
Image: Sara Lardinois.

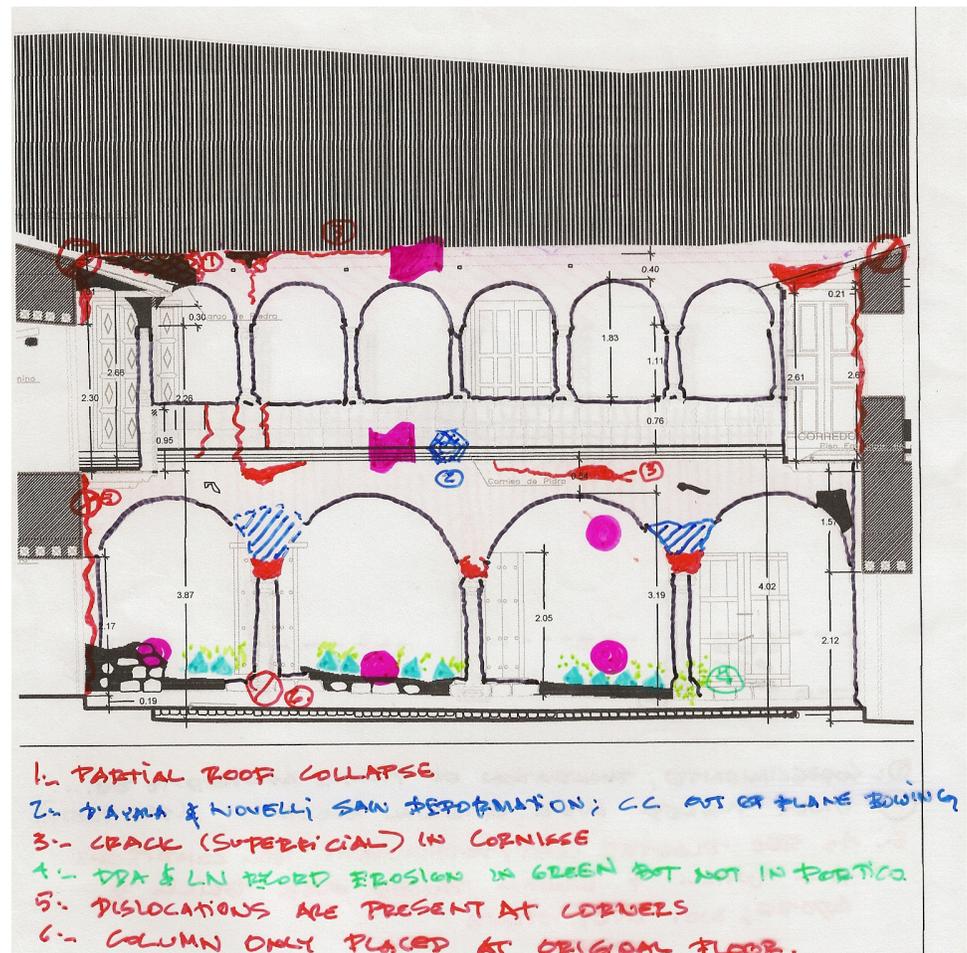
FIGURE 6.45

The fired brick and stone masonry arcades are in poor condition and unstable (Fig. 6.45). While the stones themselves are in good condition, there is significant loss of mortar. The arcade walls have long spans, which are poorly restrained. As a result, they exhibit some outward displacement and the arches themselves were in danger of collapse prior to the installation of a temporary shoring system. The west ends of both the north and south arcade walls appear to be the most unstable, with cracking and separation between the stones (Fig. 6.46). This may also be the result of displacement in the adjacent mud brick wall at the west side of the patio, brought on by the collapse and demolition of the adjacent construction. Portions of the second floor arcade at the south side of the patio have been infilled with mud bricks (Fig. 6.47).

Graphic condition survey of fired brick and stone masonry arcade wall at the north side of patio.  
 Drawing: Claudia Cancino.

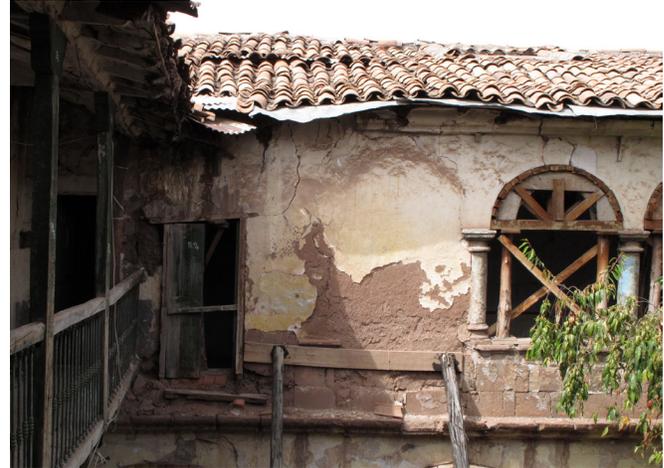
**FIGURE 6.47**  
View of infilled arcade at south side of patio.  
Image: Sara Lardinois.

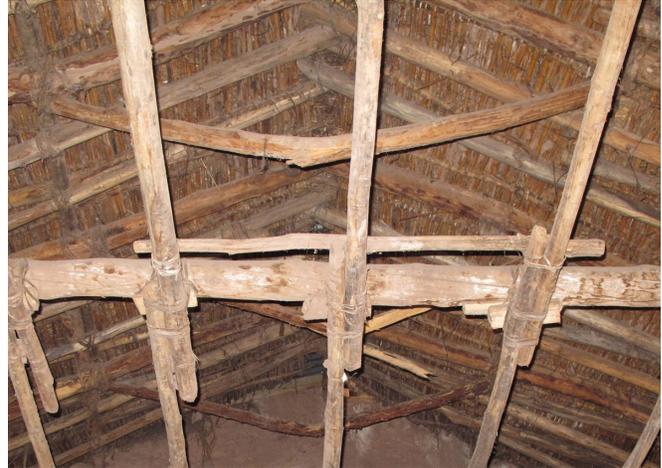
**FIGURE 6.48**  
View of broken collar ties.  
Image: Sara Lardinois.

- As a result, a large percentage of the second floor ceiling joists and plaster finish has collapsed or been intentionally removed due to its poor condition.
- The gypsum plaster ceiling finish at the underside of the roof rafters in sector B5 and other second floor galleries and porches is in poor condition, with large areas of loss.
- In some cases, the depth of erosion at the top of the mud brick walls is so great that the ends of the roof rafters and tie beams are no longer supported by the walls.
- Wood rot and beetle damage were observed in some of the wall plates and wood framing.
- At several pares y nudillos trusses, the connection between the collar ties and rafters has failed, and the collar ties are deformed or broken (Fig. 6.48).

As a result of these conditions, the roof is unable to fully resist thrust actions and is partially collapsed. The degree of collapse is greatest at the south end of sector B1 and the west end of sector B2. The deformation and collapse has given the roof an irregular profile.
