Conservation History

History of Interventions

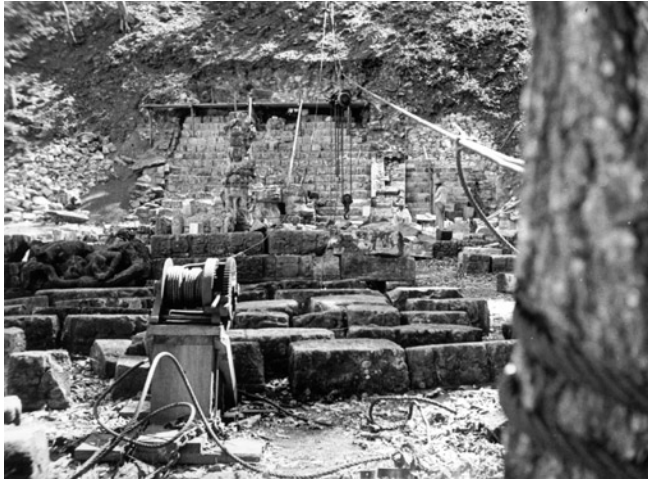
The reconstruction of the Hieroglyphic Stairway finally began in January 1937, with the stabilization of the fifteen in situ steps, which were found in poor condition, largely due to vegetation and microbiological growth. The blocks of the upper four in situ steps were lowered, photographed, and, along with the first Seated Figure, reset in cement mortar. The space behind the blocks was filled with rubble set in lime mortar, and, finally, the block joints were cleared of soil and vegetation and repointed with cement mortar (**Fig. 25**).⁴

Figure 25 In situ section of the Hieroglyphic Stairway at the beginning of the reconstruction. 1937.

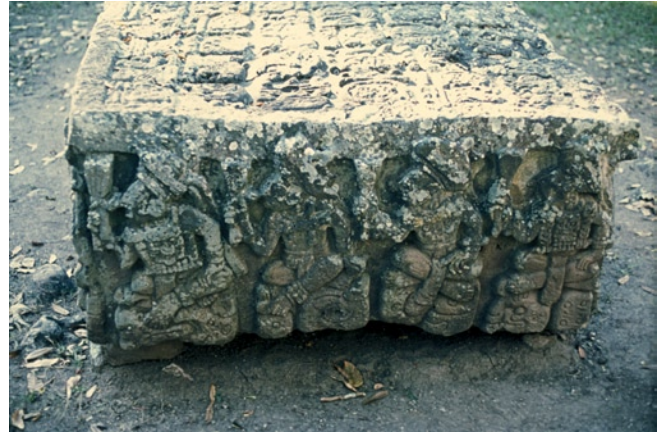
Figure 30 Altar Q before biocide treatment. Heavy lichen colonization can be seen on the upper part. 1975.

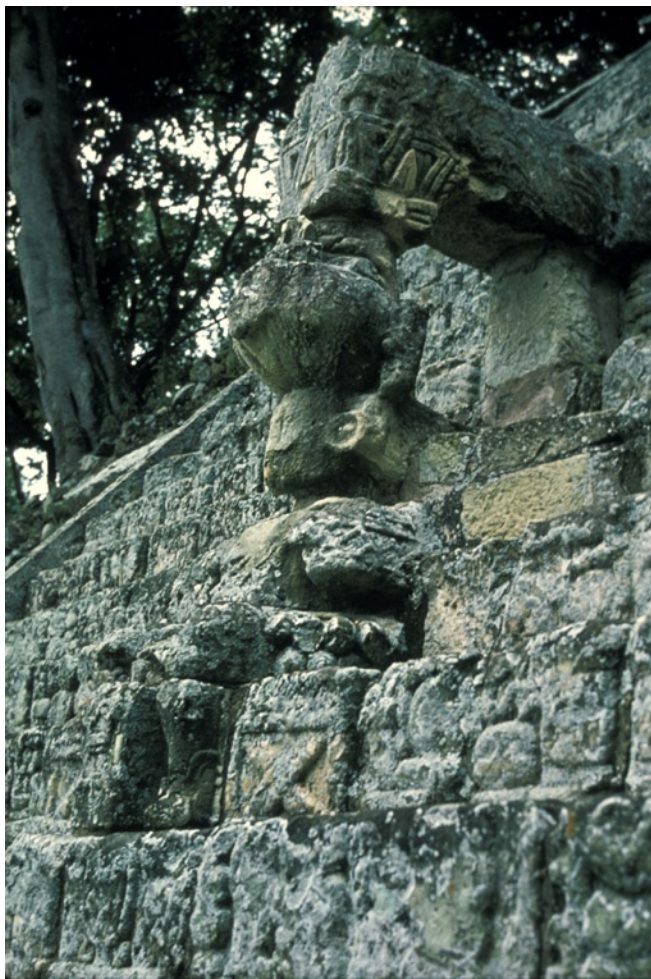
Figure 52 Hieroglyphic Stairway Seated Figure 5 before biocide treatment, showing heavy biological colonization. 1975.

south side (Hale 1978a, 7). These three trial areas were treated in January 1977 and July 1977 with Clorox and Borax,¹⁵ followed by a third, Clorox-only application, in January 1978 (Hale 1978a, 2). Because of the good results of these preliminary tests, it was decided to treat all the principal Copán monuments, including the entire Hieroglyphic Stairway (**Fig. 52**).

The Stairway was treated three times with Clorox and Borax in September 1978, December 1978, and March 1979. The microflora on the horizontal surfaces was eliminated, and 95% of the larger lichens on the vertical risers were removed. Hale insisted that the remains of the microflora would fall away naturally (Hale 1984, 520), so that mechanical cleaning by brushing was not necessary and would only add to the already extensive deterioration of the Stairway (Hale 1979d, 2). It is, however, uncertain whether Hale's recommendation against brushing was followed.

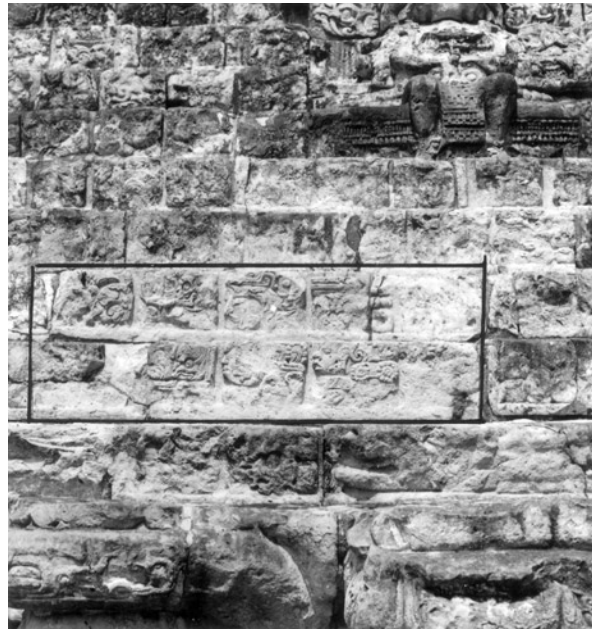
Figure 53 Area of treatment trials with Paraloid B-72 at 20% in acetone. The material was used to stabilize flaking surfaces. Paraloid B-72 at 5% was then applied as a water repellent. March 1982.

In March and April 1982, a treatment trial using Paraloid B-72 was carried out on a small area of the Hieroglyphic Stairway corresponding to blocks 21 (glyph F) and 22, step 6, and blocks 28 and 29, step 7 (**Fig. 53**) (Martínez 1983, 19,

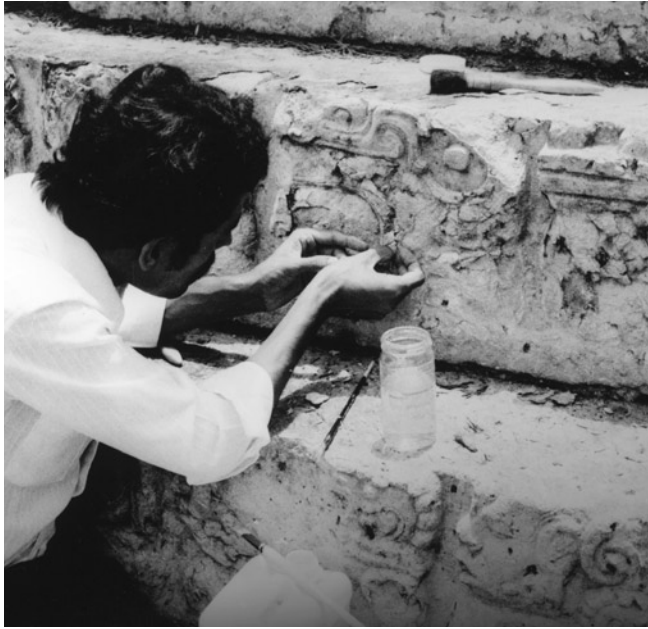
Figure 34 Reattachment of fallen stone flakes with Paraloid B-72, block 28, step 7. April 1982.

25). After the stone surface was cleaned, the detached flakes were re-adhered with a 20% solution of Paraloid B-72 in acetone (**Fig. 34**), and the entire step riser surfaces were treated with a 5% Paraloid B-72 solution as a water repellent. The treads of the steps were not treated, to provide for the evacuation of humidity (Cruz 1983, 18; Martínez 1985, 19). Interestingly, this experiment was seen more as an attempt to slow down biological recolonization than as a consolidation trial, and in that regard, it was successful, as shown by photographic documentation of the trial area a year and a half later (**Fig. 35**).

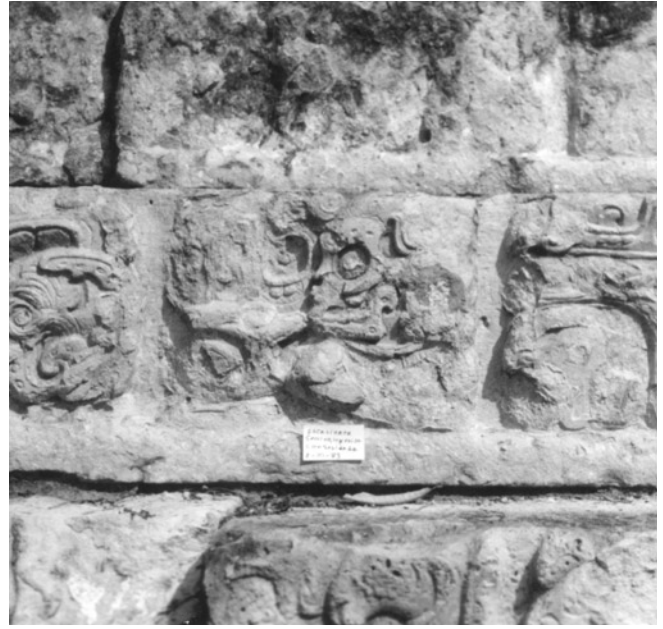
Figure 35 Block 28, step 7 (see Fig. 34), one and a half years after its treatment; there is no evident biological recolonization. November 1985.

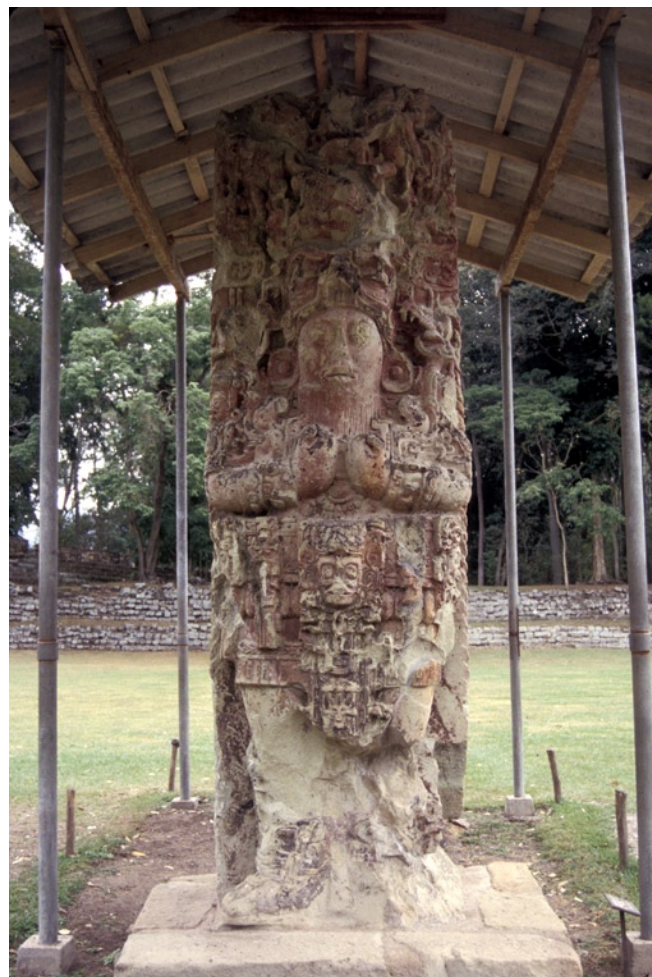
Figure 39 Basal erosion on Stela C, shown from the west. 2005.

These preliminary analyses led Feugueur to postulate that stone deterioration at Copán was due to microbiological activity, but also to the physical action of rapid wetting-drying cycles. Since most stelae are placed on slabs, groundwater was unlikely to be the source of water. More likely, humidity came from the air (mist or fog, for example) and could be increased by

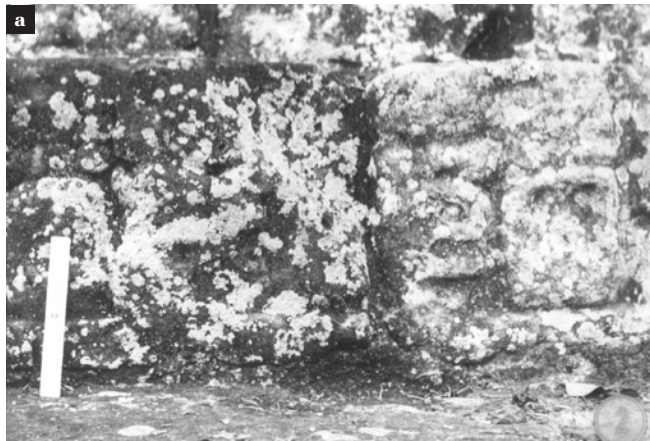
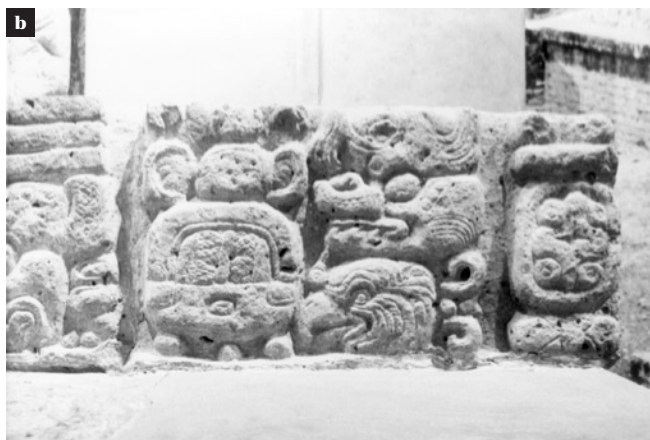
Mason Hale, a botanist from the Smithsonian Institution in Washington, D.C., visited Copán in July 1975 to examine the biological growth on the monuments and to suggest a treatment program (Hale 1975). Collecting a very large number of lichens, mosses, liverworts, and several algae, he carried out the first inventory of the principal species of the microflora (Hale 1978b; Hale 1979a). He considered the principal factor related to the biological deterioration of the stone to be the action of lichens, an already well documented phenomenon. According to Hale, lichens have both a physical effect, breaking up stone crystals as they swell in the presence of water, and a chemical effect, disintegrating stone minerals through the action of their acid secretions. Through photographic comparison of blocks preserved in a museum and those in situ covered with lichens, he put forward his case for removing them (**Figs. 40a, b**).

Figures 40a and b Comparison of Stairway blocks in situ covered with lichen growth (a) and preserved at the Peabody Museum (b). Ca. 1978.

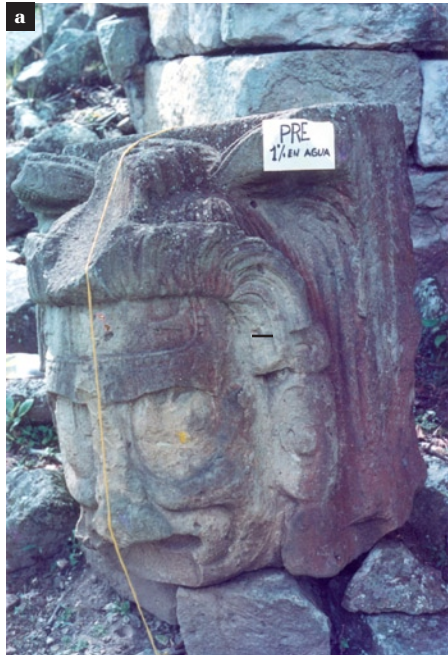
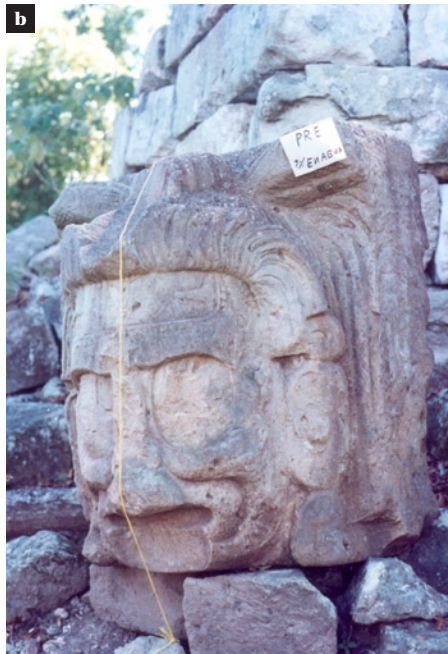
Figures 42a and b Treatment trial with the biocide Preventol, before cleaning (a), and after cleaning (b). Ca. 1987–89.

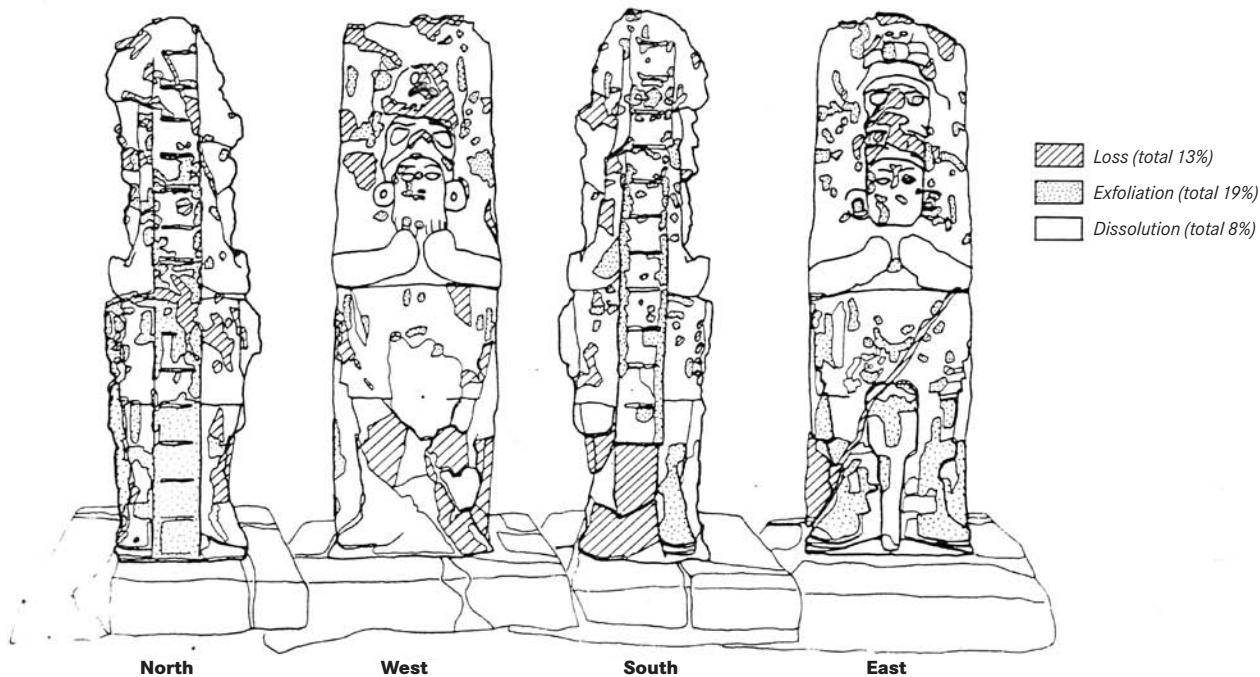
Figure 43 Graphic documentation of the condition of Stela C.

He identified three types of deterioration: loss due to fractures, forming naturally along secondary mineral planes of weakness or under an artificial force; exfoliation (or flaking), which starts by the formation of microcracks parallel to the stone surface, then leads to the formation of thin flakes that ultimately fall; and dissolution—that is, the chemical transformation of minerals. He considered the principal cause of deterioration to be rain, which induces humidity fluctuations, while he considered the secondary cause to be temperature variations.

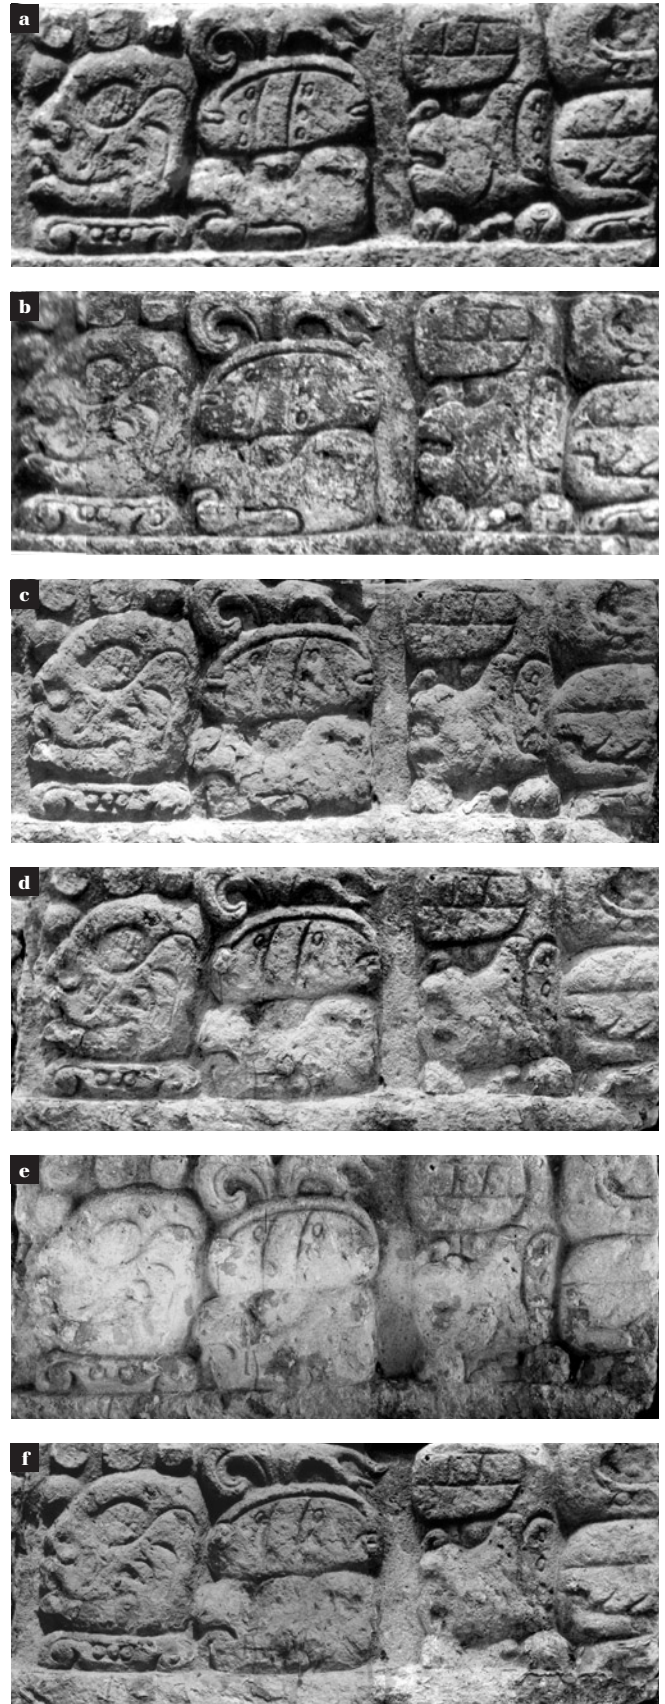
Figures 45a–f A series of historic photographs of block 409, step 45. Ca. 1895 (a), 1946–48 (b), 1979 (c), 1987 (d), 2000 (e), and 2005 (f).

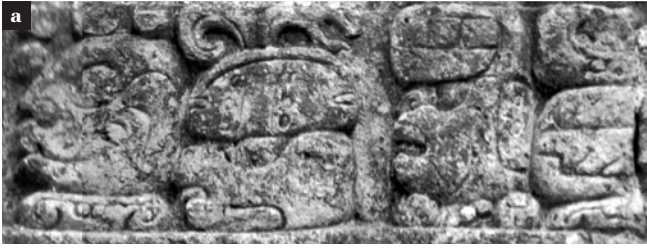
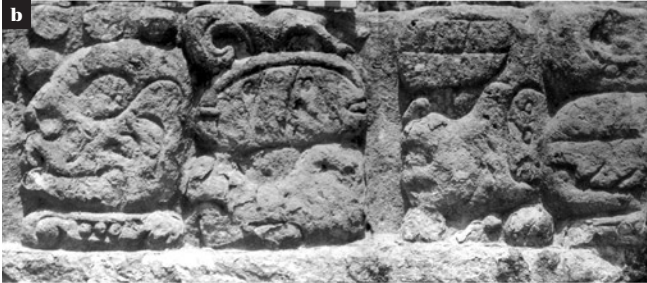
A comparison of the condition of the stone during the first forty years after excavation and the condition during the second forty years shows a very significant difference. That difference is related to the fact that during the first forty years, the blocks were located above ground on the Plaza. Subsequently, the blocks were placed on the reconstructed side of the pyramid, a location in which they were far more exposed to an aggressive and changing environment.

Figures 46a and b Block 409 in 1946–48 (a) and in 1979 (b).

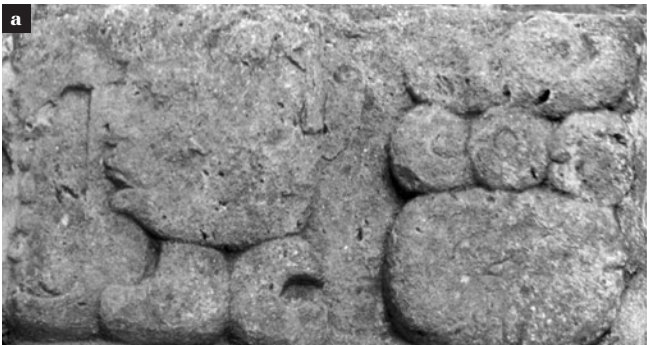
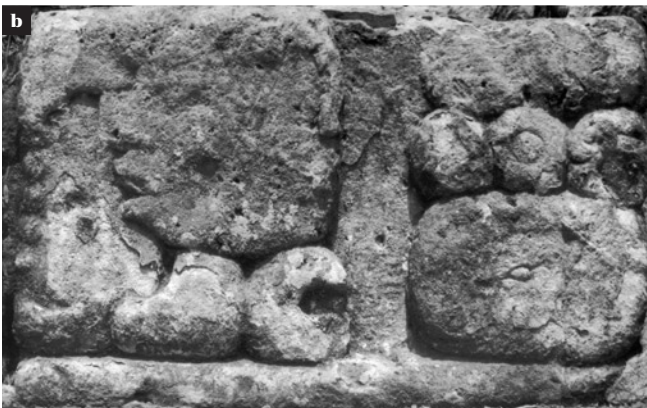
Figures 47a and b Block 545 in 1946–48 (a) and 1979 (b).

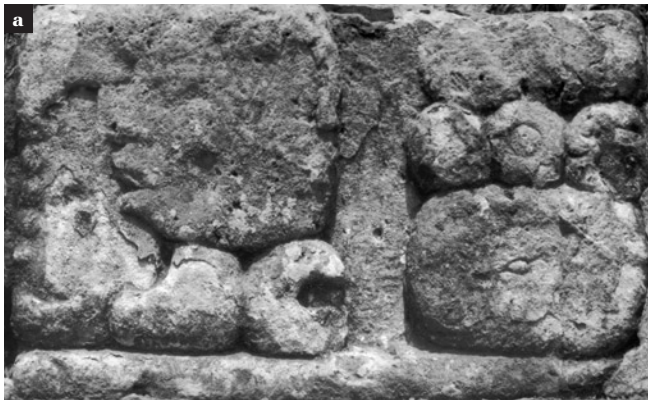
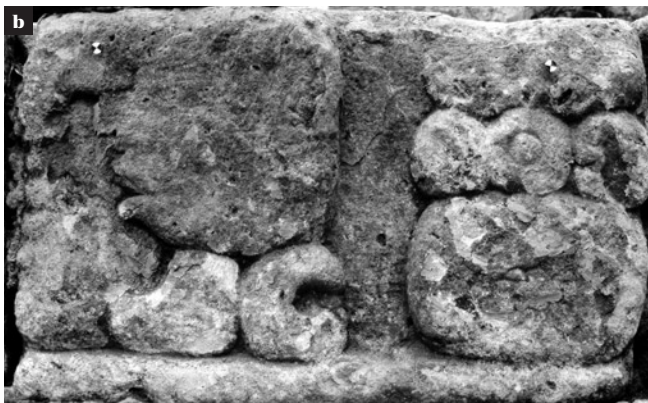
Figures 49a and b Block 345 in 1979 (a) and 2003 (b).

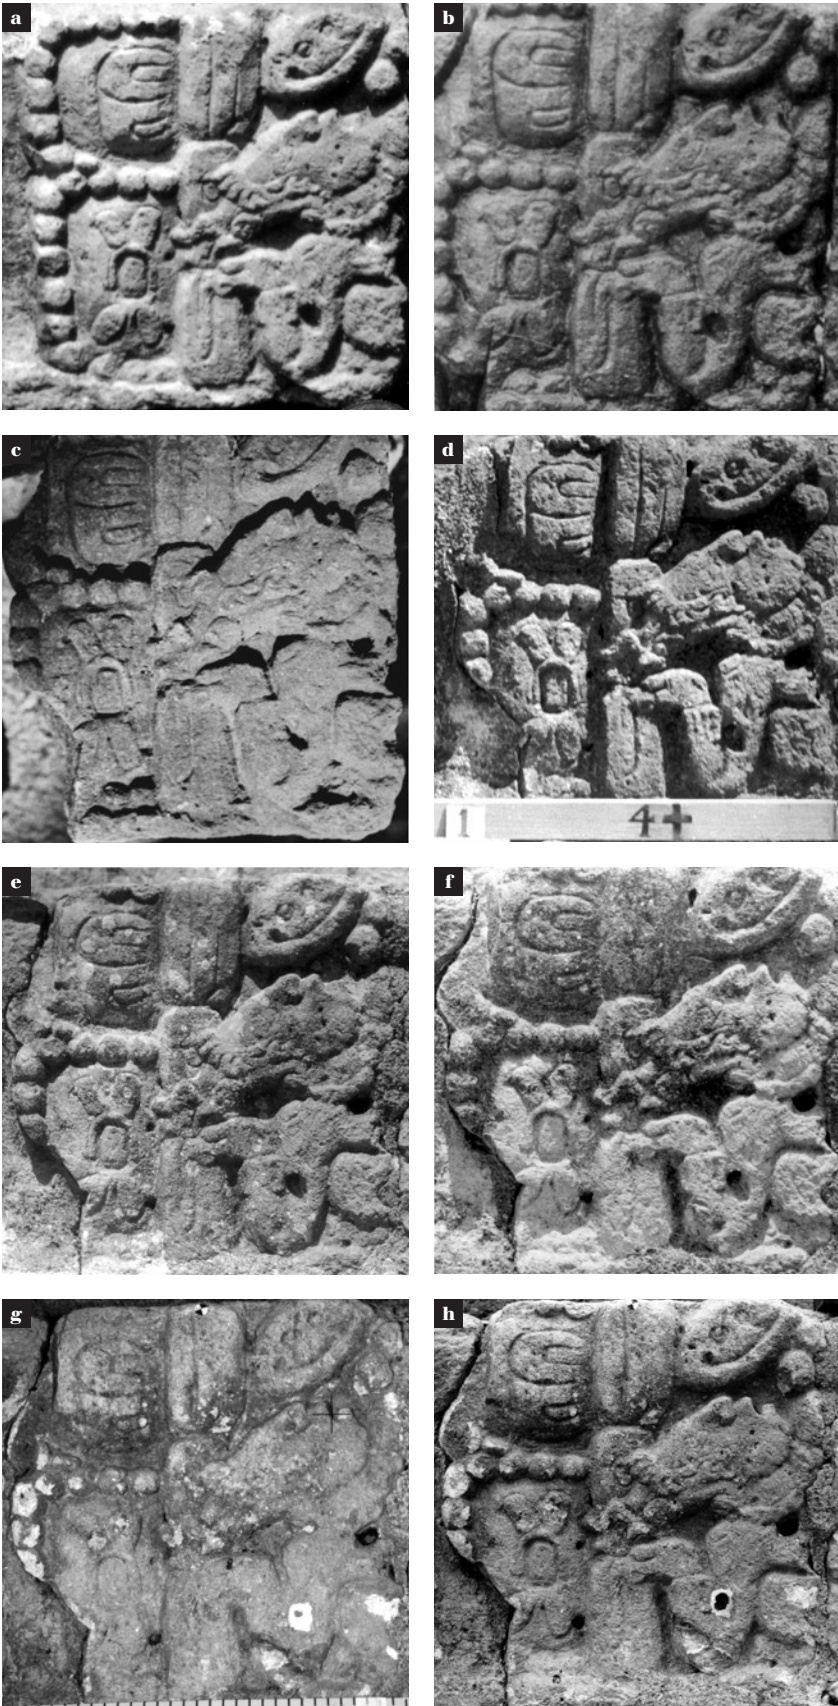
Figures 50a–h A series of historic photographs of block 594, step 65. Ca. 1895 (a), 1915 (b), 1937 (c), 1946–48 (d), 1979 (e), 1987 (f), 2000 (g), and 2003 (h).
