Seismic Retrofitting Guidelines for the Conservation of Doctrinal Chapels on the Oyón Highlands in Peru

Patricia Navarro Grau, Julio Vargas Neumann, and Maribel Beas

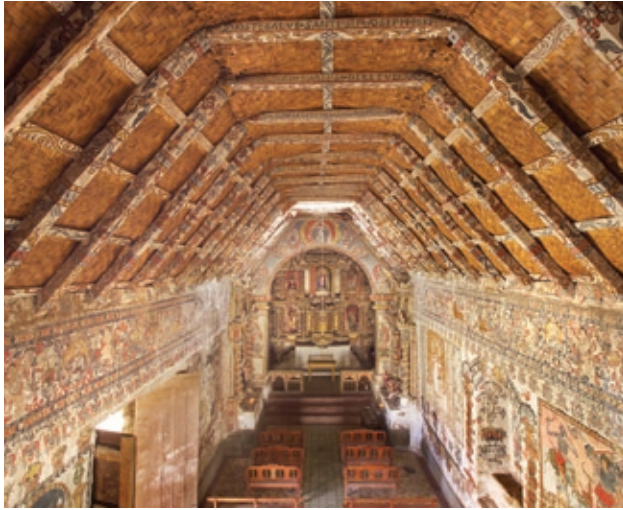
The interior wooden roof trusses are the pair and knot type, spaced 80 cm (31.2 in.) from each other and laid over a bond beam on top of the walls (fig. 2). Secondary wooden rafters resting over the upper wall beams support exterior metallic corrugated sheets. The condition of these wooden elements is structurally acceptable because of the dryness and the altitude of the Andes. Areas exposed directly to the weather and moist walls have mold and show deterioration.

FIGURE 2 Interior of the Rapaz Missionary Chapel showing roof construction. Photo: Daniel Giannoni.

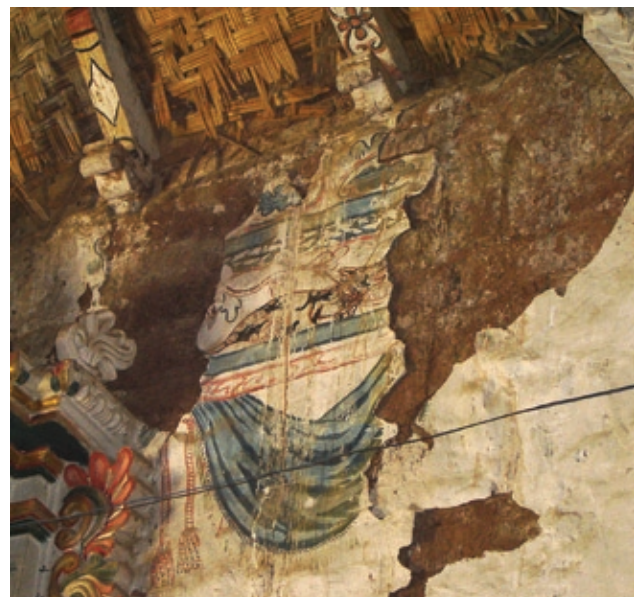
There are three sources of wall moisture in the chapels. The first one is rainwater that falls directly onto the roof. When the roof leaks, water reaches the walls. This moisture is concentrated in the upper sections of the walls and can be detected by the deterioration of mural painting and stucco in these areas (fig. 3). The second source is the effect of rainwater and wind falling laterally on the exterior walls, degrading the plaster and leaving the adobe support exposed to weather conditions. The third is rainwater moisture that rises through capillarity, causing significant damage on lower sections of the wall, especially inside the chapels where decorated finishes are found.

FIGURE 3 Moisture damage at the top of the walls, Rapaz Missionary Chapel.

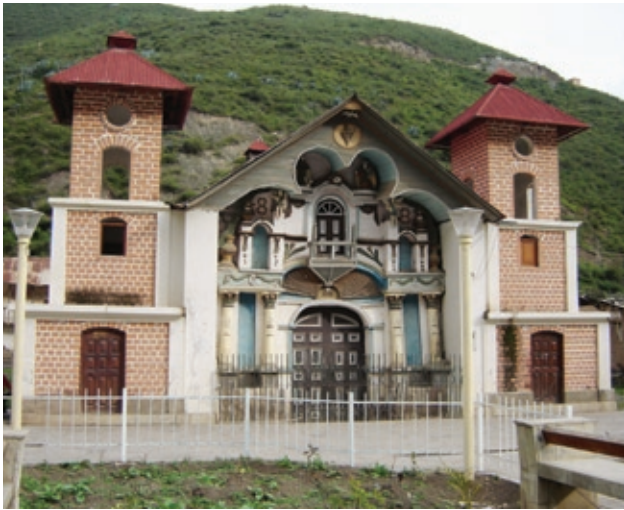
FIGURE 4 Incompatible materials used at Huacho sin Pescado Missionary Chapel.

through ignorance of adobe techniques and the incompatibility of materials, spend money trying to protect their chapels by using cement plaster on exterior and interior walls to prevent humidity penetration. New concrete elements (columns, towers, interior plaster) tied to the adobe walls have also been built (fig. 4).

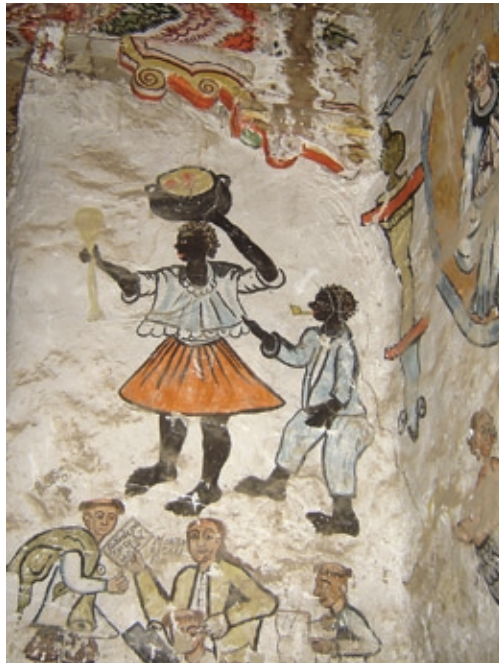
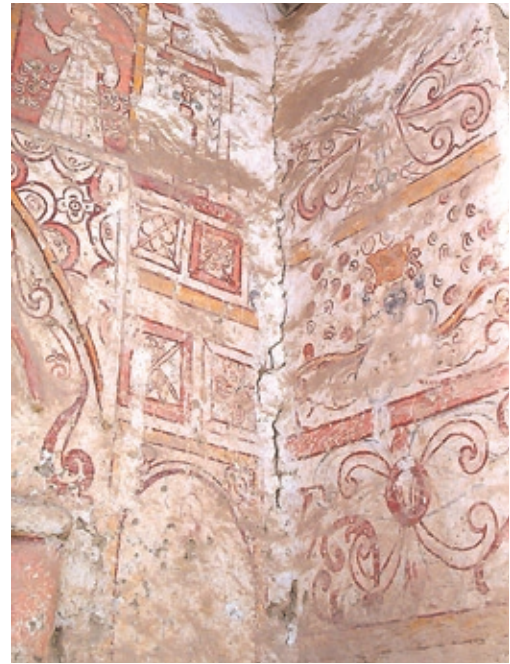
The L-shaped floor plans of the chapels are asymmetrical and irregular. In the event of seismic activity, the walls tend to vibrate independently, and the stresses are concentrated at the wall joints because of the lack of flexure and shear deformation compatibility. These vertical lines at the wall intersections or at the wall and buttress junctions are the cause of major cracks evident in the chapels.

FIGURE 7 Typical vertical seismic cracks at the wall intersections, Church of Rapaz.

Because of the importance of the mural paintings along the interior and exterior walls (fig. 7), it is extremely difficult to repair these cracks without intrusion. The traditional solution for large crack repair was to demolish parts of the wall and rebuild them, producing an effective structural integration and recovering monolithic behavior. There are alternative repair methods yet to be developed, and studied in seismic tests in order to verify their effectiveness, such as sealing by injection of an adhesive grout. Use of grout injections that produce

rigid material, such as cement mortars, is not recommended because they create stiffness discontinuities in the masonry. These discontinuities would concentrate stresses and cause new cracks during an earthquake. The current state of the art of the injection technique does not guarantee the real structural integration of the walls that is needed to recover a monolithic behavior.

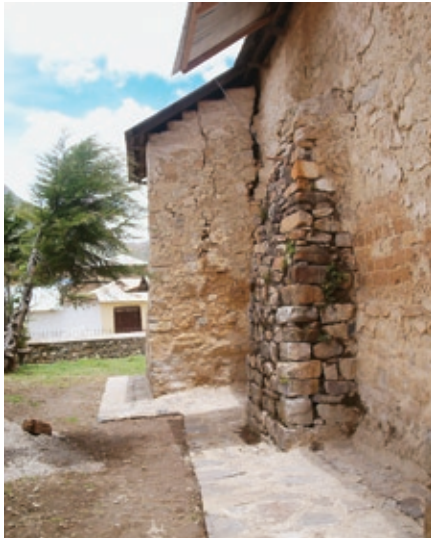
FIGURE 8 A perimeter stone walkway diverts water from the foundation walls.

- Avoid rainwater penetration by replacing the deteriorated metal roof sheets and enlarging or oversizing the washers at the points of attachment.
- Avoid rainwater penetration by installing new glass in the chapel skylight.
- Construction of a perimeter stone walkway that slopes away from the monument to prevent groundwater accumulation along the foundation walls (fig. 8).
- Conservation and consolidation of the retablos, wooden elements, main arches, and pulpits.

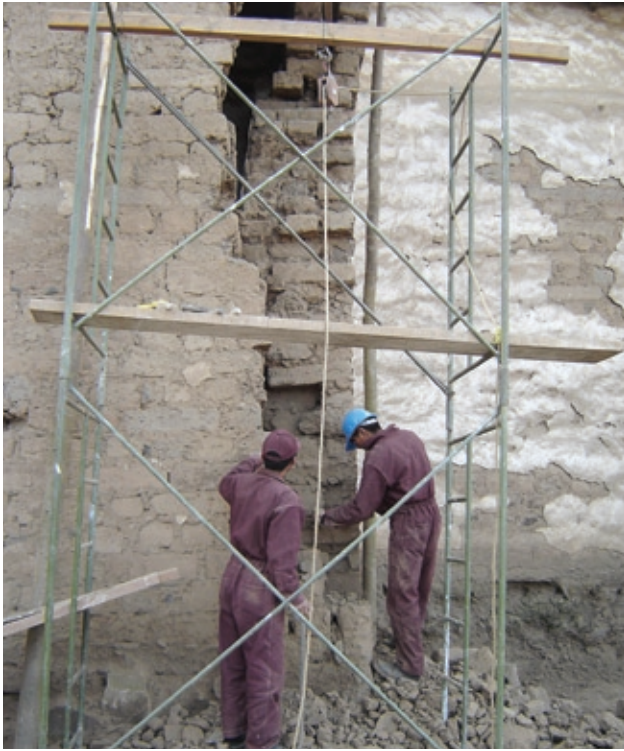
FIGURE 10 Damaged corner in the process of being demolished and rebuilt, San Pedro de Navan.

- Cracks in the sacristy and baptistry walls were repaired in the traditional way, since there was a lack of evidence of mural painting on the interior and exterior surfaces (fig. 10).
- We performed field tests to check strength and microcracking in the adobe, in an effort to optimize the seismic strength of the adobe masonry (Vargas N. et al. 1984; 1986, 257).

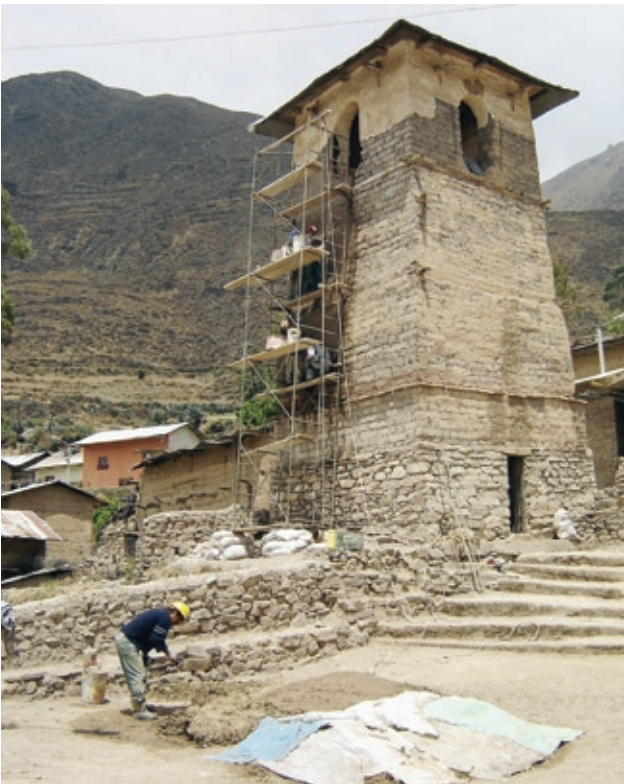
FIGURE 11 Bell tower in the process of being repaired, San Bartolomé de Curay.

The community of Curay asked Patrimonio Perú to restore the bell tower with funding by a locally operated mining company (fig. 11). We designed our working schedule in order to carry out the emergency works and the bell tower restoration at the same time. We had the hand labor of people in the community, and therefore we were able to instruct them on the earthen construction techniques and the field tests. Restoration of the bell tower included:

- removal of cement mortars
- filling of eroded areas with adobes and mud plaster
- application of mud and lime plasters
- application of color according to evidence found on the intrados of the high windows
