# Seismic Retrofit Applications of Getty Seismic Adobe Project Technology to Historic Adobe Buildings

E. Leroy Tolles

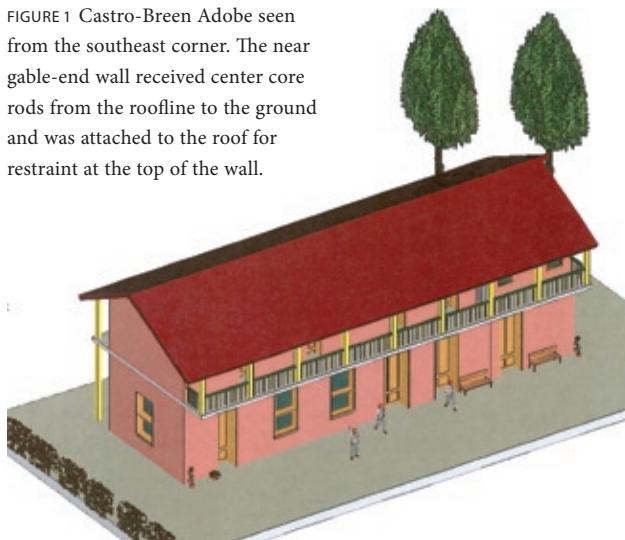
FIGURE 1 Castro-Breen Adobe seen from the southeast corner. The near gable-end wall received center core rods from the roofline to the ground and was attached to the roof for restraint at the top of the wall.

The south gable-end wall was anchored to the roofline, and the tile roof was removed from the edge

of the roof back 10 ft. (3.05 m) to provide room to reinforce the roof sheathing with plywood. Center core rods were placed in the wall from the tops of the walls to the ground level and anchored with a nonshrink, standard, commercially available nonmetallic cementitious grout. The average height of the wall was nearly 21 ft. (6.40 m), and the full height of the wall has a slenderness ratio of less than 7.6. A partial plywood diaphragm was installed and anchored to a horizontal steel rod. The locations of the elements of the retrofit system are shown in figure 2.

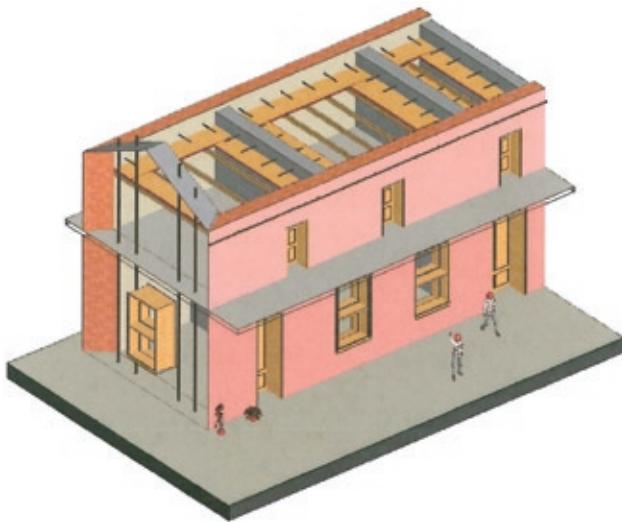
FIGURE 2 Selective use of full-height center core rods shown at the near gable-end wall, in the retrofit of the Castro-Breen Adobe. A partial plywood diaphragm with a horizontal exterior rod is used just below the roofline.

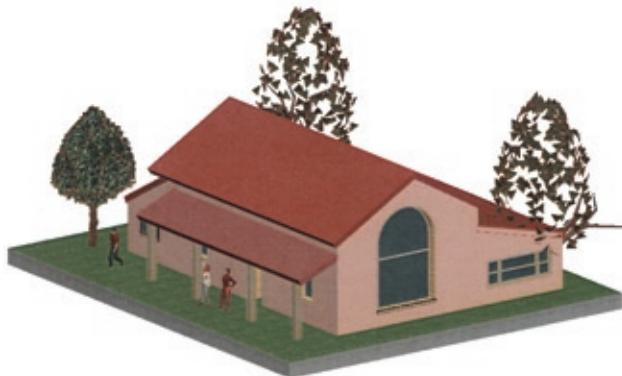
FIGURE 3 Casa de la Torre seen from the northeast corner. The retrofit included anchoring the adobe walls into the upper roof on all sides of the building; center core rods were also placed in the two walls that are visible.

Center core rods were installed into the north and east walls and anchored to the plywood roof diaphragm. The 0.75 in. (0.02 m) diameter center core rods were epoxy-coated steel reinforcing bars that were threaded on one end. The rods were placed in 2 in. (0.05 m) diameter holes that were then filled with a nonshrink cementitious grout. The north gable-end wall was already susceptible to collapse during strong ground motions, and the addition of the large window in this wall made it even more susceptible to severe damage or collapse. The long east wall is attached to the porch roof, but there are no transverse walls to provide additional lateral support. Therefore, full-height center core rods were also installed in the east wall.

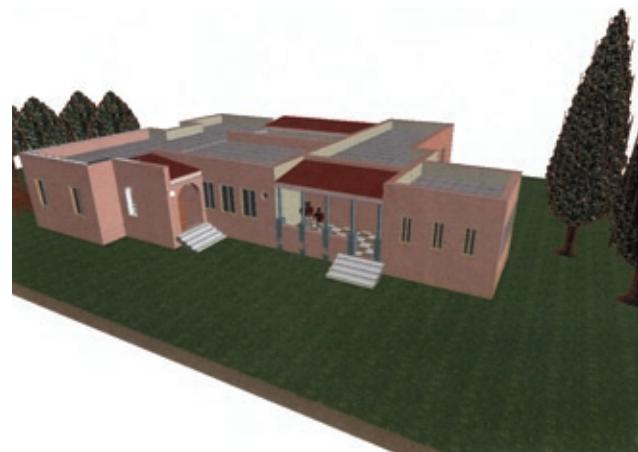
FIGURE 4 Small Adobe at Rancho Camulos seen from the northwest corner. The walls were retrofitted with center core rods throughout, because of the thinness of the walls and the large number of openings.

The principal stability issues for this building are relatively thin walls ( $S_L = 8$ ) and numerous doors and windows. To compensate for these features, which are not typical of historic adobe construction, center core rods were placed in all the walls. The rods are 0.75 in. (0.02 m) in diameter and were placed in 2 in. (0.05 m) diameter holes that were then filled with a nonshrink cementitious grout. The center core rods are placed at a maximum of 6 ft. (1.8 m) on center. In addition to the center core rods, there are anchors that connect the center core to the roof at 2 ft. (0.61 m) intervals.

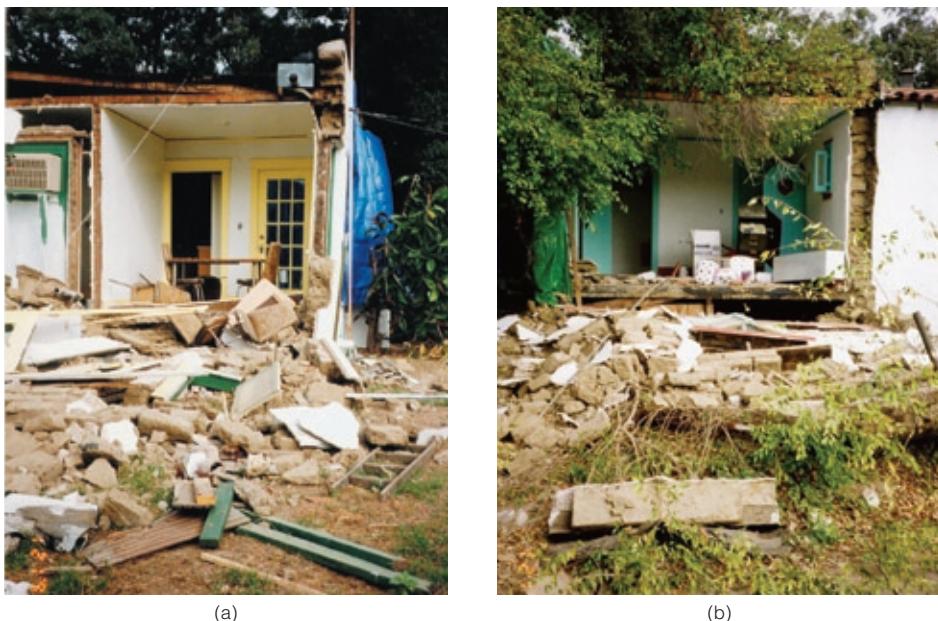
FIGURES 5A AND 5B Small Adobe at Rancho Camulos, which suffered severe damage during the 1994 Northridge earthquake. Shown here are the collapsed walls at the southwest corner (a) and the southeast corner (b) of the building.

The Small Adobe suffered severe damage from the 1994 Northridge earthquake. The south walls of two of the rooms along the south side of the building collapsed (figs. 5a and 5b). Other walls were damaged so severely that they needed reconstruction.

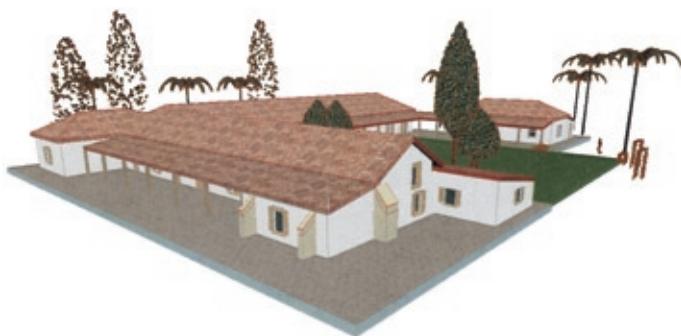
FIGURE 6 The Main Residence at Rancho Camulos seen from the southeast corner.

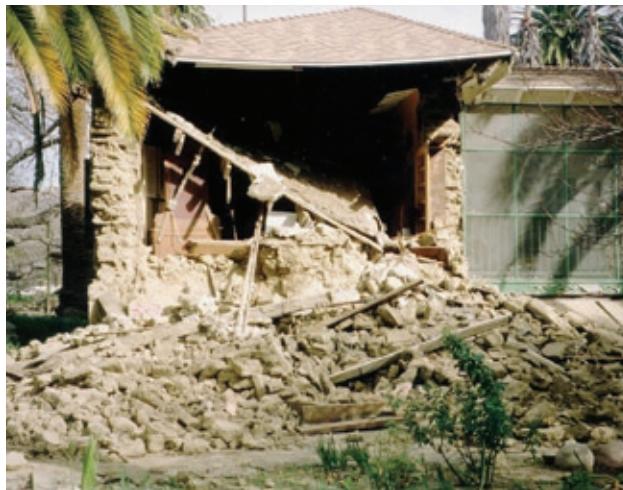
The Main Residence at Rancho Camulos also suffered serious damage during the 1994 Northridge earthquake, as shown in figures 7a and 7b. There was crack damage to many of the walls throughout the building. The walls of the bedrooms in the southeast and southwest corners of the building collapsed and required reconstruction.

FIGURES 7A AND 7B Severe earthquake damage to the Main Residence at Rancho Camulos. Collapse of the walls occurred in the southwest corner (a) and the southeast corner (b) of the building.

The retrofit of the Main Residence used a variety of retrofit techniques. The roof system was tied into the roof diaphragm with top-of-wall anchors attached with epoxy grout. The more severely damaged walls were reinforced with vertical straps on both sides of the walls. A perimeter cabling system was used throughout the building to provide longitudinal continuity to the walls. The second-floor framing was attached to the cabling system through the adobe walls. Finally, the walls that had collapsed were reconstructed with new adobe bricks and were reinforced with horizontal ladder ties in the mortar joint of every fourth course, and with vertical center core rods in 2 in. (0.05 m) diameter holes spaced at approximately 26 in. (0.66 m) on center; they were anchored in epoxy grout.

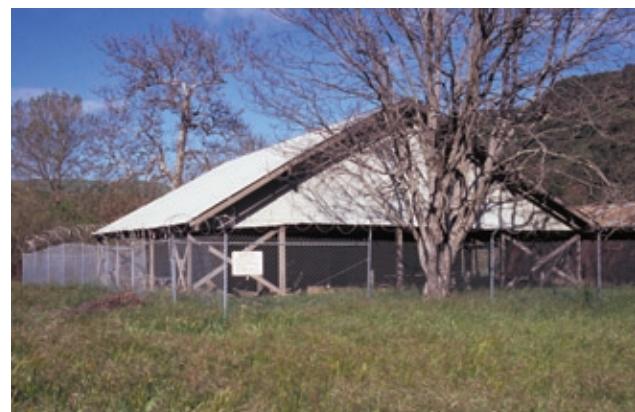
The Las Cruces Adobe was constructed in the 1840s and has been unoccupied since the early 1900s. A shelter was built over the site in the 1970s to protect the fragile ruins (fig. 8). The walls (fig. 9) and roof framing are both in poor condition. What remains of the building is original and indicative of the type of construction characteristic of that period.

FIGURE 8 Las Cruces Adobe covered by a wood shelter that protects the ruins. Photo: Gail Ostergren.

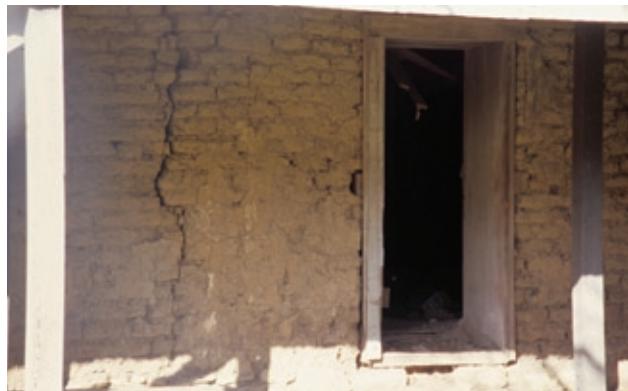
FIGURE 9 An interior wall of Las Cruces Adobe, representative of the general condition of the building. Photo: Gail Ostergren.

The goal of the retrofit was to have as minimal an impact as possible on the original building but to stabilize the ruins so that the public could access the building safely. To achieve these goals, a lightweight steel frame was designed to provide overturning stability to the walls. To increase the effectiveness of the steel frame, viscous dampers were added which allowed the steel frame to be even lighter than the original design. By increasing the damping of

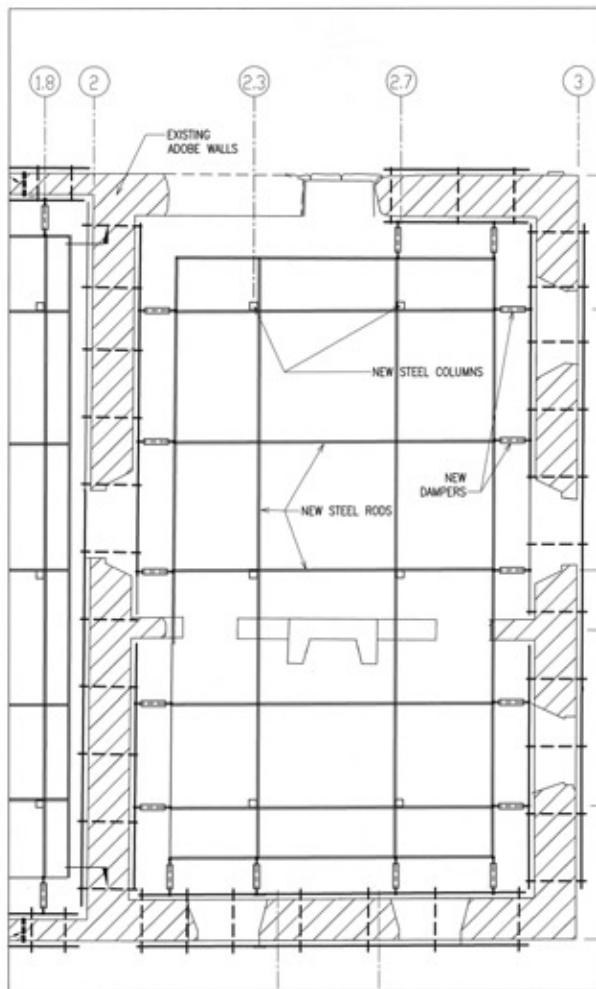
FIGURE 10 Lightweight steel frame designed for Las Cruces Adobe.

the support frame, the viscous dampers would also significantly decrease the displacements that might occur in larger seismic events. The framing system is shown in figure 10. The steel columns were 3.5 in. (0.089 m) square tubes, and the horizontal steel rods were 1 × 2 in. (0.025 × 0.05 m).
