Evolving Methodology in Seismic Retrofit: Stabilizing the Las Flores Adobe

John M. Barrow, Douglas Porter, Stephen Farneth, and E. Leroy Tolles

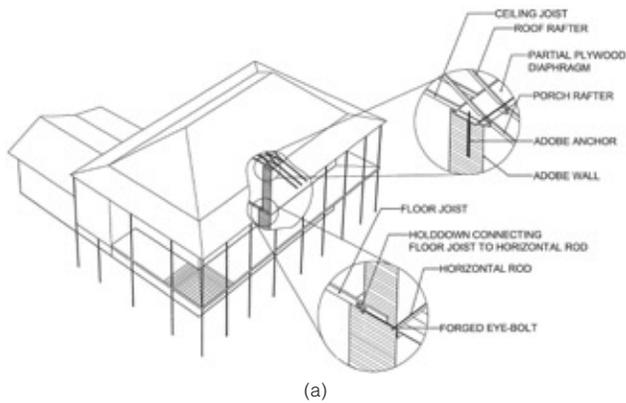
FIGURES 3A-C Las Flores Adobe retrofit design drawings. The design focused on providing lateral restraint at the tops of walls and at the level of the second-floor frame in the Monterey block (a); a section detail (b) and a plan detail (c) of the adobe anchoring system give specifics of the installation.

During the 2002 and 2003 seasons, the work was focused on the main house. The seismic retrofit consisted of the addition of a wooden bond beam to the tops of the

adobe walls, installation of center core pins, attachment of the roof frames to the tops of walls, and installation of a steel band around the exterior of the Monterey block at the level of the second-floor frame.

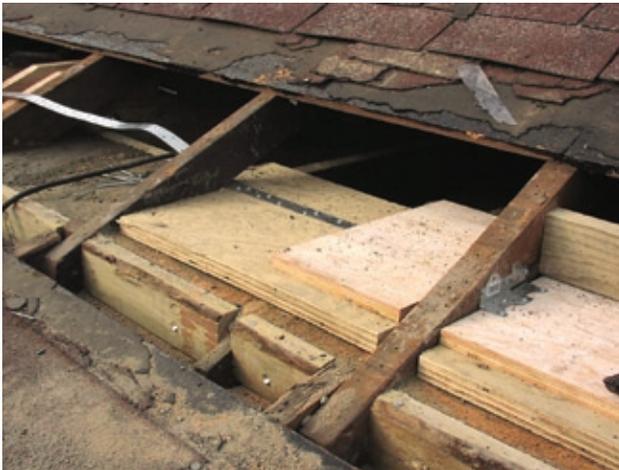
(a)

FIGURES 4A AND 4B Seismic retrofits for the main house. The tops of the walls were leveled by the addition of a pisé course. The wooden bond beam incorporated a stainless steel strap and was fastened to the walls with center core pins and to the roof frame with commercially available metal clips (a). At the level of the second-floor frame of the Monterey block, a stainless steel belt was installed below exterior plaster and tied back to floor joists with eyebolts and Simpson anchor brackets (b).

Where the tops of the adobe walls were uneven and out of level, the walls were capped with soil cement (portland cement and local soil mixed at a ratio of approximately 1 part by volume of portland to 5-7 parts

by volume of soil) applied in pisé technique. The plywood bond beam functions as a partial diaphragm and consists of two overlapping layers of pressure-treated material glued and nailed to provide longitudinal strength. Once the bond beam was placed, holes 2.5 cm (1.0 in.) in diameter were drilled down through the plywood and adobe wall center to a design depth of 80+ cm (31.2+ in.) to receive the threaded rod. Center core pins were set into the adobe with an epoxy grout. The epoxy selected for the project was a proprietary high-viscosity epoxy that is designed for stabilizing anchors into unreinforced masonry. Stainless steel strapping was nailed at 10 cm (3.9 in.) intervals on center along the top of the plywood, and each rafter was fastened to the plywood with a nailed-on Simpson L tie. Every other bolt was torque-tested to at least 27 kg (59.4 lb.) force to ensure good binding and grab in the section. This process proceeded linearly around the building until the interconnected strapping system was complete on both the one- and two-story sections (fig. 4a).

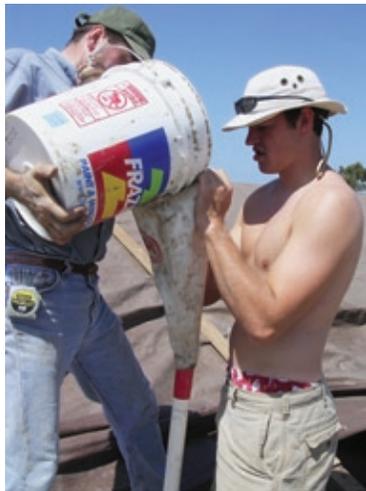
(a)

FIGURES 5A AND 5B Grout techniques for the Las Flores Adobe retrofit. For the carriage house, techniques were developed for installing an earthen grout (a). In contrast, the crew had used a resin-based grout for installing center core pins in the main house retrofit (b). The earthen grout is more compatible with the historic wall materials and provides greater possibilities for reversibility of the treatment.

Rods were fixed into place with a soil-cement grout (fig. 5a). This choice marked a major change in design and represents a desire for greater compatibility and reversibility of treatments. In contrast, the main house retrofit system relied on a resin-based grout with strength characteristics in excess of design criteria (fig. 5b). Earthen grouts are compatible with historic adobe materials and offer greater potential for reversibility and thus were chosen for the carriage house. The grout mix selected was similar to one developed by Nels Roselund (1990) and tested for use in the repair of the historic Pio Pico Adobe in Whittier, California; it consisted of adobe soil, sand, a small amount of portland

Low-tech methods were developed for placing the grout. An adobe test wall was constructed, and placement methods were developed and practiced until placement could be effected smoothly and consistently. A placement device was made by attaching a grout bag to a length of PVC pipe (fig. 5a). The pipe allowed placement to begin at the bottom of the holes, preventing voids due to trapped air bubbles. The method for placement involved filling the device with grout and twisting off the bag to prevent loss of material when transferring the grout to the hole to be filled. Holes were minimally prewetted with a 1:1 mix of denatured alcohol and water to retard absorption of the mix water by the wall materials. Workers placed grout in a prewetted hole by squeezing the grout bag and simultaneously withdrawing the pipe from the hole. Once the hole was filled to within 5 cm (2 in.) of the top, the threaded anchor was inserted. After setting, samples were exposed and visually evaluated with respect to shrinkage and voids. Sample anchors, set in grouted center cores in the test wall, were torque-tested to 88 Nm (65 ft.-lb.) to ensure that connections could be adequately tightened without failure of the grout.

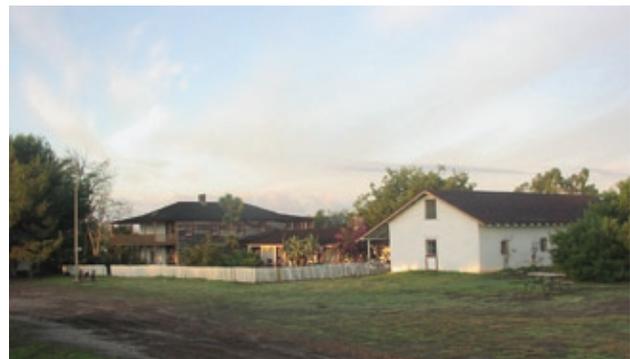
FIGURE 6 The Las Flores Adobe after completion of structural and seismic stabilization of the buildings. By the close of the 2004 construction season, porches on the Monterey block were reinstated, building envelopes were secured against weather, and interior rehabilitation was started.
