*Report on the partial re-excavation
of the Laetoli hominid trackway, Site G*

February 2011

The Getty Conservation Institute

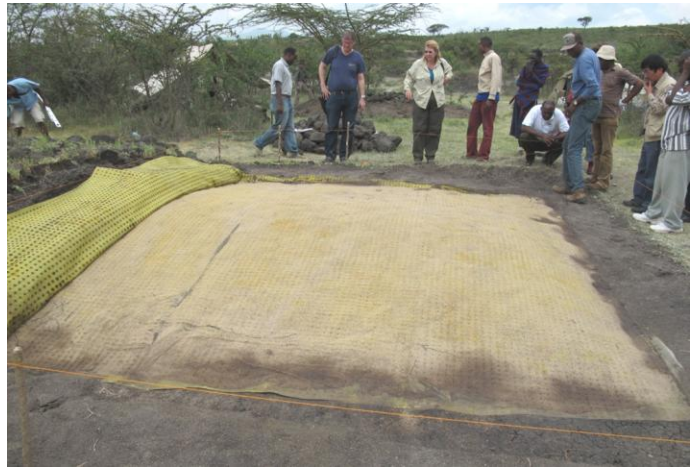
Surficial staining from Biobarrier 1 and impressions of nodules on Layer 3 after removal of Biobarrier.

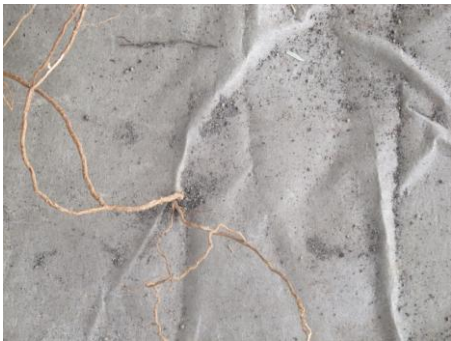
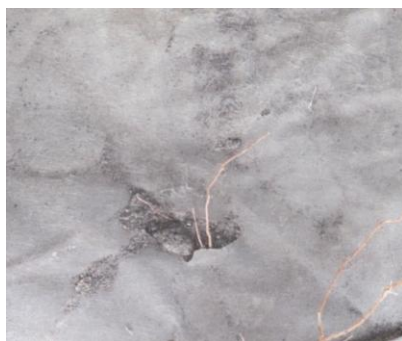
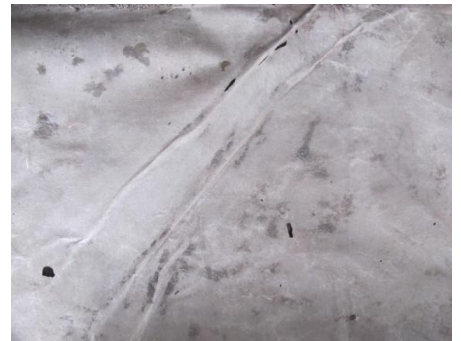
Roots penetrated geotextile in 2 places (left and center); holes may have been created by termites, allowing root access. Small holes created by termites in geotextile (right).

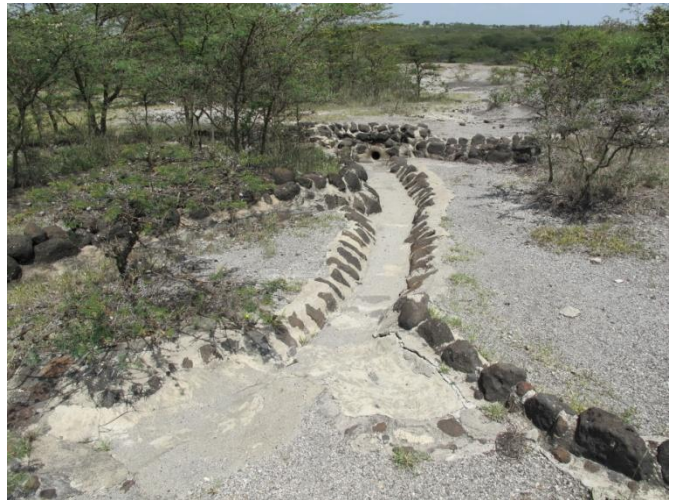
Inlet channel leading to main catchment sump; cement apron is cracking.

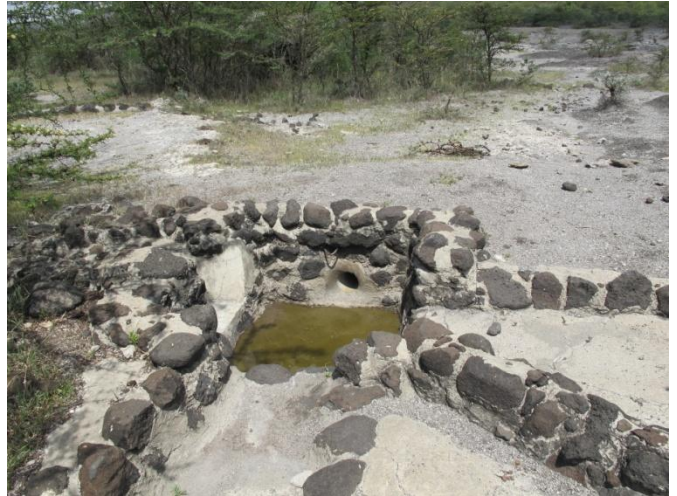
Catchment sump. Steel grill to prevent outflow pipe from clogging with vegetation is missing.

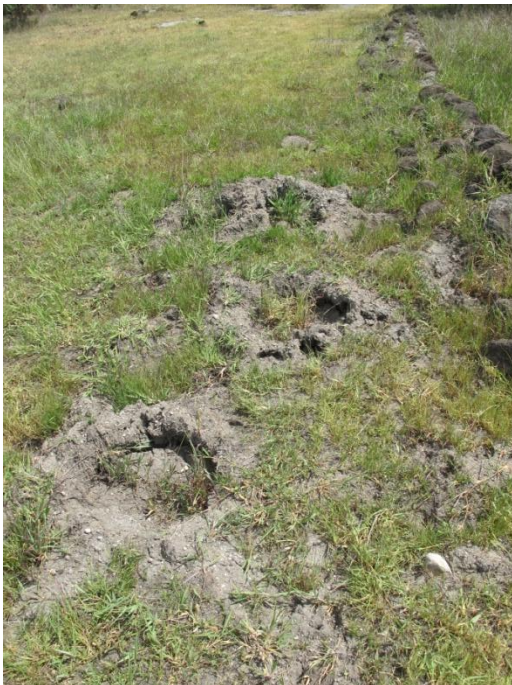
Elephant (and cattle) tracks in mud adjacent to berm where water accumulates. Thorn fence around Site G established in 1996 to deter animals from entering has been removed.

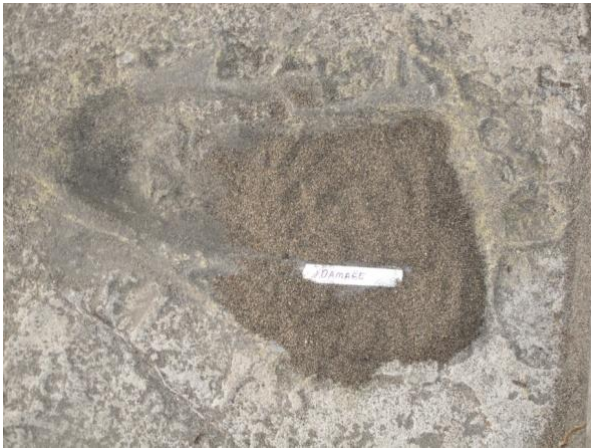
Damaged margin of print G2/3-27 protected with a piece of geotextile and labeled, with Layer 1 sand holding geotextile in place.

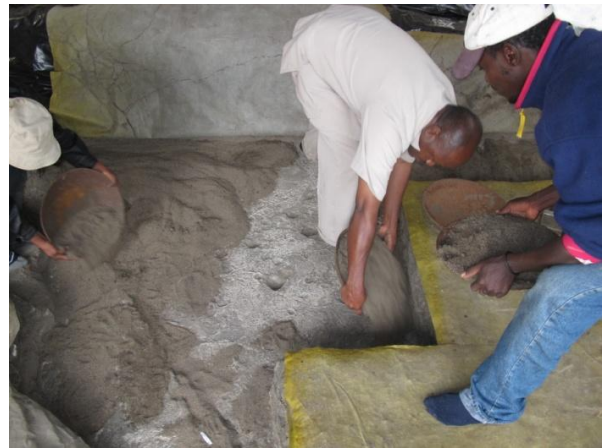
Placing Layer 1 on trackway surface. Detached piece of tuff on fault with damage label in foreground

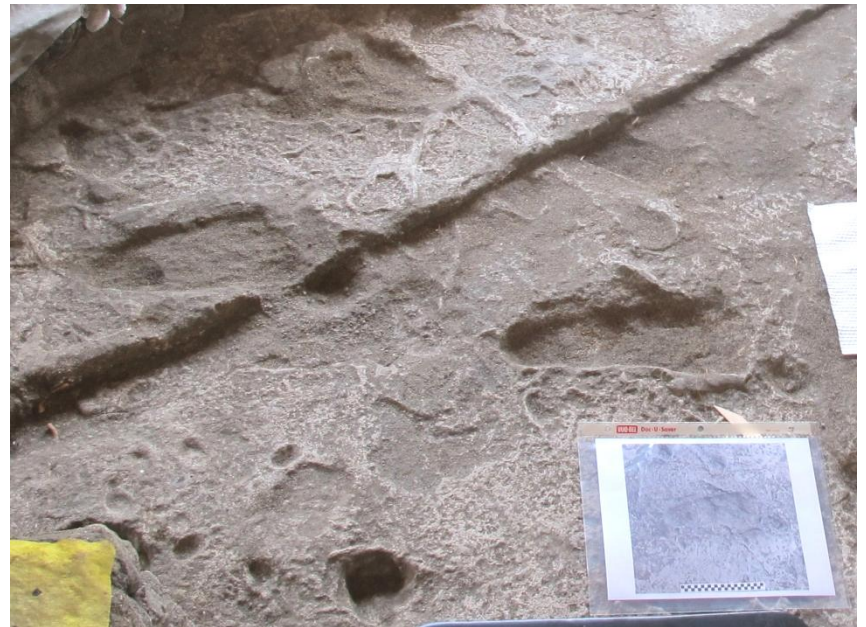
Trackway before final cleaning of tuff surface and with fill still in prints. Roots growing in Layer 1 are visible on the surface and penetrating tuff at the edge of Fault 1.

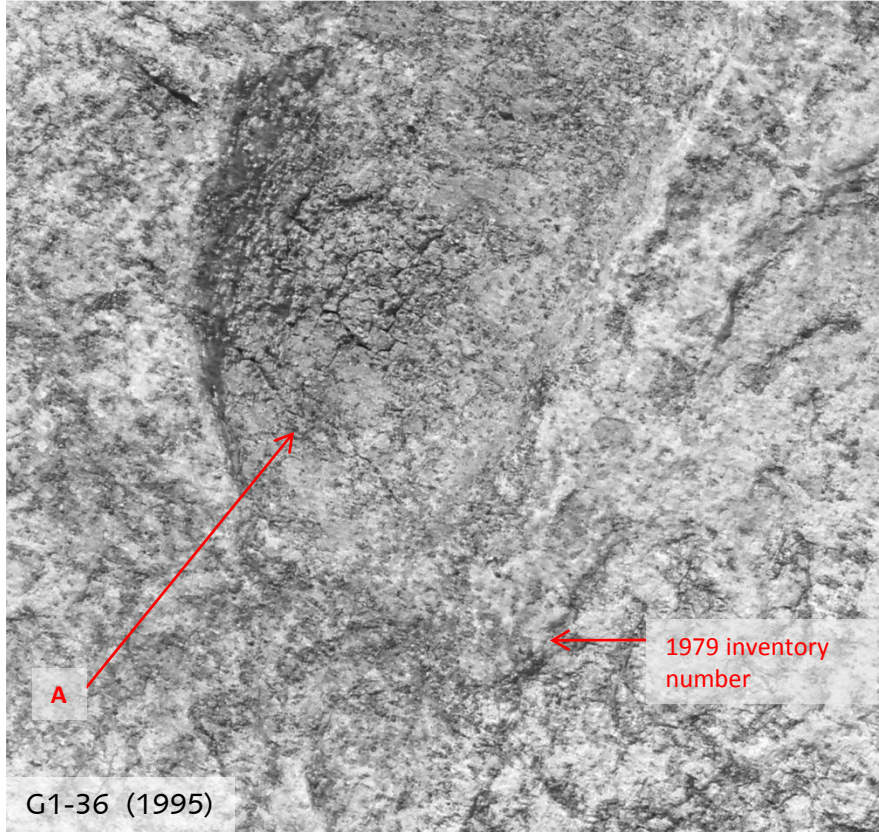
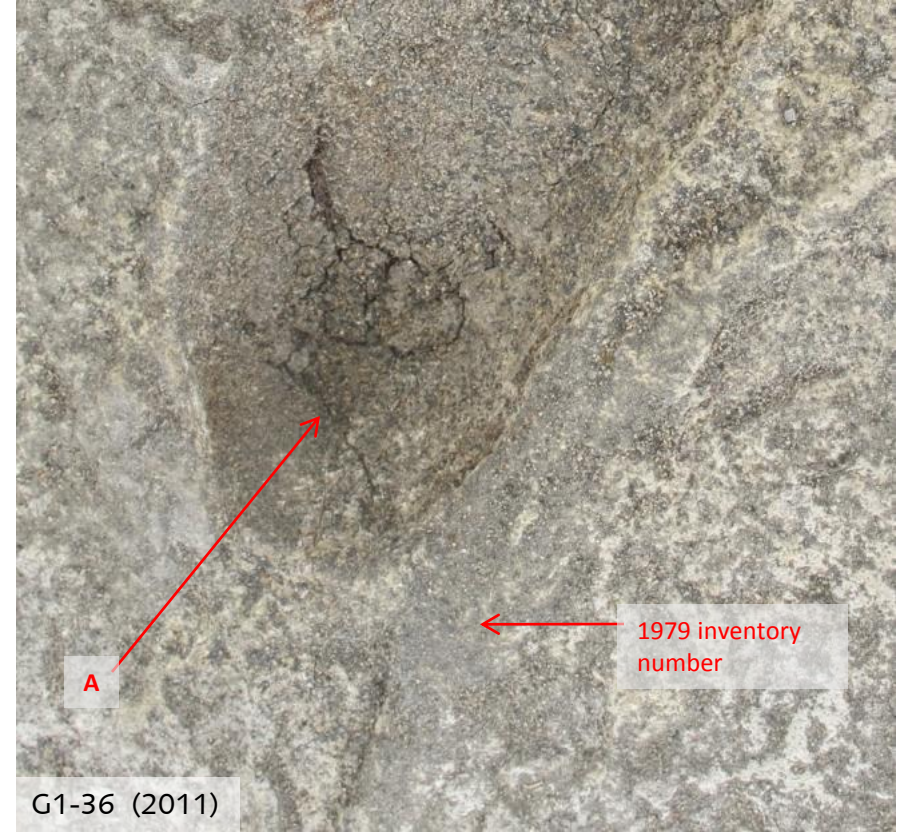
Close-up of the heel of G1-36 in 1995 and 2011. Transverse crack in heel (A) was visible in 1995 and was noted on photos and cast from 1979. Incipient cracking (possibly weathering) in heel recorded in 1995 has increased.

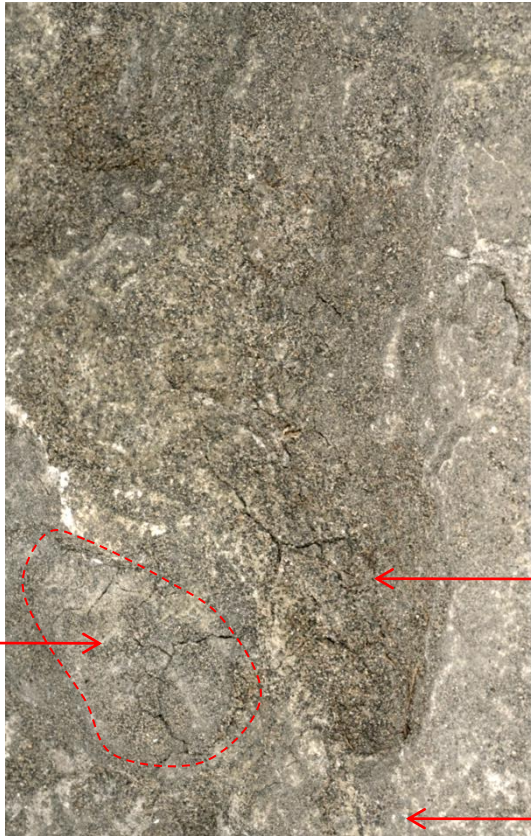
<p>1995 Condition General condition: Minor alteration/Good. [Moderate alteration/Fair]</p> <p>Tuff Conditions: Weathering: Slight weathering of the tuff along the lateral margin of print. Cracking: none. [Incipient cracking visible on the island of tuff west of the heel in 1995 has widened and cracks have propagated. Cracking in the heel and lateral margin of the print occur principally in the same area where weathering and cracking of Bedacryl layer were noted in 1995. Cracks were free of sand grains indicating opening occurred as a result of drying from re-excavation.] Losses: Minor loss of tuff outside margin of great toe and lateral margin of print. Detached/loose: none Powdering: none Other:</p> <p>Condition Related to 1978-79 [1995] Interventions: Bedacryl: Bedacryl covered the surface of the print and surrounding tuff. It was slightly deteriorated along the lateral print margin with numerous hairline cracks in Bedacryl layer, and outside the anterior margin. [Bedacryl visible as darkening on floor of print and distinct yellow halo around print] Embedding: Slight embedding noted in Bedacryl layer (not shown on graphic). [Moderate embedding and adhered sand grains] Silicone: Minor traces of silicone outside print margins. Excavation tool marks: none Inventory number on tuff: 1979 label ("1-39") visible on tuff surface. [Number partially visible] Other:</p> <p>Root damage: Rootlets, less than 1mm diameter, weaved in and out of the Bedacryl layer and a few penetrated the tuff along the lateral side, forming a root mat in the lateral heel portion. [Rootlets and hair roots penetrated tuff and cracks in heel and arch area]</p> <p>Insect activity: none</p>

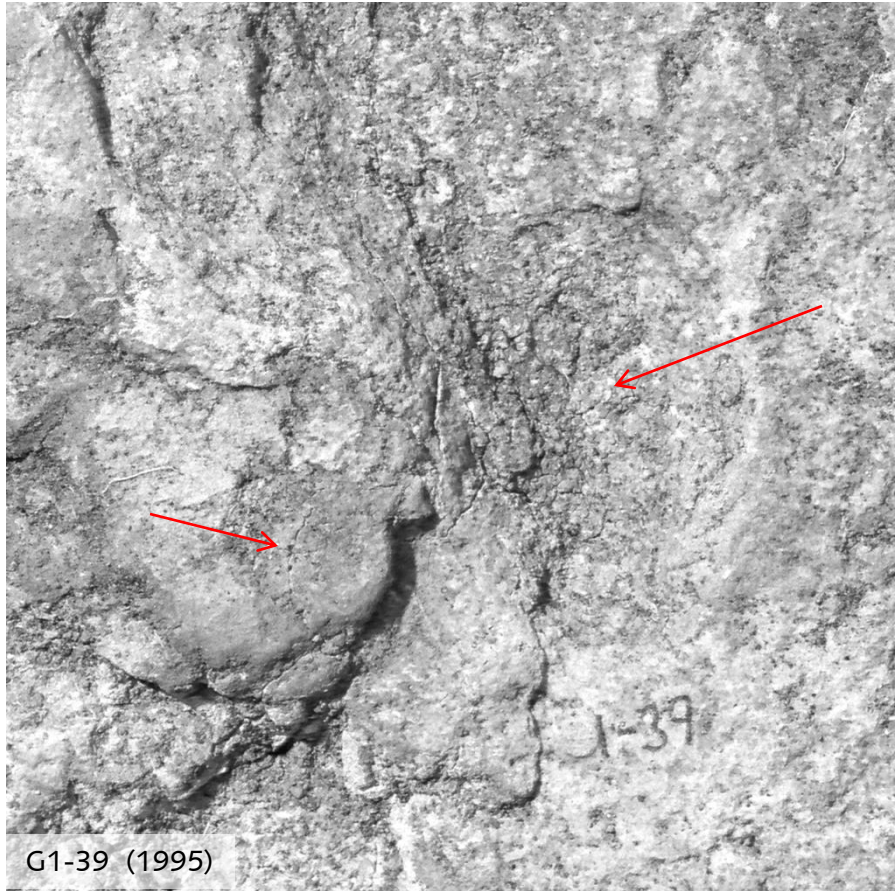
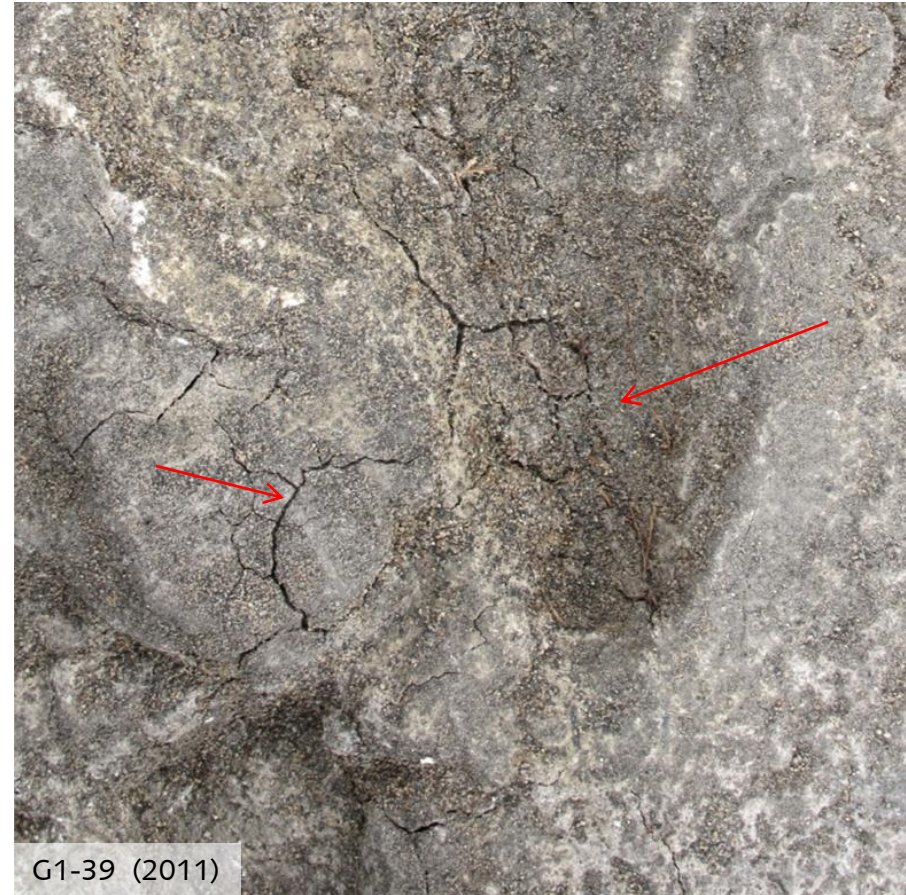
Close-up of the heel of G1-39 in 1995 and 2011. Incipient cracking on raised island of tuff and weathering along lateral margin and floor of heel, visible in 1995 and 1979 photos, increased and propagated on re-excavation and drying in 2011.

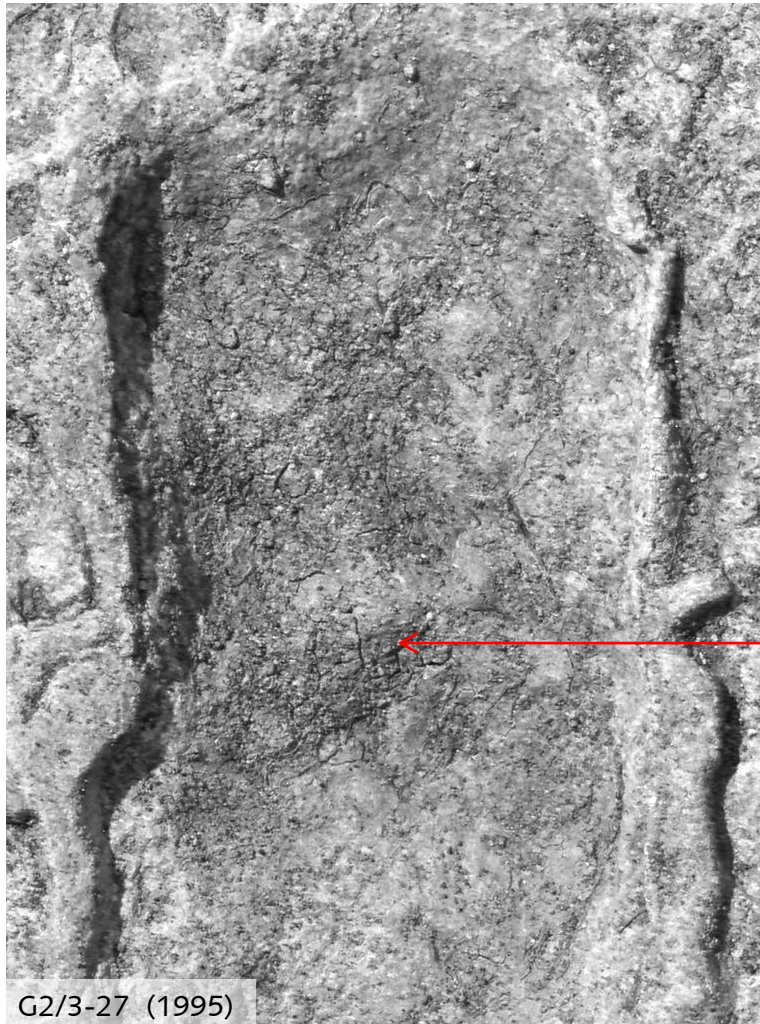
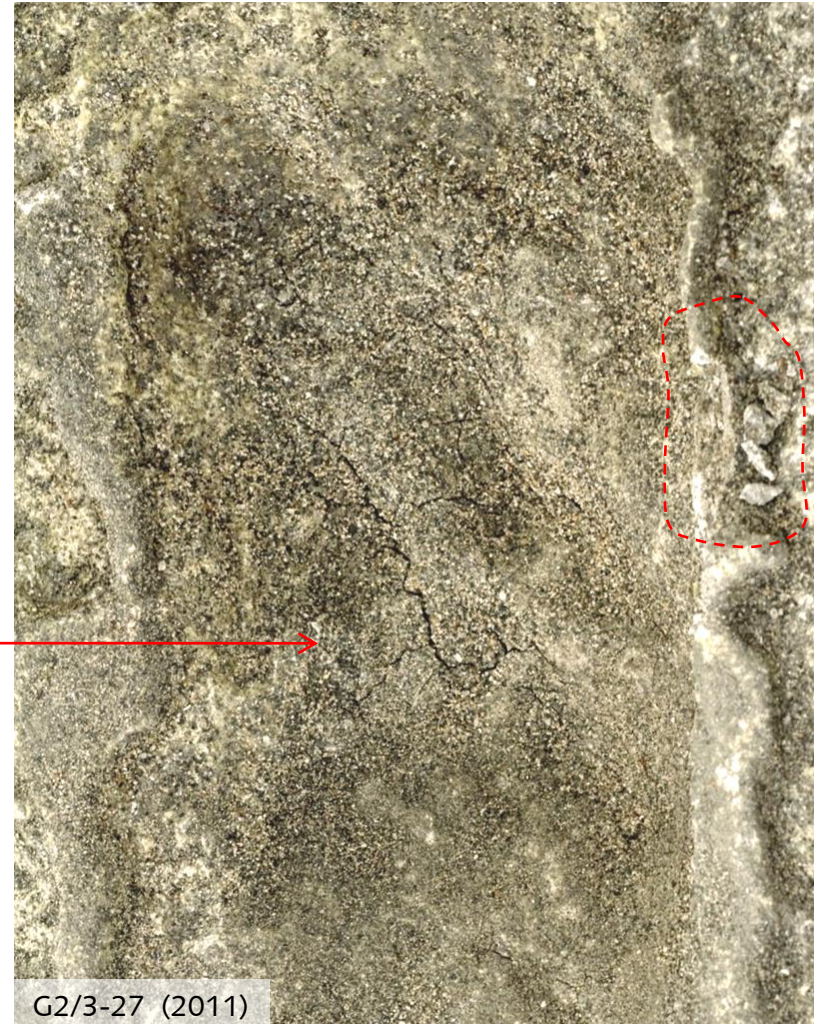
Mechanical damage: The 2011 re-excavation resulted in mechanical damage from excavation to the fossil termite burrow on print G2/3-27.

Close-up of the anterior portion of G2/3-27 in 1995 and 2011. Incipient cracking and weathering recorded in 1995 has enlarged and propagated on re-excavation and drying in 2011. Dashed line marks the area of mechanical damage to fossil termite tunnels; fragments are adjacent to broken area.

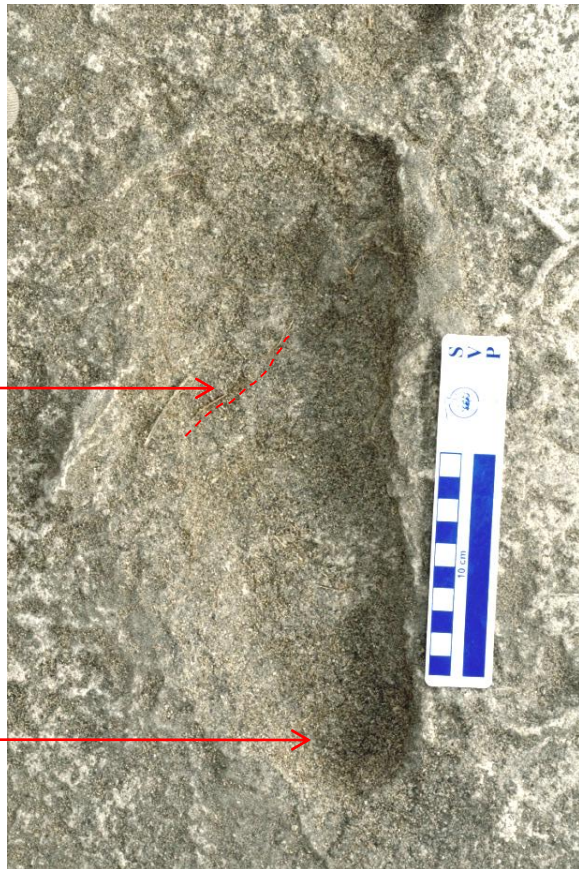
Rootlet penetrating tuff (larger root to the left is windblown fragment)

Incipient cracking

Root damage: Numerous rootlets on surface only. [Hair roots penetrate tuff and/or Bedacryl layer on floor of print. One rootlet runs across anterior portion of print weaving in and out of tuff]
Insect activity: none
1996 Interventions Consolidation/stabilization: none Fills: none Reattachment: Loose fragment of tuff outside anterior margin reattached with Paraloid B-72 [®] Root treatment: Surface rootlets removed. [Penetrating hair roots were not removed] Other: none
Comparison with 1978-79 Cast/Photograph Comparison with 1979 cast and photos showed loss of resolution on floor of the prints. Fine features, including tool marks clearly evident in the posterior portion of the cast, were obscured due to the thick layer of Bedacryl and fine particles of overburden embedded in the coating. Although consistently applied to all the well-preserved 1979 prints, no inventory number was visible <i>in situ</i> , nor could it be ascertained on the available photos.

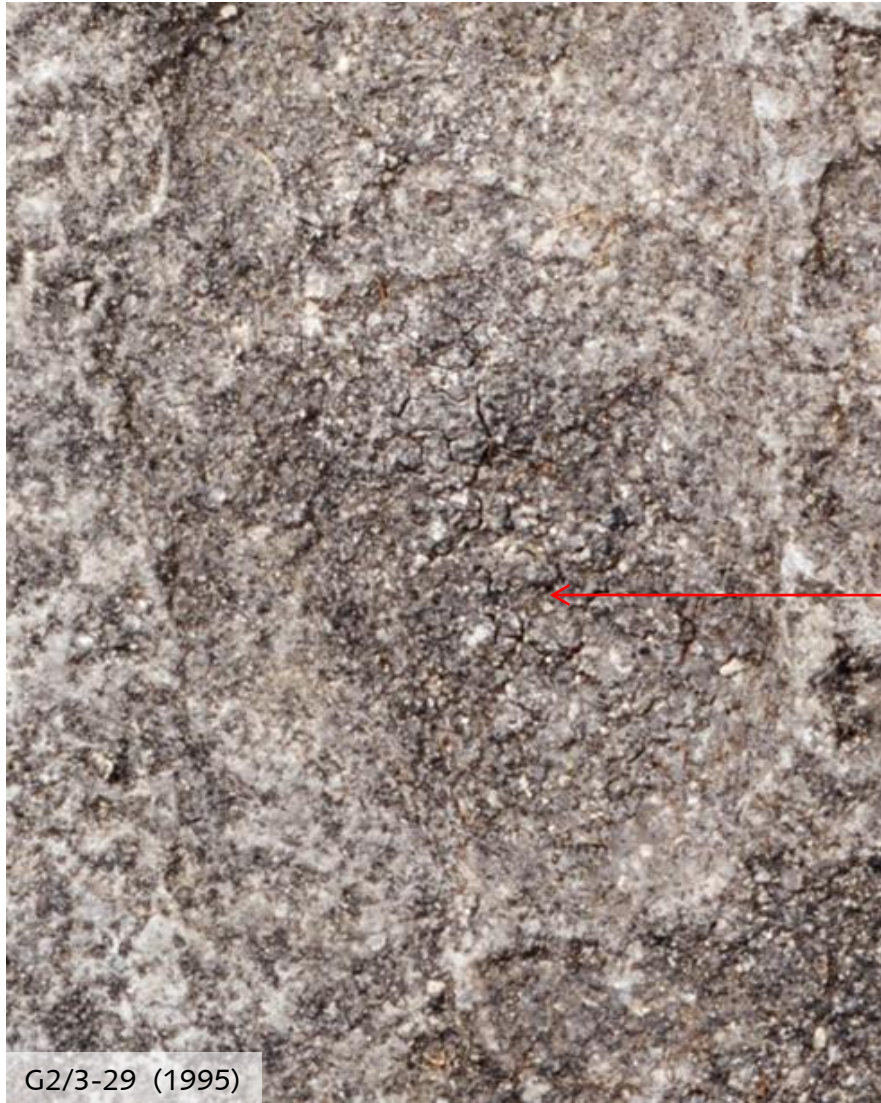
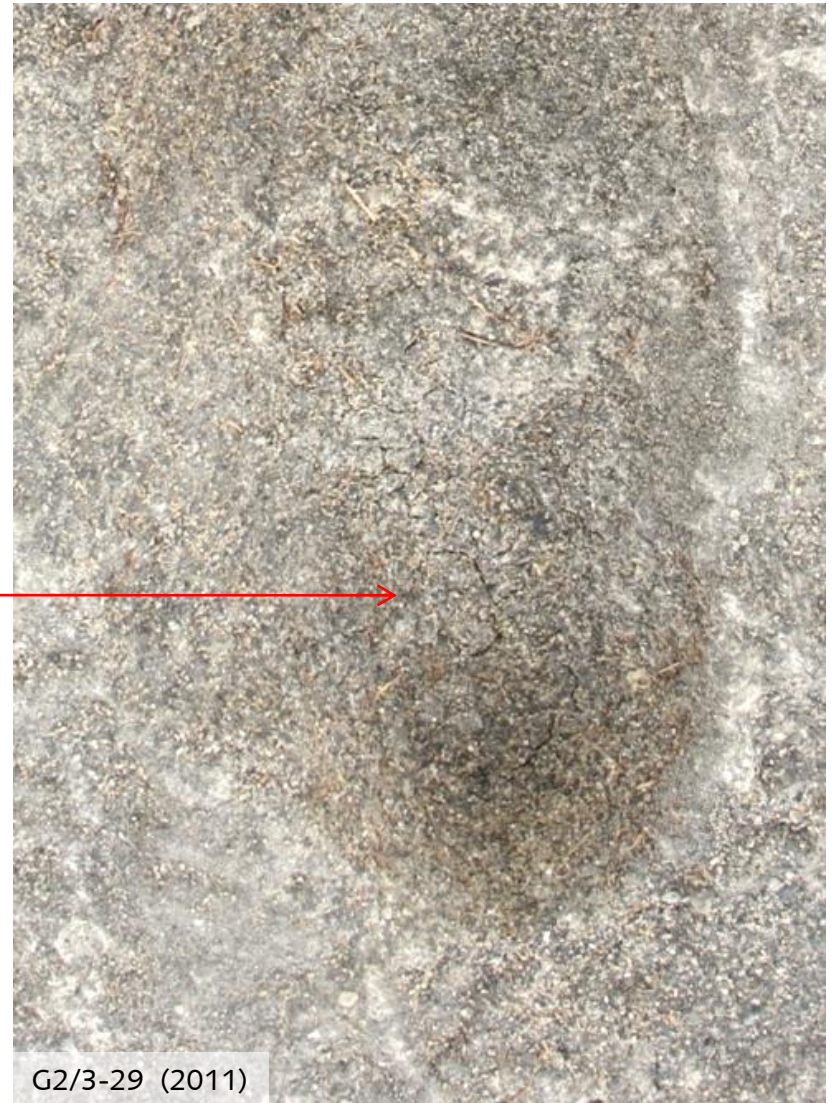
Close-up of heel of G2/3-29 in 1995 and 2011 showing incipient cracking in heel in 1995 slightly enlarged in 2011

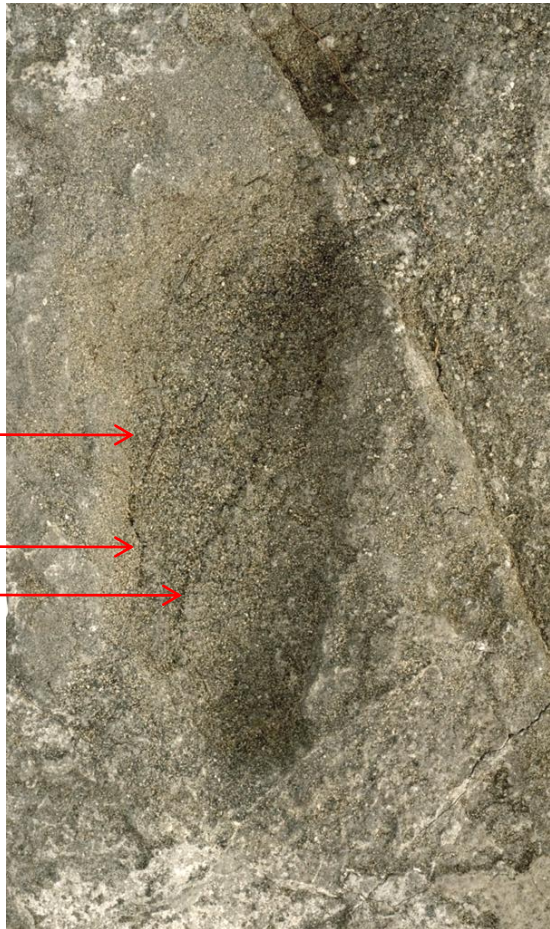
Rootlet in crack

Cracking on lateral margin and floor

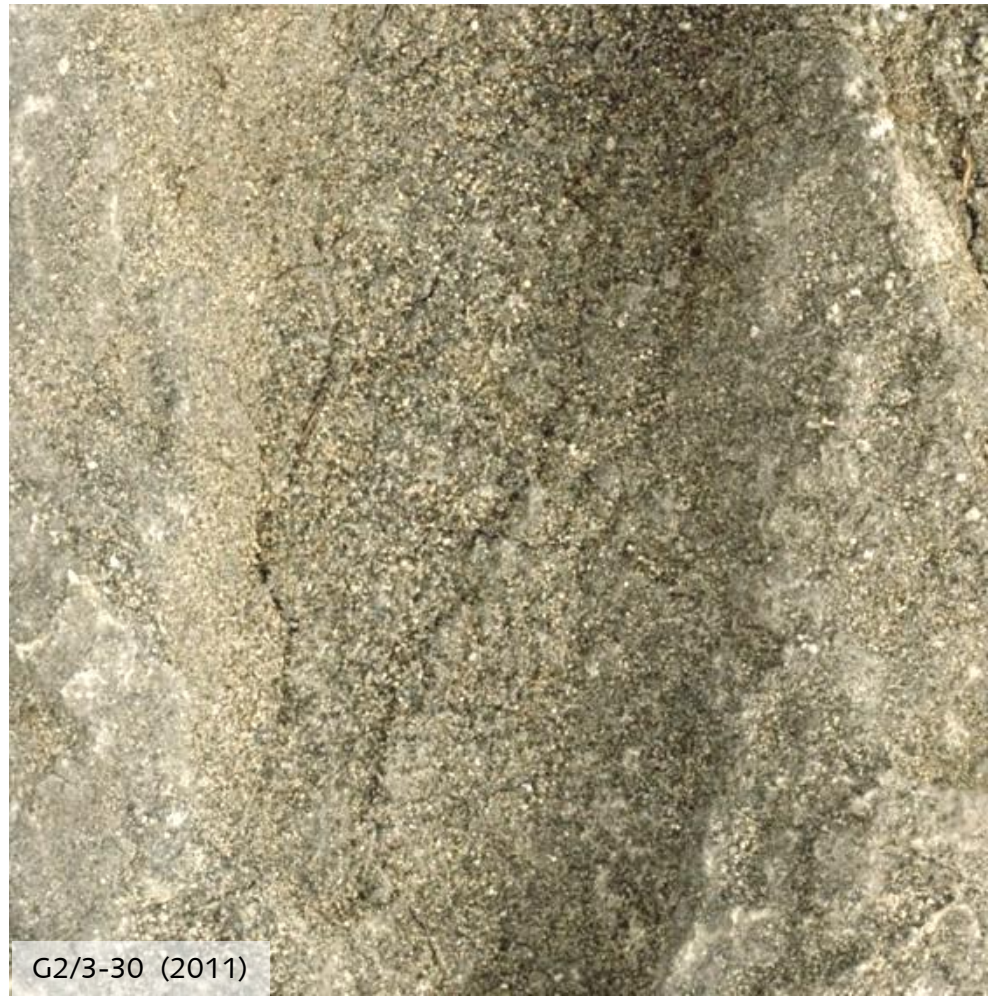
Close-up of G2/3-30 in 1995 and 2011 showing incipient weathering and hairline cracks in 1995 enlarged in 2011

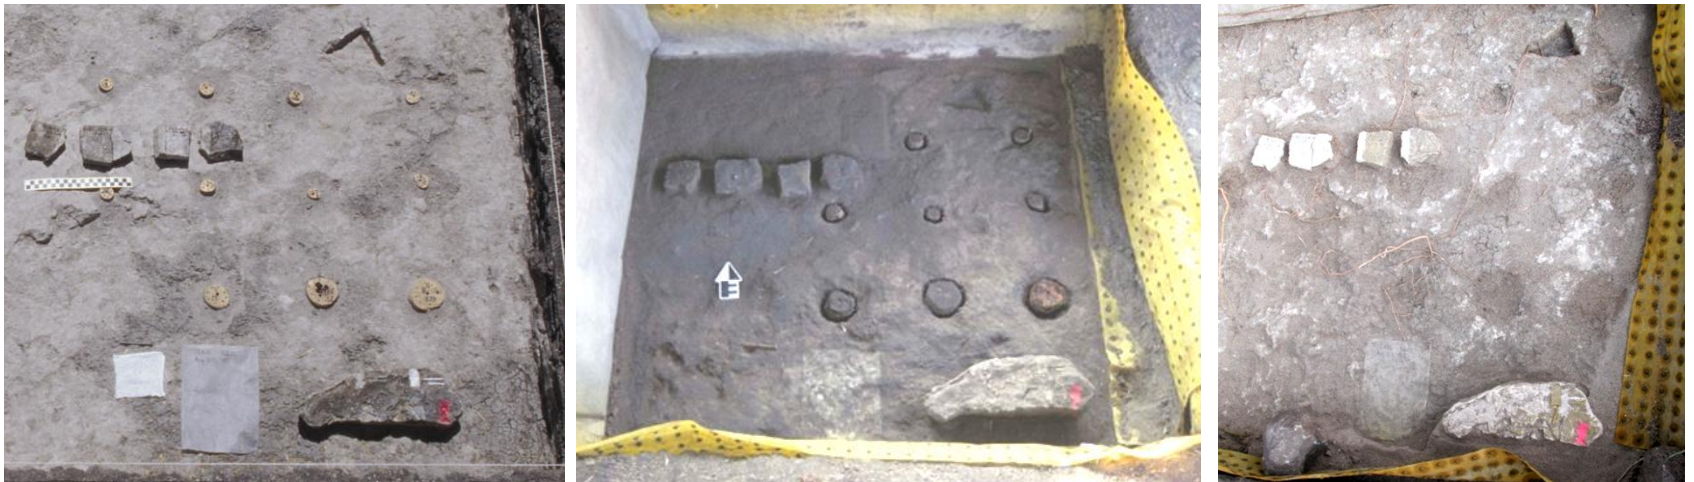
Quadrant 1 as established in 1995 (left), excavated in 1997 (center) and re-excavated in 2011 (right). Weathering and cracking of tuff floor can be seen in the 1995 photo around the geotextile and treated block.

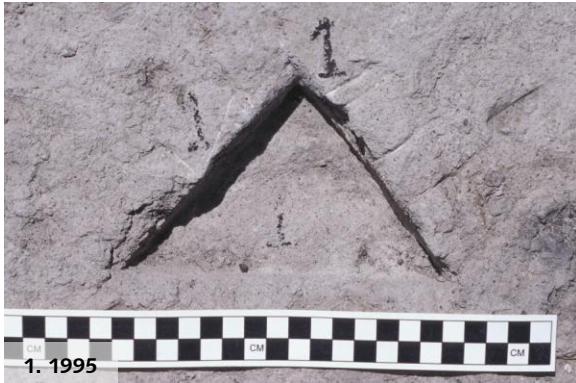
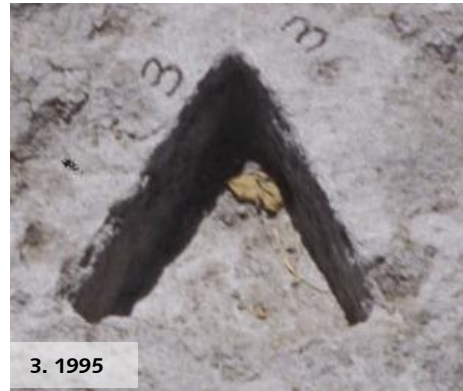
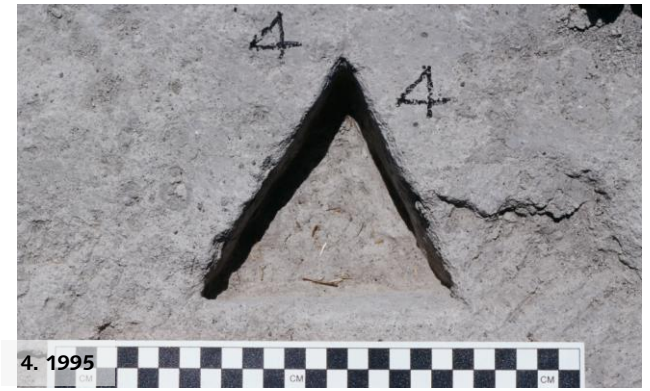
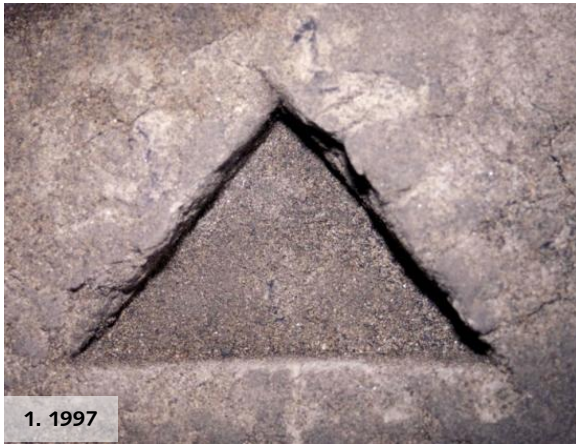
Monitoring triangles 1,3 and 4. Cracking of tuff has increased since 1995. The form, edges and score marks are little changed but obscured by embedding.
