# Seismic Retrofitting Project Modeling of Prototype Buildings

## Research Report

Paulo B. Lourenço, Federica Greco,  
Alberto Barontini, Maria Pia Ciocci,  
and Giorgos Karanikoloudis

THE GETTY CONSERVATION INSTITUTE  
LOS ANGELES  
TECMINHO – UNIVERSITY OF MINHO  
GUIMARÃES, PORTUGAL

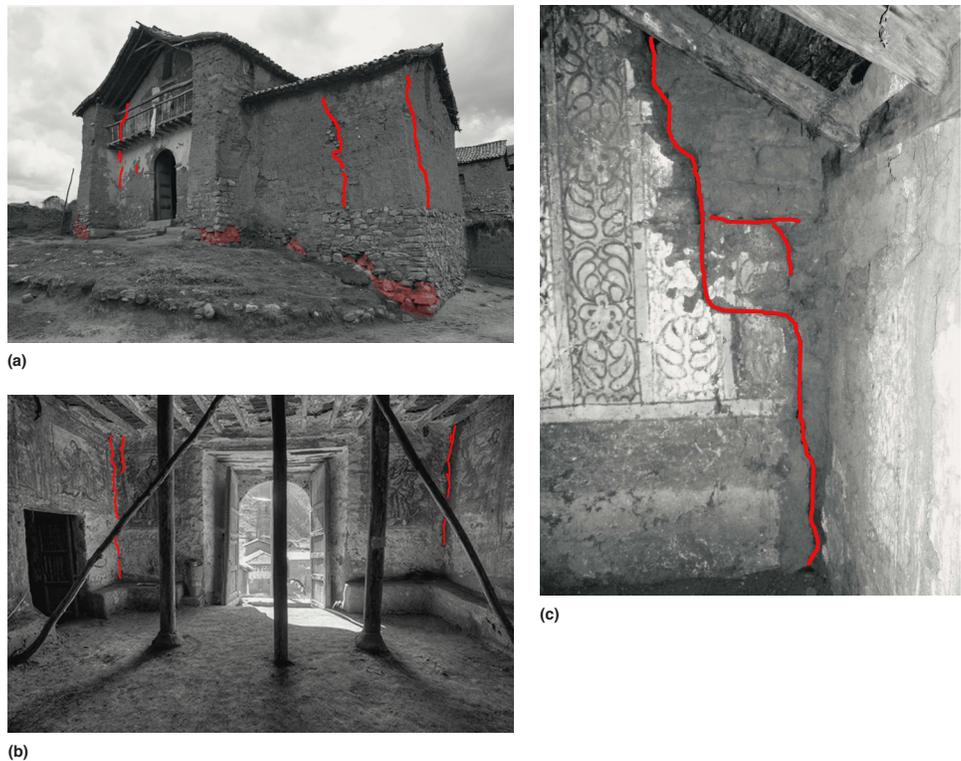
FIGURES 2.5A–C.

Photos of damage inspection on the church structure, showing crack patterns or propagation (in red): (a) crack patterns and areas of material loss in the main facade and baptistery; (b) crack patterns in the interior of the main facade (adapted from De Corso 2013); (c) crack propagation in the south corner of the choir loft (photo: Scott S. Warren for the GCI, 2011).

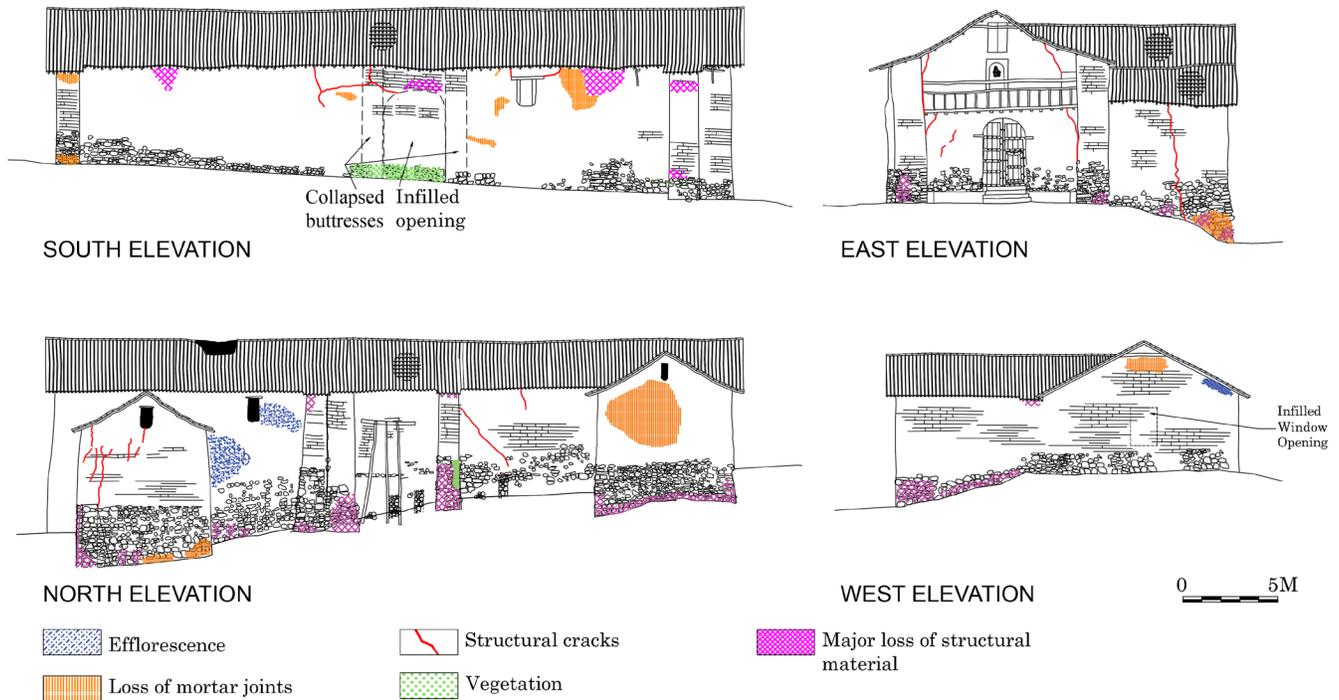
tions, such as the opening or filling of doors and niches. The south lateral wall exhibits outward displacements. On the north lateral wall there are several vertical cracks close to the east side. The damage found can be related to settlements of the base course, magnified by rising damp, loss of mortar or erosion below the base course, and possible past earthquakes (Cancino and Lardinois 2012). In many areas, the base course has evident signs of erosion and deterioration, with loose stones and missing mortar from joints. Mapping of damage to the facades is shown in figure 2.6.

**FIGURE 2.6.**  
Elevations of the church of Kuñotambo, indicating the various types of damage observed (Zanotti 2015).

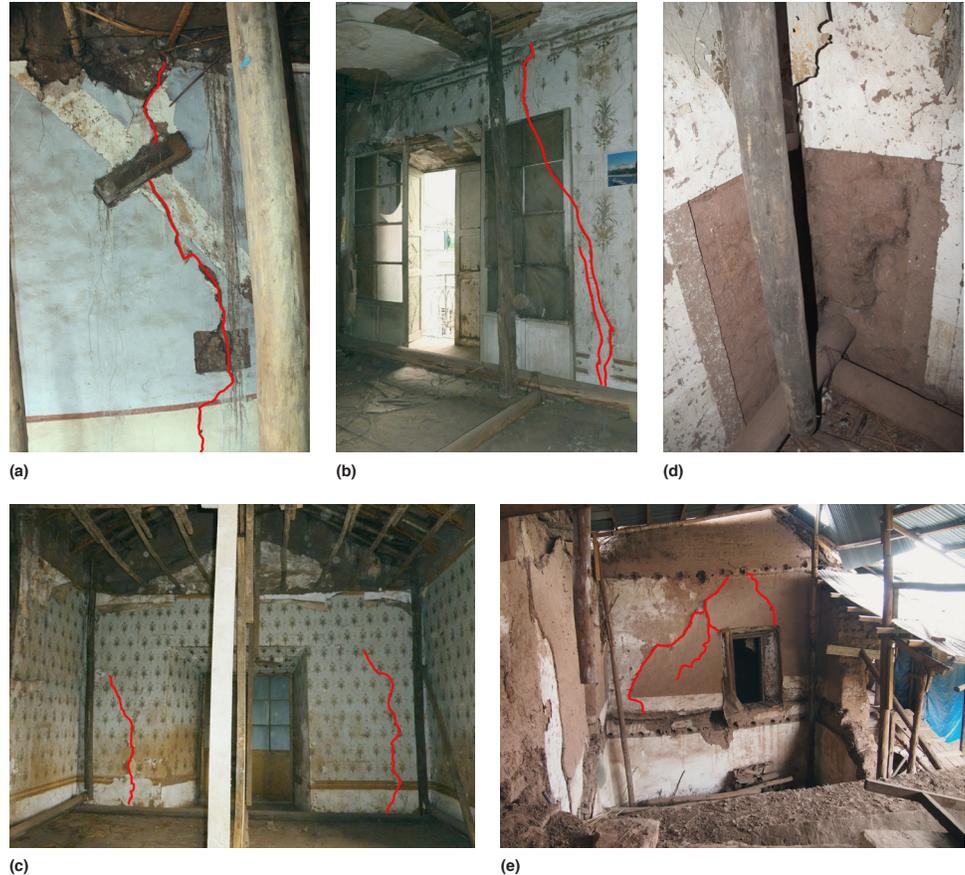
**FIGURES 2.18A–E.**

Photos showing main cracks (in red) on the second floor: (a) south wall; (b) longitudinal wall on Calle Arones; (c) central transversal wall on Calle Arones; (d) south transversal wall on Calle Arones; (e) west transversal wall on Calle Nueva Alta.

Several important cracks are present, as shown in figures 2.18a–e. Diagonal cracks are found in the connection between the external wall on Calle Arones and the transversal walls. The south wall has several vertical cracks, and shear cracks were found on the west transversal wall on Calle Nueva Alta. The longitudinal wall along Calle Arones also has several cracks. Finally, the stone blocks are in good condition, but the joints have suffered a significant loss of mortar combined with cracking and deformation in the arcades (figs. 2.19a, 2.19b). A temporary shoring system is present, but the west end of the arcades remains unstable.

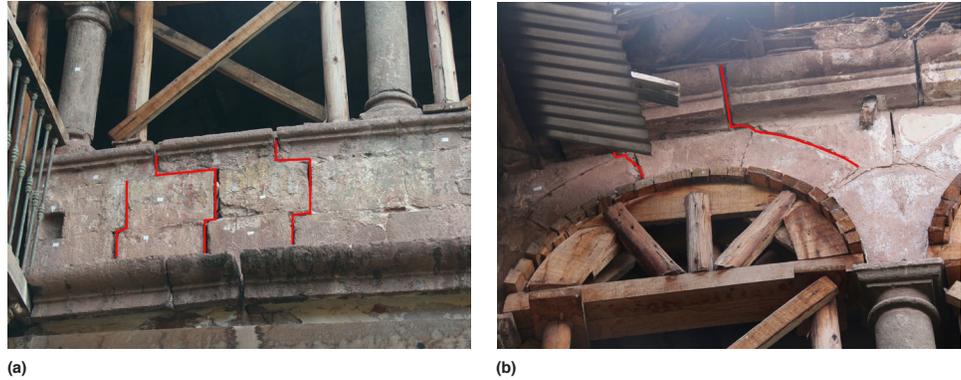
Photos identifying damage (in red) in the arcade between the first and second floors: (a) crack on the parapet approaching the north side; (b) cracks on the arch of the second floor on the north side.
