# 建筑 and 建筑构件 状况评估

## Condition Assessment of Architecture and Architectural Elements

### HUICHENG HALL: CONDITION ASSESSMENT

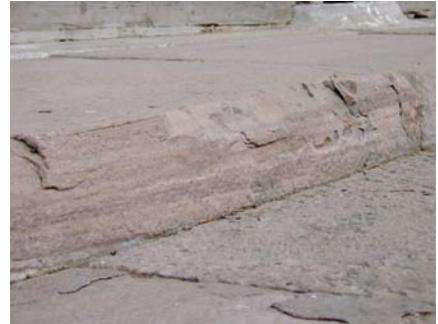
会乘殿，台基北侧踏步  
石头边角厚层缺失

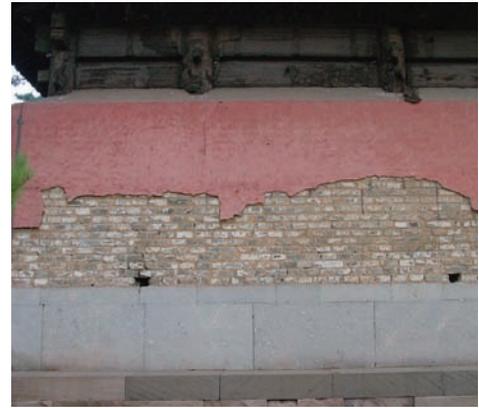
会乘殿，西立面，抹灰缺失与砖墙  
Huicheng Hall, W Facade  
Stucco loss and brick masonry

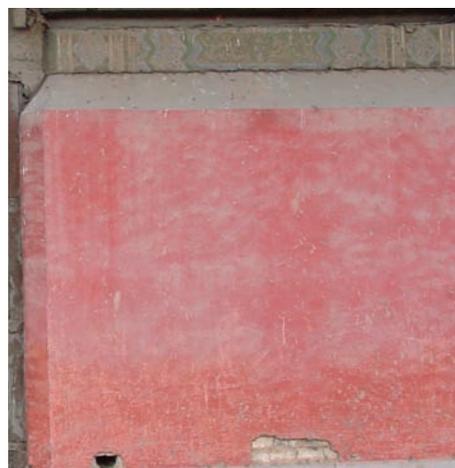
会乘殿，北立面  
抹灰表面堆积与污迹  
Huicheng Hall, N Facade  
Stucco surface deposit and staining

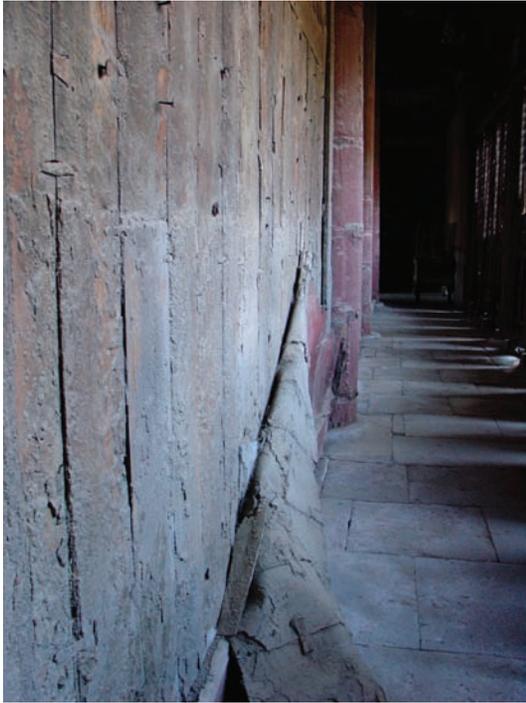
会乘殿，内部，木板照壁地仗空鼓和脱落  
Huicheng Hall, Interior  
Partition wall plaster detachment and loss

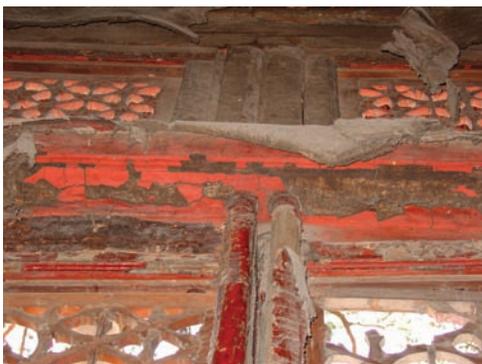
会乘殿，内部，南槛窗，严重空鼓  
Huicheng Hall, Interior, S window  
Detached painted plaster

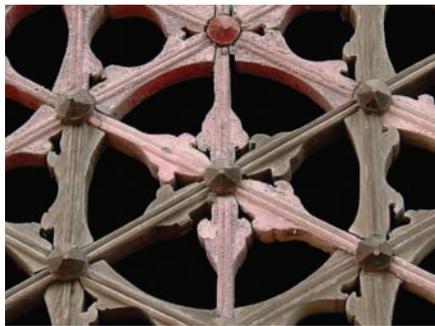
会乘殿，南立面，槛窗棂心新构件  
Huicheng Hall, S Facade  
Sill window lattice  
New components

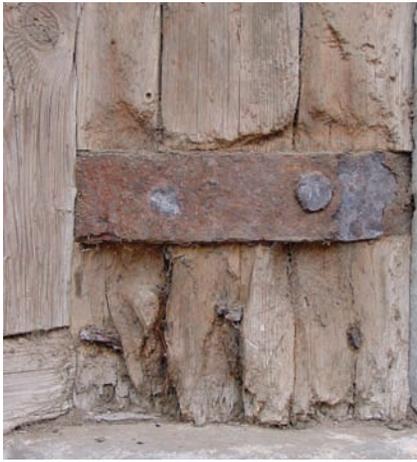
会乘殿，北立面，柱子下部的腐朽  
Huicheng Hall, N Facade,  
Column base erosion

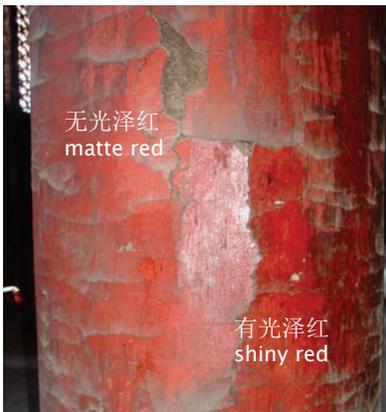
会乘殿，柱子  
柱上两种不同色泽的红漆  
明显可见。大约为先后两  
次干预活动所致。  
Huicheng Hall, column  
Two visible paint coats,  
thought to be from different  
interventions

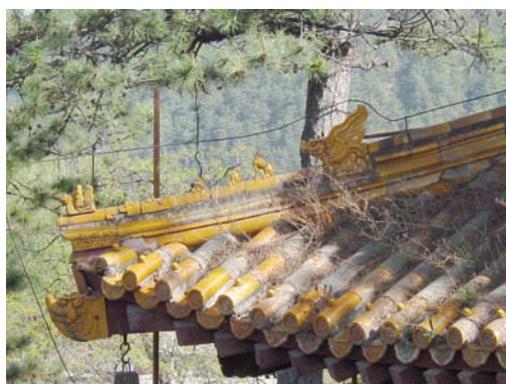
会乘殿，下檐东北角  
仙人部分缺失、琉璃脱落  
Huicheng Hall, NE hip ridge  
Loss of ornaments and glaze

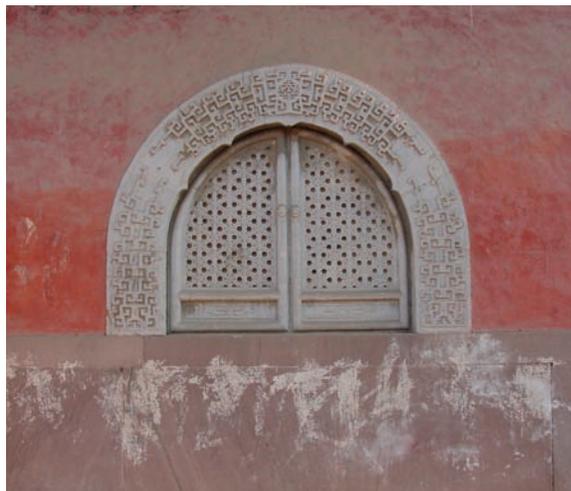
山门，北侧下碱  
残迹

Shanmen, N Sill wall  
Staining and surface deposit

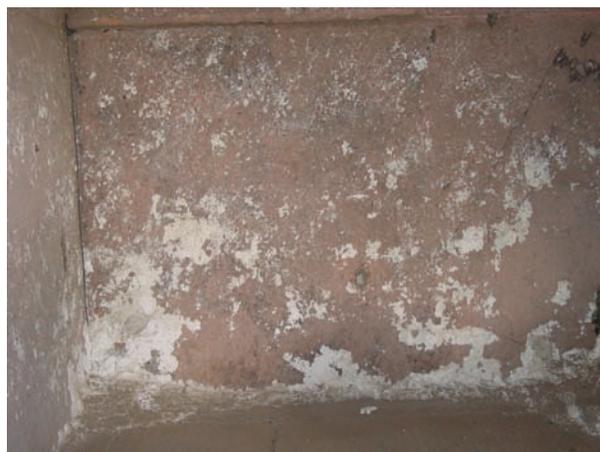
山门，室内东墙下碱  
残迹

Shanmen, E Interior sill wall  
Staining and surface deposit

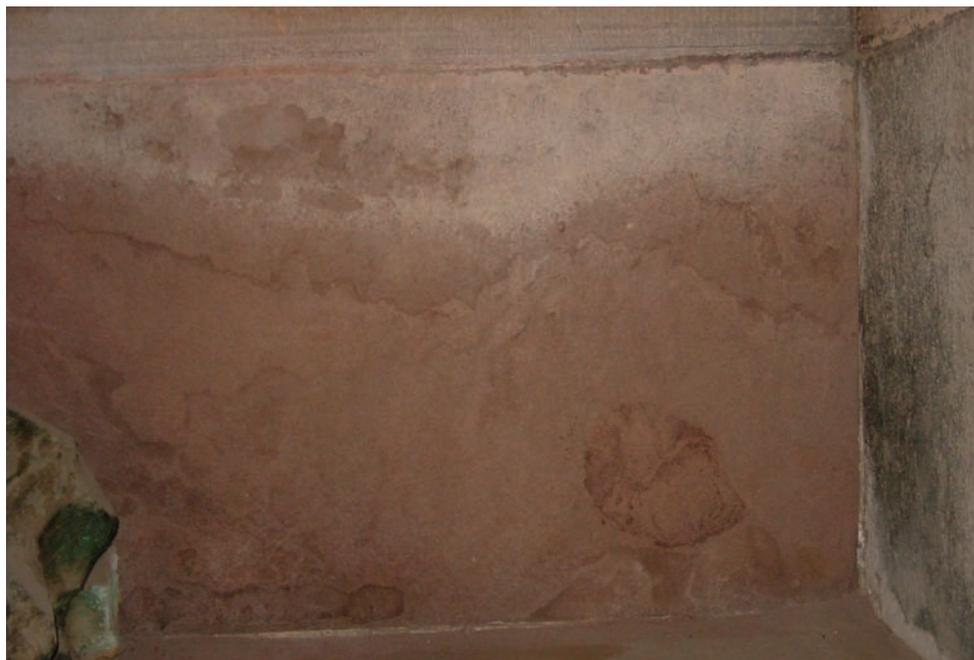
山门，室内西墙下碱  
潮气上浸引起的水迹

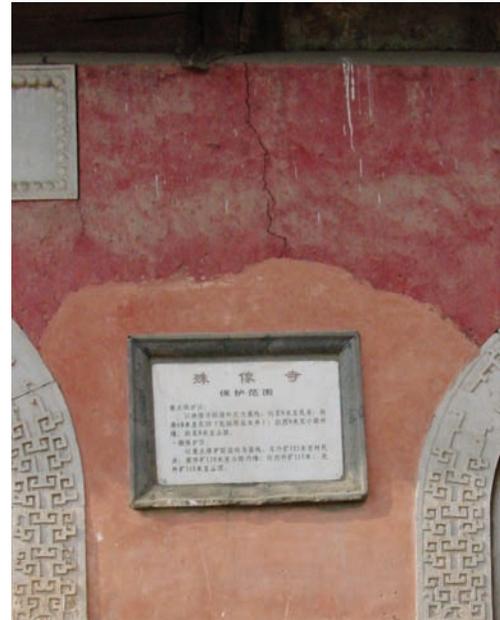
山门，南立面  
文保标志周围不和谐的重新抹灰和开裂

Shanmen, S Facade  
Incompatible replastering around new sign,  
with cracking

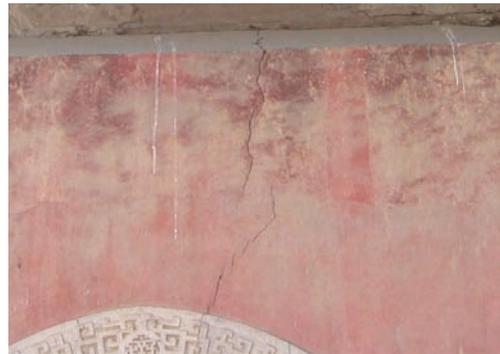
山门，北立面  
带状受潮痕迹、表面堆积和开裂

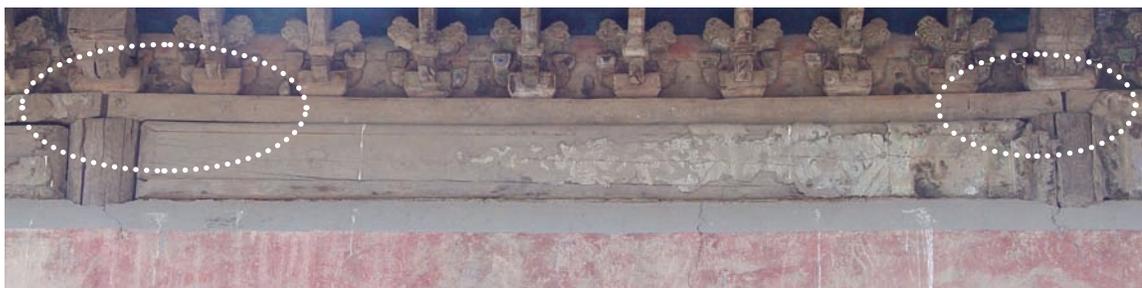
山门，北立面，额枋和平板枋  
木质暴露、开裂、平板枋弯曲  
Shanmen, N Facade, architrave and flat tie-beam  
Exposure of wood, cracking, warping of flat tie-beam

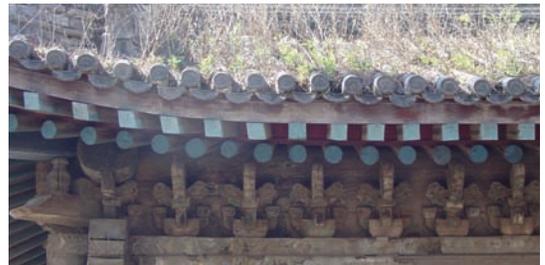
山门，北立面，东角，斗拱、挑檐檩、檐椽、飞椽  
木质暴露、开裂  
Shanmen, N Facade, E corner  
Brackets, purlins, rafters, flying rafters  
Exposed wood, cracking

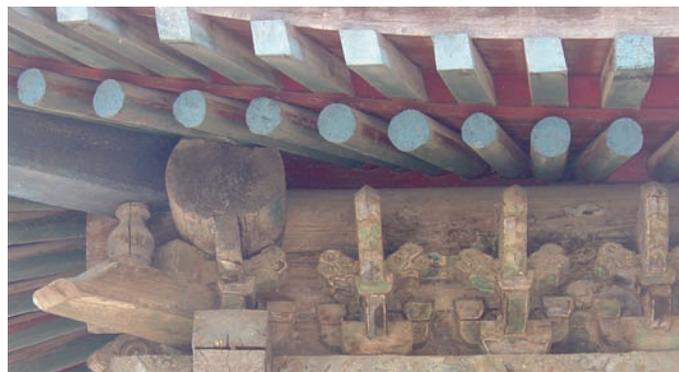
山门，北立面，东角，斗拱、挑檐檩、檐椽、飞椽  
木质暴露、开裂  
Shanmen, N Facade, E corner  
Brackets, purlins, rafters, flying rafters  
Exposed wood, cracking

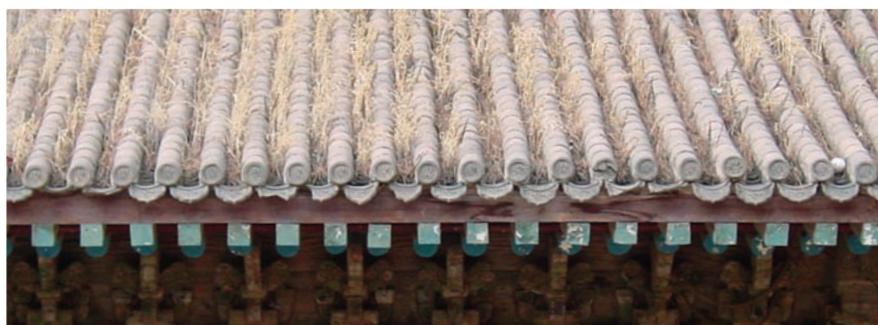
山门，南立面，屋顶  
植物生长、瓦破损与部分缺失  
Shanmen, S Facade, roof  
Biological growth, tile breakage and partial loss

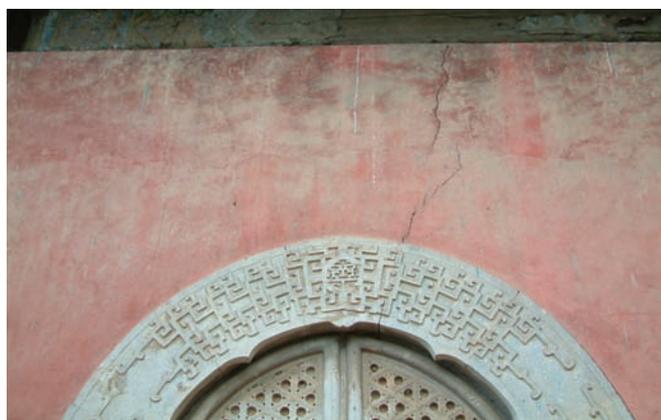
3、山门北面，窗券上墙体开裂  
N facade, cracking above stone window

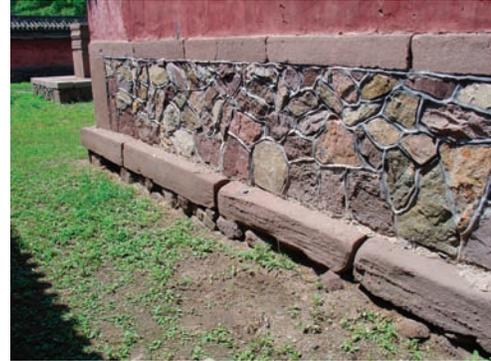
钟楼，东立面，台基石侵蚀与脱落的毛石  
Bell Tower, E Facade, platform  
Ashlar erosion and loss of rubble masonry

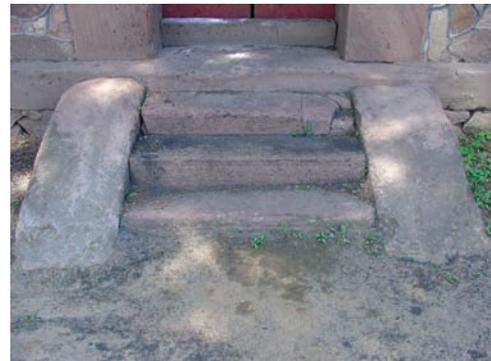
鼓楼，东立面，台阶  
台阶被侵蚀有裂缝、下层台阶与展开部分被埋  
Drum Tower, E Facade, steps  
Erosion and cracking of steps, with partial  
burial of splays and lower step

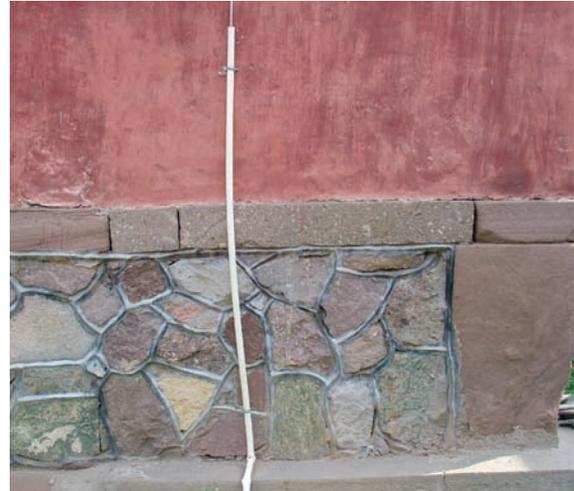
鼓楼，北下碱，腰线石可能为后来的干预活动所致  
Drum Tower, N Facade, sill wall  
Possible later intervention in stringcourse ashlar

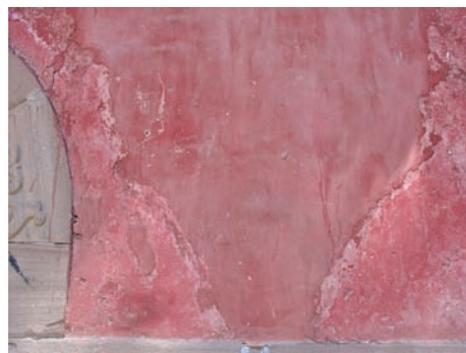
钟楼，西立面，抹灰修护  
Bell Tower, W Facade, plaster repair

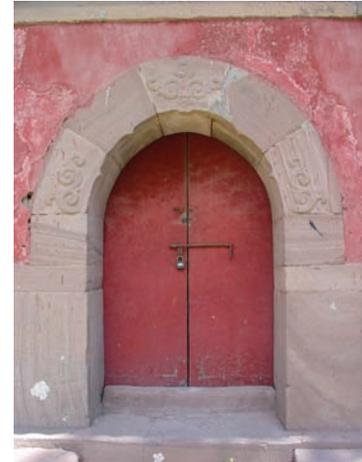
钟楼，西面墙  
入口表面的沉淀物与水泥补丁  
Bell Tower, W Facade, Entryway  
Surface deposits, cementitious  
patches

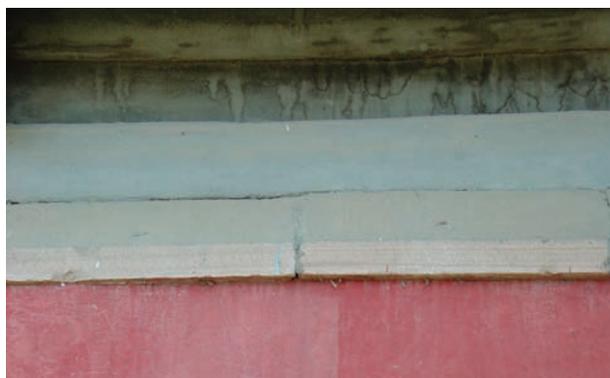
鼓楼南面墙，下层檐枋，邻近构件的污斑  
Drum Tower, S Facade  
Lower eave architrave, staining of adjacent members

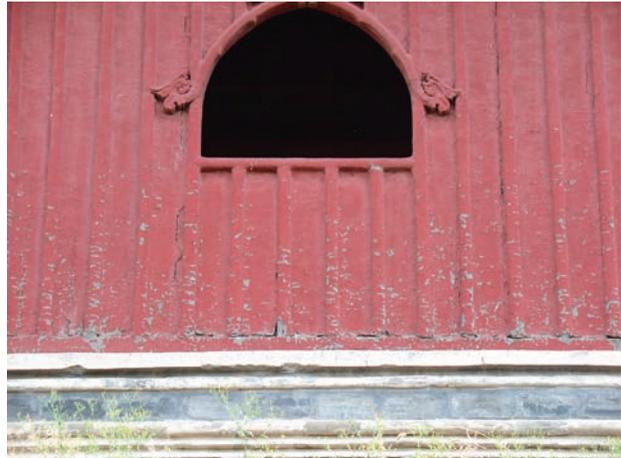
鼓楼，东立面上层，漆的裂缝及脱落。  
Drum Tower, N Facade, Upper level  
Paint cracking and loss

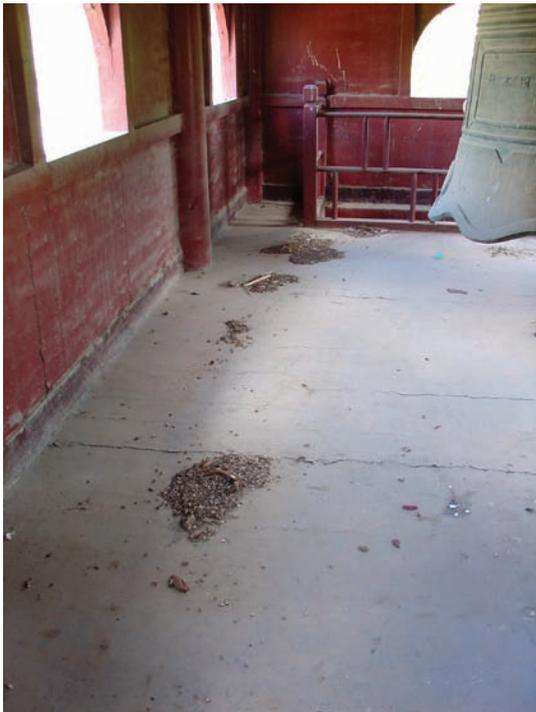
钟楼，上层屋内鸟的排泄物  
Bell Tower, Upper Chamber  
Deposits from bird droppings
