附件1：名词图解

APPENDIX 1: VISUAL GLOSSARY

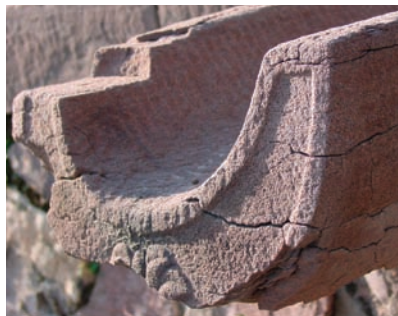
挑头
红砂岩
沿岩石层面开裂

Scupper
Red Sandstone
Cracking along
bedding planes

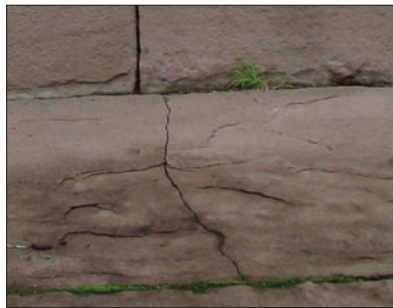
埽地石
红砂岩
开裂

Paving
Red Sandstone
Cracking and splitting

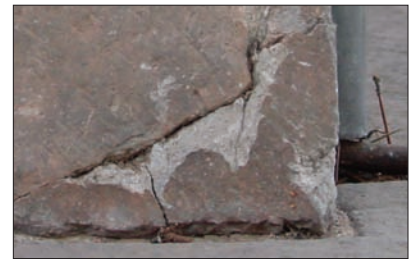
会乘殿，西北角
鸚鵡岩
裂缝（带有表面碎裂）

Huicheng Hall, NW Corner
Tuff (yingwuyan)
Crack (with surface chipping)

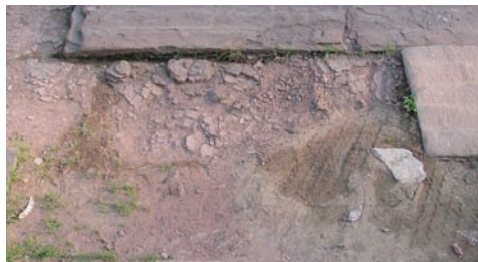
埽地石
红砂岩
表面瓦解及严重的材料
缺失

Paving stones
Red Sandstone
Disintegration of surface and severe
loss of material

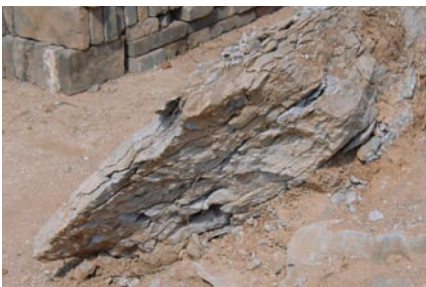
清凉楼
鸚鵡岩
粉碎的石墙
Qingliang Building
Tuff (*yingwuyan*)
Fissuring wall

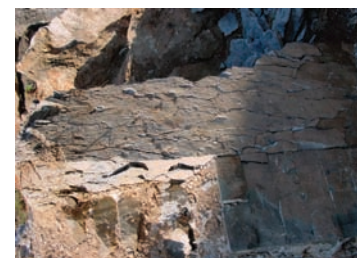
倚云楼
鸚鵡岩
粉碎的石块
Yiyun Building
Tuff (*yingwuyan*)
Fissuring block

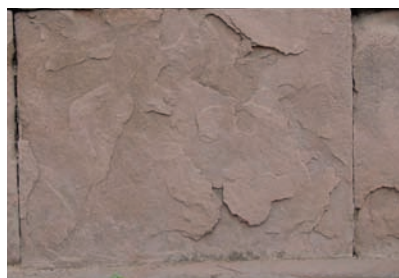
会乘殿，台基西台帮
红砂岩
起甲及剥落
Huicheng Hall, W Platform
Red Sandstone
Flaking and scaling

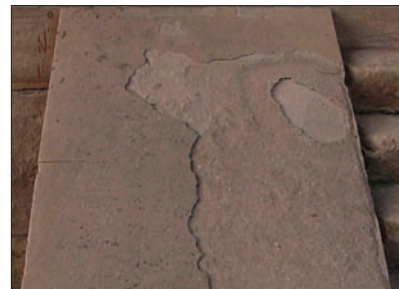
会乘殿，南侧台阶垂带石
红砂岩
起甲并剥落
Huicheng, S Stair splay
Red Sandstone
Scaling with loss

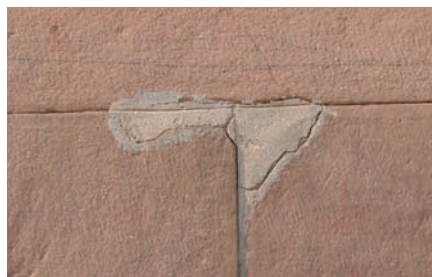
山门，南立面，墙
红砂岩条石
水泥填充
Shanmen, S Facade, sill wall
Red Sandstone ashlar blocks
Cement infill

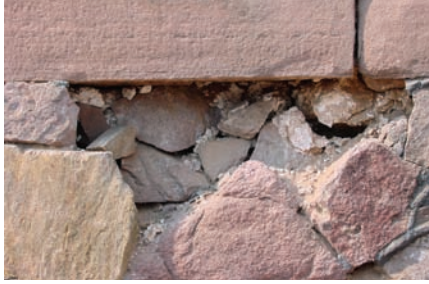
山门，南立面，台基
毛石砂岩及凝灰岩砌面
毛石缺失

Shanmen, S Facade, platform
Rubble Sandstone and tuff masonry
Loss of rubble fill

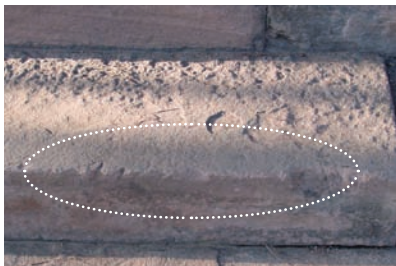
会乘殿，南踏步石
红砂石
石材边缘的切口

Huicheng Hall, S Stair tread
Red Sandstone
Edge cuts in stone

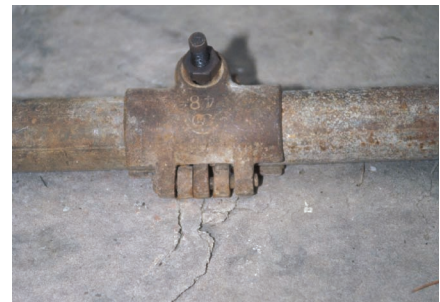
会乘殿，南踏步石
红砂石
搭脚手架所造成的损害

Huicheng Hall, S Stair
Red Sandstone
Scaffolding damage

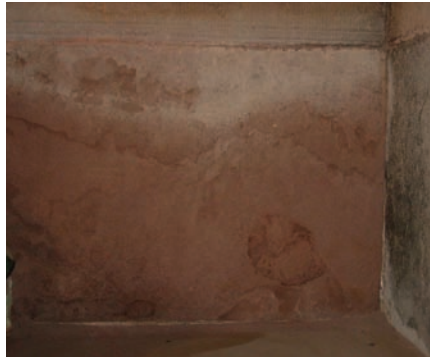
Shanmen, W Interior sill wall
Red Sandstone
Staining attributed to rising damp

山门，室内西墙下碱
红砂岩
潮气上浸引起的水迹

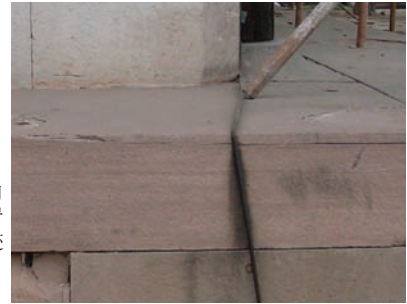
会乘殿，西立面，台基南角
红砂岩
避雷针引起的污迹

Huicheng Hall, W Facade, S corner of platform
Red Sandstone
Rusting of lightning rod resulting in staining

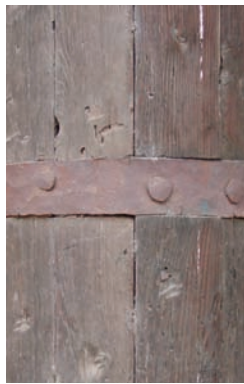
会乘殿，北立面
柱
东半部柱子颜色泛白
Huicheng Hall, N Facade
Column
Bleaching of E half of column

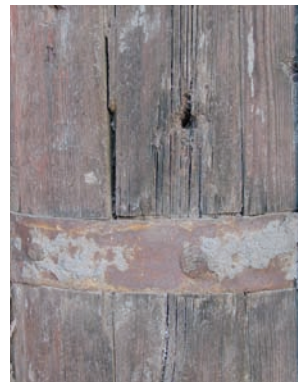
会乘殿，南立面
铁箍
退色
Huicheng Hall, S Facade
Enclosure frame
Greying

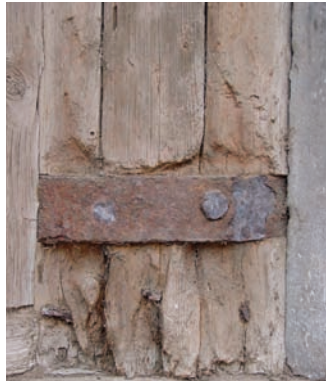
会乘殿，北立面
柱脚
腐朽
Huicheng Hall, N Facade
Base of Column
Erosion

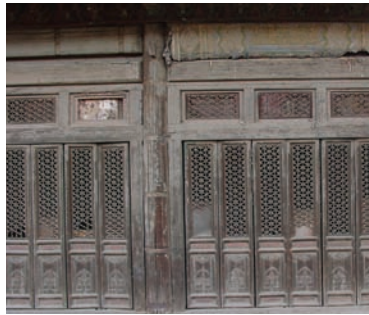
会乘殿，北立面
门、窗、枋
木质暴露
Huicheng Hall, N Facade
Doors, windows, architrave
Exposed wood

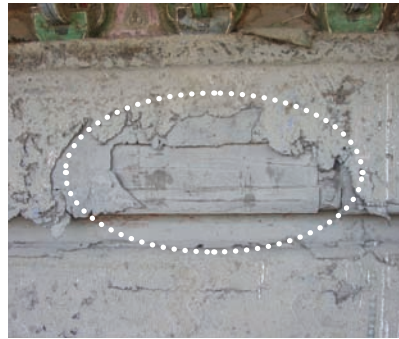
会乘殿，东立面上檐
大额枋
木质暴露
Huicheng Hall, E Facade,
Upper Eave
Greater Architrave
Exposed wood

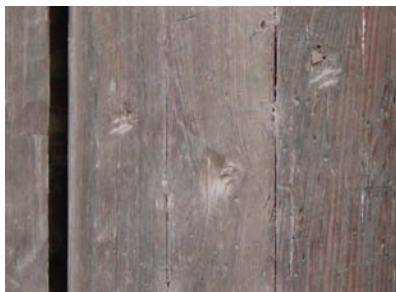
会乘殿，北立面
柱及门抱框
凿口痕迹及蚀洞
Huicheng Hall, N Facade
Column and enclosure frame
Gouge marks and scoring

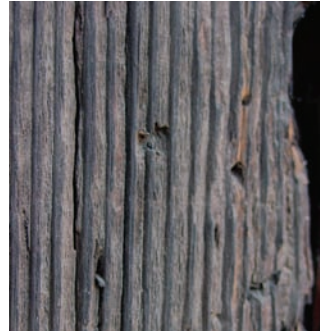
会乘殿，南立面
纹理凸起
Huicheng Hall, S Facade
Raised Grain

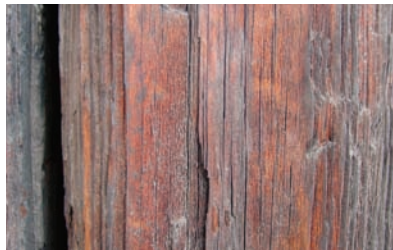
会乘殿，南立面
柱
片状开裂及其结
果——木质缺失
Huicheng Hall,
S Facade
Column
Splintering with
resultant loss

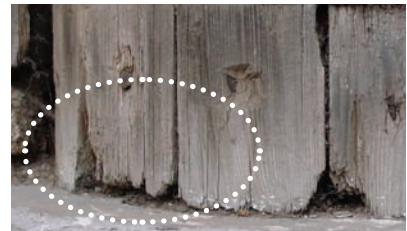
会乘殿，南立面
柱脚及其邻近的门
抱框
片状开裂及腐朽
Huicheng Hall, N
Facade
Base of column
and adjacent door
frame
Splintering and
erosion

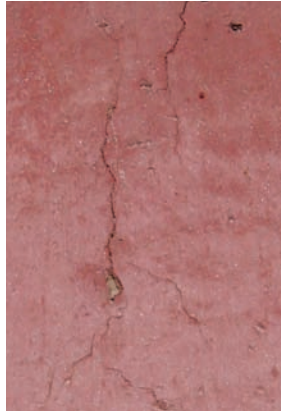
会乘殿，西立面
红色抹灰
开裂
Huicheng Hall, W Facade
Red-colored stucco
Cracking

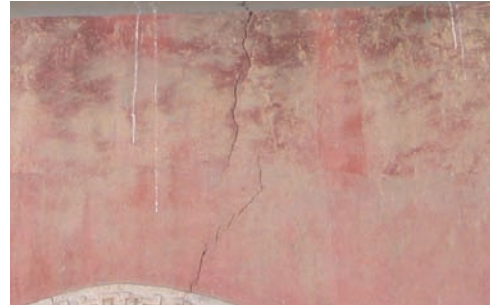
山门，北立面
红色抹灰
开裂
Shanmen, N Facade
Red-colored stucco
Cracking

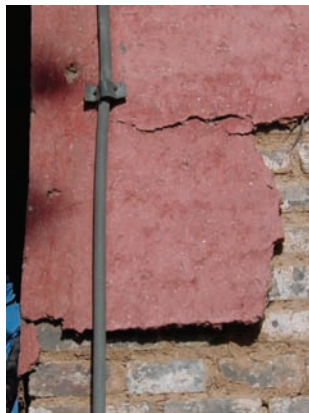
会乘殿，西立面
红色抹灰
空鼓与附近的裂缝
及脱落
Huicheng Hall,
W Facade
Red-colored stucco
Detachment with
adjacent cracking
and loss

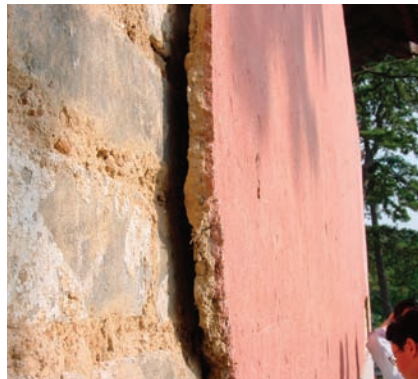
会乘殿，西立面
红色抹灰
从邻近的脱落部分看空鼓
Huicheng Hall,
W Facade
Red-colored stucco
Detachment, as seen
through adjacent loss

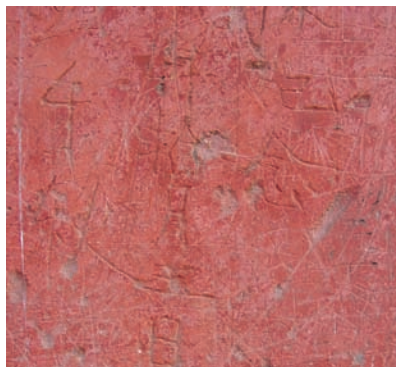
会乘殿，西立面
红色抹灰
涂写及凿痕
Huicheng Hall,
W Facade
Red-colored stucco
Graffiti and gouging

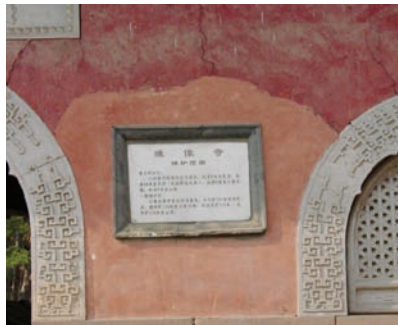
山门，南立面
红色抹灰
名牌周围不和谐
的重新抹灰
Shanmen, S Facade
Red-colored stucco
Incompatible replastering
around new sign

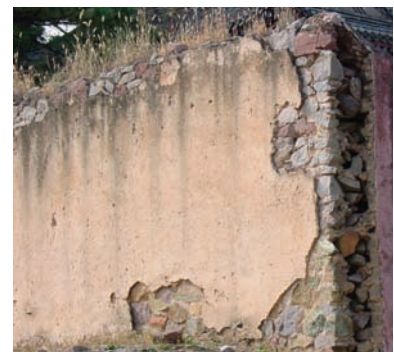
天王殿，室内西部
抹灰
脱落区域
Tianwang Hall,
E interior
Plaster
Area of loss

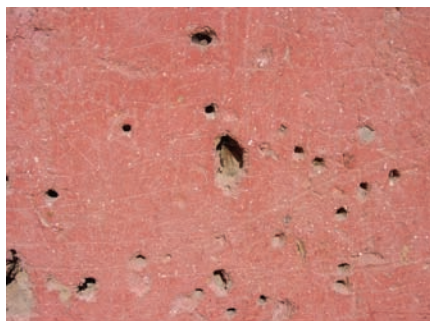
会乘殿，东立面
红色抹灰
凿及子弹造成的小坑
Huicheng Hall, E Facade Red-
colored stucco
Holes caused by gouging
and projectiles

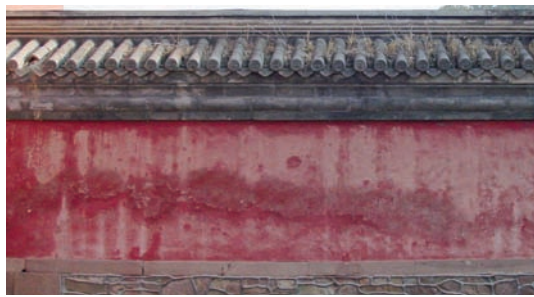
围墙，山门以西，内侧
红色抹灰
带状受潮痕迹

Site wall, W of Shanmen, Interior
Red-colored stucco
Band of staining from moisture

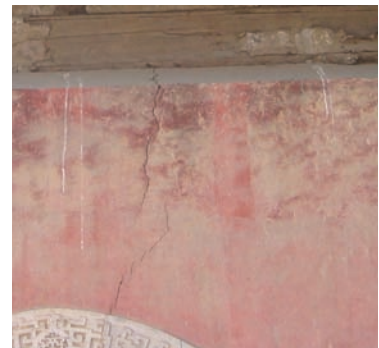
Shanmen, N Facade
Red-colored stucco
Band of staining from moisture

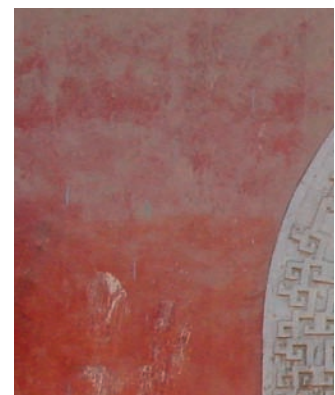
Shanmen, S Facade, W bay
Red-colored stucco
Dirt accumulation with paint drips

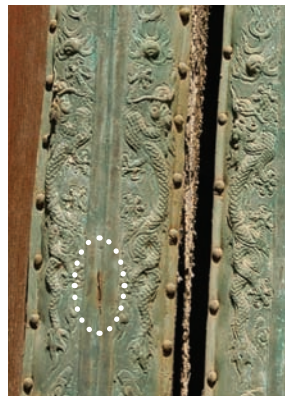
会乘殿，南立面
门扇青铜配件开裂

Huicheng Hall, S Facade
Door fitting, cuprous metal
Cracking

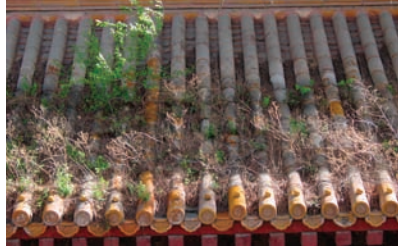
会乘殿，北立面
下檐
琉璃瓦顶
植物生长
Huicheng Hall,
N facade
Lower eave
Glazed roof tiles
Plant growth

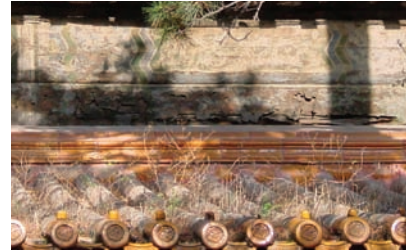
会乘殿，北立面
上檐
琉璃瓦顶
植物生长
Huicheng Hall,
N facade
Upper eave
Glazed roof tiles
Plant growth

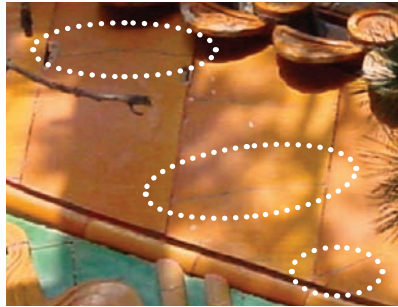
会乘殿，西山墙
琉璃瓦
开裂
Huicheng Hall, W gable
Glazed tiles
Cracking

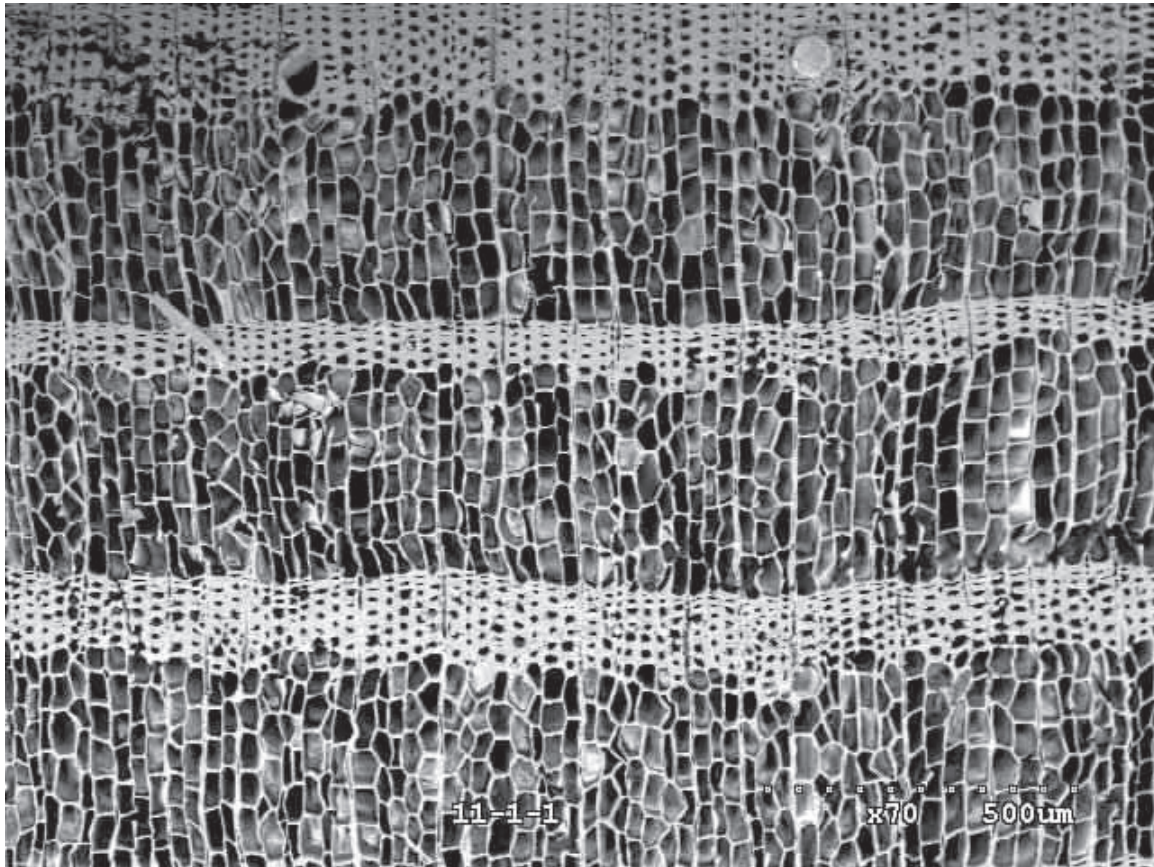
Photo J11-1-1 shows 3 annual layers over a very small area. The wood appears to be attacked by a brown rot fungus that has degraded the early wood cells more than the late wood. This type of decay causes very severe strength losses to occur and the weakened early wood cells can be seen fragmenting (see Photo's J11-2-3 and J11-2-4, J11-2-4a, J11-2-6 (high magnification of the fragmented cells, J11-2-7). Note all of the micrographs from J11-1-1 to J11-2-7 are transverse sections of the wood sample.

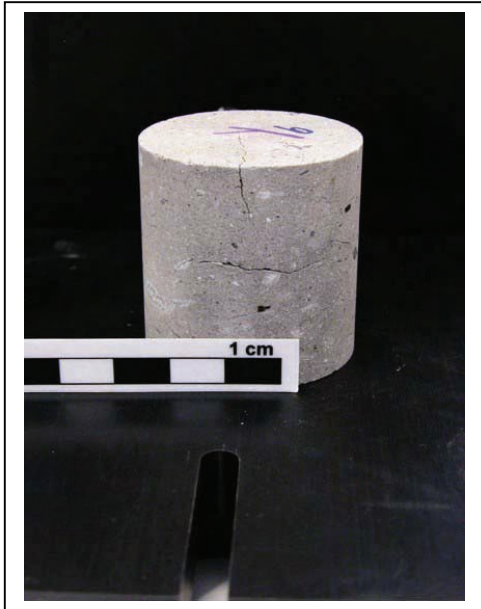
Figure 8. A smaller sample (4cm height) of stone 2 (upper) after 12 freezing-thawing cycles shows cracks parallel as well as perpendicular to the banding.

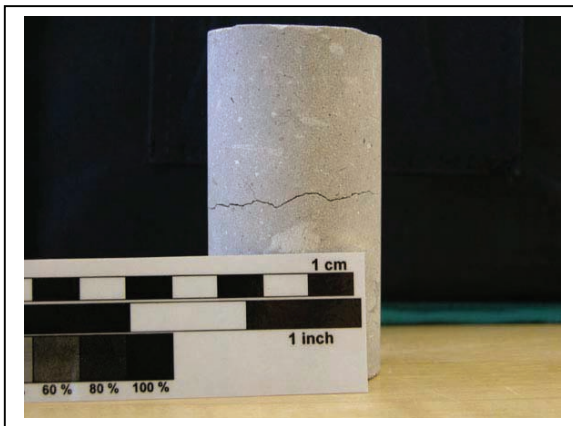
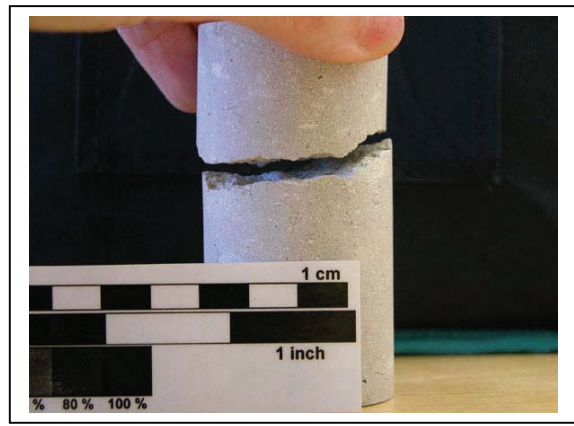
Figure 9. Stone 2 (upper) after 70 freezing-thawing cycles- Sample on the left hand side shows a level 3 of decay with open cracks, while sample on the right hand side shows a level 4 of decay, the sample is broken in two.

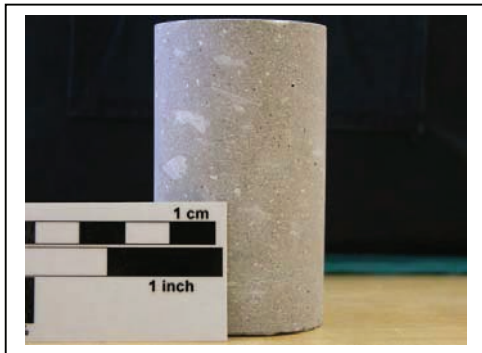
Figure 10. Stone 1 (lower) after 70 freezing-thawing cycles – no deterioration can be observed.
