# 彩绘相关构件专有词汇图释

Due to limited access the condition assessment of the interior polychrome painting (*caihua*) was conducted as a brief visual inspection from the ground. Comprehensive photographic documentation and a detailed condition assessment are recommended to build upon this initial survey.

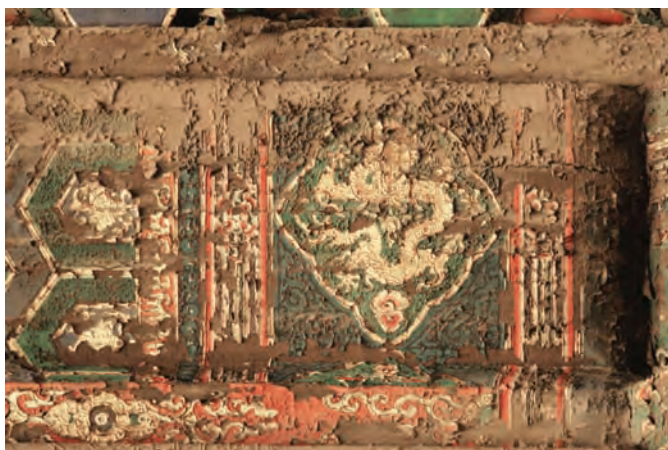
彩画表面的详细状况。

Detail of the condition of the painted surface.

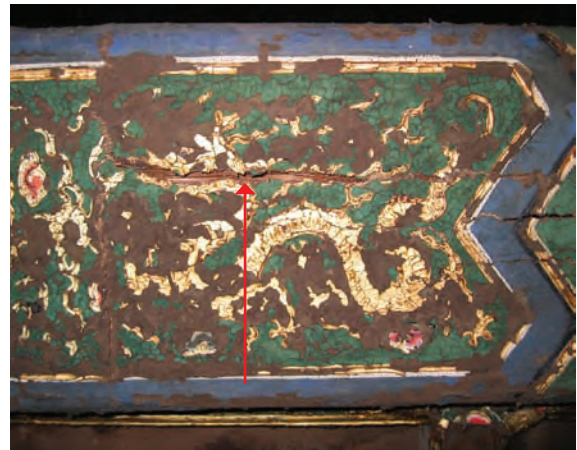
详细显示彩画表面脱落及额枋中部出现的水平开裂。

Detail showing surface paint loss and horizontal splitting of the painting occurring along the center of the architrave.

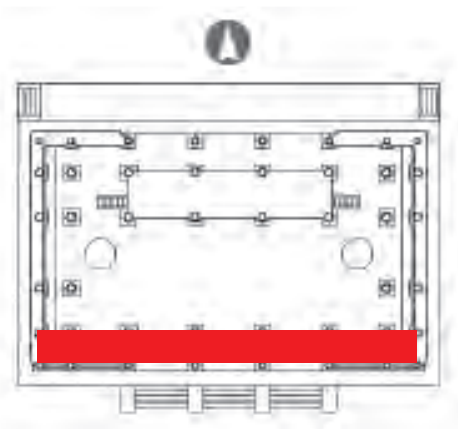
明间悬挂的匾额及彩画。

Painted decoration and hanging tablets (*bian* and *e*) on center bay.

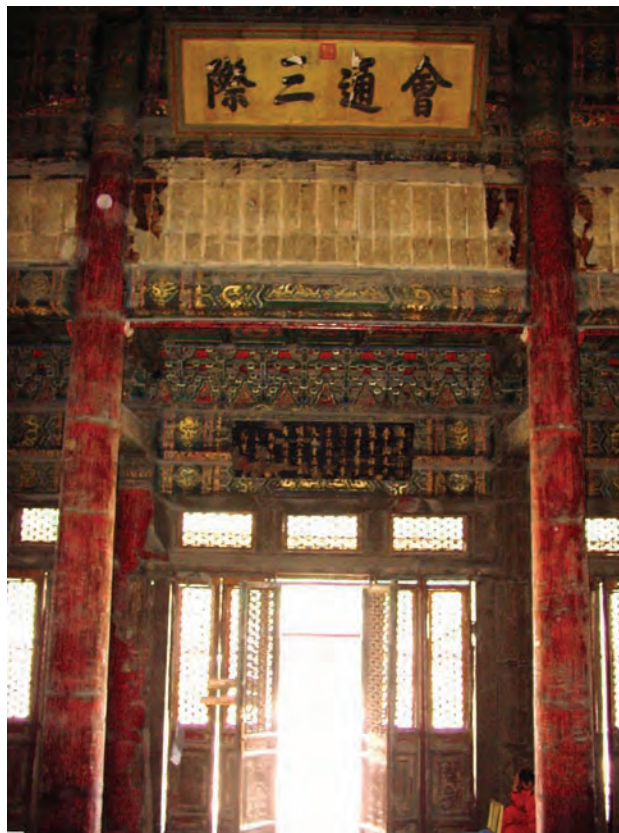
On the easternmost bay the painting has small areas of detachment including pieces of painting that are detached and hanging down. However, the most serious area is on the westernmost bay with complete loss of large areas of painting. In the center bay, the condition of both upper and lower registers of painting is partly obscured by two hanging tablets (*bian* and *e*).

南壁东端上下层的彩画。

Upper and lower registers of painting on eastern side of the south wall.

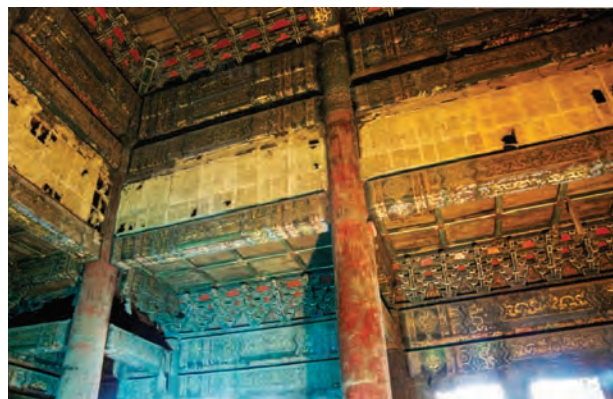
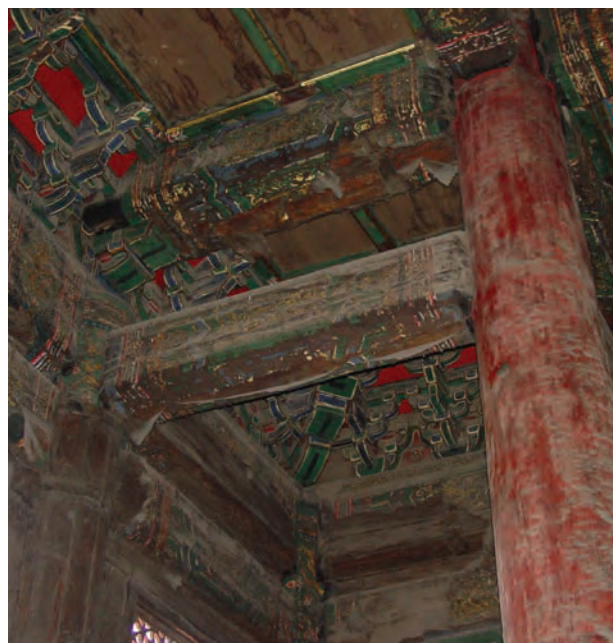
东尽间的彩画存在着小面积的空鼓，包括小片彩画剥离及悬挂下垂。最严重的部位是南立面的西尽间，彩画大面积的脱落。明间部分上下层的彩画被匾额遮挡，无法做出评估。

西尽间彩画脱落与空鼓的地方。

Loss and detached areas of painting on the westernmost bay.

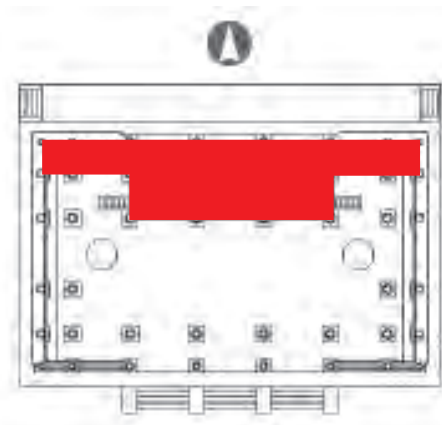
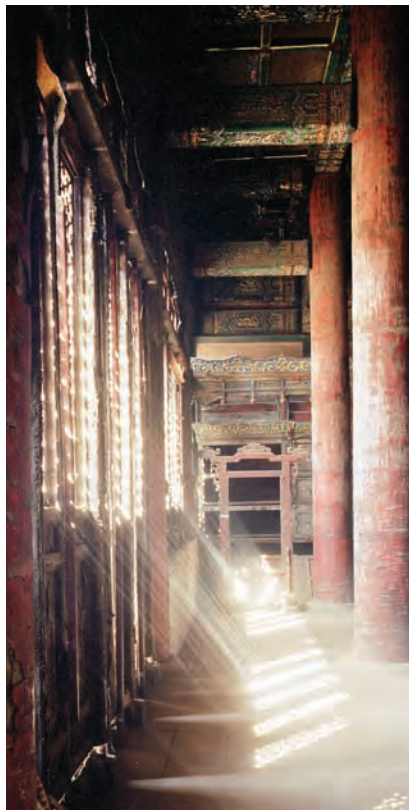
特别是整个北面走廊的装饰物与西稍间紧接佛台西边上层的大小额枋上的彩画有许多的空鼓与脱落。在北走廊中间的3开间（门面处），彩画有多处的空鼓与悬挂下垂。此外，走廊的一根木梁与许多斗拱构件都被更换过，但是没有漆饰。

北侧走廊彩画残损严重。

Condition of the painting in the north corridor is very deteriorated.

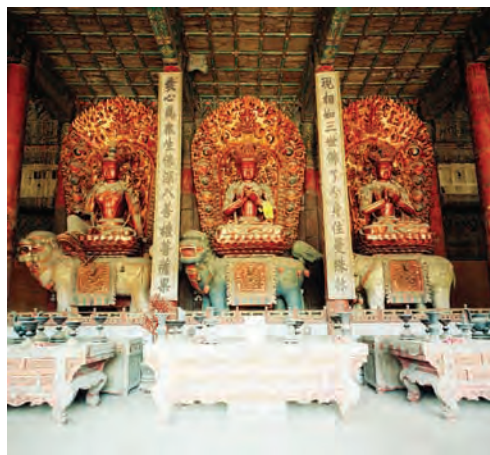
由于佛像的阻挡，中间佛台部分彩画的状况难以评估。

Condition of the painted decoration on the central altar was difficult to assess because the sculpture group partly obscured it.

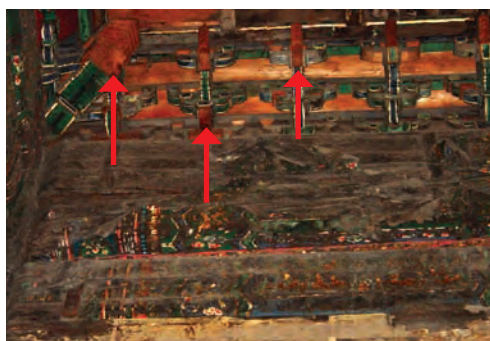
北墙西稍间上层梁枋及斗拱与彩画的状况。注意替换过的斗拱构件，都未上漆饰。

Poor condition of the painting on the architraves and brackets on the upper register of the further west bay of the north wall. Pieces of the wood brackets have been replaced and left unpainted.

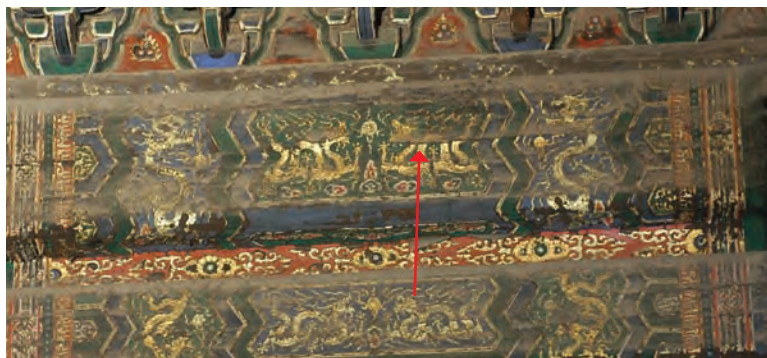
The painting on the east wall survives almost in its entirety but is showing signs of horizontal tearing on some areas of the architraves. The painting on the upper register exhibits areas of detachment and bulging while the painting on the lower register appears to be in generally good condition.

彩画沿着额枋水平方向开裂。

Horizontal splitting of the painting along the architraves.

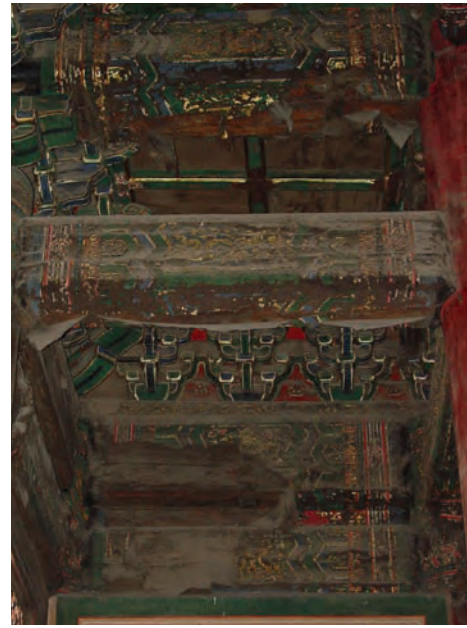
The west wall has areas of detachment and loss of painting. The condition of the painted decoration in the first bay is the most serious with tearing of the painting, detachment and large areas of loss. Similar conditions, but less severe, are visible on the second and third bays.

第一间彩画脱落的情形。

Loss of painting on the first bay.

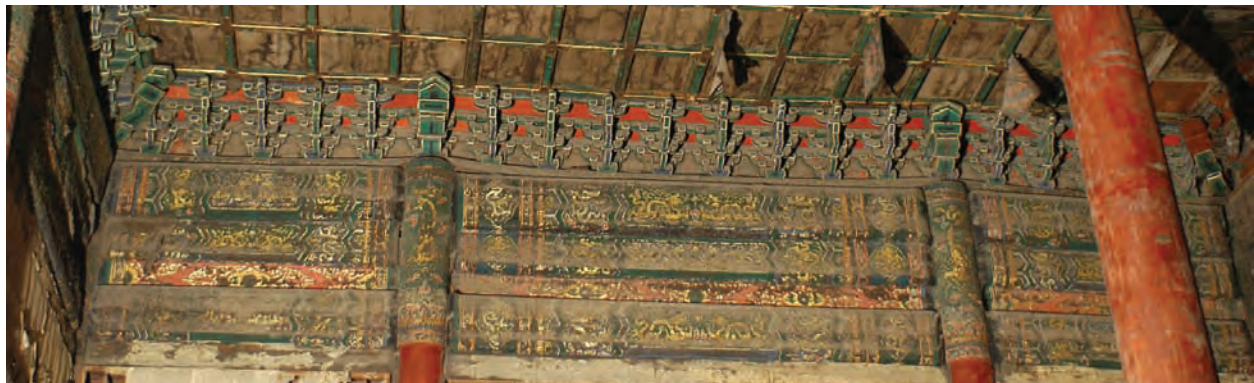
西壁上层彩画。

Upper register paintings on the west wall.

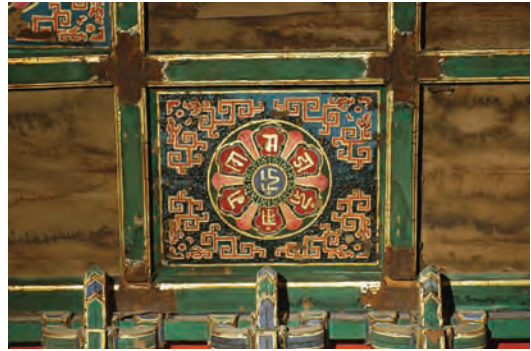
装饰天花板细部，西部少有的2块天花板彩画尚存的状况。

Detail of a decorative ceiling panel and a rare area on the western end where a few panels still survive.

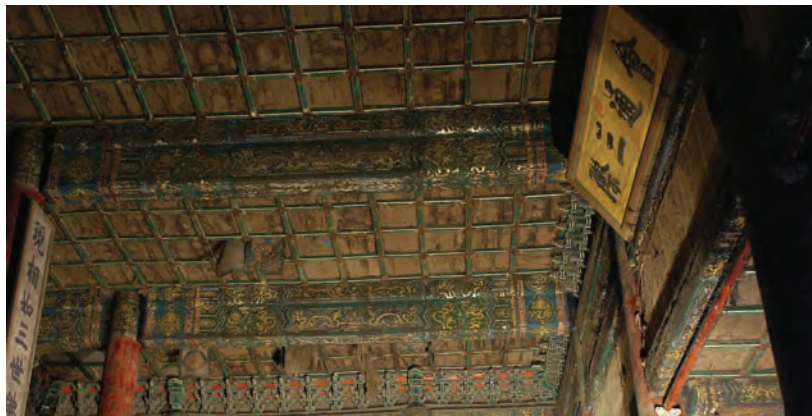
Almost all of the decorated ceiling panels have been lost. Only a few remain intact and in-situ while others are detached and hanging down. Based on a rough count carried out during the inspection in April 2004 only seven panels remained attached while eighteen were detached and hanging off. In the northeast corner alone, ten panels were detached and hanging down. The majority of surviving panels were on the lower eave ceiling, an area which is perhaps more protected than the main ceiling.

观看井口天花（自西向东看）。几乎所有装饰天花彩画已经脱落了。

View of lattice ceiling looking east. Almost all of the decorative painted panels are lost.

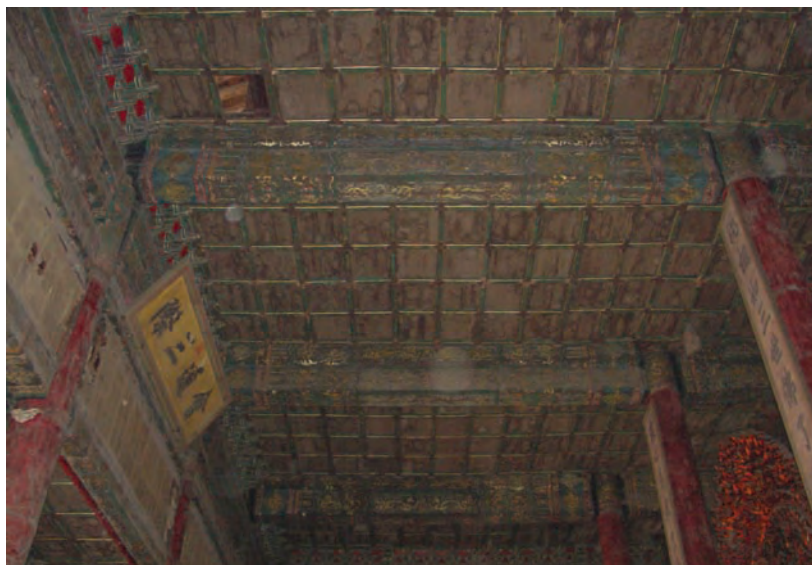
井口天花（自东向西看）。几乎所有天花彩画都已经脱落了。

View of lattice ceiling looking west. Almost all of the decorative painted panels are lost.

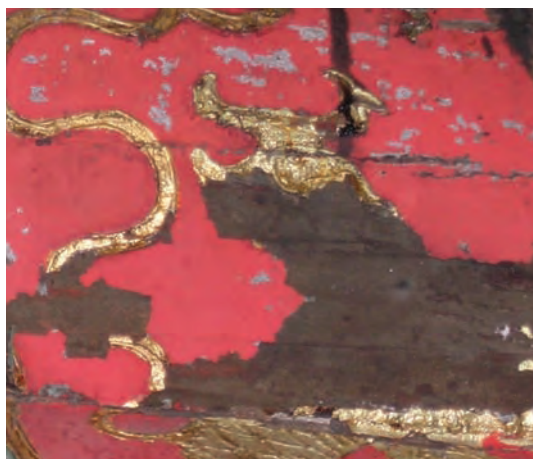
彩画缺失的部位可看出单皮灰的薄度。

The thinness of the single plaster can be seen in areas of paint loss.

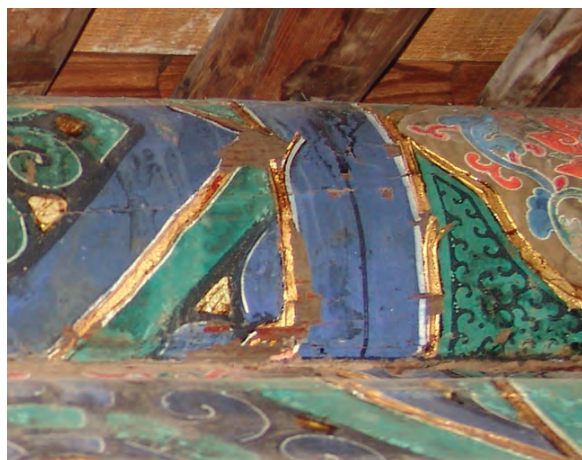
沥粉贴金起甲和彩画缺失。

Flaking of raised decoration and loss of painting.

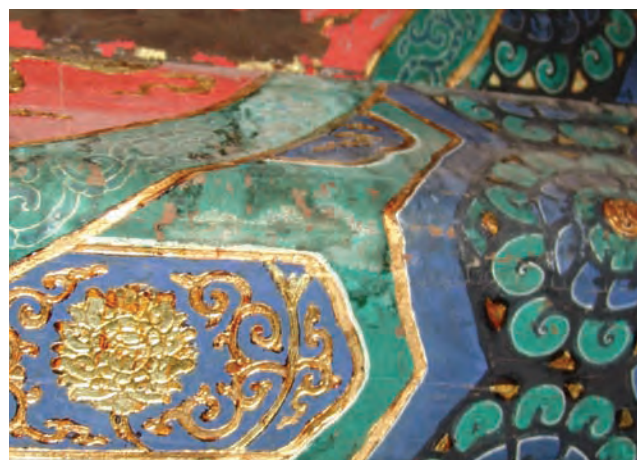
雨水渗透所造成的水渍。

Water stains caused by rain water penetration.

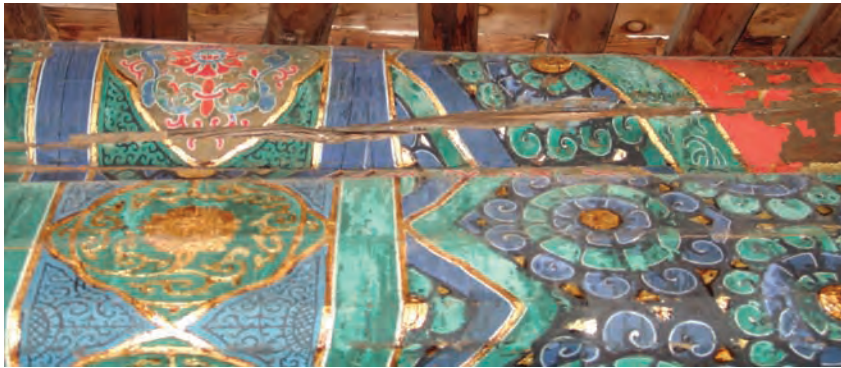
The rounded upper beam is more deteriorated than the architrave below. On the south face, there is a very pronounced horizontal crack in the wooden beam starting from the eastern end and continuing almost the entire length of the beam. There are also smaller cracks in the wood on the north face, especially on the ends. On both sides of the beam, there is a large amount of paint loss in the wrapper area and the golden dragon pattern is barely legible here. There are also water stains running along the top of the beam. The paint loss and staining are probably caused by rain water penetration through the roof. However, despite the water stains the remaining painting is still legible.

脊檩上的裂缝

Horizontal split in the upper rounded beam.

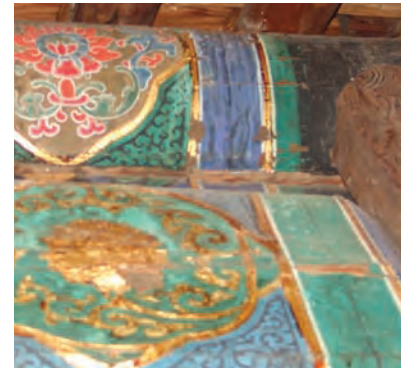
脊檩上的裂缝

Small cracks on the purlin.

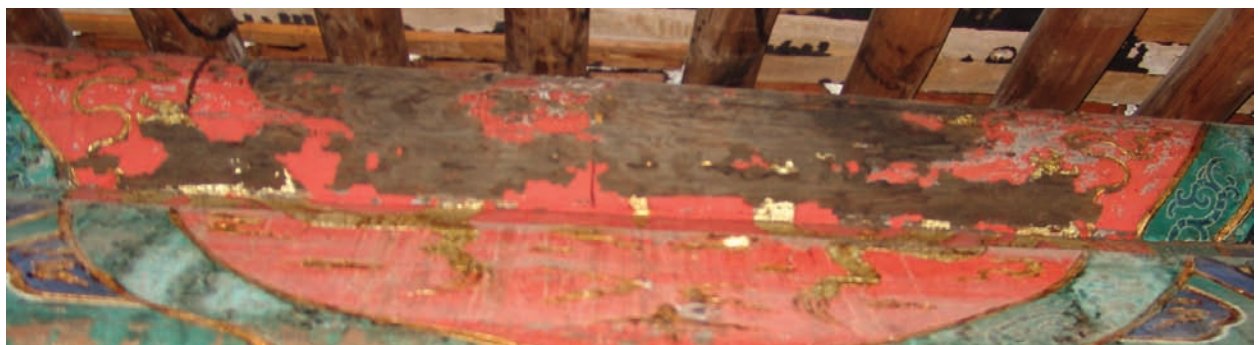
脊檩袱子纹饰的缺失

Caihua loss on the wrapper decoration on the purlin.

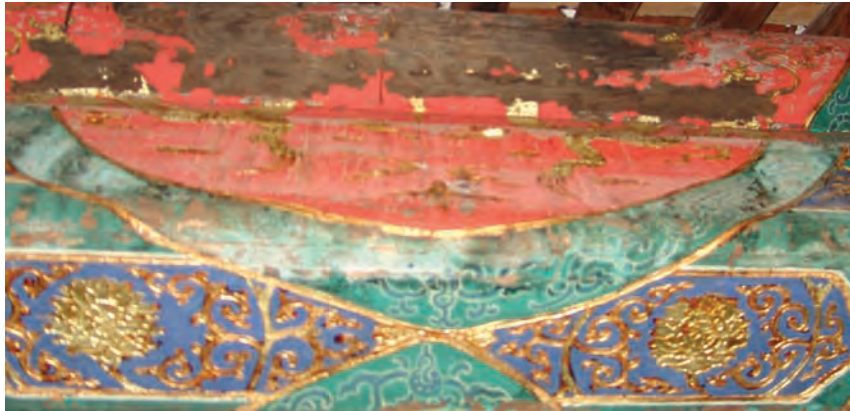
The lower ridge architrave is in relatively good condition. There are some cracks in the wood on the south face but no major paint loss. Both faces of the painted beam suffer from water staining, especially noticeable on the wrapper decoration where the staining on the north face is slightly more severe than the south. However, despite the water drip marks, the golden dragon pattern can still clearly be read. Areas of the blue and green pattern around the wrapper have suffered more water damage and paint loss making the decoration difficult to read. Water infiltration has also caused limited staining and paint loss on the underside of the architrave, but is otherwise in good condition.

脊枋袱子和其周围纹饰上的水渍

Water stain on and around the wrapper decoration.

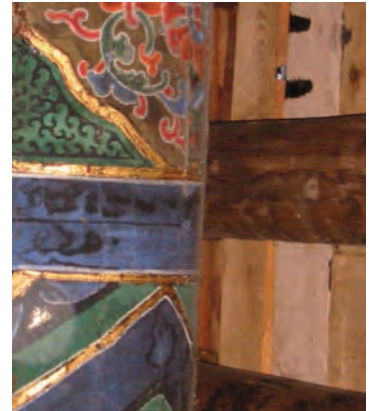
蓝绿纹饰上的水渍

Detail of water stains on blue and green painted motifs.

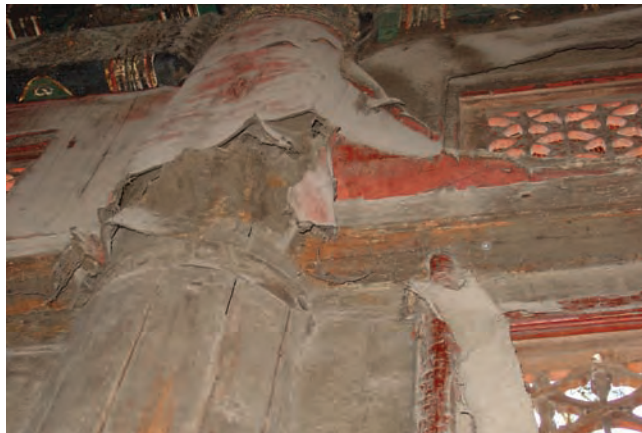
大面积空鼓并悬挂着的油饰残片。

Large areas of the painted plaster are detached and hanging off.

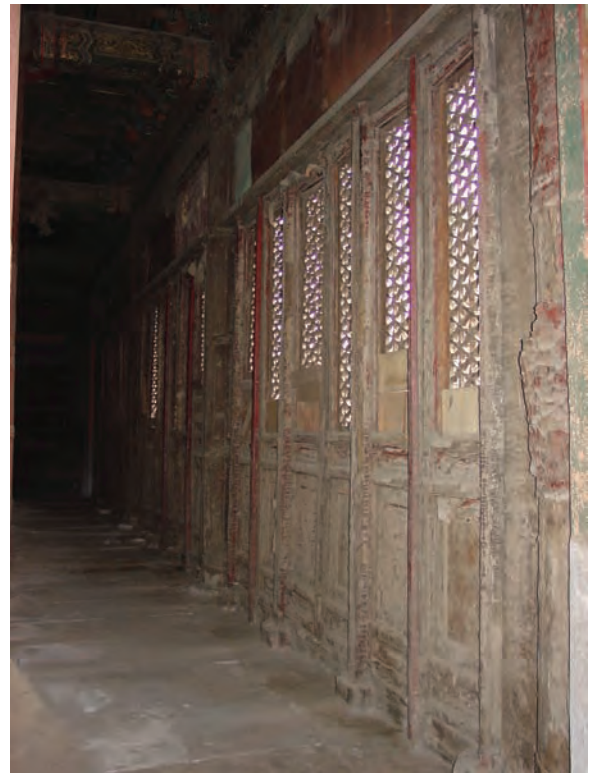
详细显示一处油饰地仗开裂与起甲的情形，下层纤维层暴露。

Detail showing an area of cracking and flaking of the painted plaster revealing the underlying fiber layer.

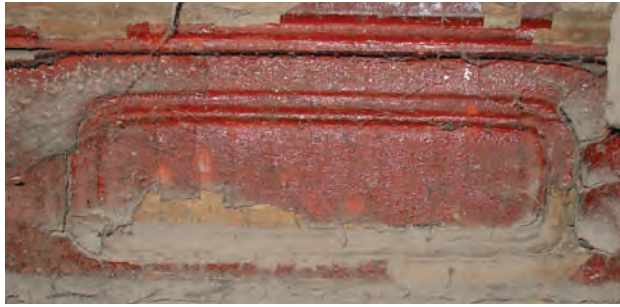
会乘殿北壁大门上油饰地仗的残破状况。

The painted plaster on the doors of the north wall are in particularly poor condition.

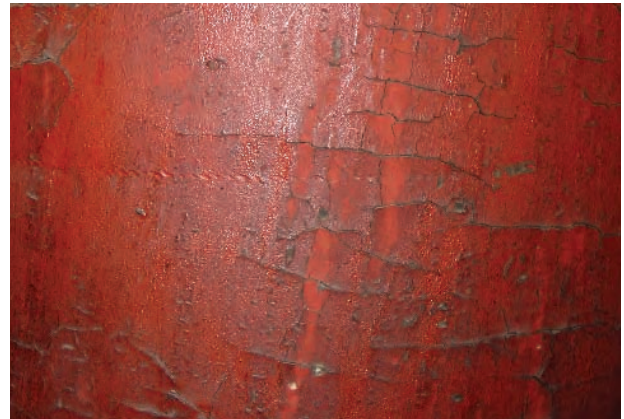
亮丽红漆的部位（细部）；猜测这红漆可能是后来直接重新刷在原来的漆层上或是一个高含鲜艳介质的部位。

Detail of the shiny areas of red paint thought to be either a later repainting applied directly over the original paint layer or a painted area with a high binding medium content.
