# MUSEUM AMSTELKRING TE AMSTERDAM

## Adviesrapport binnenklimaat

[Museum amstelkring in Amsterdam  
Advisory report on the indoor climate]

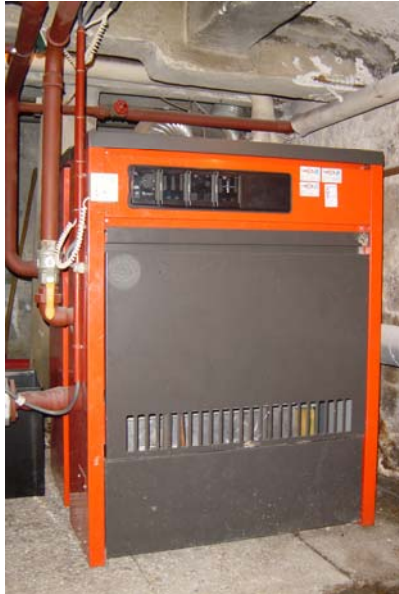
Fig. 8 The boiler

Rehema type Gas 3C

nominal capacity 138 kW

dating from 1991

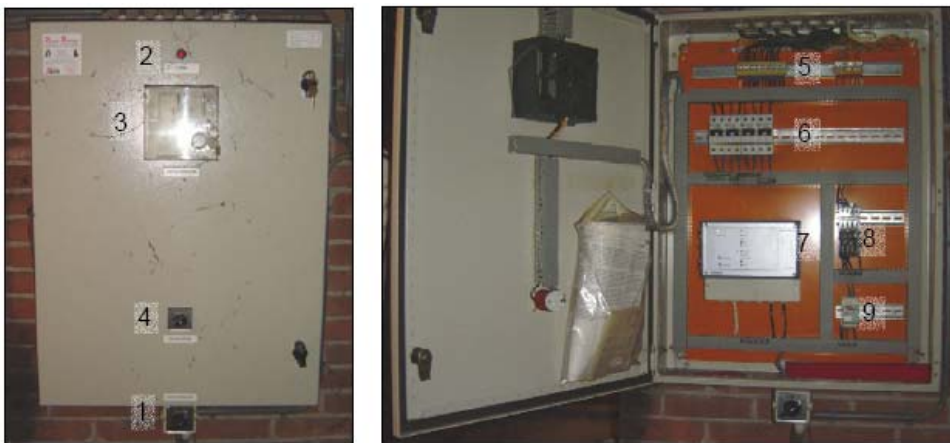
Fig. 10 Switchboard cupboard for central heating boiler

1. main switch
2. problem signal indicator
3. regulator
4. switch for dirty water pump
5. clamp rail
6. installation automatics
7. gas detection sensor
8. magnetic switch and thermal security pump
9. relais switch

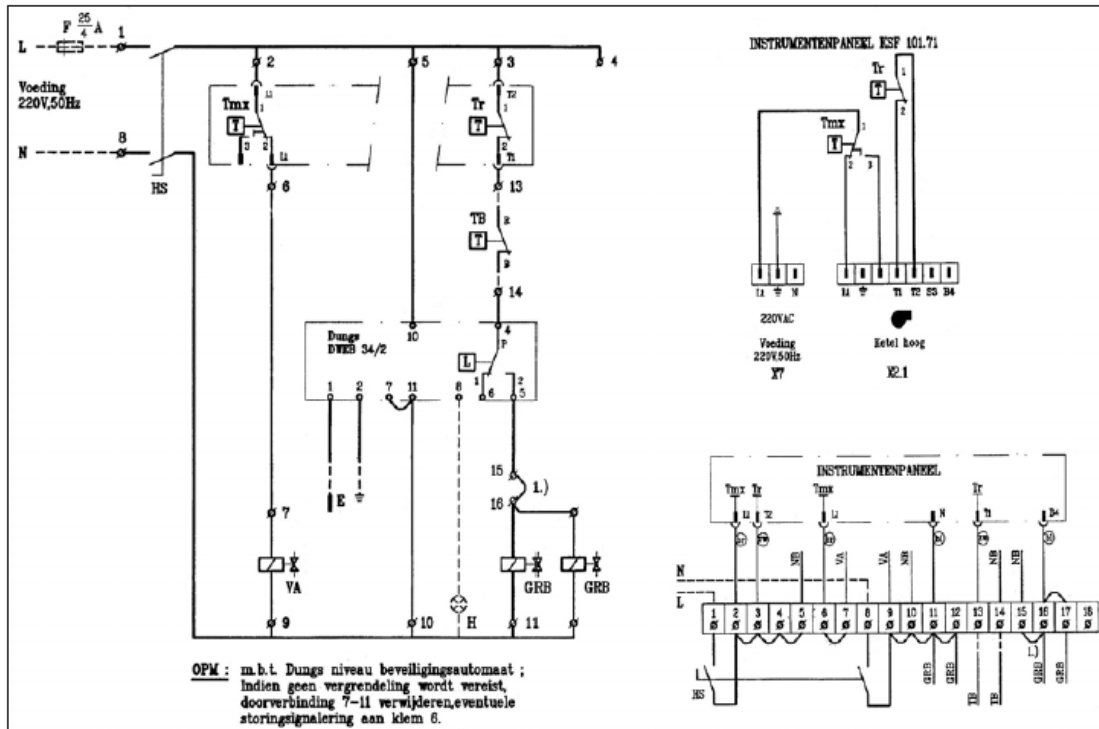
Fig.11 According to the installation engineer, Tmx (maximum temperature protection) and Tr (room thermostat) are no longer connected. Indoor temperature is regulated by outdoor climate changes only.
