Area reference	Object number	Object name or title
11		Stairs from ground to 1st floor corridor Sael/canal room, 14 steps
Object category		provenance
Stairs		built in this house

most recent assessment:	assessor:
8/14/2006	GCI/ICN

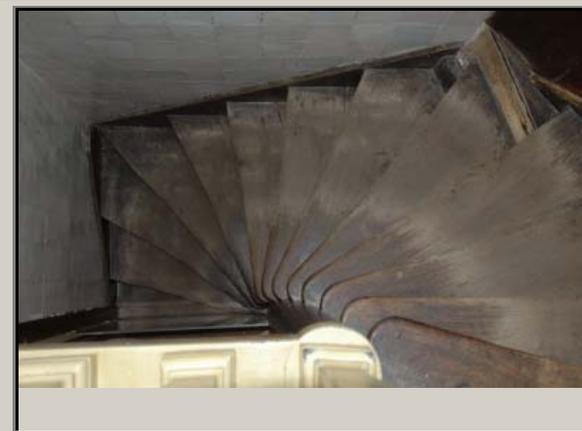
description of damage:
 2 turning points visible. Abrasion top step from 31-20 mm, 1st step 31-18/20 mm, 3rd step 31-16 mm (turning point).

visible damage 1
abrasion

visible damage 2
deformation

damage caused by 1	damage caused by 2	damage caused by 3	damage caused by 4	damage caused by 5	damage caused by 6:
PF 3/8 frequent use

comments
 In 2002 they were closed to the public and were taken out of the normal museum routing, because of the extensive abrasion of the steps. These stairs have since only been in use during weddings, and only by the bride.

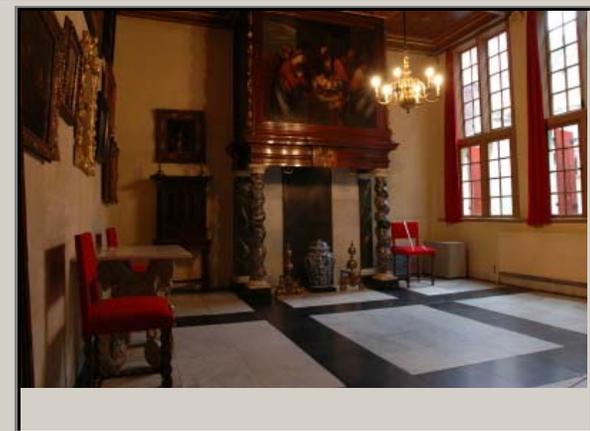
Chipping of edges, loss of corners. Some previous restorations, cracks, fractures through tiles (NB: natural veins can be mistaken for cracks). Deformation of floor - slanting towards the alley. Some stains. Compression of shell bed causing stress.

damage caused by 1	damage caused by 2	damage caused by 3
PF 3/8 frequent use	PF 3/2 continous vibration	PF 3/9 inherent stress

Floor has been interfered with during installation of central heating. Floor moves when people walk over it, but its flexible construction is made to deal with this. Maintenance of shell bed is important to prevent damage.

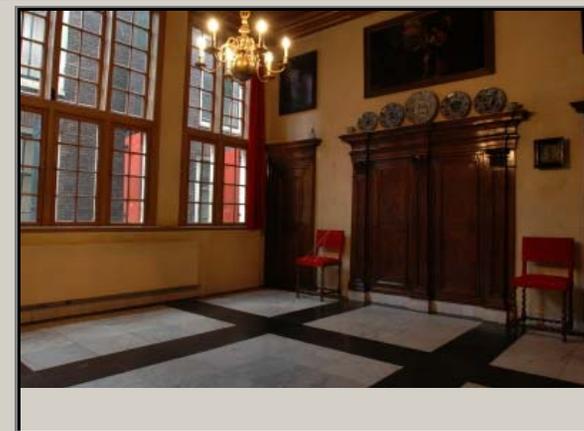
description of damage:
Groves (1-2 mm deep) at bottom turning point of doors. Doors do not close properly - slightly displaced because of building slanting. Some water stains at bottom of right architraaf. Small cracks in between panels. Small areas of damage in capitals.

visible damage 1	visible damage 4	visible damage 7:			
abrasion	crack				
visible damage 2	visible damage 5	visible damage 8:			
displacement					
visible damage 3	visible damage 6:				
staining					
damage caused by 1	damage caused by 2	damage caused by 3	damage caused by 4	damage caused by 5	damage caused by 6:
PF 3/9 inherent stress	PF 3/5 abrasion	PF 3/8 frequent use	Cont 2/3 cleaning spills

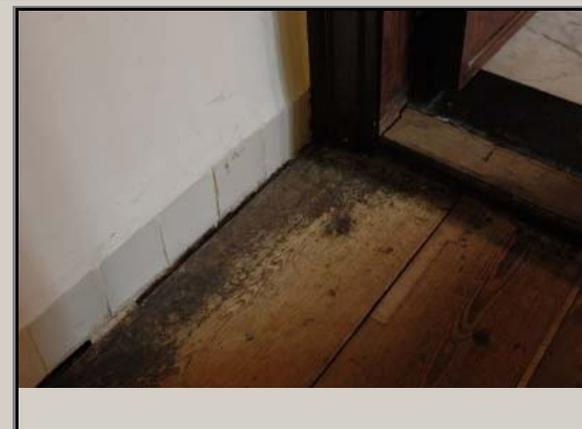
visible damage 1
deformation

visible damage 2
abrasion

visible damage 3
chip

visible damage 4
staining

visible damage 5
soiling

damage caused by 1	damage caused by 2	damage caused by 3
PF 3/5 abrasion	PF 3/8 frequent use	PF 3/9 inherent stress

comments
When replacing or repairing floor parts in the past, the springs were mechanically broken and may now be missing.

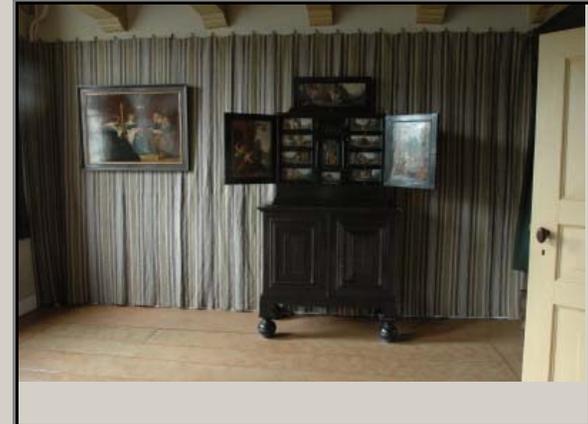
Oak wood shrunk, veneer extends for several mm. Minor cracks in oak wood and veneer. Small area of paint loss in right door, inside (possibly corresponding with joint between planks). Dents and scratch marks on bol feet. Dust deposition.

visible damage 1	visible damage 4	visible damage 7:
crack	dust	
visible damage 2	visible damage 5	visible damage 8:
flaking/delaminating	loss	
visible damage 3	visible damage 6:	
abrasion	dent

damage caused by 1	damage caused by 2	damage caused by 3	damage caused by 4	damage caused by 5	damage caused by 6:
RH 3/1 incorrect high/low	PF 3/3 handling	PF 3/9 inherent stress	Cont 3/1 dust

comments	most recent assessment:	assessor:
The canal room is the first room in the tour and is noticeable more dusty then the rest of the house.	8/14/2006	GCI/ICN

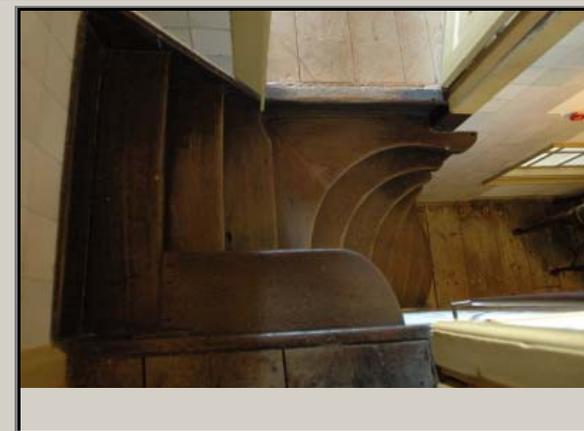
description of damage: Abrasion of steps, especially in the middle part towards the front of the step. Abrasion 2nd step from 62-52 mm, 6th step 64-58 mm, top 2 steps both 3 mm loss.	visible damage 1	visible damage 4	visible damage 7:
	abrasion		
	visible damage 2	visible damage 5	visible damage 8:
	deformation		
	visible damage 3	visible damage 6:

damage caused by 1	damage caused by 2	damage caused by 3	damage caused by 4	damage caused by 5	damage caused by 6:
PF 3/8 frequent use

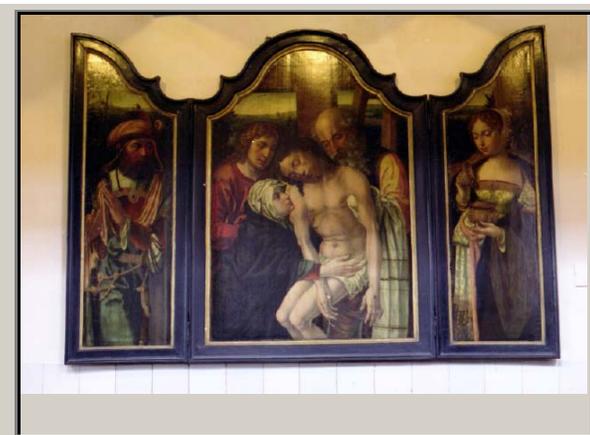
description of damage: Dust in varnish. Under raking light finger print can be seen in area of wound. Panels shrunk (old damage). Minor loss of gilding from frame.	visible damage 1	visible damage 4	visible damage 7:		
	dust	loss			
	visible damage 2	visible damage 5	visible damage 8:		
	staining				
	visible damage 3	visible damage 6:			
	crack				
damage caused by 1	damage caused by 2	damage caused by 3	damage caused by 4	damage caused by 5	damage caused by 6:
PF 3/9 inherent stress	PF 2/4 use	Cont 3/1 dust	Cont 2/4 object treatment

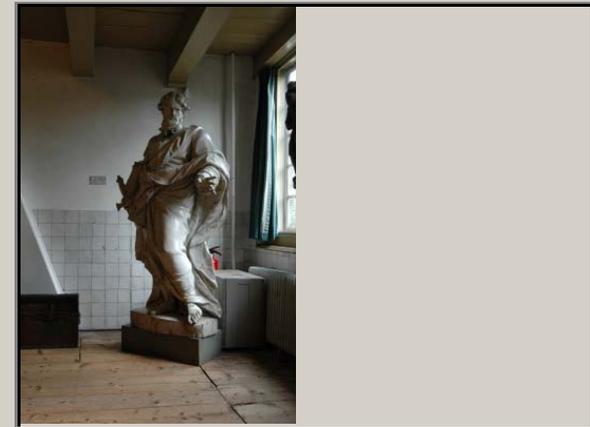
description of damage: Wood severely cracked, loss of paint and some ground layer, loss of wood in base, dust deposition (in folds), staining on lower part, old repairs using infills in different colour, evidence of woodborers' activity (inactive), abrasion of protruding parts.	visible damage 1	visible damage 4	visible damage 7:		
	crack	staining			
	visible damage 2	visible damage 5	visible damage 8:		
	flaking/delaminating	loss			
	visible damage 3	visible damage 6:			
	soiling	abrasion			
damage caused by 1	damage caused by 2	damage caused by 3	damage caused by 4	damage caused by 5	damage caused by 6:
PF 3/9 inherent stress	PF 2/3 maintenance/repai	PF 3/3 handling	Cont 3/1 dust	Cont 2/3 cleaning spills	Pests 2/2 insects

comments	most recent assessment:	assessor:
Statue is placed in front of S facing window, underneath which is a radiator. In between radiator and statue is a humidifier, set @ 50%.	8/14/2006	GCI/ICN

- Keep eye on relation between cracks and heating.
- Look into system of combined humidification & heating.
In the meantime, keep humidifiers in place.

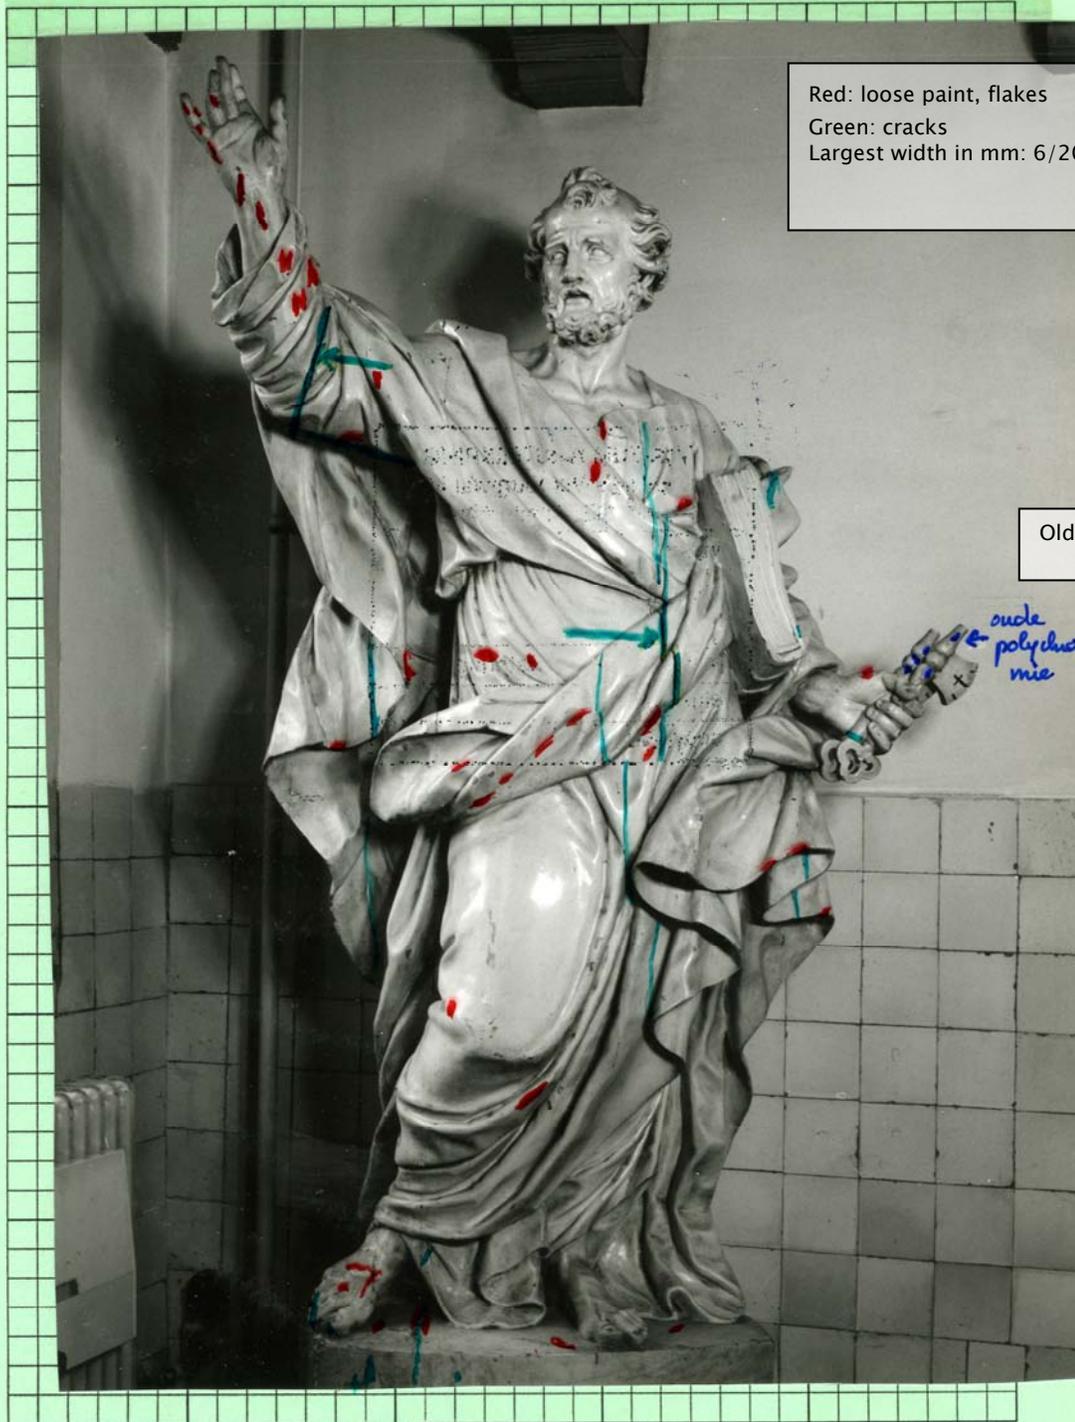
groen: scheuren, barsten, open naden*

* grootste breedte in mm: juni 2003: 4,7mm

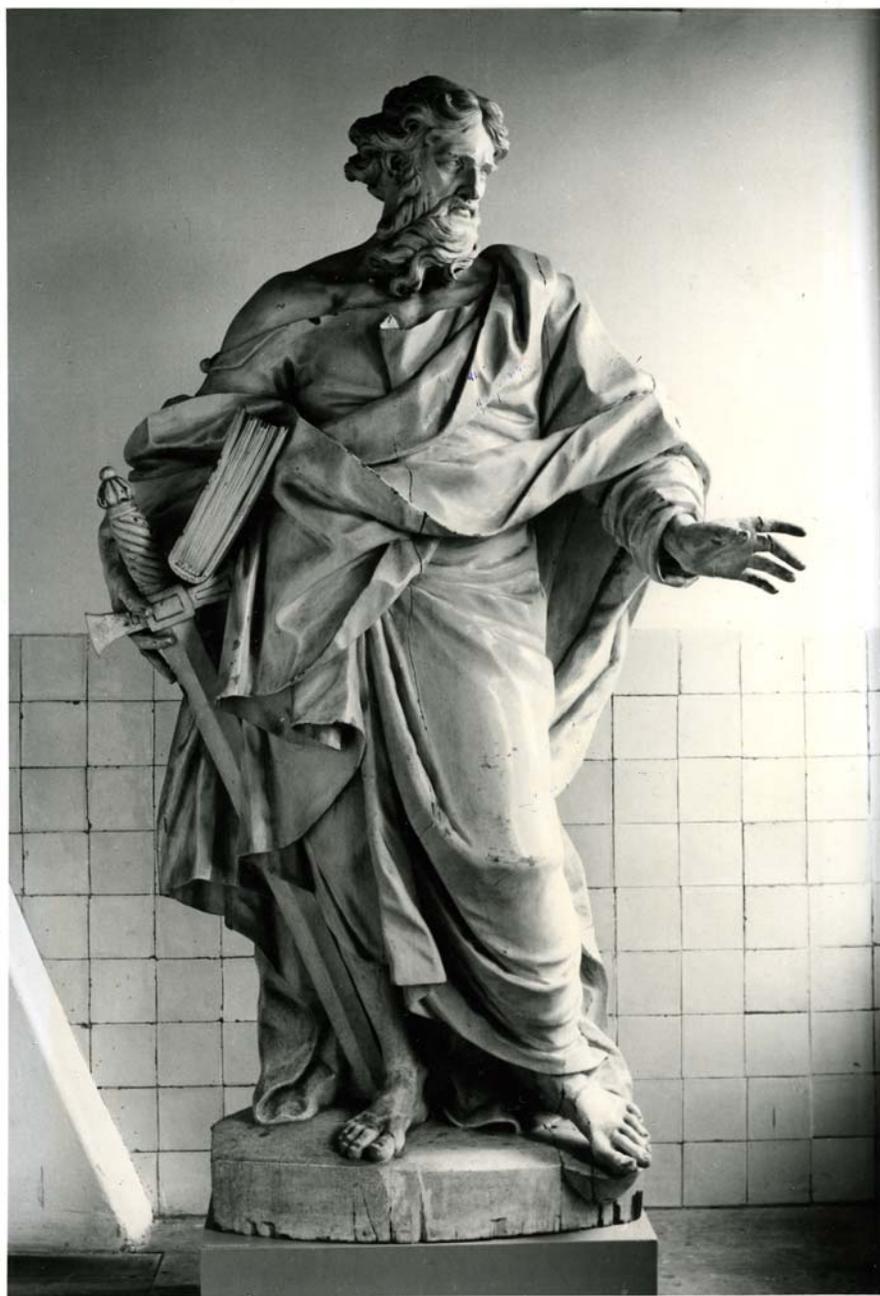
groen: scheuren, barsten, open naden*

* grootste breedte in mm: 3/1997: 4,5 mm
6/2003: 5 mm

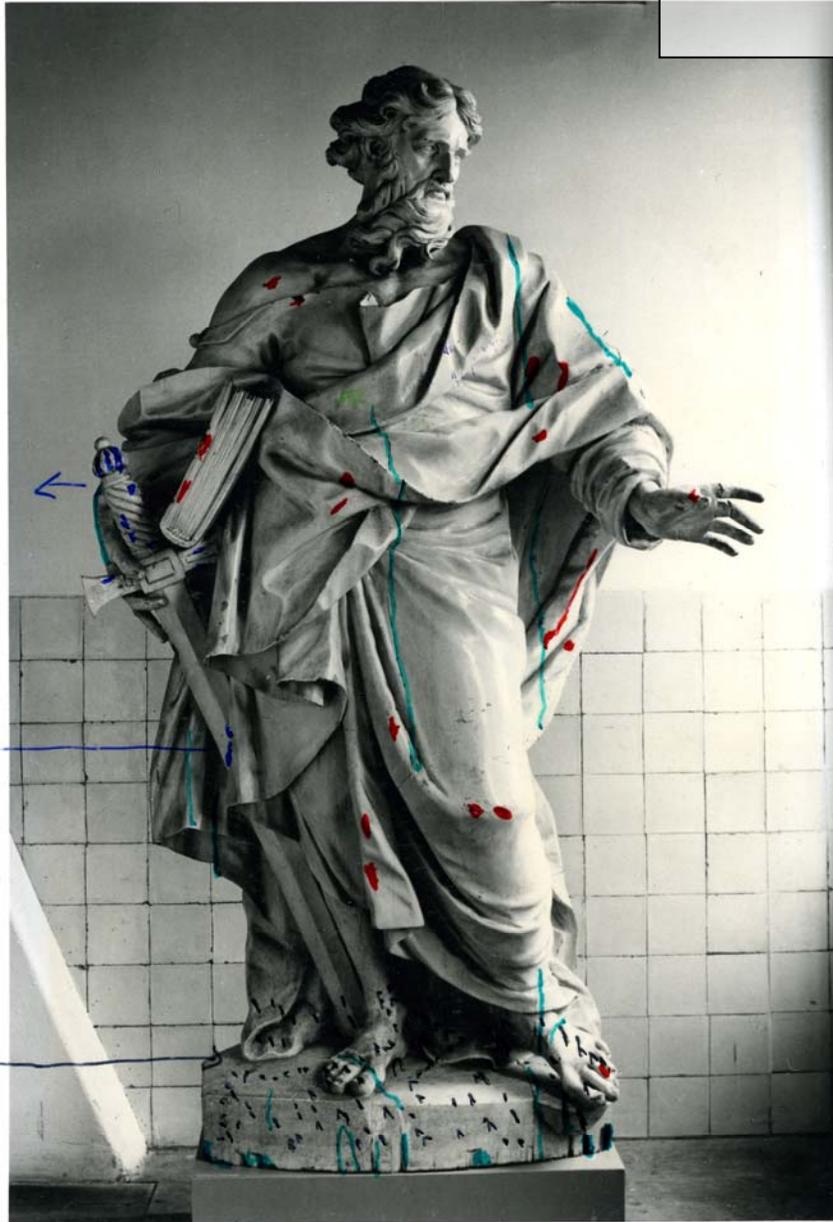
Small brown stains

bruin-
achtige
vlekjes
