## 8 Condition assessment

### 9.1.1 Comments with regard to the current condition of the building

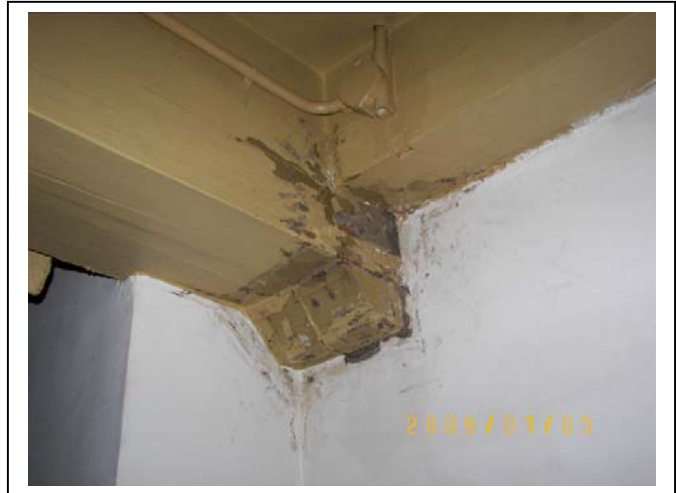
There has been an issue (first mentioned in the 1970's) with the rotting of beam heads in the north wall of the building at the Church's third level floor (the 6<sup>th</sup> level of the building), which is exposed to the elements (there is no connecting building at that level). No other rotting has been found in other walls except one with an obvious rain infiltration problem.

Damage to one of the beam heads  
(photo: TU/E)

The beam heads were repaired (potted in an epoxy resin), the walls were stuccoed and painted. The old wall may have developed cracks that were infiltrated by outside rain, resulting in the rotting beam heads. Rain generally wets north-facing walls in the Netherlands, and these walls tend to remain wet for long periods afterwards. Therefore, it is considered highly unlikely that rotting of the beam heads was caused by *in situ* condensation of the humidified air inside the building. Instead, it was a building maintenance issue in which the wall had cracked and rain infiltrated into the wall cavity and rotted the beam heads.

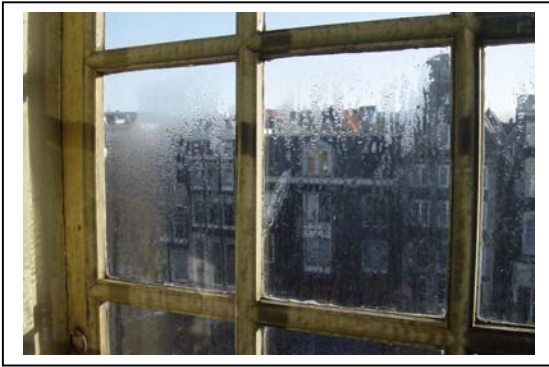
In winter, there is often condensation on the inside of the windows, resulting in rapid decay of the windowsills.

Condensation on the inside of window in the church  
(photo: TU/E)

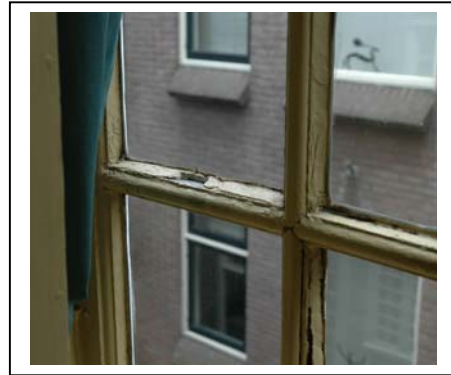
Damage to window sills, accelerated by  
condensation (photo: Paul Ryan)

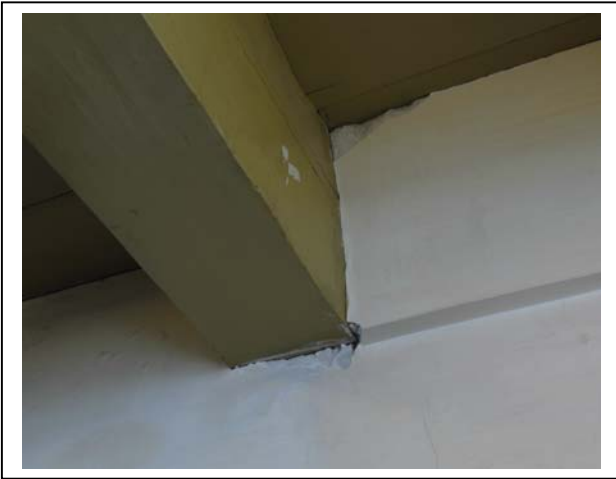
The flexing of the galleries by their own weight and when loaded with people is mitigated by the vertical tension rods. However the galleries are slightly dipping closer to the altar. One rod (near the altar, on the SW side) was broken (first noticed in the 1970's and not repaired until 2001). At this point the SW 1<sup>st</sup> gallery is sagging more, which could be an indirect result of this damage. The gallery on the opposite side also has a bend, but to a much lesser extent.

There is obviously some movement in the SW 1<sup>st</sup> gallery – the plaster underneath is crumbling away and there is damage to the beam heads.

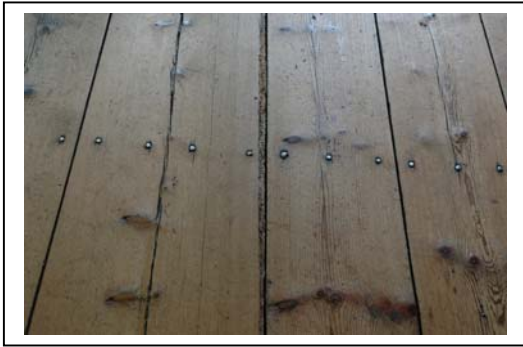
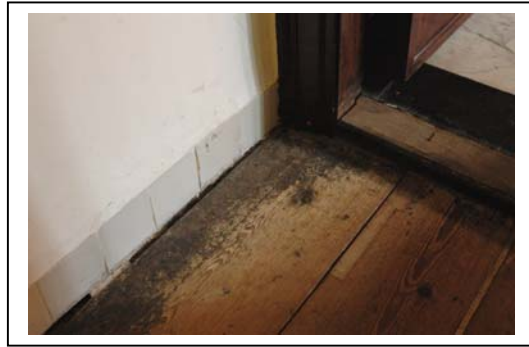
Floorboards showing shrinkage in width      Darker area around edge of floor (photos: Paul Ryan)

Damage: crimp in the width of the planks causes deformation of and splits in between floorboards. There is chipping and loss of wood in places where the springs are exposed. Around the edges of floors there is a brownish discoloration caused by ingrained dirt in old remnants of wax (?). There is damage caused by wood boring insects, although this appears to be inactive. Abrasion (less in areas of knots) is on average 5 mm in the routing, and 8 mm upon entering the church (which is a turning point). The worst abrasion (of 12 mm) is found in the area next to the organist's bench (the wood is worn away to expose groove, loss of spring).

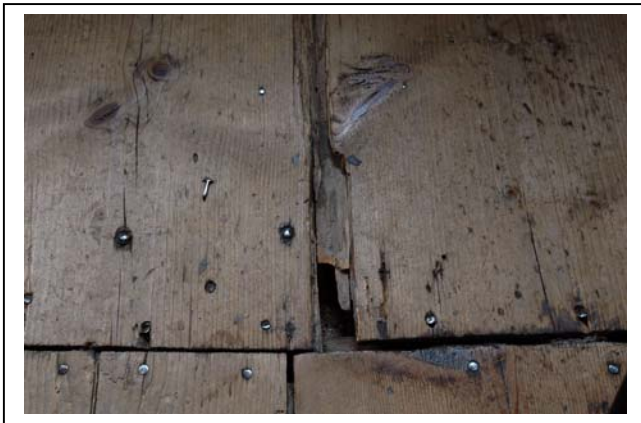
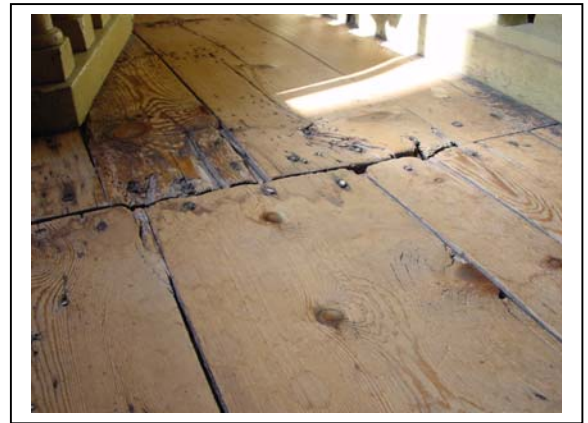
Details showing an exposed spring and related wood chipping (photos: Paul Ryan)

Observations (continued): when the pine floorboards abrade for 3 mm, the oak spring may become exposed. The pine is vulnerable when this happens and there is a lot of damage caused by walking – placing a heel at these points chips off wood fairly easily. Vulnerability of pine versus oak: pine is softwood, oak hardwood. Because the floors were not maintained at a regular basis in more recent history, i.e. splits not filled and exposed springs left untreated, damage of the wooden floor is wide spread. If left untreated, the overall condition of the floors will decrease rapidly.

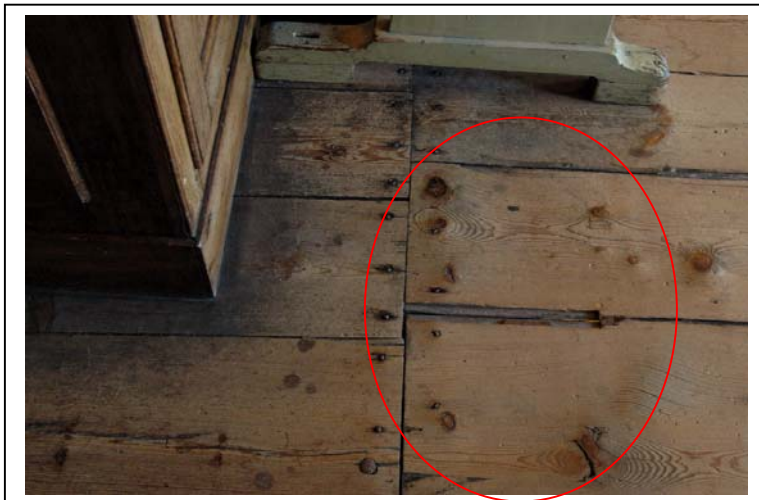
Of immediate concern is the wear in certain areas, where the thickness of the wood may have decreased to a possibly structurally unsound situation. A more detailed survey of the wooden floors is planned this year, which will identify the exact extend of this problem. The areas of concern are at the top of the stairs on the first gallery and next to the organ. The first area is a turning point and this obviously results in more abrasion. The other point is the spot where the organist jumps down from his high seat and immediately turns. This spot could easily be protected by providing a small step to avoid the jump or by covering it with a more durable material.

Area next to the organ that is more abraded. Loss of spring. (photo: Paul Ryan)

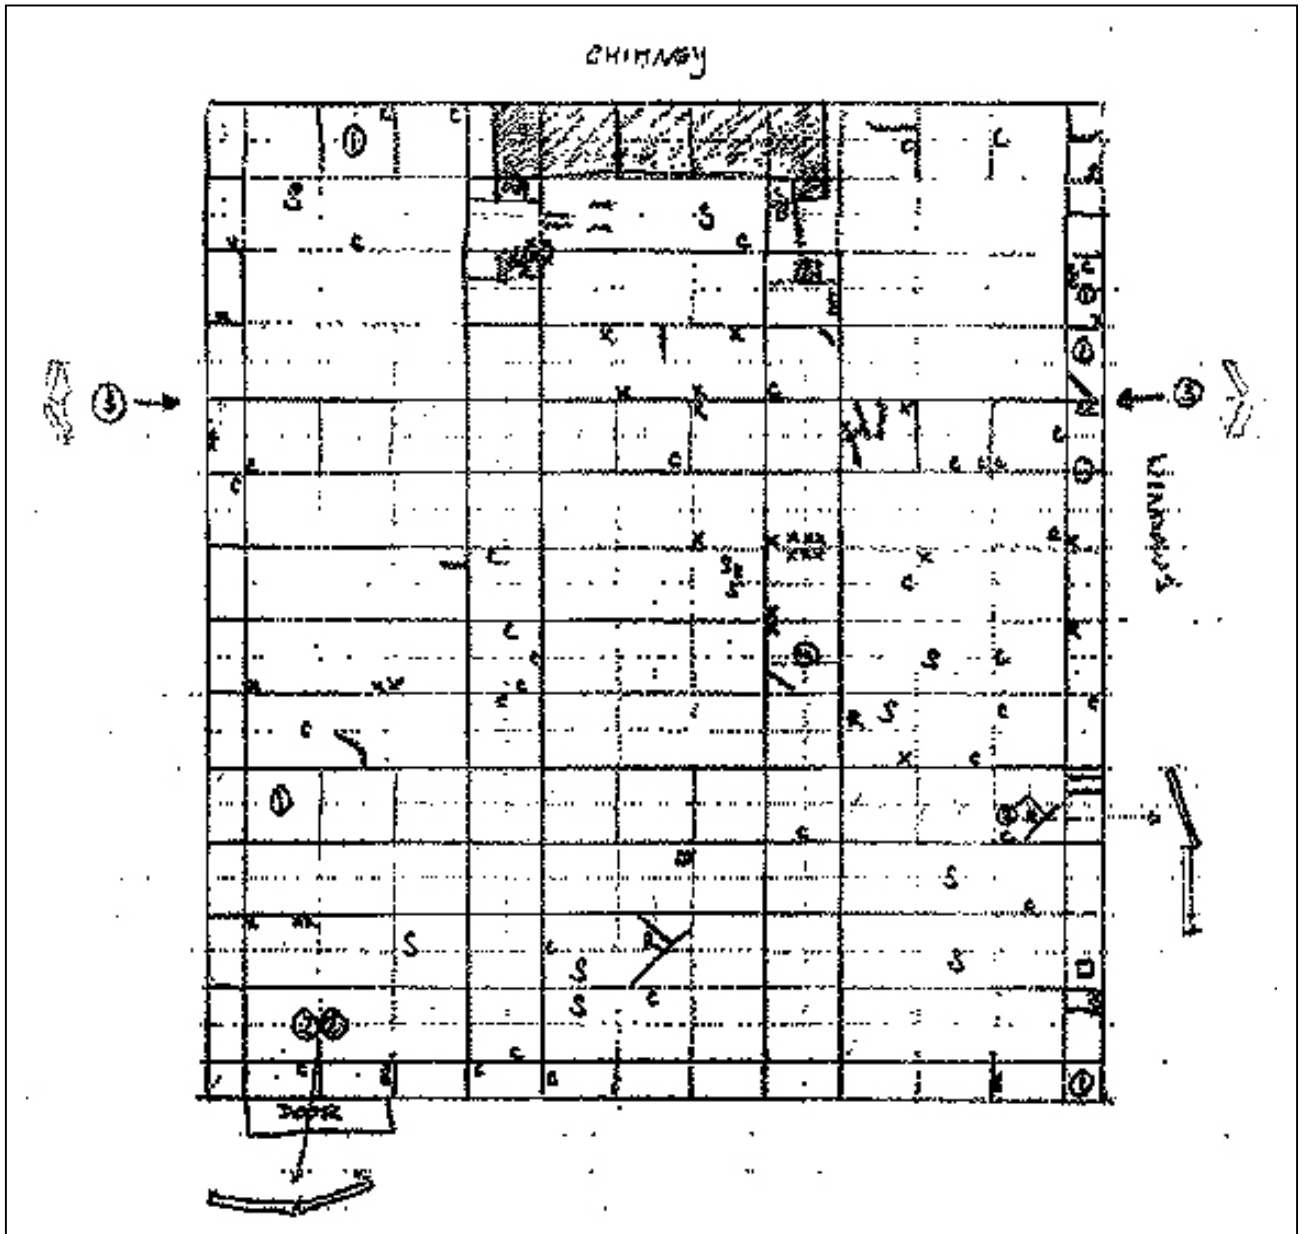
**Damage:** some scratching all over, chipping along edges and in corners, a few cracks, and sloping of the floor in the Sael.

Sketch of the damage to the floor in the Sael (c=crack, r=repair, s=stain, x=loss)  
 (source: Agnes Brokerhof)

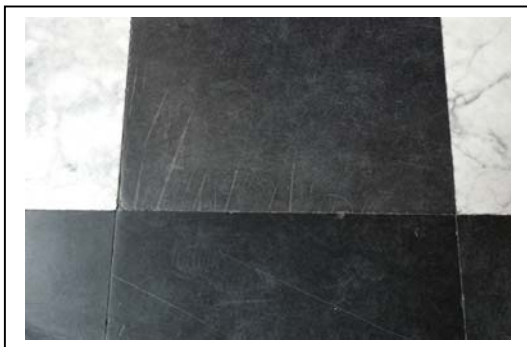
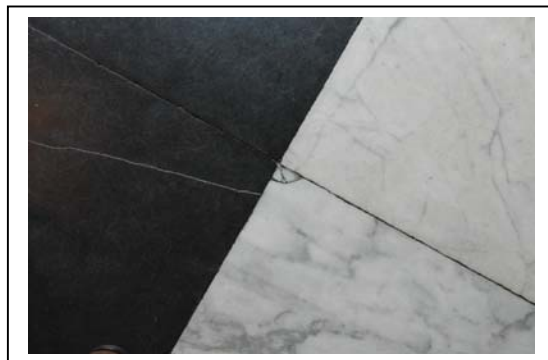
Details of damage to the Sael floor (scratching; chipping). NB: right photo shows white vein in black tile, easily mistaken for fracture . (photos: Paul Ryan)

The floor is overall scratched by shoes – a protective measure to prevent unnecessary scratching would be to forbid the wearing of hard or pointed shoes, such as stilettos or boots with metal reinforcements. Also shoes and boots with a deep profile can trap small stones that can cause scratching.

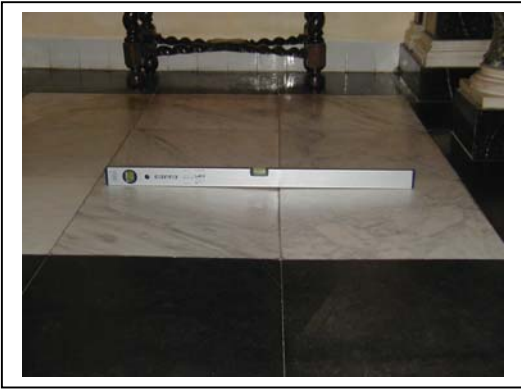
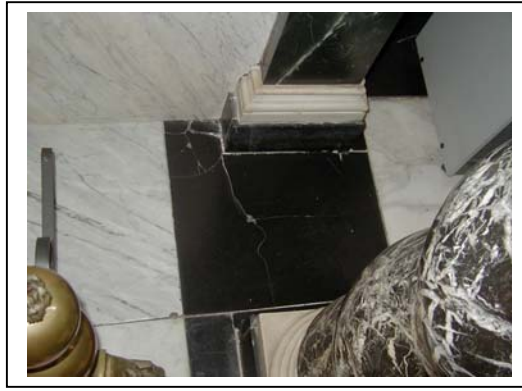
Details of damage to the Sael floor (deformation; cracking due to structural pressure of chimney piece). (photos: Paul Ryan)

Observations: the stone floors are susceptible to wear and tear, not so much in the abrasion of the material, which is relatively strong, but more in damage related to the stability of the floor. As the seashell bed is crushed over time, the curved slates will start rocking as ones walks over the floor, resulting in chipping at the edges and eventually cracking of the slates. Another contributing factor to the overall stability of the structure is the wooden floor underneath- in the Sael the floor is sagging towards the alley and the bed of seashells is not compensating for this deformation. At the moment, the slates are still secured in the shell bed. In order to avoid unnecessary damage in the future, maintaining a stable shell bed is crucial.

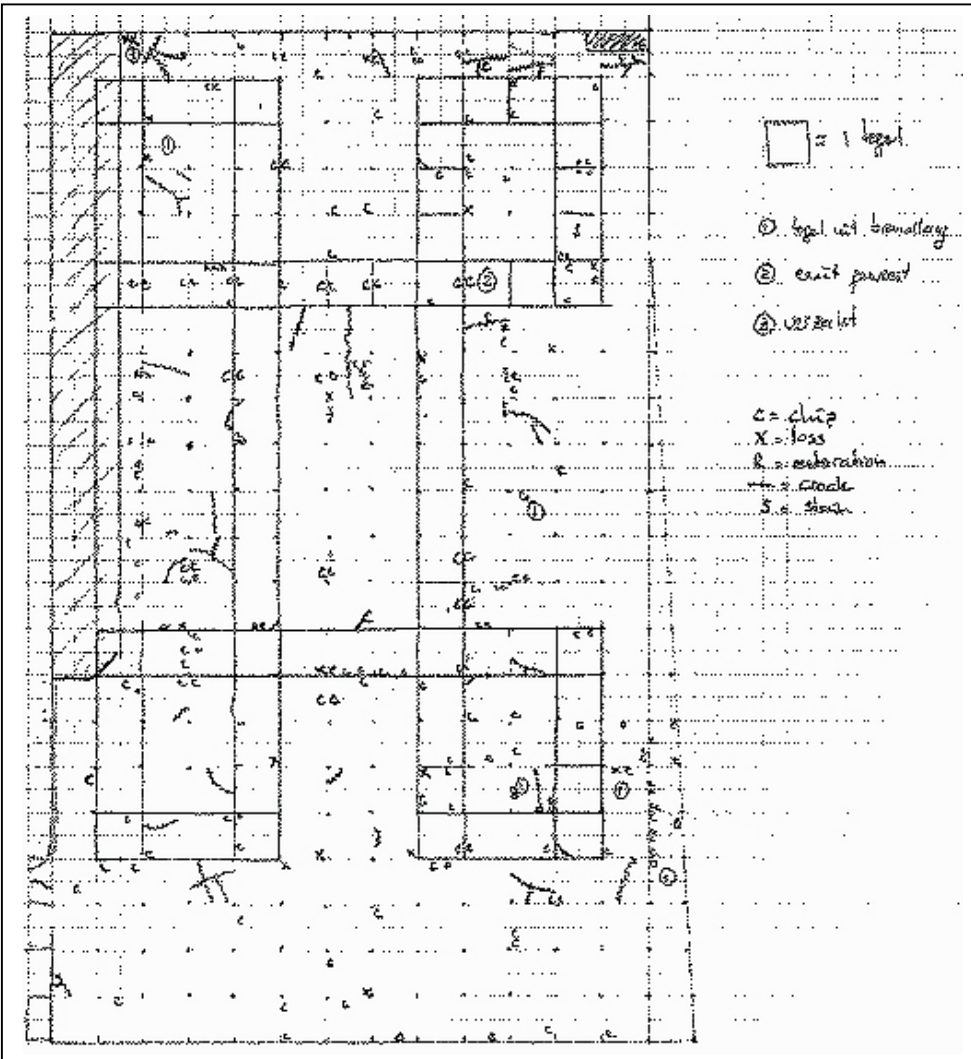
Sketch of the damage to the floor in the Jaap Leeuwenberg (c=chip, r=repair, s=stain, x=loss) (source: Agnes Brokerhof)

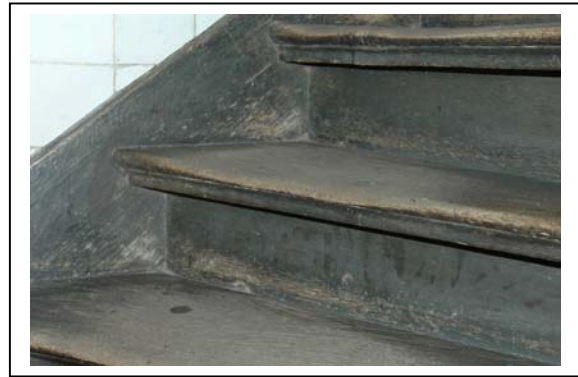
Damage: severe abrasion of steps, especially in the wider part of the triangular shaped steps.

Detail of wear and tear on one of the steps. (photos: Paul Ryan)

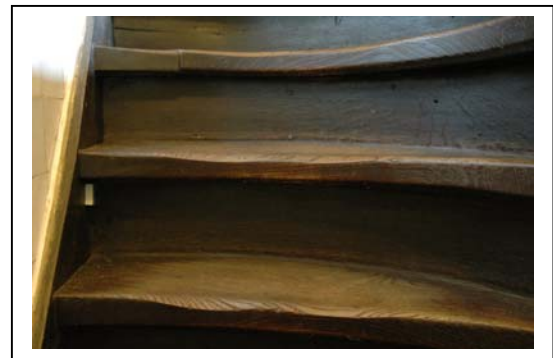
Damage: abrasion of steps, especially in the middle part towards the front of the step.

Detail of wear and tear on the steps.

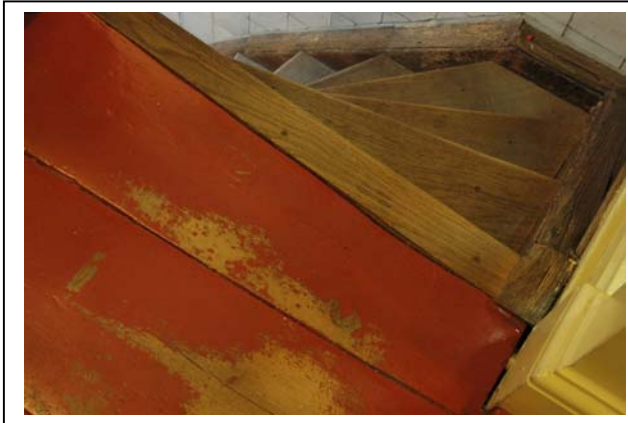
Damage (continued): the top of the stairs is dipping and the floor plank closest to the stairs is severely flexing when stepped upon. The red paint is abraded away in the area where one turns ones feet to enter the Leeuwenberg Room. The brown paint on the railing of the balustrade is largely worn away and in areas there is a thick layer of accumulated grime (from hands). As this layer is also brown, it is difficult to distinguish between paint and grime.

Top of the stairs looking down  
(photos: Paul Ryan)

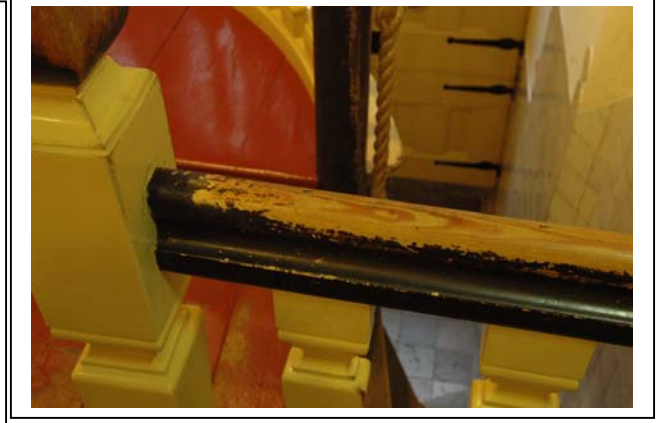
Damage to railing of balustrade on top  
of the stairs

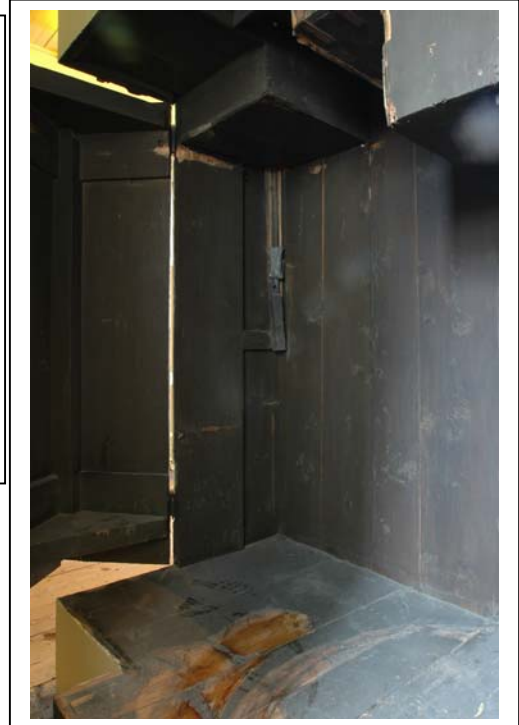
The pulpit is in good condition and has some minor scratches. The wax is blooming because of the microclimatic conditions inside the cupboard. This visual effect is not harmful and can easily be polished. There is some dust deposition. The cupboard is the weakest part with many signs of use – mainly abrasion caused by the movement of pulpit.

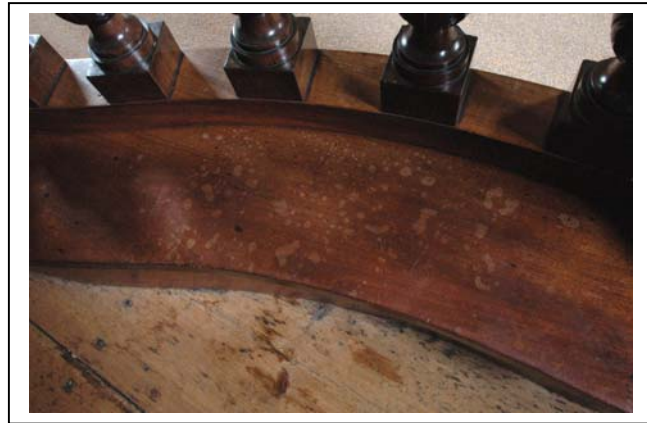
Detail of the water stains caused during baptism.

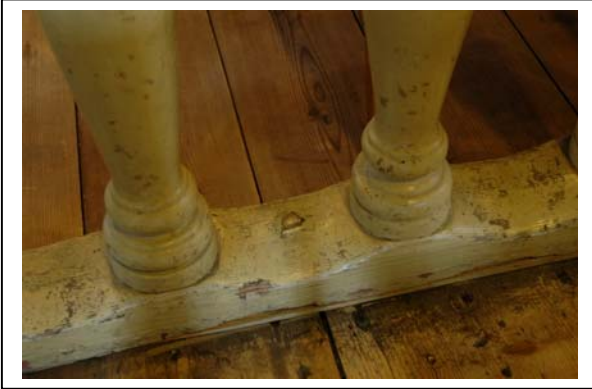
There is specific damage that appears to have been caused prior to the time the building became museum, when it was still in use as a church. For example, the worn away areas of wood in between the columns of the balustrade and, to a certain extent, the abrasion of wooden floors. On the floor there is a built up layer of dirt in areas less walked over. More recent damage can be observed in abrasion of paint and built up of grime on balustrades and doorposts caused by people touching these elements for support as they walk through. Damage caused by bumping and scratching both resulting in paint loss or dents in surfaces. In addition, some more modern nails are visible, and could possibly have been used during events to tack down cabelling. At present, the house rules forbid this kind of action. There are also signs that the handling of tripods and stands results in scratching of surfaces.

Detail of severe abrasion of the balustrade, caused during the time this was still a church (photos: Paul Ryan)

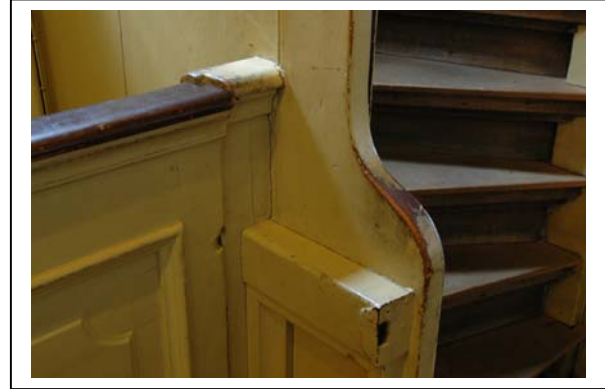
Detail of abrasion of posts of the stairs in the church

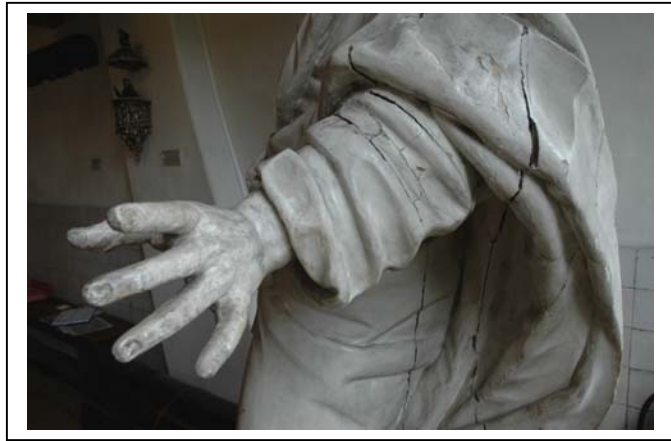
Detail of cracks in the wood (photos: Paul Ryan)

Observations: since the last condition assessment in the 1990's there is no further paint loss and cracking of the wood. The severe cracking of the wood most likely occurred when the church/building became centrally heated, which caused a severe drop in relative humidity (RH) that would have been kept over a relatively long term (several months each year). The photograph taken around 1890 shows only some minor cracking, which could prove this assumption.

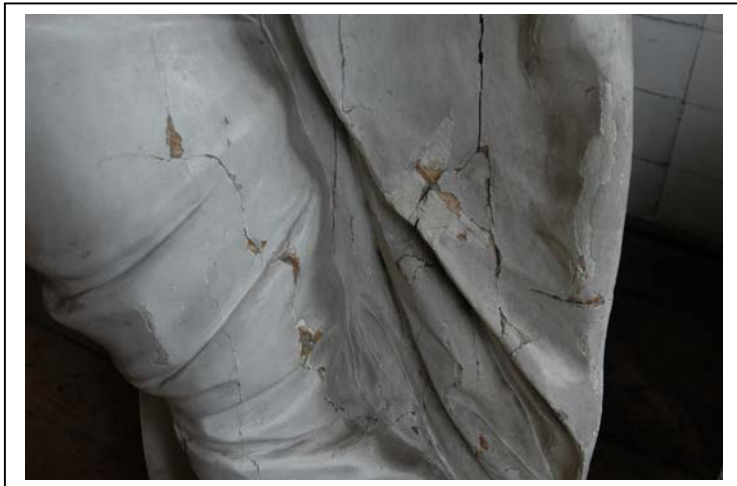
Detail of damage to lower left leg and drape (photo: Paul Ryan)

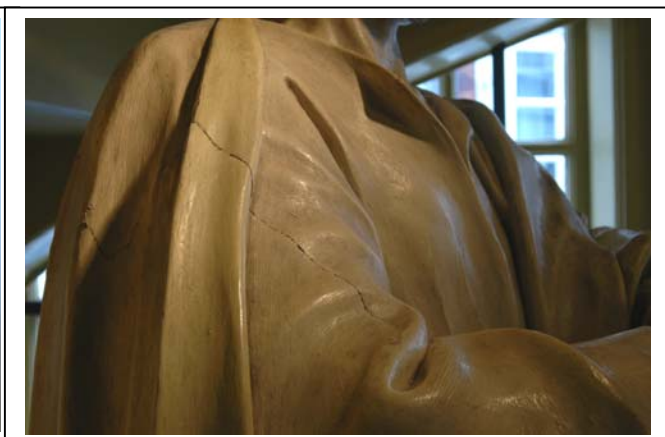
Detail of minor wood cracking

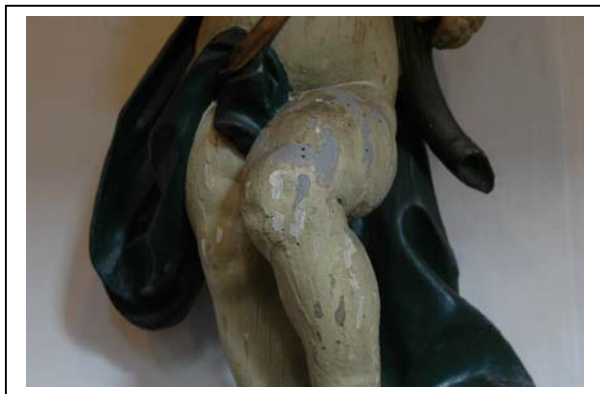
Detail of damage, showing gray infills and new paint loss (white ground layer exposed)

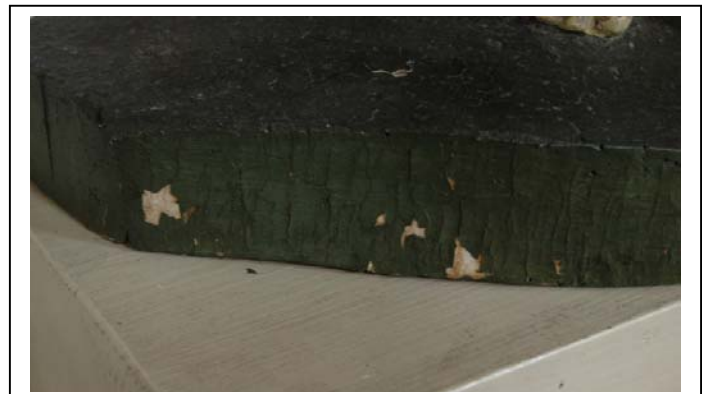
Detail of damage showing recent paint loss (photos: Paul Ryan)

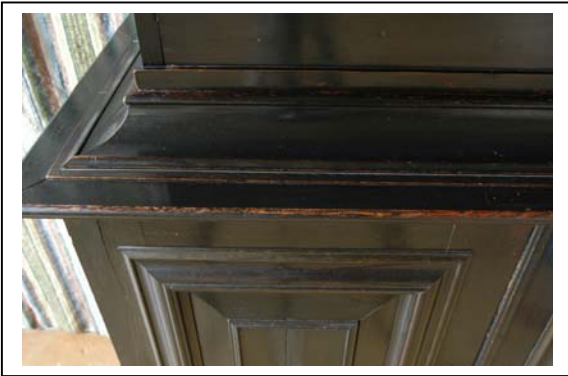
Damage: abrasion of protruding parts, veneer is locally split and it extends minimally from the surface. There is a small crack in one of painted doors with minimal paint loss. Damage at ball feet caused by bumping (feet or vacuum cleaner?). The cabinet is dusty, even though it was dusted a few days before the assessment.

Details: signs of abrasion

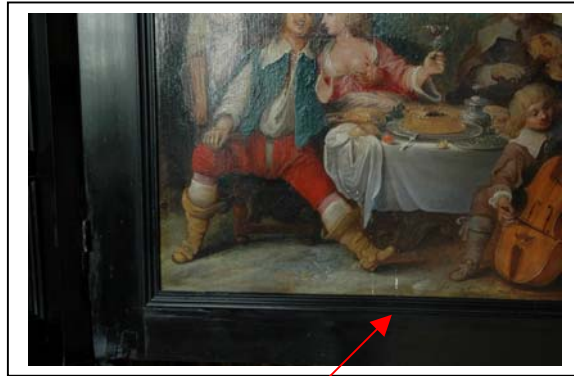
Small area of paint loss (photos: Paul Ryan)

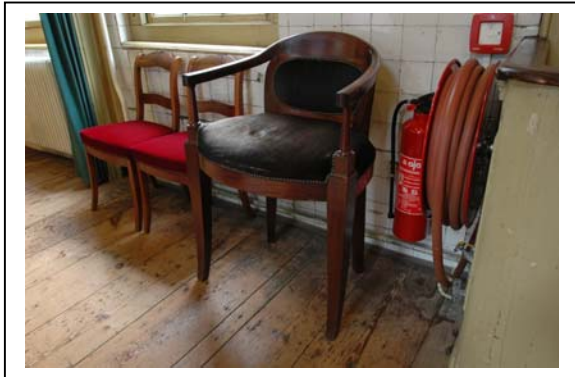
Damage: grime built-up on the armrests. Scratching, denting and some water stains on the legs. Some abrasion of the upholstery and a couple of large tears in the upholstery fabric on the front edge of the seat. Severe dust deposition on the reverse side of the chair.

Priest's chair in the church

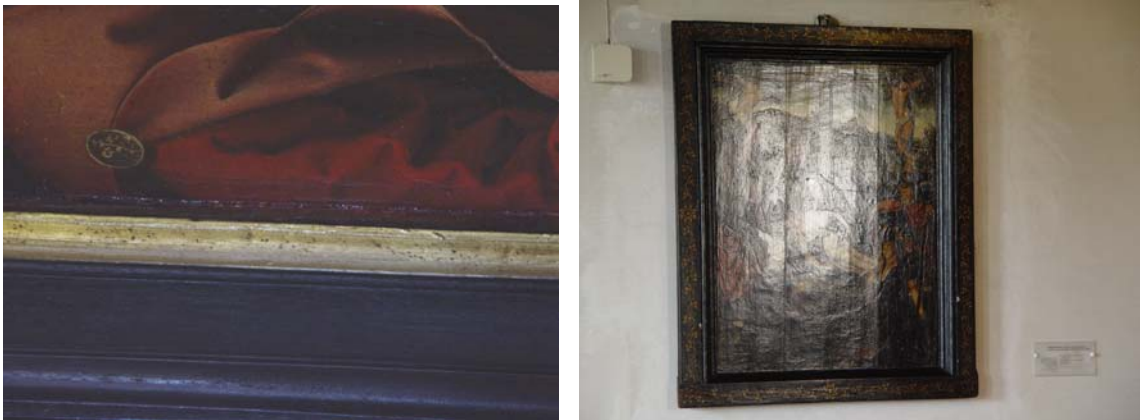
Details of panel paintings showing shrinkage and deformation (warping) (photos: ICN)
