# **FIRST PRESBYTERIAN CHURCH OF STAMFORD, CT CONSERVATION MANAGEMENT PLAN**

**FINAL REPORT**

October 16, 2017

# **First Presbyterian Church Conservation Management Plan**

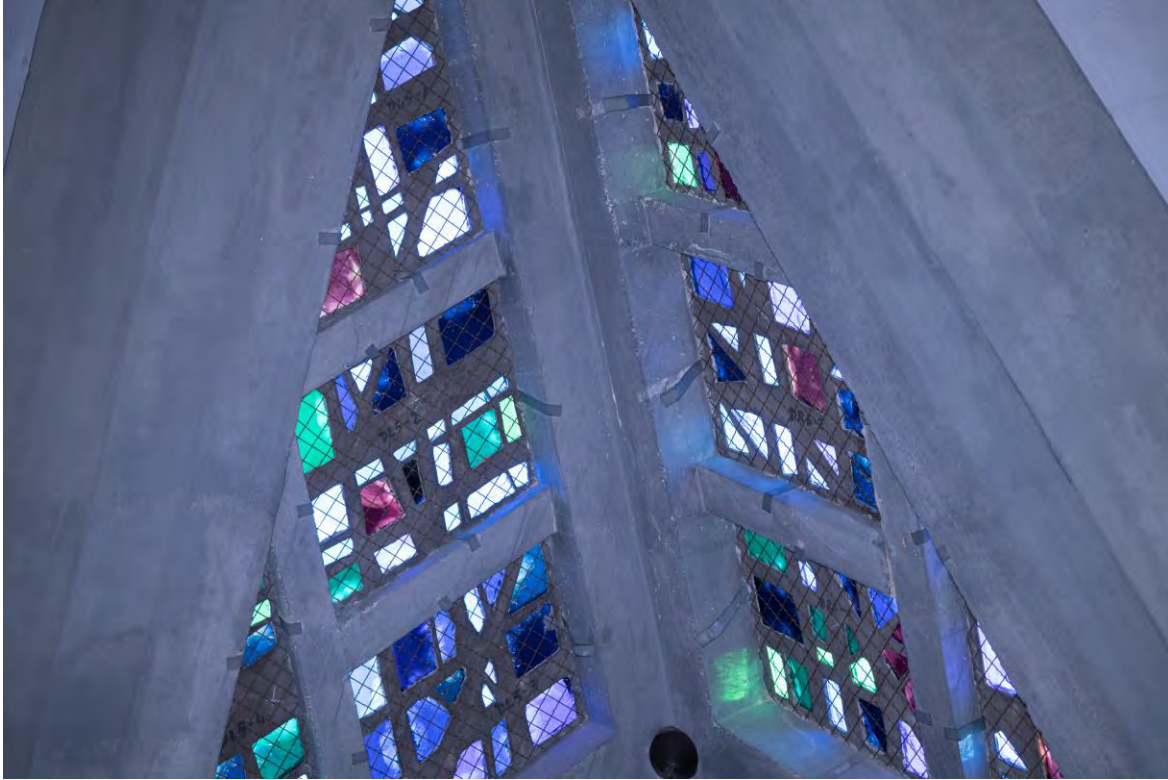
Figure 14: Conditions at interior south roof panels S21 and S22.  
Photo by Propellerheads.

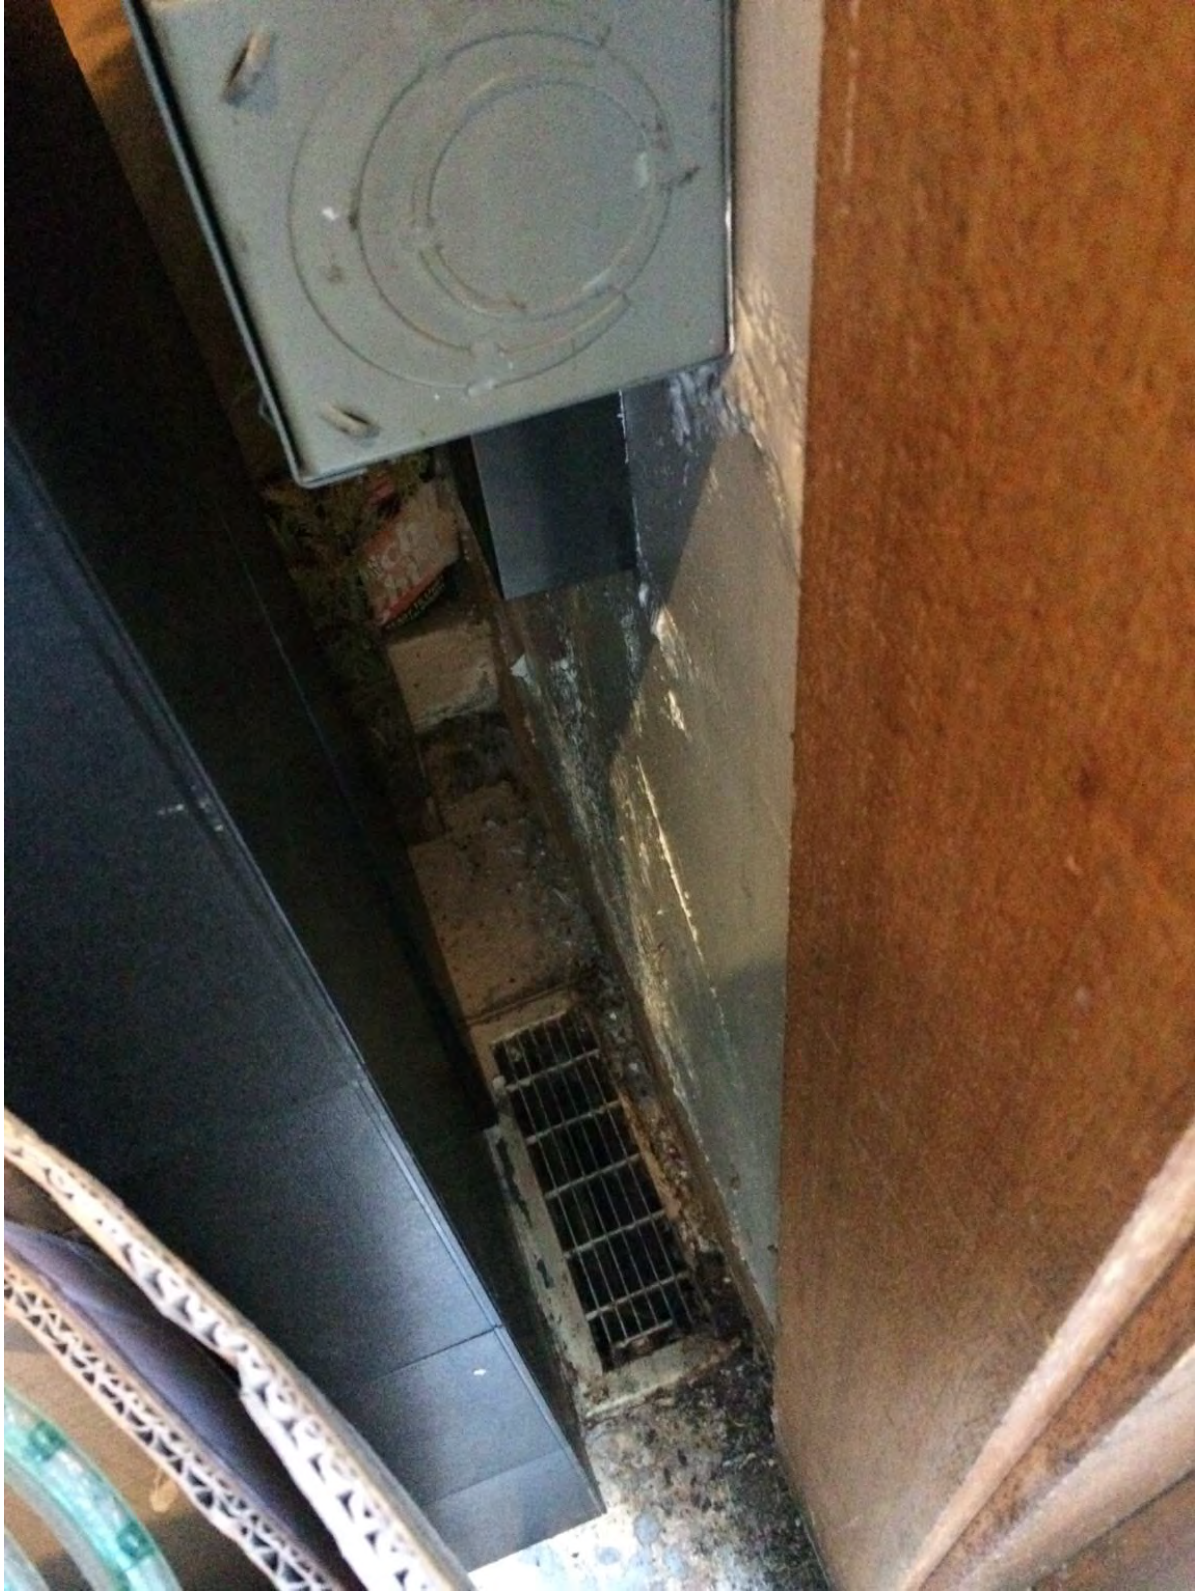
Figure 15: Condition at Choir wall interior.  
Photo by Prudon & Partners.

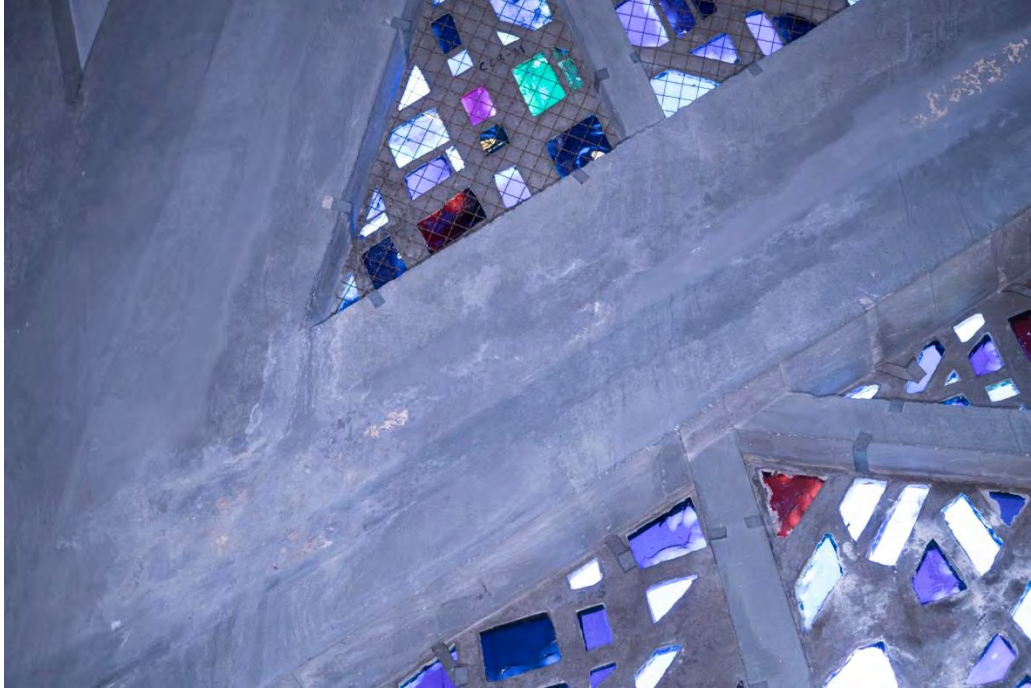
Figure 16 (above): Roof line damage.  
Photo by Propellerheads.

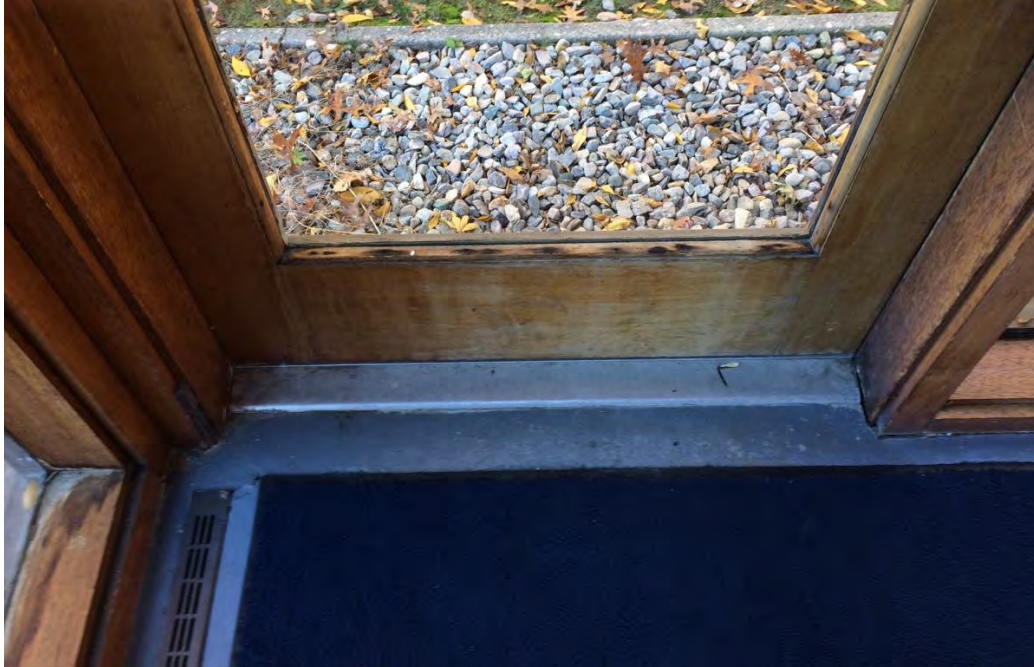
Figure 24: Conditions at connecting link. Exit to memorial garden (wood damage).  
Photo by Prudon & Partners.

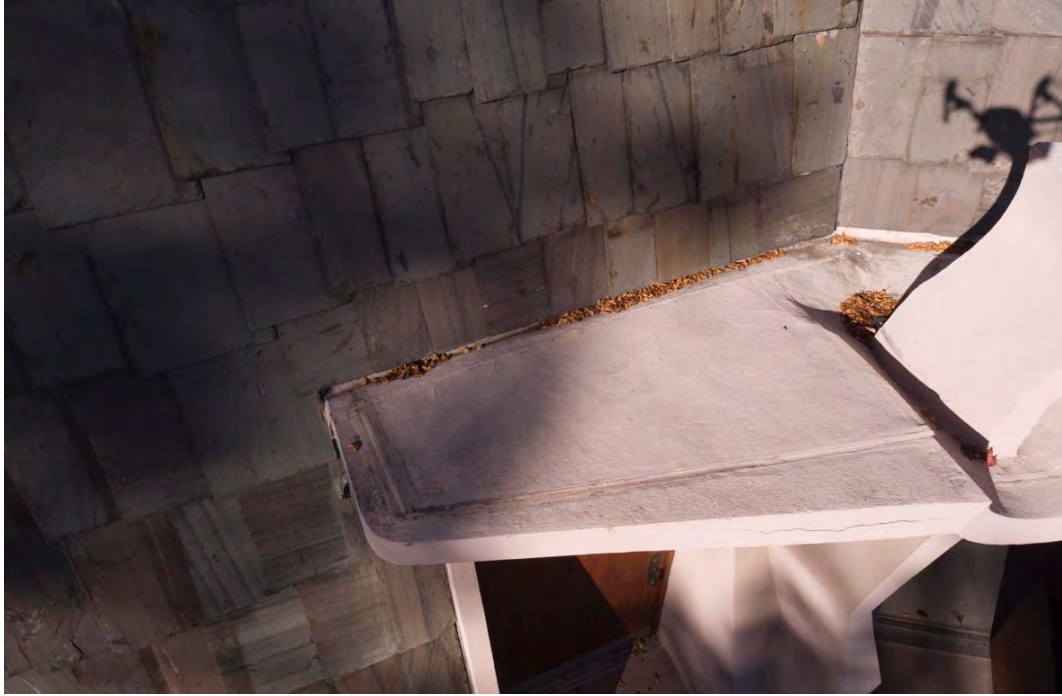
Figure 25 (above): Conditions at entry canopy (SE).  
Photo by Propellerheads.

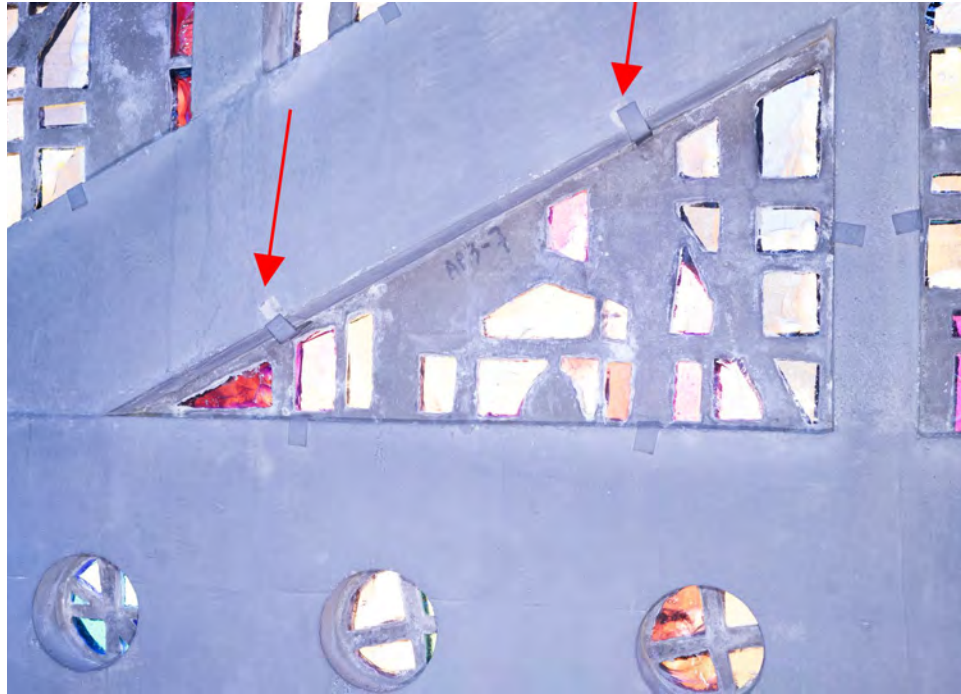
Figure A11. Typical lead straps at original concrete dalle de verre panels. It appears the anchors were used to hold the dalle de verre panels in place against the pre-cast panels while the perimeter grout set. The red arrows indicate areas of clean concrete adjacent to some of the straps, which suggests some of the anchors have been moved; the date and reason for this movement is undetermined.

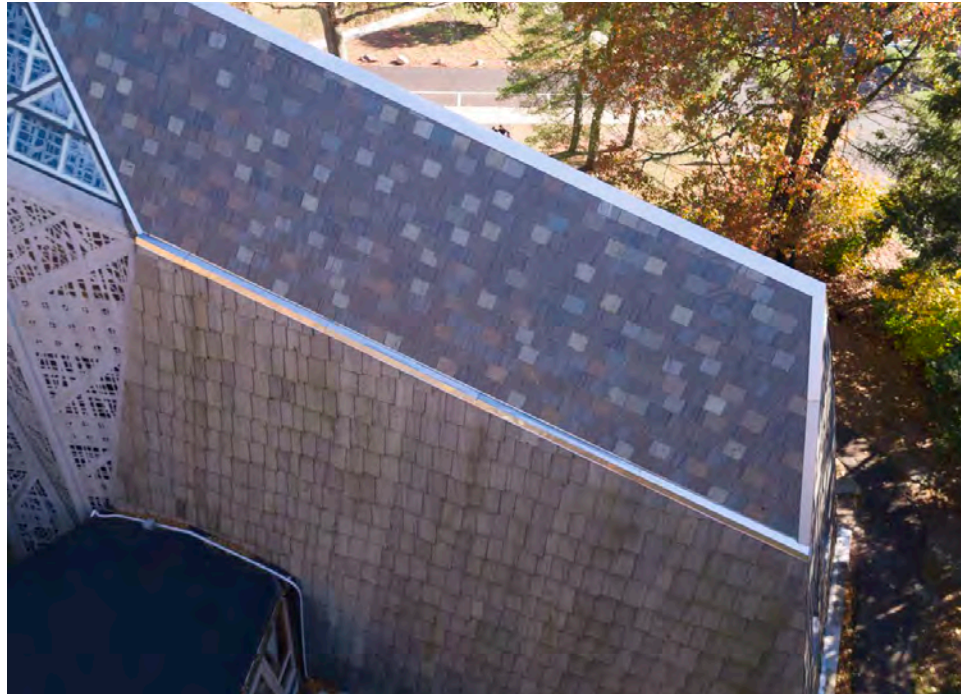
Figure A15. View of roofing and wall slate at the west end of the north elevation. The roofing slate in this area was previously replaced and varies in color from the slate over the Narthex; this work is assumed to be part of the 2003-2007 waterproofing campaign. In accordance with the original design, the roofing slate is laid in uniform horizontal lines while the slate wall shingles exhibit more variation.

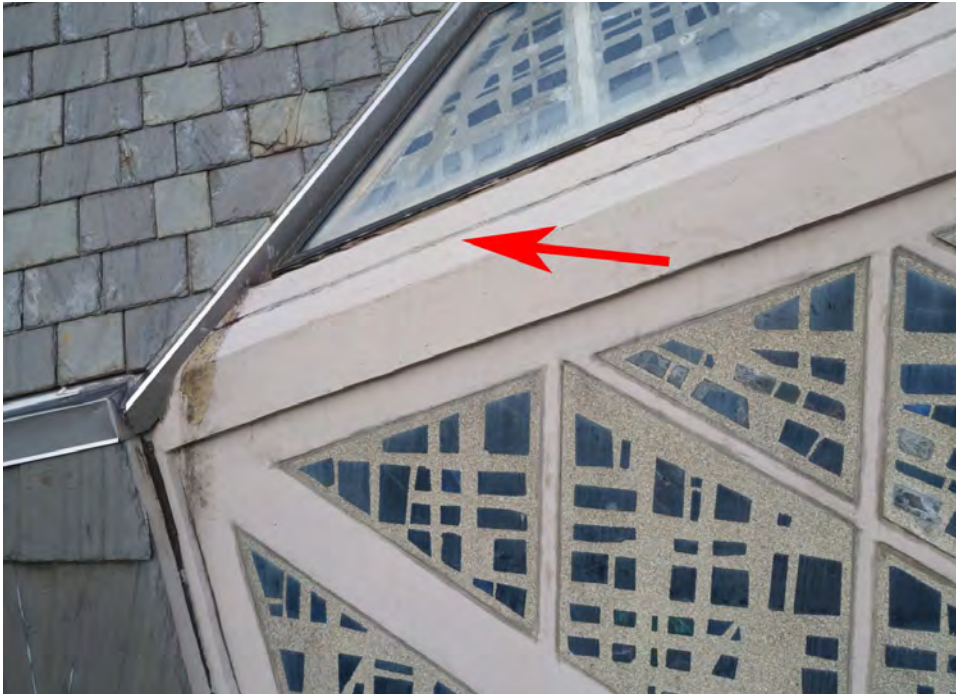
Figure A21. Red arrow indicates the reglet cut at the roofline on the south elevation in 1986. See the archival detail for this work in Figure C3. The reglet was also installed on the east elevation. The reglets are currently filled with sealant. The STO product installed in this area in 1986 was identified for replacement with a new coating during the 2003-2007 waterproofing campaign.

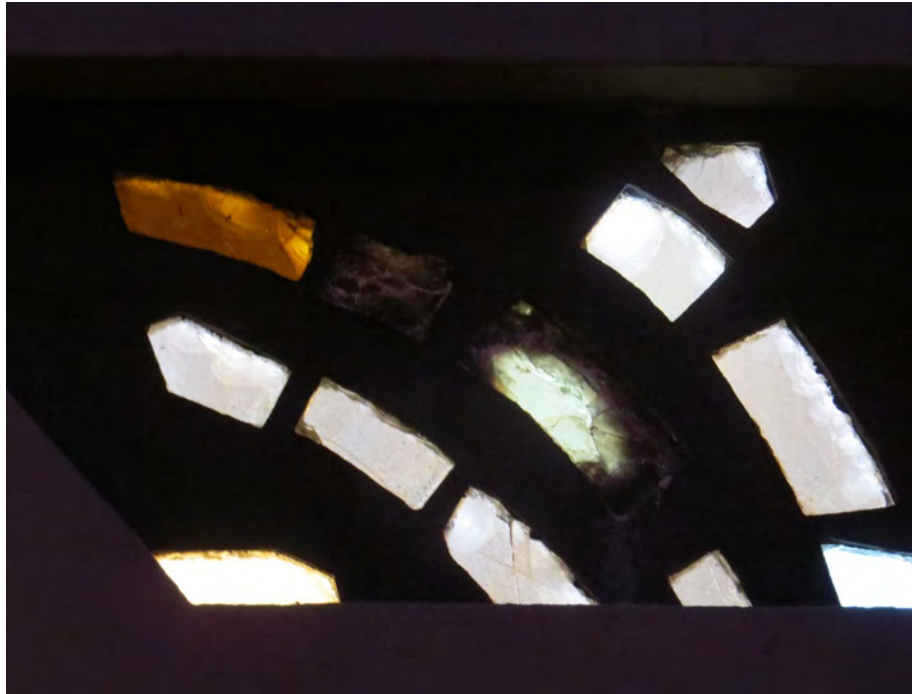
Figure A29. Typical darkened interior appearance of deteriorated glass on the south elevation due to biological growth and dirt deposition between layers of delaminating glass. Similar glass deterioration is visible on the north and east elevations.

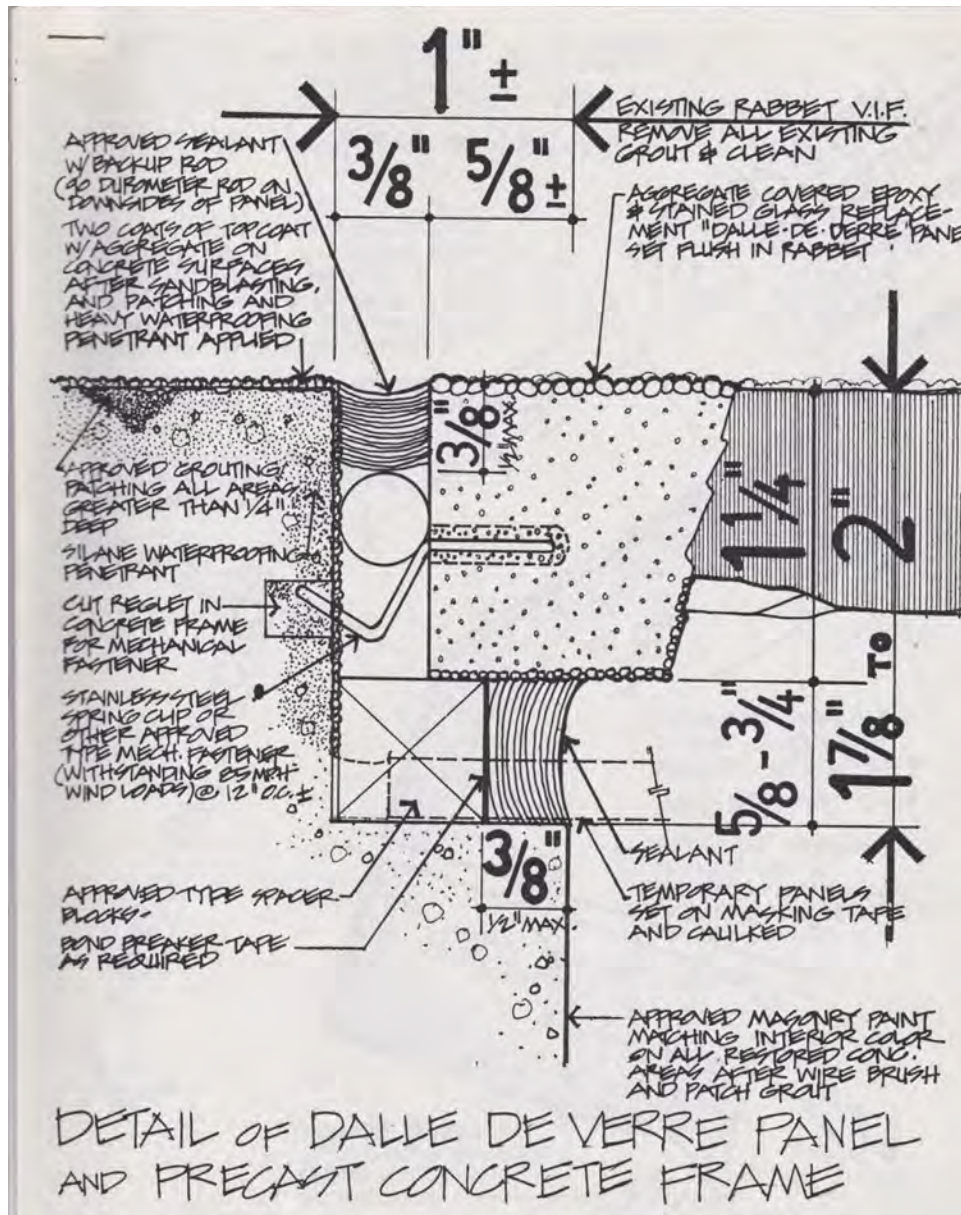
Figure C2. 1986 Construction Detail for Epoxy Dalle de Verre Panel and Precast Concrete Frame. Eberson and Toto, architects, P.C. and Viggo Bonnesen & Assoc. (Consulting Structural Engrs.), "Restoration of the Sanctuary: The First Presbyterian Church, Stamford, Connecticut," July 1986, Detail A/5. No interior sealant is currently installed. Flexible foam expansion joint filler was applied to the interior perimeter of the panels to separate them from the concrete; in some locations this foam filler is loose and protruding. Note that the epoxy matrix and glass directly abut each other. A hair-line separation between these materials is common and allows for water infiltration.

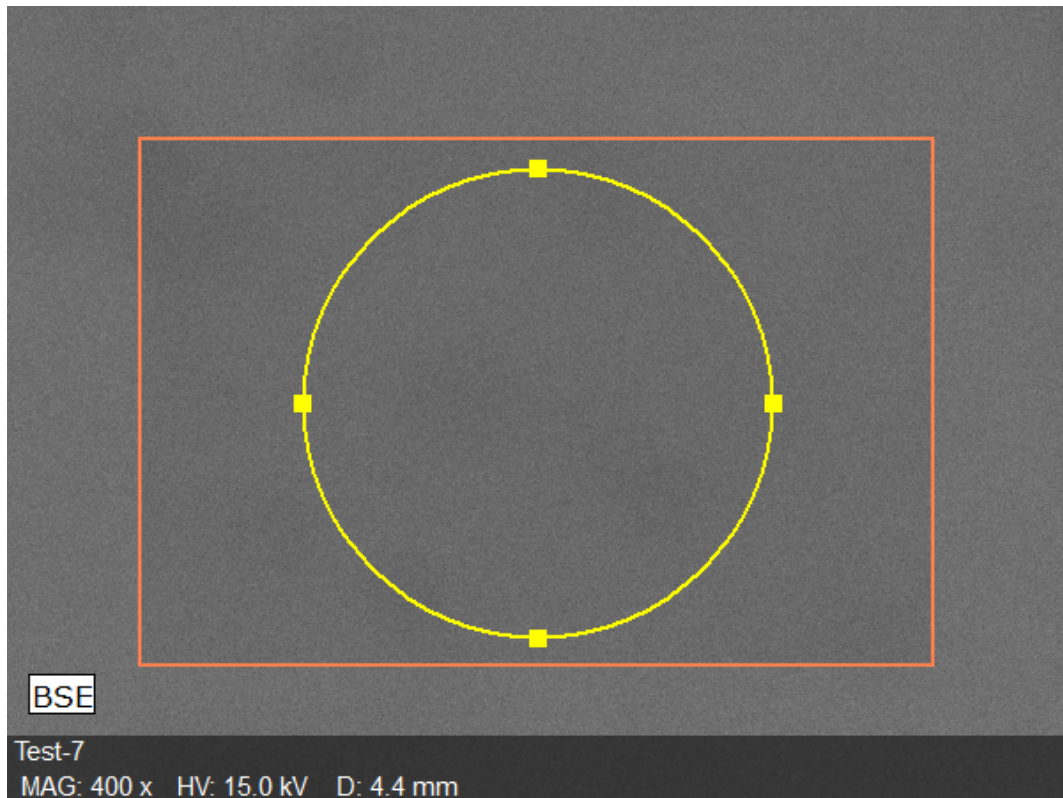
II Results from analysis of Sample A: Deterioated original purple glass.

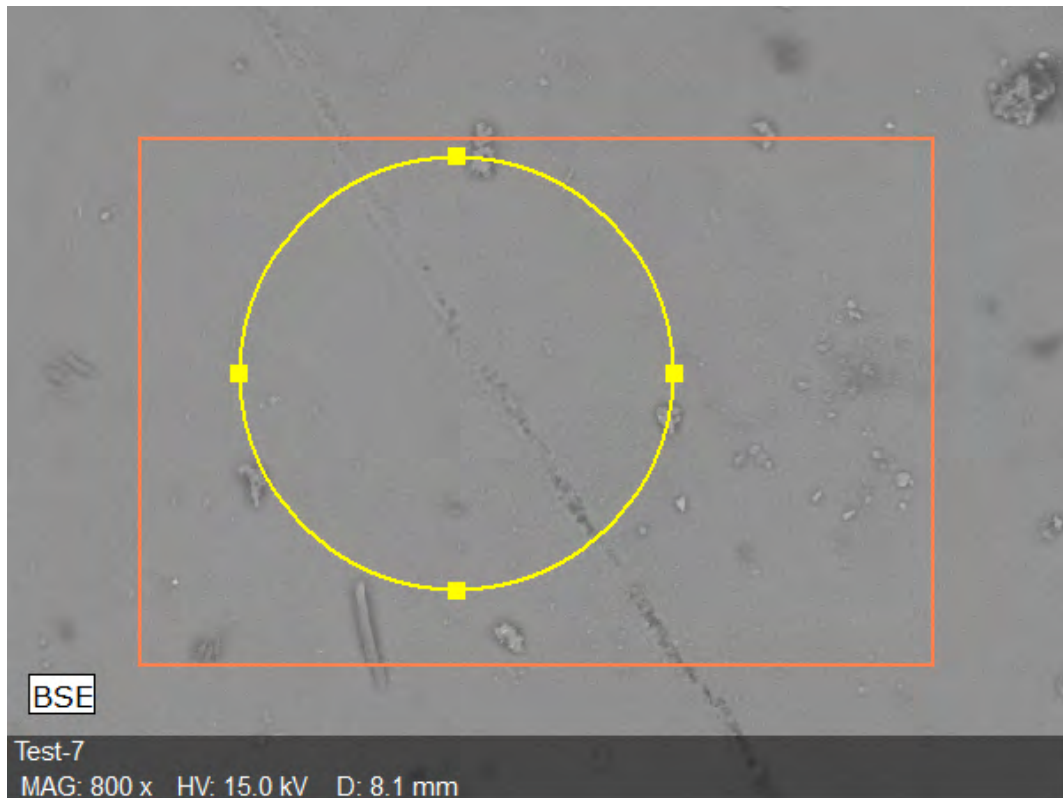
15 Results from analysis of Sample E: Deteriorated replacement purple glass

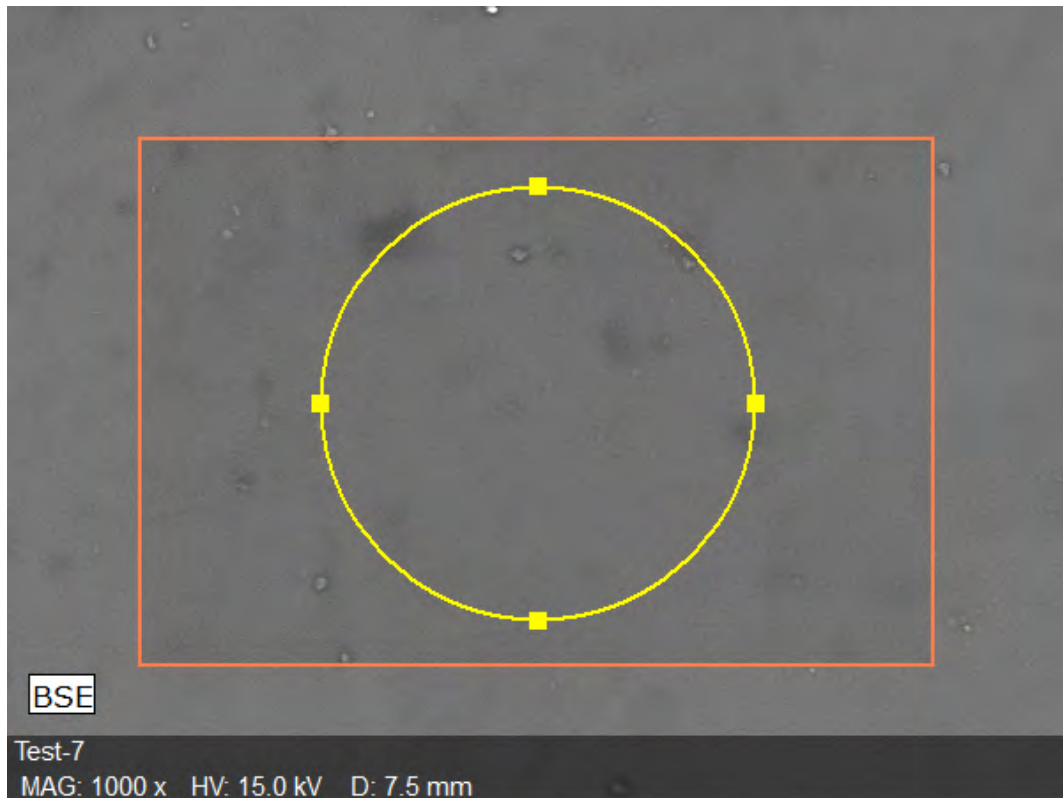
16 Results from analysis of Sample F: Deteriorated replacement orange glass

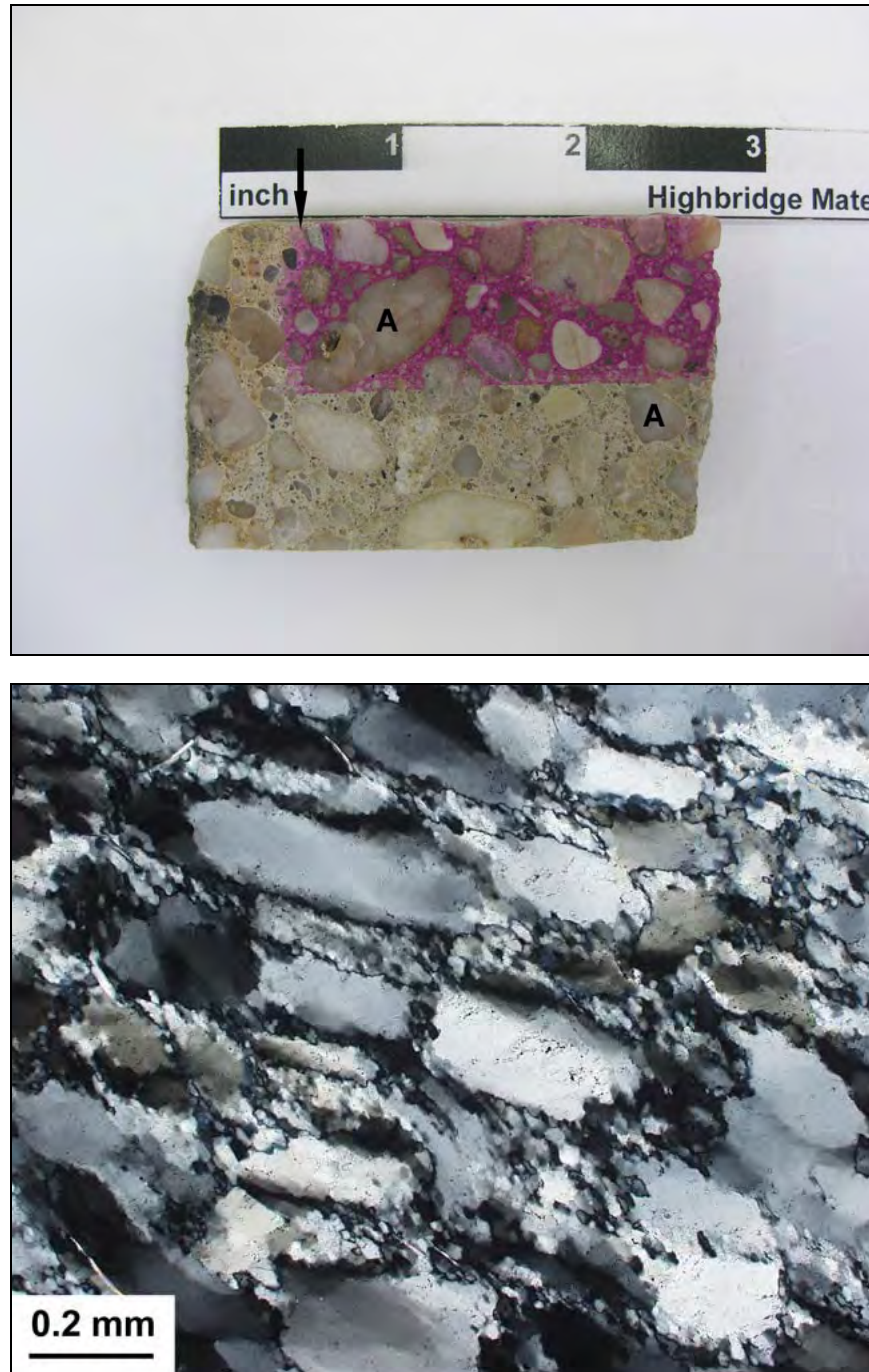
**Figure 2:** (Upper image) Photograph of the honed cross section of Core #2 with the outer surface oriented toward the left of the image. The natural gravel coarse aggregate (A) can be observed at this scale, though the sample is too small to accurately evaluate the size and distribution. Still, the stone appears to be sufficiently concentrated and the particle size distribution seems to be rich in the range of the 3/8" sieve. A portion of the section is treated with a pH indicator solution. The pink color indicates that a high alkalinity is maintained below about 5/8" depth. The uncolored upper horizon coincides with the carbonation profile of the concrete. The depth of carbonation is moderate. Only steel reinforcement with little concrete cover would be at risk for depassivation. (Lower image) This XPL photomicrograph illustrates a typical microtexture within the coarse aggregate. The mosaic of grays and whites represents deformed quartz crystals. The stone consists almost exclusively of strained quartzite. Rock types such as this are known to be slowly alkali-silica reactive.

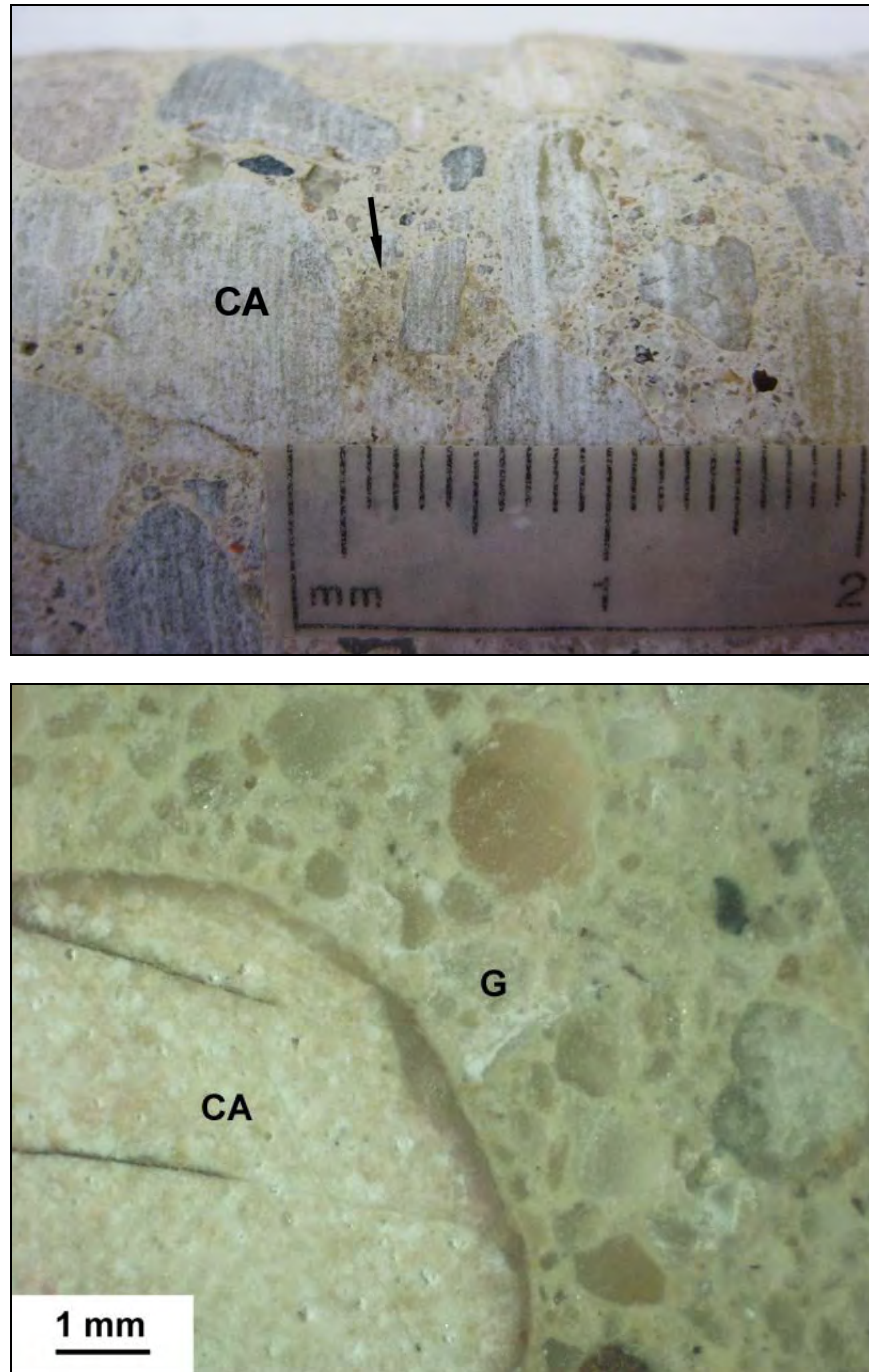
**Figure 6:** Despite the potential reactivity of the strained quartzite coarse aggregate, there is virtually no sign of reaction in the studied core sample. There are a few minor occurrences of gel phases that have exuded from the concrete after cutting. In the upper image, the arrow indicates a "wet patch" of translucent gel adjacent to a coarse aggregate grain (CA) along the cored surface. A reflected light photomicrograph of a sawn surface is shown in the lower image. A patch of white gel (G) is present in the mortar adjacent to a strained quartzite coarse aggregate that exhibits a darker reaction rim. These exudates show that some unexpanded gel is present in the micropores of the concrete and this likely represents innocuous reactions that have occurred very slowly over the service life of the concrete. No cracking of any kind is associated with these incipient reactions.

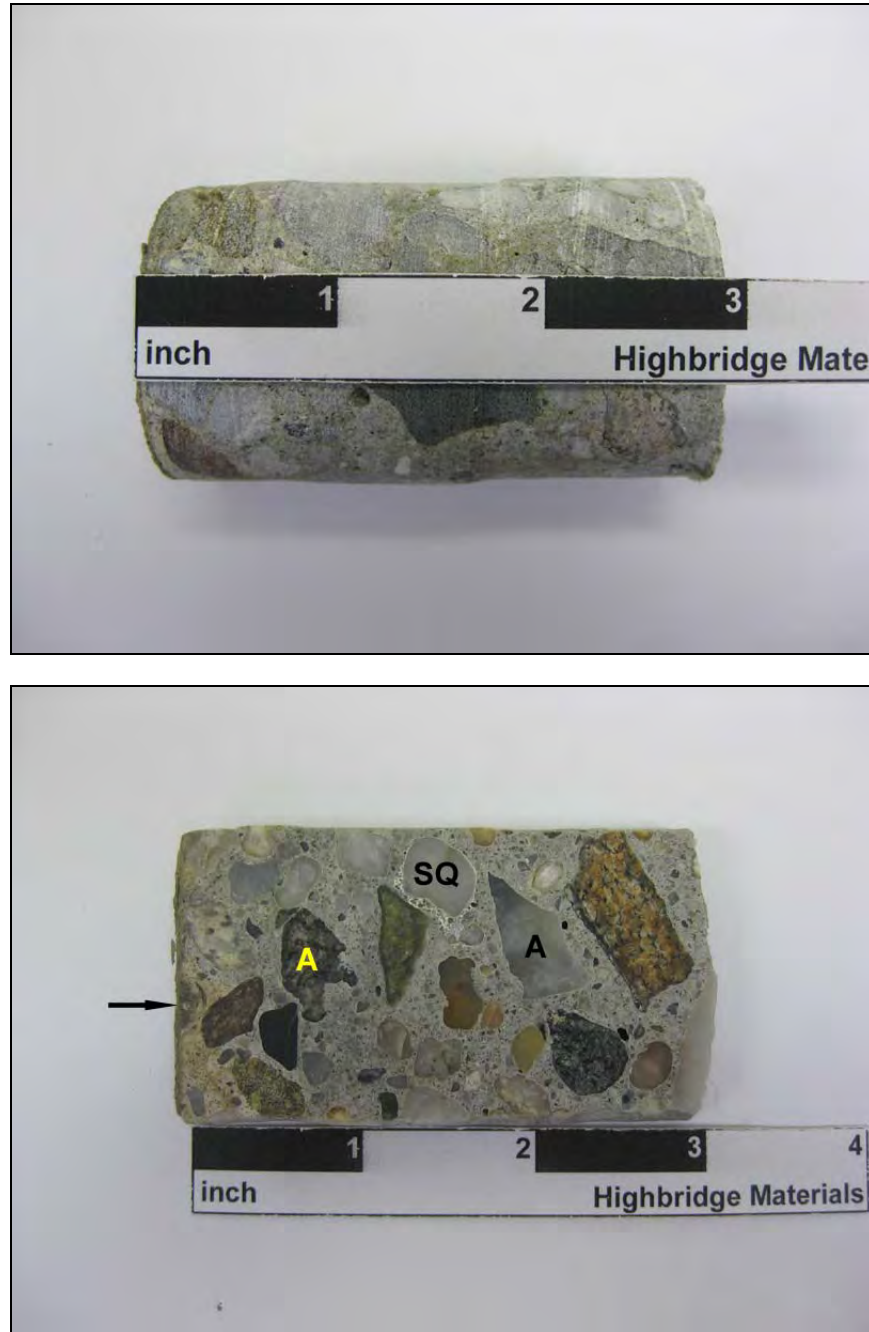
**Figure 1:** (Upper image) Photograph of Core #3. The sample is shown in side view with the outer surface oriented toward the left of the image. (Lower image) Photograph of the honed cross section of Core #32 with the outer surface oriented toward the left of the image. The natural gravel coarse aggregate (A) can be observed at this scale, though the sample is too small to accurately evaluate the size and distribution. Note that the stone exhibits different colors and grain shapes due to a more variable composition. The nominal top size in this case is at least as coarse as the 3/4" sieve. The particle size distribution is possibly consistent with a No. 57 stone. Note that one of the strained quartzite grains (SQ) is lined with a white gel deposit. The mortar has clearly absorbed some minor reaction gel from a very early stage ASR reaction in the coarse aggregate. No cracking is found in association and the reaction is considered innocuous. The arrow indicates a cross section through a small bughole that intersects the formed face. As shown in Figure 5, the forming defects have since been filled with a number of cementitious repairs.

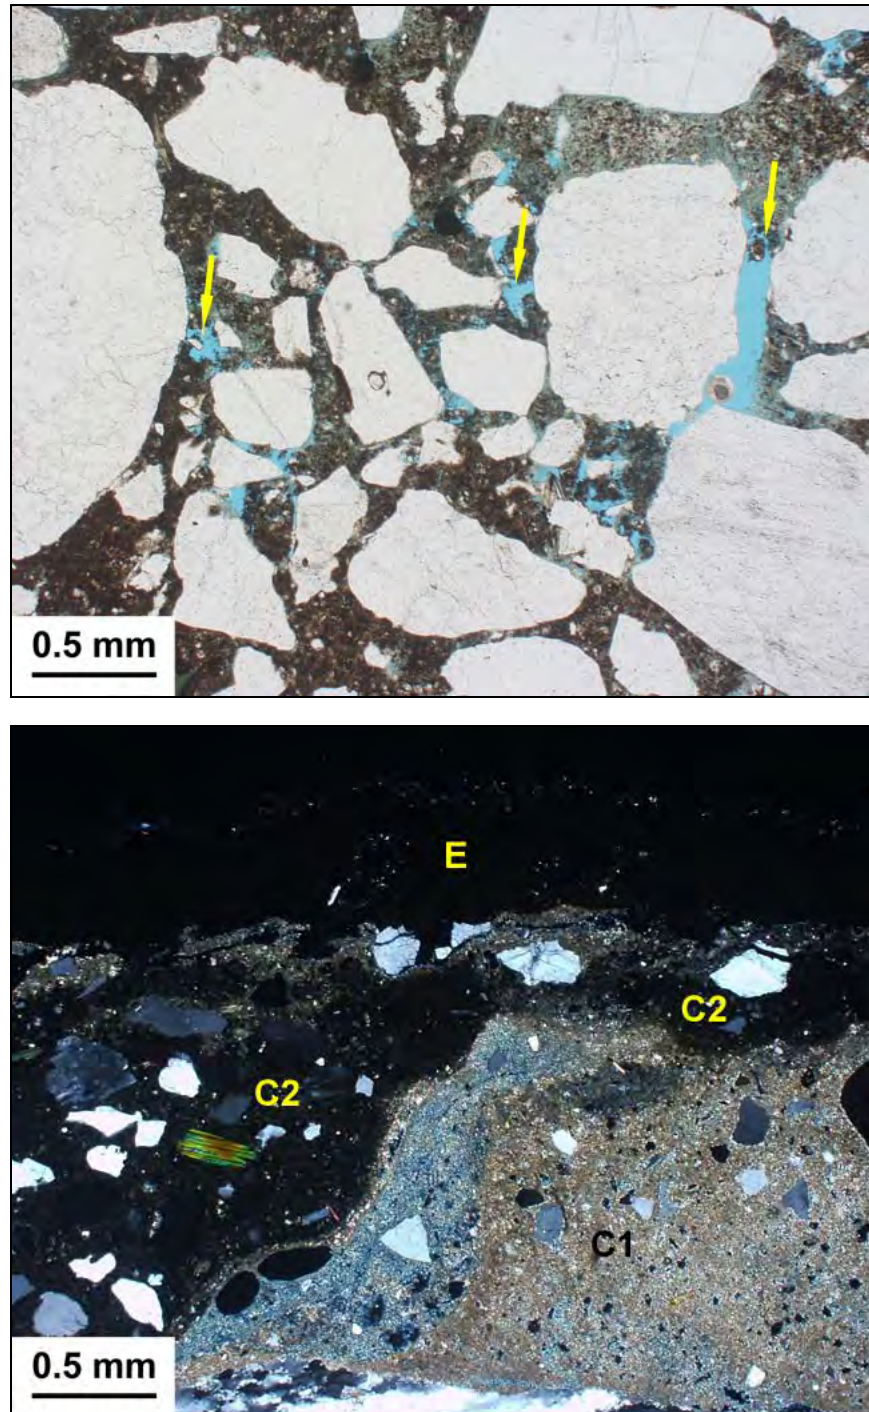
**Figure 5:** Photomicrographs illustrating the quality of the formed surface in Core #3. (Upper PPL image) The arrows indicate irregularly-shaped air-voids associated with some bugholing near the surface. (Lower XPL image) The bugholes are filled with several materials. An earlier cementitious coating (C1) is porous and fully carbonated. The carbonation is shown by the golden color under crossed polars. An overlying cementitious layer (C2) is much denser due to a lower mix water content. Both mixtures include a fine quartz sand. An elastomeric coating (E) overlies all secondary repairs.

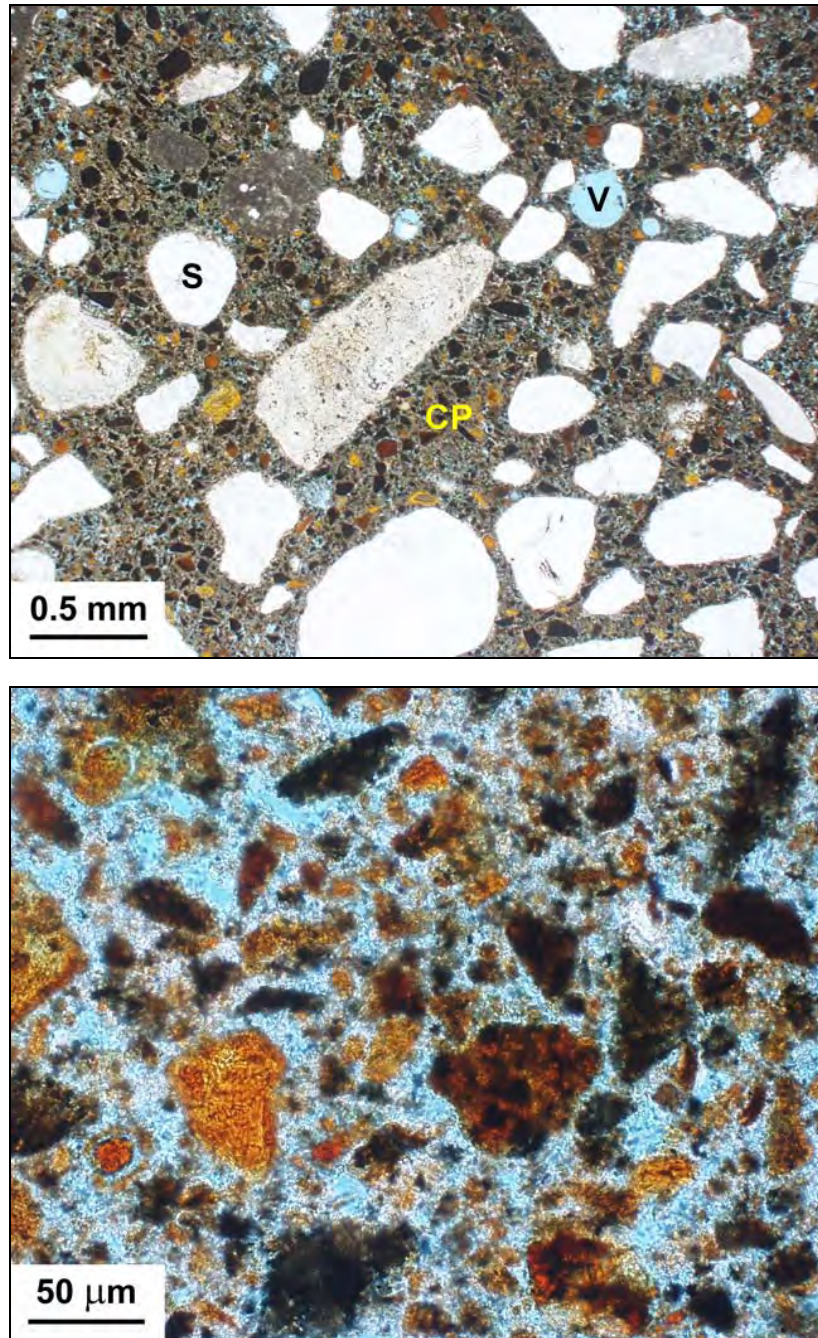
**Figure 4:** PPL photomicrograph illustrating the microstructure of the dalle de verre. The sample is impregnated with a low-viscosity, blue-dyed epoxy in order to highlight cracks, pores, and voids. (Upper image) This image is taken under a relatively low magnification. The cement paste (CP) absorbs a moderately high quantity of the dyed epoxy indicating a liquid permeable matrix. Sand grains (S) are well-coated with binder and sparsely distributed throughout the matrix. The low concentration is consistent with the 1 : 1.7 binder to sand ratio estimated for the mixture. Air-voids (V) are present at less than 1% by volume. The excellent compaction suggests a more fluid mix when fresh. (Lower image) This image is taken at higher magnification to illustrate the hydration quality of the cement. Though the hydraulic phases of the cement are well hydrated, there is a very high concentration of residual grains. These are highly particulate and angular in shape. The cement particles are closely clustered with only a sparse cementitious hydrate binding them. There is a high degree of blue-dyed epoxy absorption between the particles indicating a high permeability. This high microporosity is attributed to conversion of the cement during curing. Though not quantified, it is suspected that the water-cement ratio was higher than desirable to prevent a notable reduction in strength and increase in porosity as conversion progressed.
