Keeping It Modern

Luce Chapel is a renowned architecture in Taiwan. With its outstanding achievements, it certainly stands out in the modern architectural movement of post-war Taiwan. In October 2014, Luce Chapel was chosen to be one of the ten global classic modern architectures, and the first project within Asian architecture, which received the first "Keeping It Modern" (hereafter abbreviated as KIM) Grant from the Getty Foundation. The Grant acknowledges these 20th century modern architectures as milestones of human civilization. With high experimental mentalities, groups of architects and engineers of the previous century boldly tried out exploratory materials and cutting edge construction techniques, and built innovative architectures that have stimulated changes in their surrounding environments, histories, local culture, and forever transformed the philosophical approaches of architecture. However, the Getty Foundation also regards these architectures to be under various degrees of risks. Being fifty to sixty or even older, many of these innovative materials and techniques boldly used at the time of their construction were not, and still have not been scientifically tested

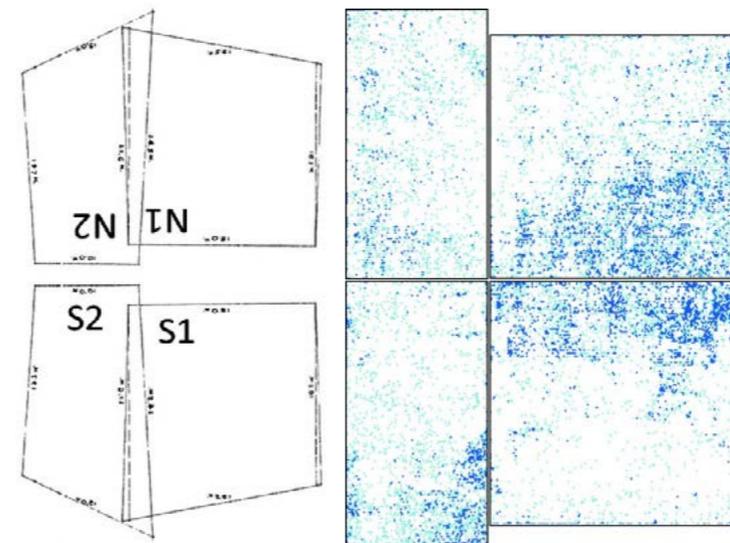
2.34 Erosion, exfoliation and pitted tesserae

2.35 Damage atlas of the tile erosion, exfoliation and pitted tesserae

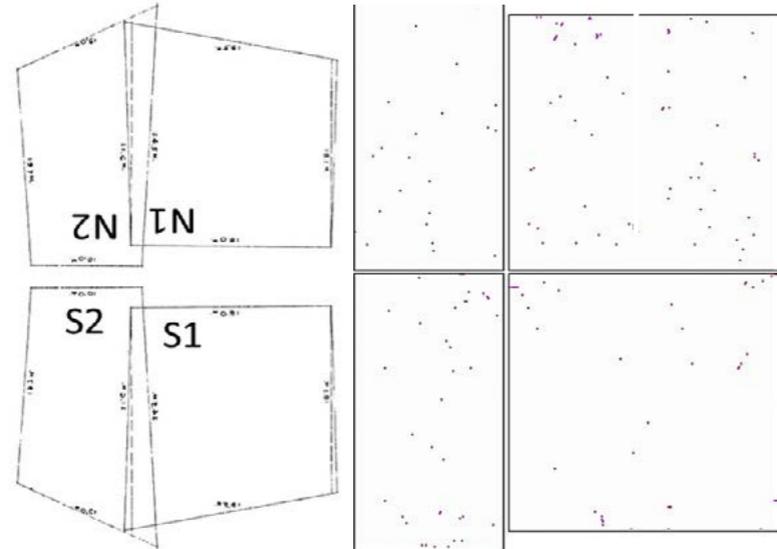
2.42 Damage atlas of tile cracks and fractures

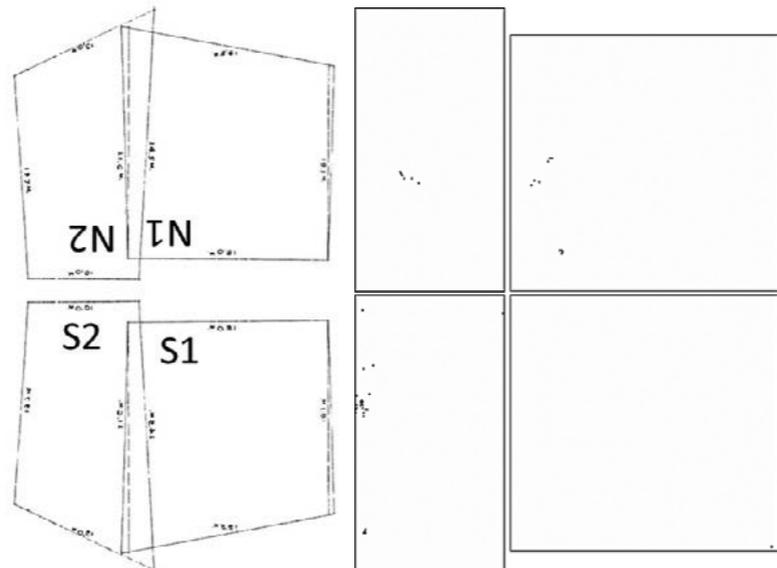
2.44 Damage atlas of tile efflorescence

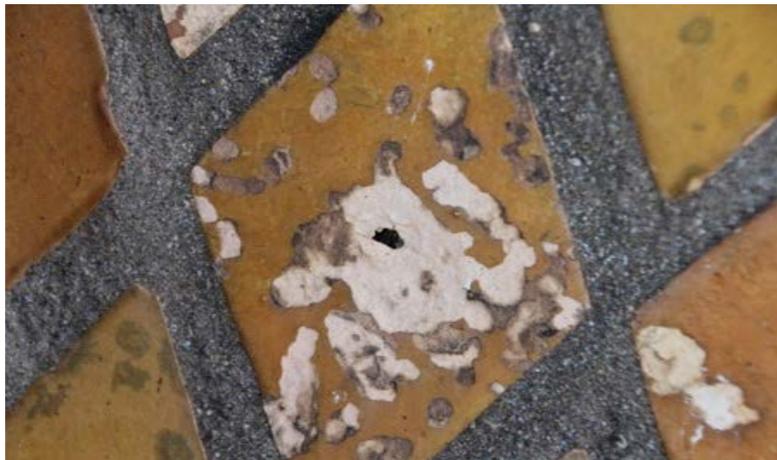
2.46 Tile perforation

V. Tile perforation (Fig. 2.45~2.42)
 Tile perforation happens on the surface of the tile or on mastoids. Once a hole penetrates a tile, water or dust may easily permeate through the cement and erode the building structure.

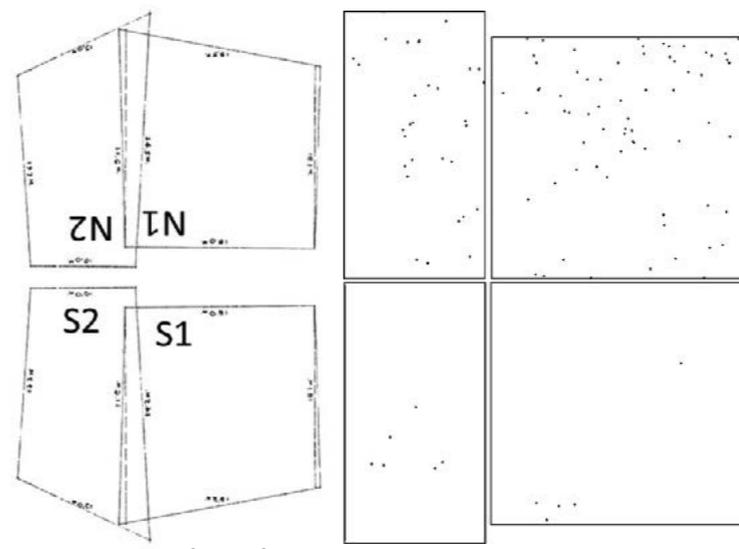
2.47 Damage atlas of tile perforation

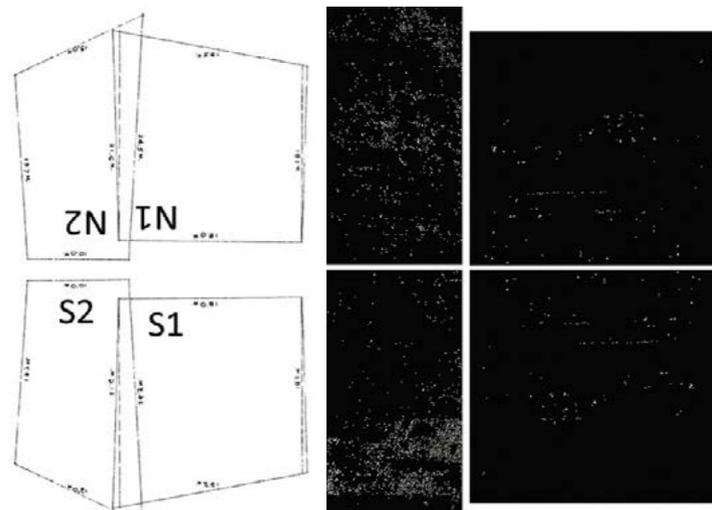
2.51 I. Damage atlas of mortar crack

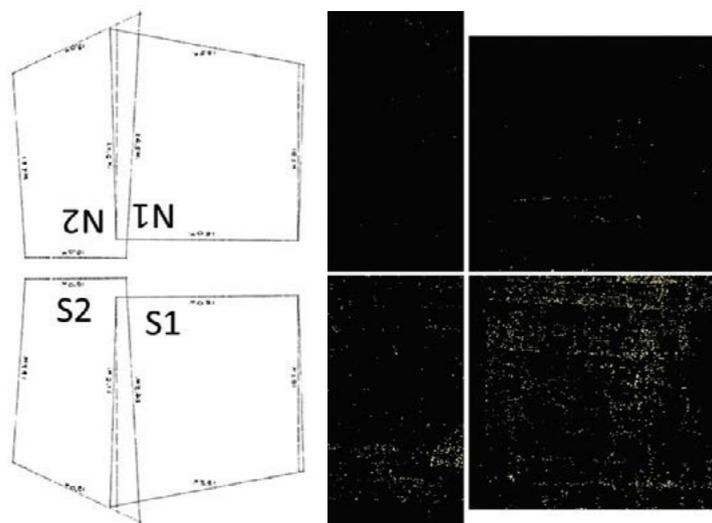
1.54 Damage atlas of mortar cracks

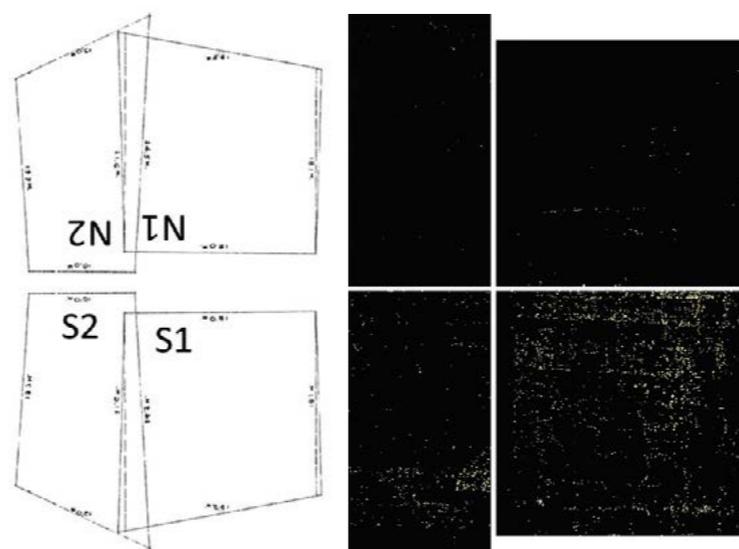
2.58 Damage atlas of mortar efflorescence

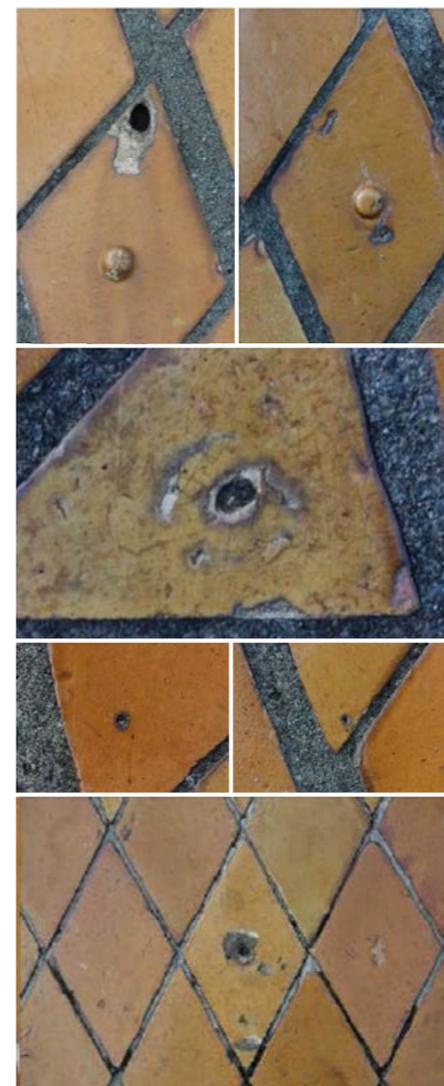
Black inclusions, holes and perforations are observed on certain tiles (Fig.3.15). The black inclusions were composed of iron oxides including Fe_2O_3 and Fe_3O_4 , which can result in corrosion and even perforation when exposed in the open air. Although the origin of these black contaminants is unknown, it could possibly have been the exposure under a working area with iron filings. Since these tiles were manufacture in mass production, a huge space must have been demanded for the storage of dried ceramic tiles before firing. Parts of the tiles could have been placed in a polluted environment where works such as iron cutting or welding took place. In these environments, iron filings would have filled the space and contaminated the tiles, leaving black and brown specks on the glaze after firing.

3.15 Black hole on the tiles of the Luce Chapel (southern wall)

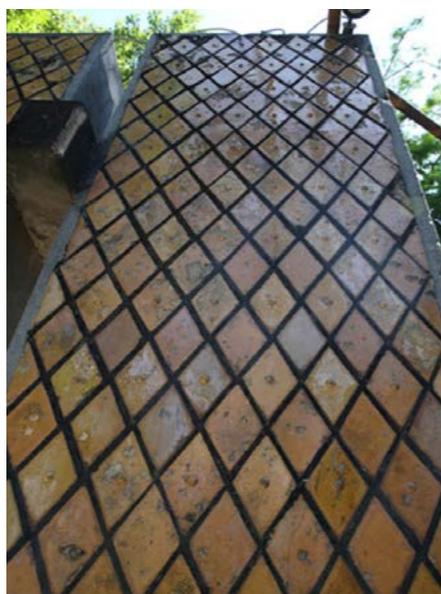
3.16b Biodeterioration of the bell tower

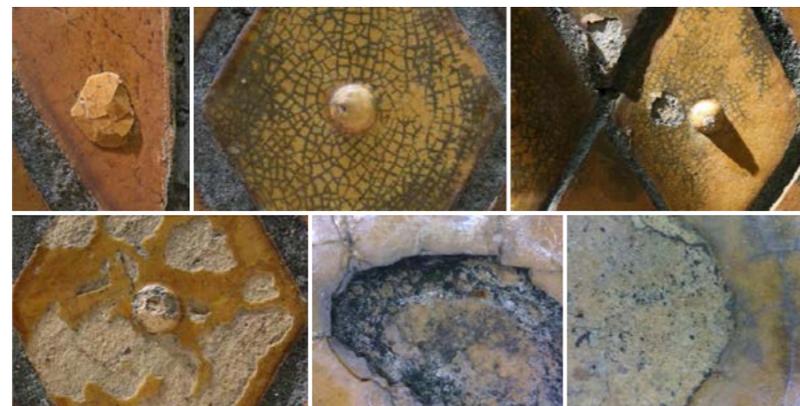
3-17 Biodeteriorations, cracks and crumbling (bell tower)

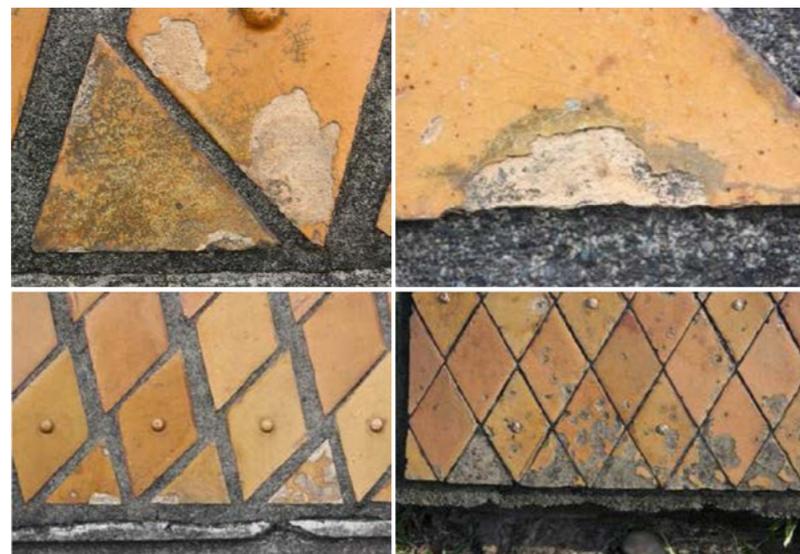
3.18 Biodeteriorations, cracks and crumbling (on the Luce Chapel)

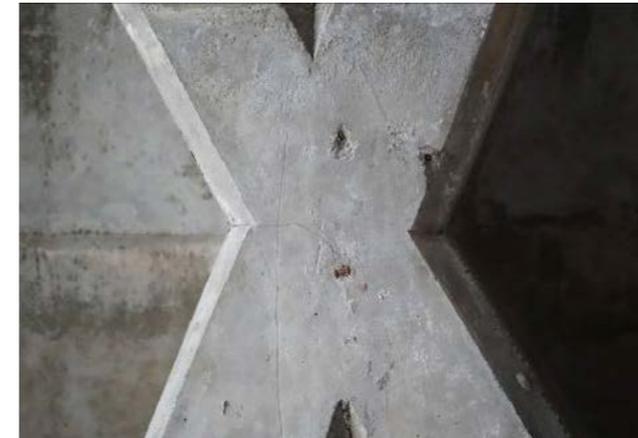
4.54 Concrete deterioration caused by concrete demolding

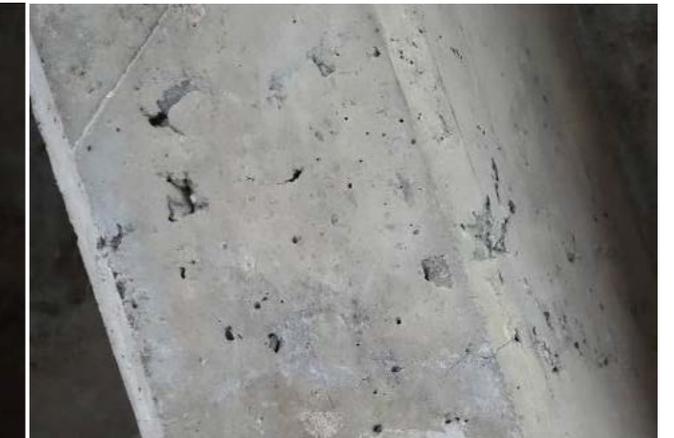
4.55 Concrete air voids formed during concrete solidification

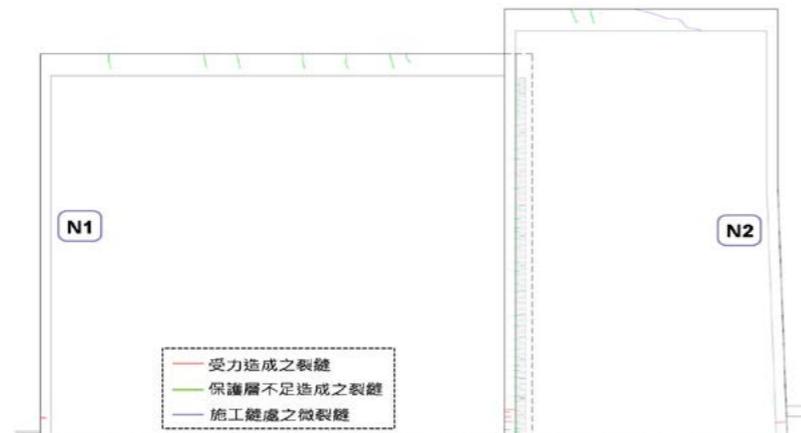
4.56 Crack distribution of the outer surfaces of the shells on the chapel's northern side

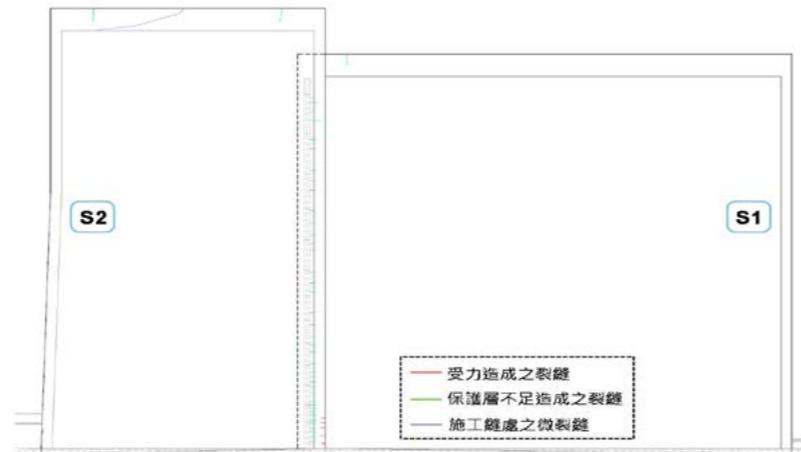
4.57 Crack distribution of the outer surfaces of the shells on the chapel's southern side

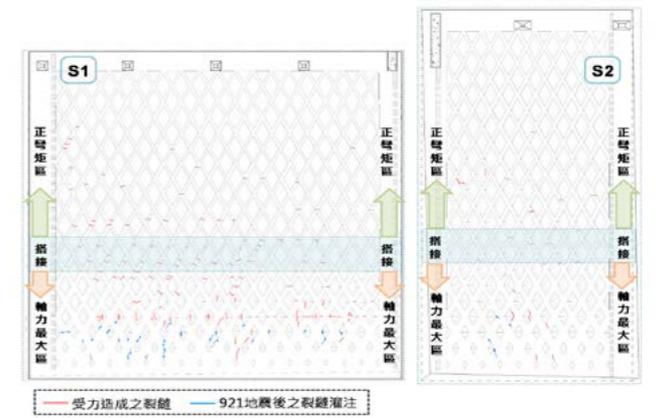
4.63 Crack distribution of the lattice-beam grids and slabs on the chapel's southern side

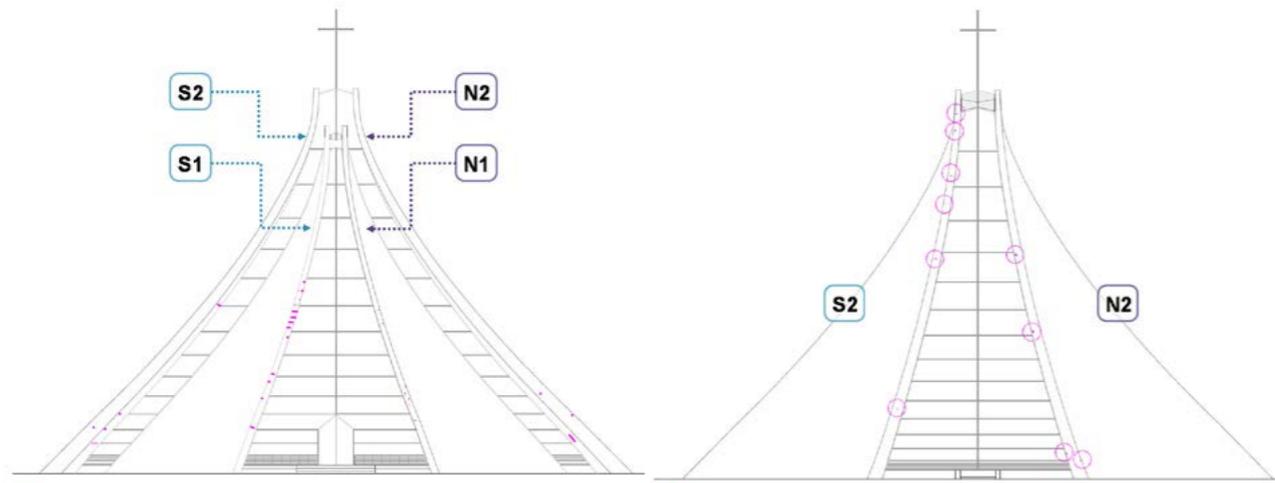
4.69 Distribution of corroded reinforcing bars and bolts (the west elevation view)

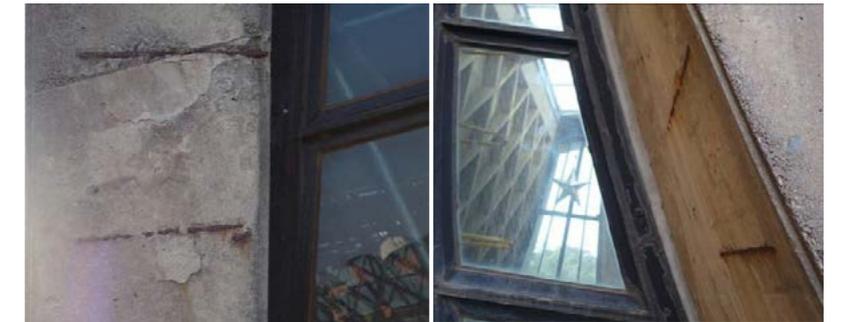
4.72 Corroded reinforcing bars at an edge column

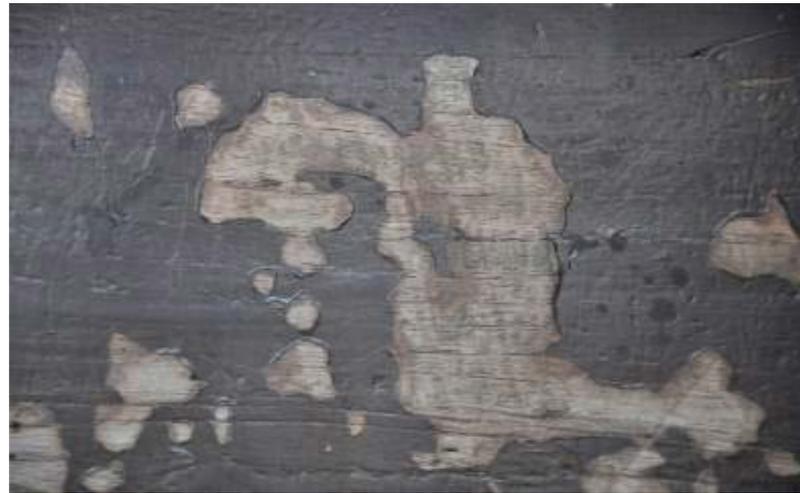
Paint deterioration usually occurs during usage, production process, and thermal expansion and contraction. The most common paint deterioration is peeling (Fig. 5.26), which is caused by various factors. It might be the incompatibility between the paint and the object or the lack of elasticity of the paint, which results hollow (Fig. 5.27), cracks (Fig. 5.28), desquamation (Fig. 5.29), flaking and other conditions. These conditions would result a space between paint layer and the object, allowing water vapor permeation, and create atomization effects. Atomization can also be the result of chemical reaction within the paint, instead of the influence of water vapor. The atomized condition of the paint on the pews; however, is caused by overexposure under the sun (Fig. 5.30).

5.26 Peeling paints

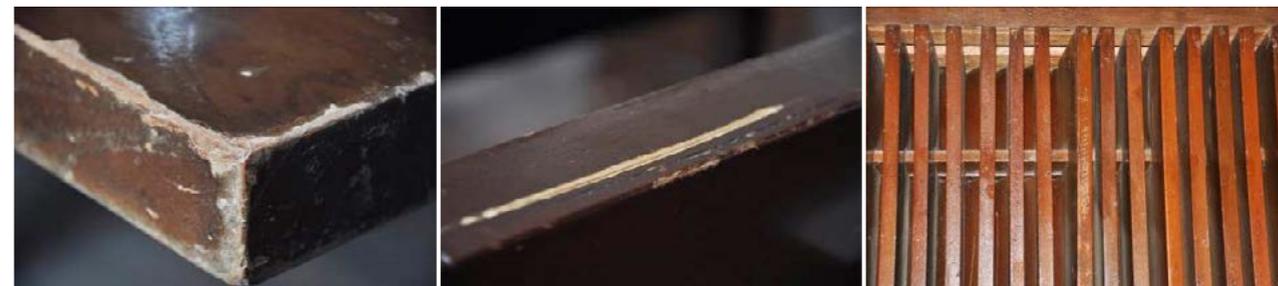
5.45 Wear and Tear

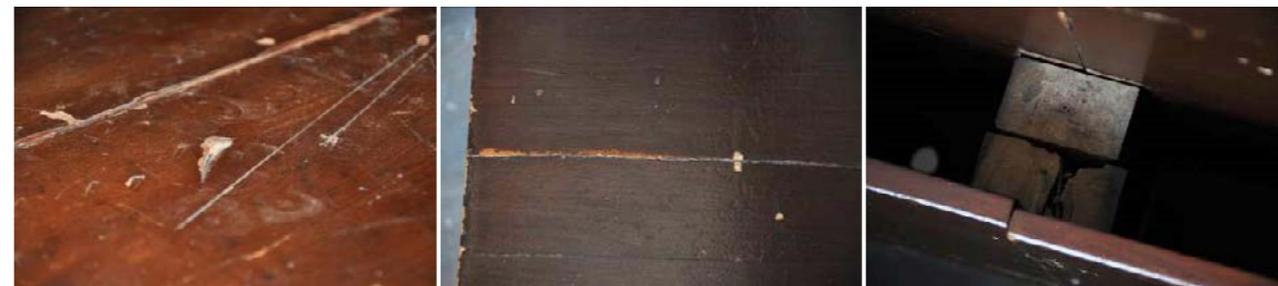
5.48 Distortion

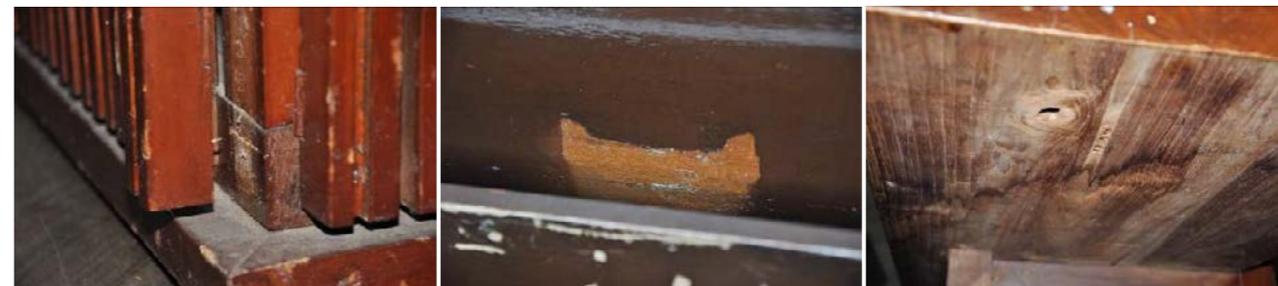
5.51 Loose components

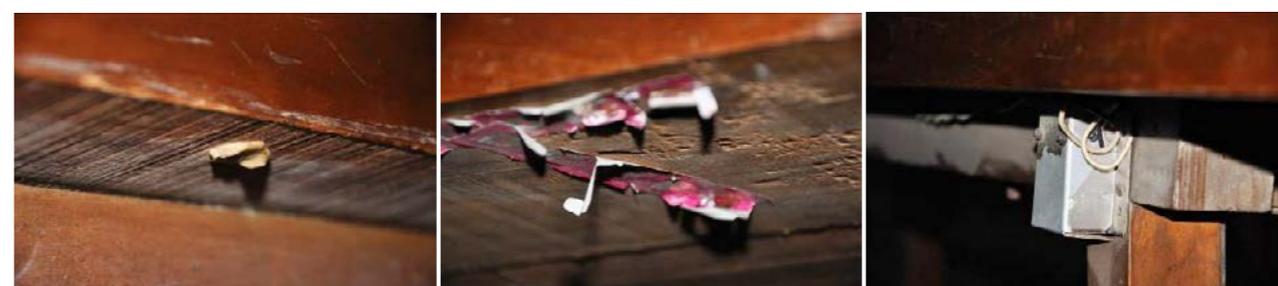
5.54 Chewing gum

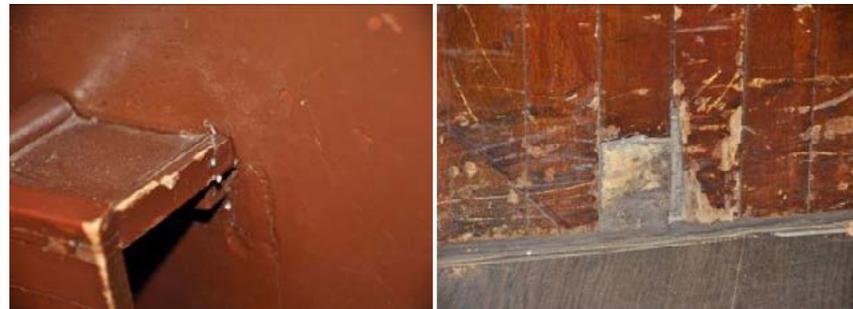
5.63 Loose components

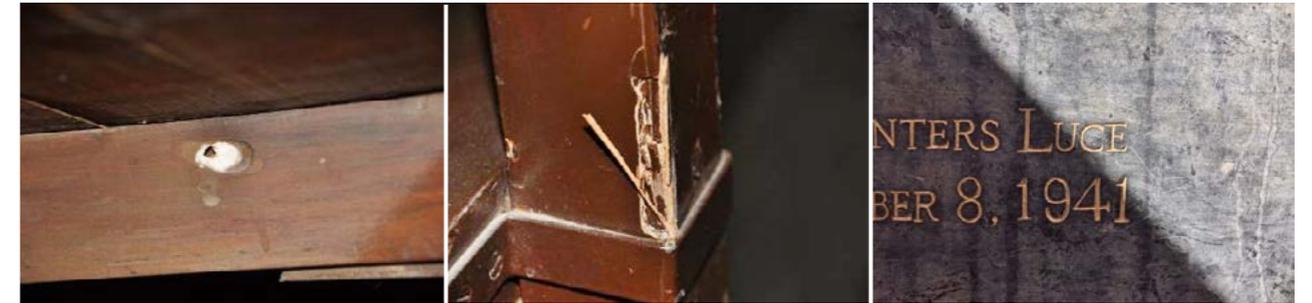
Currently the wood damages caused by wood-boring beetles are minor. The main cause of insect pest is beehives built in the wood pores (Fig.5.65), which exist on the unpatched surface of blind spots underneath the seats. These unpatched areas have become the perfect environment for parasites. Marks of infestation were found on one of the pew legs (Fig.5.66). According to the infected condition, worm eggs were probably laid in the timber before the manufacture of the pews, and eventually underwent metamorphosis and bit through the wood surface.

4.65 Beehives

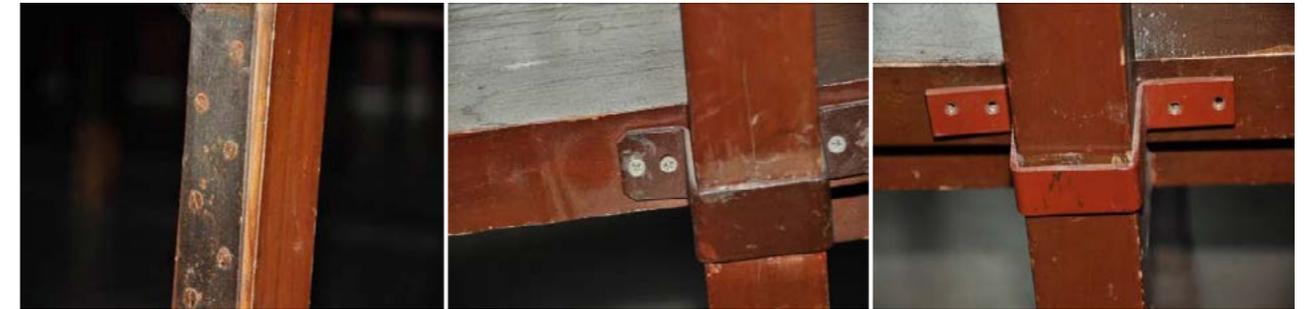
4.69 Rusts

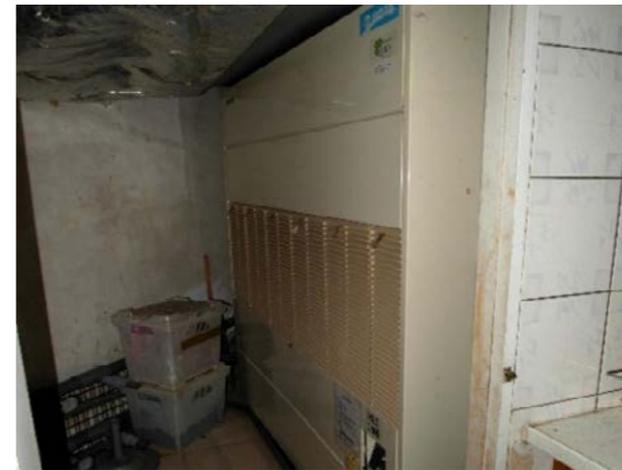
6.9 Noise from the air-conditioning engine

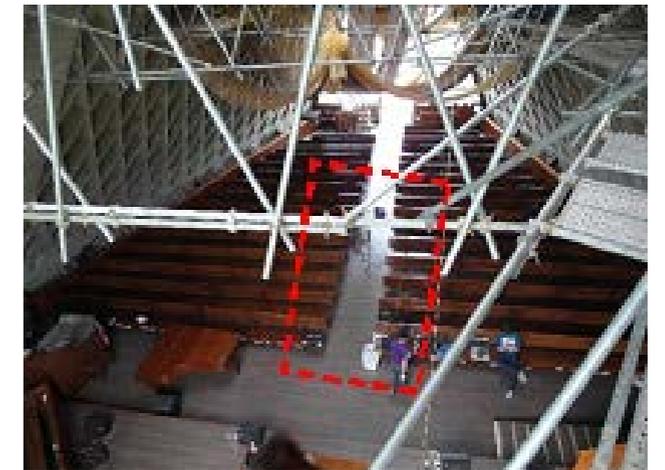
6.10 Sultry aisle seats

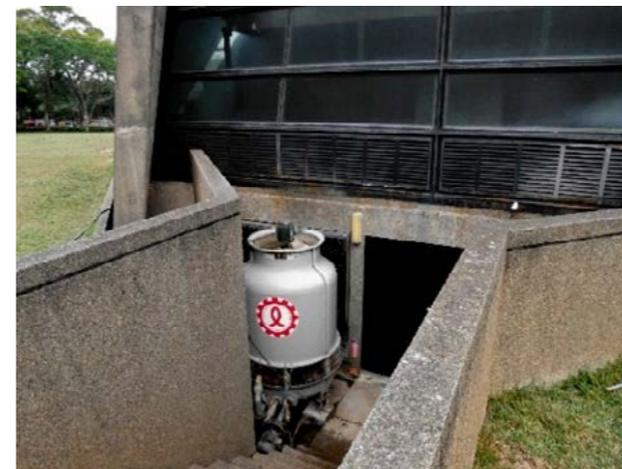
6.11 Rusted blinds caused by the vaped water from the cooling tower

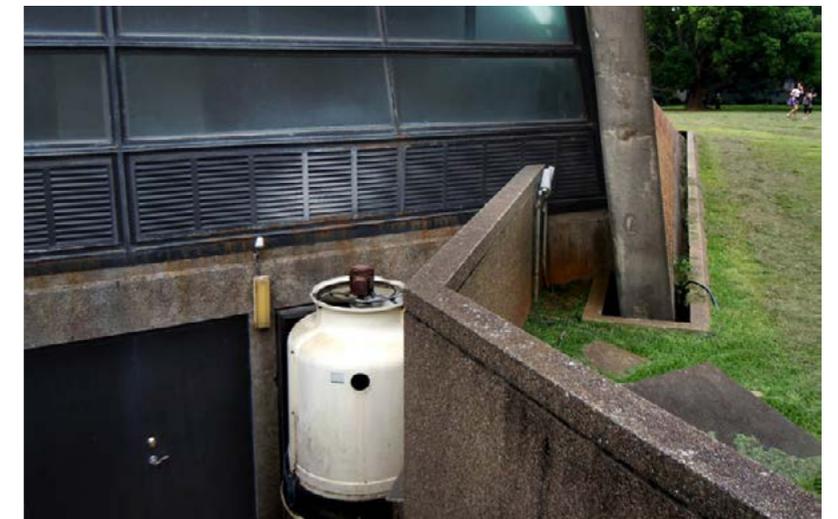
Fig.7.4 Corrosion on the metal frame of the first floor glass window
