Melnikov House

Research Report and Recommendations for a Conservation Plan

10 Krivoarbatsky Lane,
Moscow, Russia

August 2019

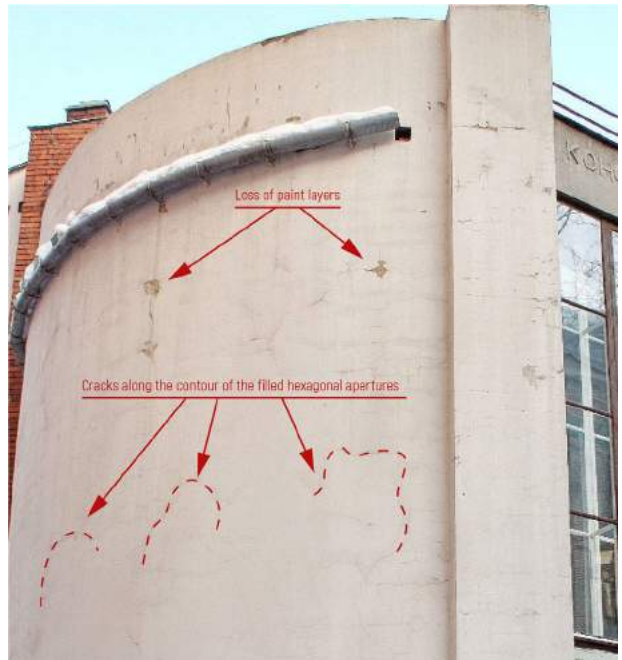
Cracks in the southwest façade of the building.

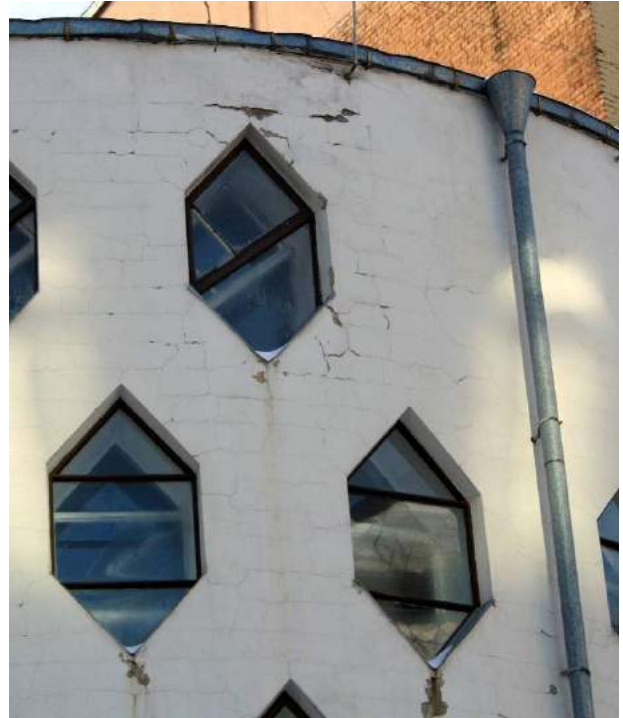
Debonding of the plaster layer from the base, its loss – near the downspout. Water stains and damage to the finish under the windowsills. Corrosion of the roof vertical projection

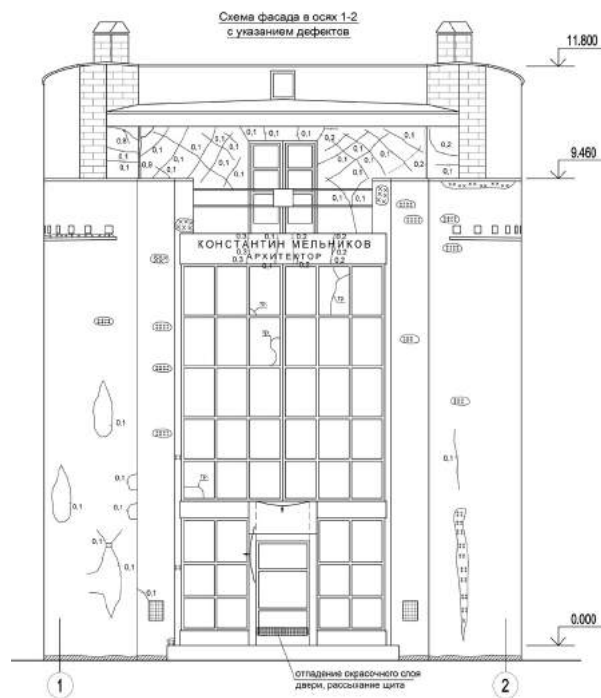
Defects of the south façade

Crack in the façade inscription

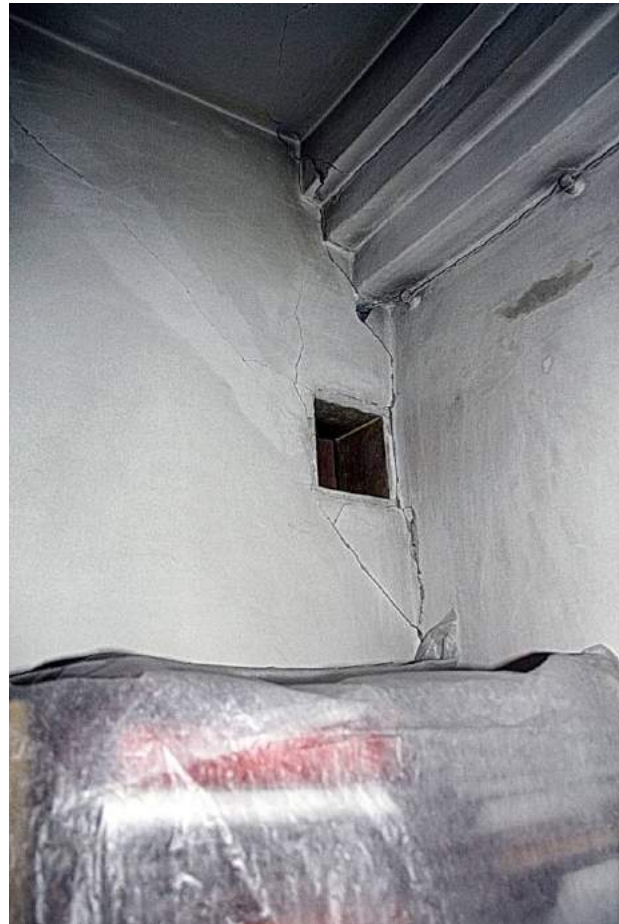
Cracks in the partition and where the partition meets the exterior wall

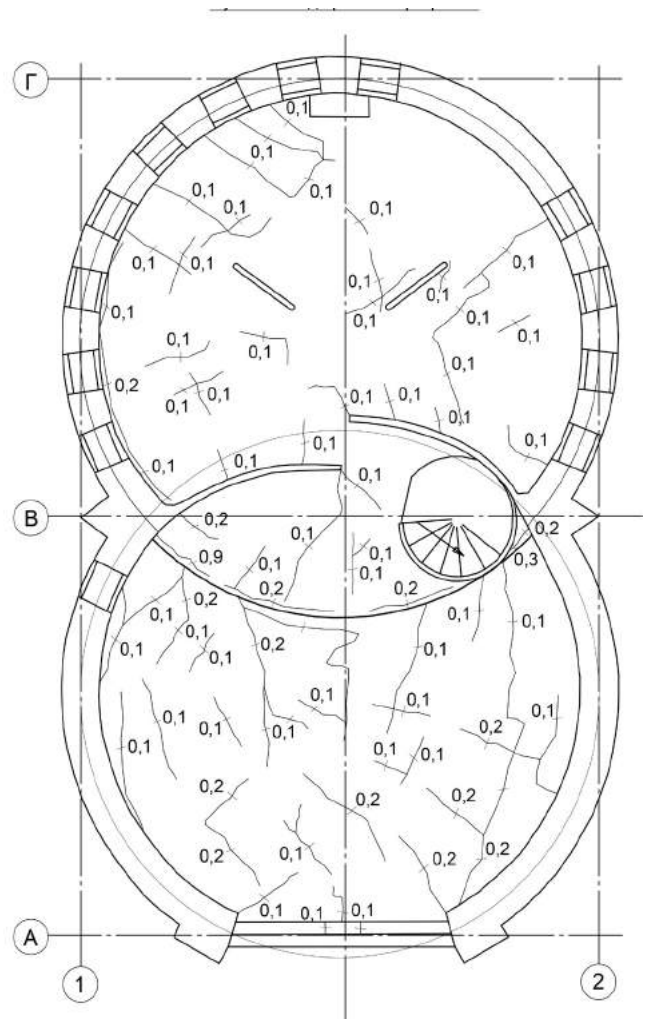
Defects of the intermediate floor. 1st floor plan

- Cracks in the ceiling finish of the large cylinder projection, mostly up to 0.1 mm wide.
- Cracks in the brick wall near the places of applied concentrated load up to 0.3 mm wide under the support of the lintel of the large window and 0.2 – 0.3 mm near the supports of the truss.
- Cracks in the glazing of the large window. More serious damage to wooden frame elements, loosening of wood surface fibers, in some places there is rot.
- Ceiling sagging reaches 100 mm.

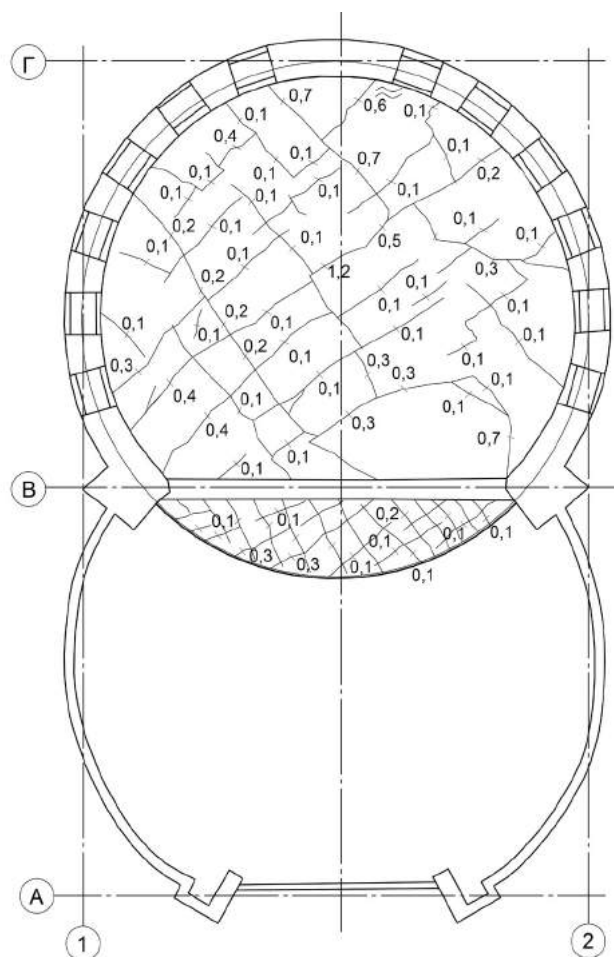
Defects of the intermediate floor. Studio. 2nd floor plan

Condensation in the gap between the frames in the studio. Destruction of the finishing layers of the frames and the walls between the frames

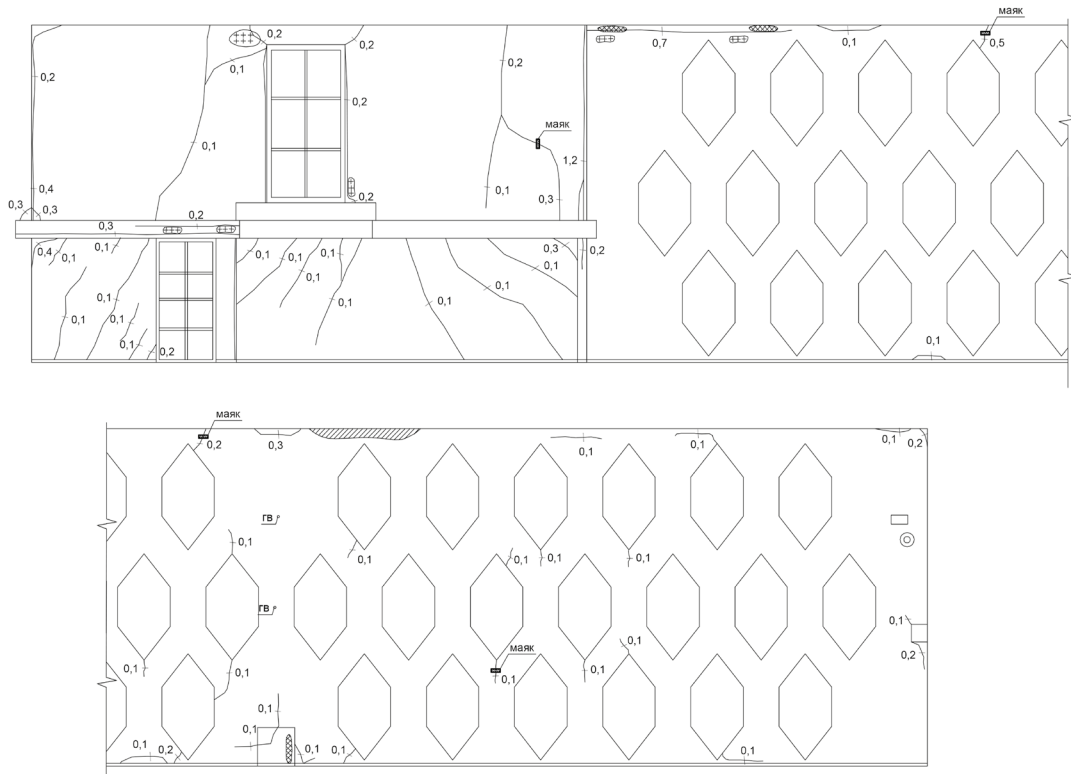
Defects of the walls. Studio. 2nd floor

- There are only few cracks in the building that can be attributed to settlement cracks – in the west façade of the small and the large cylinders. At the same time their width is minimal. The most pronounced through-wall crack initially occurred under stress and is visible in the photographs of the early 1930s.
- The most pronounced defects (cracks in partitions and ceilings) are associated with insufficient rigidity of wooden floors and settlements of the load-bearing partitions of the ground floor built on reinforced concrete foundations in the 1990s.
- Comparing the results with the materials of defect detection of 2013, the stability of deformations and the absence of any significant new defects can be definitely indicated. Nowadays some cracks are even less opened than in 2013, which can be explained by local repairs and measurement errors.

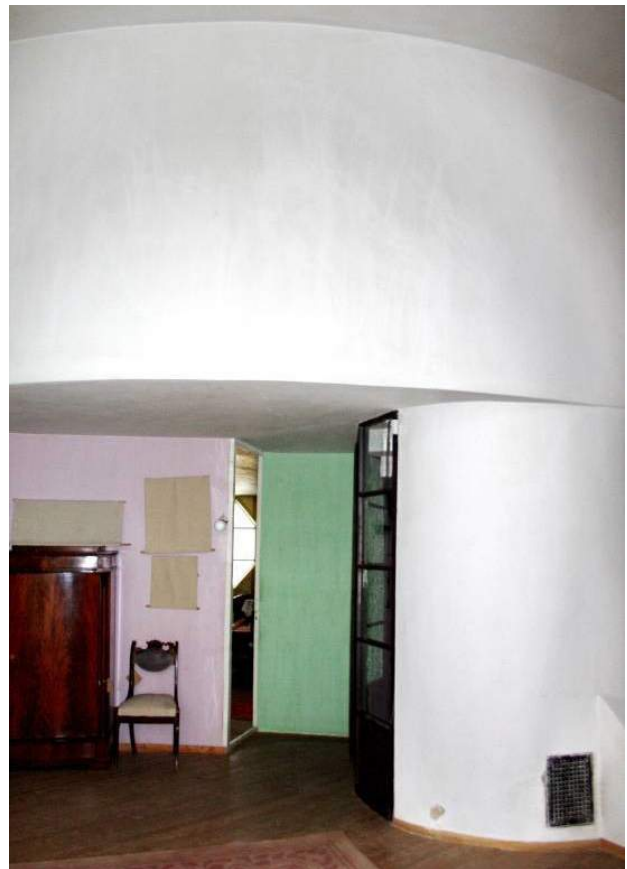
Living room on the first floor, view to the staircase. Loss of plaster on the staircase enclosure.

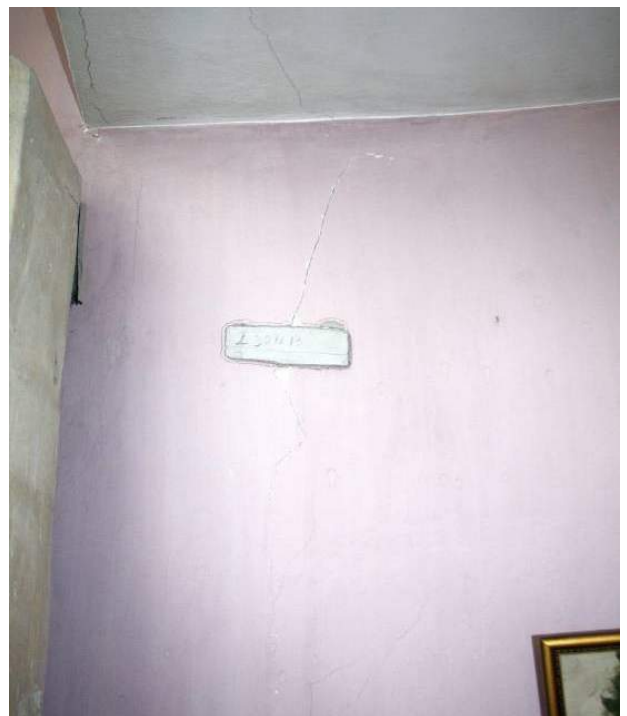
Living room on the first floor. The crack at the junction of the wooden joist and the brick wall. Cracks in the ceiling under the projection of the large cylinder

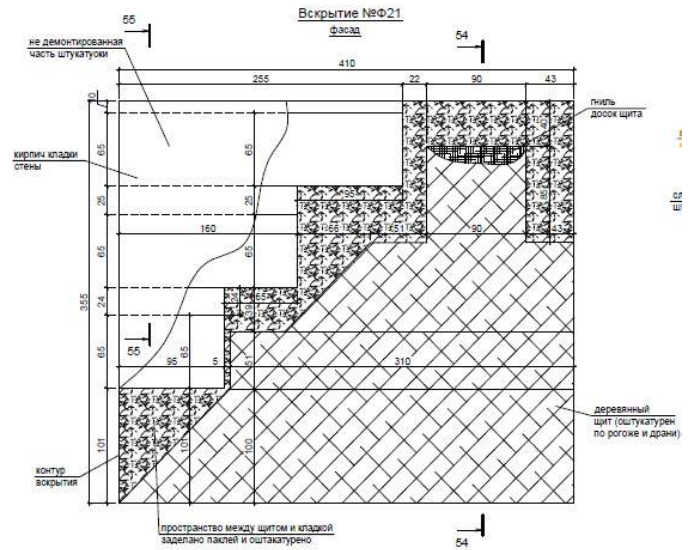
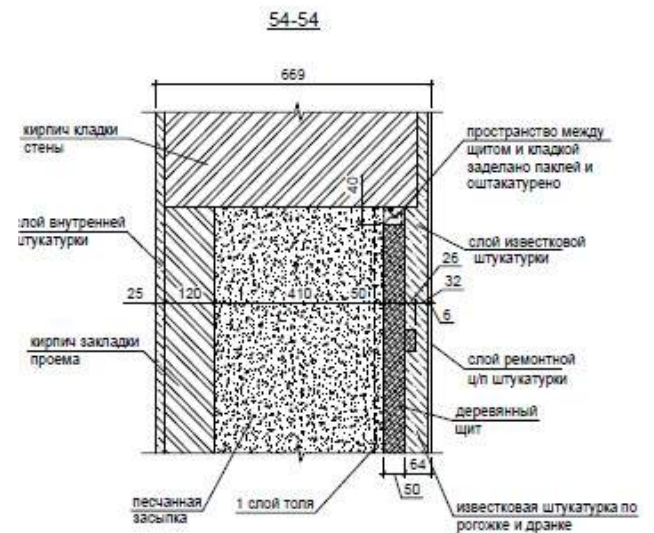
Rot on the edges of the wooden shield. Horizontal bar is loose as its connections lost strength. The tar paper layer lost its flexibility and became fragile. The layer of bast fiber fabric decayed (its remnants are visible on the right), therefore the adhesion of the plaster layer with the shield is lost.

After the examination, the filling-up was packed back into the aperture. The gaps between the shield and the brick walls were filled with tow fiber, the lath was restored and the aperture was plastered anew with the repair compound.

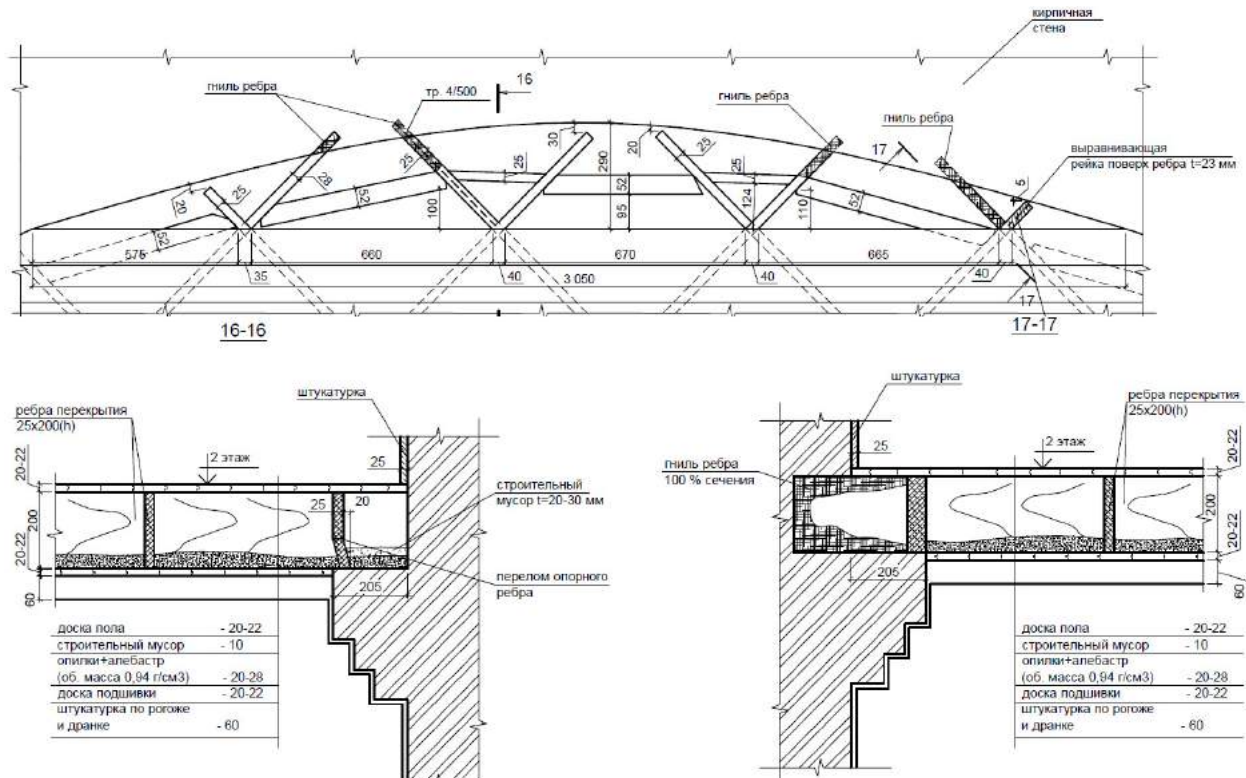
Opening B12. Bedroom. 1st floor

Damage by rot of the supporting ends of joists of the ground floor grid. The only joists damaged are those, that are built in the masonry of the walls. In the photo: the joist is mostly peeled off from weak wood.

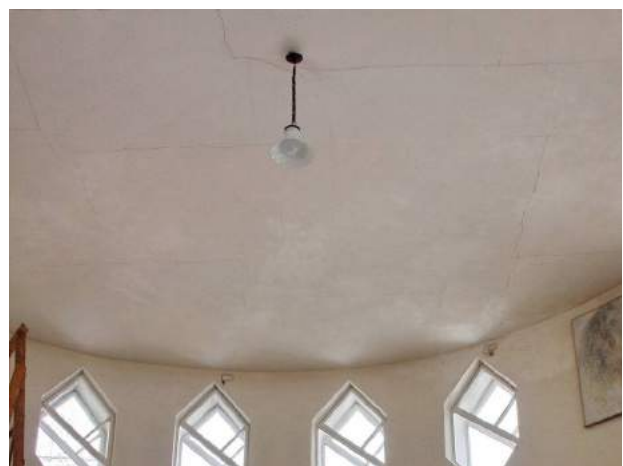
The following defects should be noted: the insufficient rigidity of the roof structures, which is seen in the form of deflection of the ceiling in the studio, which reaches 80 mm as a result of the constant load and increases because of the temporary load. This deflection is the cause of cracks on the surface of the ceiling in the studio and it also forms places of water stagnation on the roof surface along with the local deformations of the spaced sheathing.

Second floor. Studio. Cracks in the plaster layer of the ceiling
