Cathedral of Ica

4.1 Summary

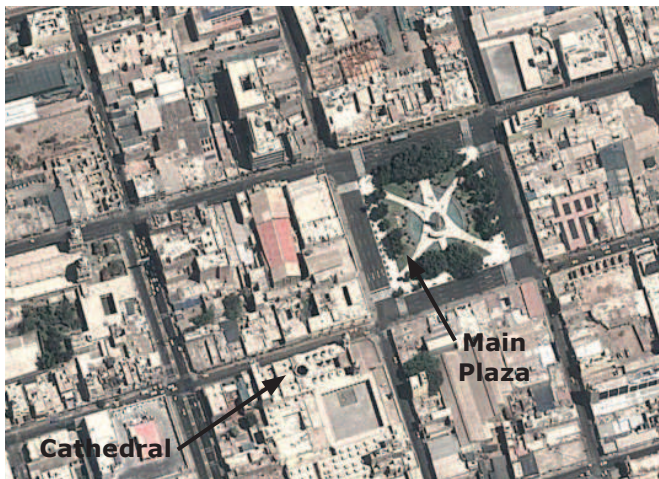
FIGURE 4.1
Satellite image showing the location of the Cathedral of Ica in relationship to the main square of Ica.
Image: © 2013 Google. Image © 2013 Digital Globe.

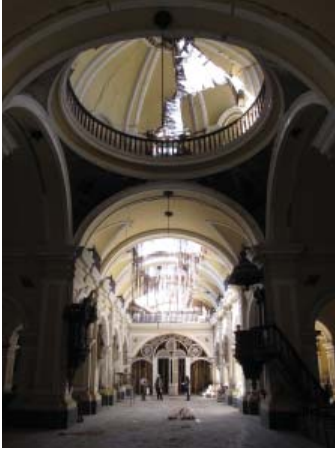
FIGURE 4.3
View of damages to the dome and vault resulting from the 2007 earthquake.

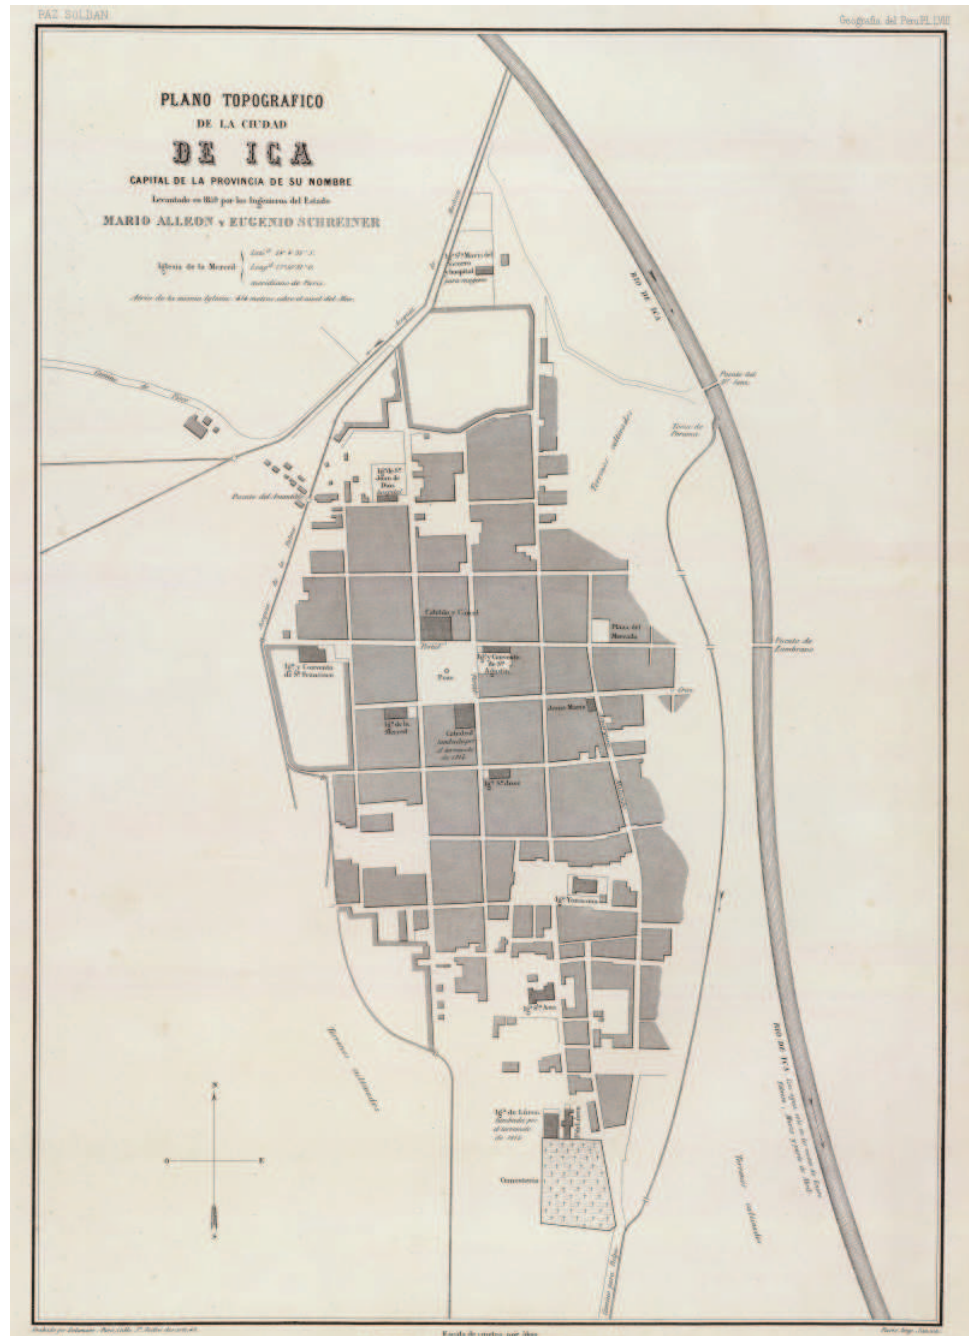
Most Jesuit churches in the New World, including the former Jesuit church of Ica, have similar floor plans that are based upon the Church of the Gesù in Rome.

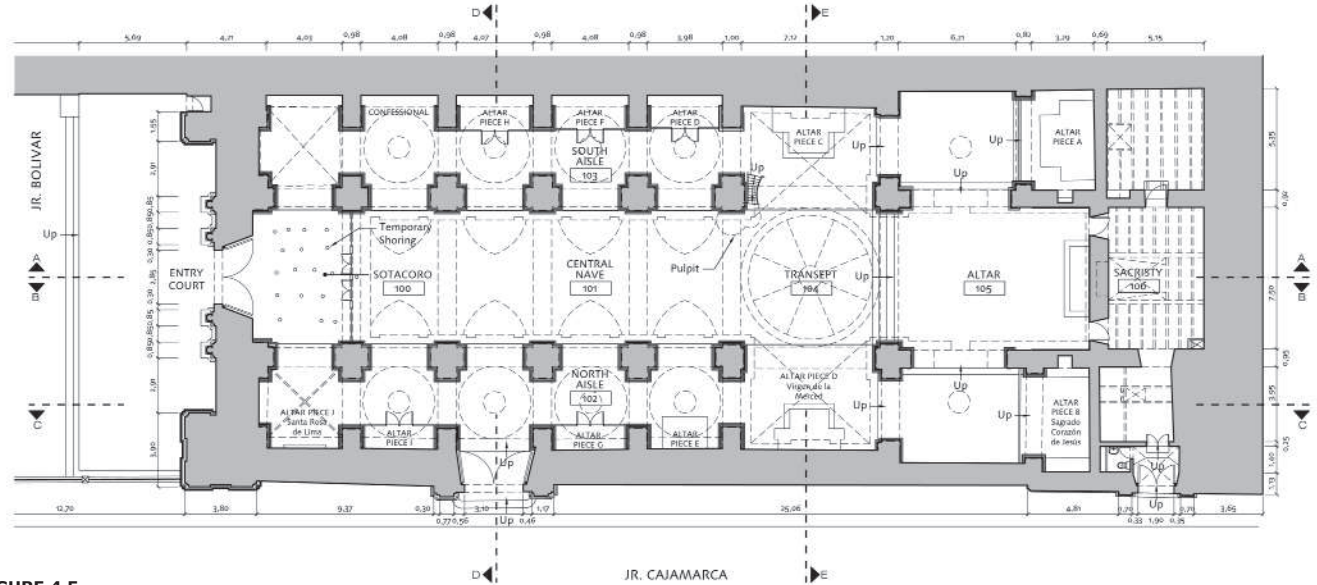
FIGURE 4.5
Floor plan, Cathedral of Ica.
Drawing: Base drawing prepared by Mirna Soto and edited by the GCI.

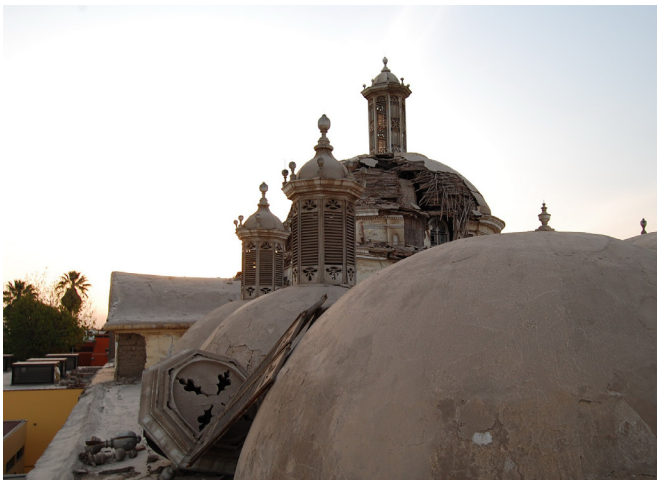
FIGURE 4.13
View of domes over south lateral aisle, with damaged main dome in the distance, 2007.
Image: Instituto Nacional de Cultura del Perú.

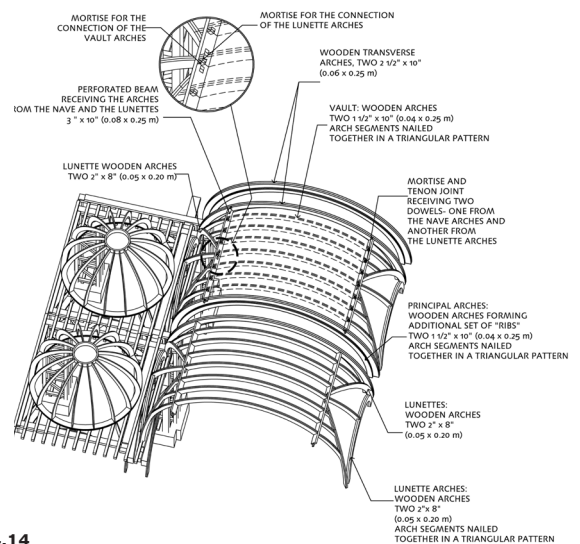
FIGURE 4.14
Detail showing the construction of the barrel vault, lunettes, and side aisle domes.
Drawing: Mirna Soto, for the GCI.

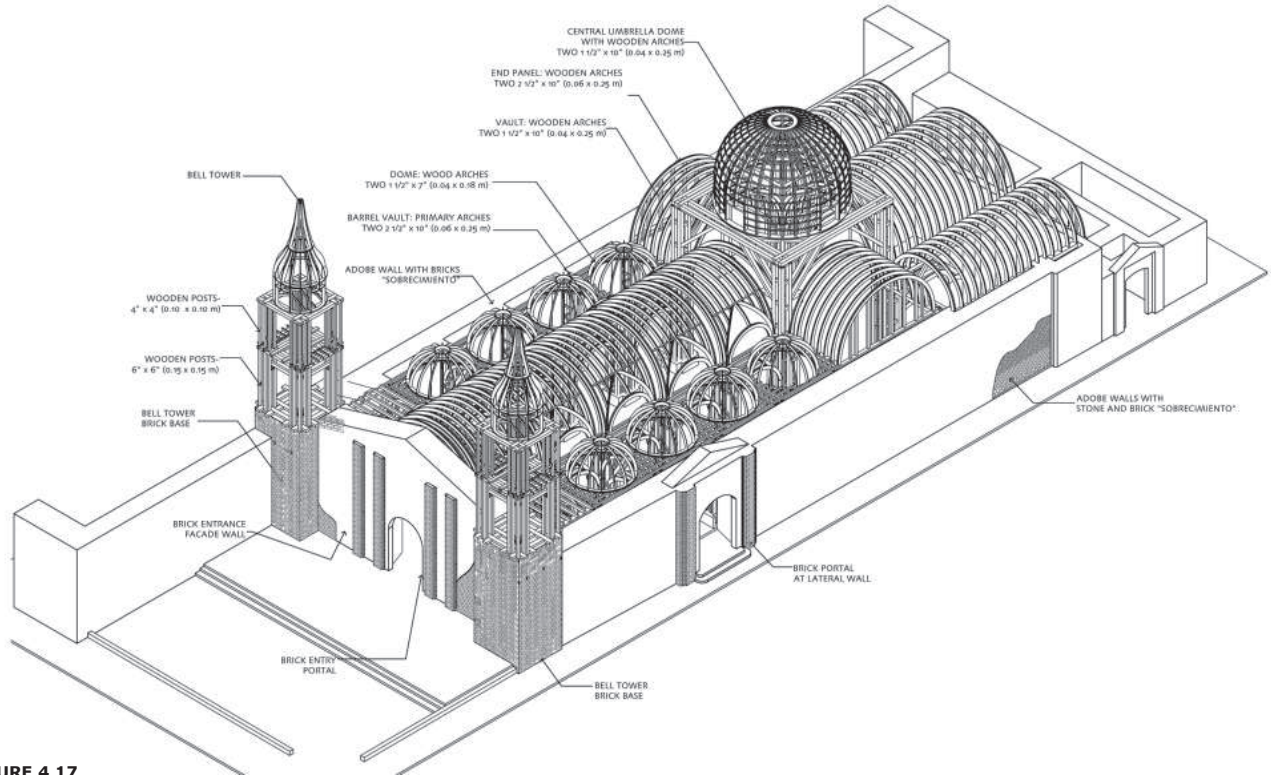
FIGURE 4.17
Overall structural scheme for the cathedral.
Drawing: Mirna Soto, for the GCI.

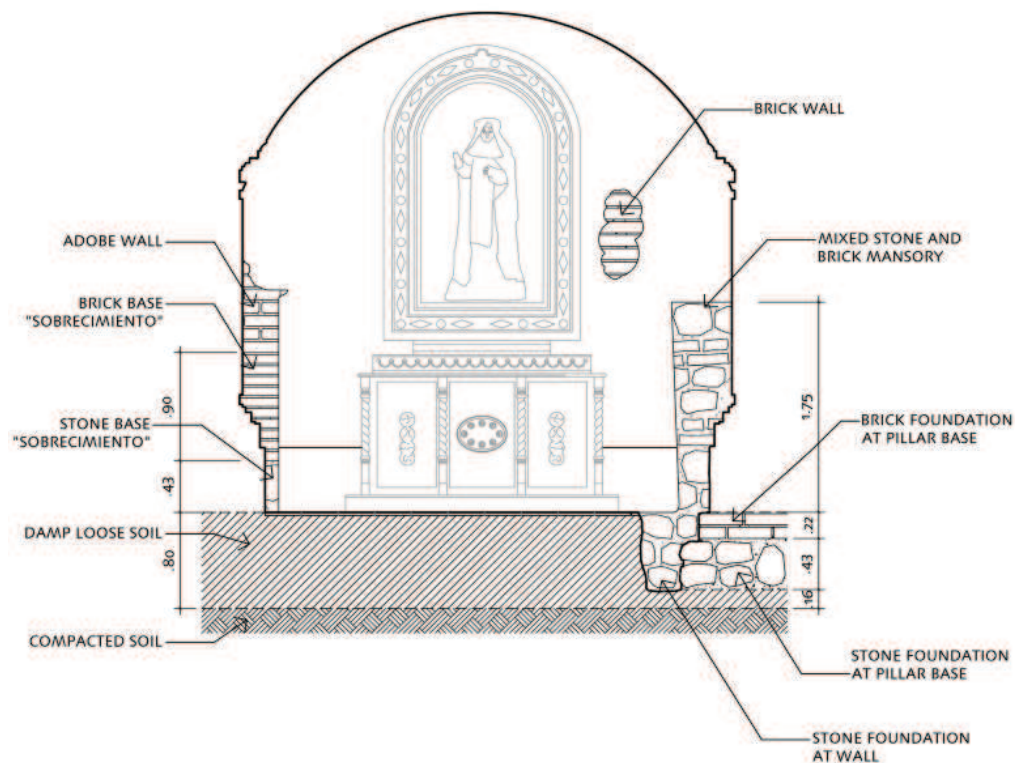
At the mud brick south lateral wall, the base course consists of a 0.60 m high fired brick masonry wall over a 0.48 m deep rubble stone foundation (prospection IS-2). Below this, the remains of vaulted fired brick catacombs were found. Both the base course and foundation are the same width as the mud brick wall above.

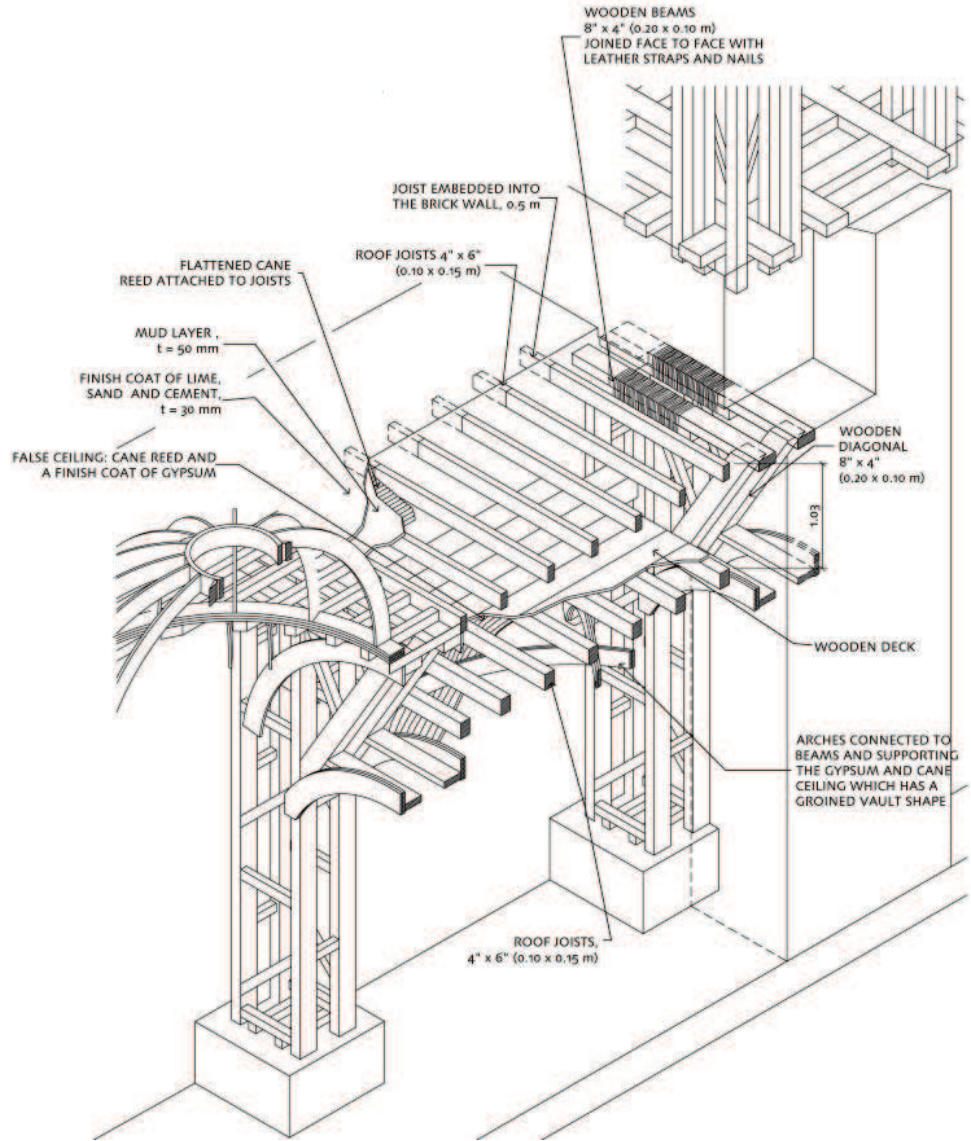
4.6 Irregularities, Alterations, Damages, and Decay

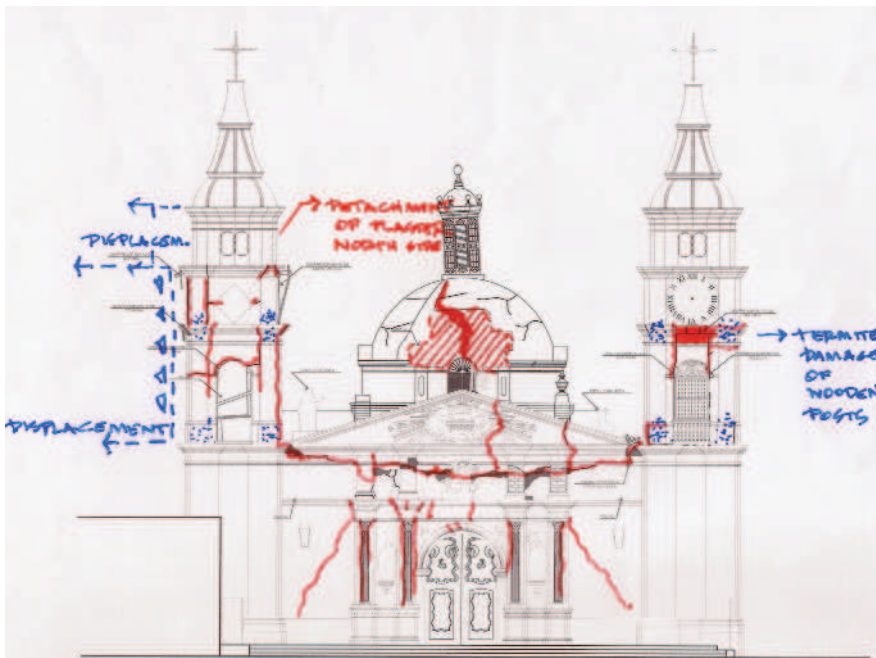
- The principal façade is in fair to poor condition. There are horizontal cracks between the lower façade and the pediment. Diagonal cracks were observed between the upper cornice and the base of the bell towers. This diagonal cracking suggests pounding of the towers during the earthquake (Fig. 4.40).
- The wood-framed portions of the towers are in poor condition and thus present a threat to the cathedral's roof system to the west. Damages include the failure of some connections, displacement of the wood elements at the south tower from their original positions, and loss of plaster. Thus, the wood posts are exposed and show signs of severe termite damage. (Fig. 4.41).

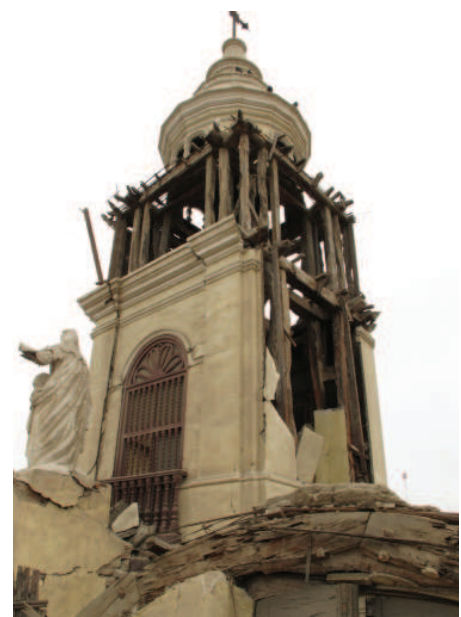
Drawing: Claudia Cancino.

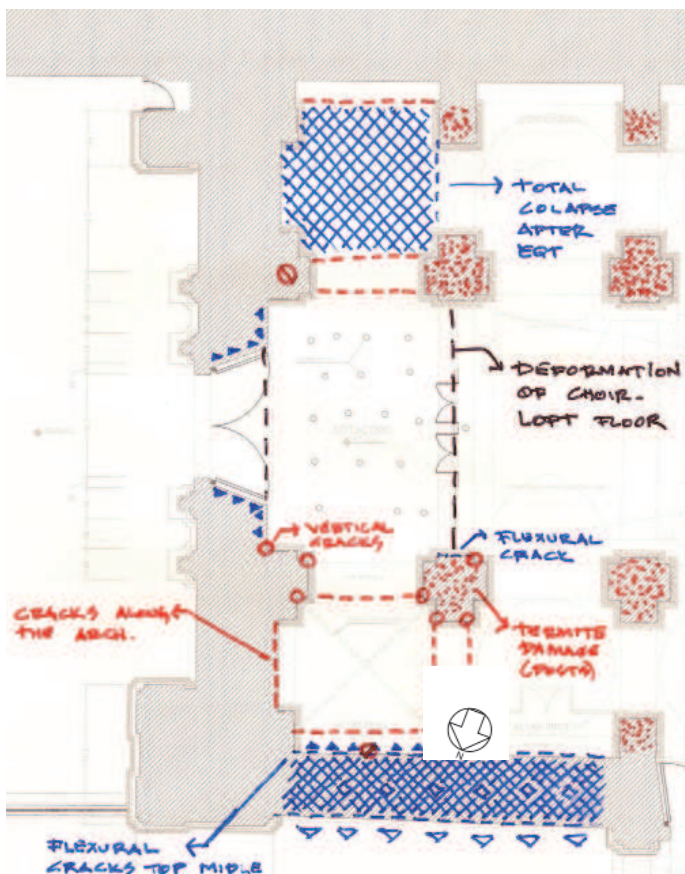
FIGURE 4.42
Sotacoro: Graphic condition survey.
Drawing: Claudia Cancino.

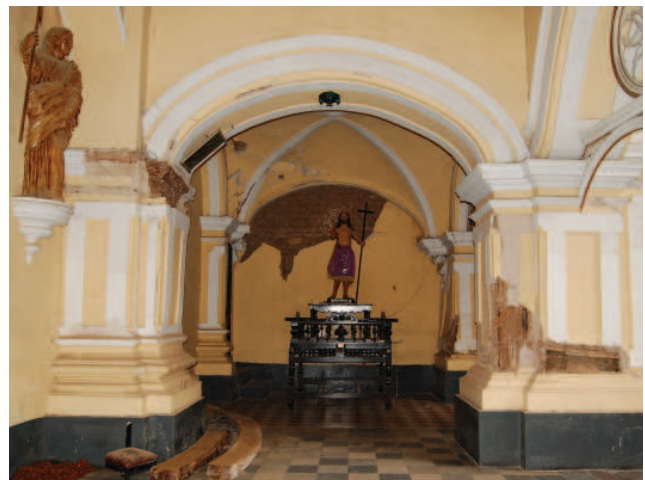
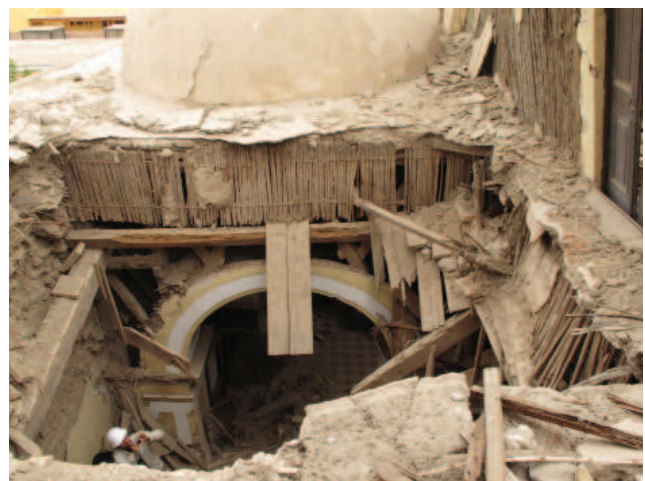
FIGURE 4.43 (TOP)
View of sotacoro, looking south and showing the intact rib-vaulted ceiling above altarpiece K, 2007.
Image: Instituto Nacional de Cultura del Perú.

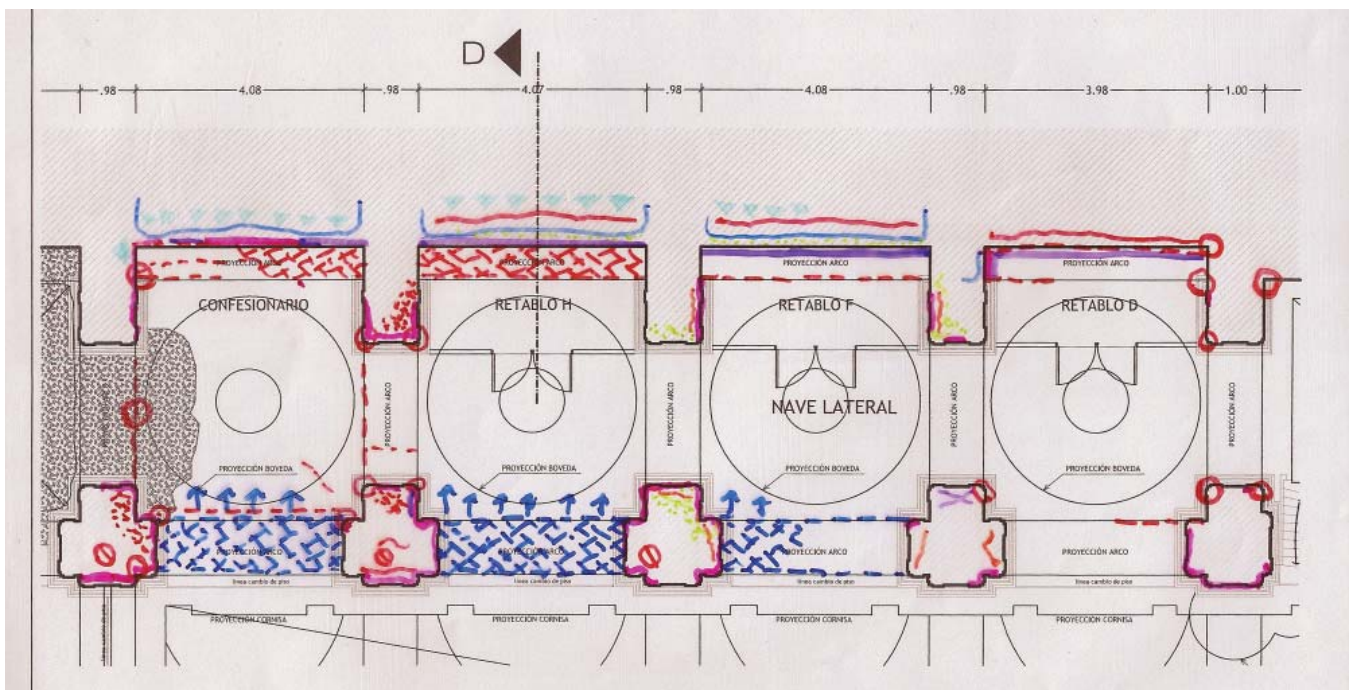
- Vertical cracking at the west pillar in altarpiece D space.

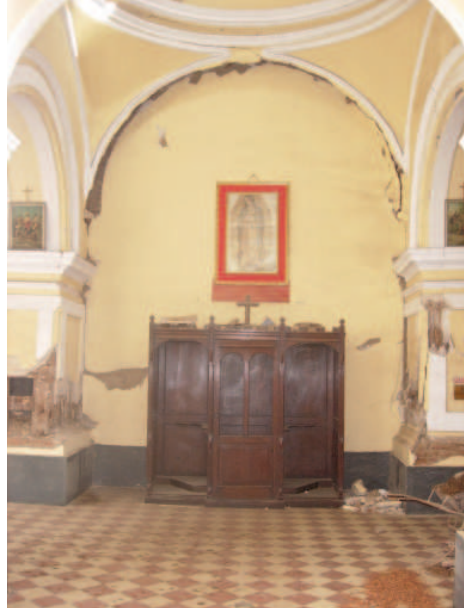
FIGURE 4.47 (RIGHT)
Sector B: Cracking and partial collapse at arches at the top of the wall, altarpiece H space, 2007.
Image: Philippe Garnier.

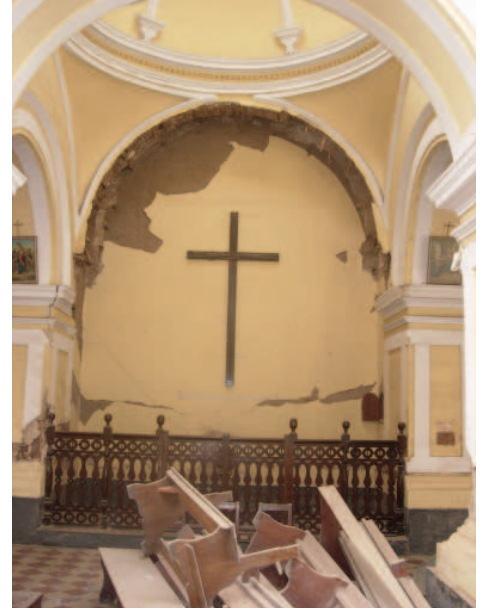
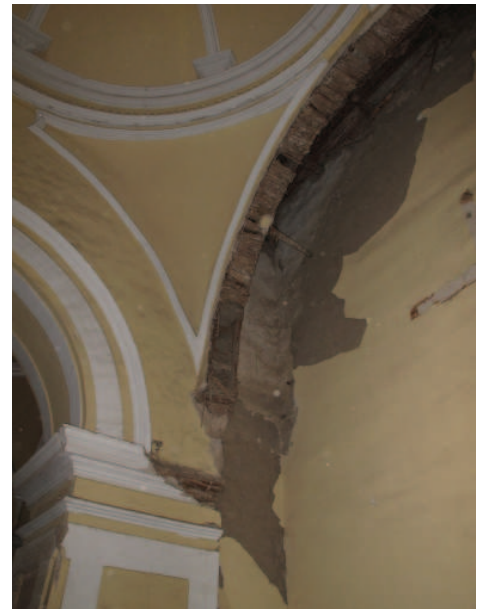
FIGURE 4.48
Sector B: Detail of cracking and partial collapse at arches along the south lateral wall.
Image: Sara Lardinois.

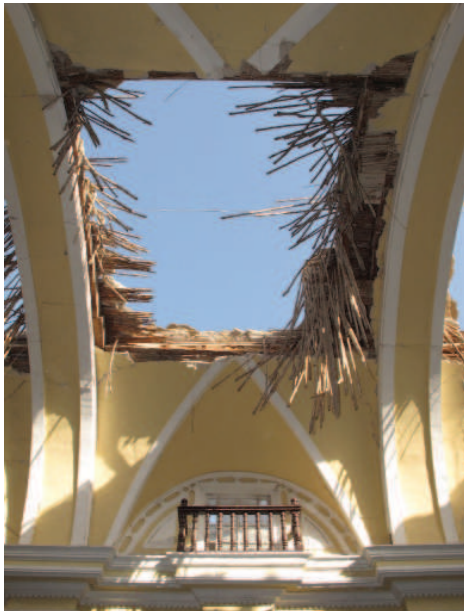
FIGURE 4.50
Sector C: View of a collapsed bay of the nave barrel vault.
Image: Sara Lardinois.

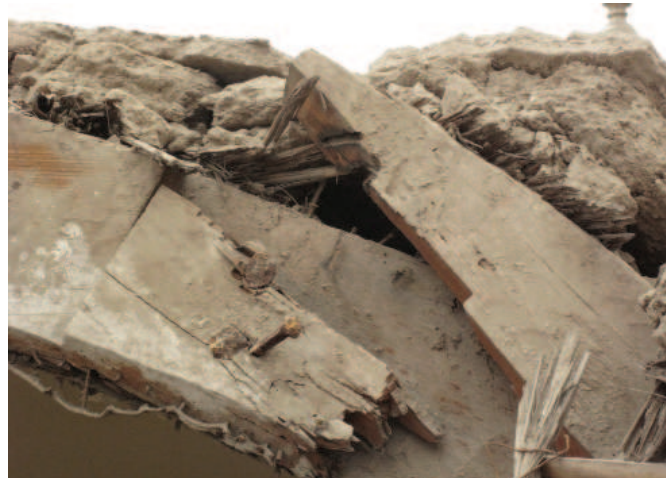
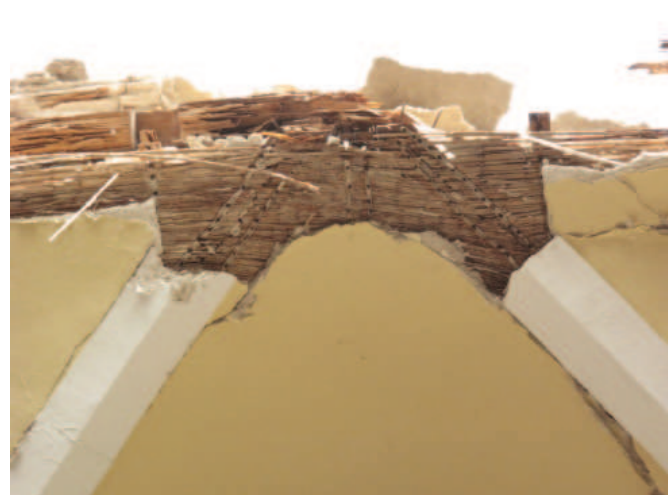
FIGURE 4.51 (TOP)
Sector C: Damage to wood arches forming the nave barrel vault, with corrosion at the nails connecting the arch segments.
Image: Claudia Cancino.

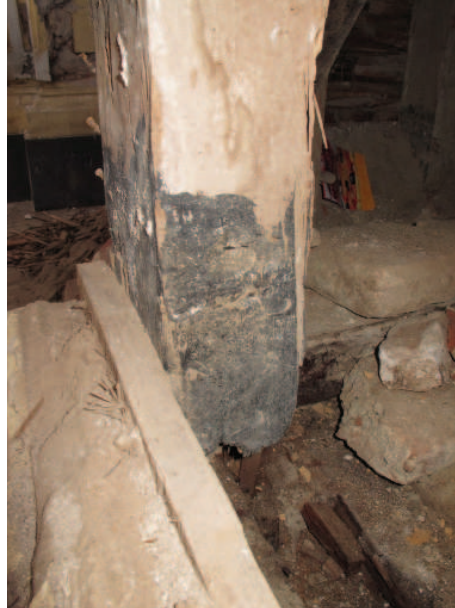
FIGURE 4.53 (NEAR RIGHT)
Sector C: View of pillar base, showing deterioration of the wood post and sill.
Image: Sara Lardinois.

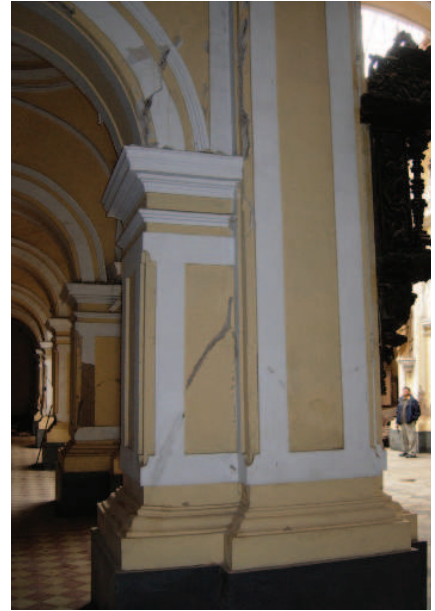
FIGURE 4.54 (FAR RIGHT)
Sector D: Cracking in west pillar at the north side aisle.
Image: Claudia Cancino

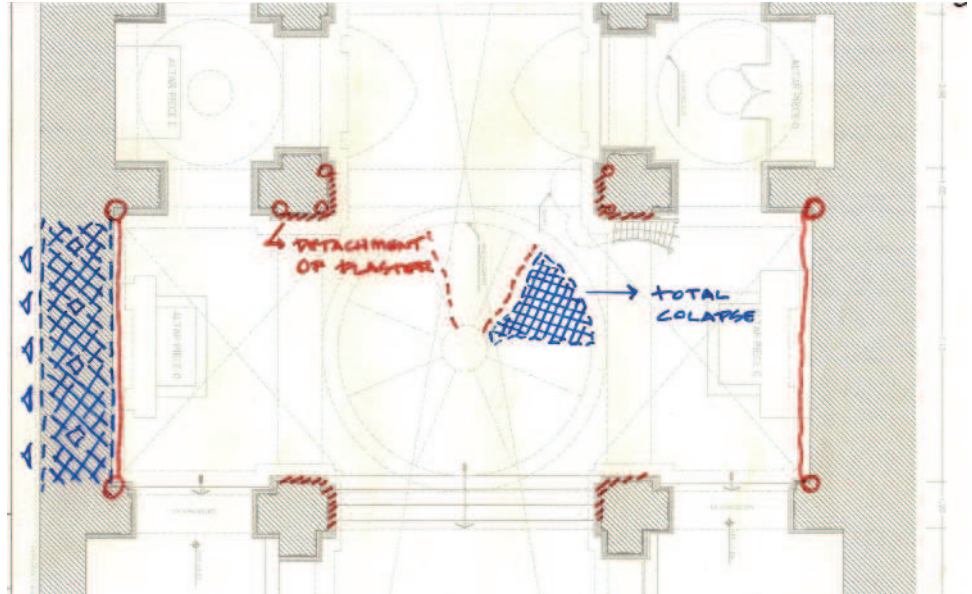
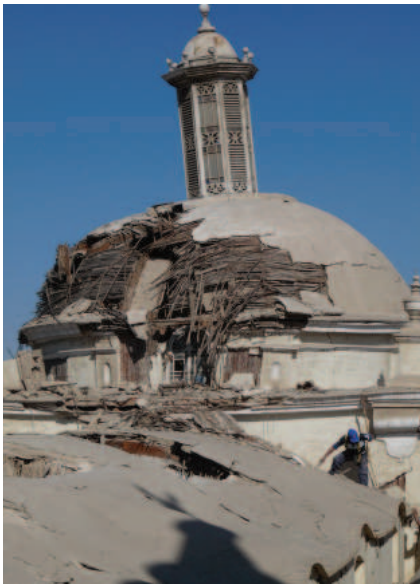
Sector E: Graphic condition survey. The combination of the dark blue hatch pattern and small dark blue arrows show out-of-plane displacement; the smaller dark blue hatch pattern alone shows areas of collapse at the main dome; the red lines show areas of horizontal cracking; and the red circles show areas of vertical cracking. Drawing: Claudia Cancino.

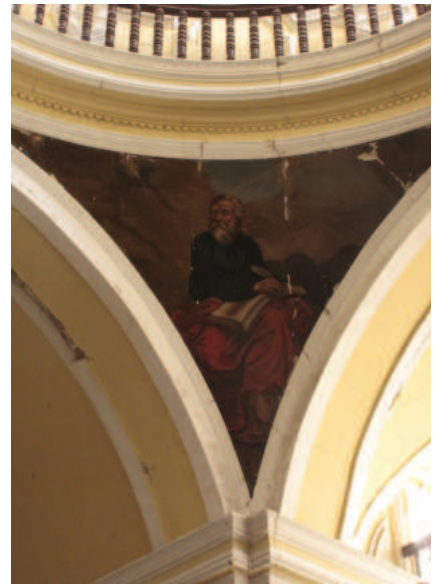
Sector E: Interior view, looking east, showing the partial collapse of the dome and barrel vault.
Image: Sara Lardinois.

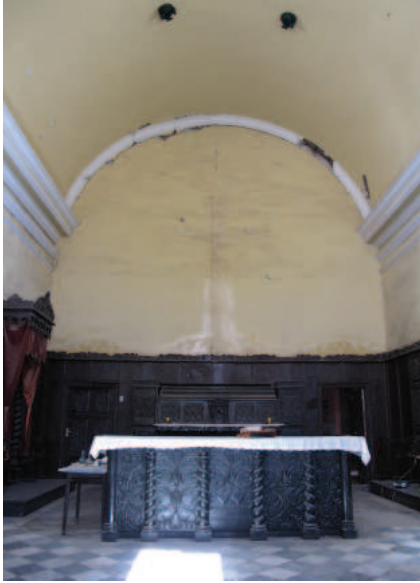
FIGURE 4.59
Sector F: The upper west wall behind the altar exhibits out-of-plane displacement and cracking.
Image: Sara Lardinois.

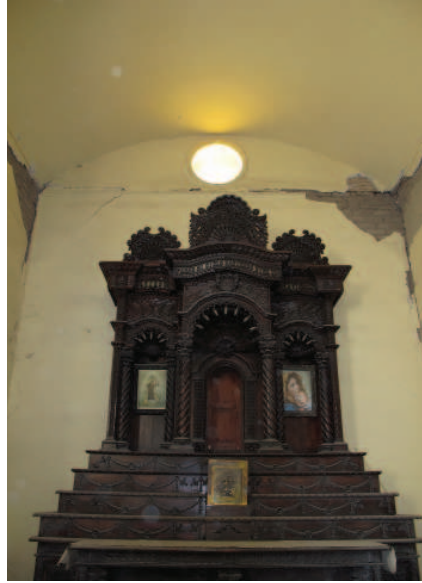
FIGURE 4.60
Sector F: View of vertical cracking in either corner at west wall of the north side chapel, behind altarpiece B.
Image: Sara Lardinois.

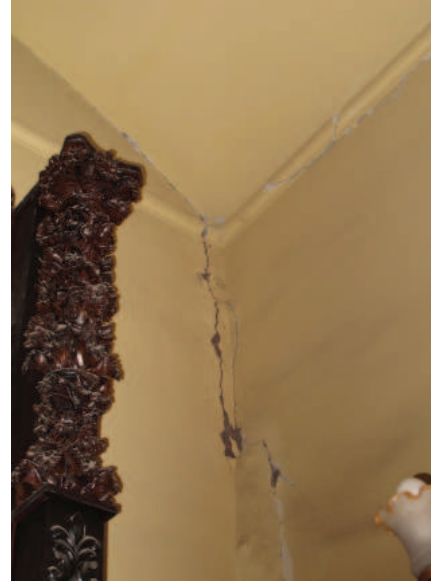
FIGURE 4.61
Sector F: Detail of vertical crack at north-west corner of the cathedral.
Image: Sara Lardinois.

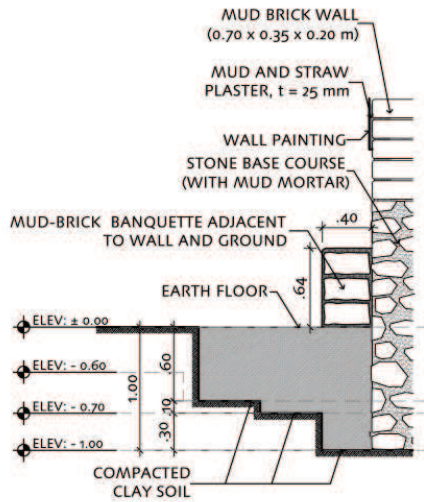
FIGURE 5.15
 Prospection IS-3, section view illustrating the base course at the southwest corner of the main church. Drawing, Mirna Soto, for the GCI.

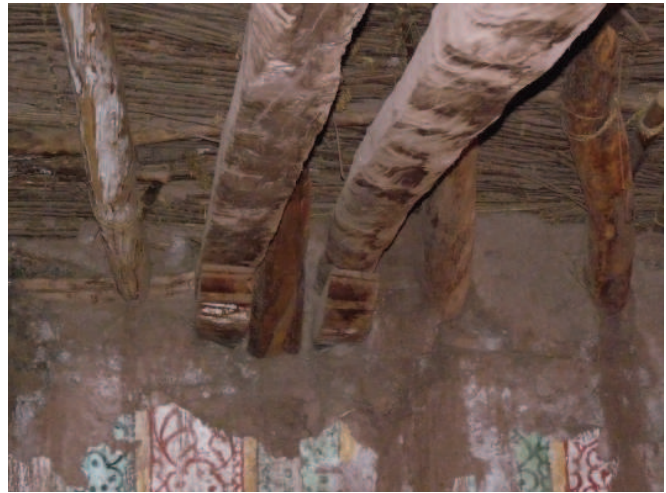
FIGURE 5.32
View of the pair of tie beams over the nave.
Image: Mirna Soto, for the GCI.

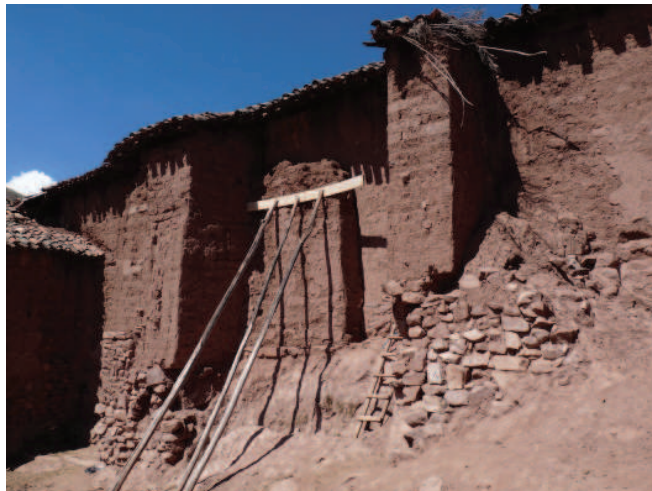
Image: Mirna Soto, for GCI.

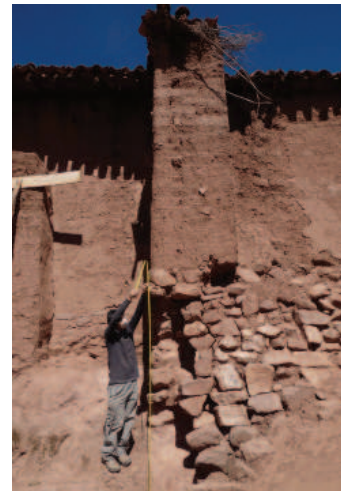
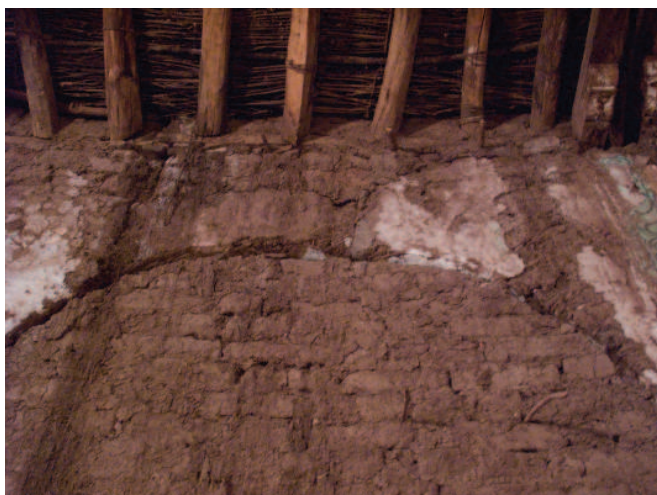
Image: Mirna Soto, for GCI.

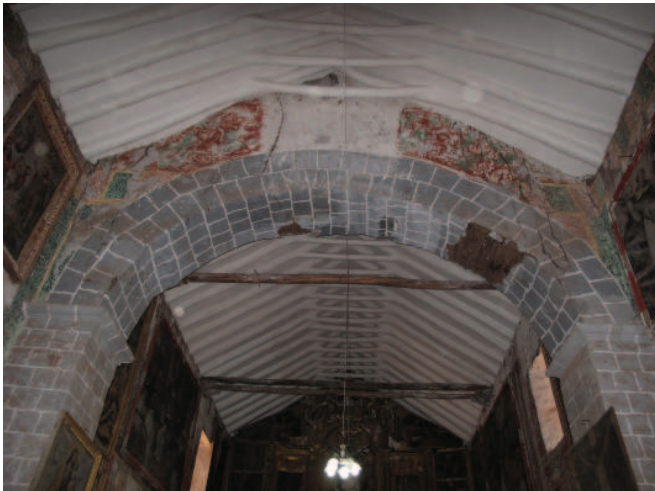
- The west lateral wall exhibits outward displacement. The loss of the western exterior buttresses may be a cause or result of this displacement. This

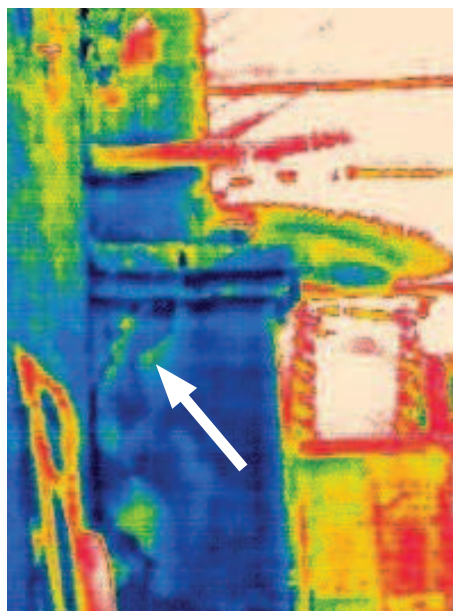
Image: Claudia Cancino.

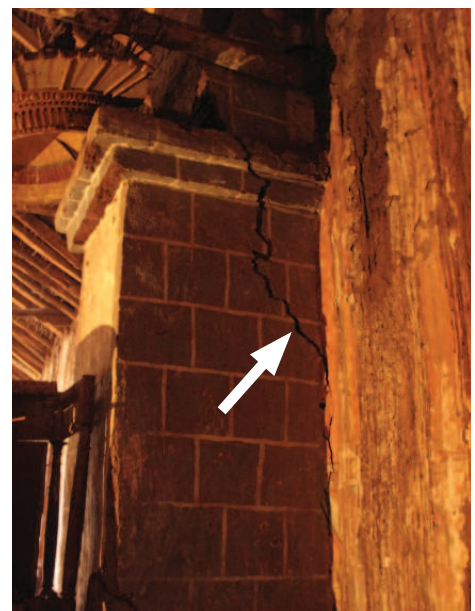
Image: Amila Ferron.

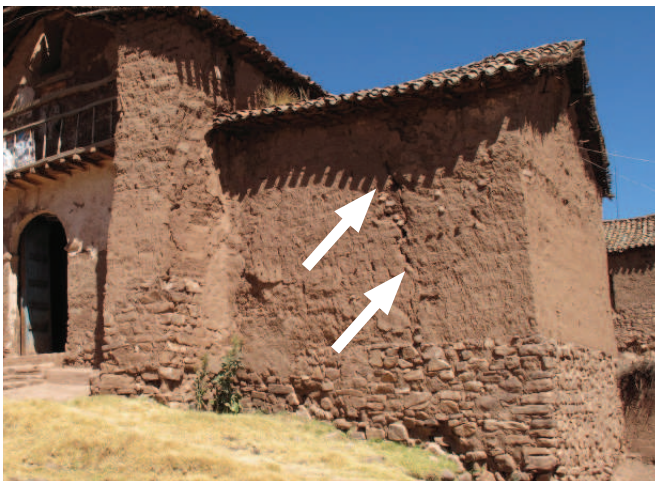
- As previously mentioned, the interior piers exhibit diagonal cracking.
- At both the base and tops of the east, south, and west walls, the mud bricks are water-damaged and partially eroded, with an average depth of loss of 50 mm. A leaking roof and rising damp are the presumed sources of this damage. The walls do not appear to be unstable as a result of the water damage; however, the erosion at the top of the wall has led to failure of some roof-wall connections. This water infiltration has also led to biological growth in the tops of the mud brick walls, as well as detachment and loss of interior plaster at the base and top of walls (Fig. 5.42).

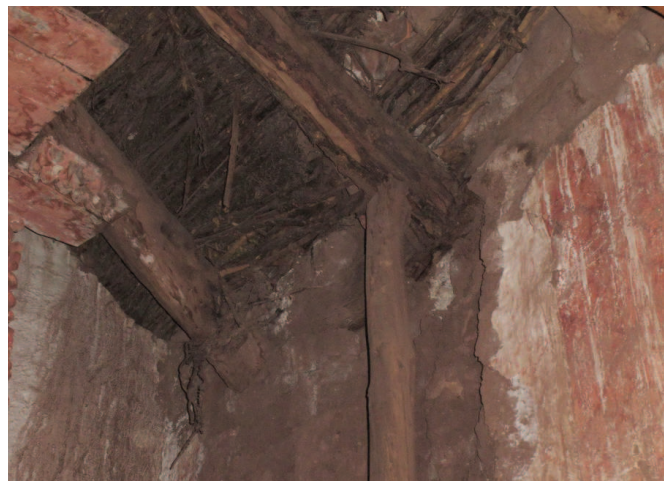
Crack in the south façade of the baptistery wing.
Image: Wilfredo Carazas, for the GCI.

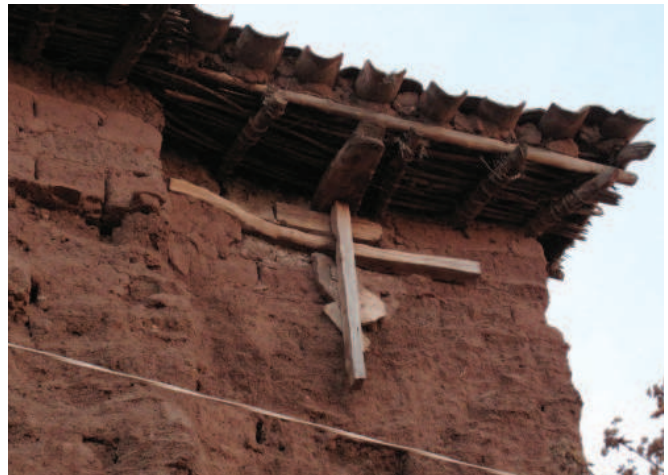
FIGURE 5.43
Wood key at south end of
west lateral wall.
Image: Claudia Cancino.

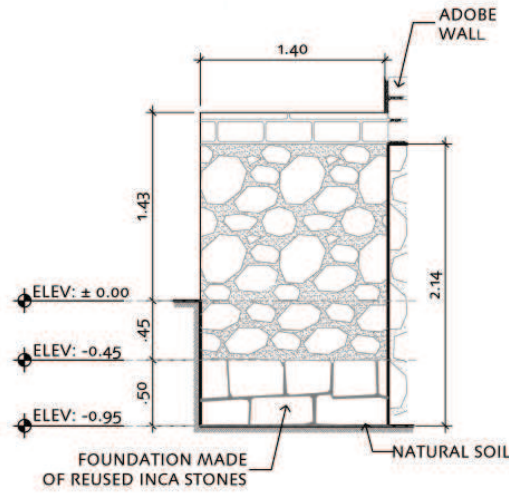
FIGURE 6.19
Prospection IS-2, illustrating the foundation configuration at the east façade wall at the southeast corner of the building, sector A1.
Drawing: Mirna Soto, for the GCI.

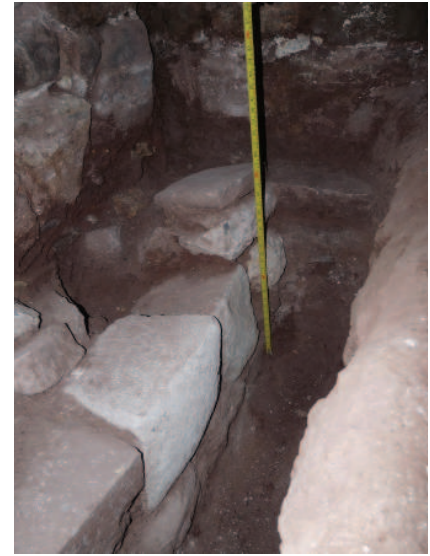
FIGURE 6.20
Prospection IS-2, photographic view of reused Inca stones.
Image: Mirna Soto, for the GCI.

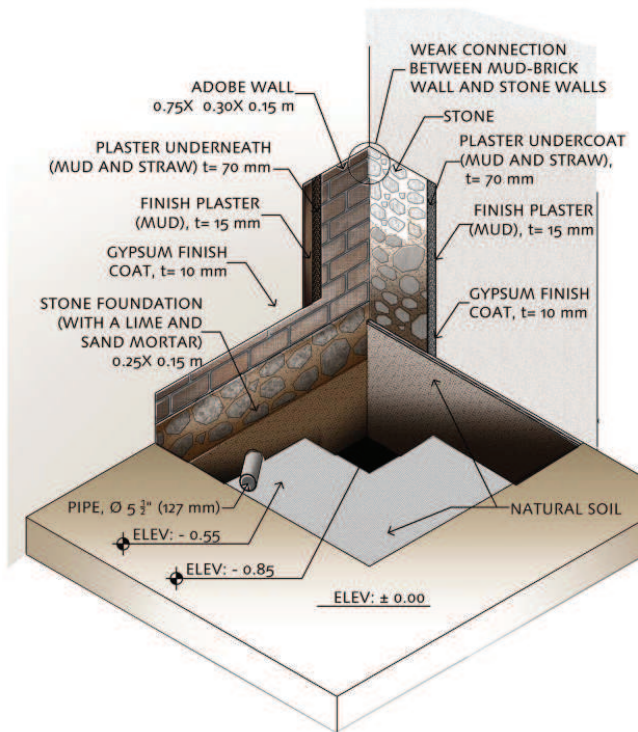
FIGURE 6.21
Prospection IS-1, showing the foundation and base course configuration at the southwest corner of room A-110, sector A1.
Rendering: Jabdiel Zapata, for the GCI.

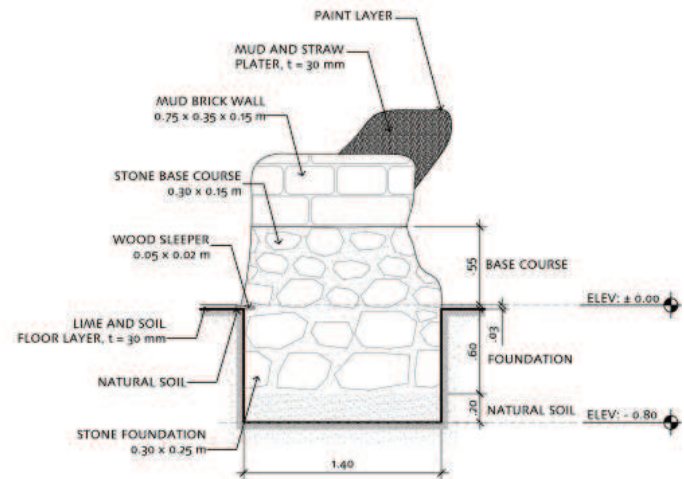
FIGURE 6.22
Prospection IS-3, illustrating foundation configuration at north wall of room A-111, sector A4.
Drawing: Mirna Soto, for the GCI.

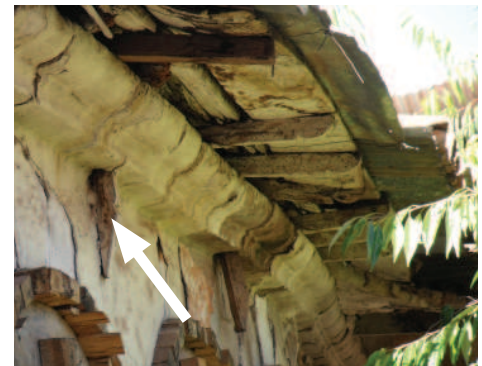
FIGURE 6.39
Wood key at intersection of tie beam and arcade wall, north side of patio.
Image: Carina Fonseca.

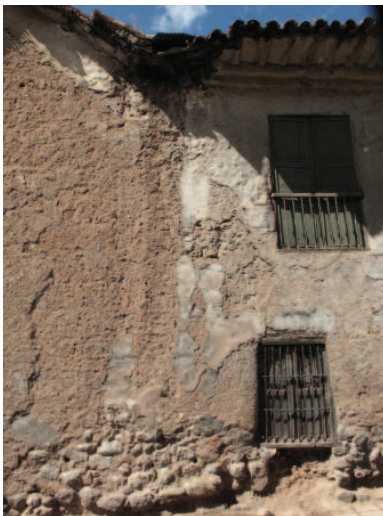
FIGURE 6.40
Erosion and loss of base course stones outside room C-109, north façade.
Image: Claudia Cancino.

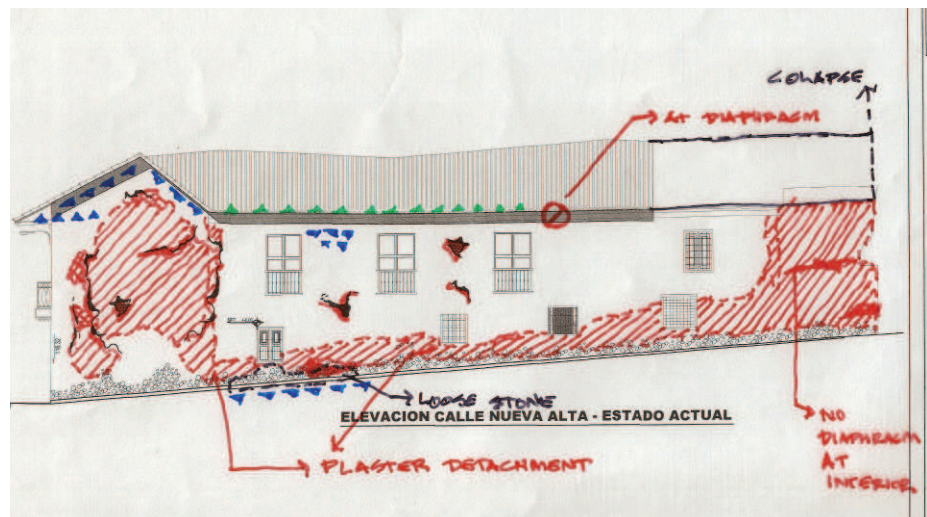
FIGURE 6.41
Graphic condition survey of north façade, indicating areas of loose and lost base course stones (in black) and plaster detachment (in red). Areas of moisture damage are indicated with the blue triangles, and green triangles mark areas where vegetation is present.
Drawing: Claudia Cancino.

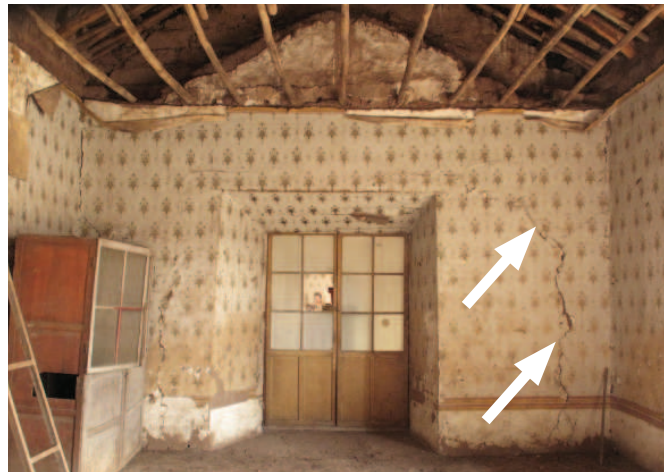
FIGURE 6.42
Vertical crack in transverse wall between rooms A-203 and A-204, adjacent to the east façade.
Image: Claudia Cancino.

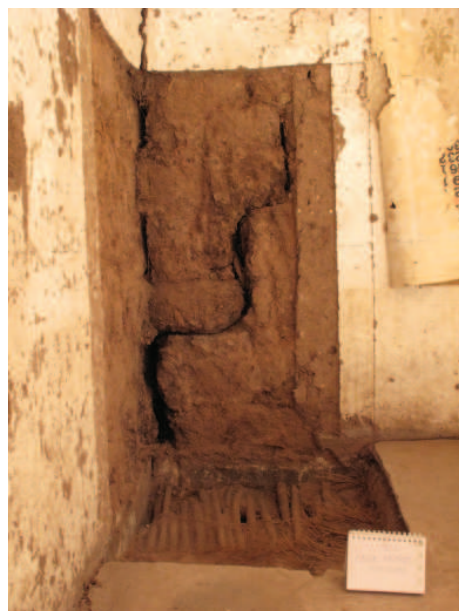
FIGURE 6.43 (LEFT)
Crack in second floor mud brick wall at southeast corner of building, indicating a disconnection between the façade at Calle Arones and the south perimeter wall.
Image: Claudia Cancino.

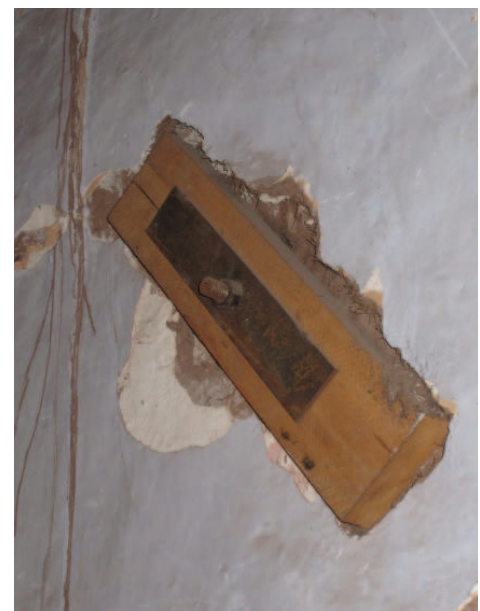
FIGURE 6.44 (RIGHT)
Threaded steel rod, plate, and wood blocking at south perimeter wall (room B-206).
Image: Sara Lardinois.

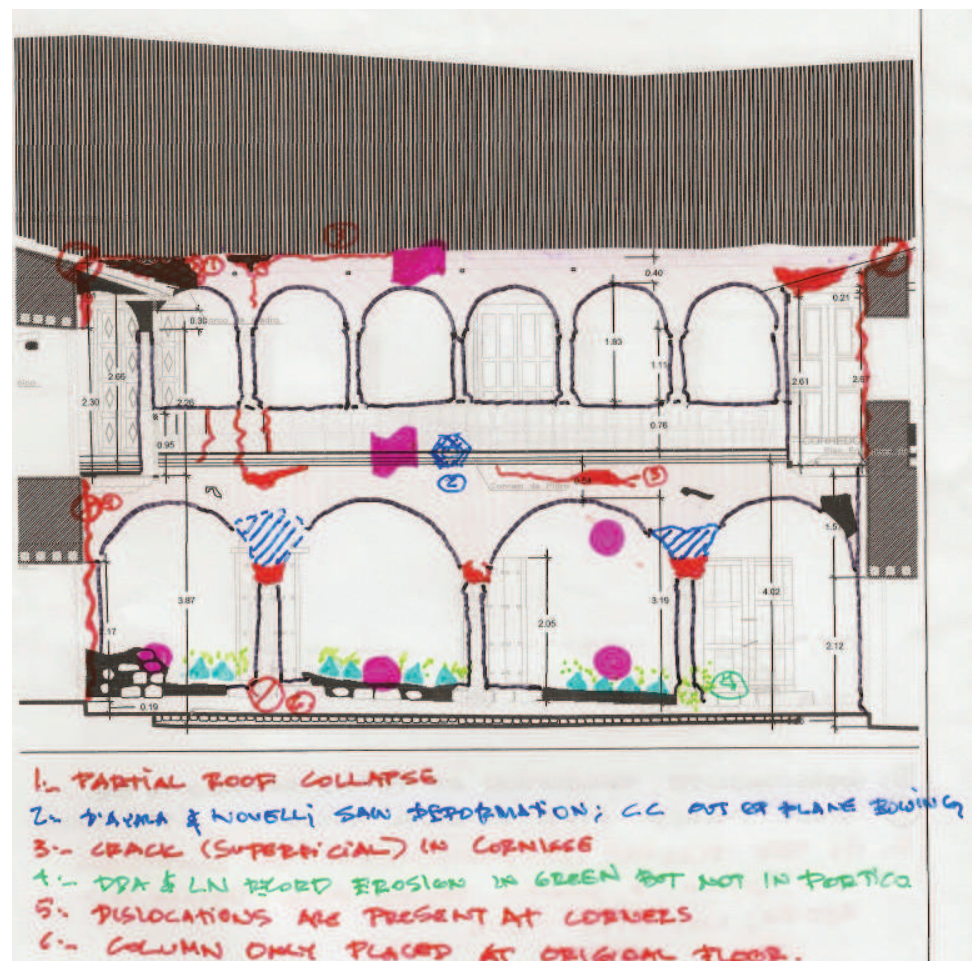
The quincha panels are in good condition.

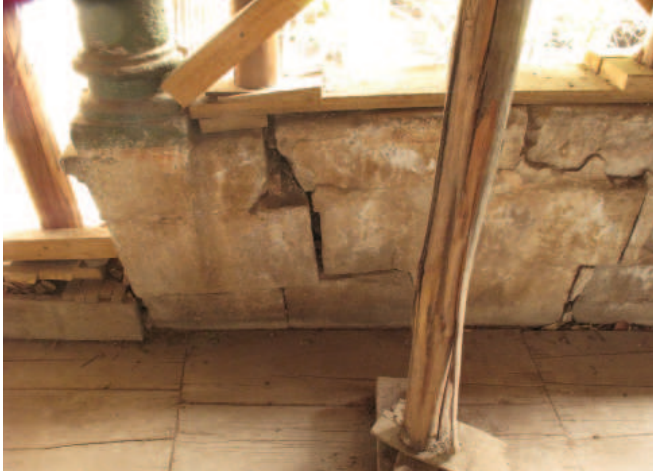
FIGURE 6.46
West end of stone masonry parapet wall at south arcade, as viewed from room B-206.
Image: Sara Lardinois.

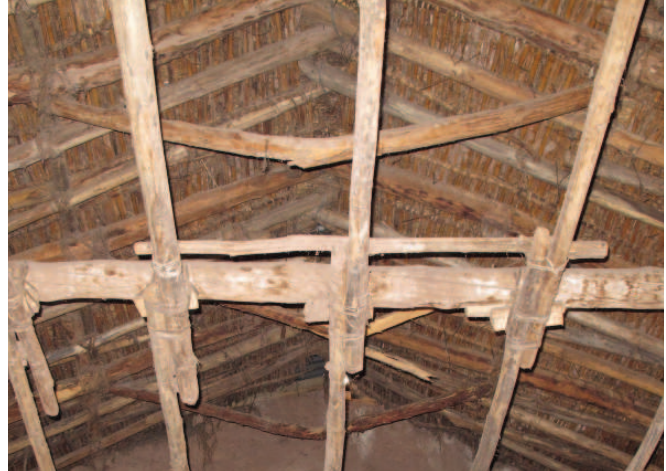
- As a result, a large percentage of the second floor ceiling joists and plaster finish has collapsed or been intentionally removed due to its poor condition.
- The gypsum plaster ceiling finish at the underside of the roof rafters in sector B5 and other second floor galleries and porches is in poor condition, with large areas of loss.
- In some cases, the depth of erosion at the top of the mud brick walls is so great that the ends of the roof rafters and tie beams are no longer supported by the walls.
- Wood rot and beetle damage were observed in some of the wall plates and wood framing.
- At several pares y nudillos trusses, the connection between the collar ties and rafters has failed, and the collar ties are deformed or broken (Fig. 6.48).
