Cathedral of Ica

4.1 Summary

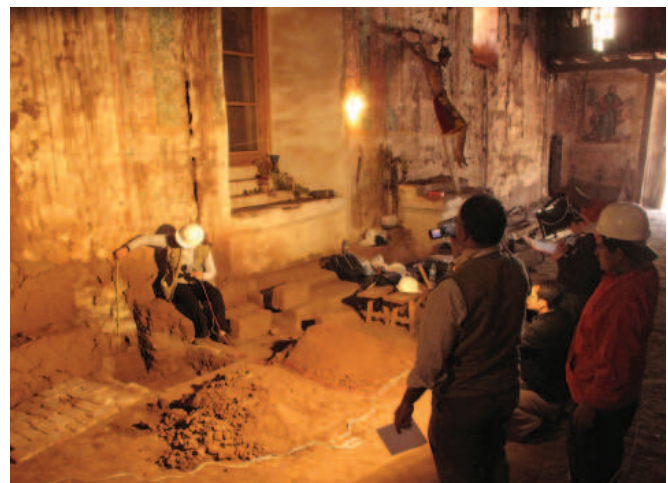
FIGURE 7.4
Prospection process: supervising architect narrating a video documenting what was discovered through a foundation prospection at the Church of Kufio Tambo.
Image: Claudia Cancino.
