**SEISMIC RETROFITTING PROJECT**  
The Earthen Architecture Initiative

Building: **KUÑO TAMBO CHURCH**  
Cusco, Perú

Sheet Title: **Structural Prospection**  
IS-1

**KT-P-1**

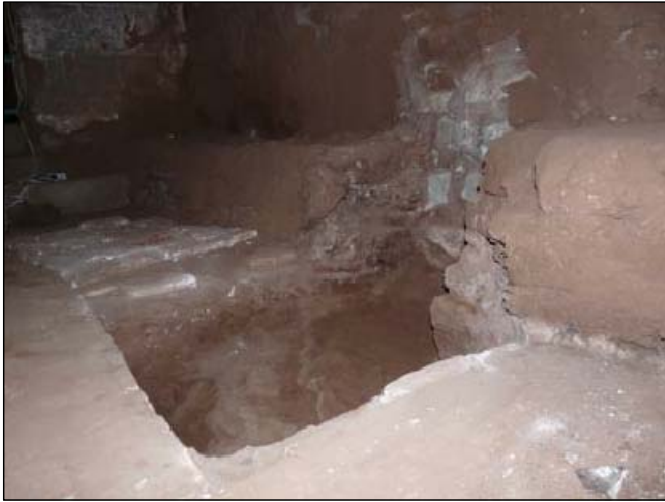
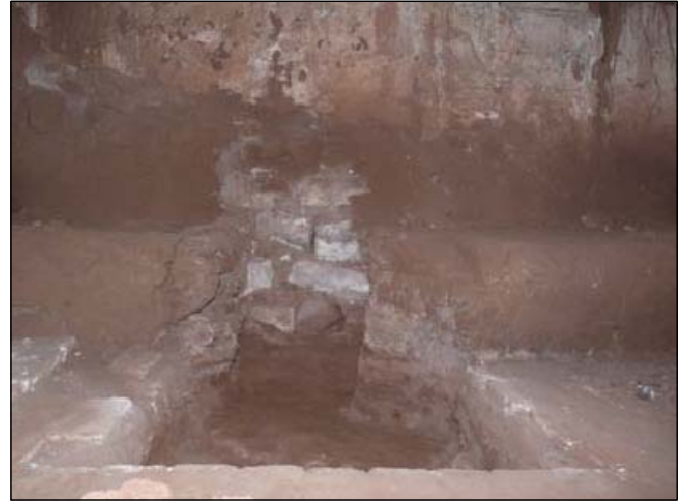
THE OBJETIVE OF OPENNING IS-1 IS TO IDENTIFY THE CHARACTERISTICS OF THE FOUNDATION. AFTER REMOVING THE BRICK FLOOR AND SOME COMPATED SOIL, AT A DEPTH OF 0.25 m WE FOUND ROCKY SOIL CORRESPONDING TO THE SLOPE OF THE HILL WHERE THE CHURCH IS SITUATED. TAKING ADVANTAGE OF THE PARTIAL LOSS OF THE BANQUETTE, WE WERE ABLE TO EXTEND THE OPENNING TO THE LATERAL WALL OF THE CHURCH AND SEE THAT ON TOP OF THE ROCKY BASE RESTS A "SOBRECIMIENTO" CONSISTING OF ANGLED STONES WITH A CLAY-RICH MORTAR TO A HEIGHT OF 1.20 m. ON TOP OF THIS "SOBRECIMIENTO" THERE IS THE ADOBE WALL. THE MUD BRICK BANQUETTE IS CONSTRUCTED ADJACENT, BUT NOT CONNECTED, TO THE WALL.

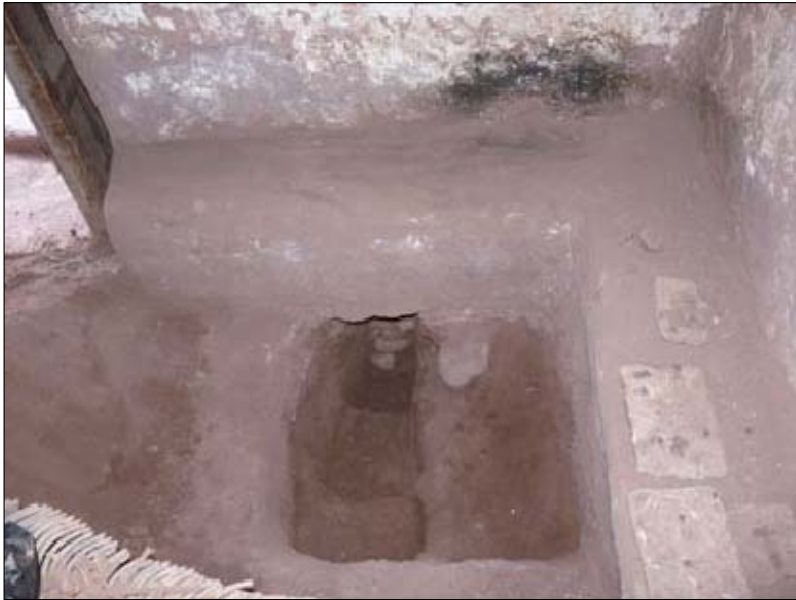
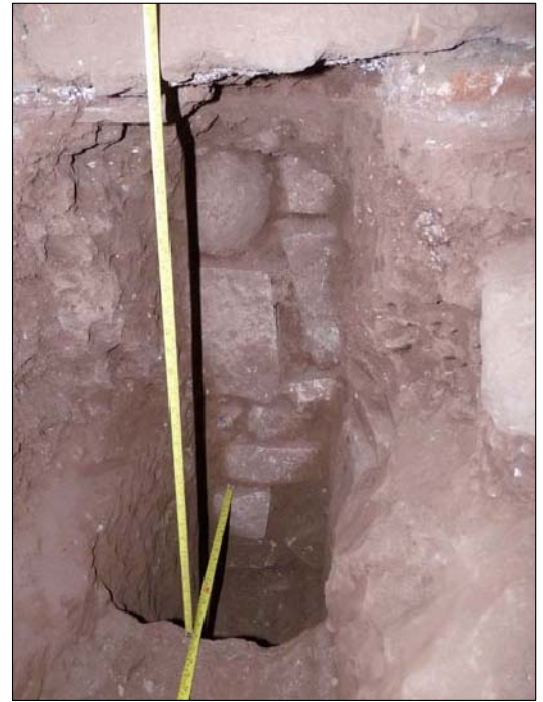
IS-3

THIS OPENING IS LOCATED AT THE FLOOR AT THE CORNER OF THE FRONT FAÇADE AND WEST LATERAL WALL, AND ITS OBJECTIVE IS TO IDENTIFY THE FOUNDATION CHARACTERISTICS IN THIS SECTOR. THERE IS AN "L"-SHAPED MUD BRICK BANQUETTE, 0.40 m HIGH BY 0.40 m WIDE, WHICH IS ADJACENT, BUT NOT CONNECTED, TO BOTH WALLS. UNLIKE PROSPECTION IS-1, THERE ARE NO BRICKS AT THE FLOOR, ONLY LOOSE EARTH. AT A DEPTH OF 0.50 m, HUMAN REMAINS WERE FOUND. BELOW THIS, THE SOIL IS MORE COMPACTED, AND THE COMPACTION INCREASED AS WE DESCENDED. BY EXTENDING THE OPENING UNDER THE MUD BRICK BANQUETTE ADJACENT TO THE MAIN FAÇADE, WE WERE ABLE TO SEE THE FOUNDATION. IT IS COMPOSED OF ANGLED STONES AND A CLAY MUD MORTAR, AND IT HAS A DEPTH OF 1.00 m AS MEASURED FROM THE FLOOR LEVEL IN THE CHURCH. UNDER THIS FOUNDATION THERE IS COMPACTED SOIL.

AS COMPARED TO PROSPECTION IS-1, THIS FOUNDATION IS DEEPER AND HAS A HIGHER LEVEL OF SOIL COMPACTION, WHICH WAS DIFFICULT TO EXCAVATE WITH THE TOOLS USED FOR THE INVESTIGATIONS. THEREFORE, WE CAN DEDUCE THAT THE CHURCH SITS ON A HILL, WITH THE HIGHEST PART IN THE ZONE OF THE ALTAR, WHICH HAS A ROCKY BASE (AS SEEN IN PROSPECTION IS-1); AND AT THE LOWER SLOPE OF THE HILL IS THE FACADE WALL, WHICH HAS A DEEPER FOUNDATION. THE LEVEL FLOOR INSIDE THE CHURCH WAS CREATED WITH A HIGHLY COMPACTED, CLAY-RICH SOIL.

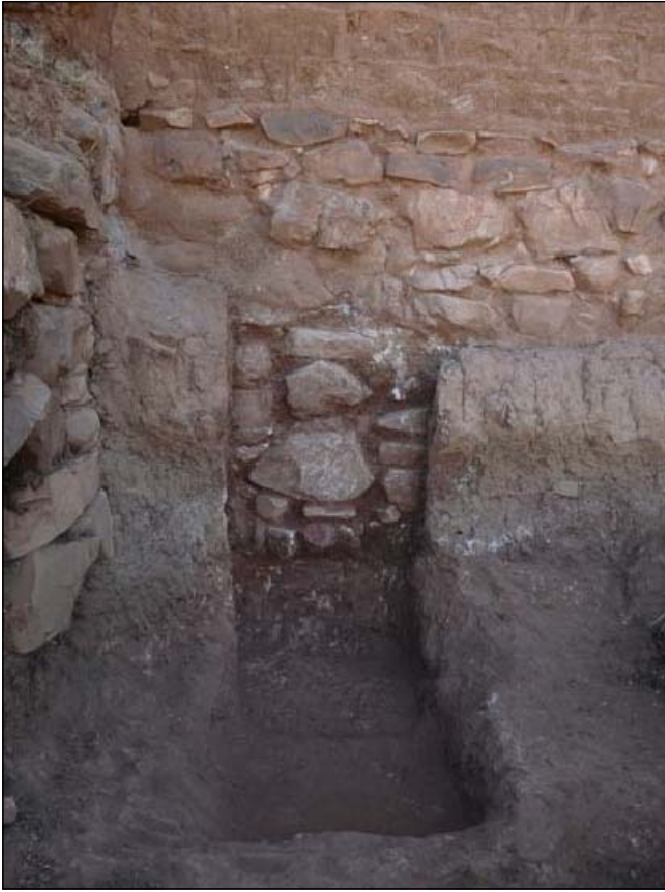
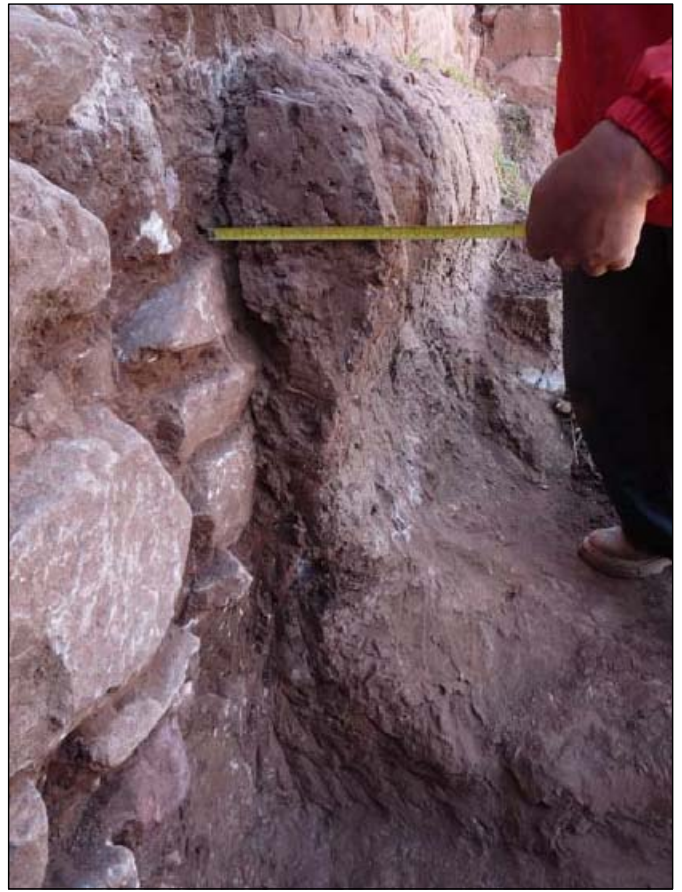
IS-2

THE OBJETIVE OF THIS OPENNING IS TO IDENTIFY THE CHARACTERISTICS OF THE BASE OF THE WALL. THE "SOBRECIMIENTO" CONSISTS OF ANGLED STONES WITH A CLAY-RICH MUD MORTAR TO A HEIGHT OF 1.80 m., AND IT RESTS ON A VERY HARD CLAY MATERIAL. OVER THE "SOBRECIMIENTO" IS THE ADOBE WALL. THE EXTERNAL FACE OF THE WALL IS PROTECTED BY A CLAY BASE OR PLINTH, WHICH IS 1.00 m HIGH AND 0.25 m THICK.

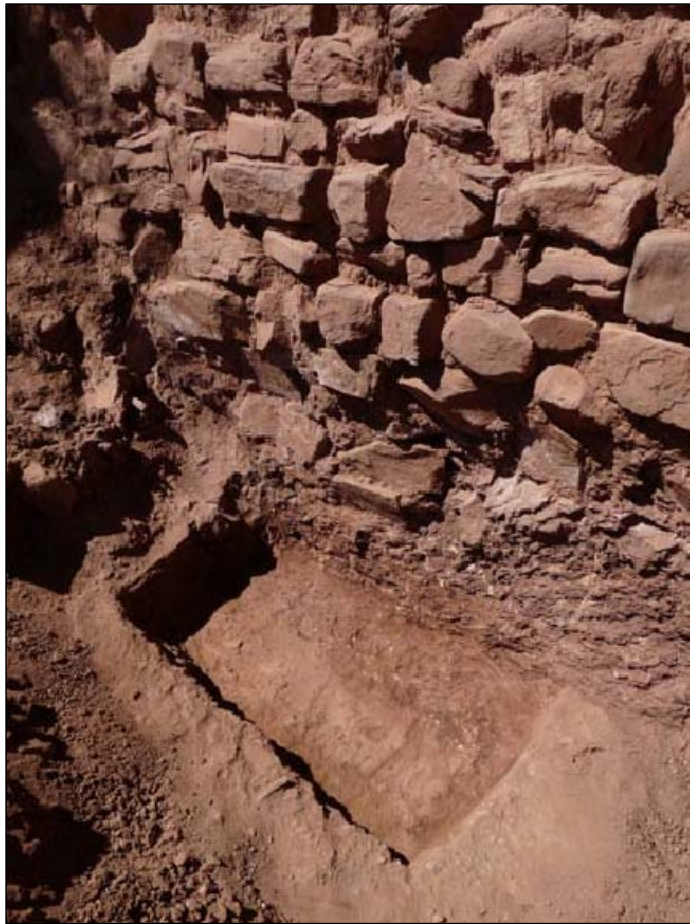
IW-5

THIS OPENING IS LOCATED AT THE EXTERIOR OF THE EAST LATERAL WALL. THERE IS A STONE "SOBRECIMIENTO" OR BASE COURSE BONDED WITH A MUD MORTAR TO A HEIGHT OF 1.65 m. UNDER IT THERE IS VERY HARD CLAY SOIL THAT PREVENTED US FROM DIGGING DEEPER.

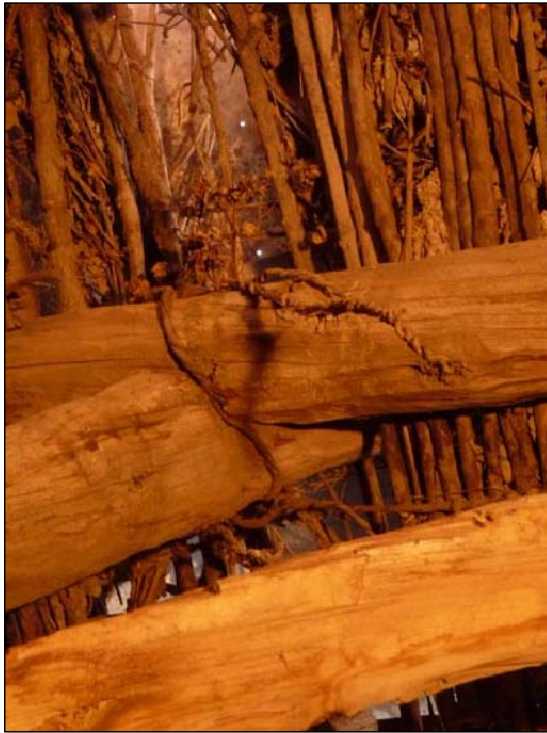
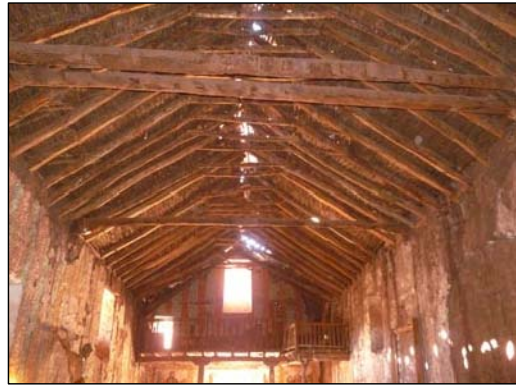
IR - 1

THIS ROOF DETAIL ILLUSTRATES THE HIGHEST PART OF THE "PAR Y NUDILLO"-TRUSSED ROOF. THE RAFTERS ARE JOINED BY HALF LAP CUTS AND ARE TIED TOGETHER WITH LEATHER STRAPS AND WROUGHT IRON NAILS. THE RAFTERS ARE MADE OF WOOD FROM THE WILLOW TREE AND ARE 8" (0.20 m) IN DIAMETER. AT THE TOP IS A RIDGE BEAM.

IT IS IMPORTANT TO MENTION THERE IS NO TRANSVERSE BRACING, EXCEPT FOR THE WOOD WALL PLATE, THE "KUR KUR" CANES, AND THE RIDGE BEAM.

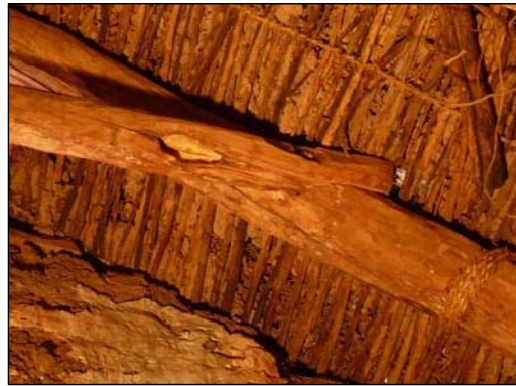
COLLAR TIE AND RAFTER JOINT

THE COLLAR TIE IS NAILED AND STRAPPED WITH LEATHER, SIMILAR TO THE RAFTERS, BUT IT IS NOT JOINED BY HALF LAP CUTS.

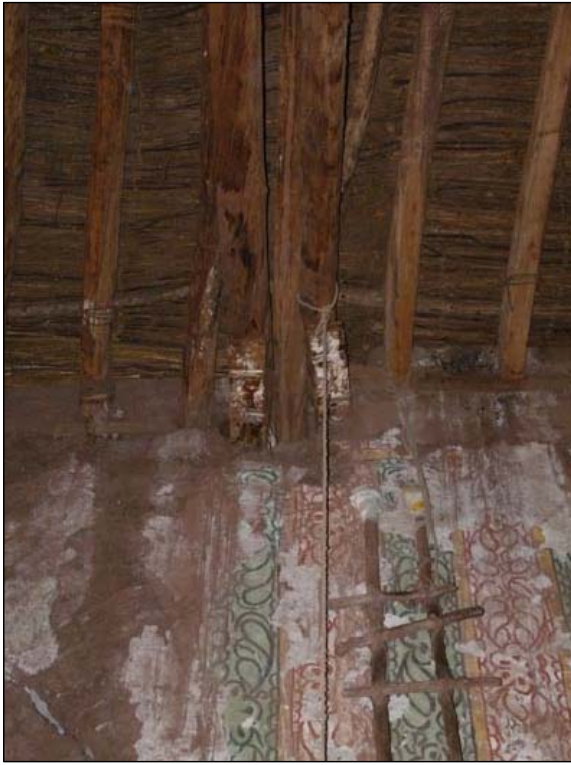
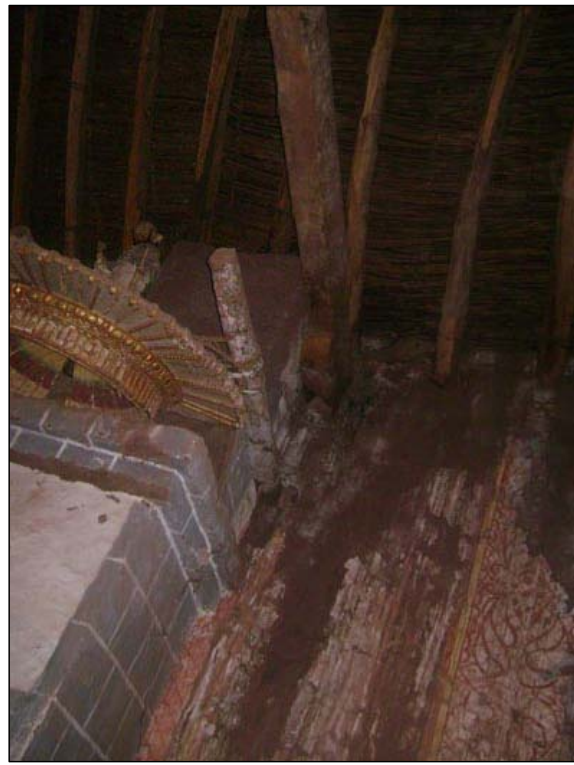
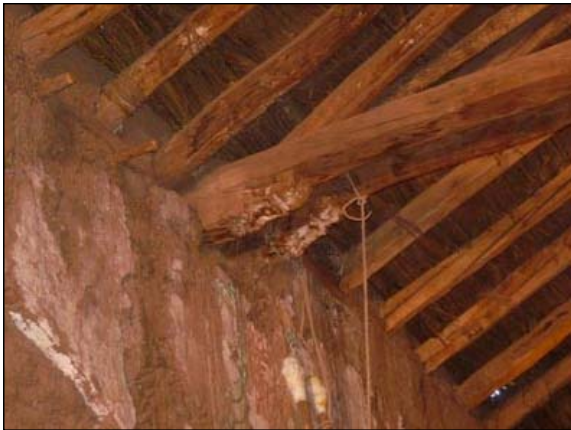
IR-2

THIS STRUCTURAL DETAIL SHOWS THE CONNECTION BETWEEN THE EAST AND WEST LATERAL WALLS AND THE "PAR Y NUDILLO" TRUSSES. ON TOP OF THE ADOBE WALLS THERE ARE PIECES OF WOOD (WALL PLATES), NEITHER CONTINUOUS NOR TIED TOGETHER, WITH HORIZONTAL AND VERTICAL GAPS BETWEEN THEM. THUS, THEY ARE NOT REALLY BOND BEAMS - THEIR ONLY FUNCTION IS TO SUPPORT THE ENDS OF THE ROOF RAFTERS. THE ENDS OF THE RAFTERS HAVE A 90 DEGREE CUT, ALLOWING THEM TO REST ON THE WALL PLATES. THE ROOF IS FRAMED WITH "PAR Y NUDILLO" (RAFTER AND COLLER TIE) TRUSSES. THERE IS EVIDENCE OF RECENT INTERVENTIONS AT THE ROOF. ORIGINALLY, THE ROOF OVER THE ALTAR SHOULD HAVE BEEN HIGHER TO ACCOMMODATE A TRIUMPHAL ARCH BETWEEN THE NAVE AND PRESBYTERY / ALTAR. THE ROOF HAS SINCE BEEN RECONSTRUCTED AT A LOWER LEVEL, GIVING IT THE SAME HEIGHT AS THE REST OF THE NAVE. THIS WAS MADE POSSIBLE BY THE DESTRUCTION OF THE UPPER PART OF THE TRIUMPHAL ARCH, ORIGINALLY CONSTRUCTED OUT OF QUINCHA, AND ITS WALL PAINTINGS DEPICTING STONE MASONRY VOUSOIRS. PAIRS OF TIE BEAMS RUN TRANSVERSALLY ACCROSS THE NAVE. THEY ARE EMBEDDED APPROXIMATELY 0.60 m INTO TO THE EAST AND WEST WALLS AND ARE SUPPORTED BY CORBELS PROJECTING 0.40 m INTO THE NAVE. IN THE SPACE BETWEEN EACH PAIR OF TIE BEAMS, THERE IS AN INCLINED RAFTER WHICH RESTS DIRECTLY ON THE ADOBE WALL.

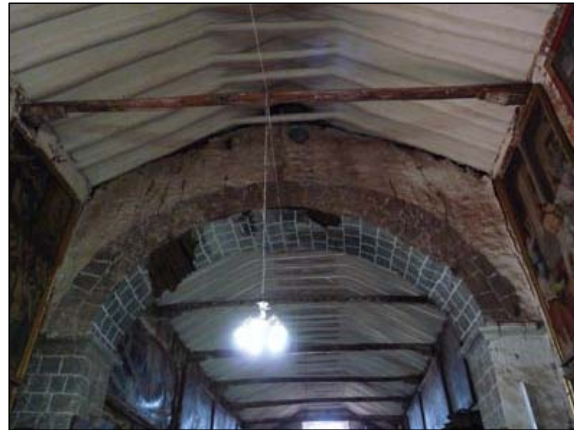
TRIUMPHAL ARCH AT THE CHURCH OF RONDOCAN, WITH THE SAME CHARACTERISTICS OF THE TRIUMPHAL ARCH THAT IS MISSING IN THE CHURCH OF KUÑO TAMBO

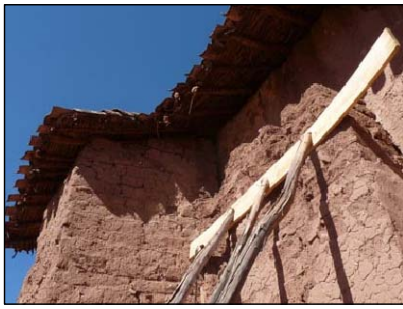
IW-2

IN THIS SECTOR THERE ARE TWO BUTTRESSES CONSTRUCTED OVER A STONE MASONRY AND MUD MORTAR BASE. ONE OF THESE IS CONNECTED TO THE EAST WALL. THE OTHER ONE IS NOT CONNECTED TO THE EAST WALL - IT IS JUST CONSTRUCTED ADJACENT TO IT. THE STONE BASE AT THIS SECOND BUTTRESSES IS DETERIORATING AND LACKS STABILITY.

NEXT TO THESE BUTTRESSES IS AN OPENNING WHICH HAD BEEN COVERED WITH AN ADOBE WALL. CURRENTLY THIS WALL IS UNSTABLE AND EXHIBITS VERTICAL DISPLACEMENT, AND AS A RESULT IT HAS BEEN SHORED UP.

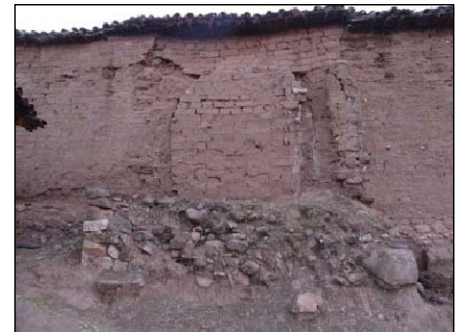
IW-9

THIS OPENNING IS LOCATED AT THE SECOND BUTTRESSES NEXT TO THE INFILLED LATERAL DOOR OPENING ON THE WEST WALL. IT HAS TOTALLY COLLAPSED, WITH ONLY THE STONE BASE REMAINING. THIS GIVES AN INDICATION OF HOW THE REMAINING BUTTRESSES WILL CONTINUE TO DETERIORATE IN THE FUTURE IF THEY ARE NOT MAINTAINED.

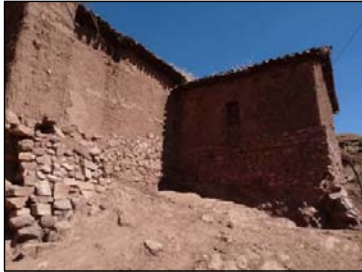
IW-6

THIS OPENNING IS LOCATED IN BETWEEN THE EAST LATERAL WALL AND SACRISTY WALL. THESE WALLS ARE CONNECTED, PROVIDING BRACING FOR THE CHURCH WALLS.

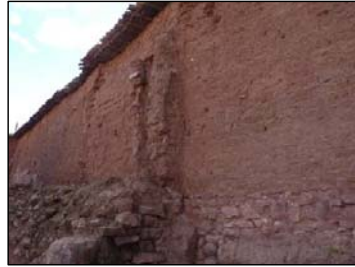
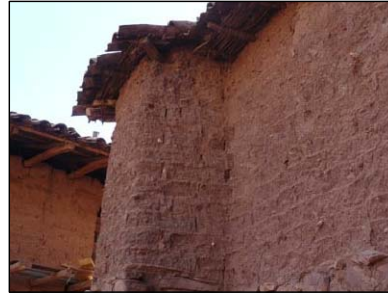
IW-7

THIS OPENNING IS LOCATED AT THE INTERSECTION OF THE WEST AND NORTH WALLS. ONE CAN SEE THAT THE BUTTRESSES AND WALLS ARE CONNECTED. IT IS IMPORTANT TO MENTION THAT THIS BUTTRESSES IS IN GOOD CONDITION, AS COMPARED TO THE OTHERS.

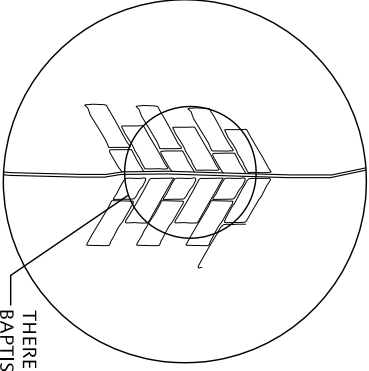
THERE IS NO CONNECTION BETWEEN THE BAPTISTERY AND THE CHURCH WALL

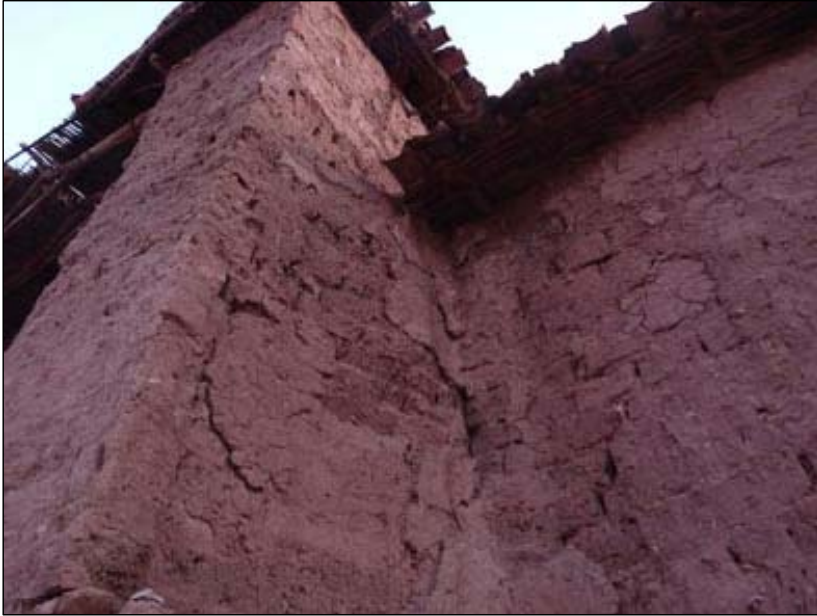
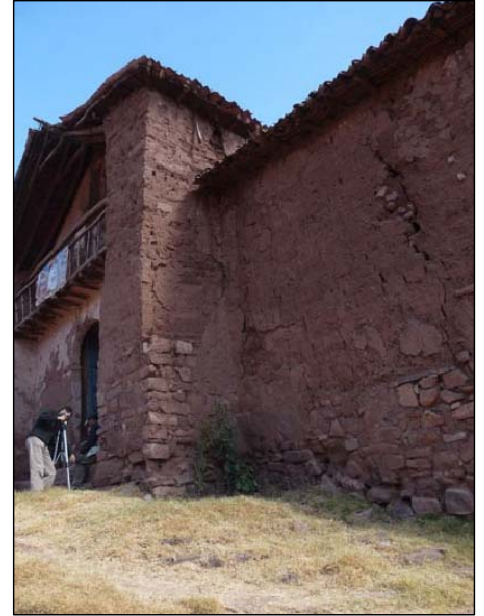
IW-10

THIS OPENNING IS LOCATED IN BETWEEN THE BAPTISTERY AND FRONT FAÇADE WALLS AND SHOWS THE LACK OF CONNECTION BETWEEN THOSE ELEMENTS. IT CONFIRMS THAT THE BAPTISTERY IS CONSTRUCTED ADJACENT TO THE CHURCH.
