Proposals for Future Conservation Actions

Testing of Stone and Masonry Conservation Techniques and Materials

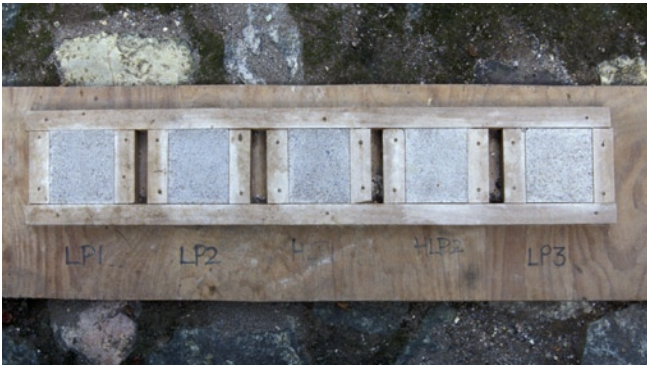
The samples left on site, both under the shelter and exposed at the top of the Stairway, have been visually assessed on a regular basis since 2001 (**Figs. 101, 102**). After two years, both sets of mortars were found to be in good condition, with no loss and no internal shrinkage cracks—just space between the wooden mold and the edge of the mortar samples due to shrinkage of the wood. The samples left under the shelter showed no change after two years. The exposed samples exhibit slightly eroded, rough surfaces due to rainwater erosion, and one sample has black algae on its surface.

Figure 101 Lime-based mortar trial samples made in December 2001, shown after two and a half years of sheltered exposure on the Stairway. August 2004.

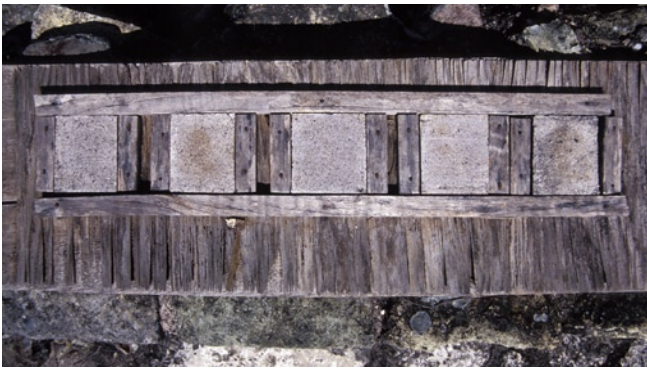
Figure 102 Lime-based mortar trial samples made in December 2001, shown after three years of unsheltered exposure at the top of the Stairway. December 2004.

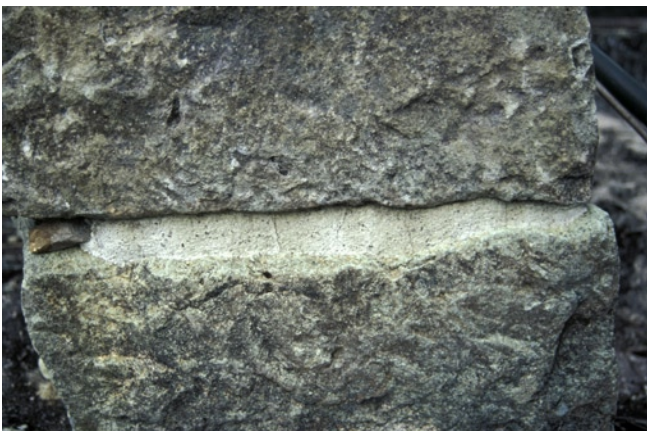
Four additional mortar mixes were prepared in February 2005 to test the addition of pumice from Guatemala as a pozzolanic additive, as well as the use of additional Honduran limes (1992 Chiquilas lime putty and 2002 Chiquilas lime putty) and sands (INDECO Chamelecón sand). These four mixes were placed in wooden molds and left under the tarp. The mortar mix with the added pumice was also placed between two nonsculpted stones from the pile next to the Stairway environmental monitoring station. A year later, the exposed repointing mortar trial with pumice is in good condition, despite the presence of a vertical crack, which formed immediately after placement, and areas of slight erosion from rainwater (**Fig. 105**). The sample of the same mix left under the shelter was unchanged, but the surface of the three other mortar samples had become rough, in contrast to the still-smooth surface of the pumice admixture mortar. Given the protection of the shelter, the apparent erosion of these three samples is difficult to explain.

Figure 103 Lime-based mortar mix with added pumice, made in February 2005, shown after ten months of unsheltered exposure at the top of the Stairway. December 2005.

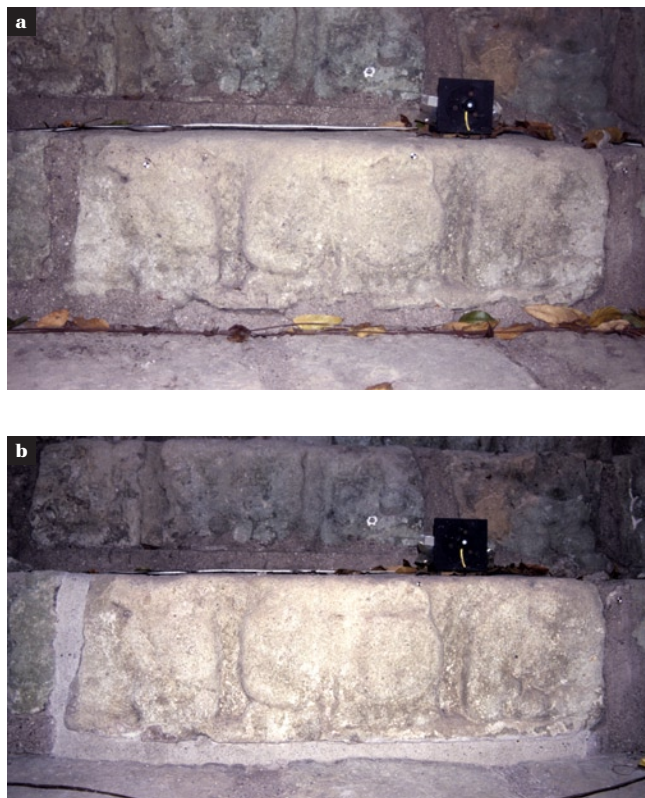
More than two years later, the two repointing mortar tests of blocks 406–407 and 488 were in good, unchanged condition. Either of these mortars, made with locally available materials and without any synthetic additives, could be used on the Stairway with adequate results, both functionally and aesthetically.

Figures 105a and b Treatment trial block 488, step 52, before (a) and after (b) mortar removal and repointing.

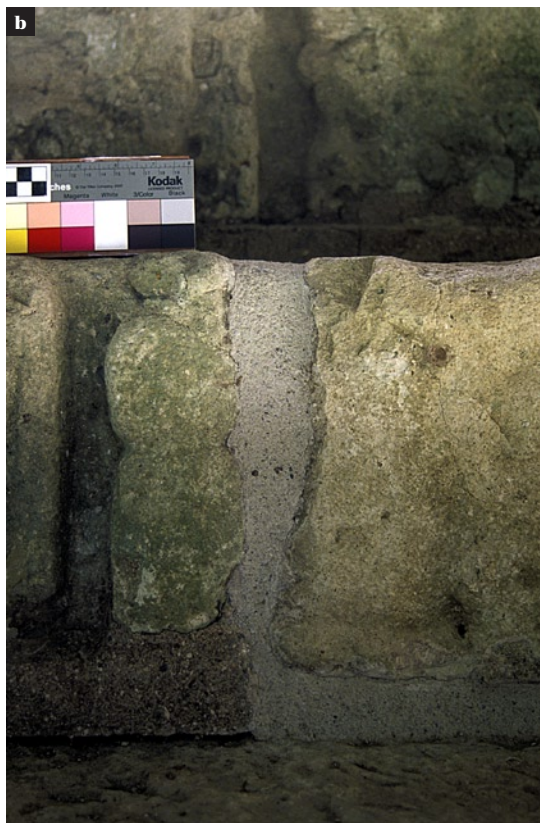
Figures 106a and b Comparison of two trial mortars for repointing: for block 406, step 43, the mortar was chosen to match the existing joint mortar (a); for block 488, step 52, the mortar was chosen to blend in with the variety of block colors (b).

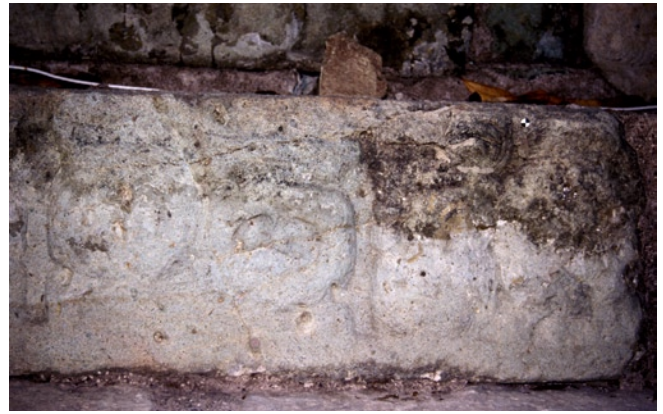
Figure 107 Treatment trial block 463, step 50, glyphs F and G, shown after the cleaning of glyph F (on the left) with water and a light toothbrushing; glyph G (on the right) has not been cleaned.

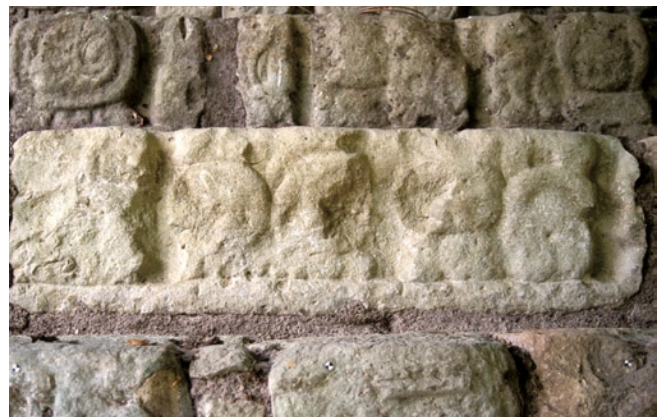
Figure 108 Treatment trial block 197, step 23, shown after cleaning with water and a light toothbrushing.

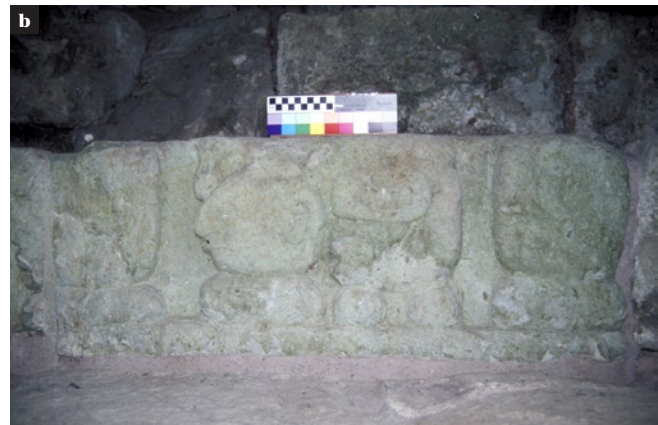
Figures 114a and b Treatment trial block 407, step 43, before (a) and after (b) treatment. There is an improvement in readability of surfaces after reduction of darkened consolidant from previous treatments and stabilization with edging repairs and with fills of lime-based mortars, colored with pigments to match the stone.

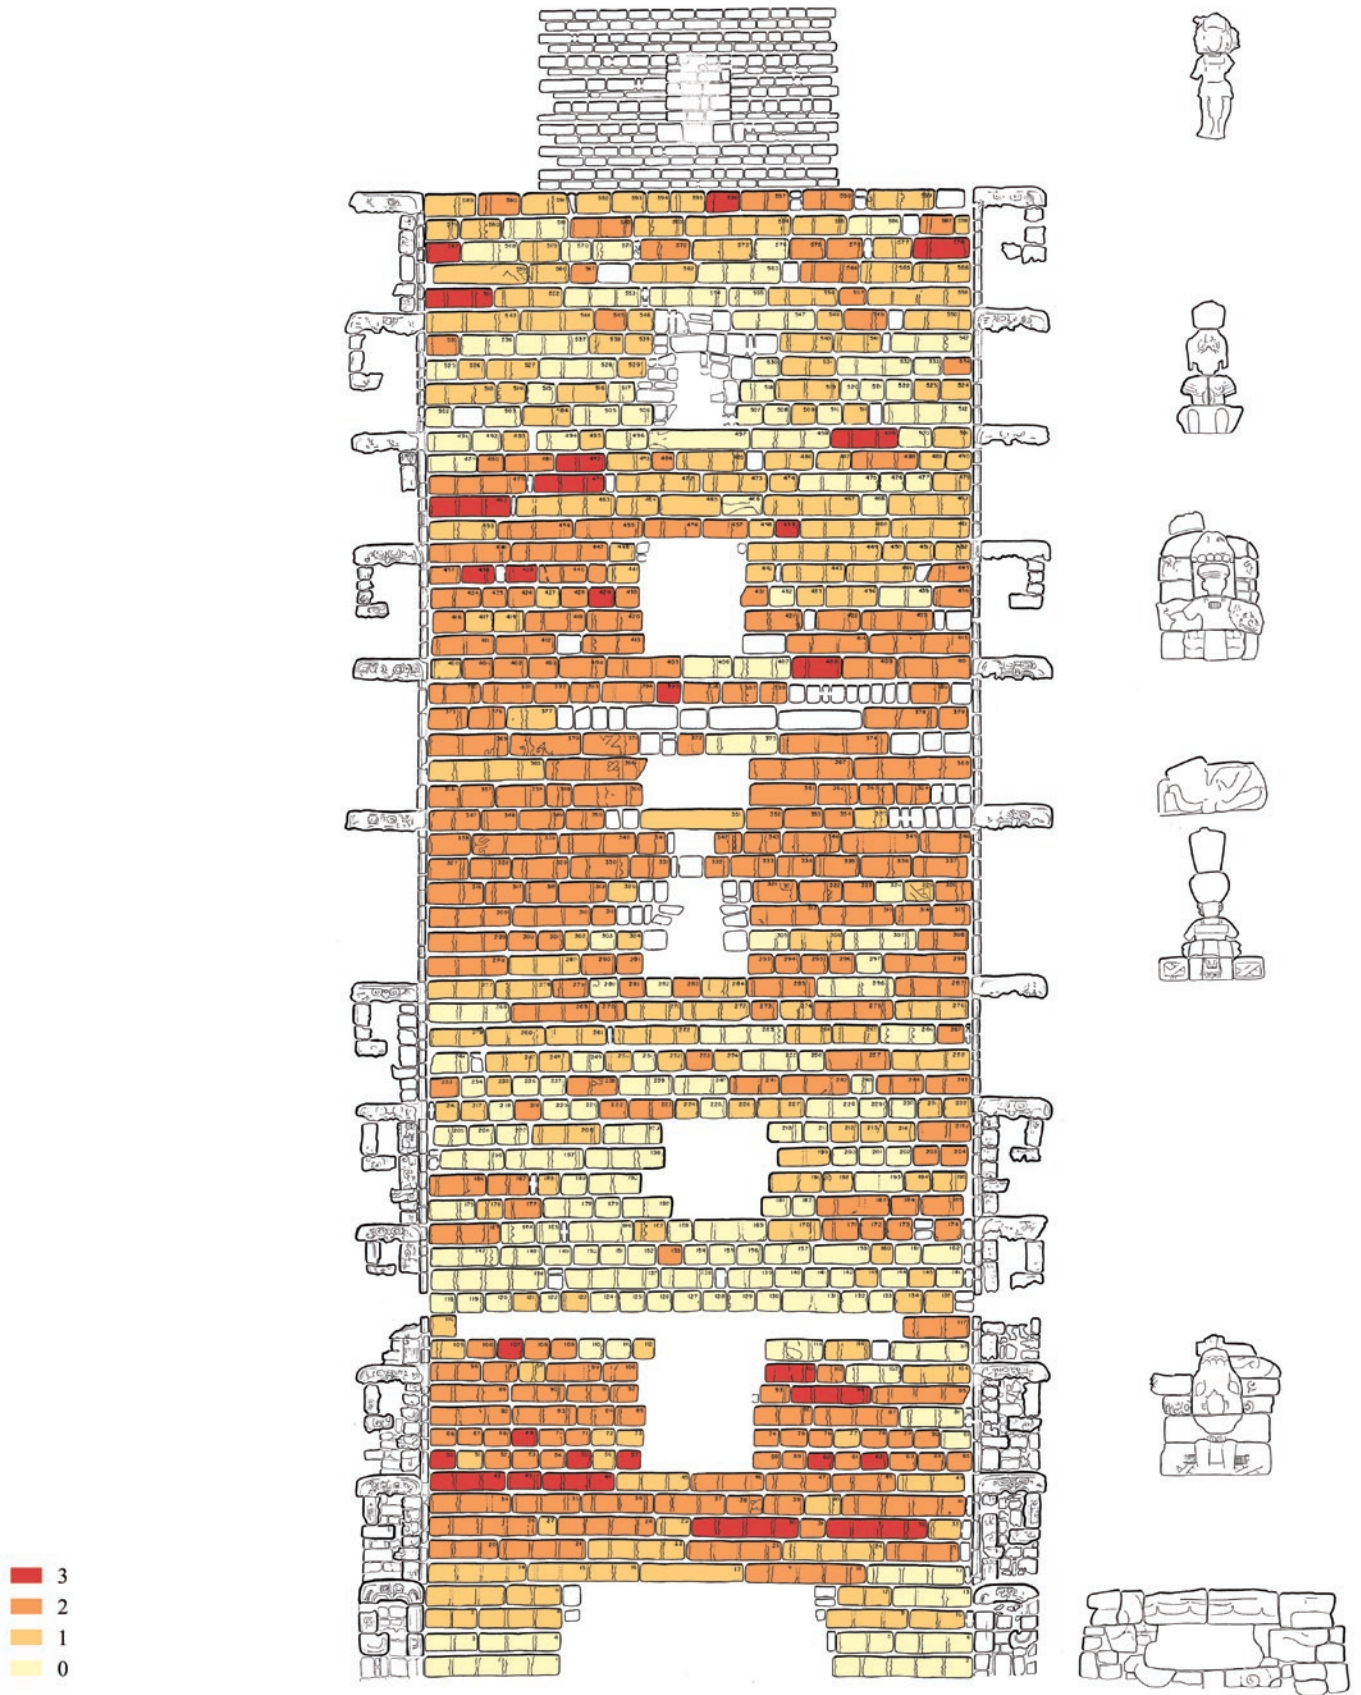
Figure 117 The extent of Stairway riser surfaces that have undergone surface consolidation treatments in the past. Treatment levels of individual blocks are designated on a scale from 0 to 3, with 3 indicating the greatest level of treatment.

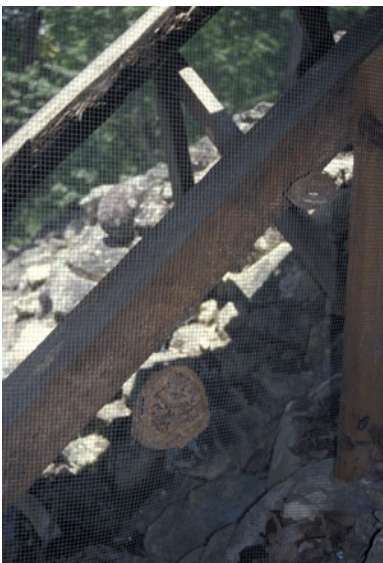
Figure 120 Metal screening leaf barrier to the north of the Stairway, with wasp's nest.

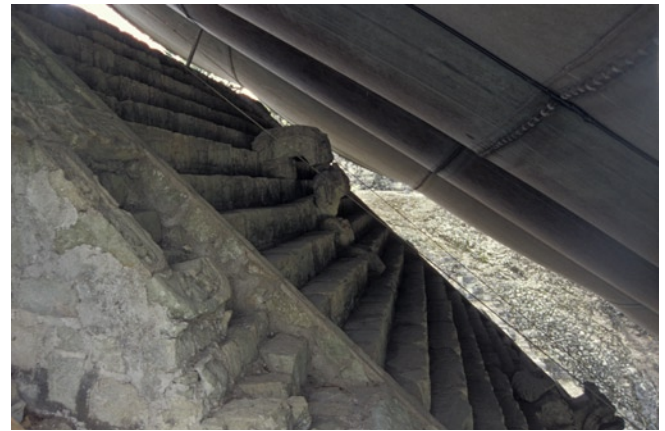
Figure 130 Shelter in 2000; note the proximity of the tarpaulin to the top of the Stairway.

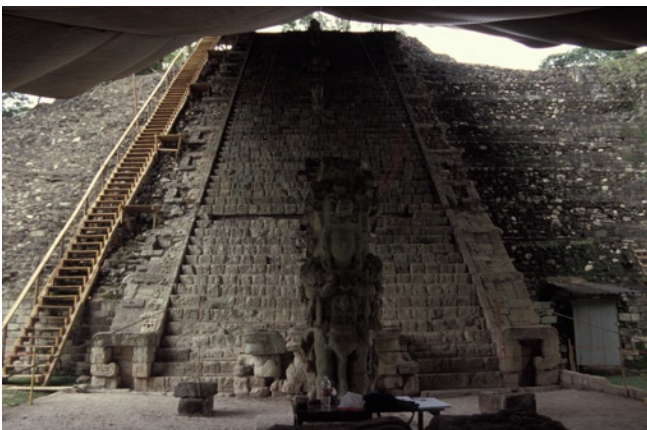
Figure 133 View from the Plaza, as the public sees the Hieroglyphic Stairway. The visibility of the upper portion is poor because of the contrast between the bright sky and the dimly lit upper part of the Stairway.

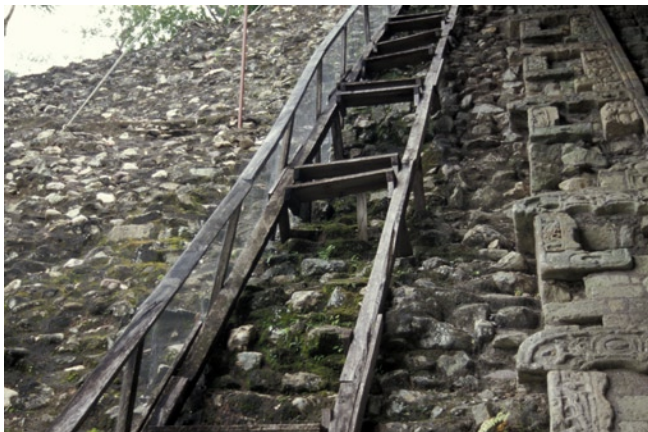
Figure 155 Area of increased biological growth near the Stairway, where rainwater flows toward it.

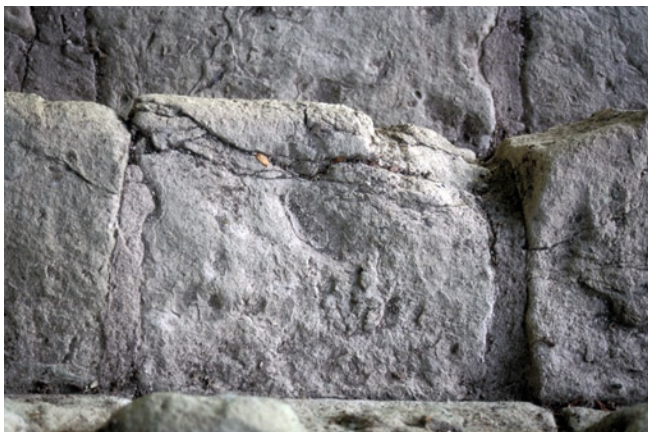
Figure 140 An in situ block (step 10, block 55) tread surface seen from above; the parallel cracks are behind the carved block face.

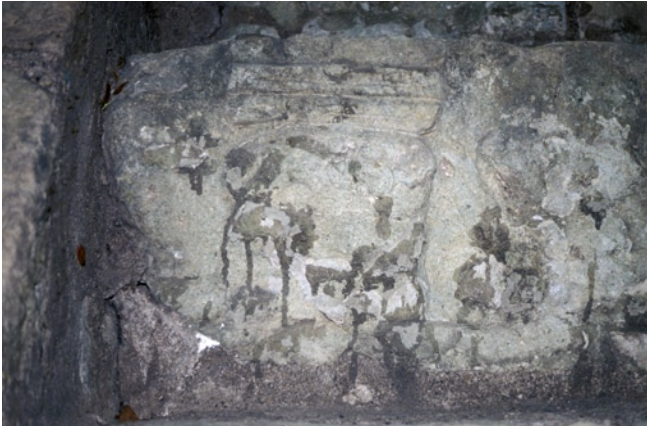
Figure 141 Glyph A, block 515, step 55, with darkened surfaces caused by previous consolidation treatments.

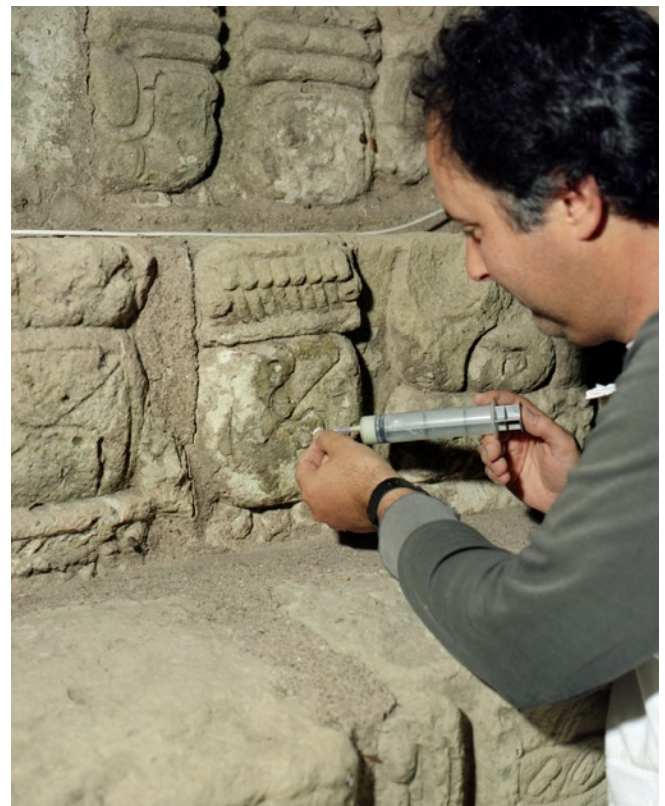
Figure 144 The microgrouting of a flaking surface of treatment trial block 578, step 61.

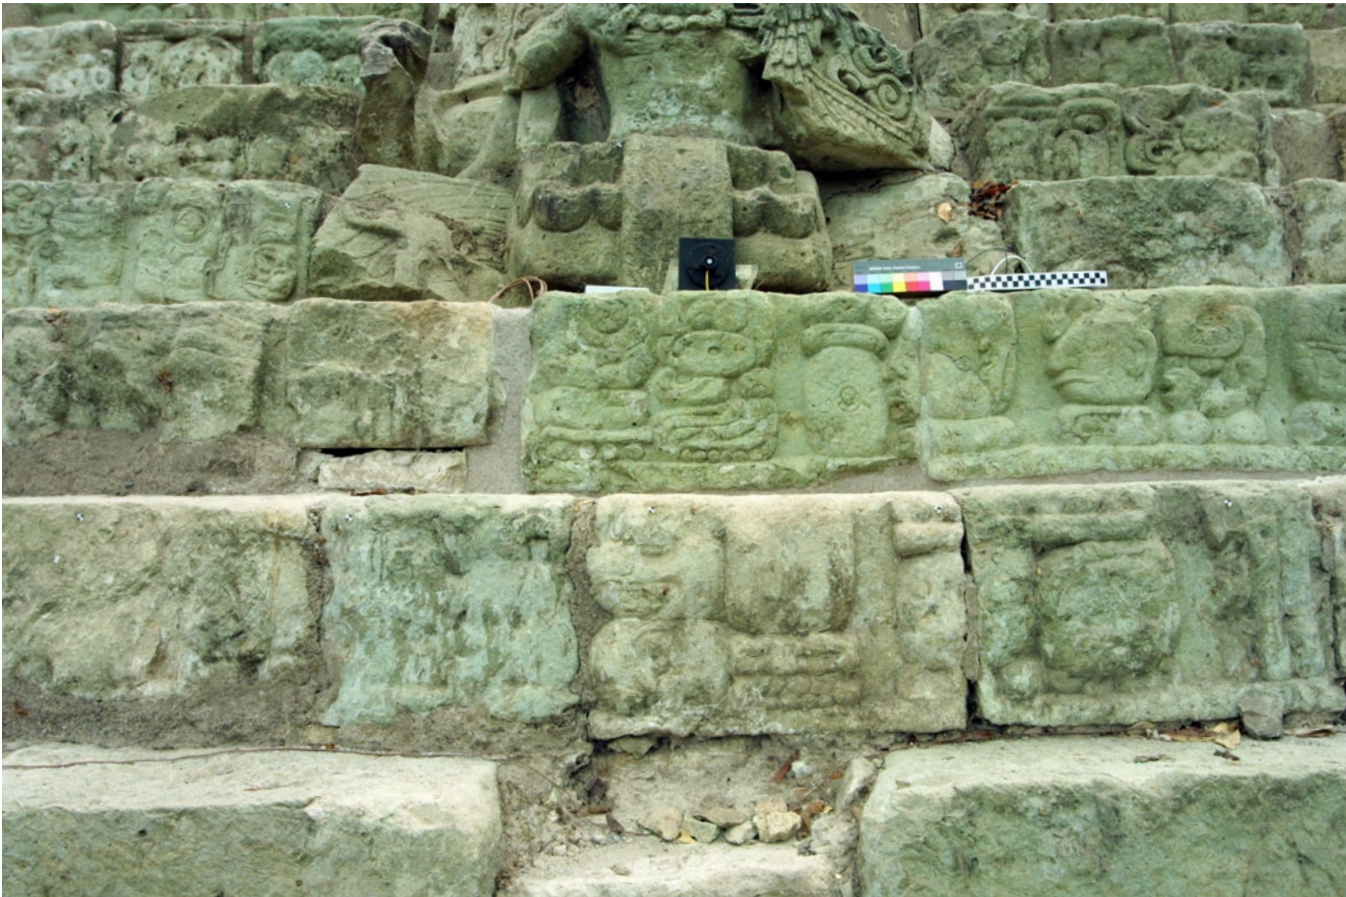
Figure 145 A view of step 42, in the foreground, shows missing repointing mortar (right) and previous repointing, where mortar covers edges of the blocks (left).

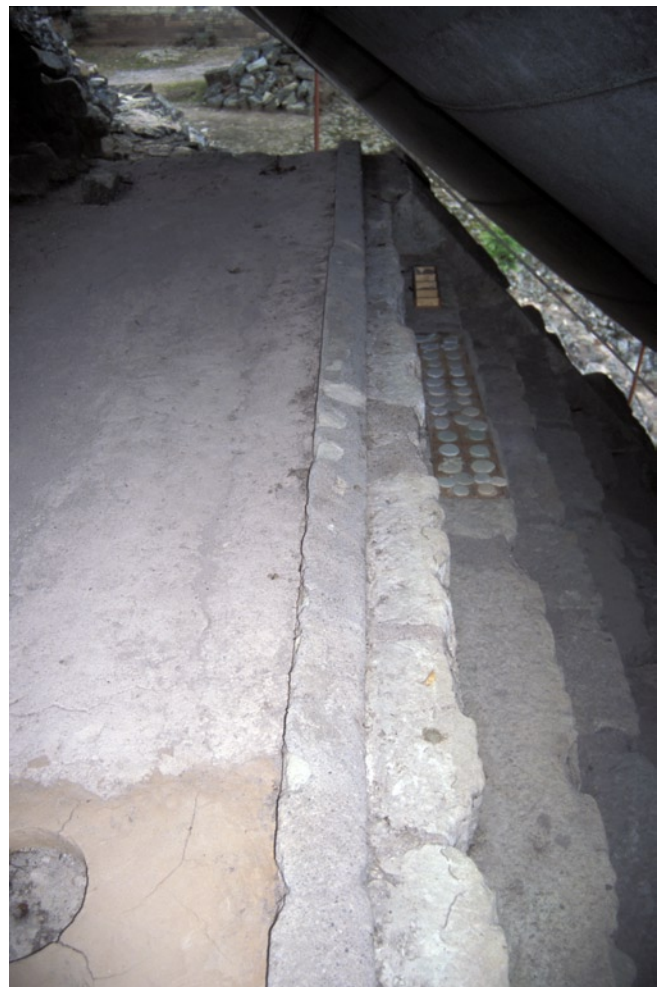
Figure 147 View of the mortar platform and cement lip above the last step of the reconstructed Stairway, looking south.
