# Appendix A: Identification System for Blocks and Glyphs of the Hieroglyphic Stairway

# Appendix C: Photographic Documentation of Stairway Blocks Chosen for Condition Monitoring

# Appendix D: Illustrated Glossary of Stairway Stone Conditions

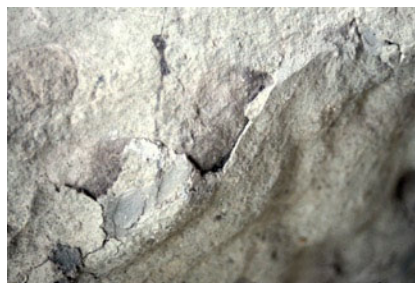
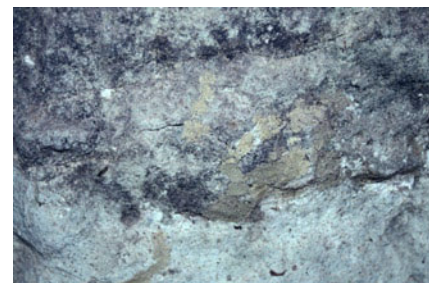
### **Detachment**

Intact surface section of stone separated from the underlying substrate, a condition that can be detected by tapping the surface and listening for a hollow sound. Detachments can be blind (no visual sign of their presence) or open.

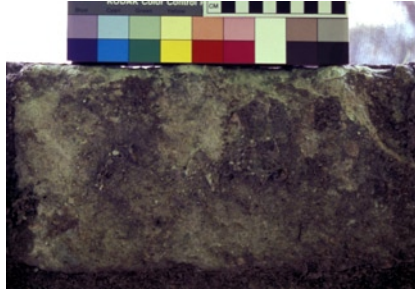
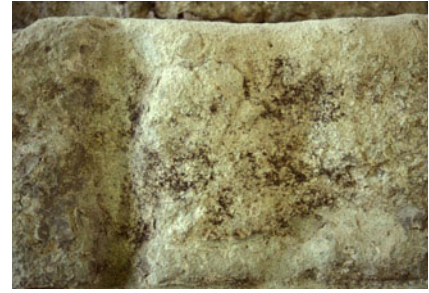
### Disaggregation

Loss of cohesion of stone surface, which has disintegrated into powder or small particles.

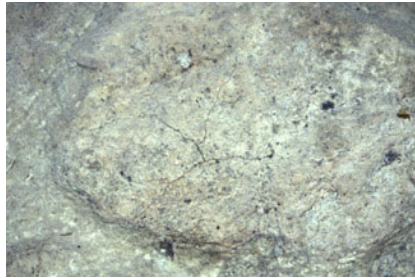
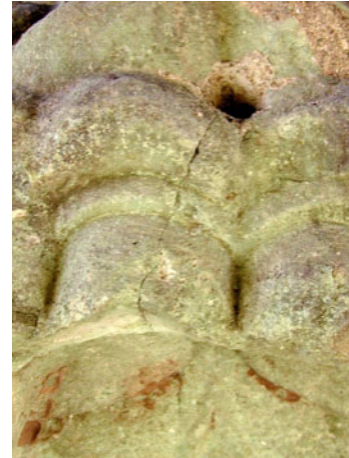
### Fissure

Fine linear break (crack) of the stone surface.

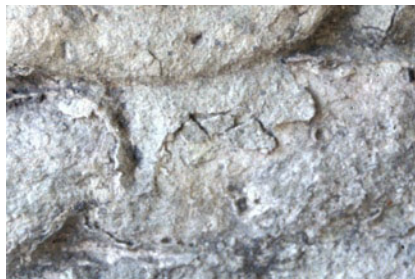
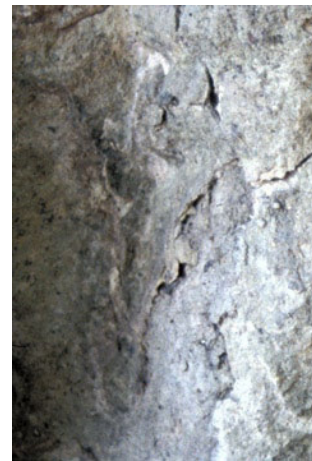
### Flaking

Total or partial detachment of small, flat, thin stone elements (flakes) of irregular form or thickness, following the profile of the stone surface.

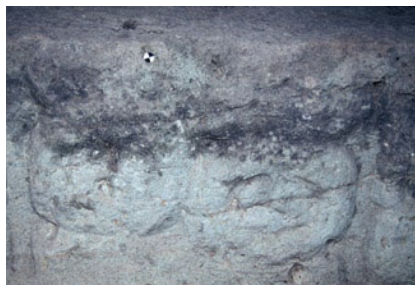
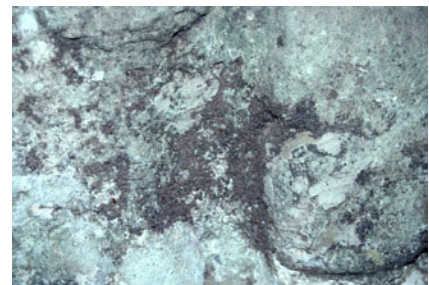
### Microbiological organisms

Colonization by fungi, algae, lichens, mosses, and/or bacteria.

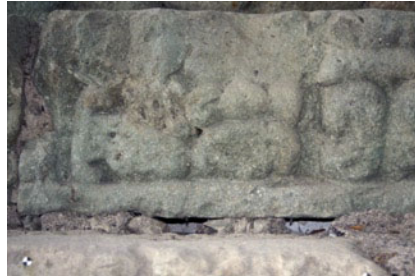
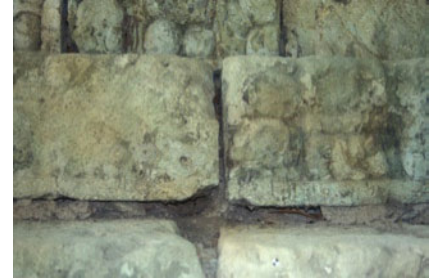
**Mortar loss**

Area where the pointing mortar is missing.

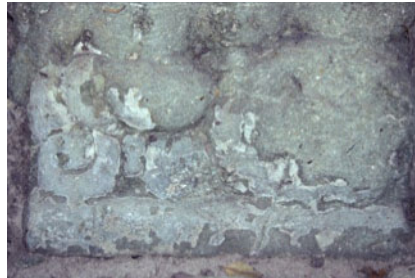
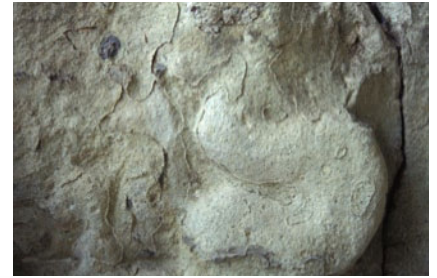
**Superficial loss**

Area where stone surface is missing, as compared to the remaining outermost surface of a stone block (not to the conjectural original surface).

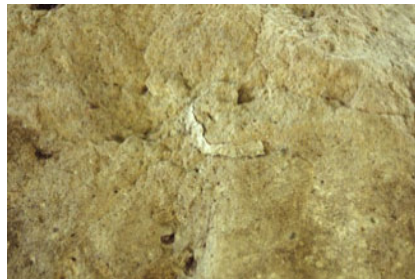
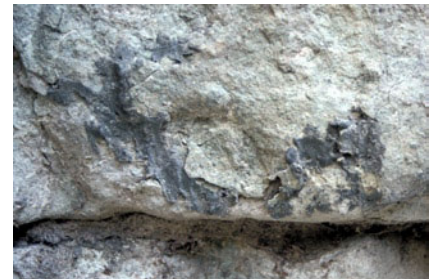
**Fill/edging repair**

Stabilization treatment done to fill areas of loss or edges of flakes with a binder-aggregate mixture.

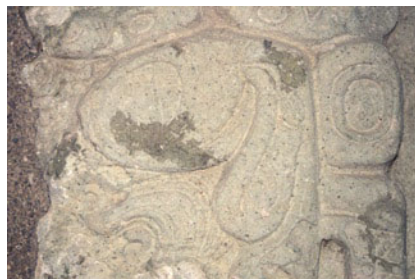
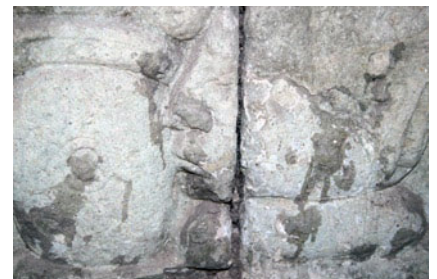
**Surface consolidation**

Stabilization treatment of the stone surface with a liquid binding material.
