# 山门 状况评估

## Shanmen Condition Assessment

Shanmen, or the gatehouse, is a simple rectangular structure, three bays wide and one bay deep. The gatehouse has surviving painted polychrome decoration on both exterior and interior architectural wooden surfaces.

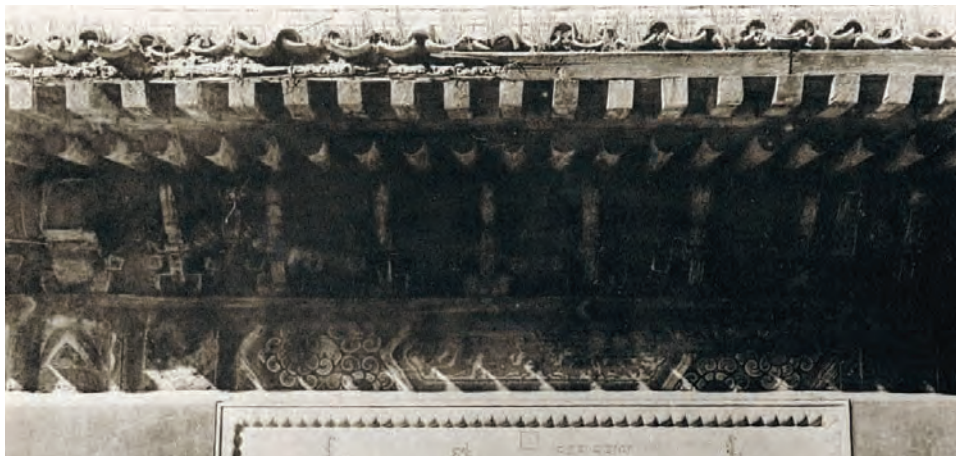
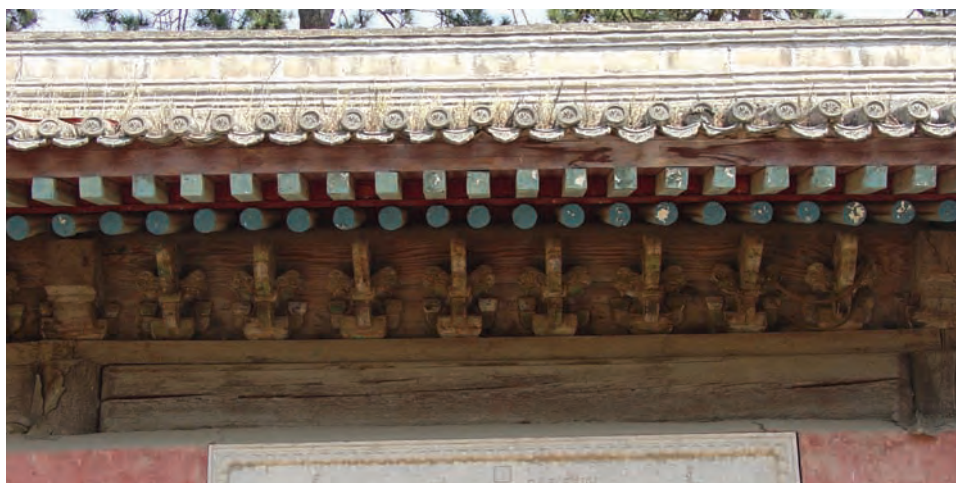
1933年关野贞所摄照片，及2004年5月南立面明间相同位置。彩画几乎全部脱落，屋顶结构全部更换过。

1933 Sekino photograph, of the gatehouse, south facade, center bay, and the same area in May 2004. Almost total loss of the painting has occurred and complete replacement of the roof structure.

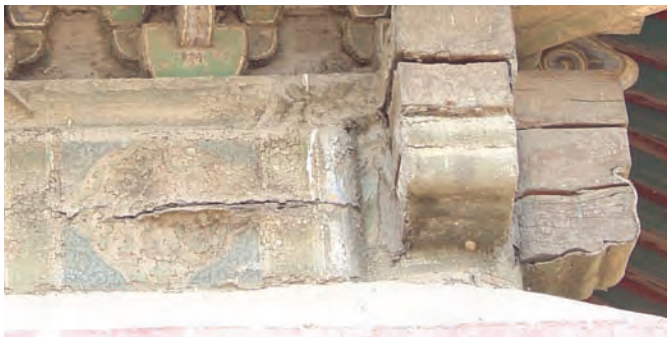
彩画上的水平裂缝。

Horizontal cracking of the painting.

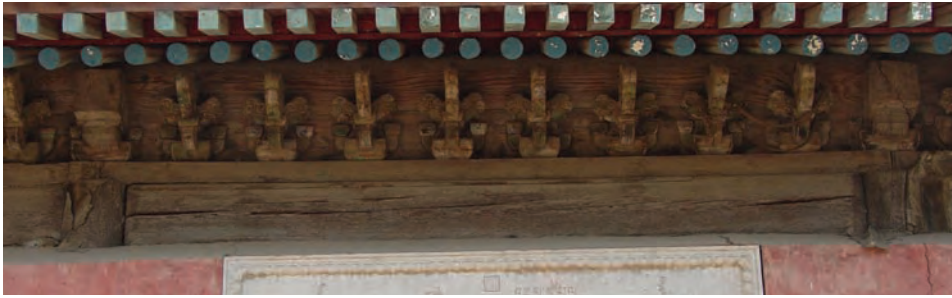
明间额枋上的彩画完全脱落，木质表面有水平裂缝。

Horizontal cracking on main architrave beam in the center bay where all of the painting has been lost.

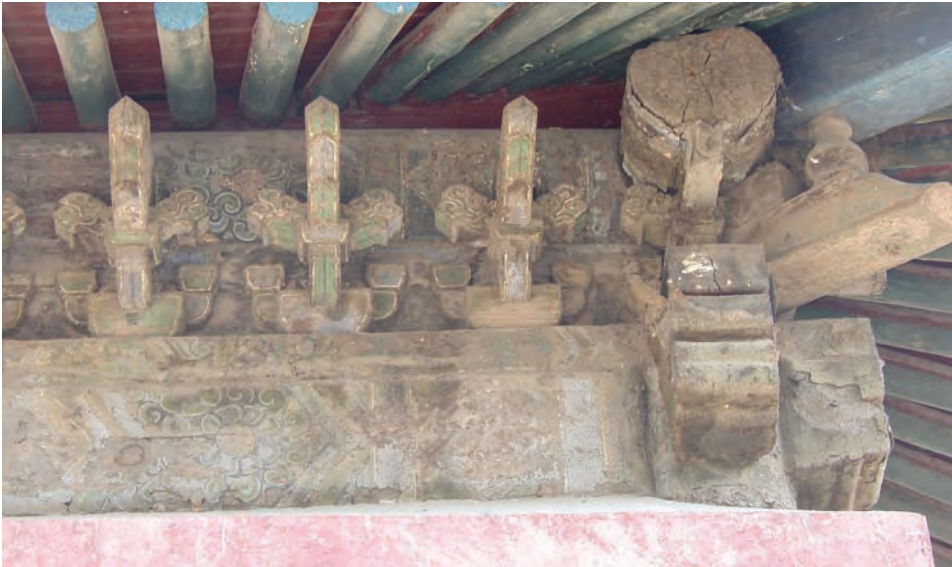
东尽间东部彩画保存最完好。彩画表层有污迹和风化现象。

Section of the east bay showing best preserved area of painting. Note still the staining and weathered condition of the painting.

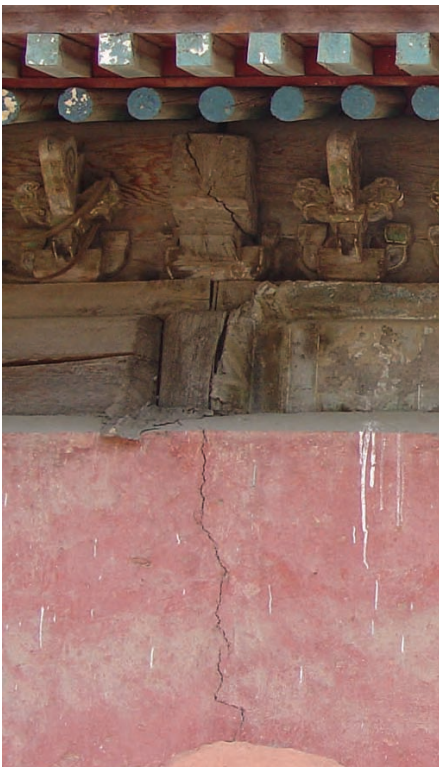
南立面檐柱上的纵向裂缝，从木材直延伸到墙面抹灰，造成该部位画层的脱落。

Vertical crack on column of south facade extends from the wood column down to the wall plaster and contributed to the loss of painting in this area.

明间东侧檐柱上的纵向裂缝从木构件一直延伸到墙面抹灰，可能是造成此处彩画脱落的原因。

Vertical crack on column between center and east bay extends from the wooden elements to the wall plaster and most likely contributed to the loss of painting in this area.

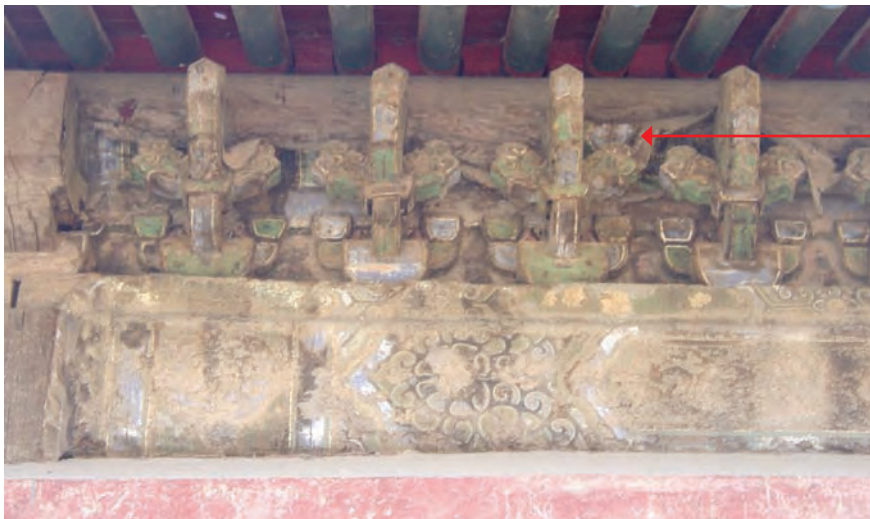
北墙彩画细部。挑檐檩上彩画大部分已经脱落。这里可见一小部分已剥离的彩画，被下面的斗拱挡住。

Details of painting on north facade. Most of the painted plaster on the purlin is lost. Here a small piece is detached and falling, supported in place by the brackets.

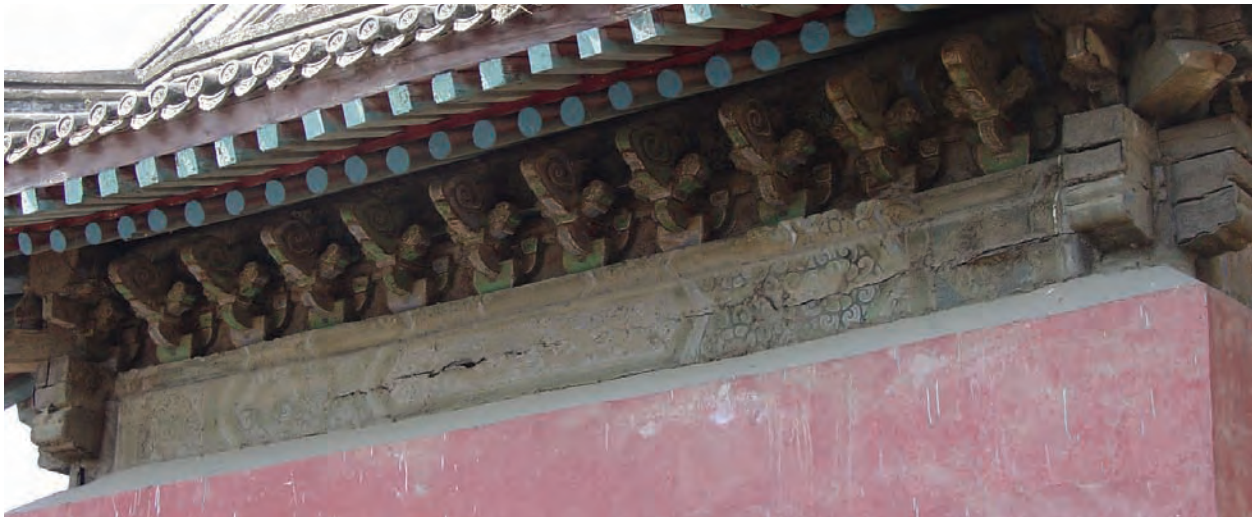
额枋彩画上存在一条全长达额枋全长2/3的大裂缝。额枋北端表面存在较少污垢及更清晰的装饰图案。

A large horizontal crack runs along two thirds of the main architrave painting. There is less dirt on the northern end of the main architrave painting where the decorative pattern is most visible.

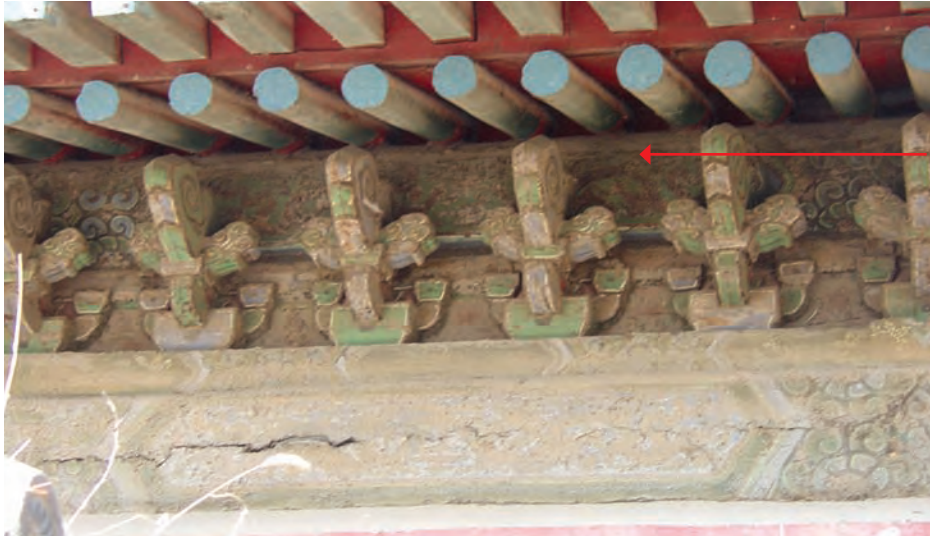
挑檐檩最上缘彩画脱落。

The painted plaster is lost on the top edge of the purlin.

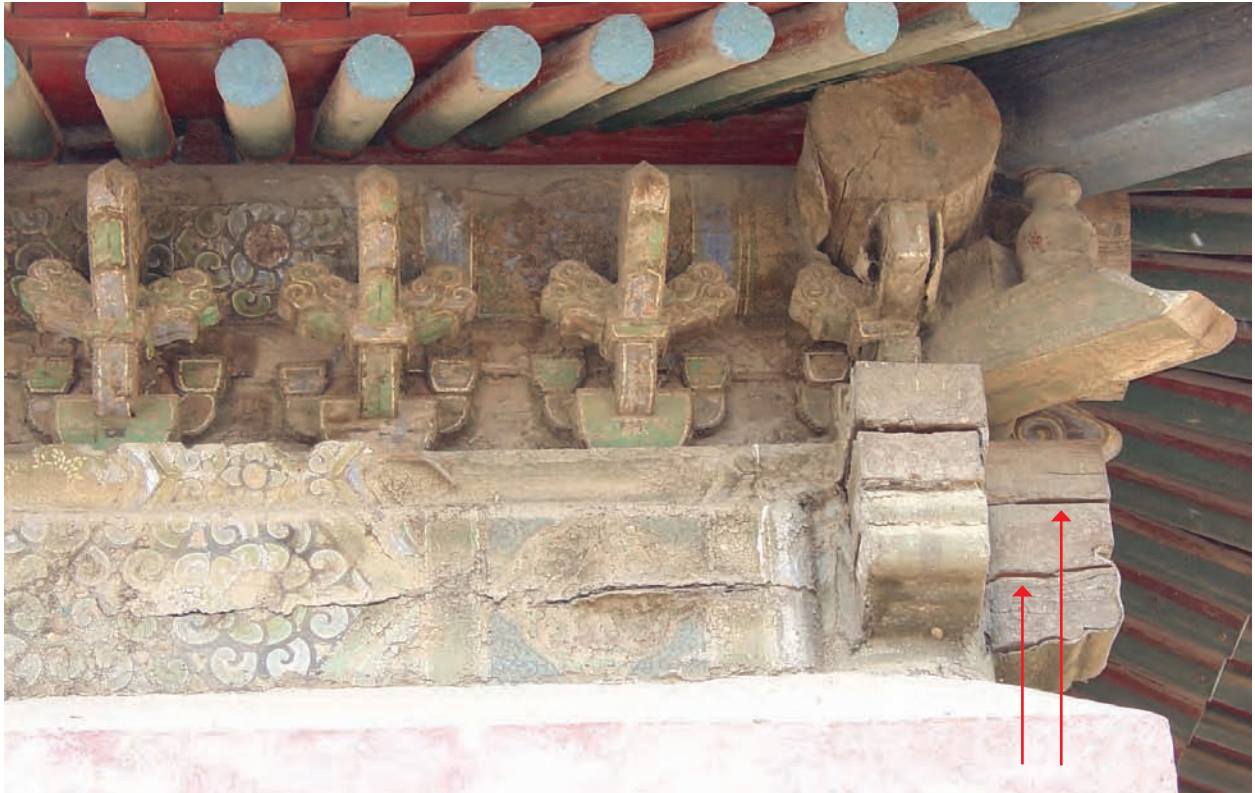
东立面北端的装饰图形最为清晰。注意霸王拳上的裂缝，彩画在该处完全脱落。

The decorative motifs are most legible toward the northern end of the east facade. Note the cracking of the end of the greater architrave (at right) where all of the painting has been lost.

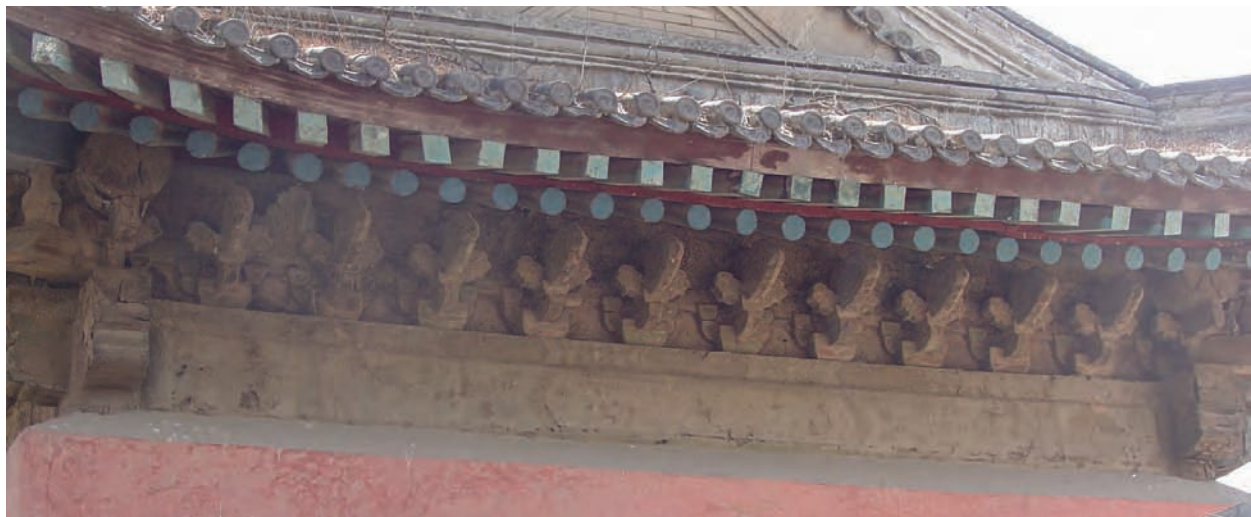
山门西立面彩画几乎完整保存。

Nearly all of the painting survives on the west facade of the gatehouse.

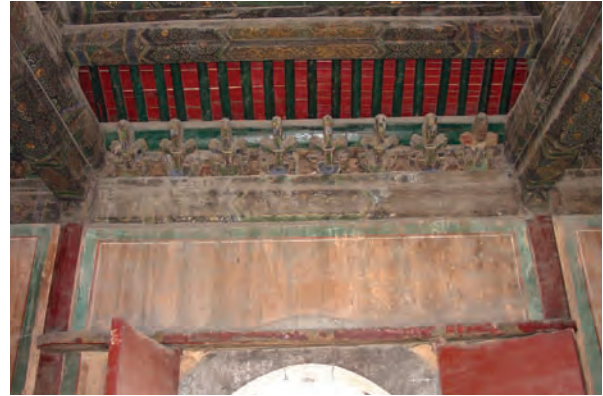
室内墙壁上雨水渗透的痕迹。

Evidence of rainwater infiltration on inner walls.

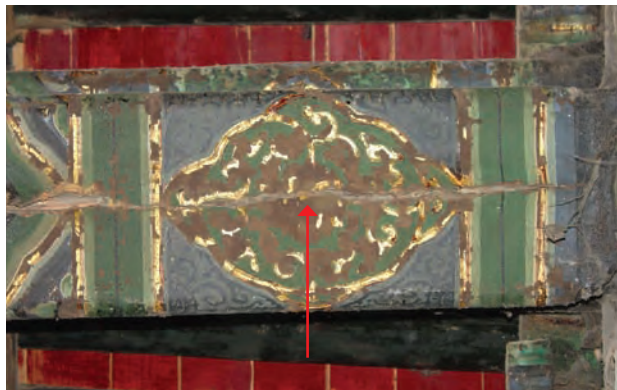
梁上画层的水平裂纹。

Horizontal cracking of painting along beam.

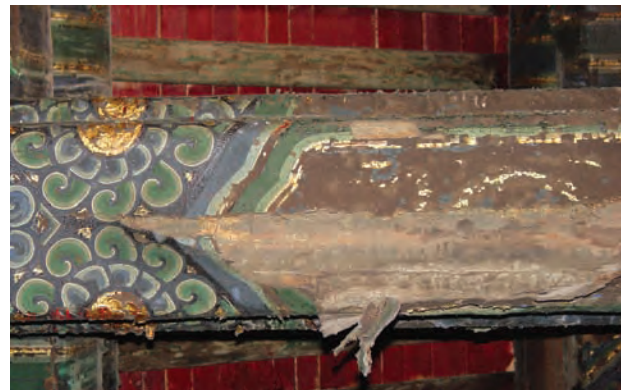
水平裂缝造成彩画完全脱落。

Horizontal cracks in the painting leading to loss.

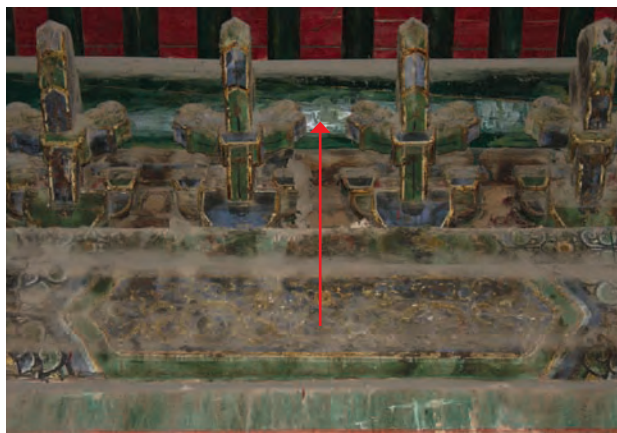
被替换的檐檩（漆为绿色）。

Replaced purlin (painted green).

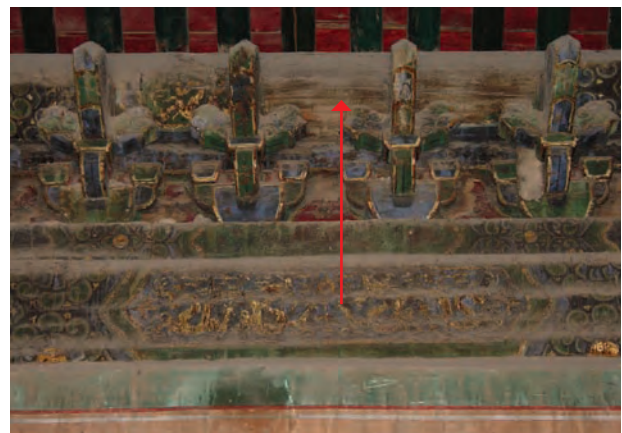
檐檩上的彩画缺失（明间南墙）。

Loss of painting on purlin (south wall, center bay).

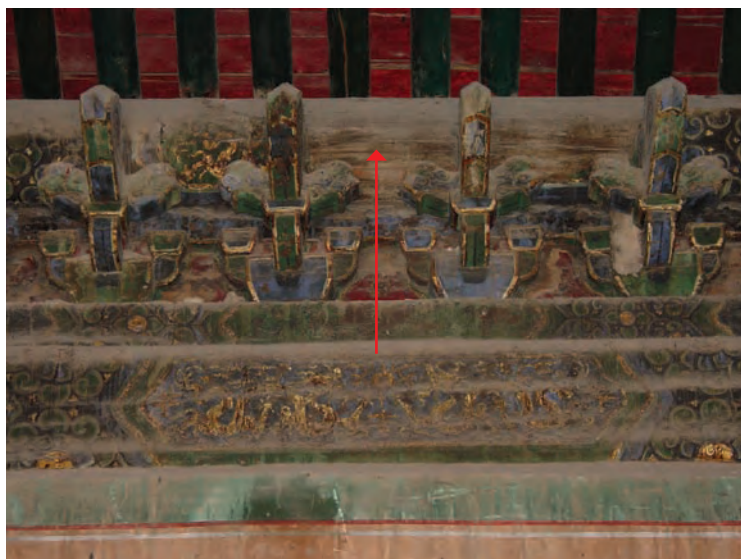
明间彩画细节，请注意檐檩上彩画的缺失  
Detail of center bay showing loss of painting on the purlin.

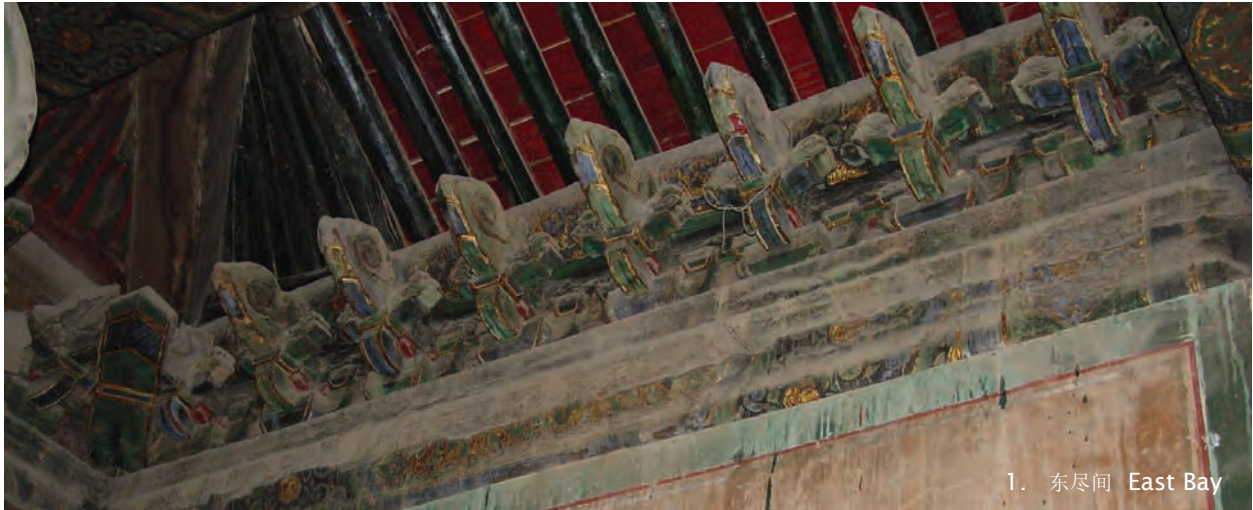
1. 东尽间 East Bay

东尽间：东尽间可见一些深色印迹（油漆），可能来源于1975年对屋顶的维修。较大水平裂缝贯穿额枋正中。

East Bay: paint drips, possibly from the 1975 repairs to the roof, are visible on the east bay. The main architrave has a large horizontal crack running across it.

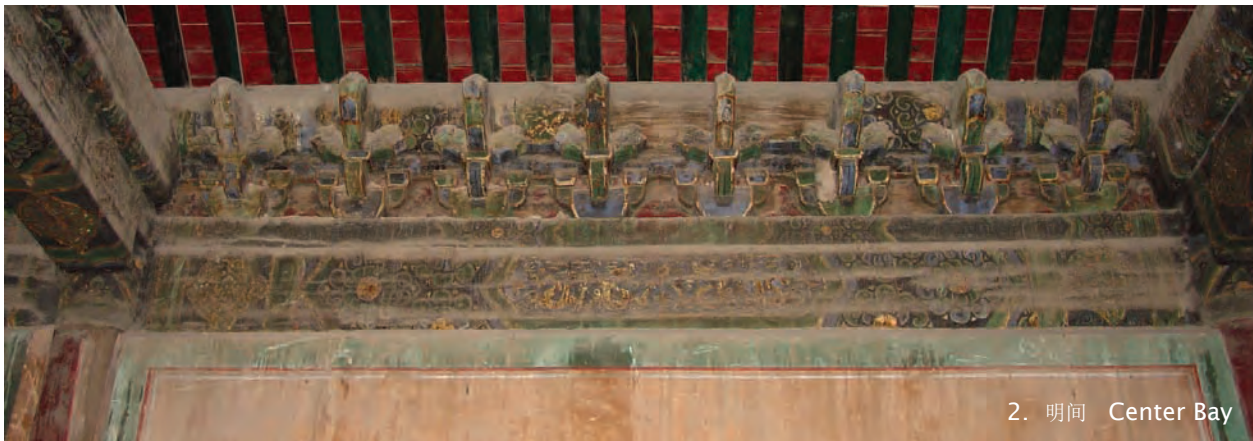
2. 明间 Center Bay

明间：明间檐檩彩画中部缺失，但额枋、平板枋上彩画保存完整。

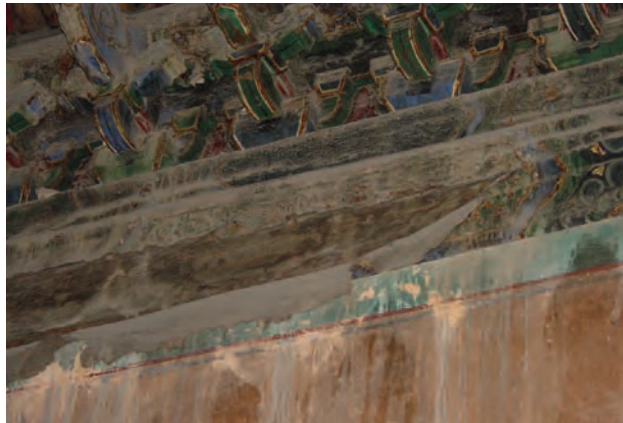
沿西尽间额枋上一水平裂缝出现的彩画缺失和剥离，局部彩画外翻下垂。

Area of loss and detached area of painting along a horizontal crack on the west bay with pieces hanging down.

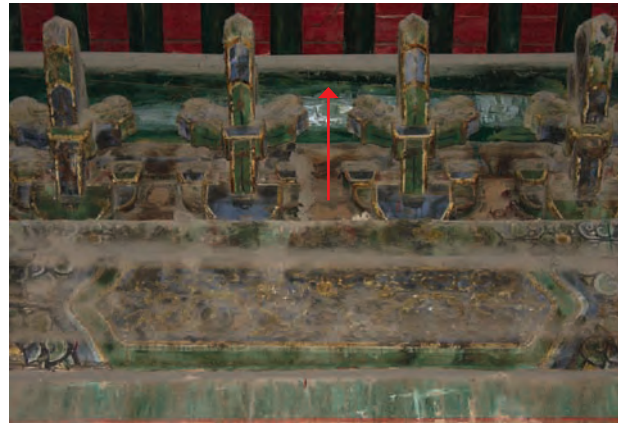
明间经更换的檐檩（以绿色断白）。

Replaced purlin (painted green) on center bay.

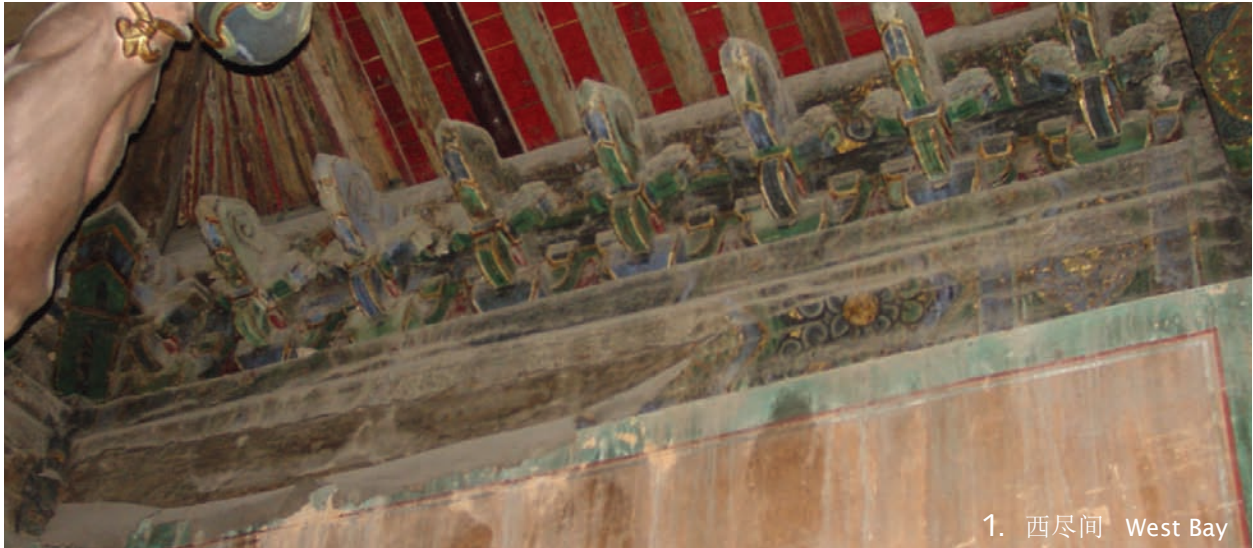
1. 西尽间 West Bay

西尽间：西尽间西端彩画呈现剥离和缺失。

West Bay: there is detachment and loss of painting on the western end of the west bay.

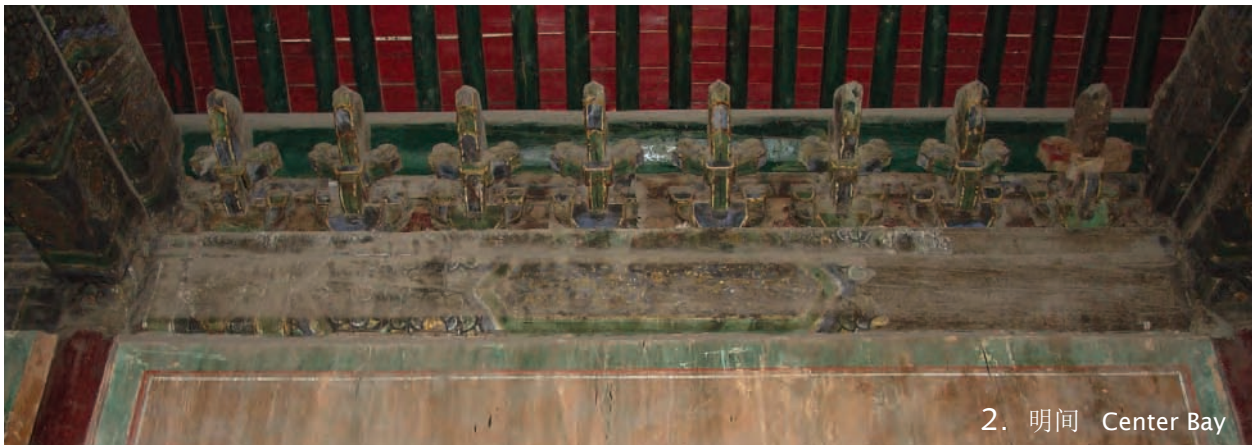
2. 明间 Center Bay

明间：明间额枋的三分之一（东段）出现彩画缺失。明间檐檩经过替换且漆以绿色，断白不作装饰。

Center Bay: there is loss of painting on the eastern third of the center bay architrave. The center bay purlin has been completely replaced and is painted green.

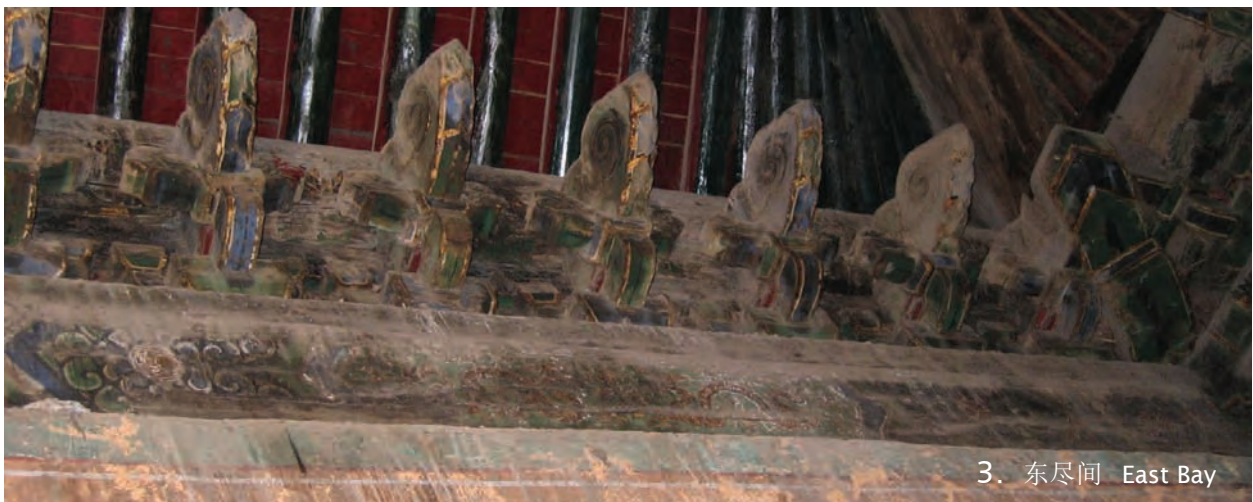
3. 东尽间 East Bay

东尽间：抹灰表面磨损严重。东尽间西端彩画存在缺失。

East Bay: the plaster surface is very abraded from moisture drips. The east bay painting is lost at the far western end.

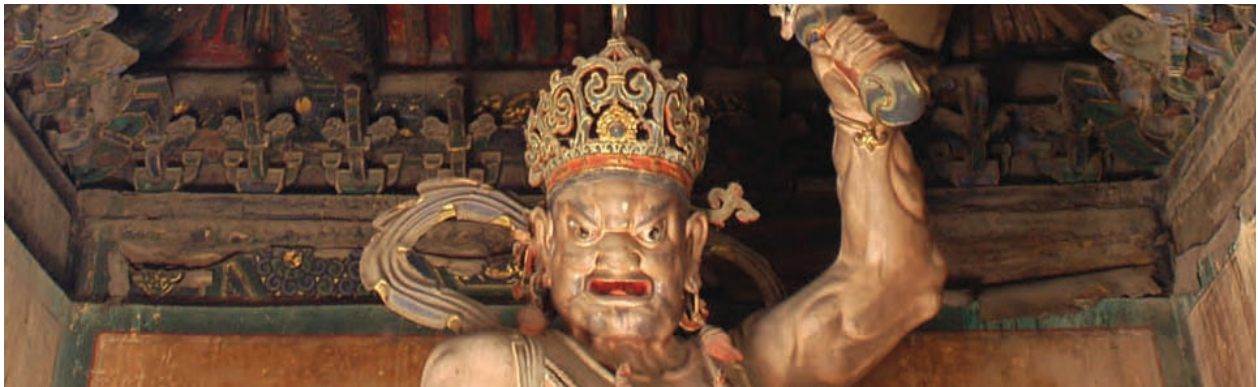
在哼哈二将中“哈”的塑像后可见的脱落彩画。  
Fallen piece of painting found on the ground behind the Temple Guardian *Ha*.

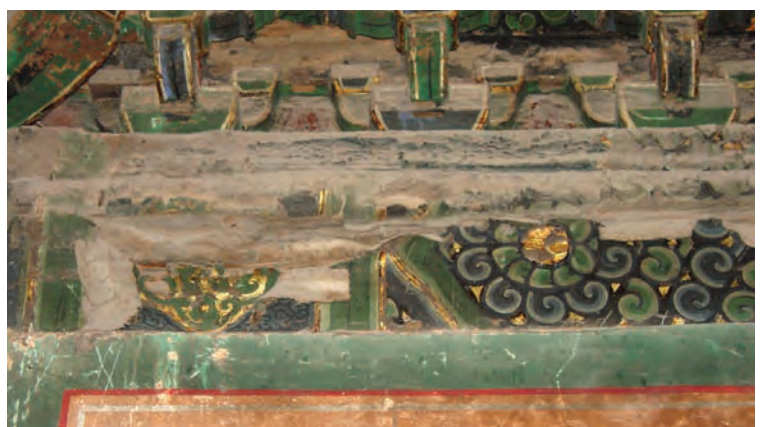
大额枋上剥离下垂的彩画局部。  
Detached and falling area of painting on the architrave.

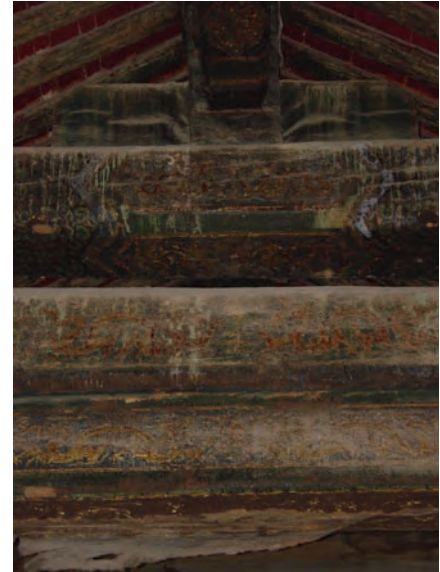
梁细部表现出积灰、水流痕迹及彩画上的污点。

Detail of painted decoration showing dust, drip marks, staining and areas of detachment of the painted plaster.

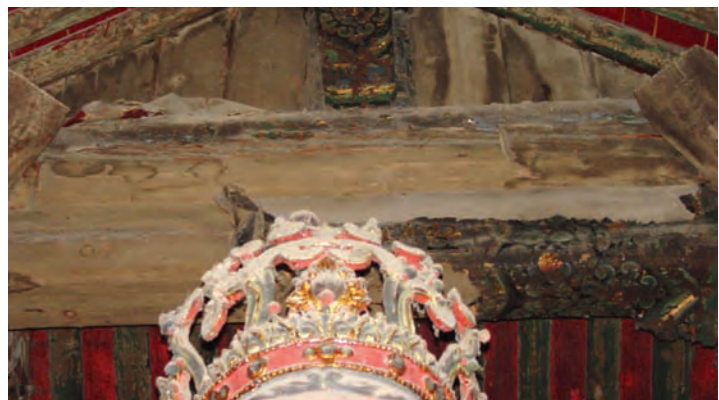
局部照片，可见踩步金上的彩画缺失及暴露木材上的水迹。

Detail showing loss of the painting on one of the beams and areas of moisture staining on the exposed wood.

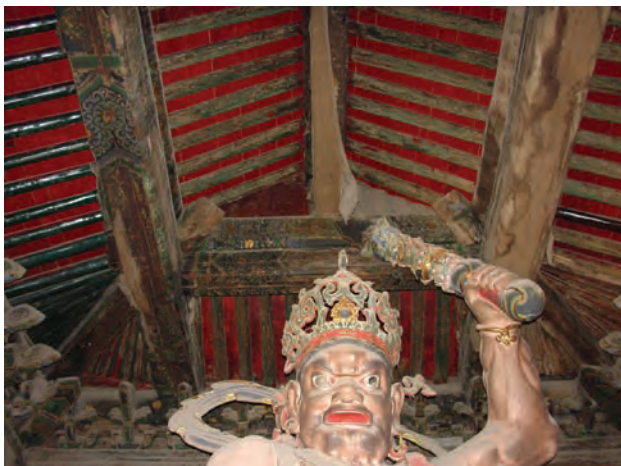
西段屋顶可见大面积地仗层缺失和剥离。请注意暴露的木梁表面的水迹。

Large areas of plaster loss and detachment are visible on the west end ceiling. Note the moisture staining on the exposed wooden beam.

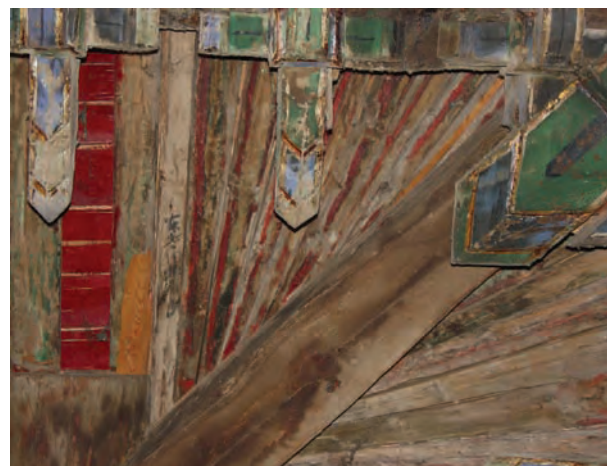
屋顶西北角可见不存油饰的角梁及椽，说明这一部位全部彩画缺失或部分梁构件的更换。

Northwest corner of ceiling showing unpainted beams. Indicating complete loss of painting or replacement of some of the beams.

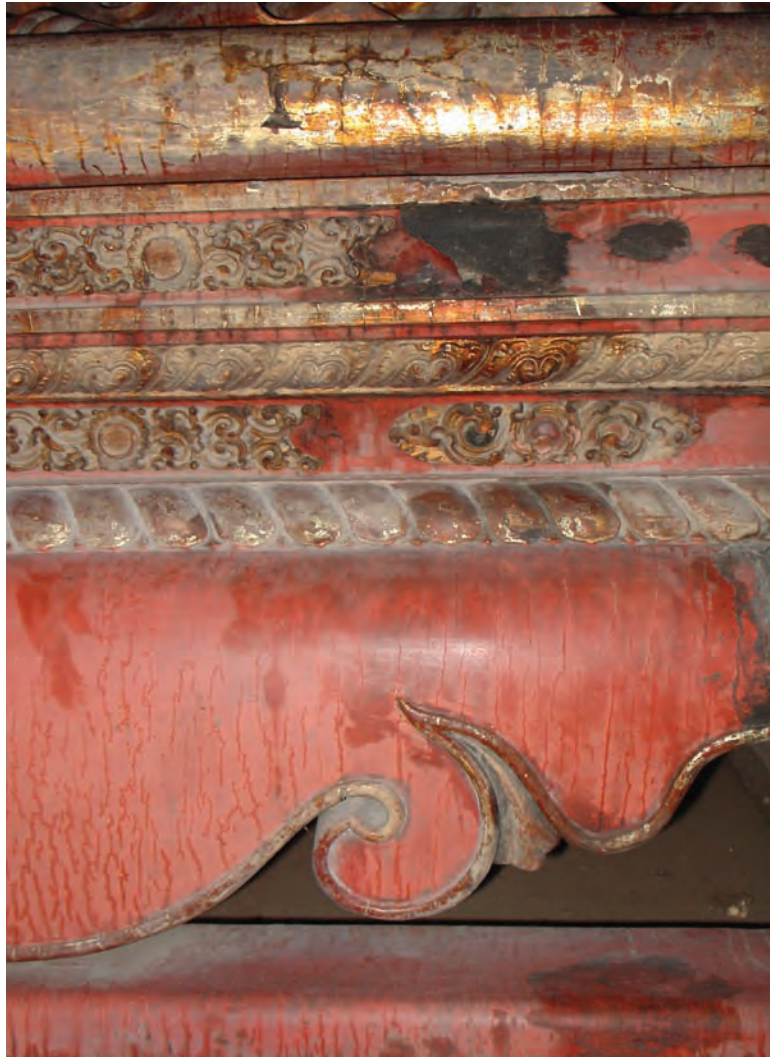
塑像底部细节显示缺失部分以及近期所沾上的蜡滴和污迹, 推测应是由座椅底部所放置的蜡烛造成的。

Detail of sculpture base showing a loss and recent wax drips and staining, presumably from the positioning of candles on the throne base.

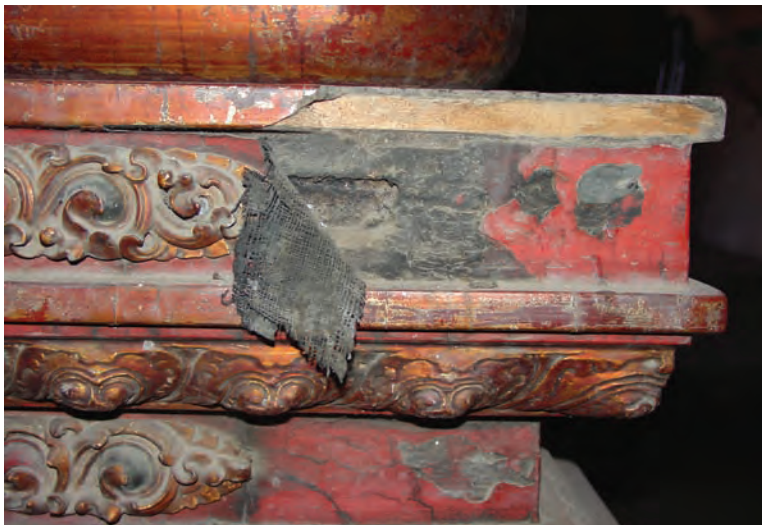
座椅底部西面的缺失。所施工艺可见为在地仗层上覆盖一层纺织品, 再加一层厚地仗层并在表面油漆。

West side of throne base showing a loss. The technique of execution is visible here showing a plaster layer covered with textile and finished with a thick layer of plaster which is then painted.

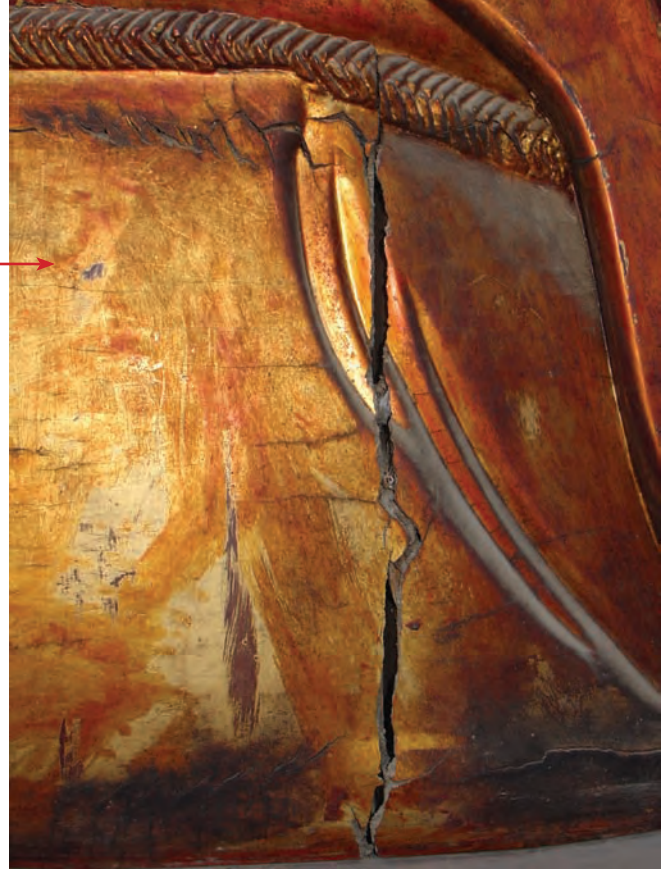
塑像背面细部显示表面一条大裂缝和较粗糙的清漆施工工艺。  
Detail from back of sculpture showing large crack and sloppy application of varnish.

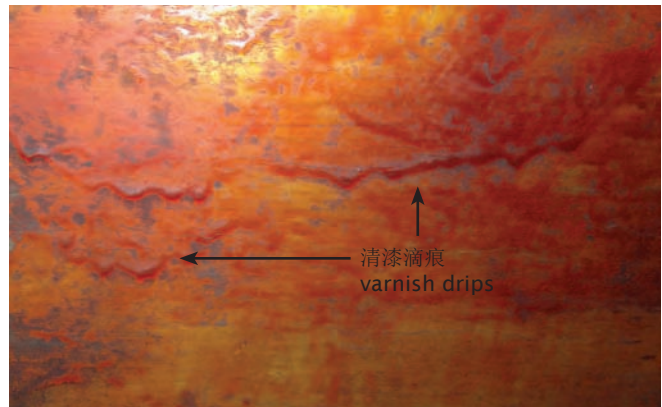
清漆层的滴痕。将清漆施加于镀金面上，使塑像表面呈现红色金属的效果。  
Dried drips of varnish applied over a layer of gilding to give the sculpture a reddish metallic appearance.

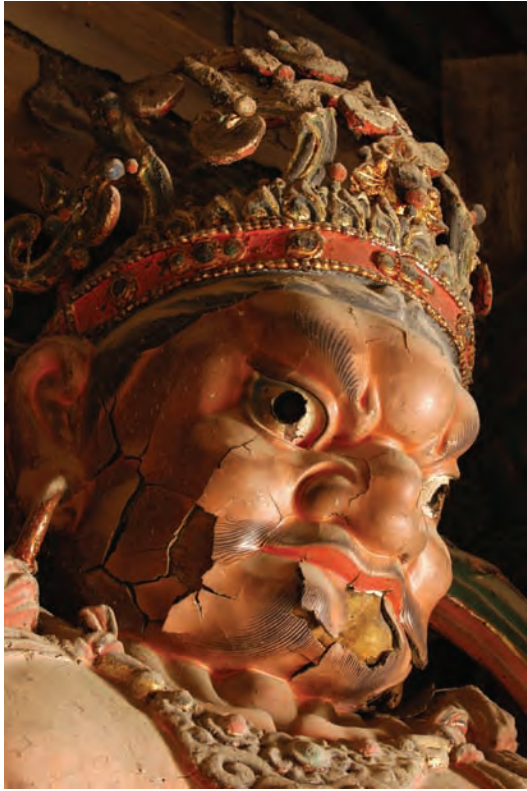
“哼”头部细节，可见严重开裂及油饰地仗层的缺失。  
Detail of head of Temple Guardian *Heng* showing severe cracking and loss of the painted plaster layer.

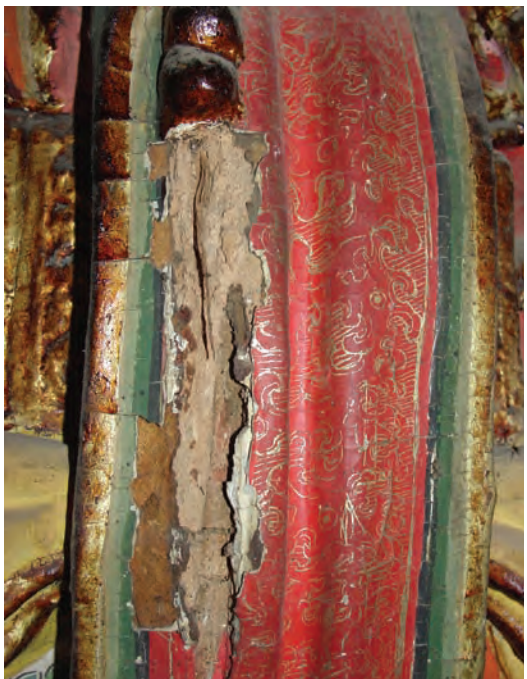
位于突出装饰及精致装饰部分的小面积缺失，例如飘带以及在金属线骨架上构造的球形装饰。  
Small losses to protruding and delicate areas of ornamentation such as ribbons and ball decoration which are built up on a wire armature.

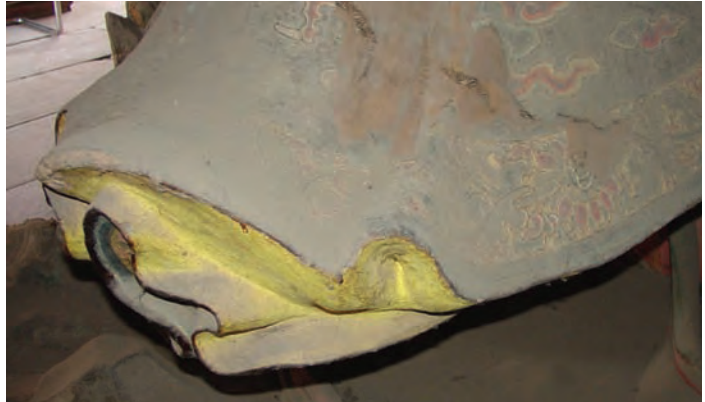
厚灰尘层覆盖油饰表面，可见较大裂缝。  
Thick layer of dust covers the paint surface and large cracks are visible.

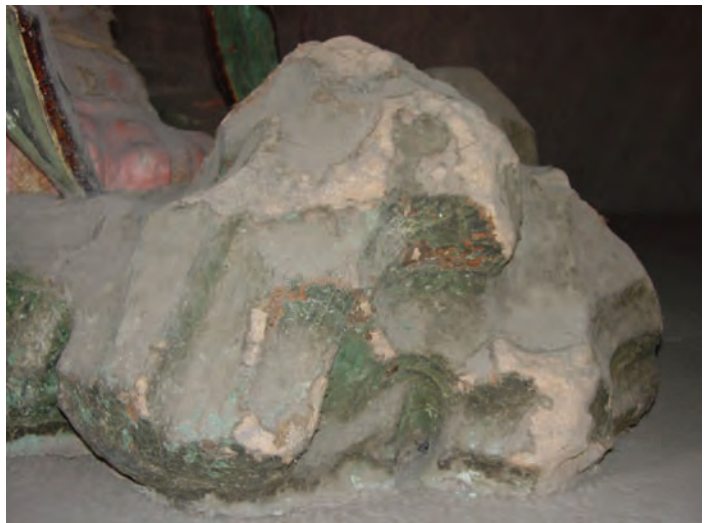
塑像基座上可见小面积缺失。  
Small losses can be seen on the sculpture base.

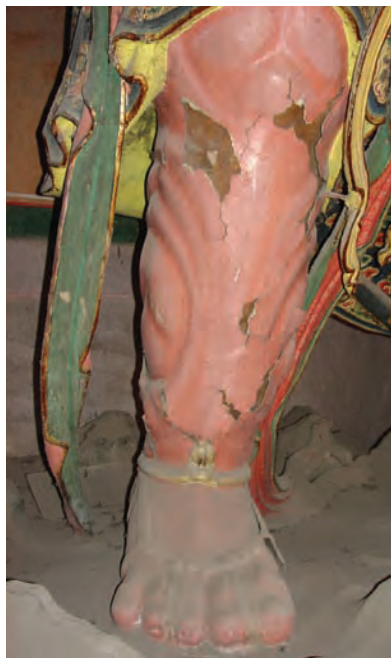
右腿可见严重裂缝及上部油饰地仗层的缺失，露出其下的棕色纤维层。  
The right leg shows severe cracking and loss of the upper painted plaster layer revealing a brown textile layer below.

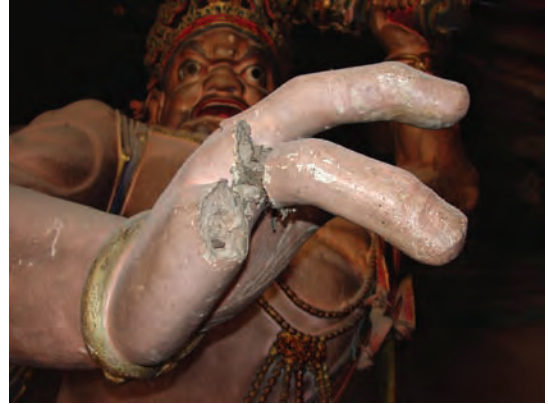
右手食指和小指缺失。右手无名指断裂并脱离，只由内部铁丝骨架连接。

The second and fifth fingers are lost on the right hand. The fourth finger of right hand is broken and detached, held on by the inner metal armature.

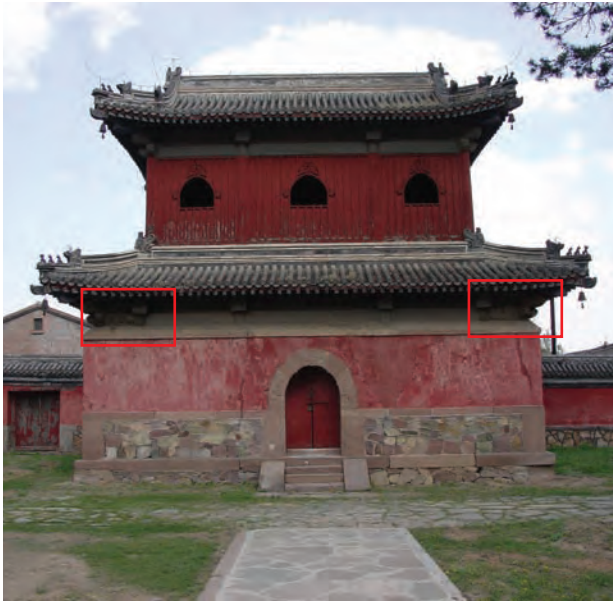
小片彩画虽然残损严重，但仍可见于下层西南及西北角。

Small patches of painting, though deteriorated, still survive on the southwest and northwest corners of the lower level of the Bell Tower.

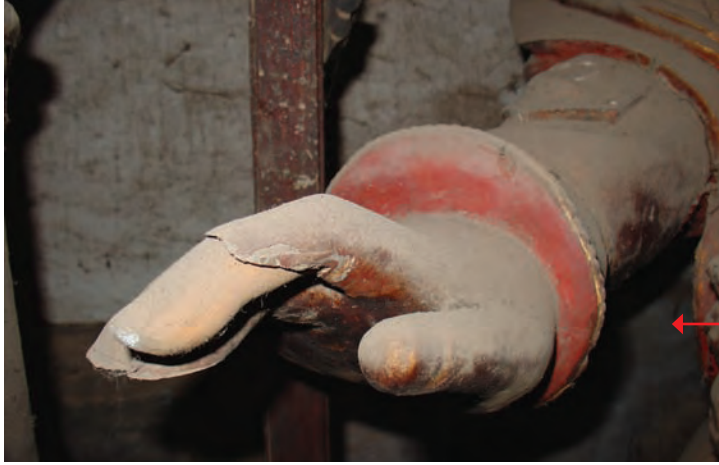
韦陀像右手的缺损。并注意堆积有厚重的尘土。

Loss on the right hand of *Weituo*. Note also heavy dust deposition.

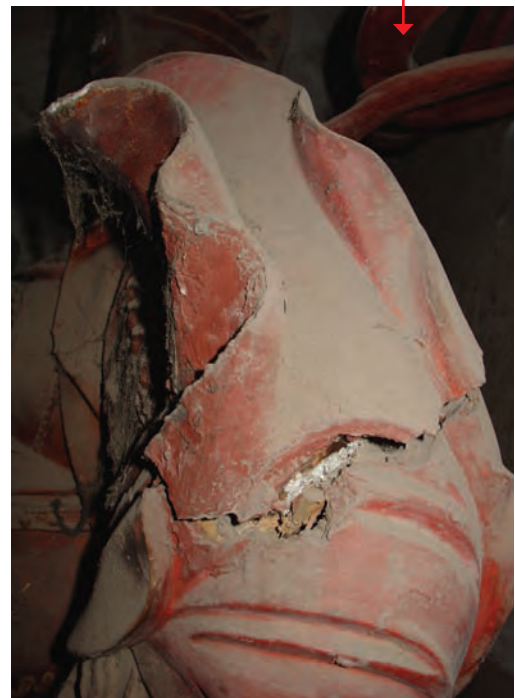
韦陀像左臂的裂缝。

Crack on left arm of *Weituo*.
