Eames House Conservation Project: Investigations 2011 to 2016

Research Report

Edited by Laura Matarese
with Chandler McCoy and Gail Ostergren

The Getty Conservation Institute

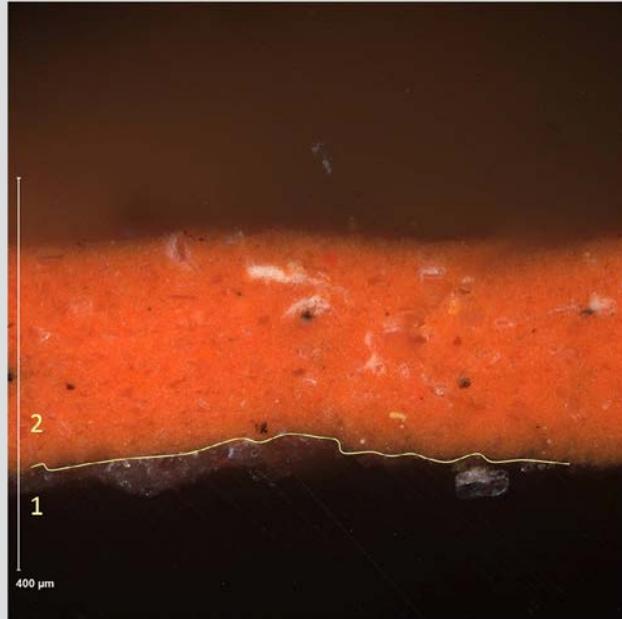
FIGURE 1.15A
Cross section East Exterior_4. Crossed polarizing filters. 20× objective. Annotated to show layer structure.

No complex stratigraphy is observed in the sample from the orange-red panel (East Exterior_4), which comprises a single paint layer directly on the panel support. This paint was found to contain probably two different orange-red colorants: lead chromate and an organic pigment, the identity of which has not been determined.

Sample taken from a crack near the edge of the orange panel where it meets the black frame; white layer visible beneath; possibly some panel fibers included in the sample.

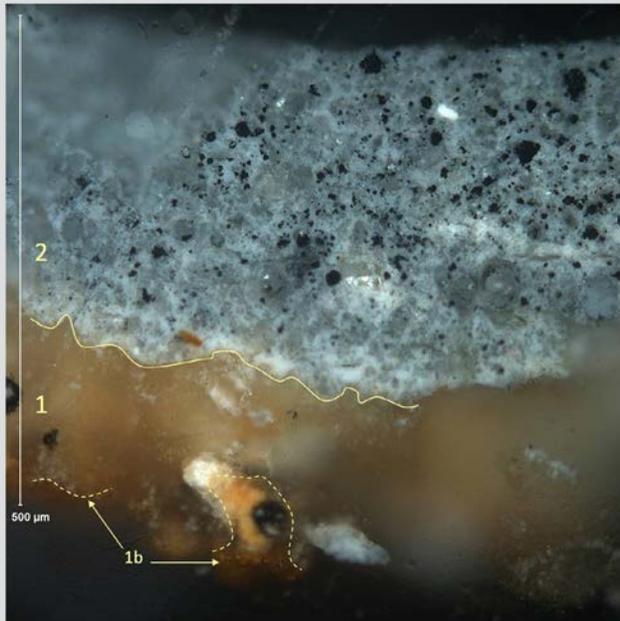
FIGURE 1.17A
Cross section East Interior_6a. Crossed polarizing filters. 20× objective. Annotated to show layer structure.

Cross section East Interior_6a is the lower fragment that consists of gray primer, possibly also some putty, and shows corrosion products on its underside. Cross section East Interior_6b includes the upper paint layers of dark gray, red, and near-black. The orientation of the upper fragment, East Interior_6b, as depicted below, has been deter-

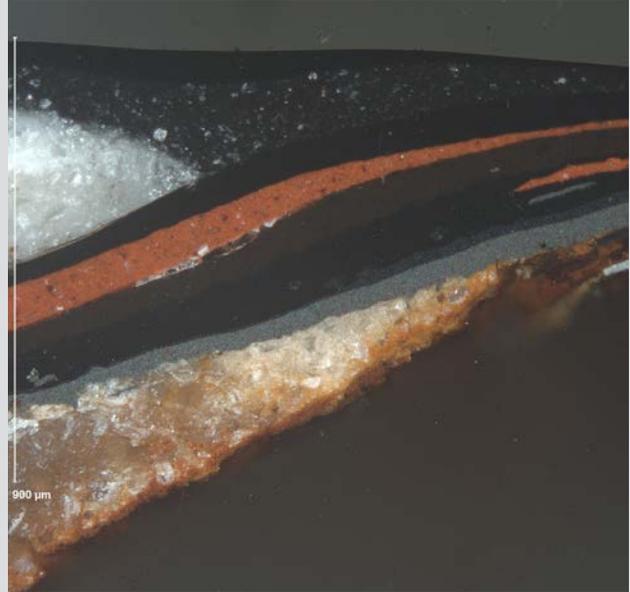
FIGURE 1.22B
Cross section North Exterior_10. Crossed polarizing filters. 10x objective.

From corner of window frame, black paint bubbled up from failed putty/corrosion; sample may include a red primer and putty.

Cross section North Exterior_10 contains a complex stratigraphy, with several layers in common with sample East Exterior_2b, as noted earlier. The layer structure of sample North Exterior_10 is summarized in table 1.21.

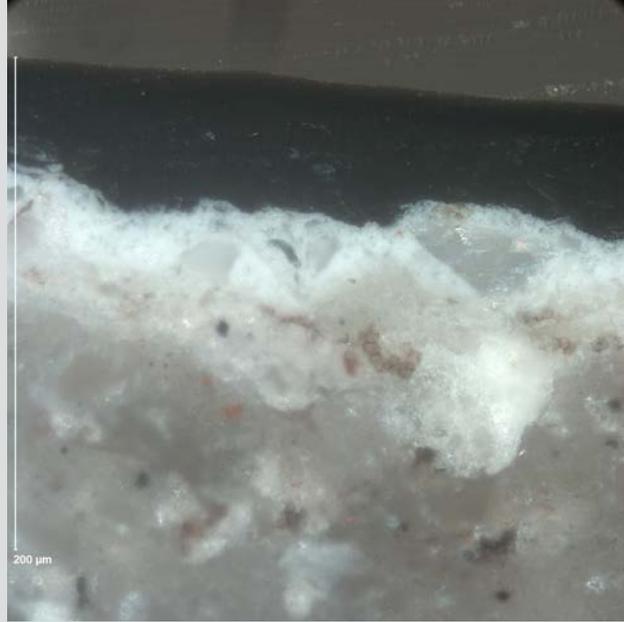
FIGURE 1.33A
Cross section West Exterior_14; Crossed polarizing filters. 50× objective.

Loose fragment from edge of loss in black paint on metal frame.

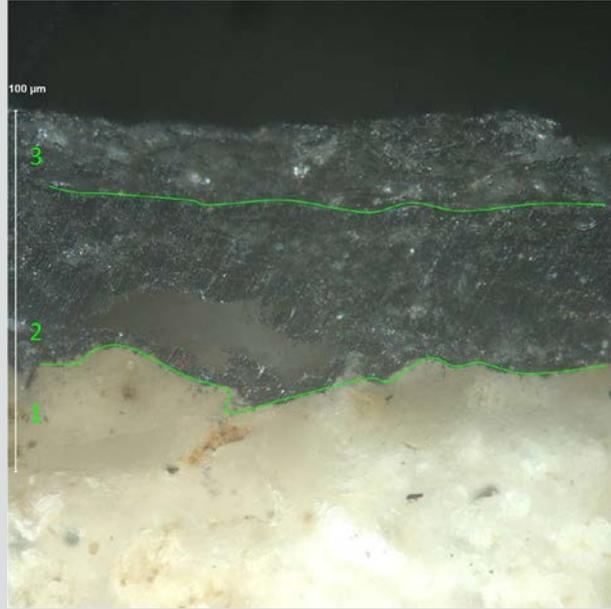
FIGURE 1.34A
Cross section West Exterior_15; Crossed polarizing filters. 50x objective + 1.5x magnifier (= 75x). Annotated to show layer structure.

Metallic paint at location of impact damage site on silver-painted panel. Sample also includes some of the underlying panel material.

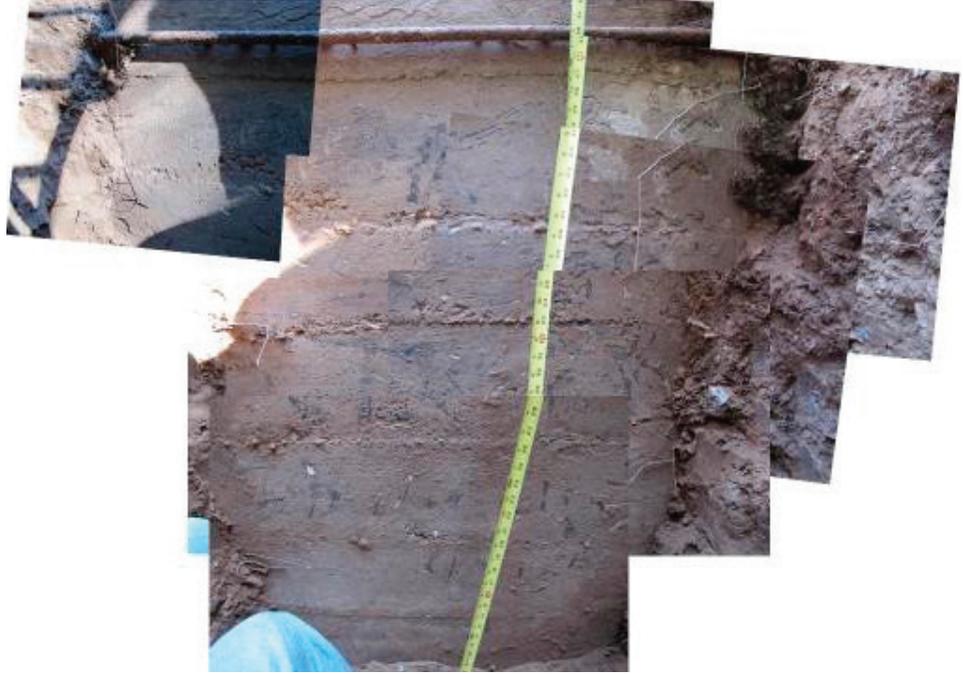
Composite image of the soil side of retaining wall. The attachment of tree roots was seen at various depths.

In the visual inspection performed on March 26, 2012, both the nailing and furring strips were found to be in good condition and are providing adequate support for the wall panel. Only the nailing and furring strips closest to the floor (fig. 4.47) show advanced deterioration. Nails used in the furring strips are lightly rusted and show tidemarks of rust on the wood around them indicating past condensation. Dark stains found on the bottom surface of the wood panel were tested at the GCI laboratories and were found not to contain fungi
