3.4 Geological and Environmental Description

3.5 Structural Description

3.6 Irregularities, Alterations, Damages, and Decay

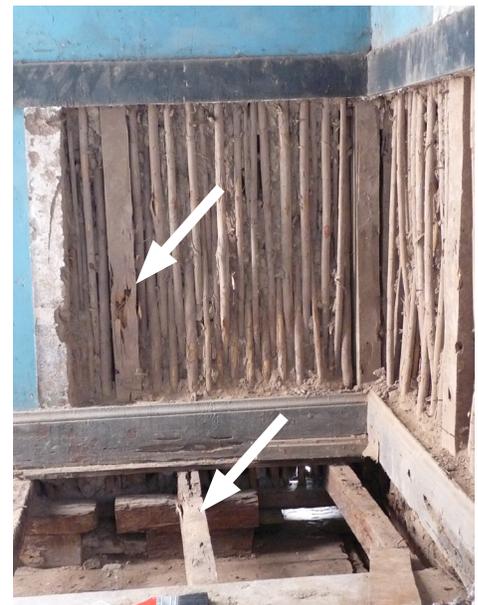
FIGURE 3.28 (FAR RIGHT)
 Prospection IIIIS-1, showing the quincha posts and floor joists do not align.
 Drawing: Mirna Soto for the GCI.

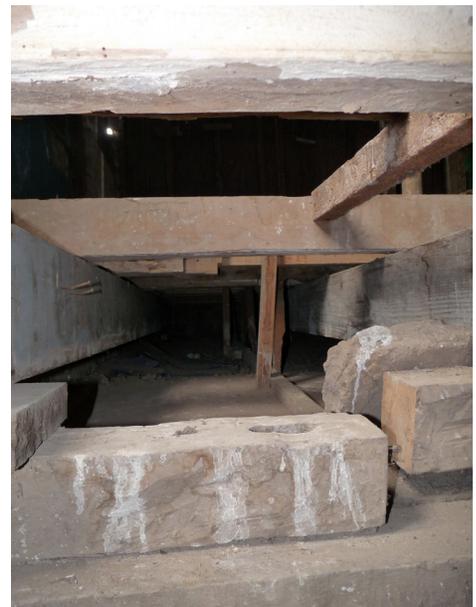
Prospection IIS-1, showing the overlapping beam ends, which presumably relate to the removal of a wall in the bar below.
Image: Mirna Soto, for the GCI.

- The structure of sector A is in most danger, as it appears that an original internal mud brick wall that originally supported the quincha walls above has been replaced with a column. Furthermore, the placement and overlapping of the wood floor beams above does not work and only adds load to the structure above. At that same sector, the conditions of the quincha partition walls at the second floor are poor and may lead to the collapse of the third floor area above the bar. Finally, the fact that this sector is located at the corner makes the building even more vulnerable to collapse during an earthquake.

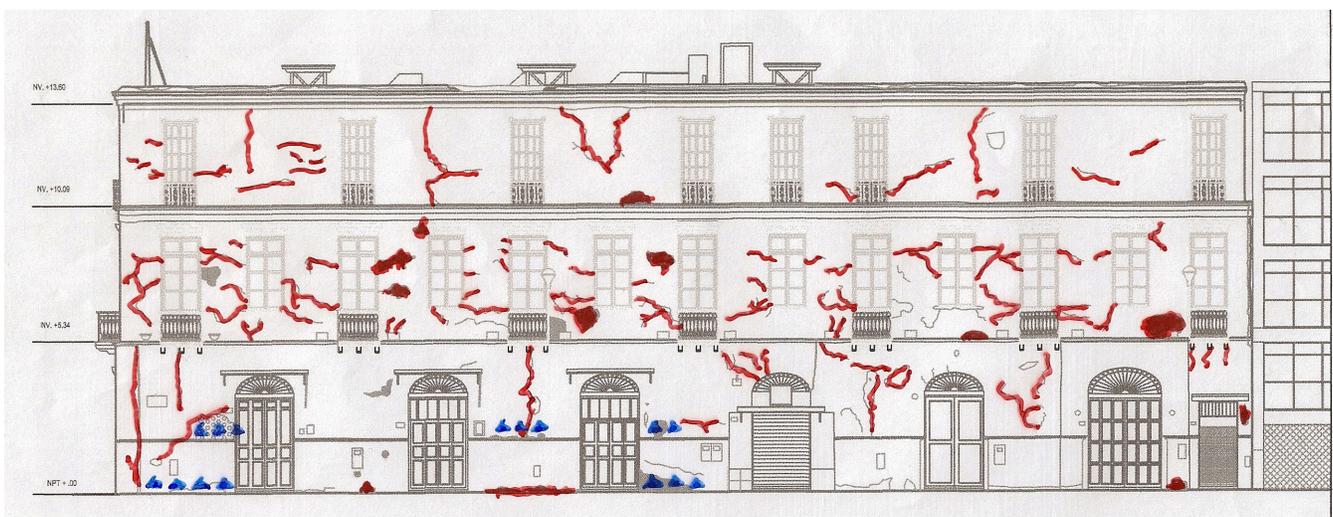
FIGURE 3.44

Both of the street façades show some signs of cracking, particularly at the second floor spandrels. There is diagonal and vertical structural cracking at the corner of the first floor at the northeast end of the long northwest façade (Jirón Carabaya). The northeast façade along Jirón Ancash also shows significant cracking in the second floor at the southeast end near the adjacent casona and at the third floor span-

Northwest façade, graphic condition survey indicating observed cracks and areas of plaster loss in red and humidity in blue.

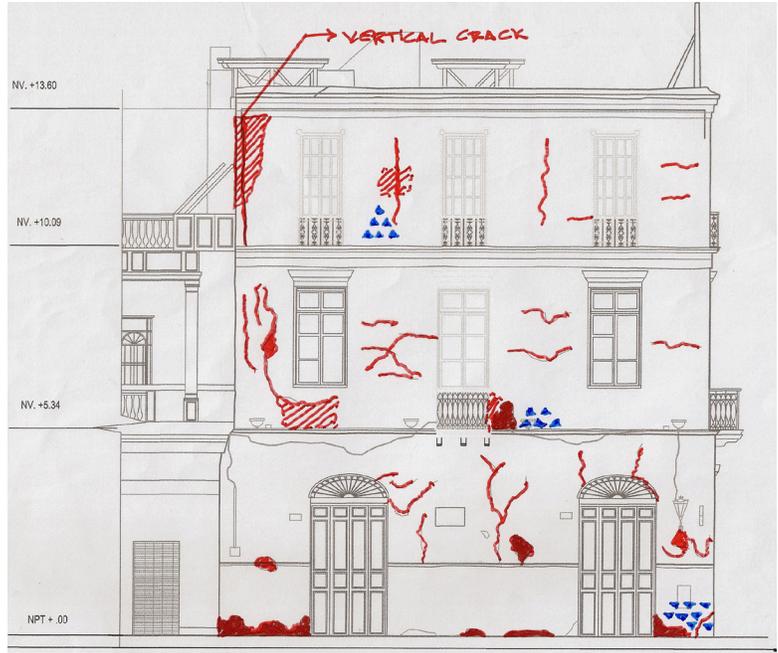
drels (Figs. 3.44, 3.45). The patio façades are in fair condition but also show signs of cracking at the third level spandrels and also at the corners of the openings (Figs. 3.46, 3.47).

FIGURE 3.45
Northeast façade, graphic condition survey indicating observed cracks and areas of plaster loss in red and humidity in blue.
Drawing: Claudia Cancino.

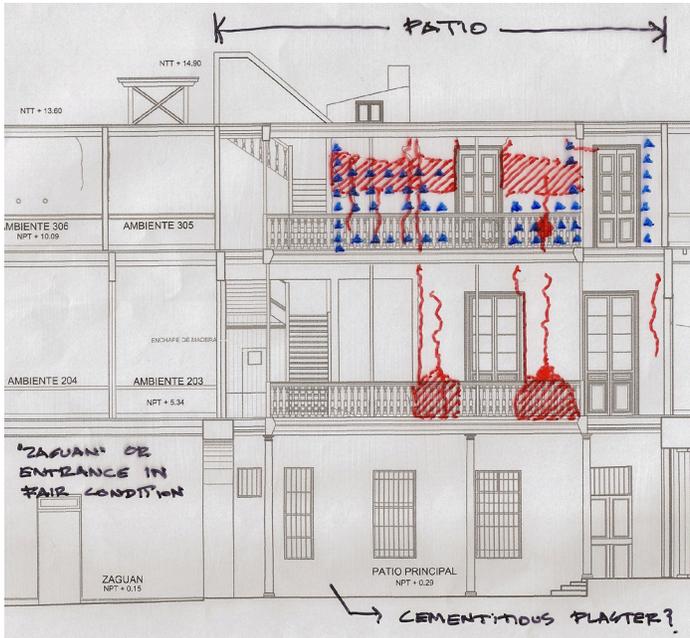
FIGURE 3.46
Northeast patio façade, graphic condition survey indicating observed cracks and areas of plaster loss in red and humidity in blue.
Drawing: Claudia Cancino.

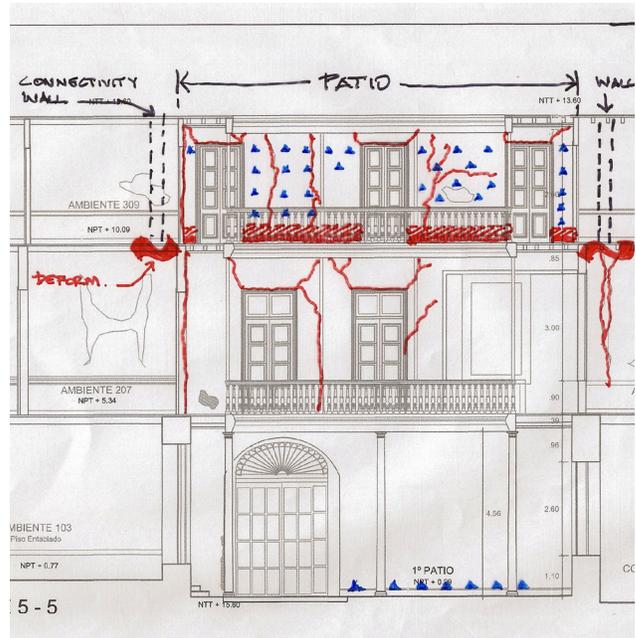
FIGURE 3.47
Northwest patio façade, graphic condition survey indicating observed cracks and areas of plaster loss in red and humidity in blue.
Drawing: Claudia Cancino.

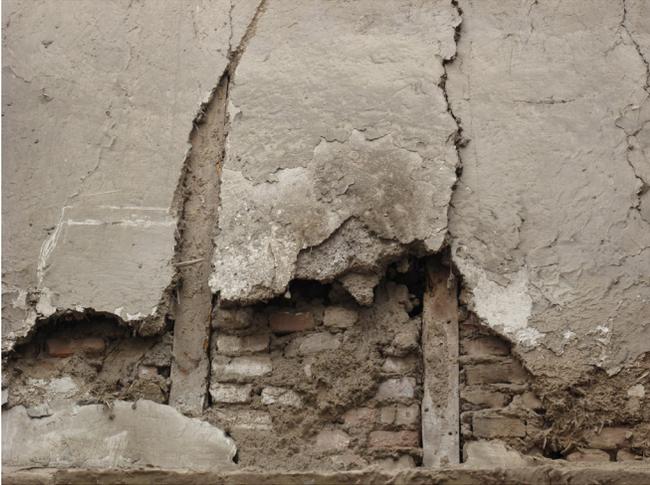
The second floor quincha walls are in poor condition, particularly in sector A and at the long wall in sector B that borders the adjacent casona. Cracks and plaster detachment were observed in many walls, typically in areas corresponding to posts within the walls and at openings. The detachment of the painted mud plaster at the quincha frame bases and posts is exposing the internal wood structure to deterioration (Figs. 3.48–3.51). The presence of termites in nearly all wood elements suggests that the panel structure connections may not perform well during future seismic events. The deterioration and previously-mentioned lack of proper connections / interlocking makes it difficult for the quincha frames to restrain lateral or vertical movements.

FIGURE 3.48
Typical plaster detachment at quincha wall bases and posts.
Image: Claudia Cancino.

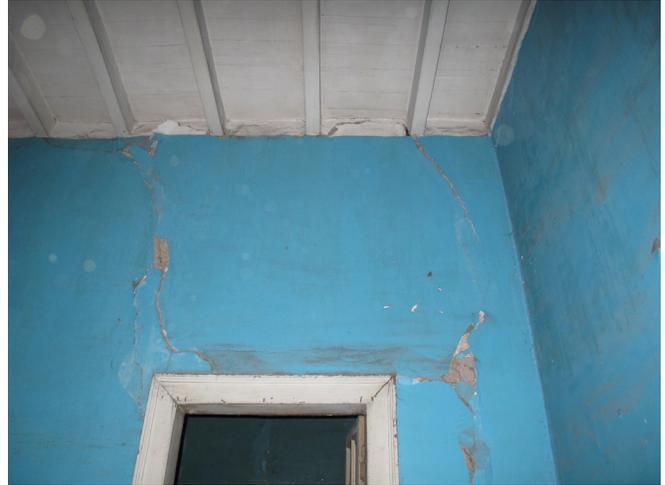
FIGURE 3.49
Typical crack pattern at openings in quincha walls.
Image: Claudia Cancino.

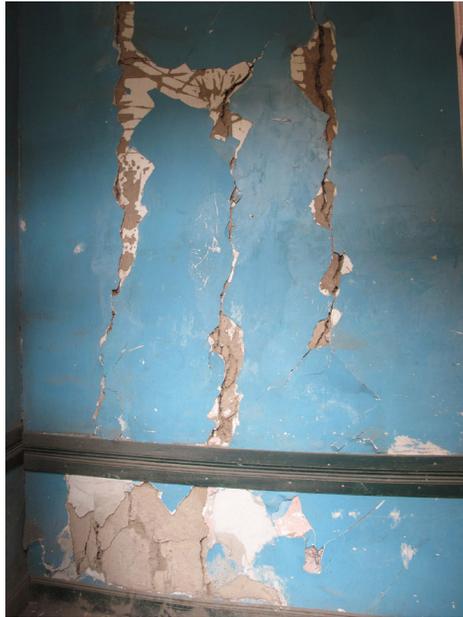
FIGURE 3.50
Typical crack pattern, corresponding to the
quincha post locations.
Image: Claudia Cancino.

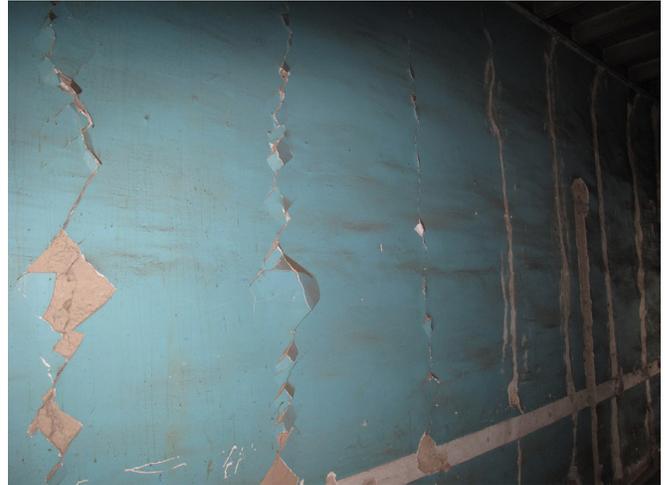
FIGURE 3.51
Vertical cracks corresponding to quincha post locations, southeast
wall of corridor 246, sector C.
Image: Amila Ferron.

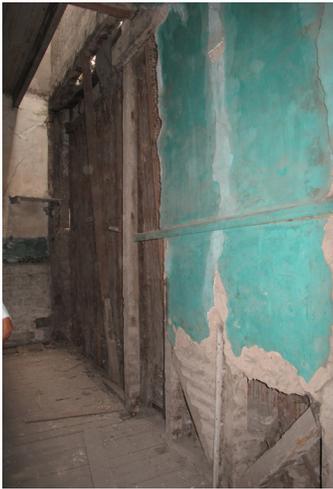
FIGURE 3.52
Northwest wall of room 243.
Image: Claudia Cancino.

- **Sector A:** It is likely that the wall separating sectors B and C at the first floor probably originally to the northeast façade. It has since been removed to create a larger dining room for El Cordano bar and a metal column has been installed to support the floor structure above. The overlapping wood beams at the second floor, above the El Cordano main dining room, appear to be alterations made to accommodate this transformation. Of particular concern is the northwest wall of room 243 over the bar dining room. With the removal of the mud brick wall, the second floor quincha wall frame was left hanging from the third floor quincha frame and is not bearing on the floor, thus creating a total disconnection between two floors (Fig. 3.52).
