Eames House Conservation Project Cemesto Panel Investigations Phase I

Research Report

Getty
Conservation
Institute

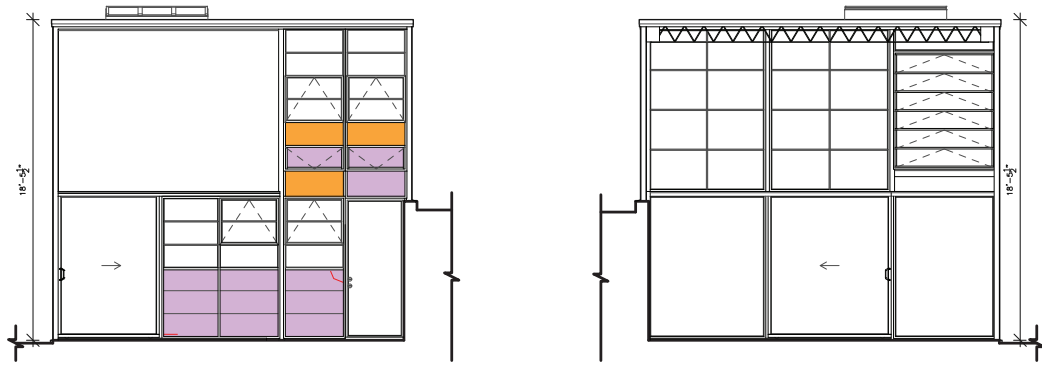
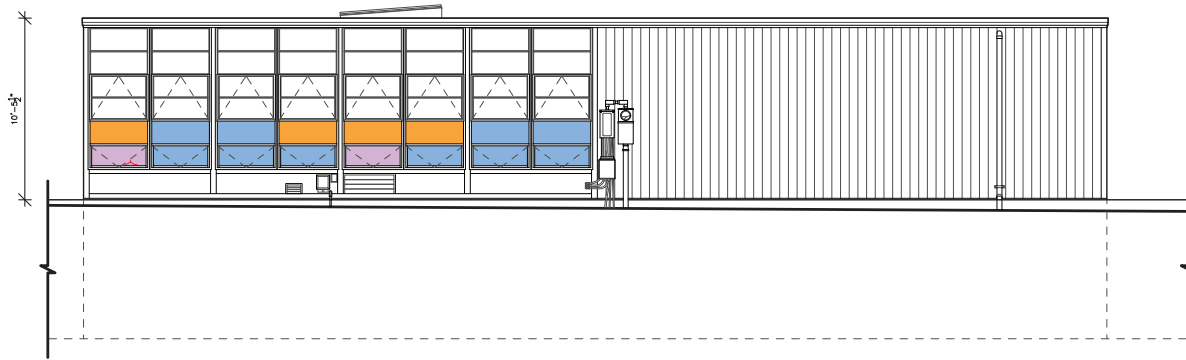
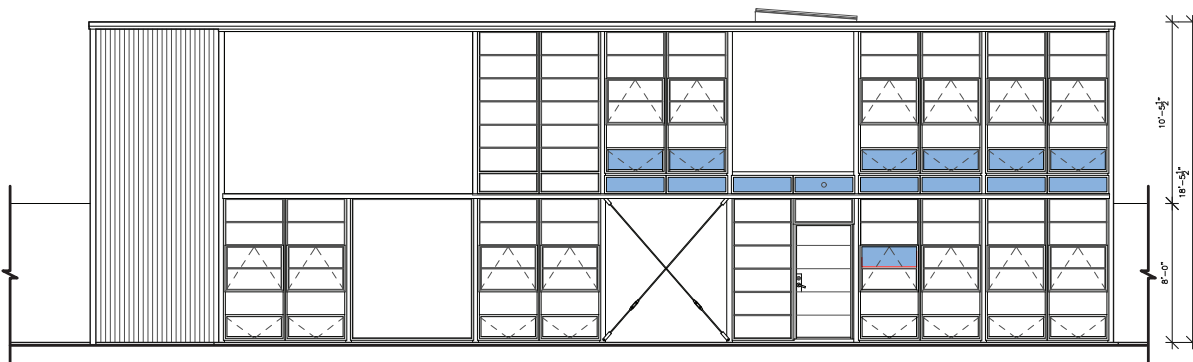
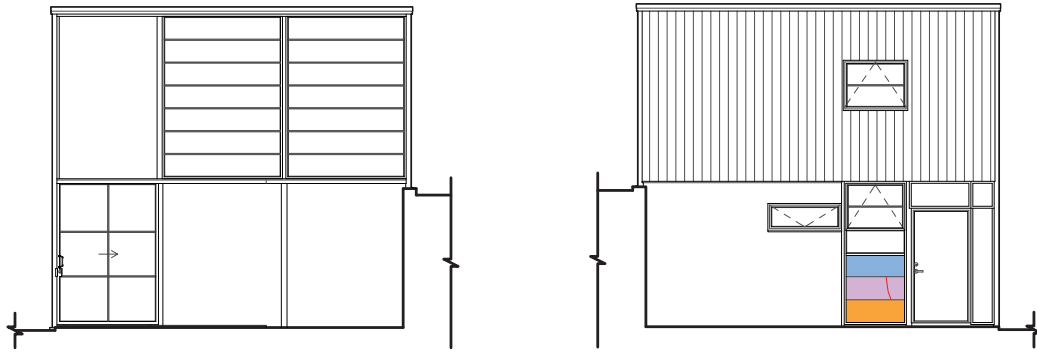
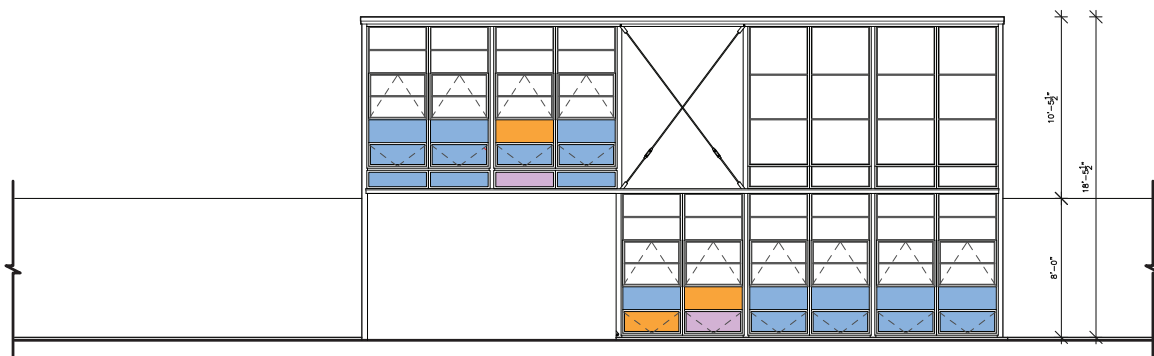
Initial condition assessment, 2015 (Revised in 2018).
 Exterior elevations

FIGURE 3.2 Elevations showing the initial condition assessment of the exterior Cemesto panel faces of the Eames residence and studio. Drawing by Getty Conservation Institute, 2018, adapted from Historic American Building Survey CA-2903, Library of Congress, Prints & Photographs Division.

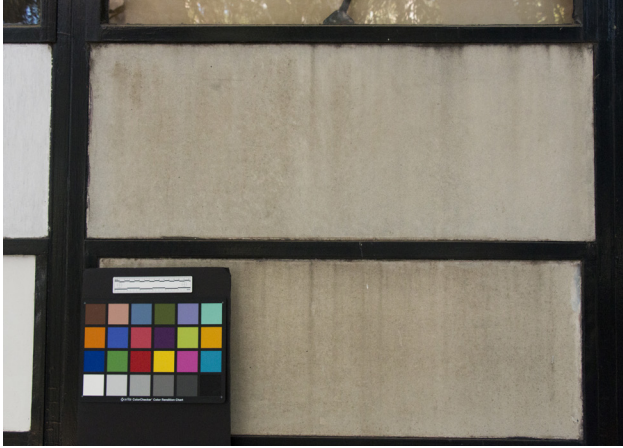
FIGURE 3.3 Photo of Eames residence exterior, east elevation, showing heavy soiling on panels HE-8-5 and HE-8-6. Photo: Laura Matarese and Chandler McCoy, 2015. ©J. Paul Getty Trust.

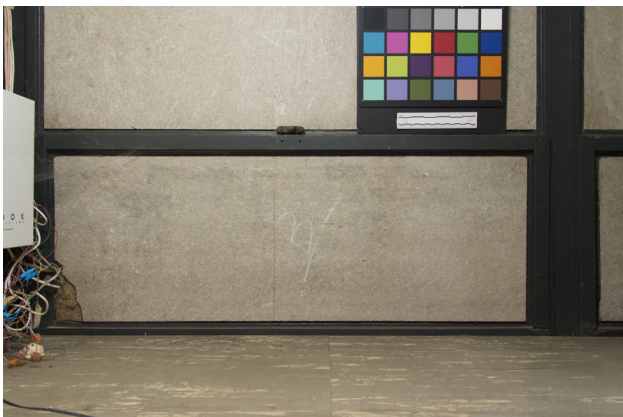
FIGURE 3.7 The letter B written in chalk in the center of the asbestos-cement facing of a lower panel in the Eames studio interior. Note broken lower left corner, possibly caused during the installation of telecommunication and internet wires. Photo: Laura Matarese and Chandler McCoy, 2015. ©J. Paul Getty Trust.

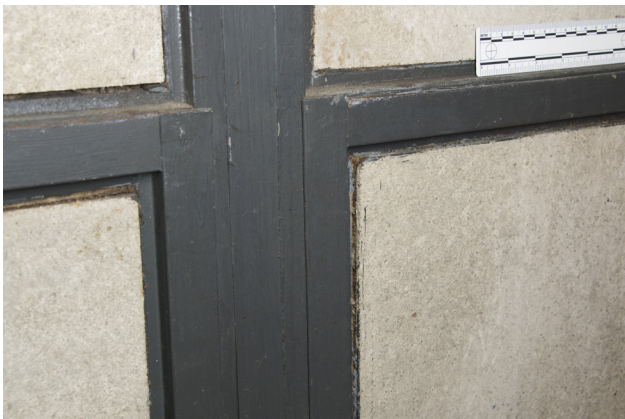
FIGURE 3.9 Panels on the studio interior, west elevation, shown protruding from the frame, exposing the Celotex fiberboard core. Photo: Laura Matarese and Chandler McCoy, 2015. ©J. Paul Getty Trust.

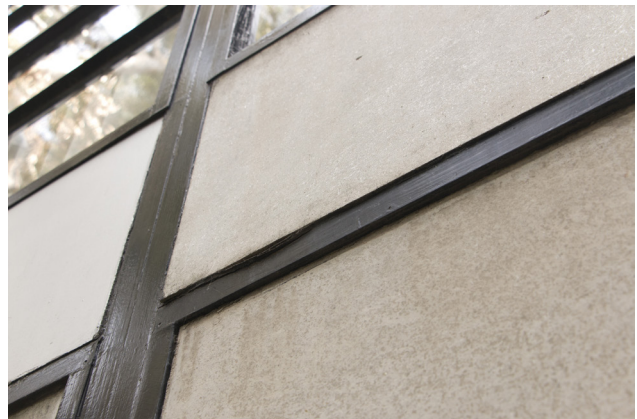
FIGURE 3.10 Panel on the residence exterior, north elevation, showing the outer asbestos-cement facing detaching from the fiberboard core and sealant on the lower corners. Photo: Laura Matarese and Chandler McCoy, 2015. ©J. Paul Getty Trust.

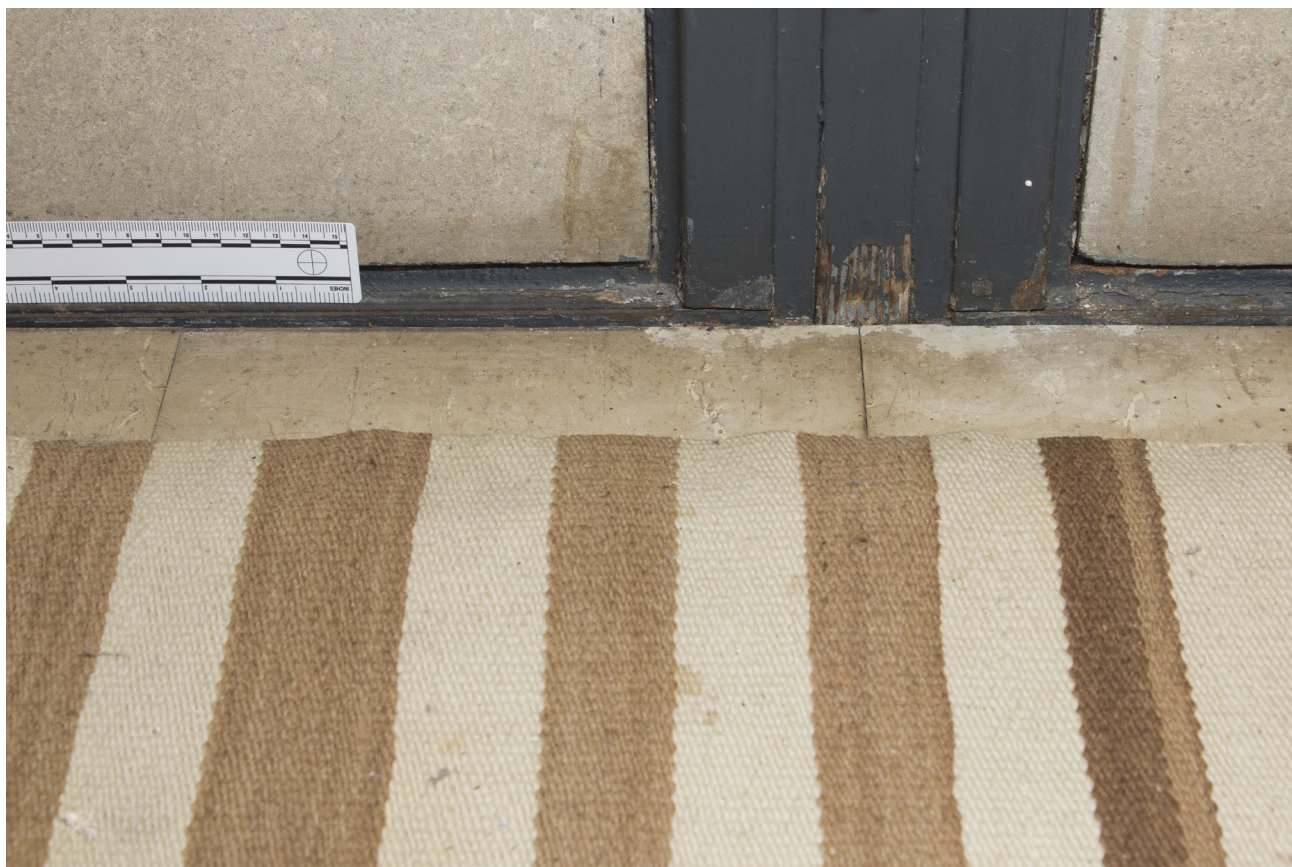
FIGURE 3.11 Example of rust in the lower corners of a steel frame surrounding Cemesto panels. Photo: Laura Matarese and Chandler McCoy, 2015. ©J. Paul Getty Trust.

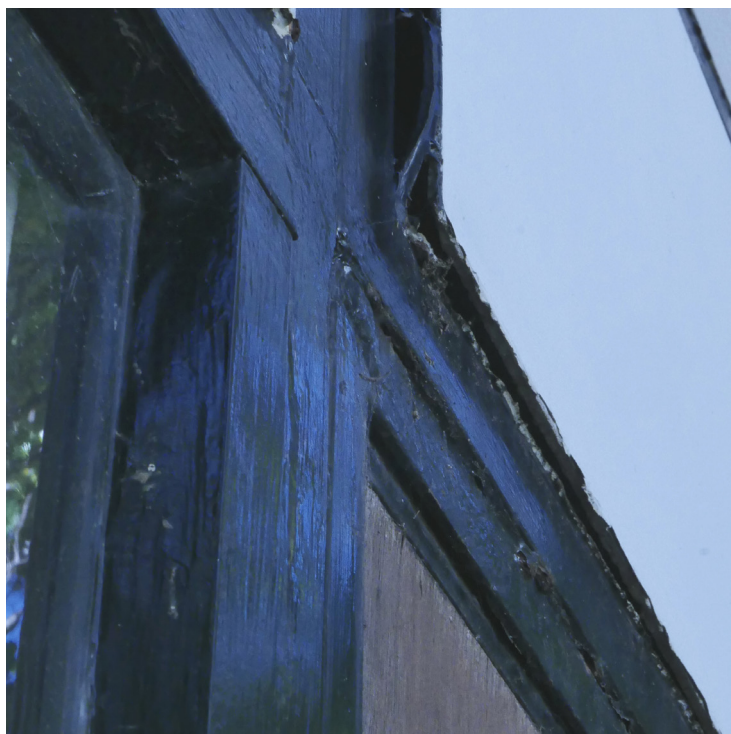
FIGURE 3.12 Panel on the residence exterior, north elevation, damaged after heavy rainfall in 2017. The outer asbestos-cement facing has been pushed out and detached from the Celotex fiberboard core, adhesive, and outer sealant. Photo: Laura Matarese and Chandler McCoy, 2017. ©J. Paul Getty Trust.

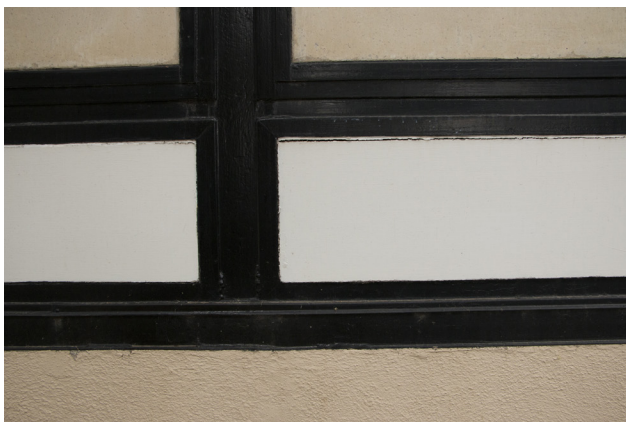
FIGURE 3.13 Panel SE-11, studio exterior, east elevation, in 2015, prior to detaching and falling off in 2017. Note the signs of cracking and breaking away at the top of the panel. Photo: Laura Matarese and Chandler McCoy, 2015. ©J. Paul Getty Trust.

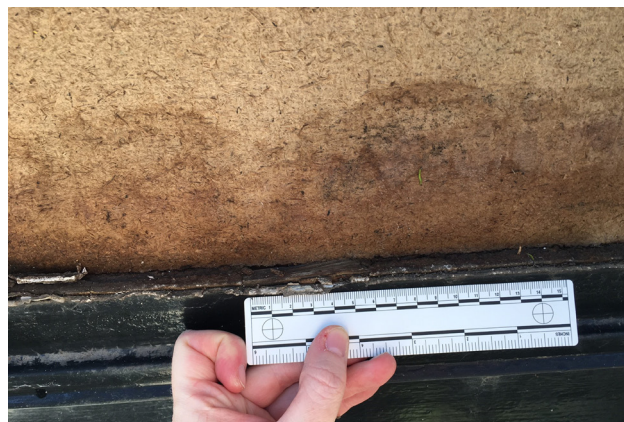
FIGURE 3.14 Panel SE-11 in 2017, showing damage after heavy rainfall. The Celotex fiberboard core, exposed when the exterior asbestos-cement facing fell off, was saturated with water. Wood shims were found to have been installed around the panel to hold it in place, as shown here under the exposed core. Photo: Laura Matarese and Chandler McCoy, 2017. ©J. Paul Getty Trust.

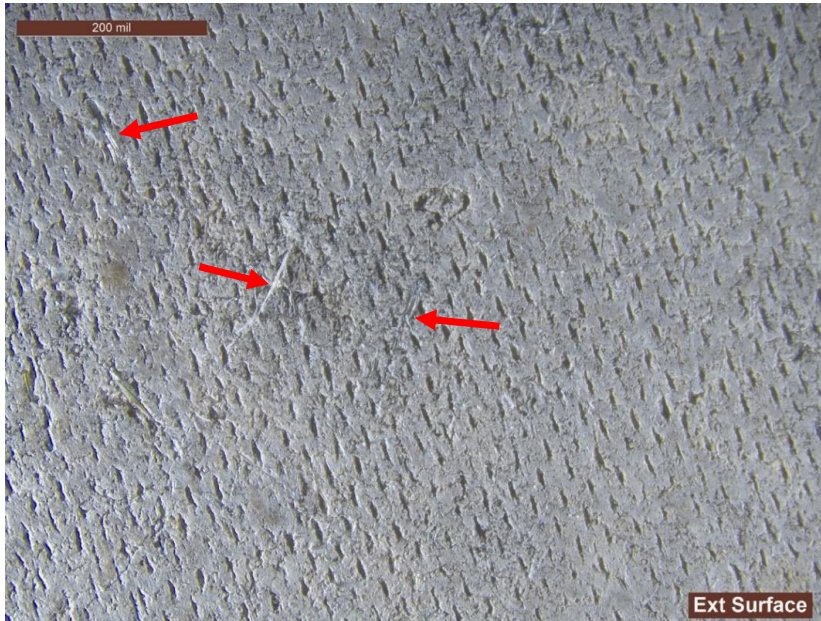
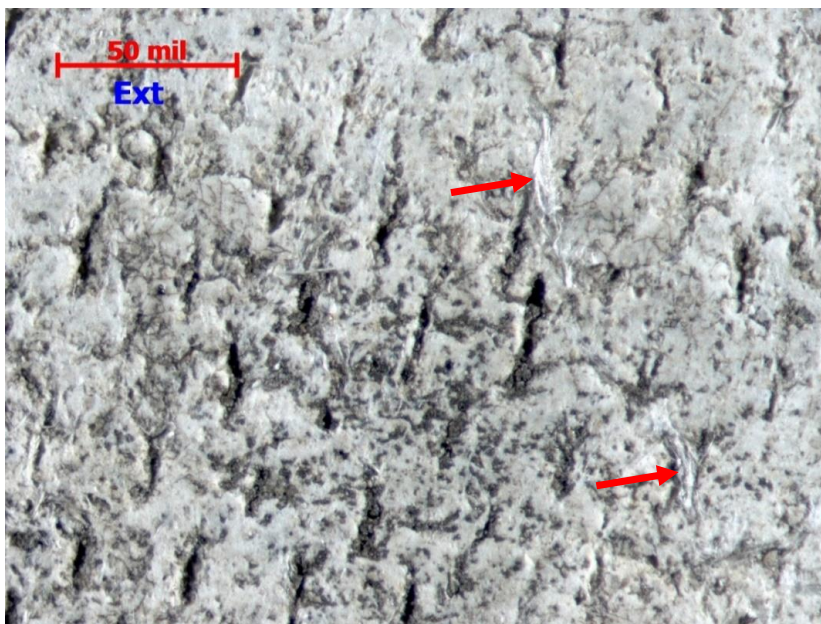
Figure 4. Sample D3. Close-up views of the exterior surface, as received. The black debris or spots were identified as residue of biological growth. Asbestos strands were often exposed (arrows). Thin, short, parallel indentations were cast from manufacturing and would be useful in improving paint adherence.

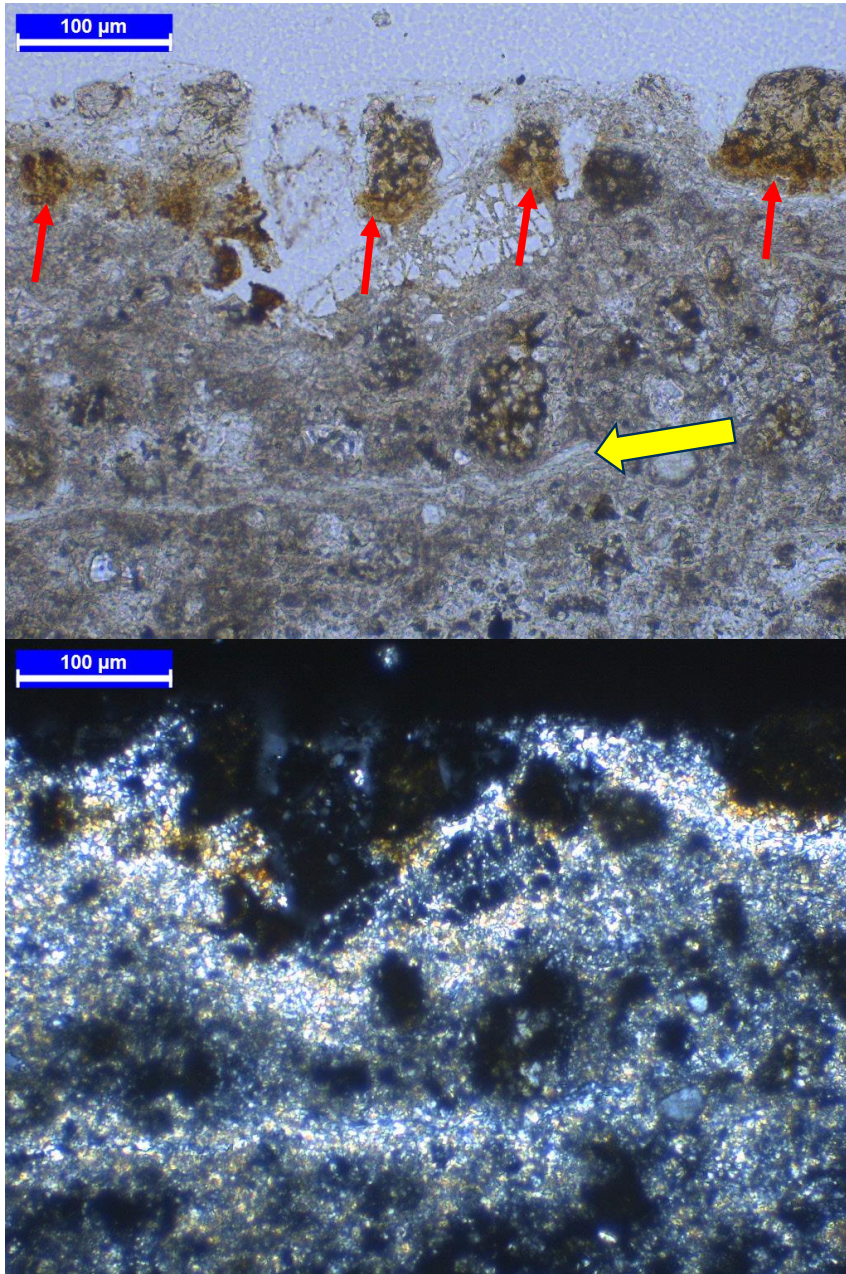
Figure 8. Thin-section photographs show a near-surface region of the exterior sheet where brown staining or discoloration was observed on the planar surface. The discoloration appeared to be caused by hydration or leaching of large near-surface cement particles (red arrows). Paste is partially carbonated and surficial paste appeared to be leached or decalcified. Yellow arrow indicates a thin asbestos strand, along which paste is carbonated as well. Top photo: plane-polarized light. Bottom photo: cross-polarized light.
