# Seismic Retrofitting Guidelines for the Conservation of Doctrinal Chapels on the Oyón Highlands in Peru

Patricia Navarro Grau, Julio Vargas Neumann, and Maribel Beas

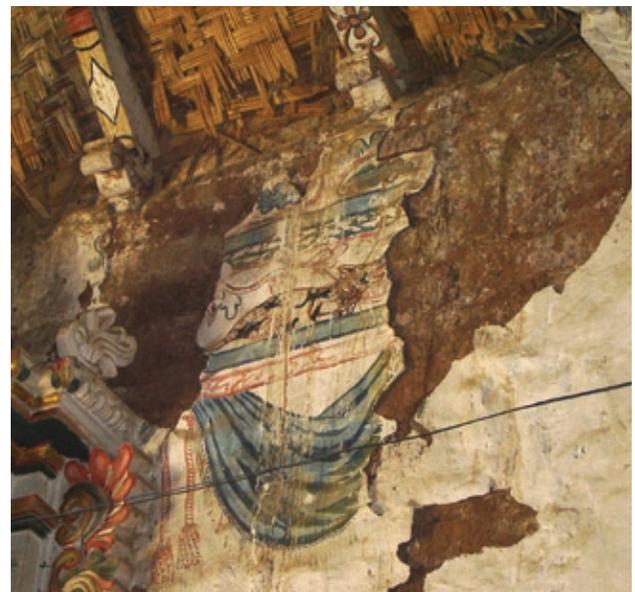
There are three sources of wall moisture in the chapels. The first one is rainwater that falls directly onto the roof. When the roof leaks, water reaches the walls. This moisture is concentrated in the upper sections of the walls and can be detected by the deterioration of mural painting and stucco in these areas (fig. 3). The second source is the effect of rainwater and wind falling laterally on the exterior walls, degrading the plaster and leaving the adobe support exposed to weather conditions. The third is rainwater moisture that rises through capillarity, causing significant damage on lower sections of the wall, especially inside the chapels where decorated finishes are found.

FIGURE 3 Moisture damage at the top of the walls, Rapaz Missionary Chapel.

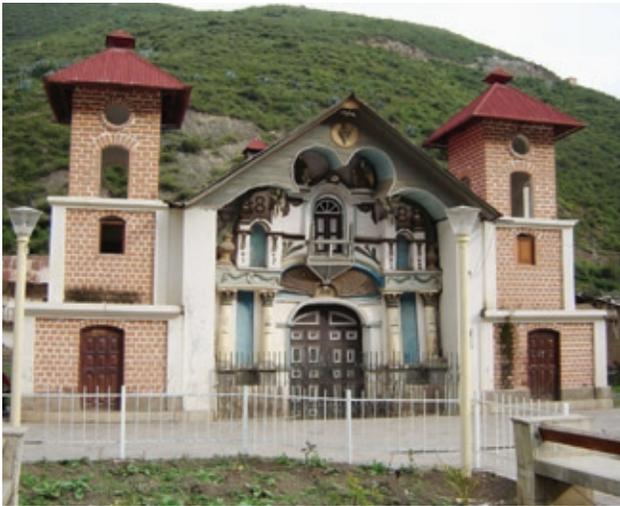
FIGURE 4 Incompatible materials used at Huacho sin Pescado Missionary Chapel.

through ignorance of adobe techniques and the incompatibility of materials, spend money trying to protect their chapels by using cement plaster on exterior and interior walls to prevent humidity penetration. New concrete elements (columns, towers, interior plaster) tied to the adobe walls have also been built (fig. 4).

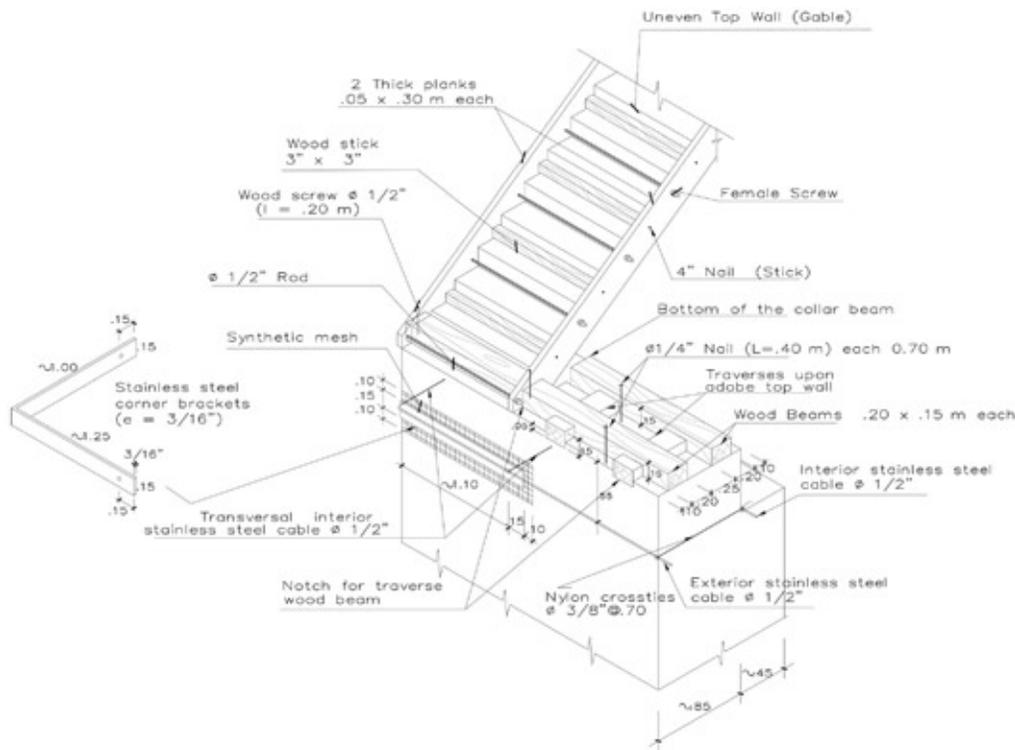
FIGURE 6 Design of a minimal intervention reinforcement for the Church of Rapaz (detail of upper corner).

On behalf of these goals, the following structural interventions have been decided upon (fig. 6).

There is a perimeter bond made of wooden elements on the main sacristy. On the side walls of the chapel, reinforcement consists of two parallel longitudinal pieces well connected by transverse wooden elements. Vertical constraint between the bond beam and the walls is achieved through 6 mm (0.23 in.) diameter and 0.60 m (23.6 in.) long forged iron nails. The main purpose of the beam is to achieve anchoring and continuity between the masonry walls and the wooden roof system, which rests on the side walls and the pair and knot trusses. Simultaneously, the pair and knot trusses rest on the longitudinal beam embedded in the wall, which transfers vertical and horizontal loads. It is expected that this continuity delivers the upper lateral restriction that the long side walls require during a seismic event that tends to overturn the walls. During the inelastic

The installation of perimeter horizontal cables on the interior and exterior surfaces of the walls produces a structural global confinement that is very effective in controlling crack development during earthquakes. The cables should be of stainless rather than galvanized steel, in order to prevent alkaline reactions when they are in contact with lime products, commonly used in stuccos and paintings. Cables will be concealed between the two roof structures previously described.

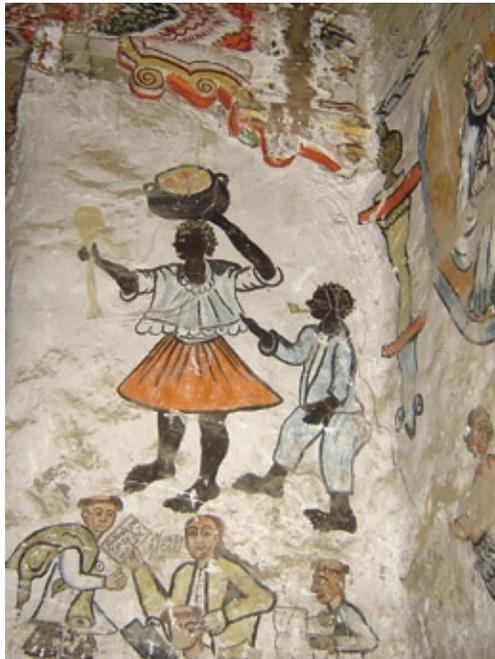
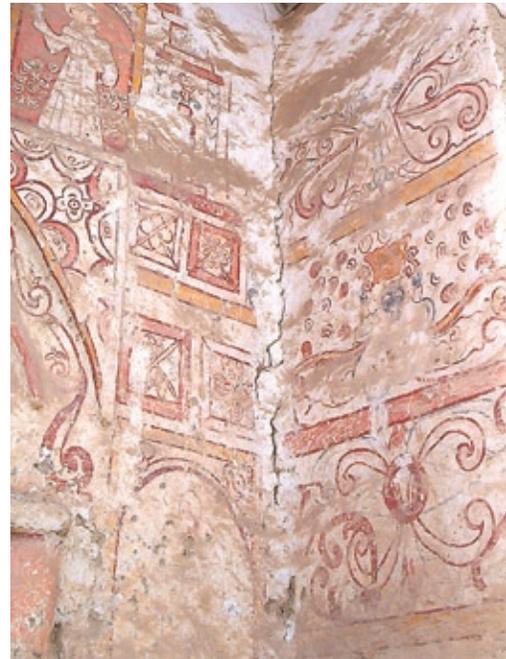
Moderate cracks are found along the chapel walls. This cracking is old but cumulative. Cracks are due to seismic activity and weather in the highlands, which, at an altitude of 4000 m (13,123 ft.) above sea level, are very cold and dry, with a heavy rainy season. Cracks are located at

wall intersections, wall joints, buttresses, and the corners of openings (door and windows). If new seismic activity should occur, the cracks will increase in number and size, forming wall segments separated by cracks. These segments will move independently, shifting until partial or total collapse of walls and roofs occurs.

The L-shaped floor plans of the chapels are asymmetrical and irregular. In the event of seismic activity, the walls tend to vibrate independently, and the stresses are concentrated at the wall joints because of the lack of flexure and shear deformation compatibility. These vertical lines at the wall intersections or at the wall and buttress junctions are the cause of major cracks evident in the chapels.

FIGURE 7 Typical vertical seismic cracks at the wall intersections, Church of Rapaz.

Because of the importance of the mural paintings along the interior and exterior walls (fig. 7), it is extremely difficult to repair these cracks without intrusion. The traditional solution for large crack repair was to demolish parts of the wall and rebuild them, producing an effective structural integration and recovering monolithic behavior. There are alternative repair methods yet to be developed, and studied in seismic tests in order to verify their effectiveness, such as sealing by injection of an adhesive grout. Use of grout injections that produce

rigid material, such as cement mortars, is not recommended because they create stiffness discontinuities in the masonry. These discontinuities would concentrate stresses and cause new cracks during an earthquake. The current state of the art of the injection technique does not guarantee the real structural integration of the walls that is needed to recover a monolithic behavior.

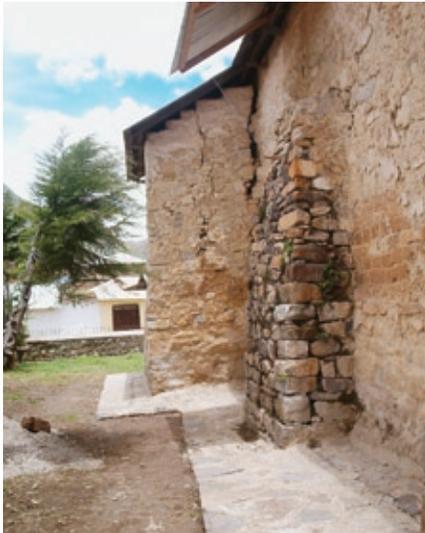
FIGURE 8 A perimeter stone walkway diverts water from the foundation walls.

- Avoid rainwater penetration by replacing the deteriorated metal roof sheets and enlarging or oversizing the washers at the points of attachment.
- Avoid rainwater penetration by installing new glass in the chapel skylight.
- Construction of a perimeter stone walkway that slopes away from the monument to prevent groundwater accumulation along the foundation walls (fig. 8).
- Conservation and consolidation of the retablos, wooden elements, main arches, and pulpits.

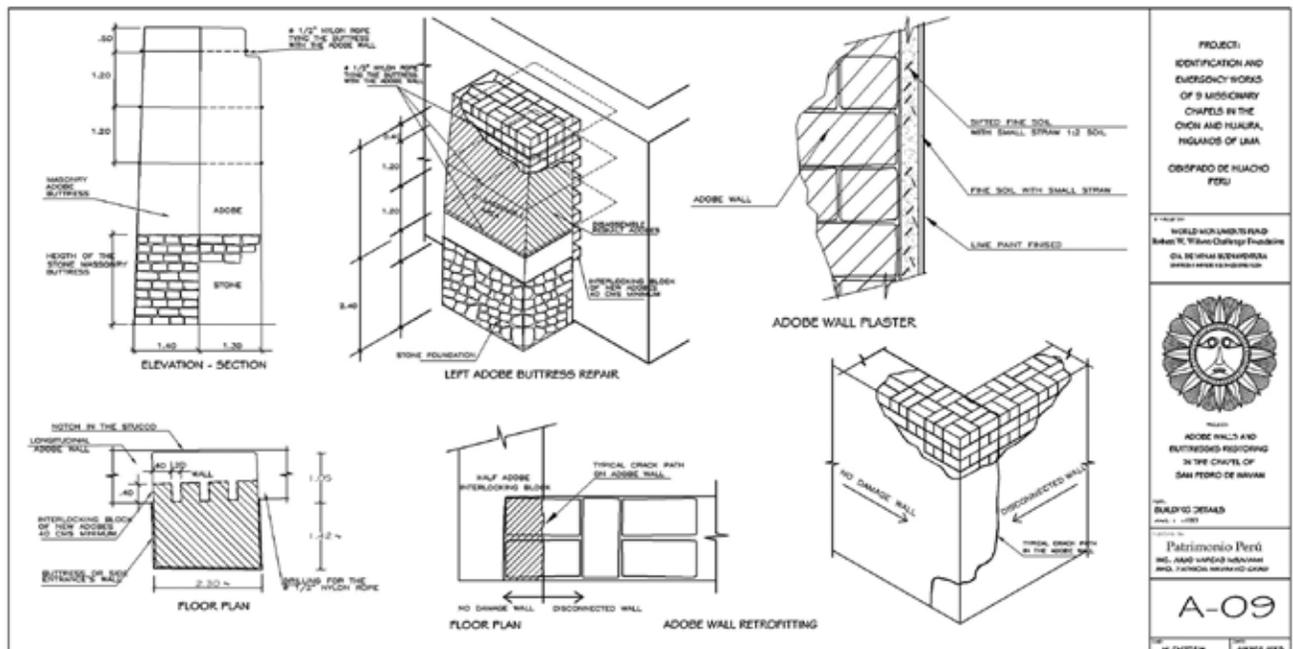
The San Pedro de Navan Chapel was one of the most damaged and unstable chapels in the area. We designed several restoration details (fig. 9), relying on engineer Julio Vargas Neumann’s expertise. Additionally, with the help of the community’s people, we were able to work on the following tasks relating to crack repair:

FIGURE 9 Retrofit design details, San Pedro de Navan.

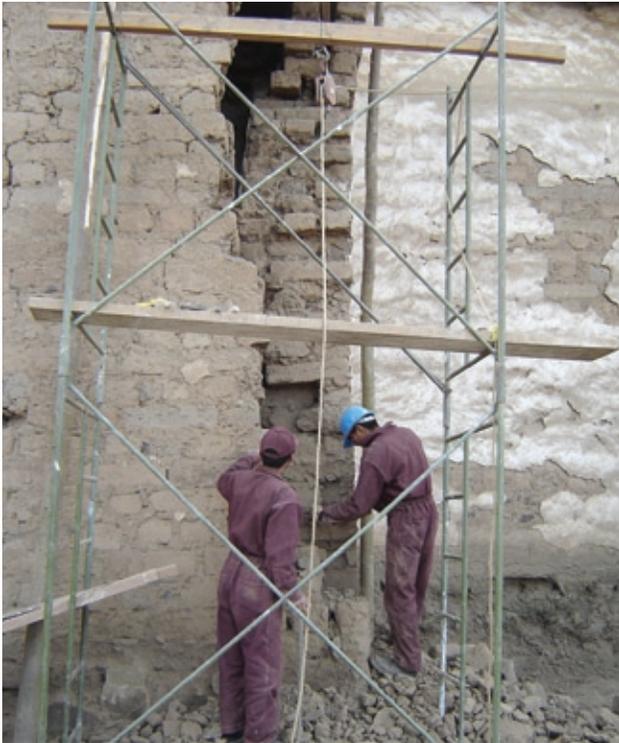
FIGURE 10 Damaged corner in the process of being demolished and rebuilt, San Pedro de Navan.

- Cracks in the sacristy and baptistry walls were repaired in the traditional way, since there was a lack of evidence of mural painting on the interior and exterior surfaces (fig. 10).
- We performed field tests to check strength and microcracking in the adobe, in an effort to optimize the seismic strength of the adobe masonry (Vargas N. et al. 1984; 1986, 257).

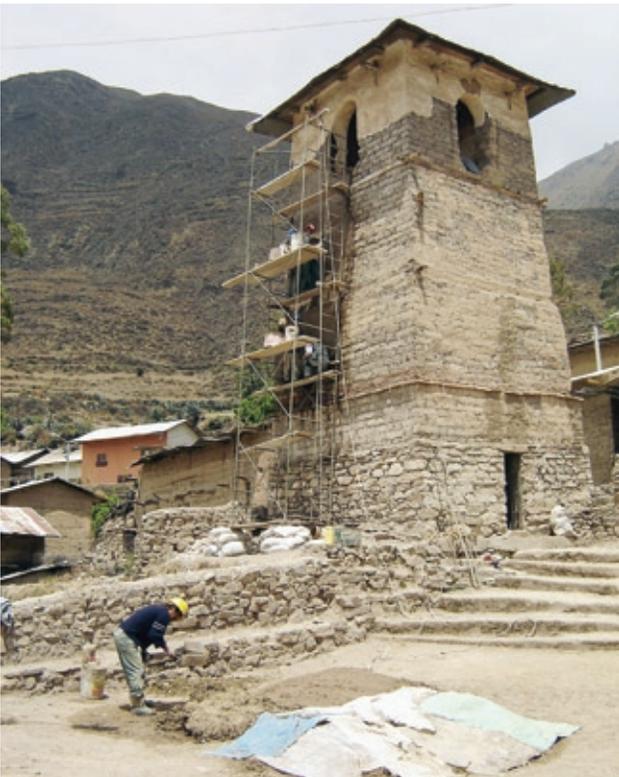
FIGURE 11 Bell tower in the process of being repaired, San Bartolomé de Curay.

The community of Curay asked Patrimonio Perú to restore the bell tower with funding by a locally operated mining company (fig. 11). We designed our working schedule in order to carry out the emergency works and the bell tower restoration at the same time. We had the hand labor of people in the community, and therefore we were able to instruct them on the earthen construction techniques and the field tests. Restoration of the bell tower included:

- removal of cement mortars
- filling of eroded areas with adobes and mud plaster
- application of mud and lime plasters
- application of color according to evidence found on the intrados of the high windows
