Application of Stability-Based Retrofit Measures on Some Historic and Older Adobe Buildings in California

Frederick A. Webster

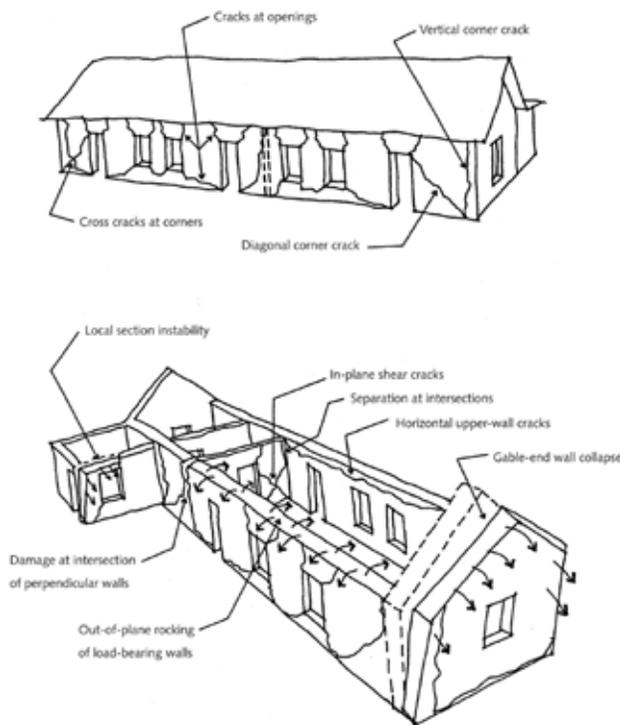
Out-of-plane damage is initiated as vertical cracks that form at the intersection of perpendicular walls. These cracks extend downward or diagonally to the base and run horizontally along the base between transverse walls. During an earthquake, walls rock out of plane, rotating about the horizontal crack at the base. As a consequence of out-of-plane wall motion, longitudinal walls pull away from the transverse walls. In many cases there is no physical connection at the intersection of longitudinal and transverse walls, because the walls were constructed by simple abutment.

FIGURE 3 Types of damage observed in historic and older adobe buildings. (Reproduced from Tolles et al. 1996, 20.)

Diagonal and x-cracks result from shear forces in the plane of the wall. These cracks are generally not serious unless the relative displacement across the cracks is large. These cracks represent a lessening of in-plane lateral stiffness, but unless a segment of wall on one side of the crack is in danger of losing purchase on the adjacent segment, such as at or near a corner, the gravity load path remains intact. Diagonal cracks also occur at the stress concentrations at the corners of doorways and windows and result from PGA levels as low as 0.1–0.2 g.

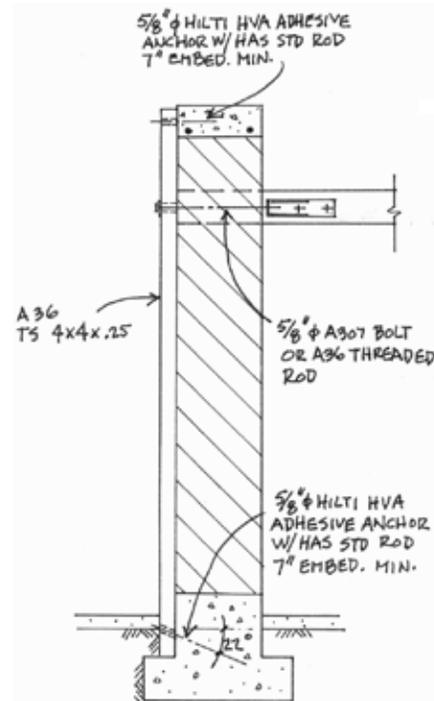
distress at the discontinuities of the bond beam. Three stability-based retrofit measures were utilized in this project:

FIGURE 4 Typical wall section of the Shafter Courthouse, showing continuity hardware interconnecting discontinuous bond beams.

Miscellaneous continuity hardware in the form of steel straps and brackets was used to tie the bond beams together at various levels. Tube steel posts were used to anchor discontinuous bond beam elements to continuous bond beam elements at a different elevation, as well as to the foundation (fig. 4).

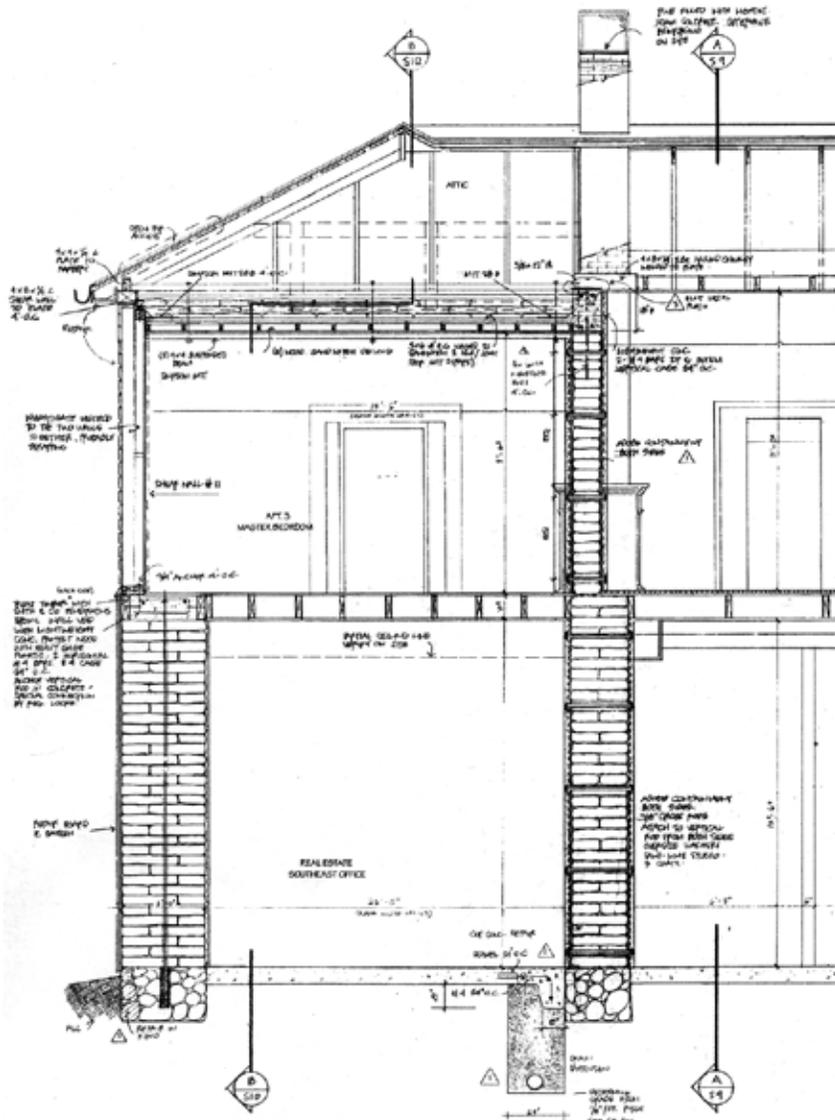
FIGURE 5 Salvador Vallejo Adobe wall and floor section, showing retrofit measures.

spalled adobe and bulging plaster could be seen. The south wall had serious coving damage resulting from rising damp. A few areas at the tops of the walls also showed erosion damage from roof leaks.

The design also provided wall steel-strap continuity at the second floor and a lightweight reinforced concrete bond beam at the roof level. Roof and floor diaphragms were upgraded where necessary. Other seismic upgrade measures for the Salvador Vallejo Adobe included:

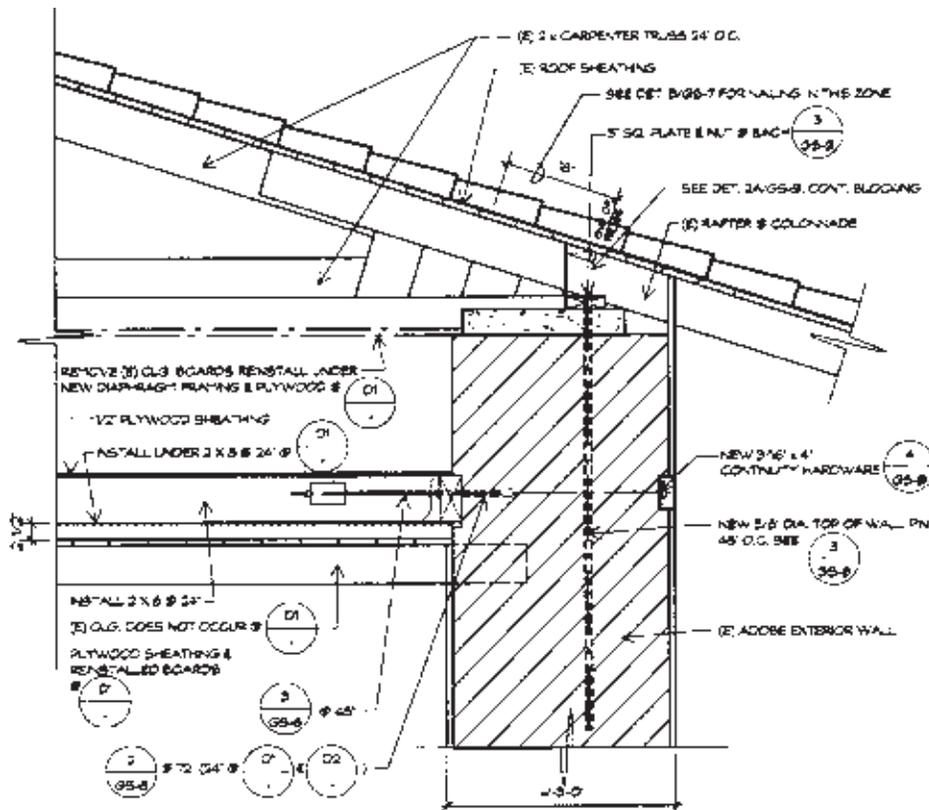
FIGURE 6 Typical top-of-wall stability-based measures for the Mission San Miguel gift shop.

Stability-based measures utilized in the phase 1 retrofit effort included adding structural continuity at the ceiling level, supporting out-of-plane overturning stability, and containing wall material. Thin stainless steel straps that were through-wall-tied with stainless steel all-thread rods to a continuous ledger beam on the inside surface were installed at the tops of the walls, to serve as continuity hardware. The through-wall ties also acted as top-of-wall anchorage in conjunction with

a plywood diaphragm installed at or just above the ceiling level. Overturning stability was accomplished with stainless steel top-of-wall pins 3–4 ft. (0.9–1.2 m) on center, in conjunction with the top-of-wall continuity strap and diaphragm. Containment of the friable top courses of the wall was provided by the top-of-wall pins in conjunction with the top-of-wall continuity hardware, through-wall-tied to the ledger beam and diaphragm on the interior. Figure 6 shows a typical top-of-wall section and the stability-based measures utilized in this first phase of the Mission San Miguel seismic upgrade.
