Salk Institute for Biological Studies Conservation Project: Teak Window Wall Assemblies

Phase 1: Research and Investigation Results
and Preliminary Conservation Proposals

Sara Lardinois

The Getty Conservation Institute

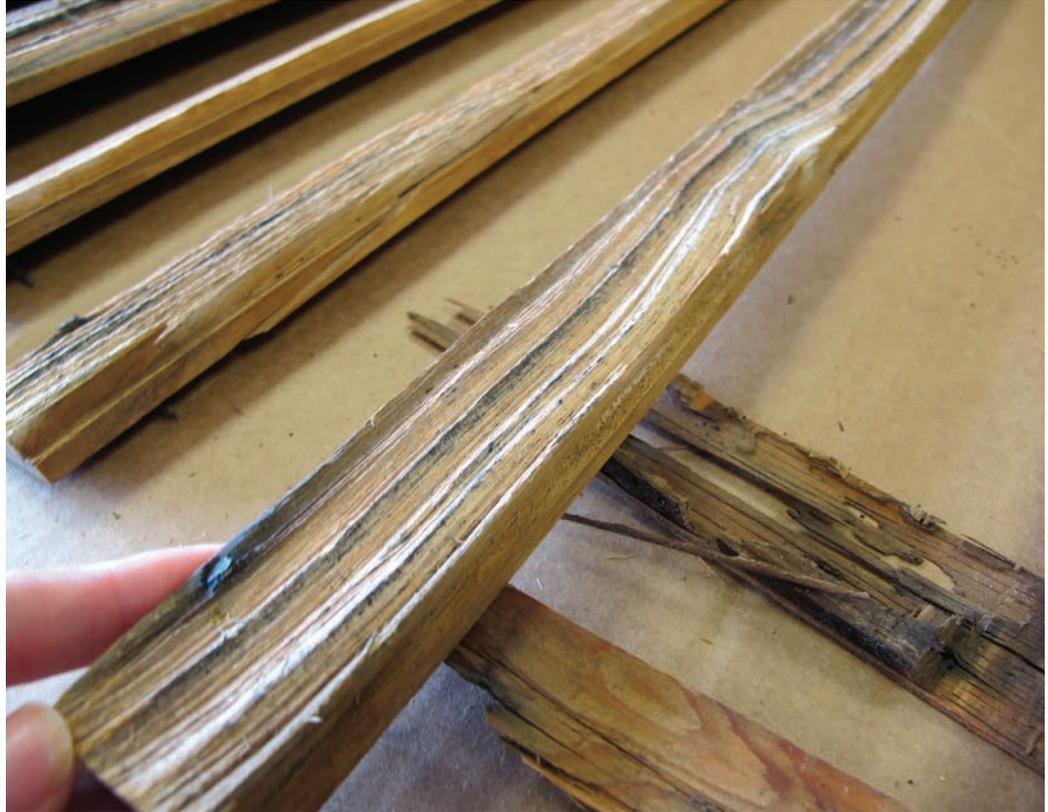
FIGURE 4.4
Vertical T&G boards from window wall assembly NO6K, which were blown out of place during a February 2014 storm. Note the severely deteriorated surface of the teak. Image: J. Paul Getty Trust.

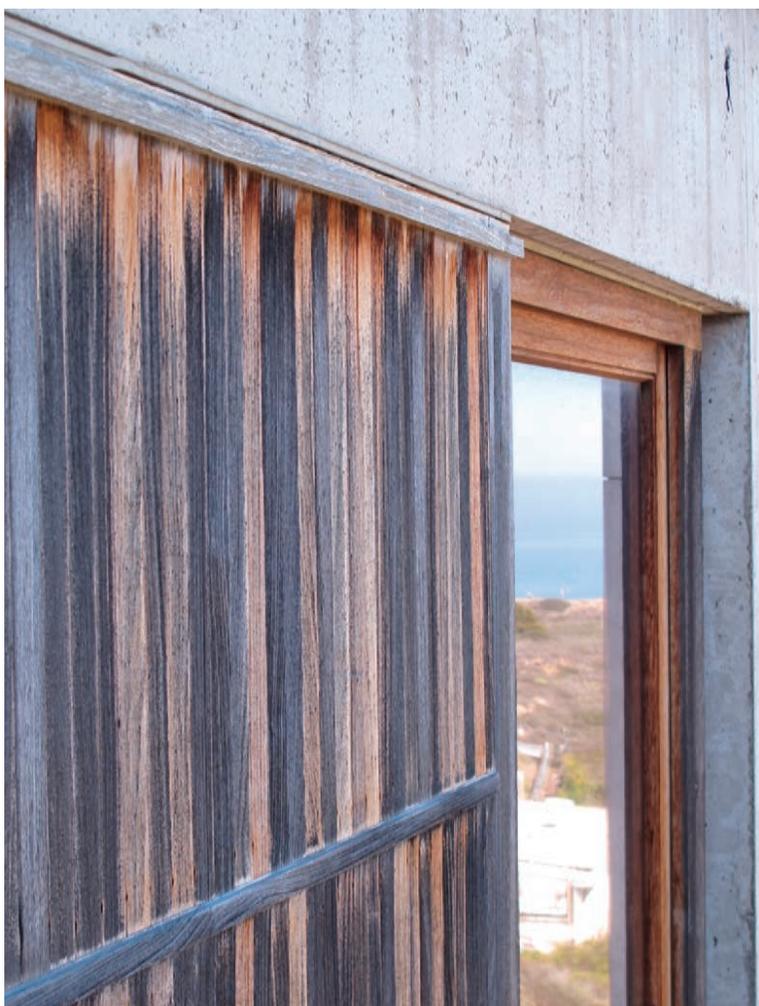
FIGURE 4.5
Vertical T&G boards from window wall assembly NO6K. The outer edge of the grooved piece has weathered away, giving the appearance of a shiplap rather than T&G joint. Image: J. Paul Getty Trust.

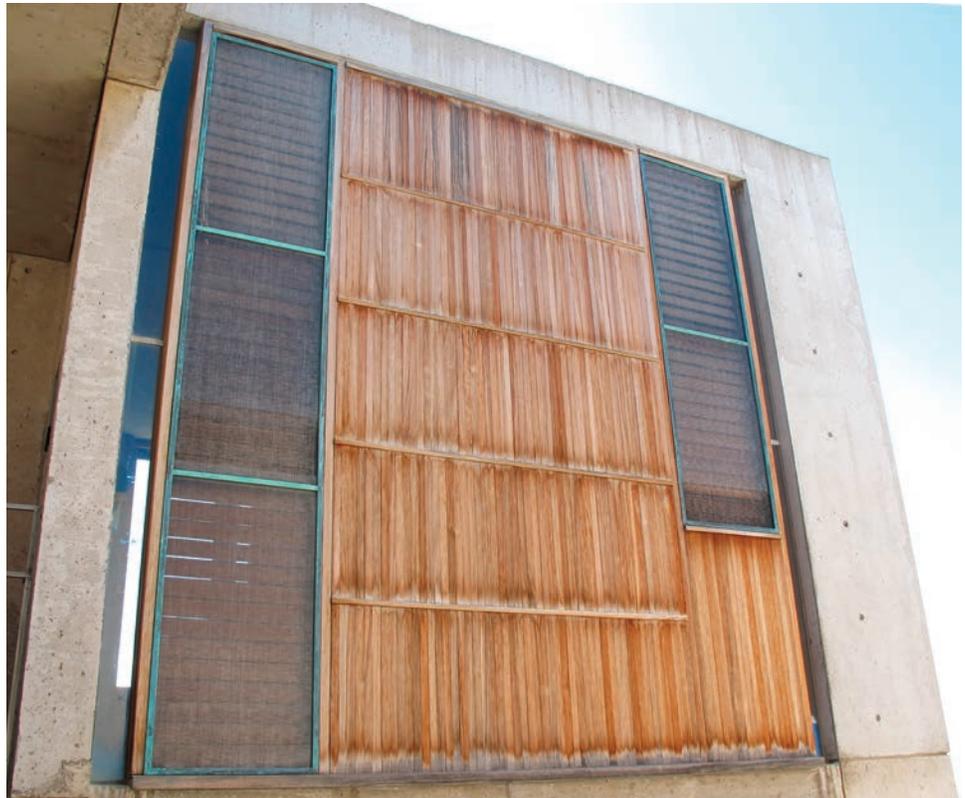
FIGURE 4.7
North wing office, north-facing window, sixth floor (NO6A). The teak exhibits minimal erosion, and the horizontal drips still overlap the tops of the vertical T&G boards. Image: J. Paul Getty Trust.

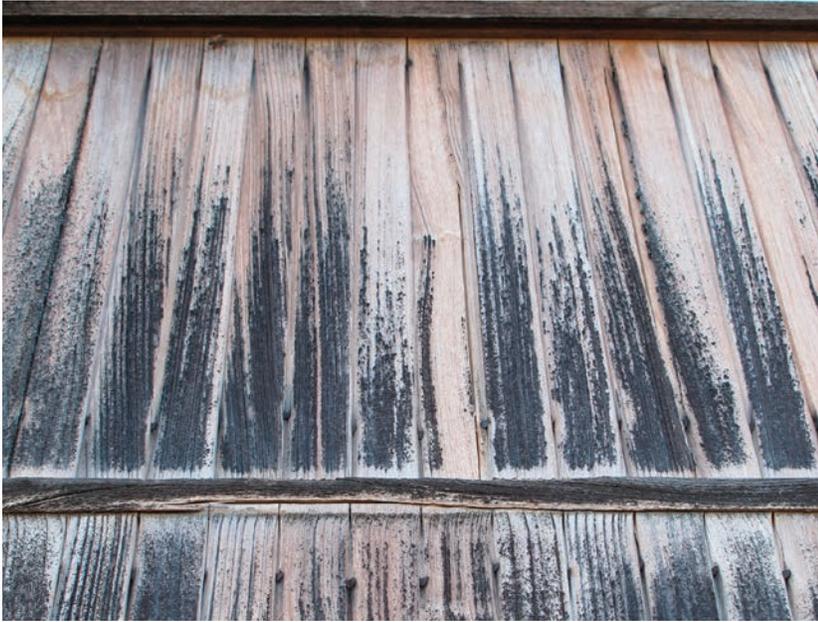
FIGURE 4.11
Detail view of a west-facing window in the northern west office wing (NO6J).
The fungal biofilm presents as a black, sooty material deposited on the surface
of the teak or in the cracks.
Image: J. Paul Getty Trust.

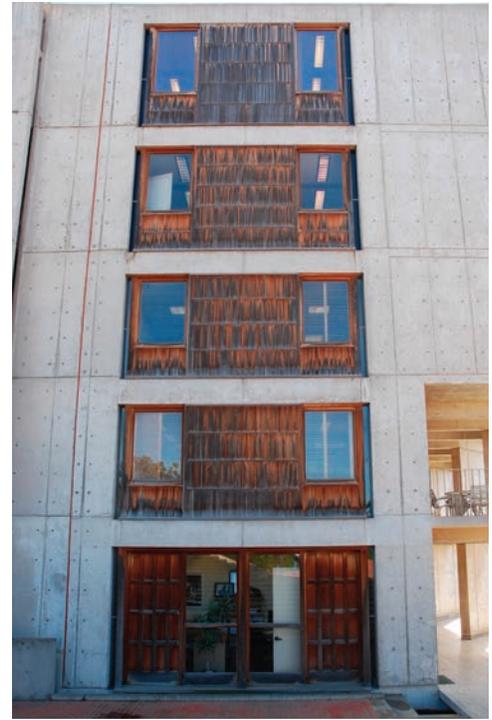
FIGURE 4.12
North elevation of the northern west office wing.
The heaviest growths of the fungal biofilm occur
on elevations with limited exposure to UV light.
Image: J. Paul Getty Trust.

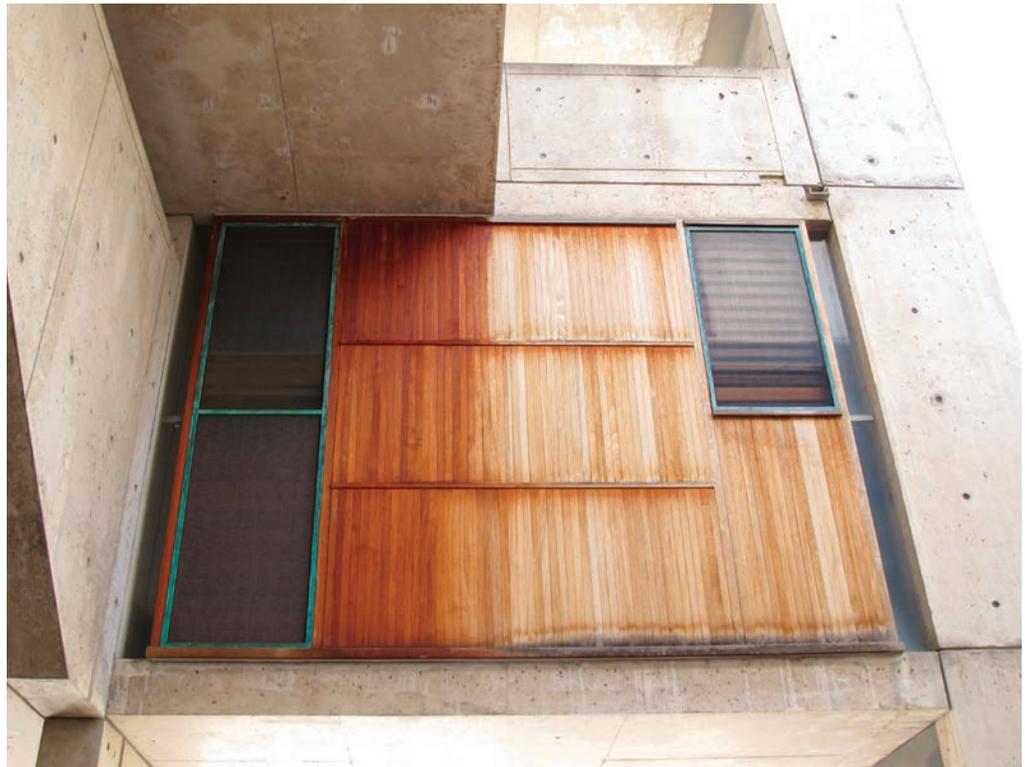
FIGURE 4.13
North study tower (4N), north-
facing lower study window
(NL3A). The overhang of the
walkway at upper left protects
part of the fenestration from
UV exposure, resulting in
differential weathering of the
later surface coatings.
Image: J. Paul Getty Trust.

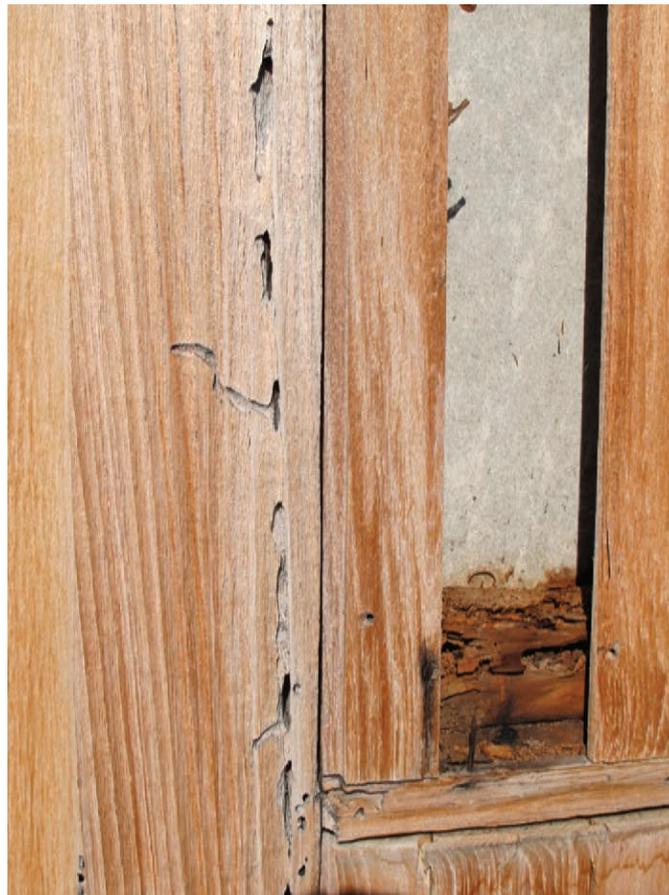
FIGURE 4.15
South study tower (7S), south-facing upper study window (SU6A). The second vertical siding member from the left has fallen out of place on both the second and fourth panels, due to surface erosion and failure of the adhesives that held this board in place.
Image: J. Paul Getty Trust.

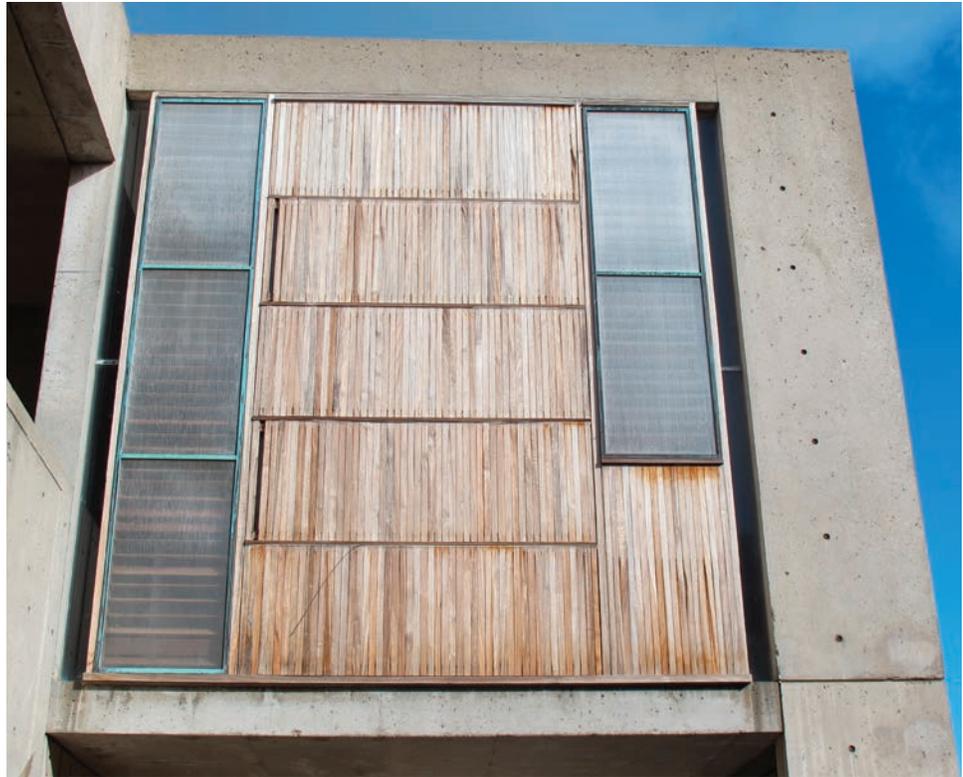
FIGURE 4.16
North wing office, sixth floor, south-facing window (NO6K). The project team investigates failure of the vertical siding boards and furring strips following a storm in February 2014.
Image: J. Paul Getty Trust.

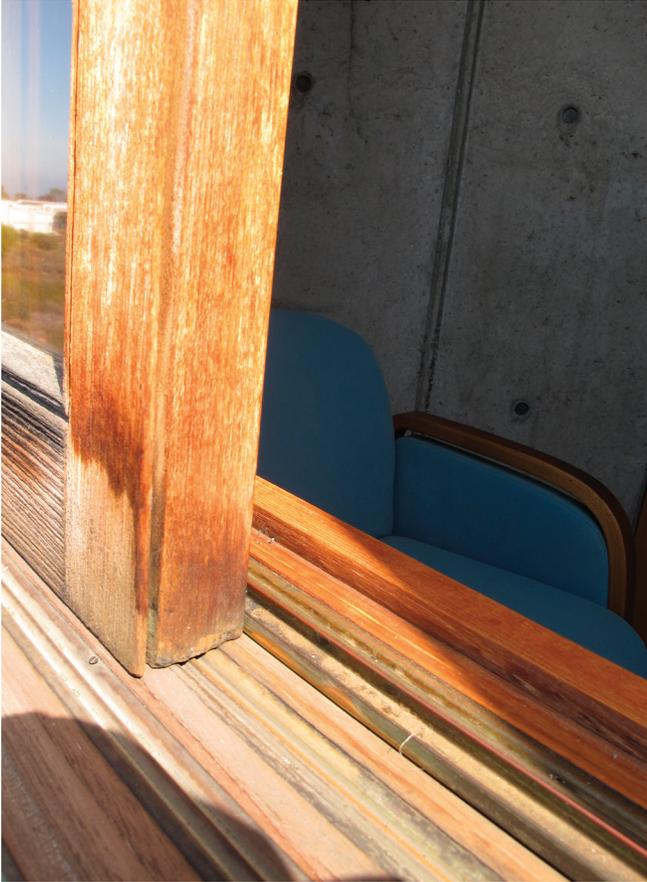
FIGURE 4.19 (TOP LEFT)
Southern west office wing, west-facing window (SO4B). Two bronze angles have been attached to the sill, directly behind the bottom rail of the window sash, in what is believed to be one of the earliest retrofits to improve the performance of the windows.
Image: J. Paul Getty Trust.

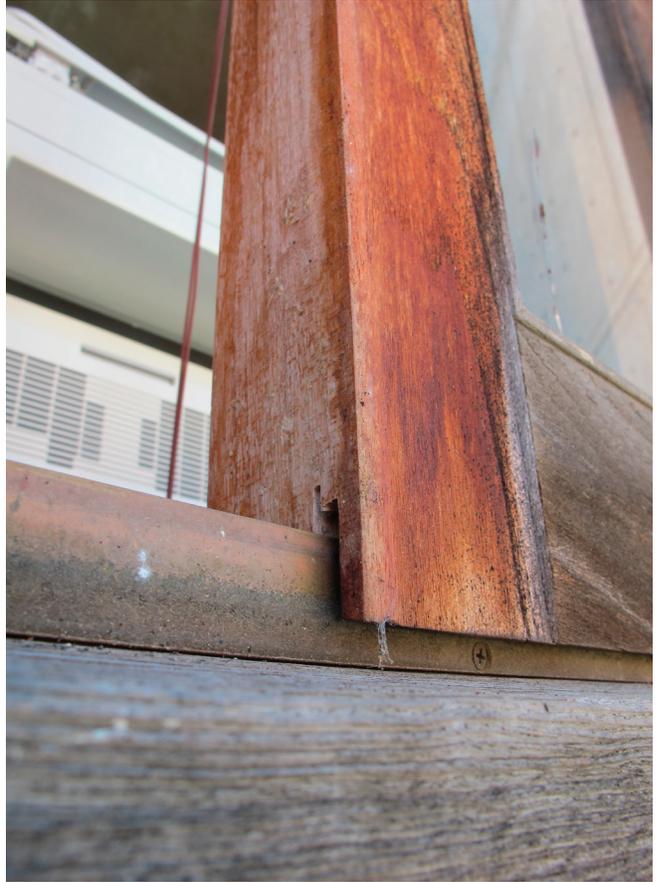
FIGURE 4.20 (TOP RIGHT)
South study tower (1S), north-facing lower study window (SL2C), showing the bronze metal strip installed at the exterior face of the track in an attempt to reduce water infiltration.
Image: J. Paul Getty Trust.

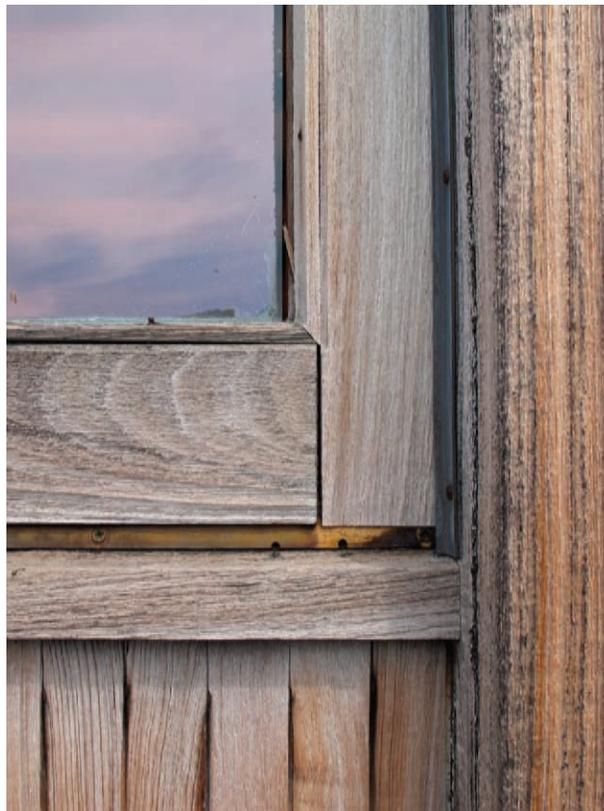
FIGURE 4.21 (BOTTOM)
Northern west office wing, south-facing window (NO6K). Vertical weather stripping has been installed at the right jamb in an attempt to prevent air and moisture infiltration.
Image: J. Paul Getty Trust.

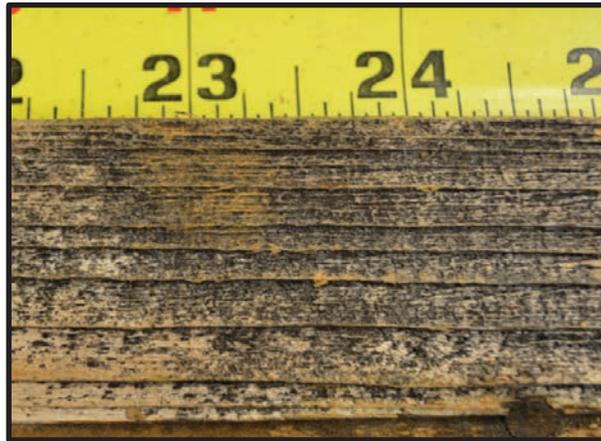
Figure 2.2. Detail of the bottom of specimen S from the Salk with erosion of the earlywood, likely due to a combination of natural processes and aggressive cleaning practices.

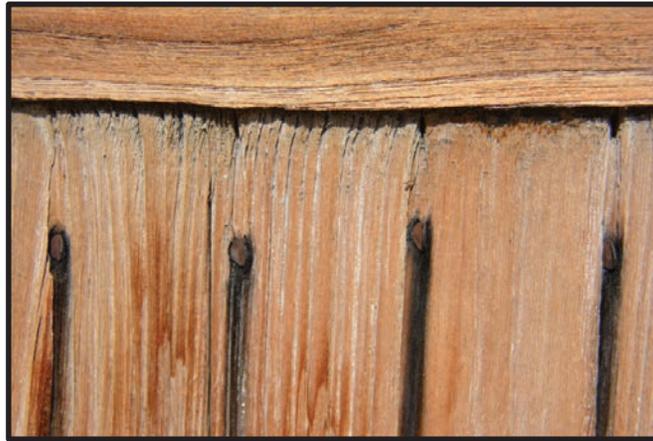
Figure 2.3. Stains on teak slats caused by a combination of moisture and a chemical reaction between extractives in the wood and the exposed metal fasteners after significant weathering occurred.

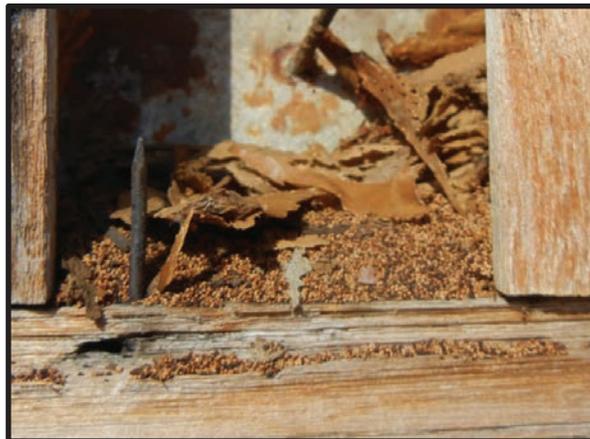
Figure 2.6. Frass found behind a teak slat removed for specimen analysis, study tower 10, NU7C.

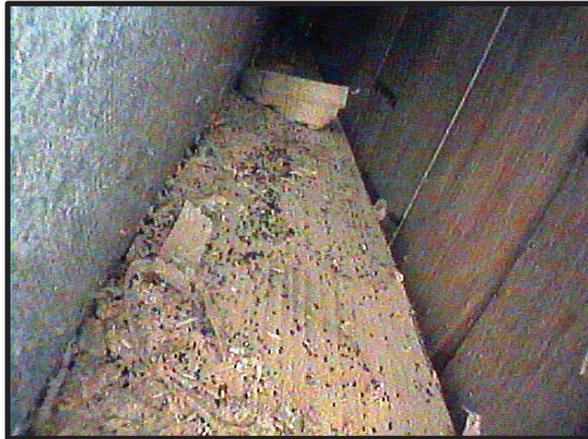
Figure 3.5. Videoscope image of interior fenestration cavity showing termite frass.

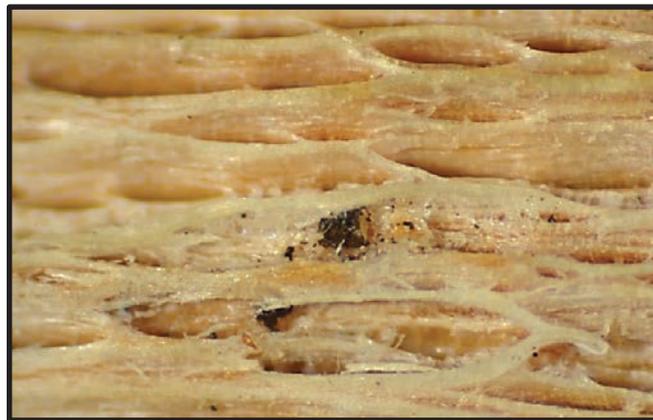
Figure 4.1. Specimen F, viewed under the stereomicroscope, showing weathered wood surface, open cellular structure, and weak cellular bonds. Note biological growth (center).

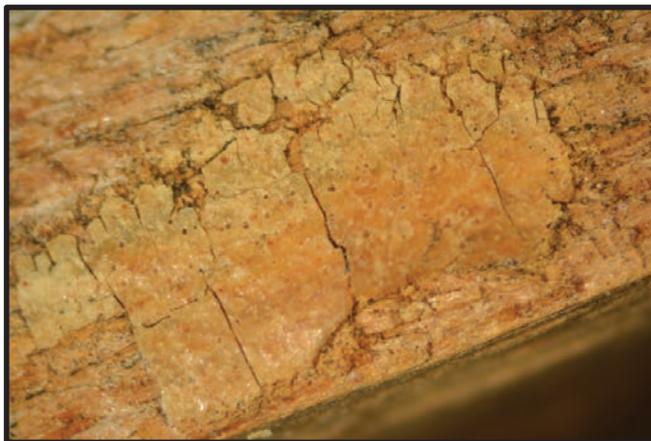
Figure 4.5. Specimen G showing remnants of an adhesive on the side face.

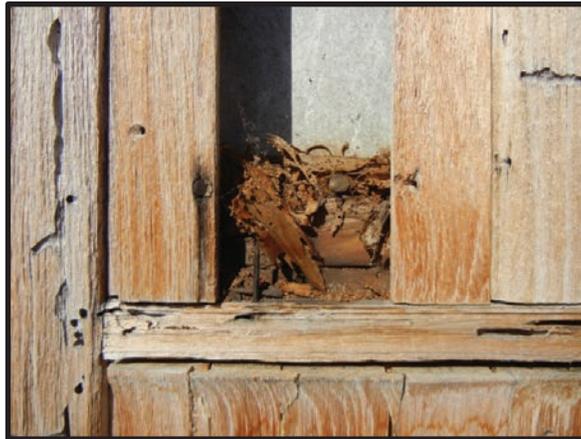
Figure 4.12. Location of specimen E and the surrounding teak slats showing superficial drywood termite damage.

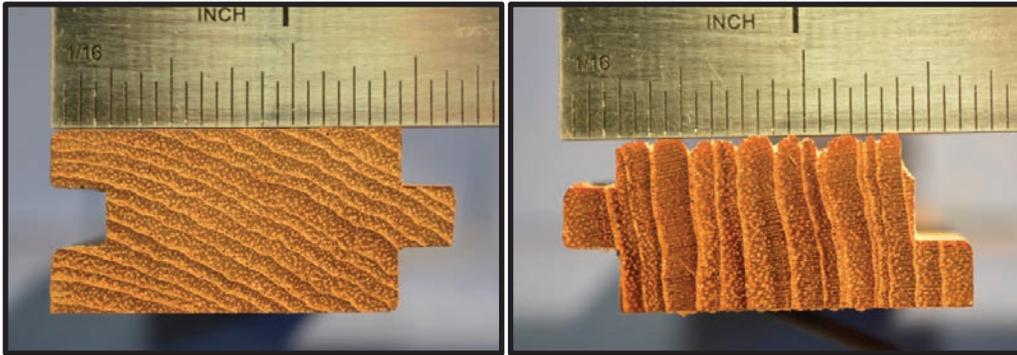
Figure 5.9. (Left) Specimen P, view of top, tongue-and-groove profile; (right) specimen W, view of top, apparent shiplap profile that erosion due to weathering has resulted in failure and loss of the top groove rail.

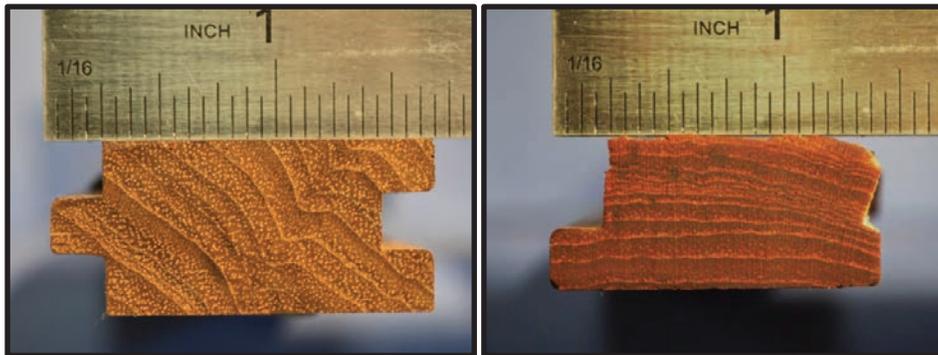
Figure 5.10. (Left) Specimen J, view of top, tongue-and-groove profile; (right) specimen G, view of top, apparent shiplap profile that erosion due to weathering has resulted in failure and loss of the top groove rail.

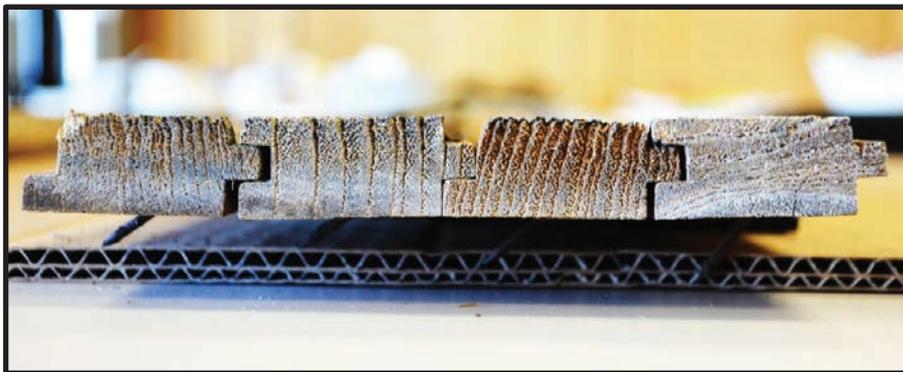
Figure 5.11. End grain of tongue-and-groove slats from panel that fell during a January 2014 storm. Note the loss of the upper groove rail on the slat, second from right.

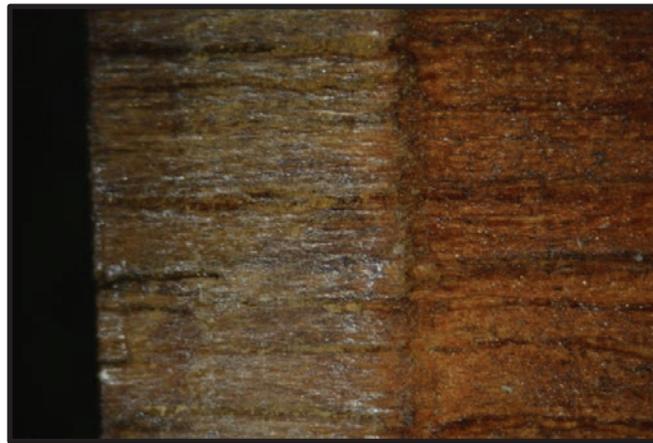
Figure 5.12. Specimen J showing the uncoated, protected top edge (left) and the surface treatment on the exposed face (right).

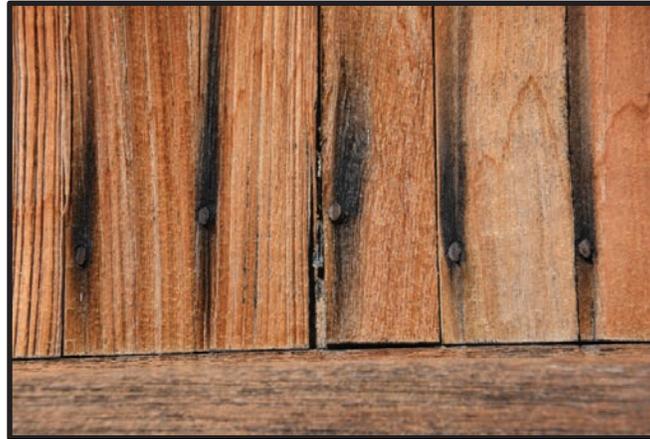
Figure 6.1. Vertical-sawn and rift-sawn slats on the left show a rough, ridged surface texture, while flat-sawn slats on the right show a smoother, more uniform appearance. The black stains are due to corrosion of the nails, not to the cut of the wood.

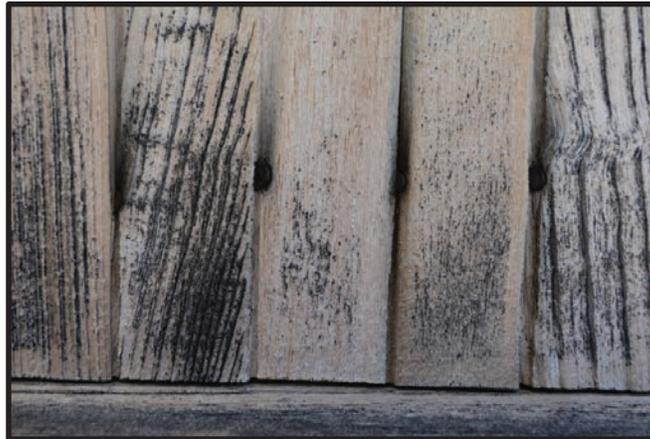
Figure 6.2. Two flat-sawn slats with minimal biological growth adjacent to rift-sawn and vertical-sawn material with more concentrated biological growth.

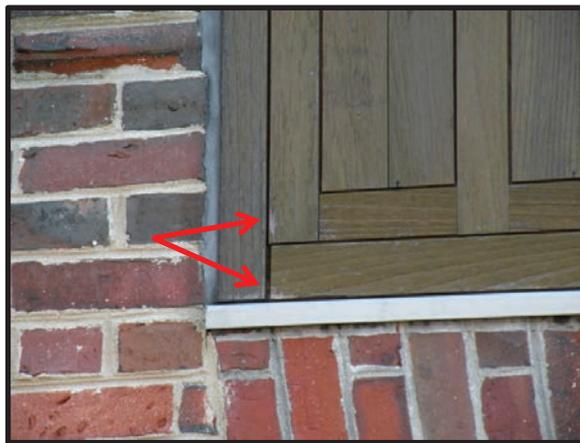
Figure 7.7. North elevation, first-floor teak fenestration unit. The arrows indicate where that the treatment has begun to fail.
