FORT SELDEN
ADOBE TEST WALL PROJECT
PHASE I
FINAL REPORT

FORT SELDEN STATE MONUMENT
RADIUM SPRINGS, NEW MEXICO

ANNE OLIVER
HISTORIC PRESERVATION AND ARCHITECTURAL CONSERVATION
SOCORRO, NEW MEXICO

JULY 2000

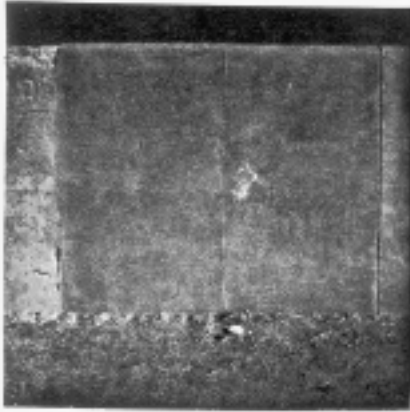
Example of Very Little Erosion
(1S2)

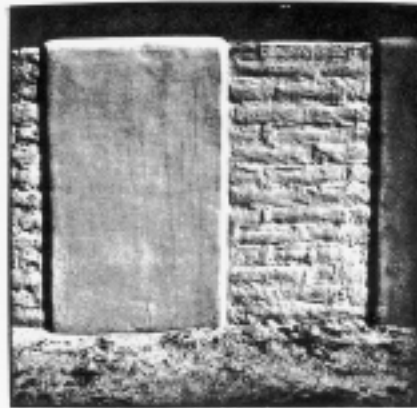
Example of Little Erosion
(2E5)

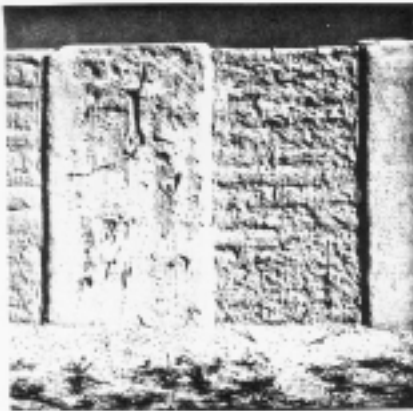
Example of Moderate Erosion
(2E7)

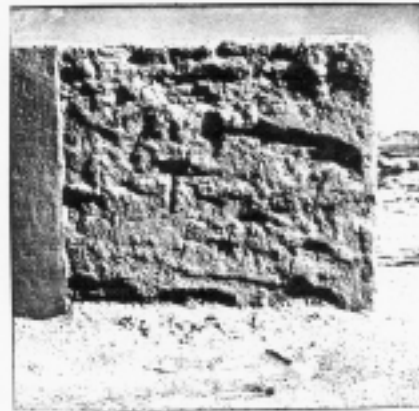
Example of Serious Erosion
(2W1)

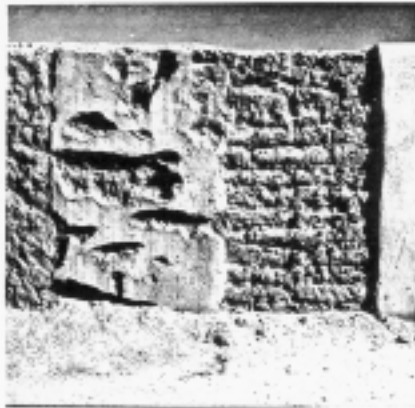
Example of Very Serious Erosion (2W12)

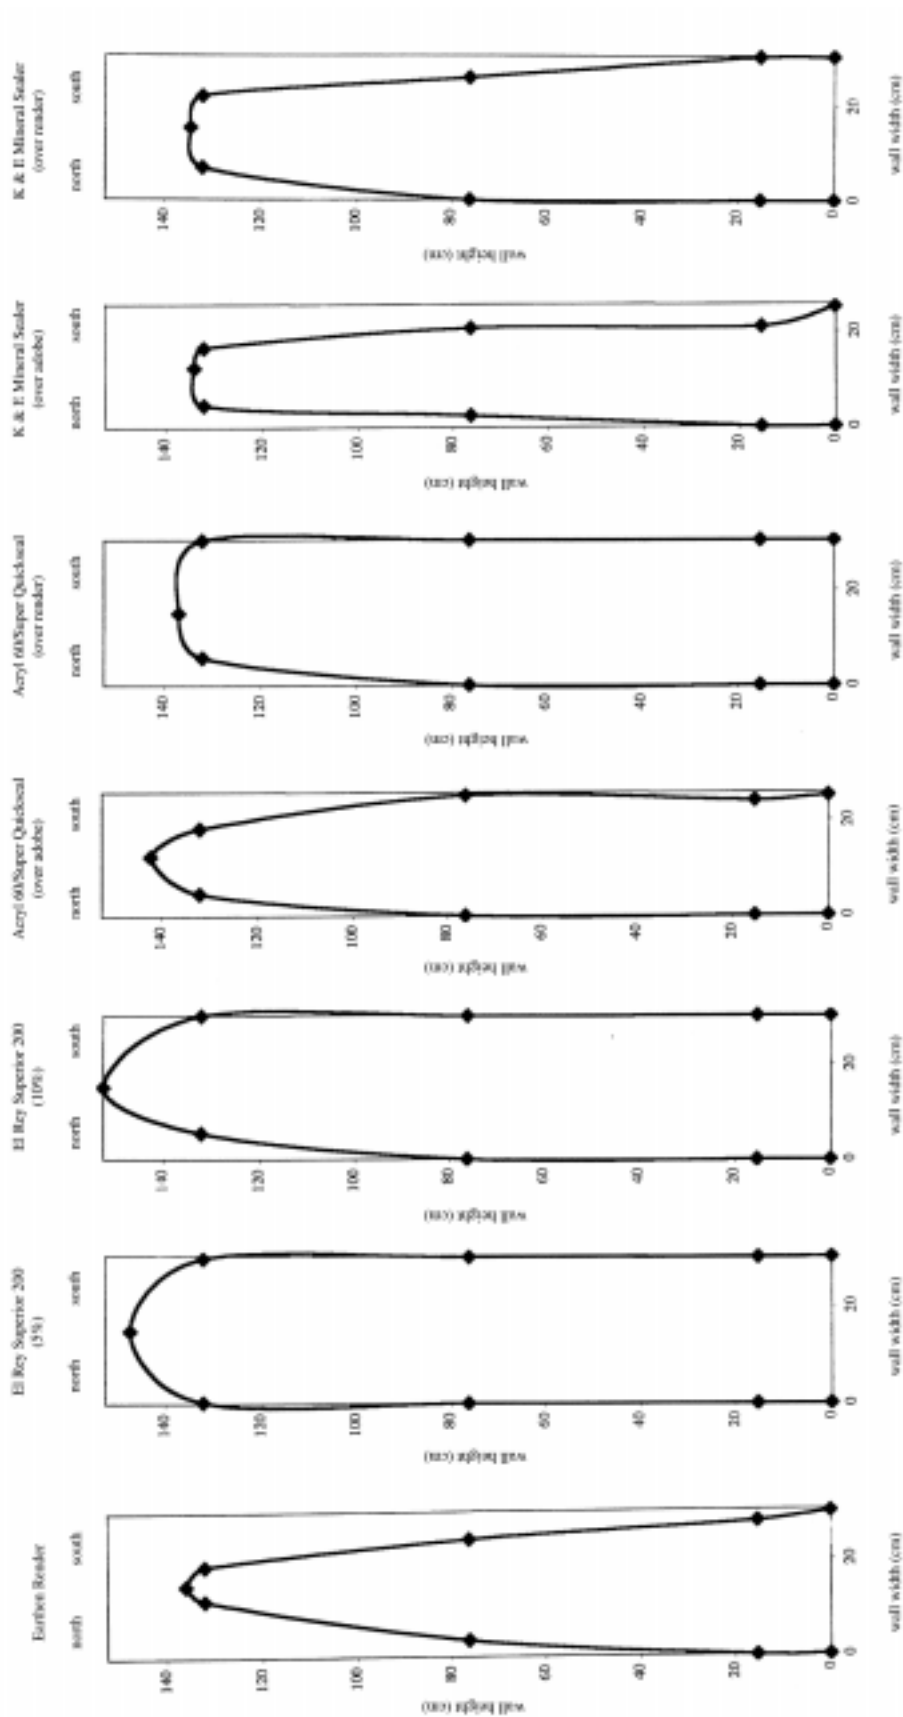
Within each panel, wall tops always displayed the greatest erosion. In fact, most of the monitoring rods have been lost from the top of the west wall face, a testament to the fact that it was the most exposed to wind and precipitation. Erosion at mid-wall was generally low and similar to erosion at the wall base when those rods were exposed. However, most of the wall base rods were buried beneath grade due to the deposition of material from the eroding panel above and the accumulation of wind-blown particulate. Thus many of the wall bases at this height have essentially been backfilled and erosion has stopped. Wall base rods on the south face of test wall 1, the most sheltered exposure, were exposed because erosion on the wall above was minimal and wind-blown deposits did not accumulate. Despite remaining exposed, wall base erosion on the south face was low except on panels 9 and 12 (agave juice and Seal-Krete) which displayed poor overall erosion resistance.

Figure 4a. Cross sections of representative panels from test wall 1, the protective coating experiment, which were derived using the 2000 data from the aluminum monitoring rods installed in the walls during construction. The rectangular outlines indicate the approximate original dimensions of the walls and the heavier lines the approximate present dimensions of the walls. The cross sections are taken through panels 1 (unamended earth), 2 (earthen render amended with El Rey Superior at 5% and 10%), 5 (adobe and earthen render sprayed with Acryl 60 and then coated with Super Quickseal) and 6 (adobe and earthen render sprayed with K & E Mineral Sealer).

Nevertheless, it can be observed that amended earthen renders, and El Rey Superior 200 in particular, provide the best erosion resistance. On all exposures, almost no material has been lost from the vertical faces of the walls while the wall tops are often at their original height. Roll-on coatings applied over earthen renders, as illustrated by Acryl 60/Super Quickseal, provide a comparable level of protection on the vertical wall faces but do not protect the wall top much better than unamended earthen render. Roll-on coatings applied directly to the adobe walls do not perform as well, although they do provide more erosion resistance on vertical wall faces than do unamended earthen renders or sprays. Spray coatings applied over both adobe and earthen render, as typified by K & E Mineral Sealer, appear to provide a small increase in erosion resistance in comparison with unamended earthen renders. However, this is contradicted by qualitative observations: the spray applications tend to fail completely in localized areas a short time after application, and provide much less overall erosion resistance than the unamended earthen renders.

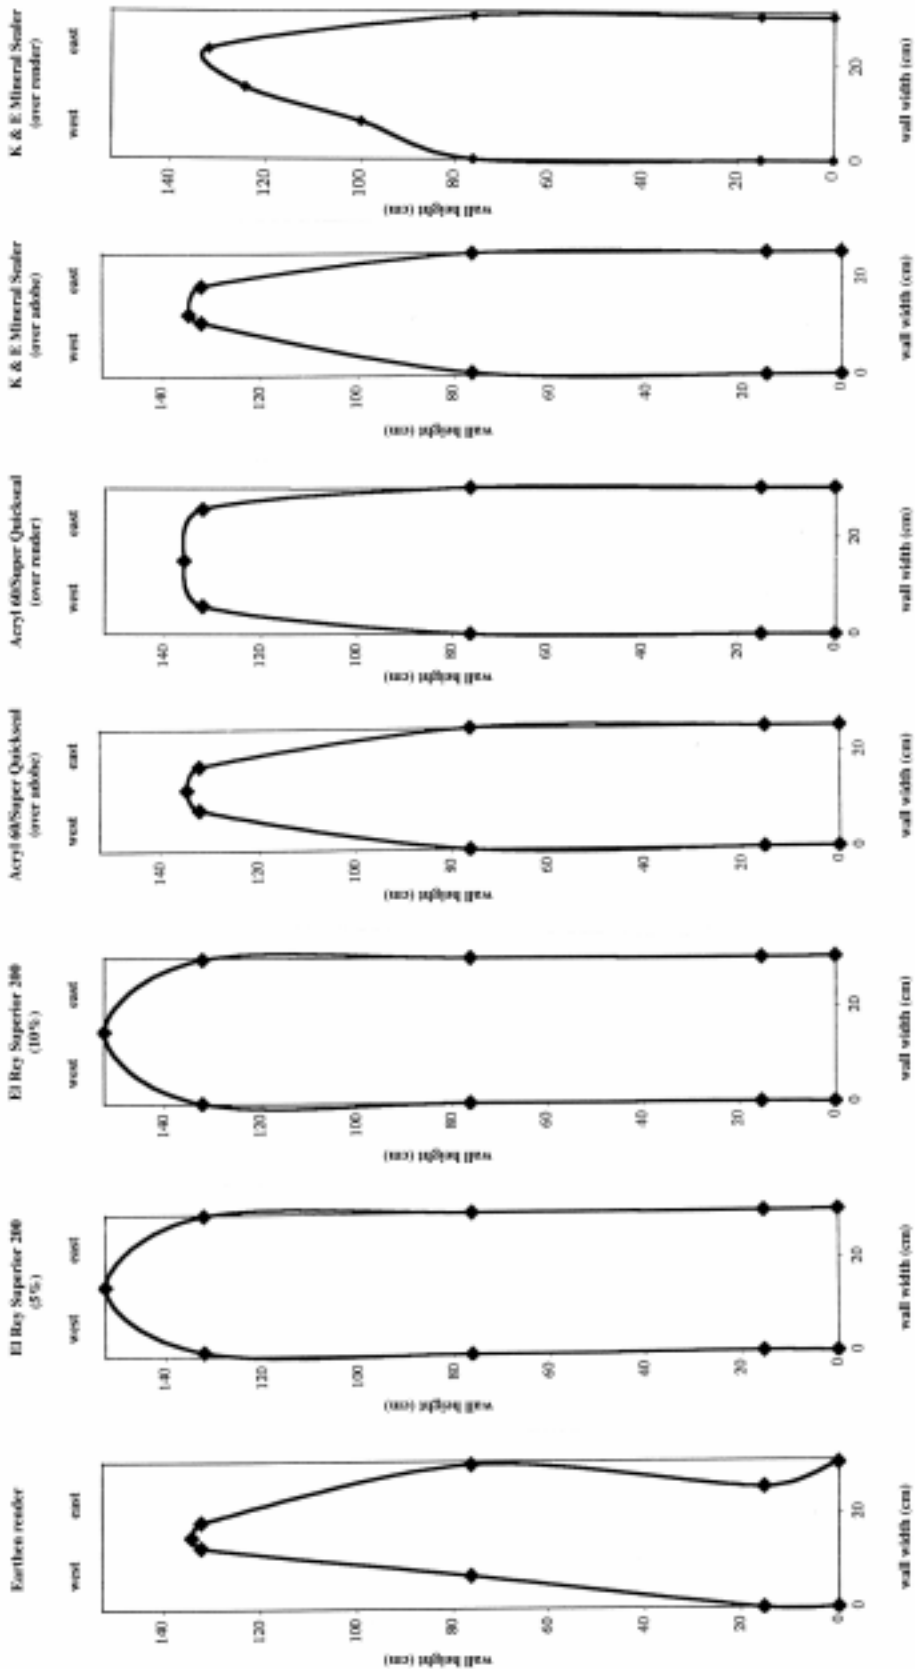
Figure 4b. Cross sections of representative panels from test wall 2, the protective coating experiment, which were derived using the 2000 data from the aluminum monitoring rods installed in the walls during construction. The rectangular outlines indicate the approximate original dimensions of the walls and the heavier lines the approximate present dimensions of the walls. The cross sections are taken through panels 1 (unamended earth), 2 (earthen render amended with El Rey Superior at 5% and 10%), 5 (adobe and earthen render sprayed with Acryl 60 and then coated with Super Quickseal) and 6 (adobe and earthen render sprayed with K & E Mineral Sealer).

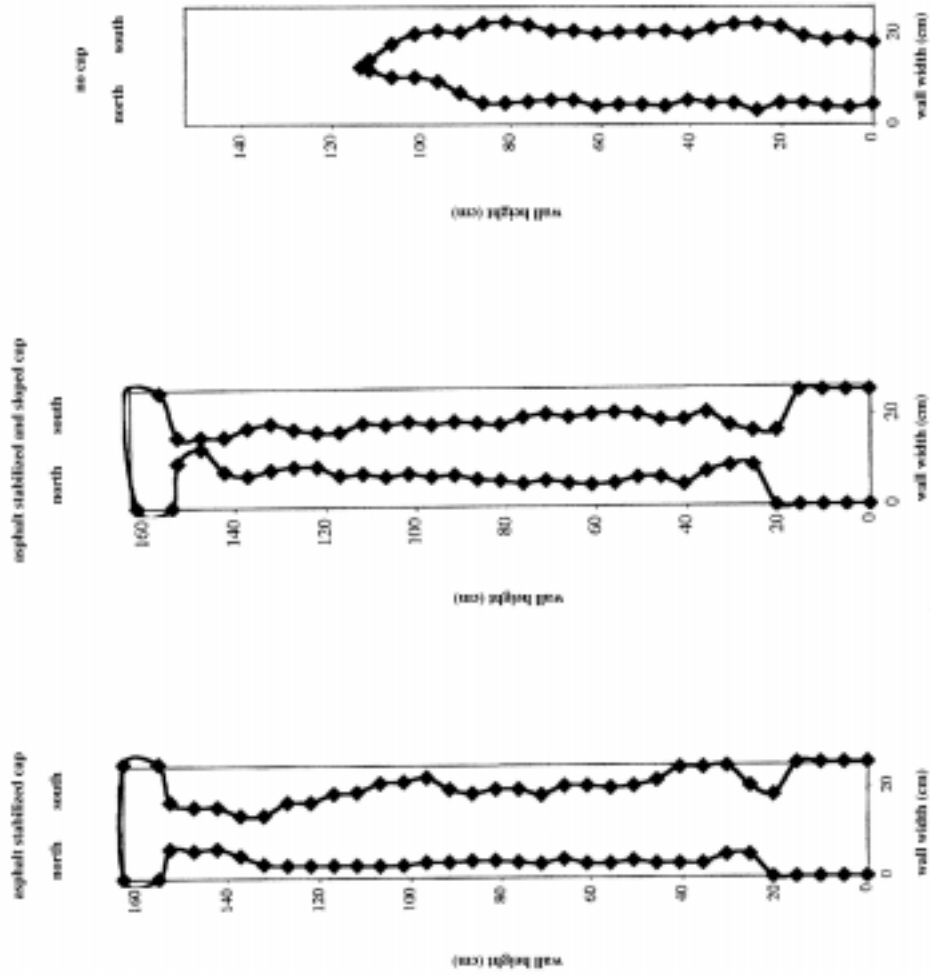
The cross sections illustrate that caps do reduce erosion on the wall tops. After fifteen years of exposure, the walls beneath the two caps have lost no height, while the uncapped wall has lost 23% of its height. The cross sections also illustrate that of the two remaining capped walls, the wall with the asphalt stabilized (and unsloped) cap displayed the least erosion on the upper vertical wall faces.

Figure 5. Cross sections of the two remaining caps on test wall 3, the wall cap experiment, and test wall 5, the uncapped control, which were derived from field measurements taken in July 2000. The rectangular outlines indicate the approximate original dimensions of the walls and the heavier lines the approximate present dimensions of the walls; none of the walls were rendered. The cross sections are taken through panels 3(N/S)1 (asphalt stabilized cap), 3(N/S)2 (asphalt stabilized and sloped adobe cap), and 5(N/S) (no cap).

on the upper faces of capped and uncapped walls are similar. In fact, the uncapped wall appears to lose material more rapidly towards the wall top, contradicting the theory that caps cause accelerated erosion.

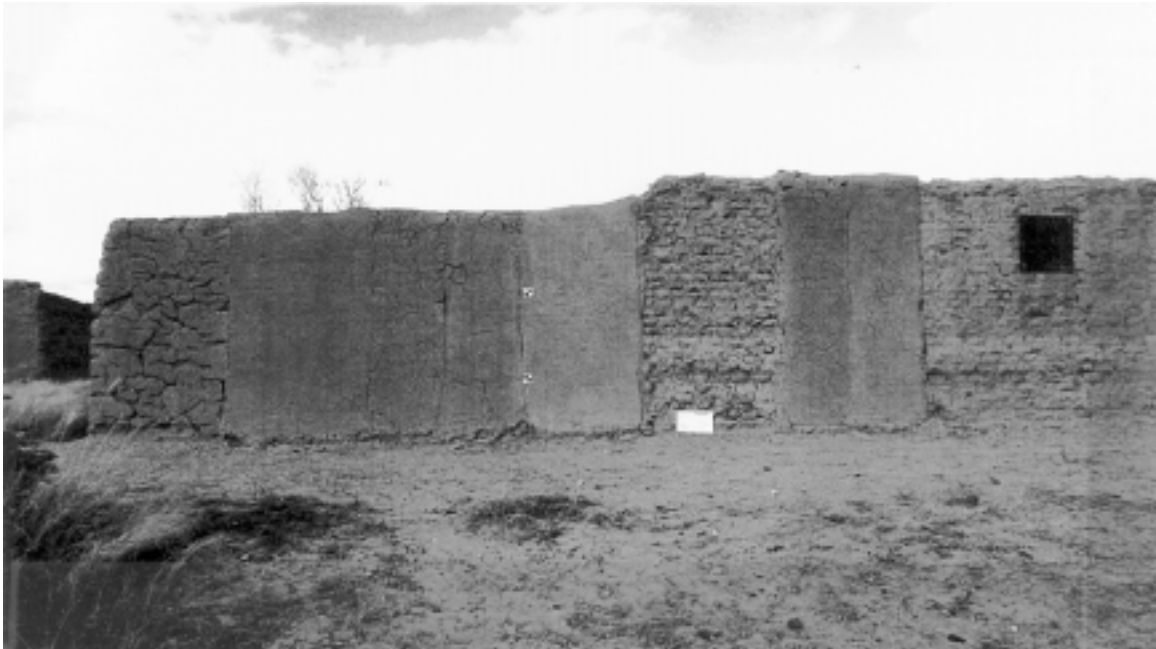
The protective coating on test panel 1 served as the control, and was composed of unamended earthen render applied in two coats, each 3/4" thick. The unamended protective coating weathered into a pattern identical to the unamended earthen renders used in the Adobe Test Wall Project – Phase I. This weathering pattern was caused by the erosion of the finish coat and the resultant exposure and erosion of cracks in the bottom coat; these cracks were produced as the unamended soil dried and shrank immediately after application. The channels formed by the weathered cracks have caused some erosion of the historic adobe. While both coats are intact on the bottom two-thirds of the wall, the finish coat has eroded from the top third, exposing the bottom coat and leading to the erosional pattern just described.

Figure 6. The 1997 appearance of protective coating test panels 1-6, which were applied to historic walls in 1992. Panel 1, the control, is at the left end and panel 6 is at the right end. This photograph is of the south face of the south wall of Features 16 and 17.

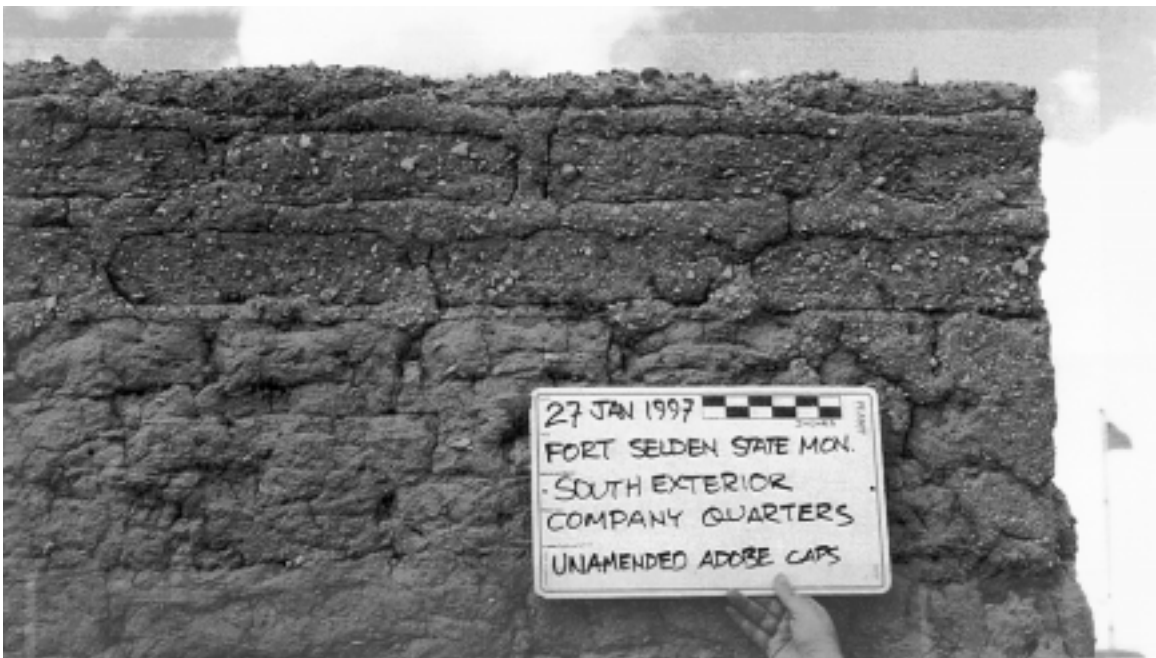
Figure 7. The 1997 appearance of the south face of test panel 7, an unamended adobe cap installed in 1992 on the west end of the south wall of historic Feature 16. The top course of adobes has since weathered to about 1/3 of its original height; there is little difference in erosion between the cap and the wall.
