Boston City Hall

Conservation Management Plan

January 2021

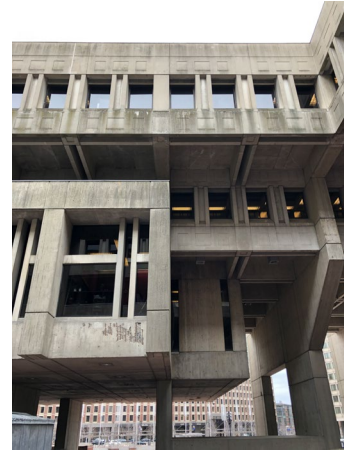
Spalling and organic staining.

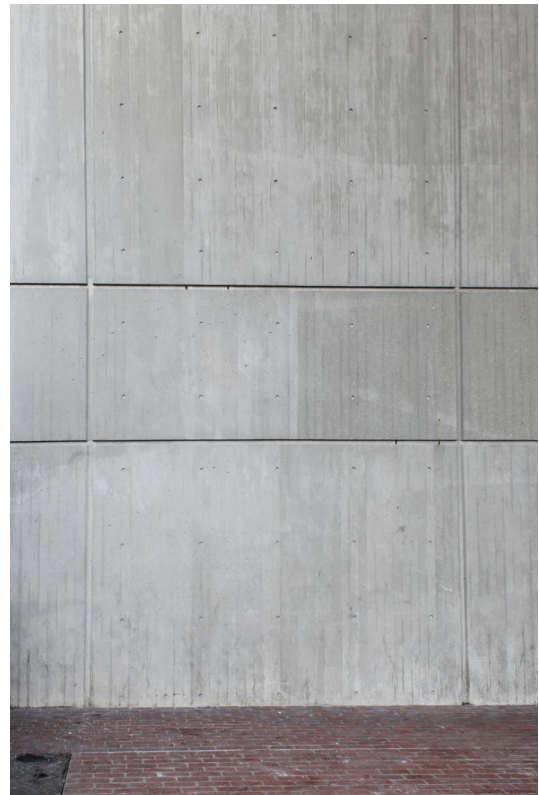
Sample of wall with filled form tie holes at the columns and partially filled tie holes in the field (January 11, 2021).

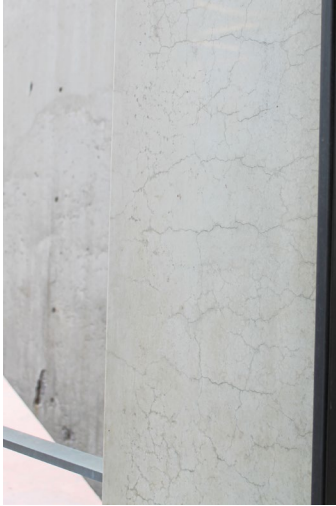
Top: Crazing located outside of council chamber at fire stair balcony (March 29, 2018).

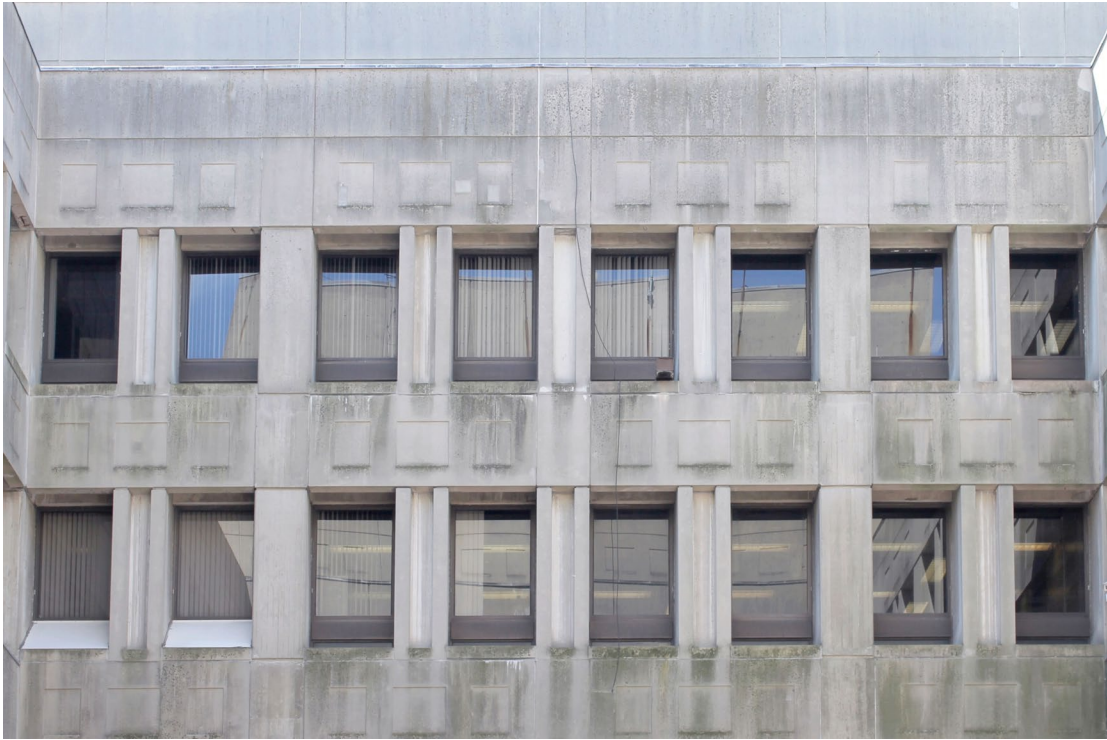
Courtyard at sixth and seventh floors, north-facing facade—representative soiling conditions on precast concrete sections (May 23, 2018).

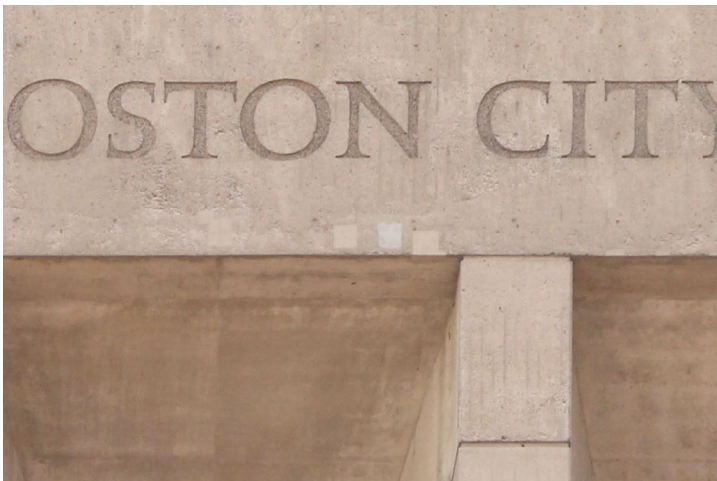
Example of poorly matched patches.

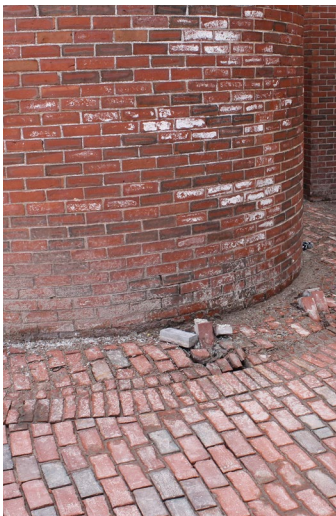
Bottom: Displacement and
efflorescence (March 29, 2018).

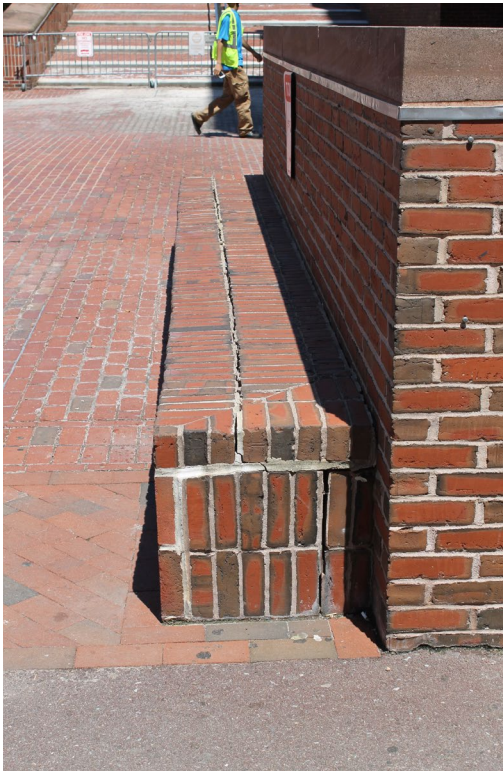
Top: General masonry failure adjacent to accessible ramp to the west entry (May 23, 2018).

Bottom: Staining from seasonal salt piles located in this area. Image also shows added concrete stair “nosings” which are not original (May 23, 2018).

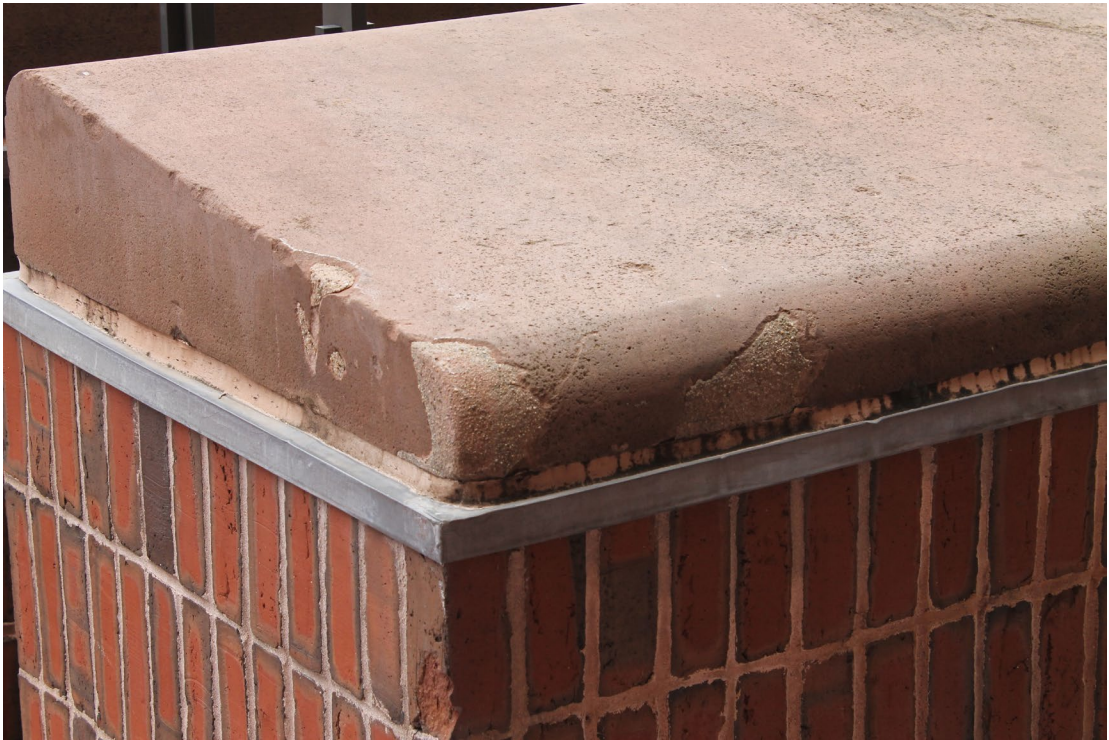
Poorly matched brownstone repairs and through-wall flashing detail (May 23, 2018).

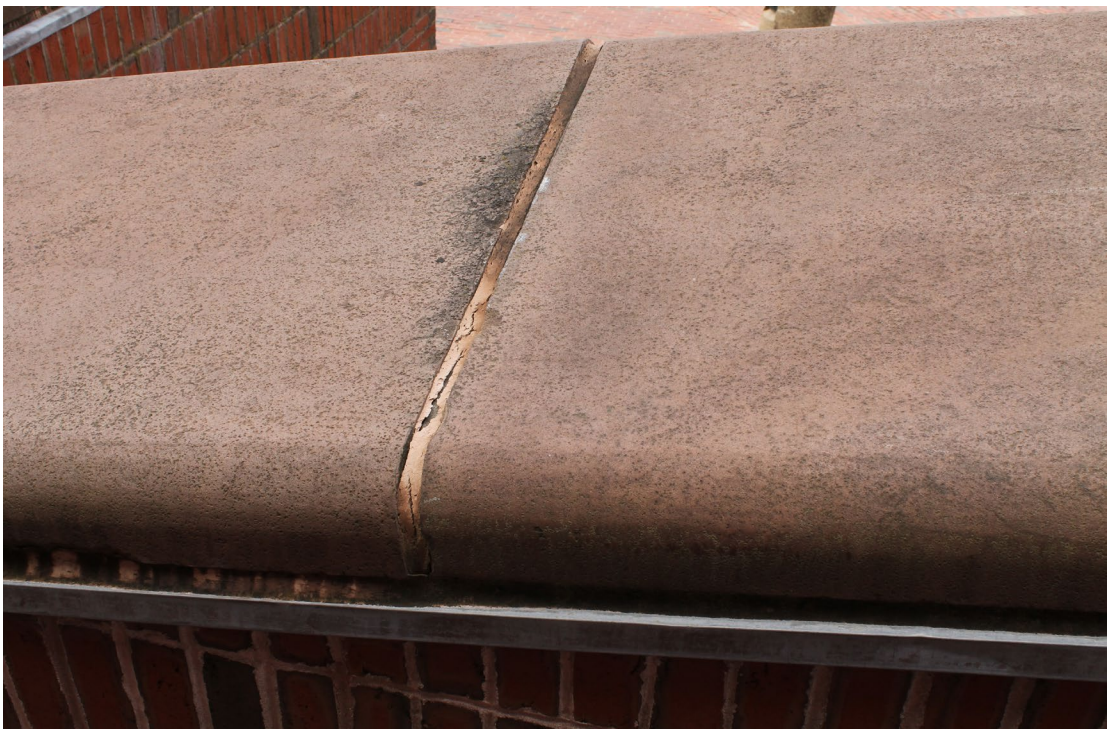
Brownstone with sealant mortar joint (May 23, 2018).

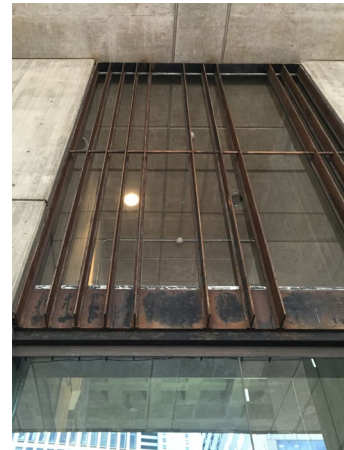
Rust development at steel window mullions on the south elevation (May 16, 2016).

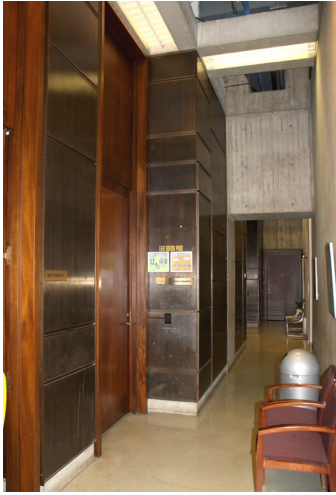
Typical bronze paneling conditions, city council corridor (June 21, 2018).
