# The Gateway Arch

GATEWAY ARCH NATIONAL PARK  
ST. LOUIS, MO

CONSERVATION  
MANAGEMENT PLAN

AUGUST 2020

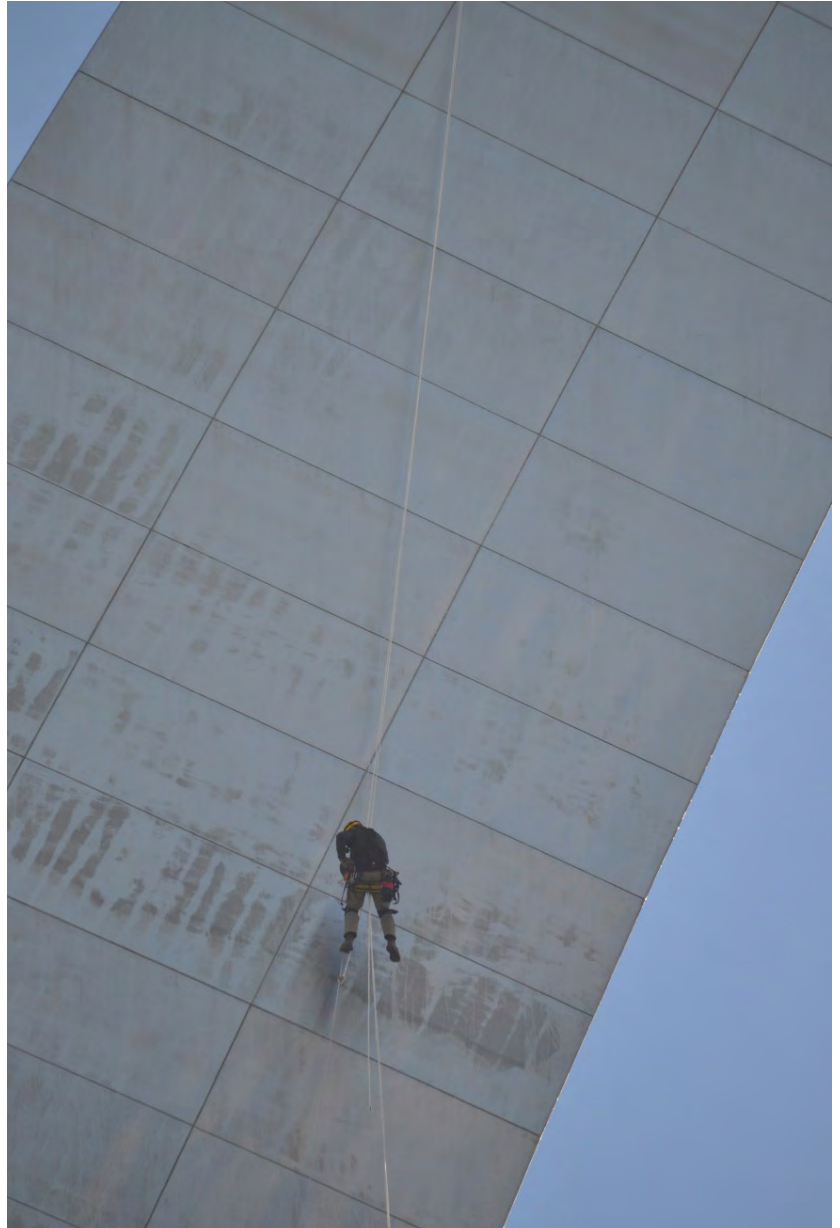
*Figure 2-37—Inspection of severe staining on the west intrados of the north elg at 424 feet above grade. Source: S. Kelley*

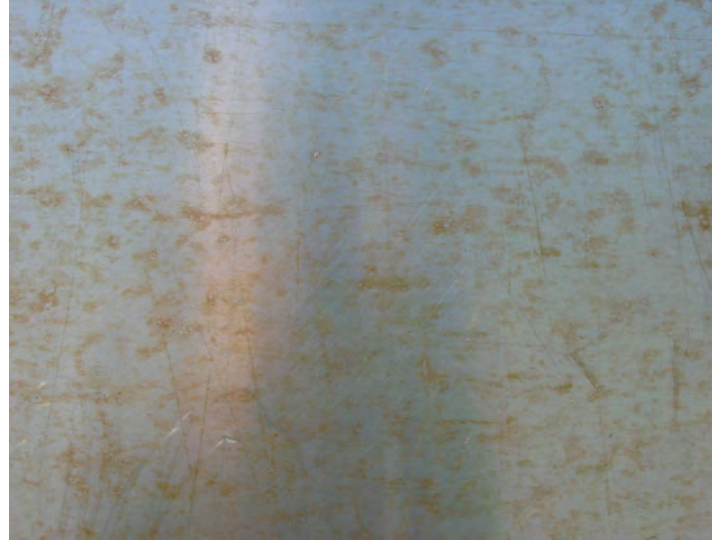
*Figure 5-1—Discoloration in the form of superficial corrosion staining to the stainless steel surface. This is a typical condition at the base and lower reaches of the monument. Source: S. Kelley*

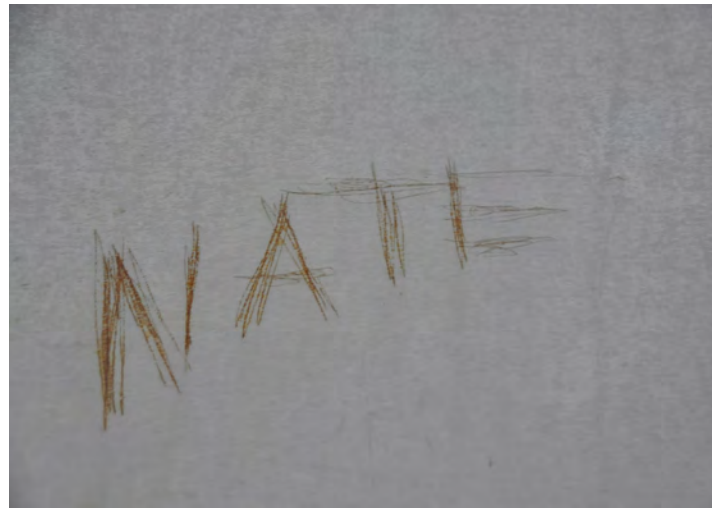
*Figure 5-2—Corrosion associated with incised graffiti is the result of corrosion of iron particles from the implements used to scratch the graffiti. Source: S. Kelley*

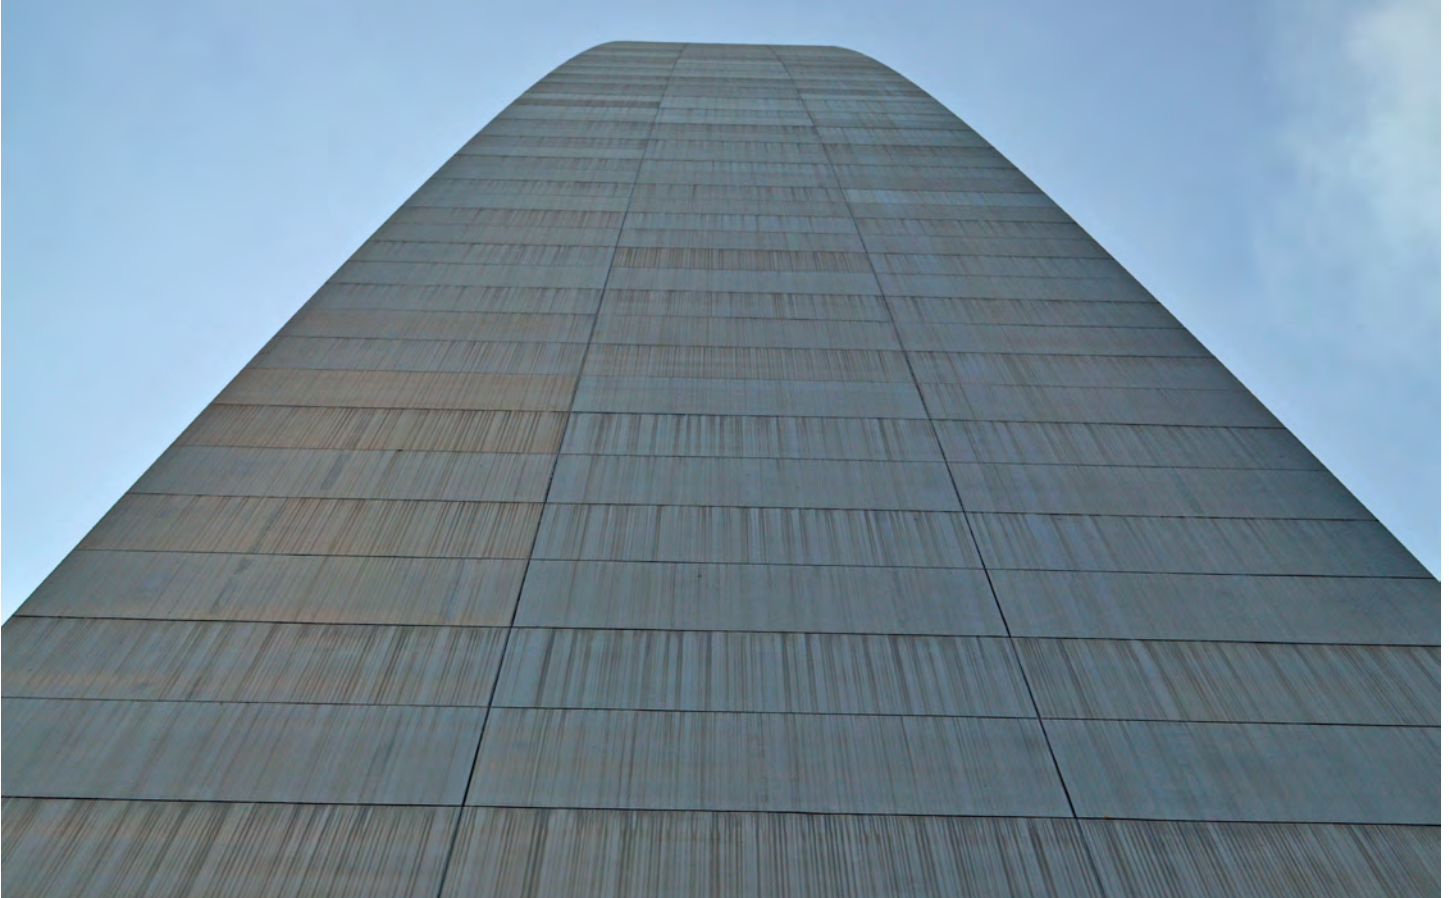
*Figure 5-3—Deposits composed of atmospheric pollutants that cause vertical streaking emanating from field welds and shop welds. Source: S. Kelley*

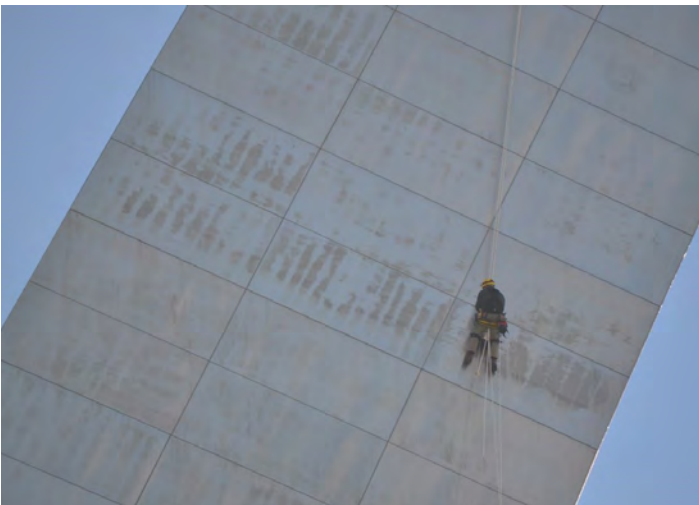
*Figure 5-4—Deposits on the upper reaches of the monument that collect on the indented “oil canning” of the panels that occurs between interior stiffeners.*

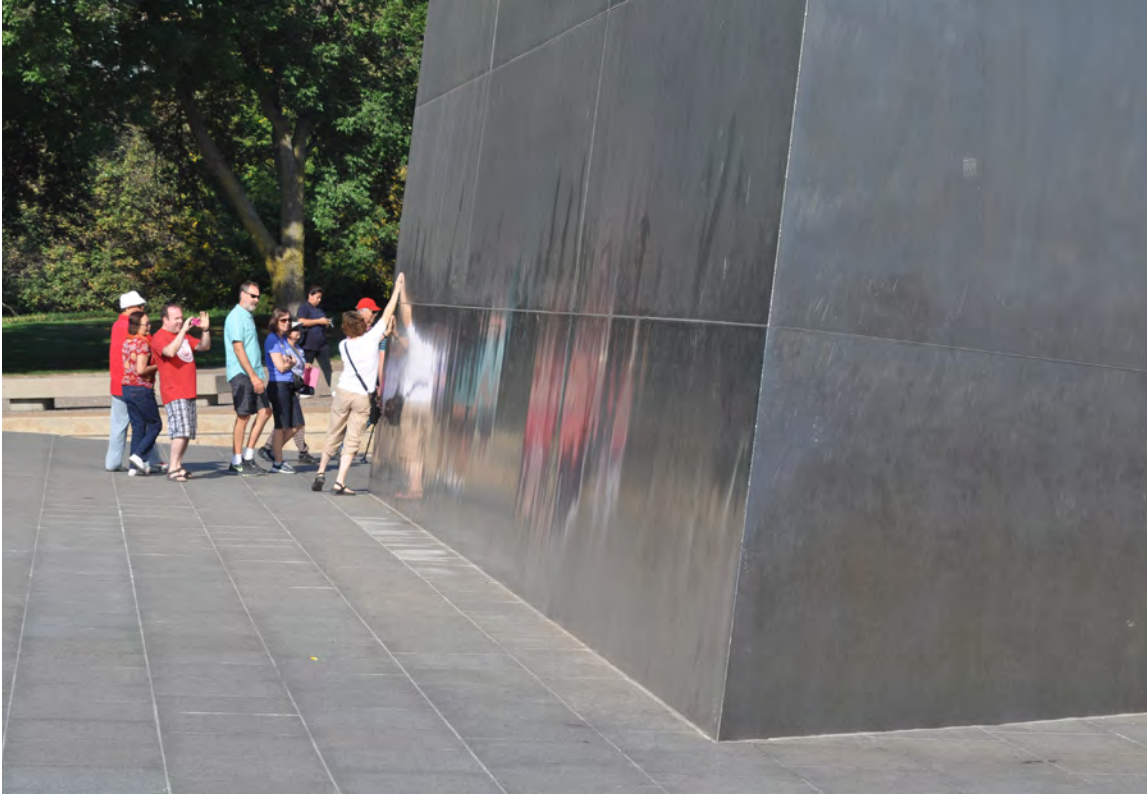
*Figure 5-5—  
Oil deposits at the  
base of the monument  
from visitors touching  
the stainless steel  
surface.*

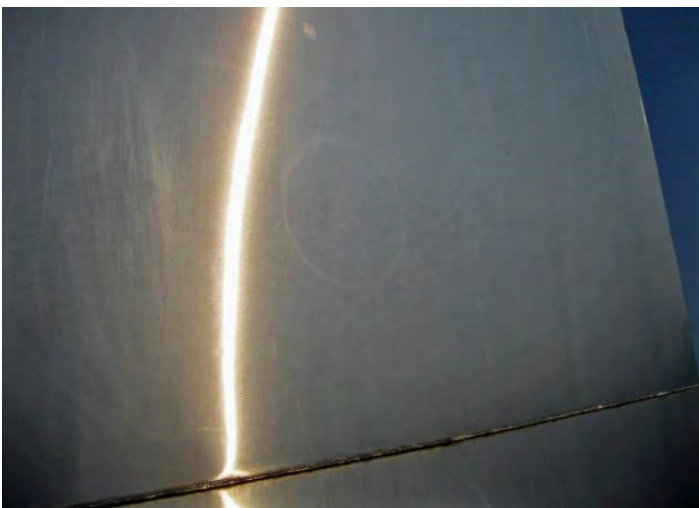
*Figure 5-6—Faint circular blemish caused by suction  
cups that were used to handle the stainless steel panels  
during fabrication. Source: 2015 Gateway Arch Corrosion  
Investigation Part III, WJE*

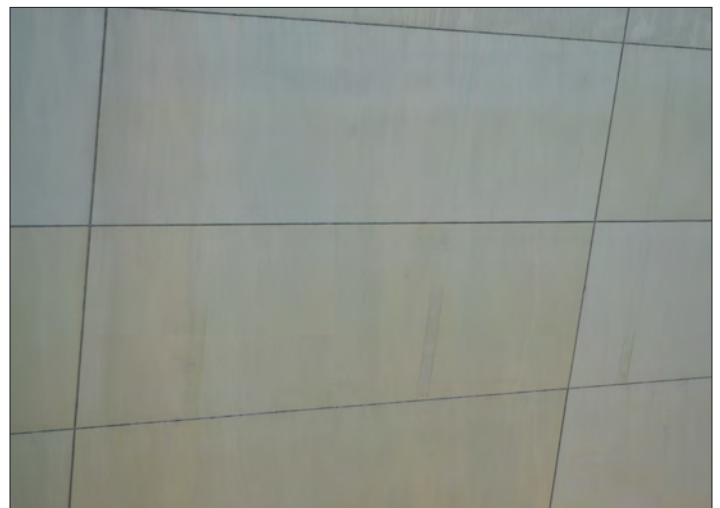
*Figure 5-7—Blemishes in the form of darkened vertical lines  
caused by straps that were used to handle the segment of the  
monument during shipping. Source: S. Kelley*

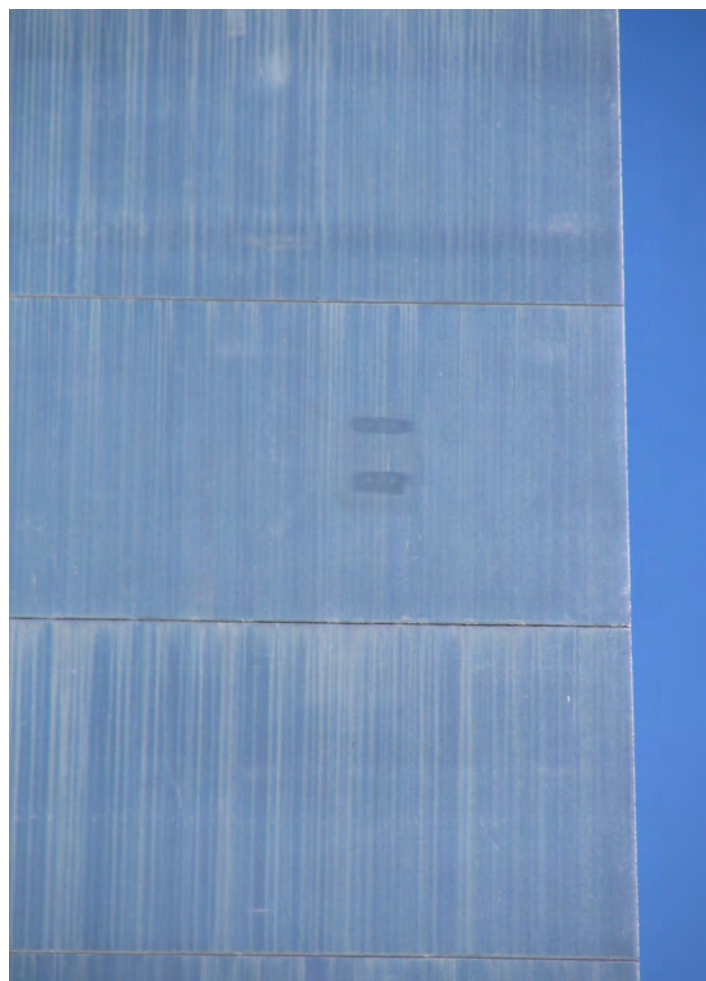
*Figure 5-8—Blemishes on the extrados where the creeper crane was attached to the leg during erection. Source: S. Kelley*

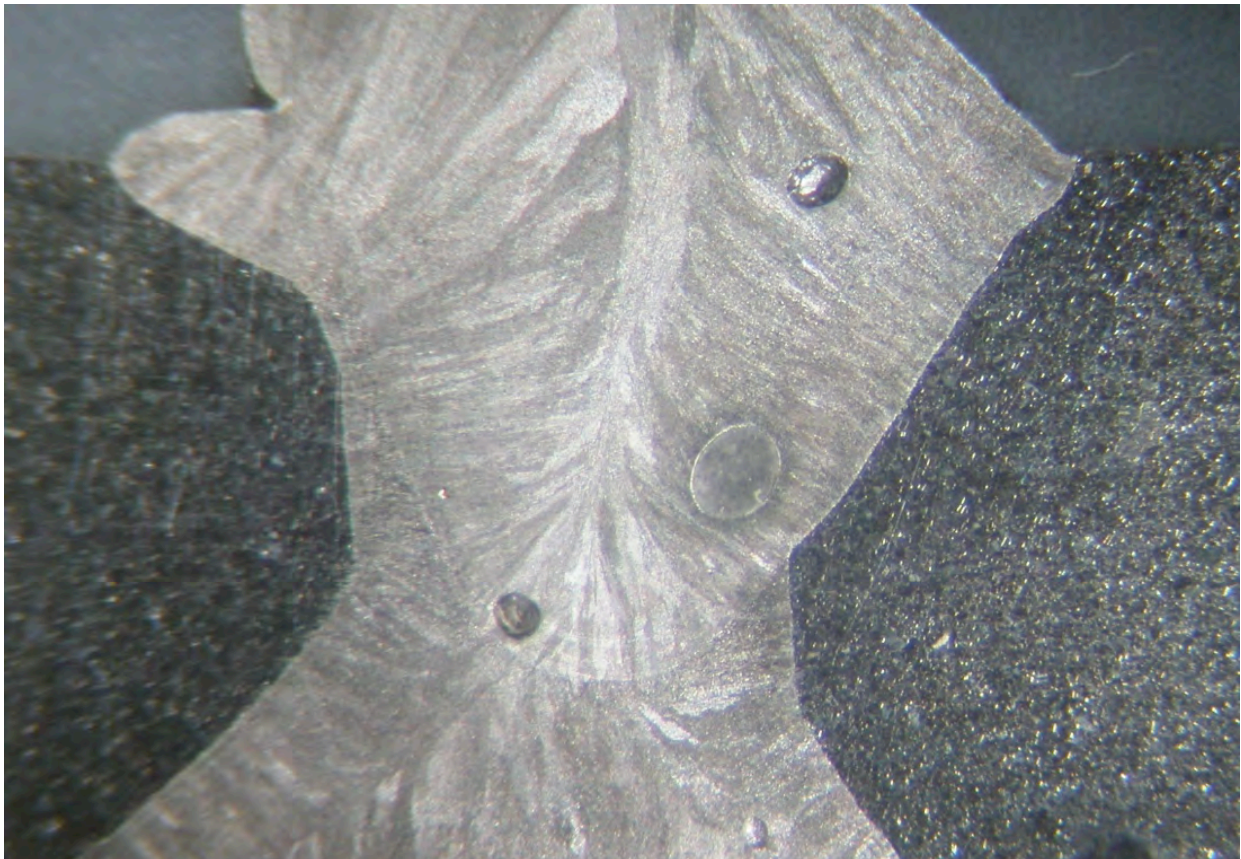
Figure A28: Macrograph, W4, etched condition, showing weld porosity. The largest void, which is located near mid thickness, has an approximate diameter of 0.04". (Photo taken by authors in 2014)

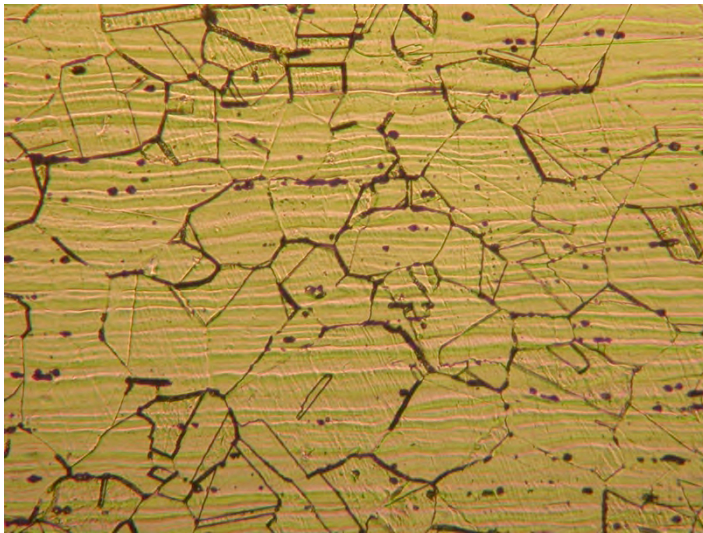
Figure A34: Micrograph sample 5, etched condition showing sensitized grains in the plate. (256x) (Photo taken by authors in 2014)

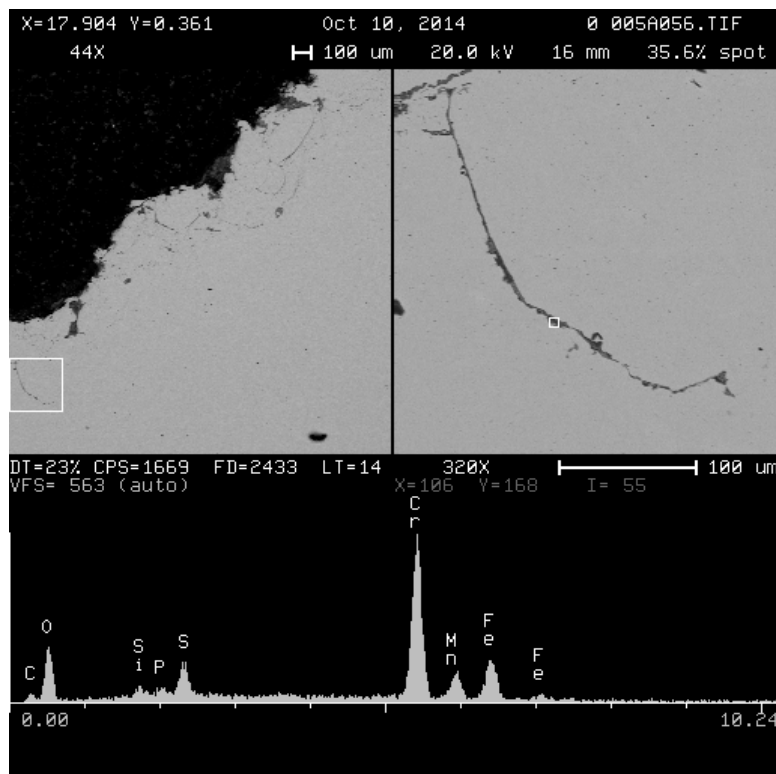
Figure A39: SEM micrograph, sample 5 same area, documenting that the observed linear areas are CrO and not cracks in all areas. No corrosion was observed. (RJ Lee SEM sample scan 2014)

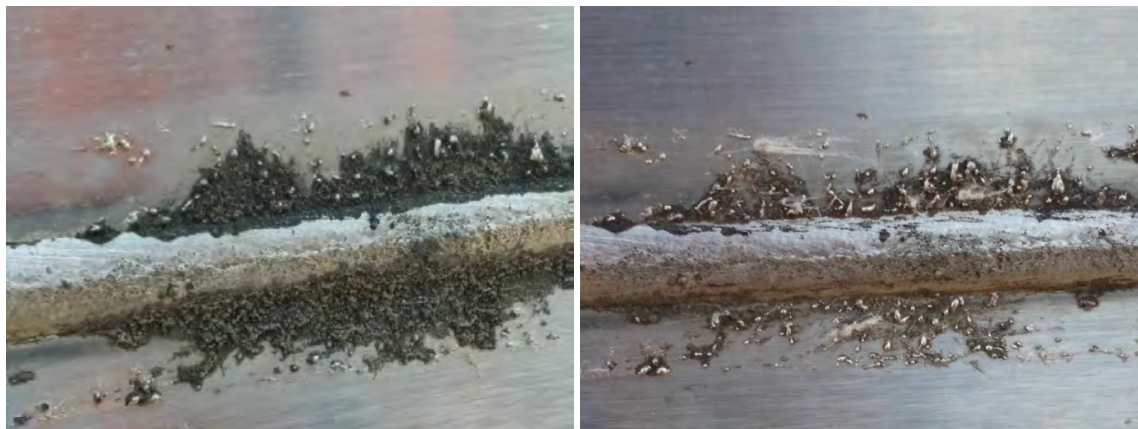
Figures C1 and C2: Dark deposit accumulation around and extrados weld, before collection of sample 2B (C1, left) and after sample collection and additional cleaning with an alcohol dampened cloth (C2, right). (Photo taken by authors in 2014)

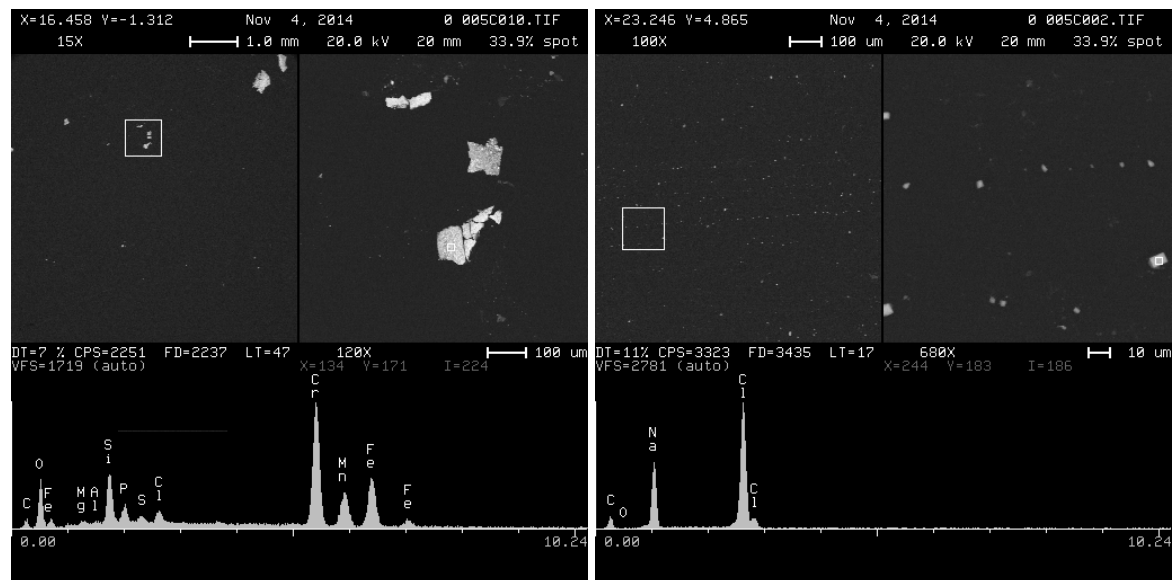
Figure C36 and C37: These were typical of the oxidized (corroded) steel or iron slag (left) and many small sodium chloride particles (deicing salt, right) on the lift. (RJ Lee SEM sample scans 2014)

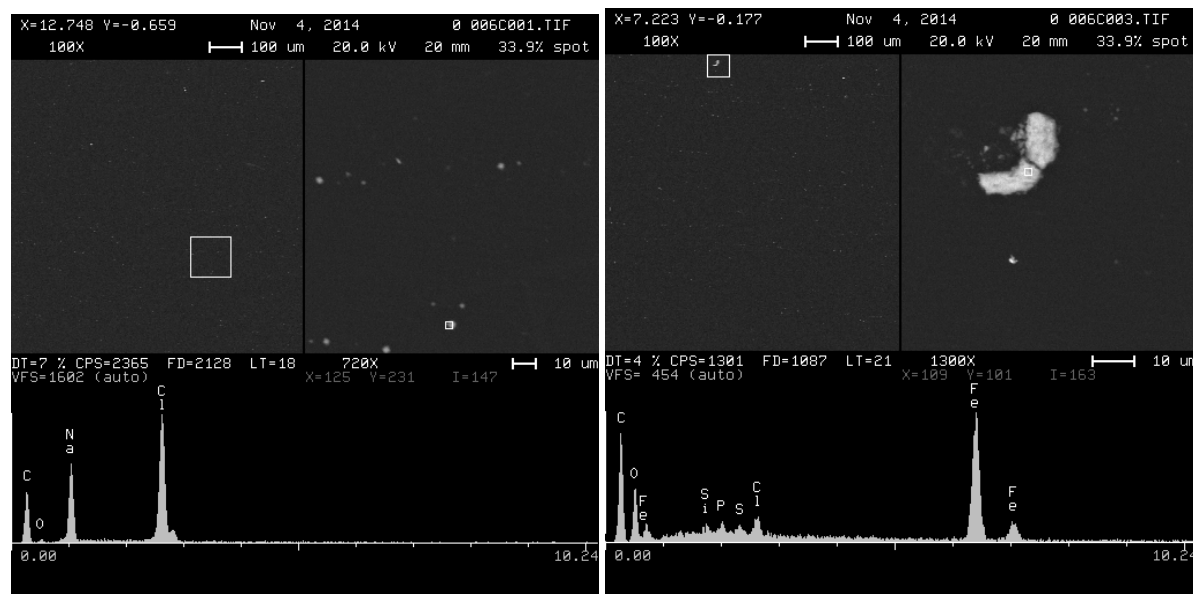
Figure C42: Sodium chloride (deicing salt) was found in combination with clay and iron/chloride/carbon organic particles were also found. (RJ Lee SEM sample scan 2014)

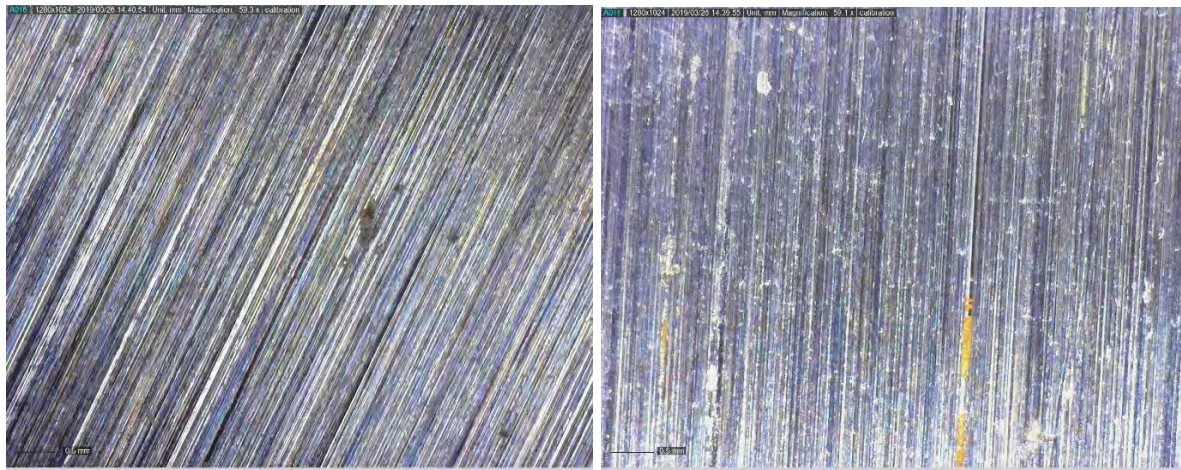
H.1 Sample Astropak #7 401 buffer 59.1x images: (L) Deicing salts staining was completely removed with some minor surface pitting observed, (R) Some embedded iron particles and resultant staining were still present on the surface but only clearly visible under microscopic examination.

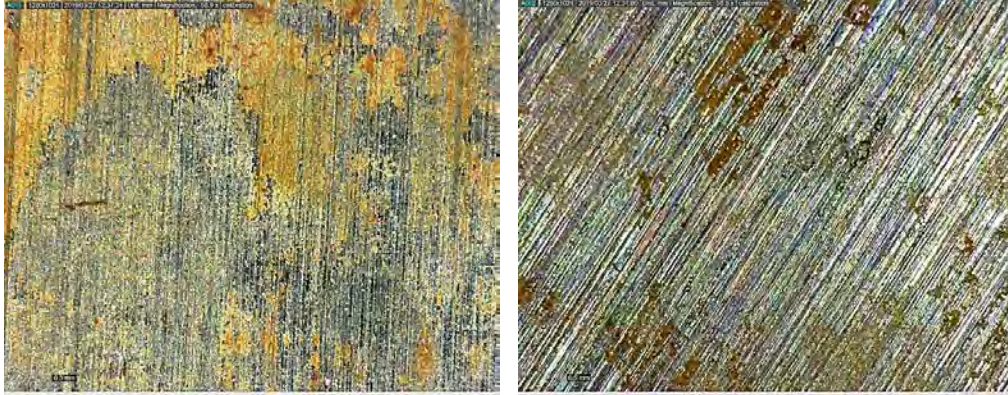
H.6 Sample Karcher sample 3B images: (L) Neither the deicing salts nor the embedded carbon steel had been removed from the surface. 58.9x, (R) Staining around visible areas of embedded iron was visible. The cleaning method was not considered effective. 58.8x.

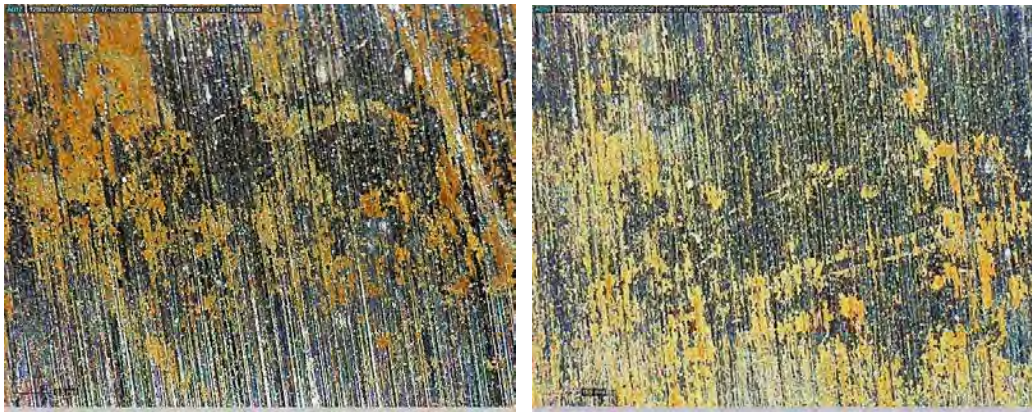
H.7 Sample Karcher sample 4A water cleaning images: (L) The significant visible remaining staining was associated with deicing salts pitting. 58.9x, (R) Staining around areas with embedded iron in scratches was visible indicating that it had not been removed. The cleaning method was not considered effective. 59x.

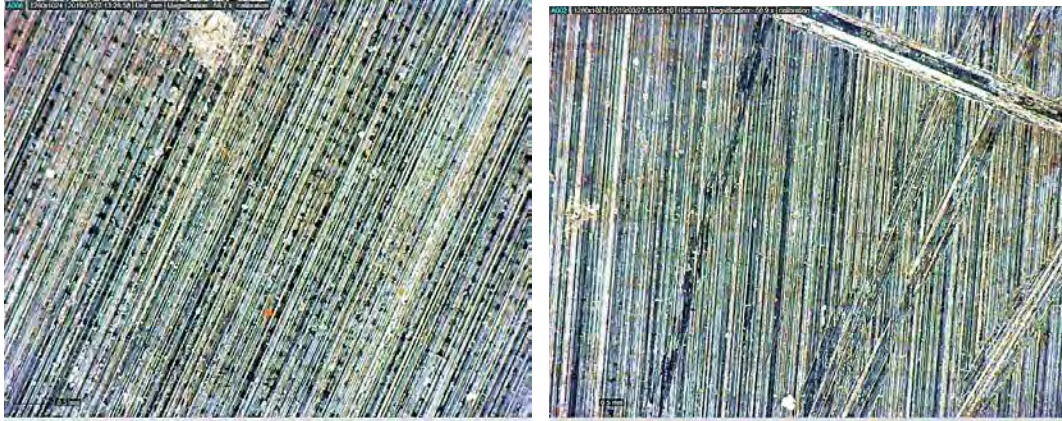
H.13 Sample Adapt laser cleaning sample 11C cleaning images: The embedded carbon steel and corrosion staining were reduced but still visible and heat related surface damage (dark areas) was observed. (L) Heat related surface damage and the embedded iron were visible. 58.7x, (R) Other areas had less heat damage but still had visible corrosion staining. 58.9x. See Section G.3 for commentary about laser cleaning heat damage.

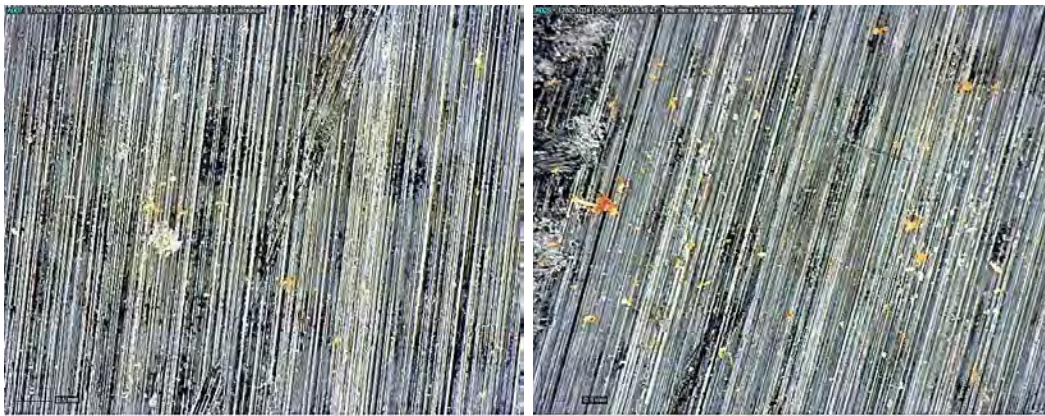
H.14 Sample Adapt laser cleaning sample 11D cleaning images: (L, 59.1x and R, 58.4x) Some embedded carbon steel and corrosion staining were visible and heat related surface damage (dark areas). See Section G.3 for commentary about laser cleaning heat damage.

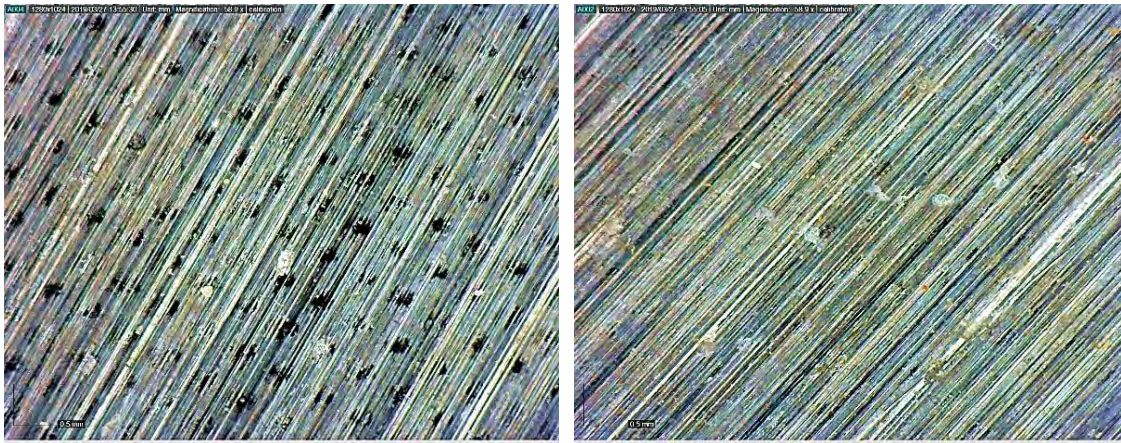
H.16 Sample Adapt laser cleaning sample 12B cleaning images: (L) Remnants of the corrosion staining were still visible and there was significant heat related surface damage (dark areas). 58.9x, (R) Other areas had less heat damage and visible corrosion staining. 58.9x. See Section G.3 for commentary about laser cleaning heat damage.

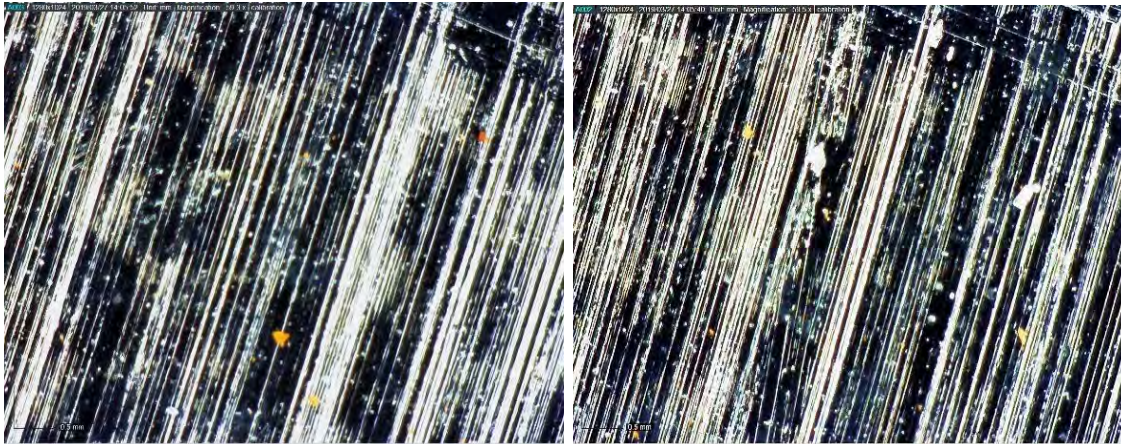
H.17 Sample Adapt laser cleaning sample 13 cleaning images: (L, 59.3x and R, 59.5x) Embedded carbon steel particles were visible and some very light corrosion staining. There was significant heat related surface damage (dark areas) over the entire surface and some areas had melted (polished grain line was gone). See Section G.3 for commentary about laser cleaning heat damage.

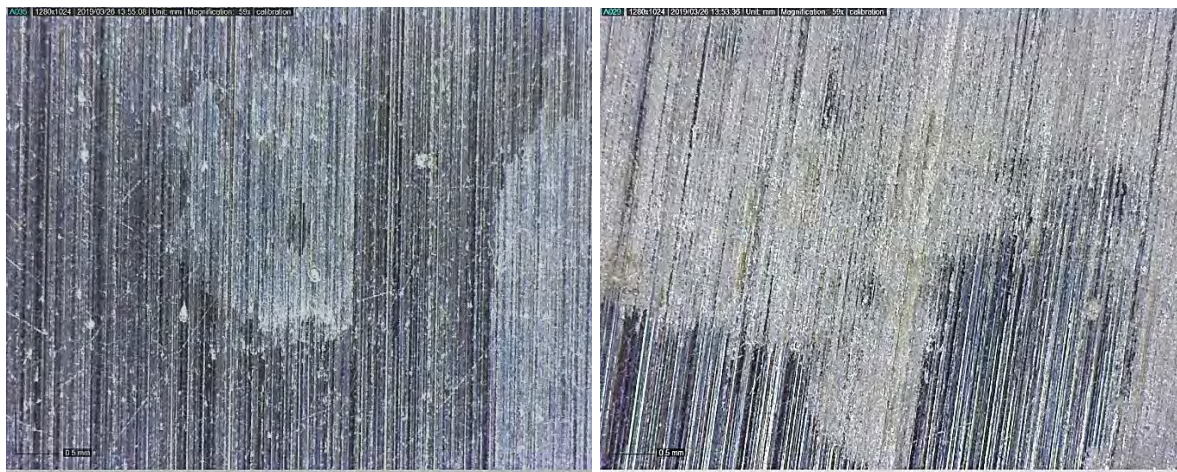
Figure I.1: Unidentified white toned surface deposit at (L) 10X and (R) 60X
