CONSERVATION AND  
MANAGEMENT PLAN

THE NATIONAL  
LIBRARY OF KOSOVO  
PJETËR BOGDANI  
BIBLIOTEKA KOMBËTARE  
E KOSOVËS

OCT. 2017 PRISHTINA, KOSOVO  
KOSOVO ARCHITECTURE FOUNDATION

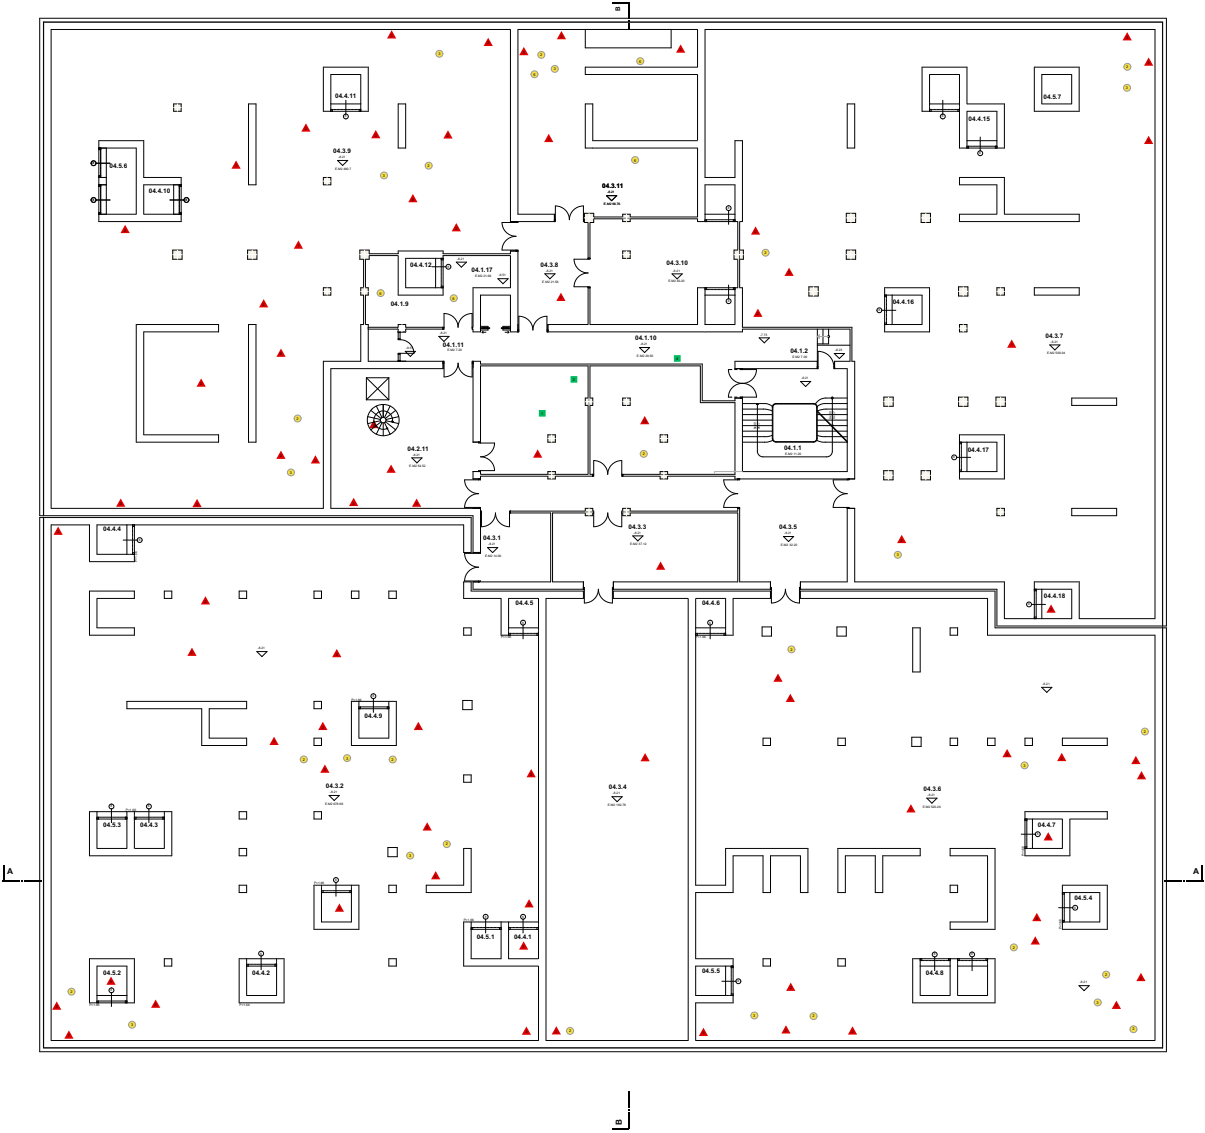
**FIGURE 17** - Illustration of identified problems in the cellar

During investigations on site and a study of the original construction drawings there appears to be a double construction for the walls and floor of the lower levels. The intention was clear, to isolate the basement from groundwater. However this has failed. This could have failed for several reasons:

1. The gap was not constructed at all or not constructed properly.
2. The gap is too small
3. There are physical connections between the walls and floor are allowing water to flow through capillary action across this gap.
4. There is an overabundance of water and this gap is serving as a reservoir
5. There is condensation from water vapour within the gap on the inside wall

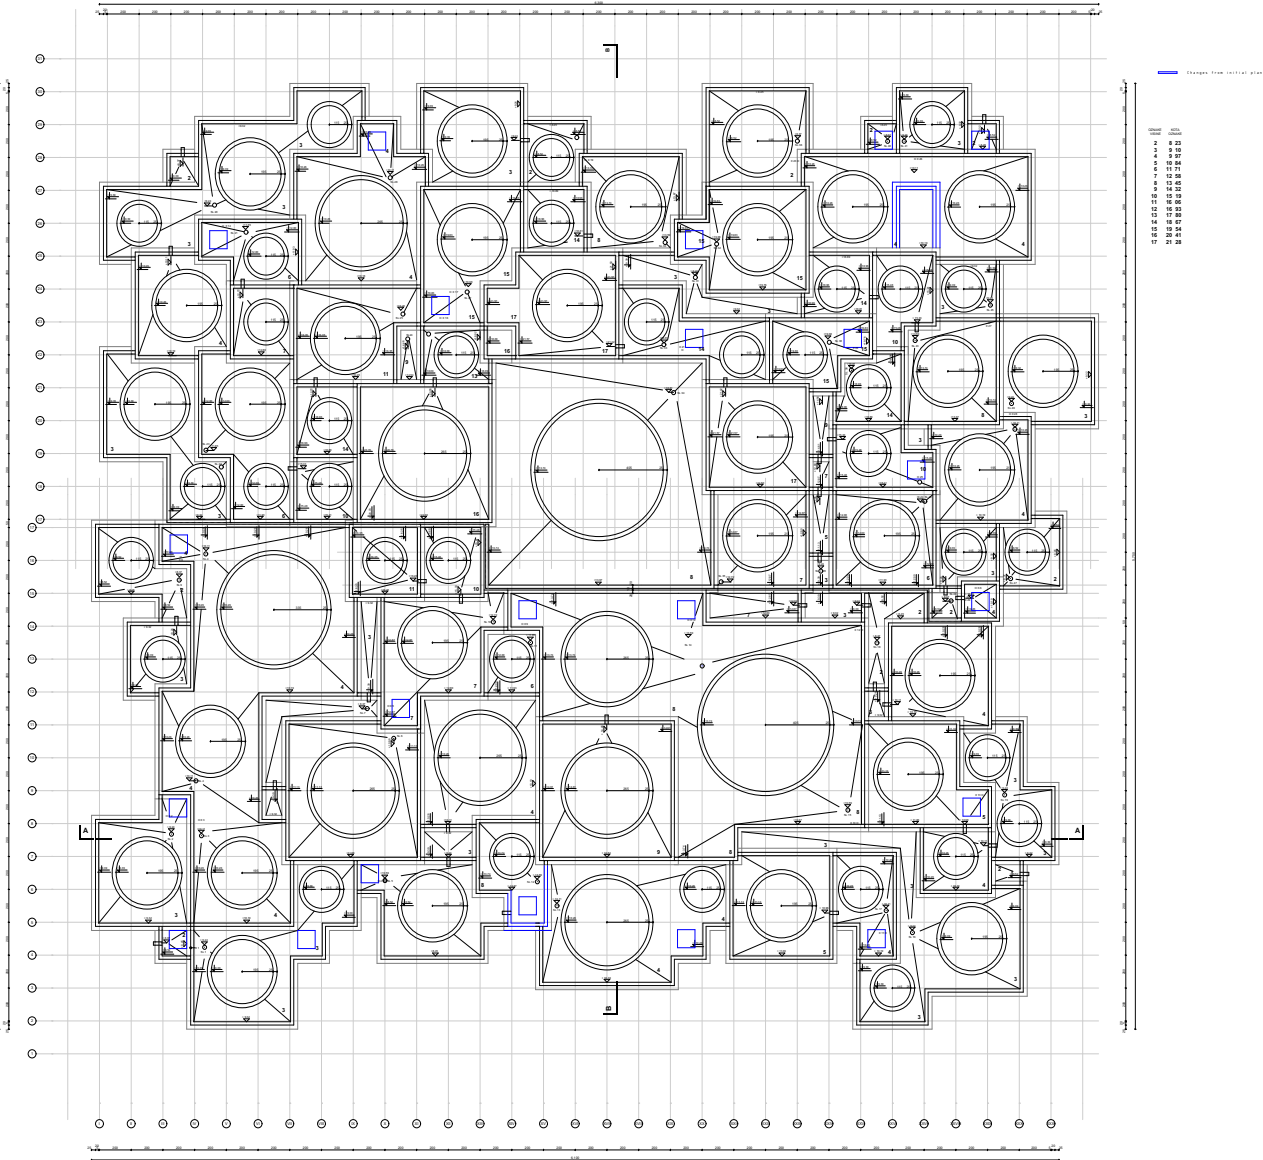
**FIGURE 25** - Illustration of identified problems in the roof

The original roof was well designed and executed however there are numerous problems related to this original design. These are as follows:

- 1) **PITCH** or slope of the roof is insufficient. It is approximately less than 1% to the drains. This is not adequate and should be improved where possible to 2% slope. This would have the added benefit of improving the thermal properties of the roof.

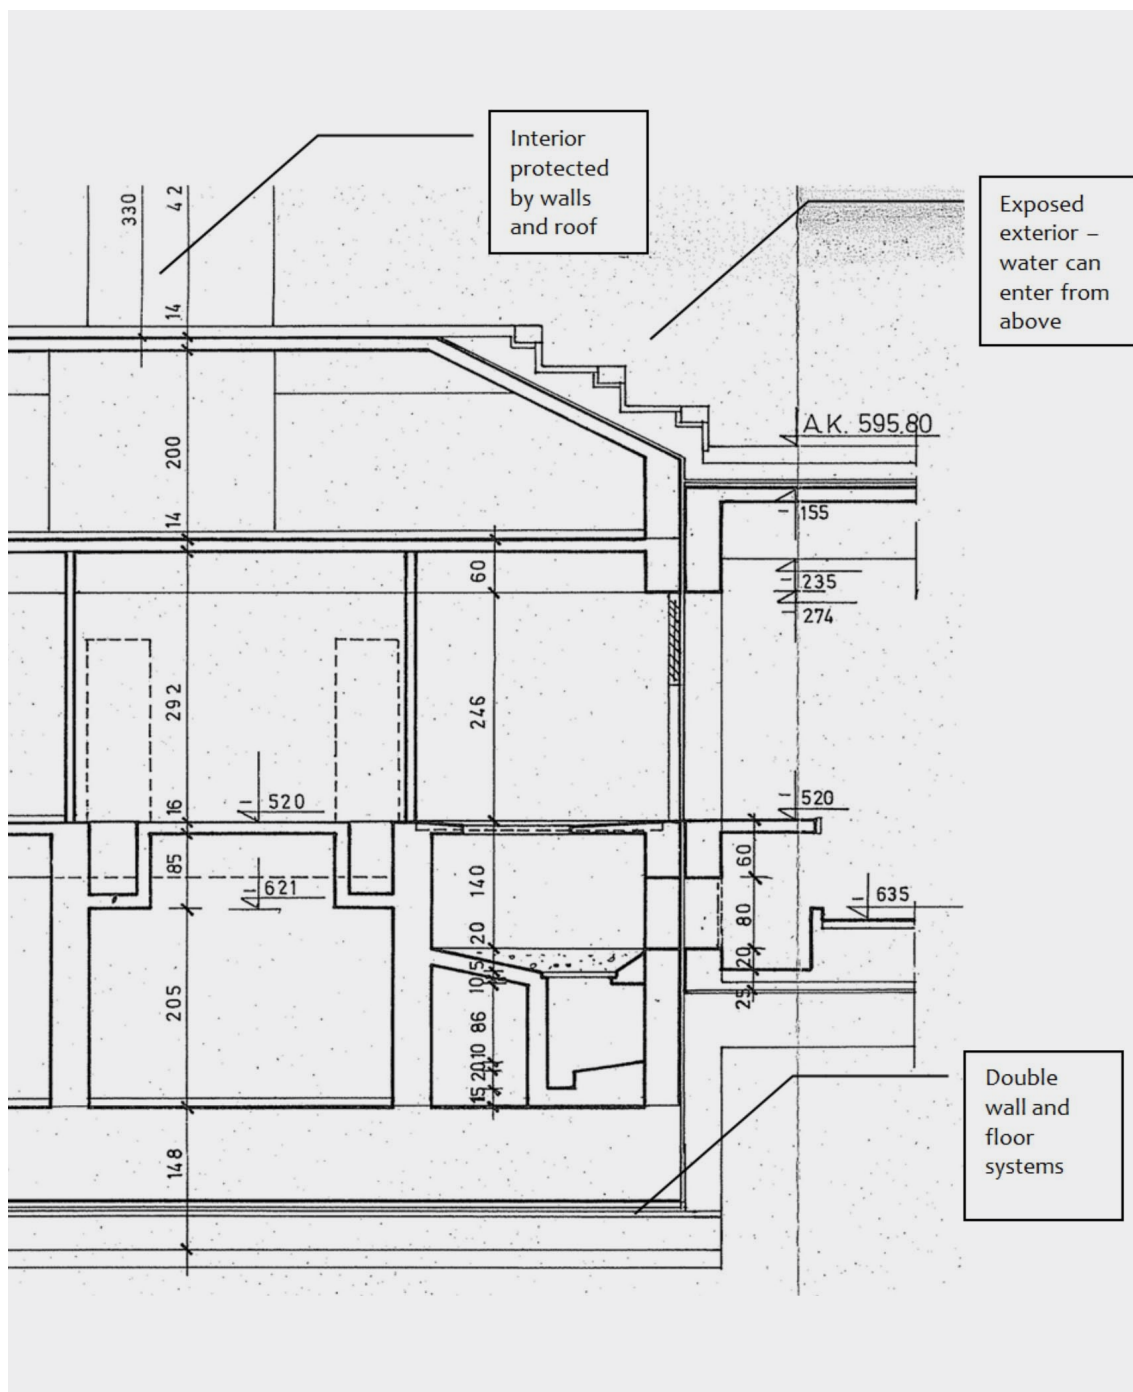
**FIGURE 35**  
Original plan drawing showing the double wall system in the lower levels. The dimension reads 1cm but this could also be 10 cm which seems more likely. It is unknown how these were interconnected.

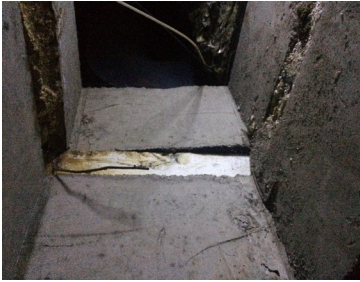
Evidence of water leaking through the slab

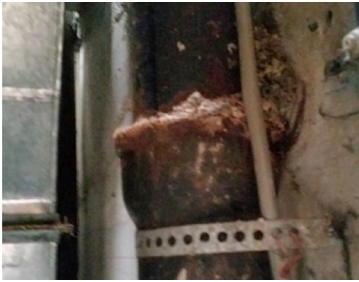
Mechanical systems have been poorly installed with open holes. Not only does this permit water to enter the building but also significantly reduces thermal properties. This will eventually lead to a failure of the wall and further water infiltration.

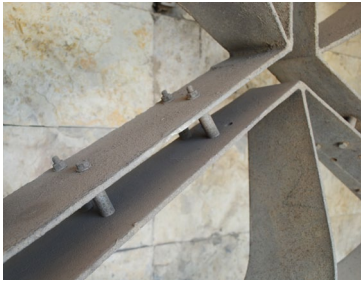
The connection of the grid to the façade. Small cracks have been observed in the stone and concrete at this connection point along with staining, most likely due to differential thermal expansion and contraction

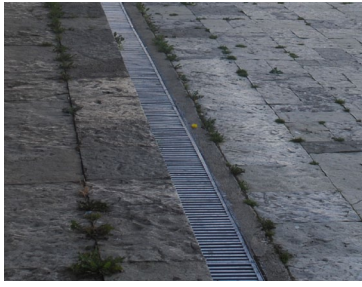
WALL - Stone surface finish on the main stair in good condition

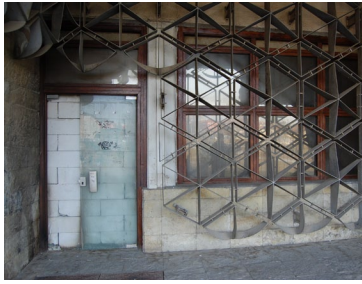
**FIGURE 131**  
replacement PVC plastic operable windows with faux wood grain finish. These have been installed in nearly every floor of the library. While not original in form or material they are useful for ventilation.
