Leibniz Institute for
Astrophysics Potsdam

The Einstein Tower in Potsdam

Final Report 2018

The Einstein Tower

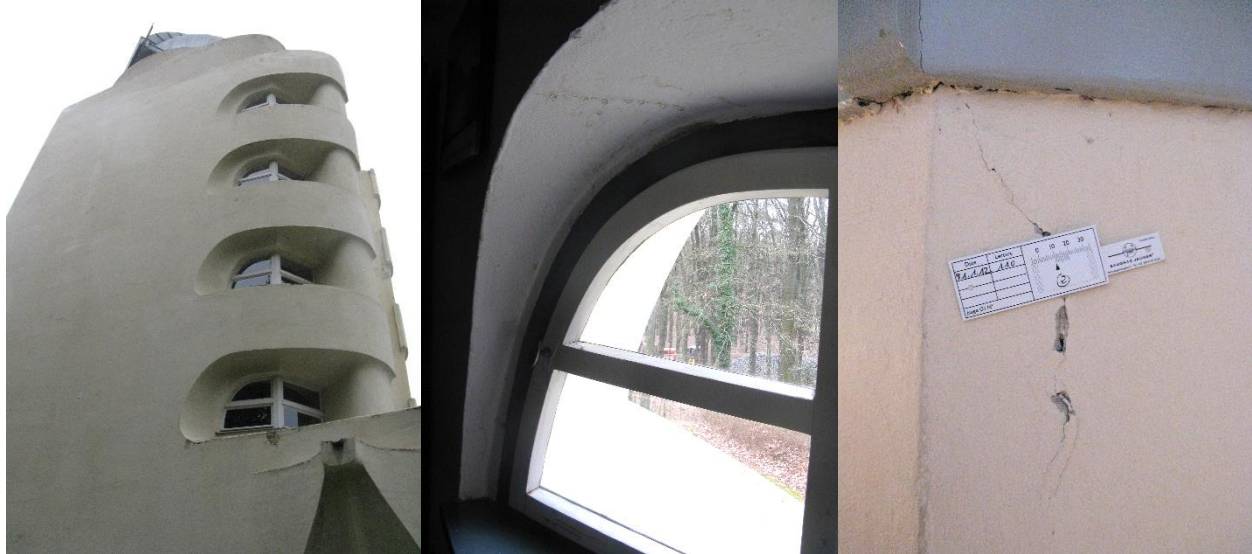
The mixed construction of the Einstein Tower is the underlying cause for the recurring damage pattern. The concrete quality and iron reinforcements do not conform to current standards, and no efficient way to remove rain water and humidity was available leading to fissures in the rendering coat, which facilitate an easy entry of rain water and moisture. This caused damages after freezing temperatures and corrosion of the iron reinforcements (structural members) above the windows and throughout the building structure.

The first major renovation in 1927 because of widespread moisture penetration commenced under the supervision of Mendelsohn himself leading to a massive addition of sheet metal (window sills and roofing) significantly changing the character of the building. These measures, however, were not very effective necessitating major repairs about every 5–10 years.

Small cracks on the exterior walls and spalling along the window sills (left). The crack allowed water to penetrate into the building, which is visible as a chain of water droplets at the top of the window linings (middle). The temporal evolution of cracks is monitored with precision markers (right). (Credit: Jürgen Rendtel)

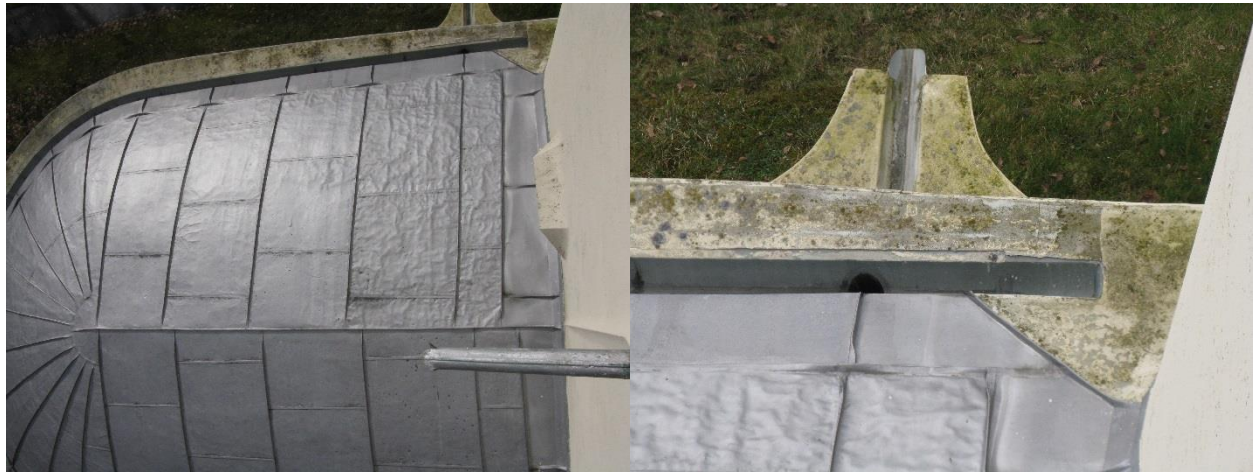
Build-up of biological materials (moss, algae, lichen, ...) over the winter month affecting exterior walls and sheet metal roof covers. One of the most problematic parts is the rainwater drainage and the interface between the sheet metal roof and the vertical structure of the tower, where rainwater enters the building. (Credit: Jürgen Rendtel)

A functional damage due to the algae is not to be expected, so that the decision for the intervals of paint renewal can be justified at first purely by the optical appearance. Algae on facades are the subject of current research. Therefore, an exchange of information with practitioners is recommended to choose suitable algae removal measures and color on the monument to be able to comply with longer intervals for repainting.

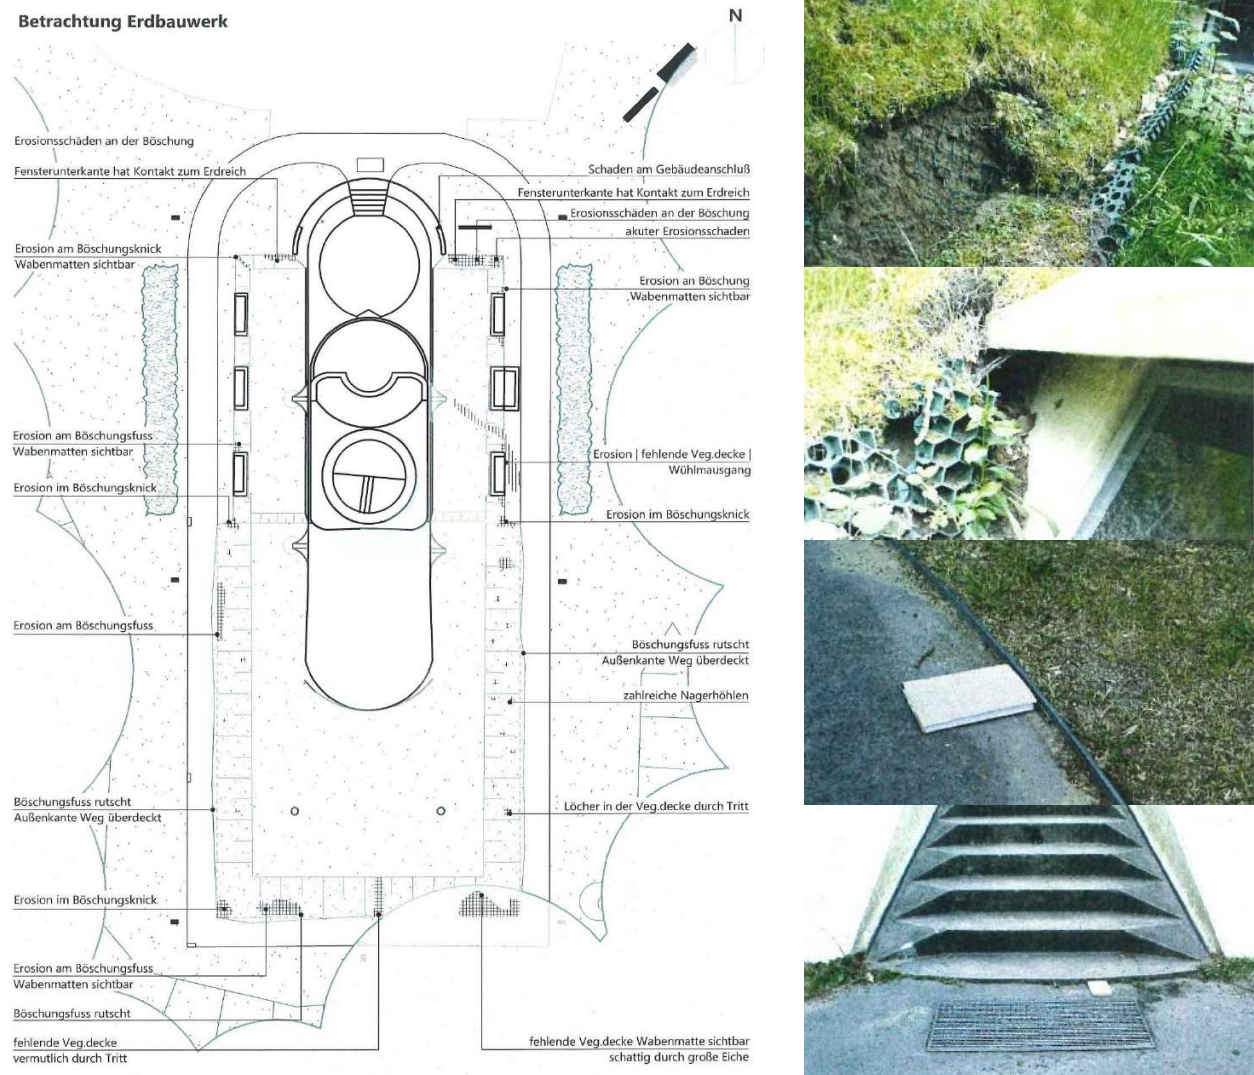
The grass covered walls show clearly traces of erosion on all sides. Slides and wash-outs uncovered in many places the installed honeycomb mats, which were placed below the turf to avoid surface erosion. Especially in areas with a slope of 1:4 at the North side and in areas of the embankments, the honeycomb mats are exposed in large areas. In particular, the interfaces between turf and windows exhibit erosion damage. The installation of an insufficiently stable body of soil led to slides and wash-outs along the entire length of the embankments. The bottom of the embankment “migrated” downwards even beyond the borders of the paths (stabilized by some steel bands) leading around the building. Rodents dug numerous holes into the embankment, especially on the west side. Further damages are caused by unattended visitors of the Einstein Tower, who climb up the embankments to get a glimpse of the interior. Parts of the honeycomb mats are now uncovered as a result.

The recorded damage to the body of soil is partly significant. One reason for the strong erosion damage consists in the insufficient stability of the substrate. The superficial protection against erosion with honeycomb mats works well with embankment slopes of 1:1. However, a slope of 1:4 is too steep so that the entire backfilled embankment has shifted. This process has been compounded by the absence of a continuous wire mesh protection against rodents so that a system of burrows additionally destabilizes the embankment.

The surface material of the bituminous path is largely worn away, and the originally bright appearance of the cover has been lost. The two-sided steel straps rise now up to 2 cm above the surface and prevent rainwater from draining laterally. A stumbling edge is now present caused by the grating just in front of the entry stairs. This grating is not contemporary, and it is disruptive in geometry and appearance. All four drainage gratings under the rainwater spills, including the connection pipe, are clogged with sand, leaves, and soil. The connection point of the rainwater pipes is not known. A controlled drainage of the rainwater is no longer guaranteed. The small drainage covers along the paths are clogged with foliage and earth. The connection points are not known. They are in no working condition. The water-bound path leading from the

north to the observatory shows strong erosion damage. The grain size and mixture of the surface material is not suitable for this inclination and is flushed down the slope. The cobblestone troughs are uncovered and impaired and have become ineffective.

Damages related to the earth cover of the spectrograph room and the surrounding landscape, which includes erosion of the walls, especially where the slope is very steep, destruction of the honeycomb support structure, rodent burrows, and washed-out surface covers of the surrounding paths. (Credit: Dipl.-Ing. Daniel Sprenger)

The missing surface coat of the paths has to be reinstalled. The overhanging steel edge must be adjusted to conform to the slope. The drainage systems for the roof water are not functional, the rainwater accumulates on the basement roof and leads to the growth of moss within the grass cover, which accelerates the erosion in the slope area. The system of open drainage channels along the way are not functional, and the connection of the existing drainage pipes has to be clarified. The paths between the astrophysical institute's buildings are made of water-based, fine-gravel surface coating, which is not sufficiently stable and largely destroyed by erosion. The transverse drainage grooves are exposed, and the concrete reinforcements also lay open and create a risk for accidents.

In order to permanently produce a stable embankment, the material of the backfilled wall must be replaced in accordance with the requirements of the guideline by the Forschungsgesellschaft Landschaftsentwicklung Landschaftsbau (FLL) for roof greening. Embankment areas with a slope of more than 1:2 require additional engineering solutions for slope stabilization. It is necessary to clarify the extent to which the body of soil is a valuable original substance. Depending on the material, some of the soil could be retained in non-erosion areas.

Embankments. At least in the region of the embankments, the body of soil is to be replaced by a suitable layer-stable material. In addition, the embankments must be protected against penetrating rodents. Embankments with a slope of more than 1:2 require additional engineering measures: we propose a design as a reinforced earth wall.

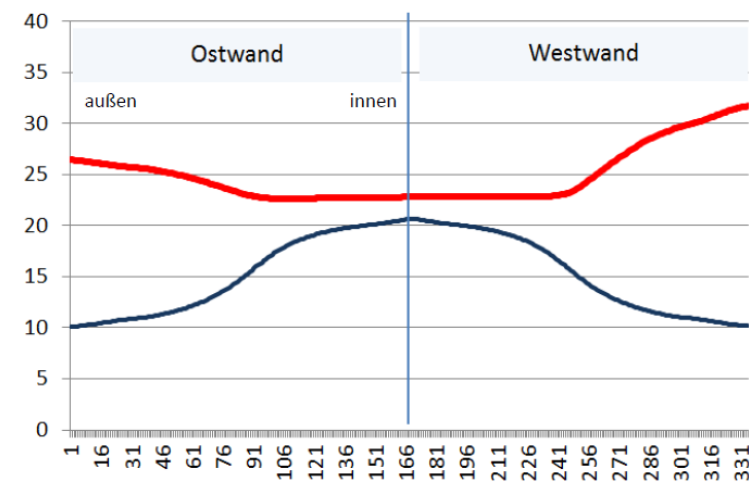
Maximum and minimum temperatures (°C) over the wall cross-section (millimeters) for east and west walls within a period of 30 summer days. The interior of the tower is not shown, to the left of the vertical line the east wall, to the right the west wall. (Credit: John Grunewald and Hans Petzold, TU Dresden)

At the tower, a horizontal crack is visible in the west wall at the window level above the first platform, both inside and outside. If it passes through the entire wall is not certain but likely. It had to be determined why this crack is present on the west side only but not on the east side at the analogue place. A one-dimensional simulation was carried out assuming a non-stationary interior and exterior climate. Air temperatures on the outside are the same, but the radiation and the impact by driving rain are different. On the west wall about 6 K higher maximum temperatures occur, since here the solar radiation is superimposed upon the higher outside air temperature in the afternoon. Since the

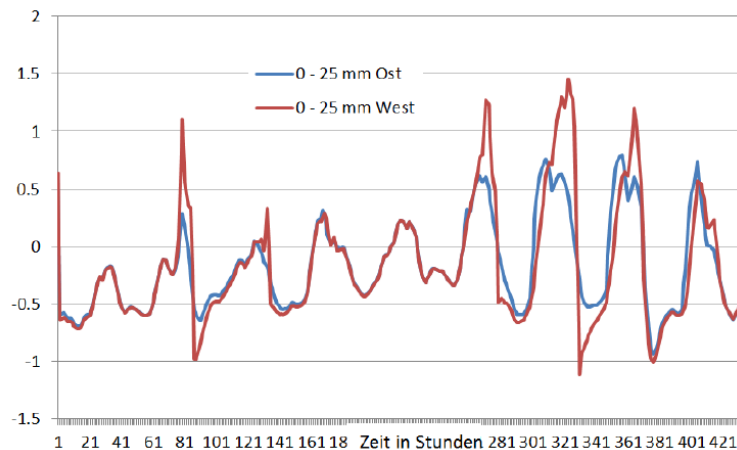
On days with direct radiation, the temperature gradient in the west wall is significantly higher. In the middle of the plotted period, two cloudy days are visible where the gradients are approximately equal. The irradiation and therefore the temperature load on the outer wall is thus significantly higher in the west than in the east. However, these temperature gradients per se are not so high that such severe damage – crack through the entire cross-section of the wall – would only point to this cause. More likely is a superposition of an unknown constructive weakness (impact of window linings, possibly corrosion of steel elements, which were not inspected during renovation, etc.) upon the influence of temperature.

Temperature gradient (°C) between the surface (0mm) and 25 mm depth in the east and west wall of the tower over a period of 18 days. The time is given in hours since the start of the measurements. (Credit: John Grunewald and Hans Petzold, TU Dresden)

In order to investigate the cause more closely, it would be advisable to continuously record the length of the crack. Length measurements should be possible in the range of 10^{-2} mm or even more accurately and can be connected to the existing installed data acquisition system. Thus, diurnal and annual influences of the climate will become evident.

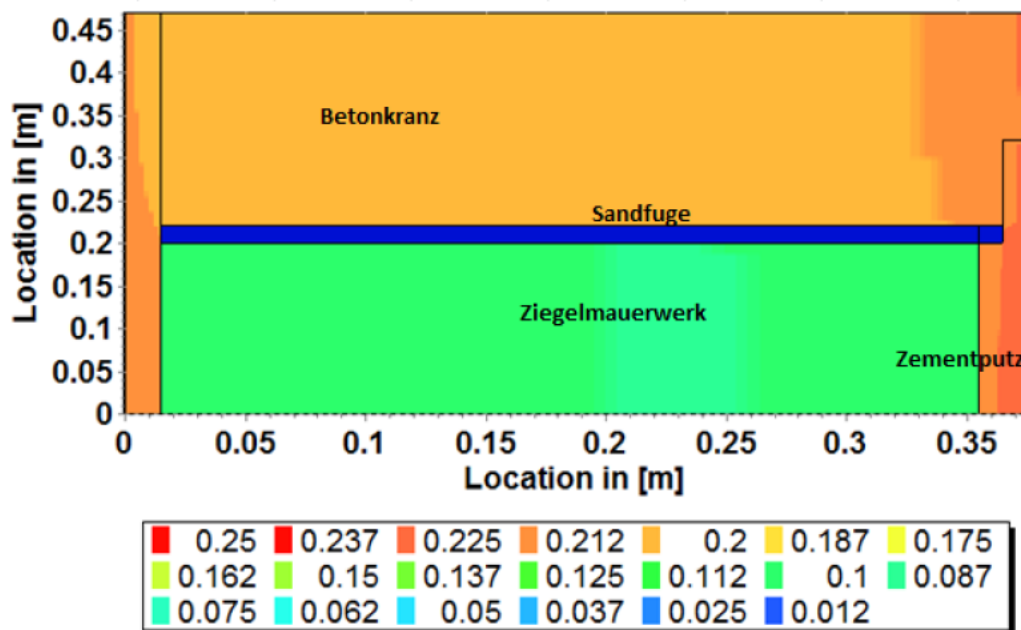
Two-dimensional thermal expansion (millimeters) of the concrete ring, sand joint, brick wall, and concrete render for a typical summer day. (Credit: John Grunewald and Hans Petzold, TU Dresden)

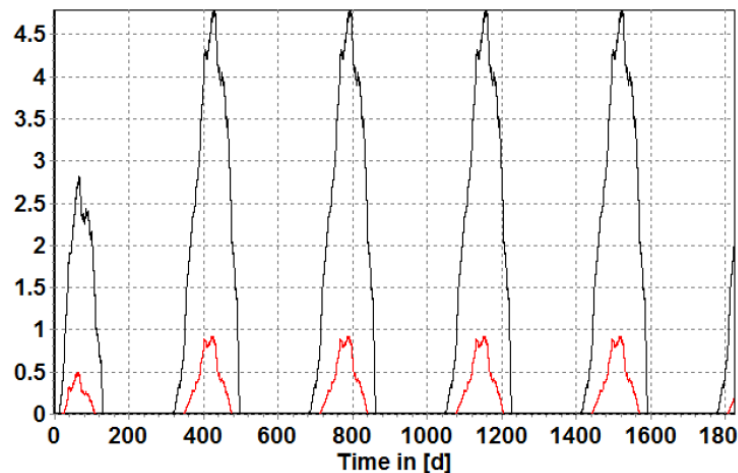
Condensate mass under the roof covering in indoor climate 20 °C and 50% (black) and 20 °C and 40% (red line) in kg m^{-2} over five years. In the first year a “transient oscillation” occurs due to the start conditions of the simulation. According to moisture protection elaborated in DIN 4108 (so-called glazier proof) 0.5 kg m^{-2} would be permissible. (Credit: John Grunewald and Hans Petzold, TU Dresden)

A simulation with real climate conditions shows that the design has some reserves in practice. At 20 °C and 40% humidity, the condensate volume would be a little less than 1 kg m^{-2} at a real outdoor climate. Since an adjacent layer is not absorbent, only 0.5 kg m^{-2} would be permissible according to the German standard DIN 4108. Due to the solar radiation impinging on the level roof during the warm seasons, the (calculated) moisture dries well and there is no continuous build up in the following years. With the more realistic 14°C and 40% mentioned above no condensate would occur.

Under real conditions of use no damage is to be expected due to surface or internal condensation. If, during a new roofing, an insulation (a few centimeters thickness) is placed under the roof seal, which would also be sensible as summer heat protection, a vapor barrier should be installed on the “warm” side of the insulation.
