CONSERVATION SURVEY

MAX-LIEBLING-HOUSE

29, IDELSON STREET, TEL AVIV

Tel Aviv/Berlin, 2016/17

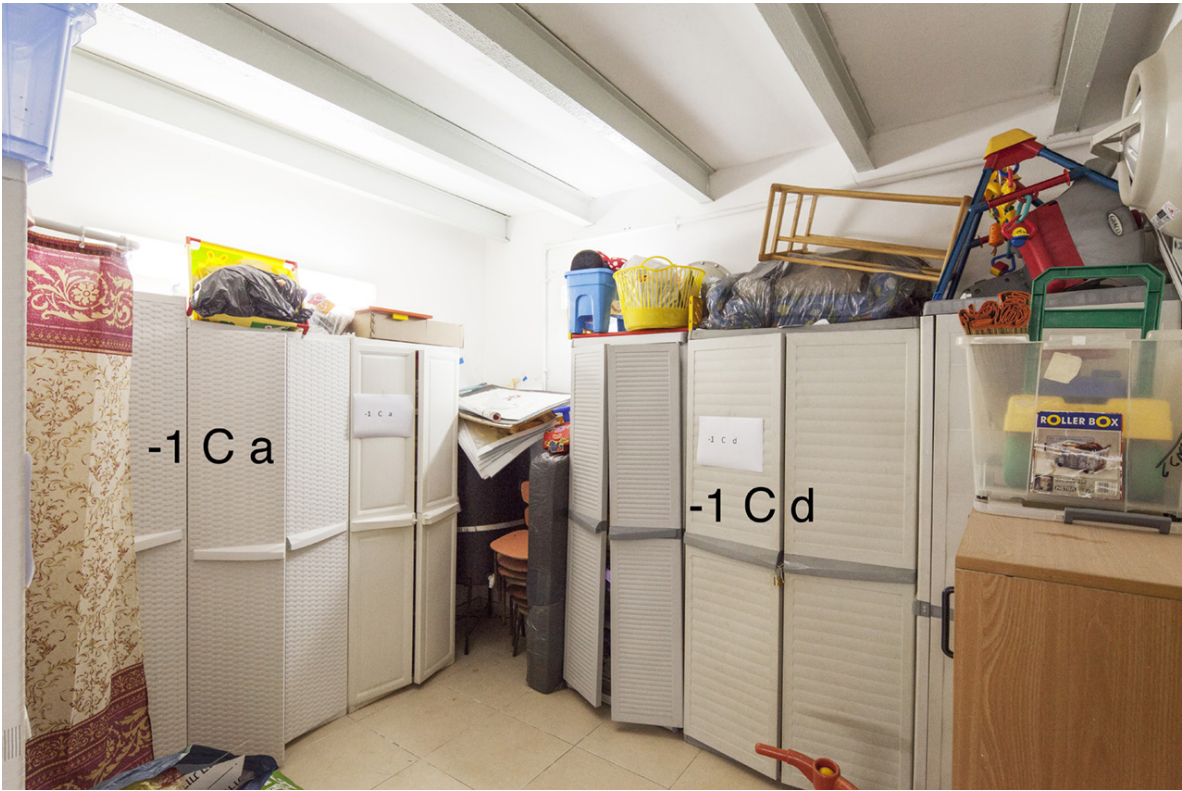
Room -1.C; _MG_3619.jpg; photo: Aviad Bar Ness, 2015

DATE		FLOOR		FUNCTION	ROOM
04/30/2015		Basement		Protection room	-1.C
ELEMENT	TYPE	DESCRIPTION	CONDITION, NOTES	DATING	ORIGINAL MATERIALS AND COLORS
FLOOR					
	F.2.1	Ceramic floor and base tiles, beige		Probably 2008	
WALLS AND BUILT-IN ELEMENTS					
a		Concrete wall strengthening the original construction		Wall 1937; supplementary wall 2008	
b		Concrete wall strengthening the original construction		Wall 1937; supplementary wall 2008	
c		Concrete wall strengthening the original construction, two round ventilation openings		Wall 1937; supplementary wall 2008	
D-1.E.02	D.2.3	Solid protective door	New	2008	
d		Concrete wall strengthening the original construction		Wall 1937; supplementary wall 2008	
CEILING					
		Concrete ceiling of the air raid shelter construction strengthened with painted I-beams		Ceiling 1937; supplementary beams 2008	Concrete

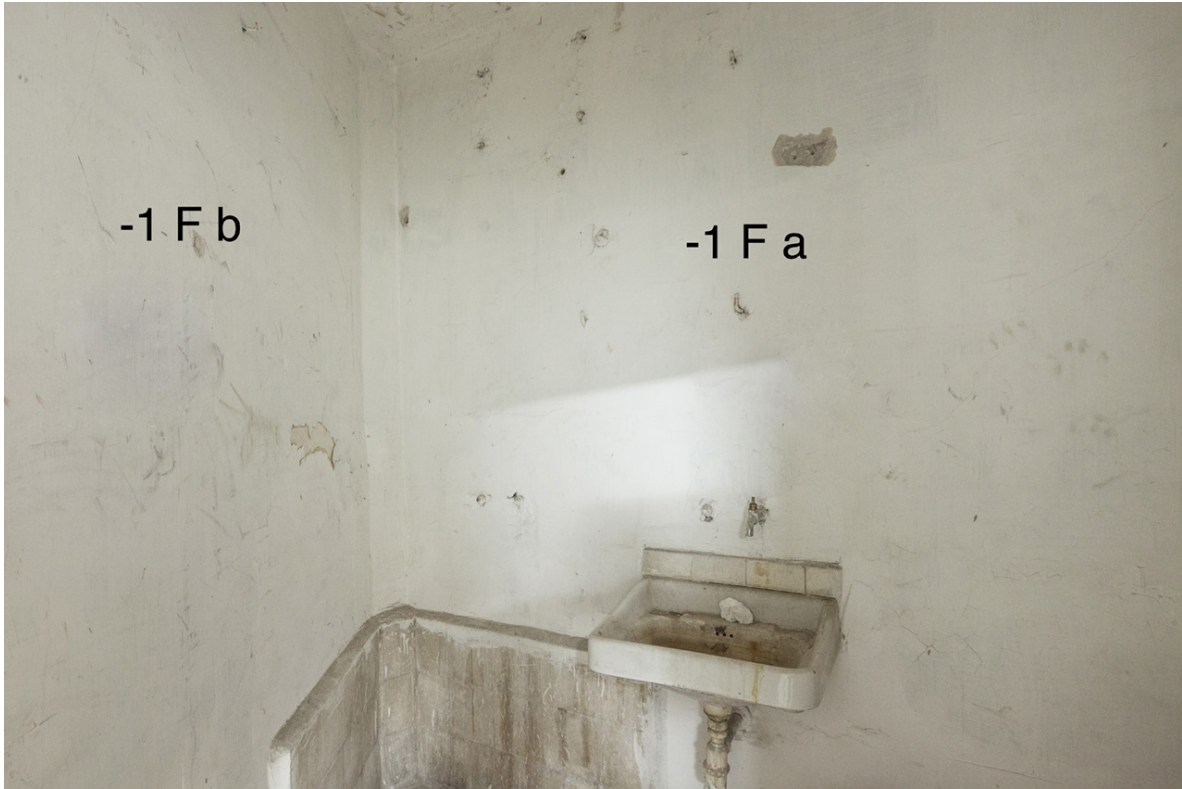
Room -1.F; _MG_3628.jpg; photo: Aviad Bar Ness, 2015

D-1.F.01	D.2.1	Door opening	Door leaf missing, frame original	1937	M13, (probably C.1.6)
d		Concrete wall	Paint renewed	1937	M6
W-1.F.03	W.3.1	Single-sash casement window; vertical iron bars and wire mesh on the outside	Original glass and handles; iron elements corroded	1937	M13; grille: M23; glass: M20
CEILING					
		Concrete ceiling	Paint renewed	1937	Concrete/white

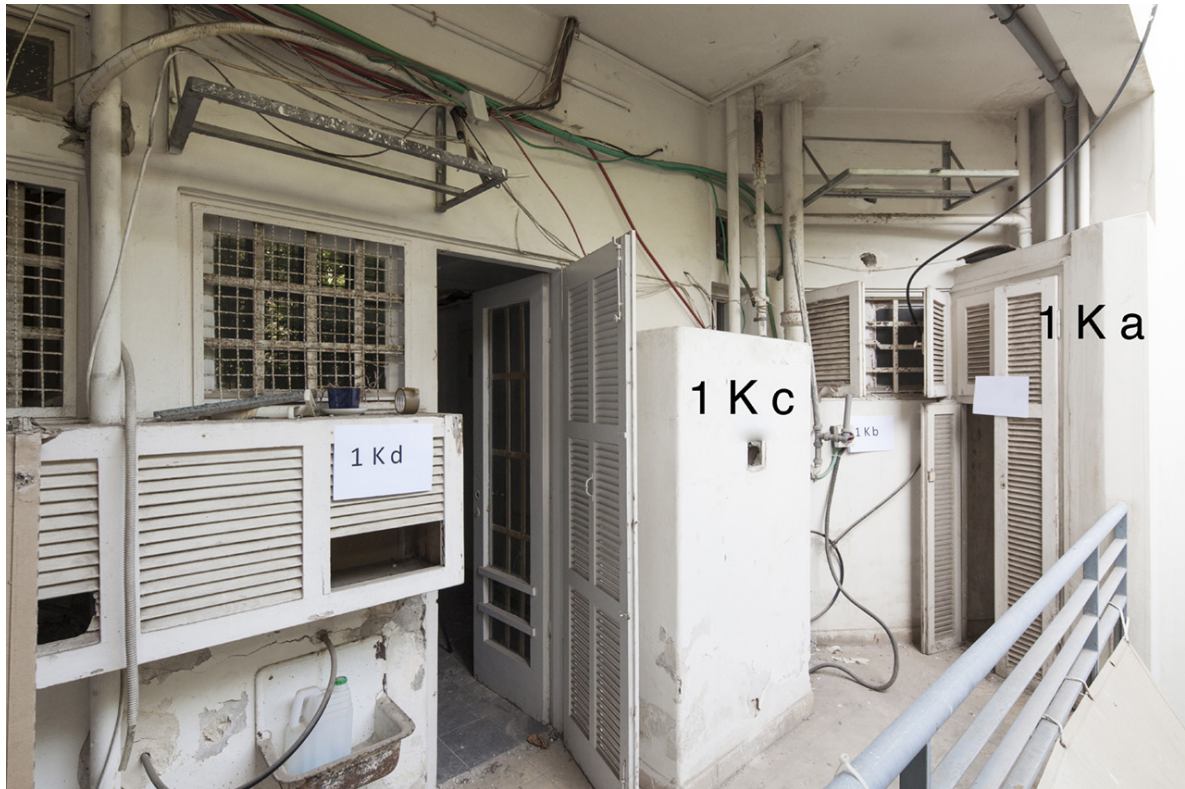
Room 01.K; _MG_3330.jpg; photo: Aviad Bar Ness, 2015

DATE		FLOOR		FUNCTION	ROOM
04/30/2015		2nd Floor		Balcony (B.2)	01.K
ELEMENT	TYPE	DESCRIPTION	CONDITION, NOTES	DATING	ORIGINAL MATERIALS AND COLORS
FLOOR					
	F.1.1	Terrazzo floor and base tiles; balcony curb of terrazzo blocks	Original flooring partly damaged, loose tiles, scratched surface, cracks, discolorations; curb blocks replaced	1937; balcony edge 1990s	M4
WALLS AND BUILT-IN ELEMENTS					
a		Rendered exterior wall with a laundry closet in a solid housing; cast-iron roof drainpipes running vertically through the closet	Paint renewed	1937	M7, (C.1.4); wood: M13, (C.1.6)
Laundry cupboard	S.1	Laundry closet with a hatch door in window W01.P.15 of the adjacent bathroom 01.P; double doors with wooden frames and slats	Paint renewed; internal arrangement original	1937	Wood: M13, (C.1.6)
b		Rendered exterior wall; cast-iron drainage and water pipes running vertically in front of the facade; wall-mounted steel rack for an air-conditioning unit and two core holes through the upper part of the wall; several open installations for water and electricity	Paint renewed; wall-mounted installations, core holes and wiring new	Wall, plaster, drainage and water pipes 1937; paint, technical installations and wiring 1960s-1990s	M7, (C.1.4)

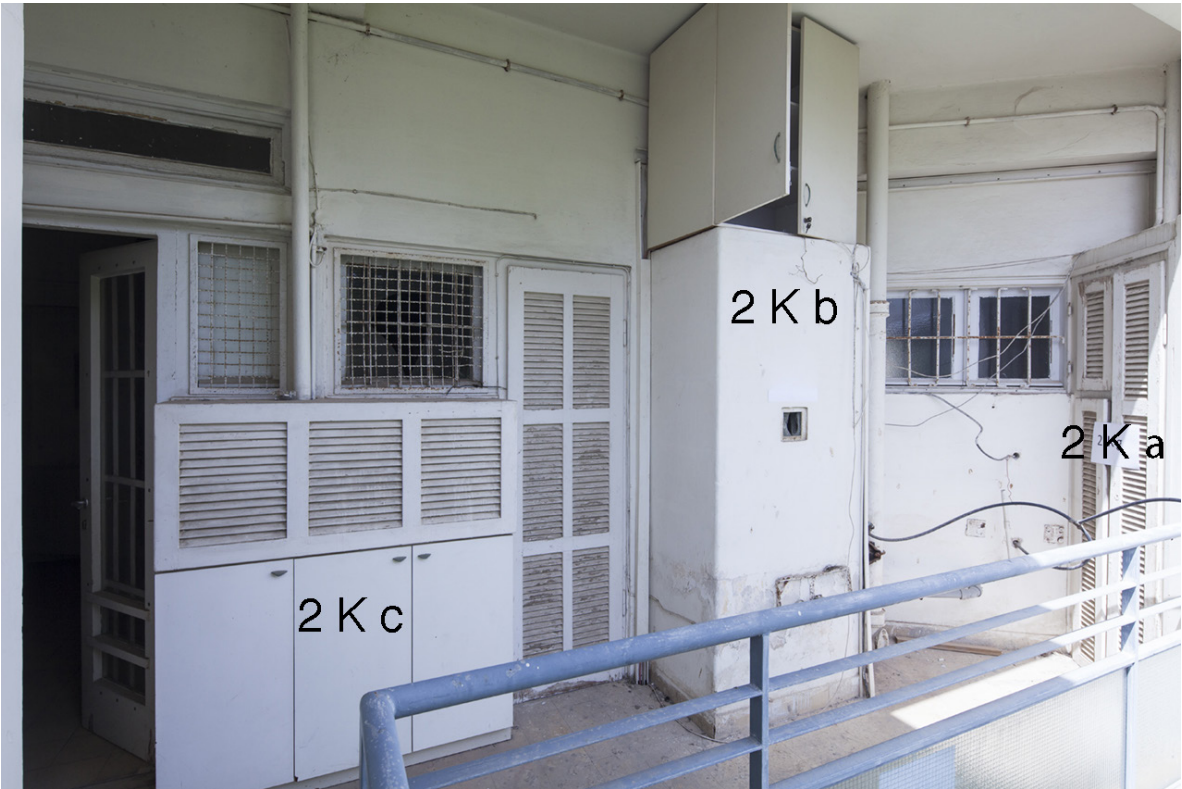
Room 02.K; _MG_3164.jpg; photo: Aviad Bar Ness, 2015

DATE		FLOOR		FUNCTION	ROOM
04/30/2015		3rd Floor		Balcony (B.2)	02.K
ELEMENT	TYPE	DESCRIPTION	CONDITION, NOTES	DATING	ORIGINAL MATERIALS AND COLORS
FLOOR					
	F.1.1	Terrazzo floor and base tiles; terrazzo curb at the balcony edge; floor drain with square cover plate (11.5 x 11.5cm)	Original flooring partly damaged, loose tiles, scratched surface, cracks, discolorations; edge blocks replaced; original drain cover	1937; balcony edge 1990s	M4; drain cover plate: M25
WALLS AND BUILT-IN ELEMENTS					
a		Rendered exterior wall with a laundry closet in a solid housing; cast-iron roof drainpipes running vertically through the closet	Paint renewed	1937	M7, (C.1.4); wood: M13, (C.1.6)
Laundry closet	S.1	Laundry closet with a hatch door combined with window W.02.P.16 of the adjacent bathroom 02.P; double doors with wooden frames and slats	Paint renewed; internal arrangement original	1937	Wood: M13, (C.1.6)

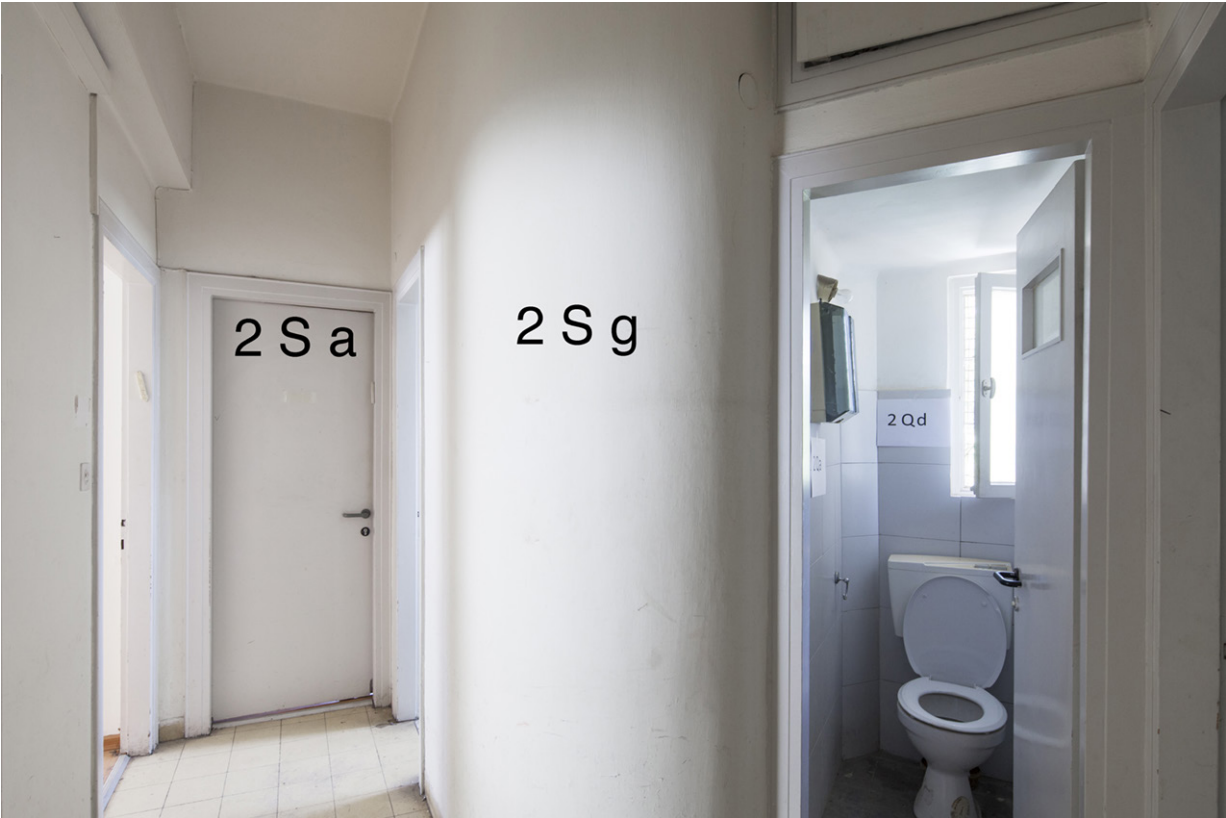
Room 02.S; _MG_3183.jpg; photo: Aviad Bar Ness, 2015

DATE		FLOOR		FUNCTION	ROOM
04/30/2015		3rd Floor		Corridor	02.S
ELEMENT	TYPE	DESCRIPTION	CONDITION, NOTES	DATING	ORIGINAL MATERIALS AND COLORS
FLOOR					
	F.1.1	Terrazzo floor and base tiles	Partly scratched surface, cracks	1937	M4
WALLS AND BUILT-IN ELEMENTS					
a		Plastered interior wall; open wiring	Surface renewed	Wall and plaster 1937; wiring 1960s-1990s	M7, (C.1.5)
D02.O.01	D.1.5	Single-leaf solid door with a wooden frame	Paint renewed and handles replaced	1937; handles 1990s or later	Wood: M13, (C.1.6)
b		Plastered interior wall; thickness of wall less than that of adjoining concrete columns and beam; flush-mounted light switch next to D02.N.01; open wiring	Surface renewed; flush-mounted light switch original	Wall, plaster and light switch 1937; wiring 1960s-1990s	M7, (C.1.5); light switch: M26
D02.N.01	D.1.5	Single-leaf solid door with a wooden frame	Paint renewed and handles replaced	1937; handles 1990s or later	Wood: M13, (C.1.6)

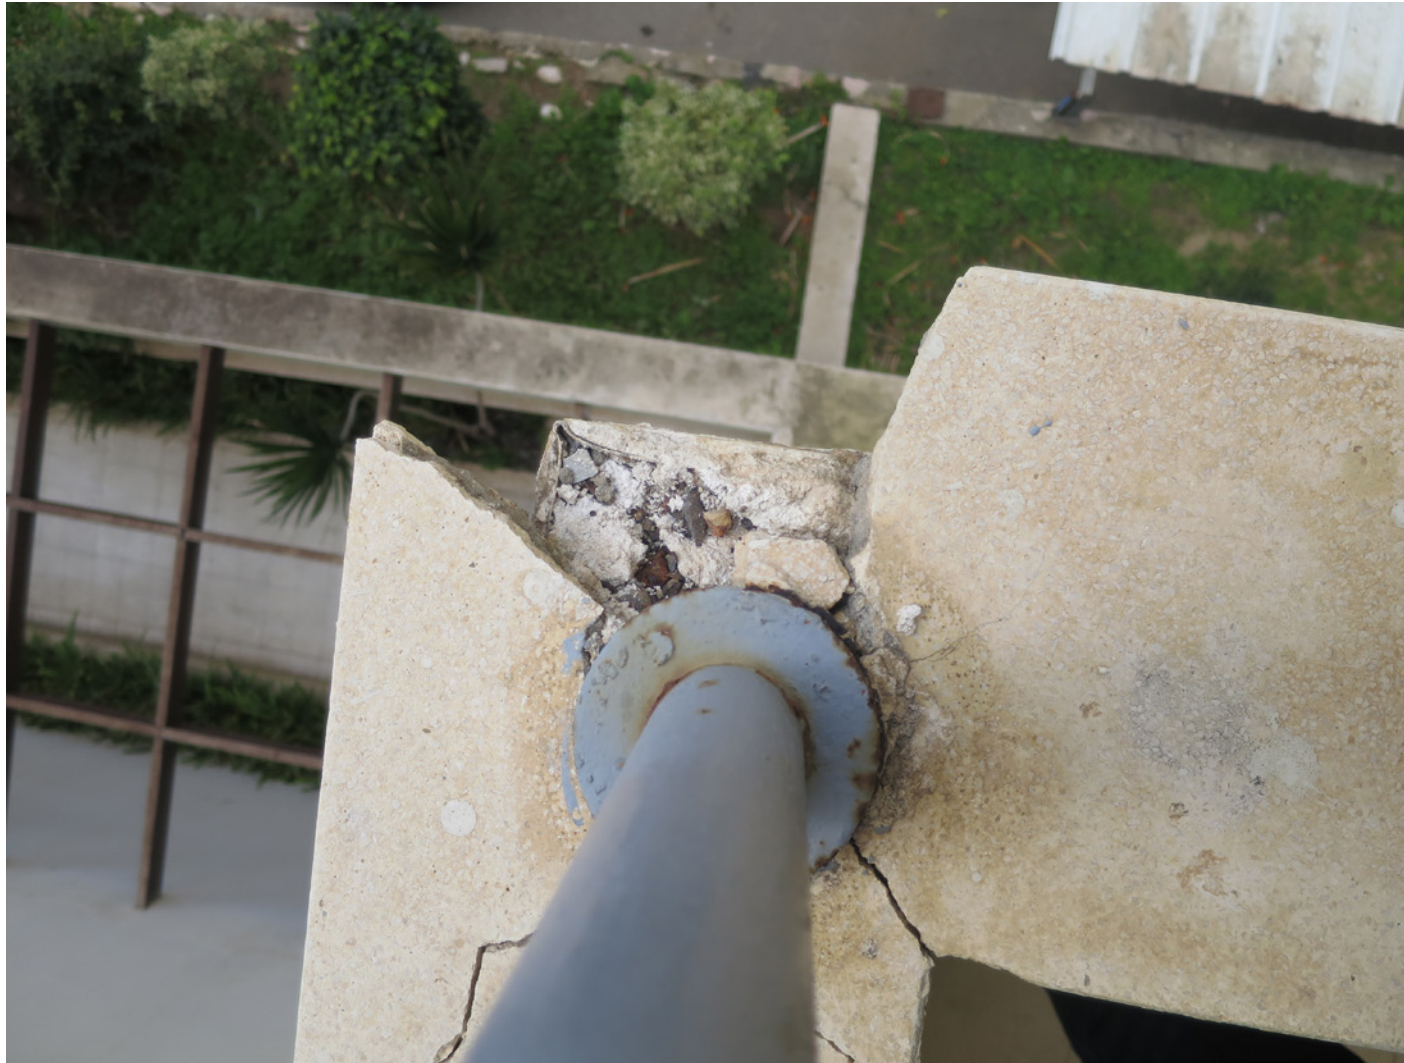
Fig. 174 Damaged terrazzo coping on the balcony, 2016

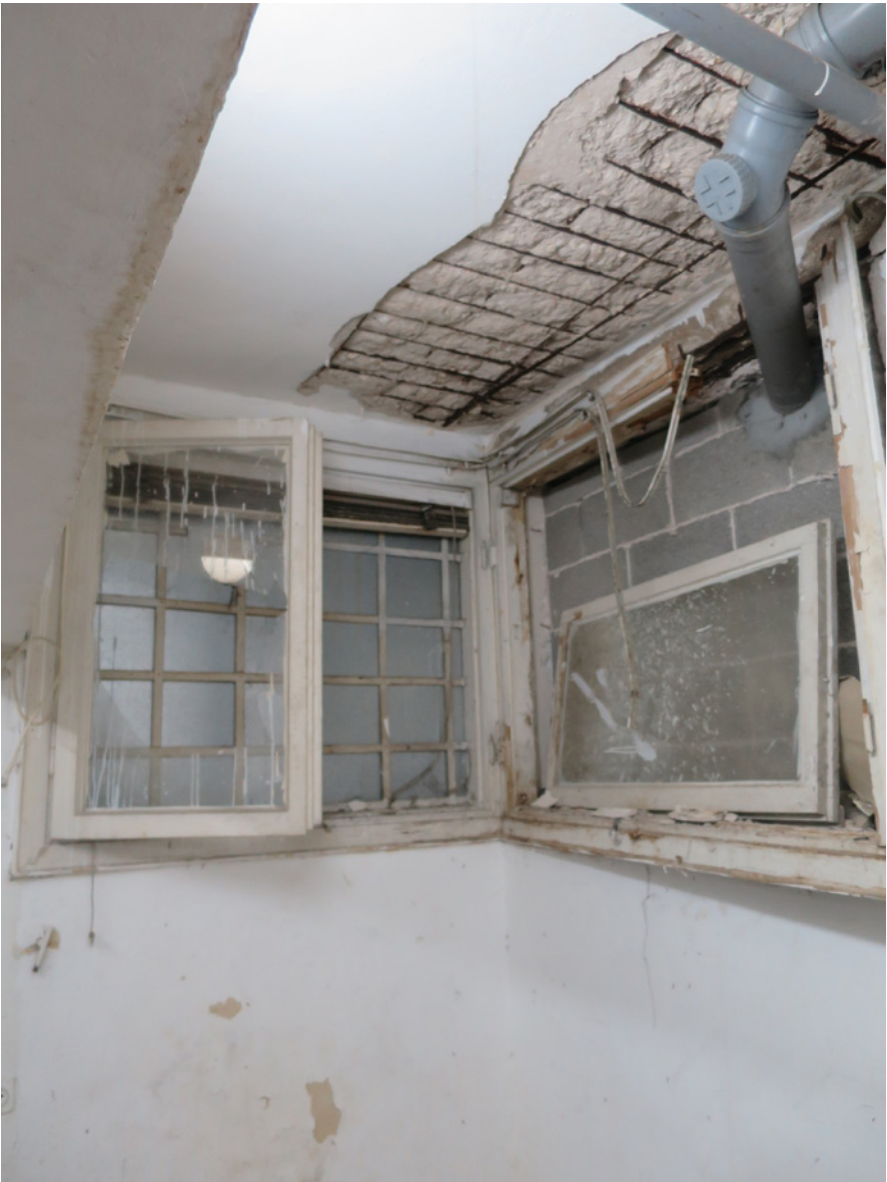
Fig. 175 Corroded reinforcement of a concrete ceiling in the basement, 2016

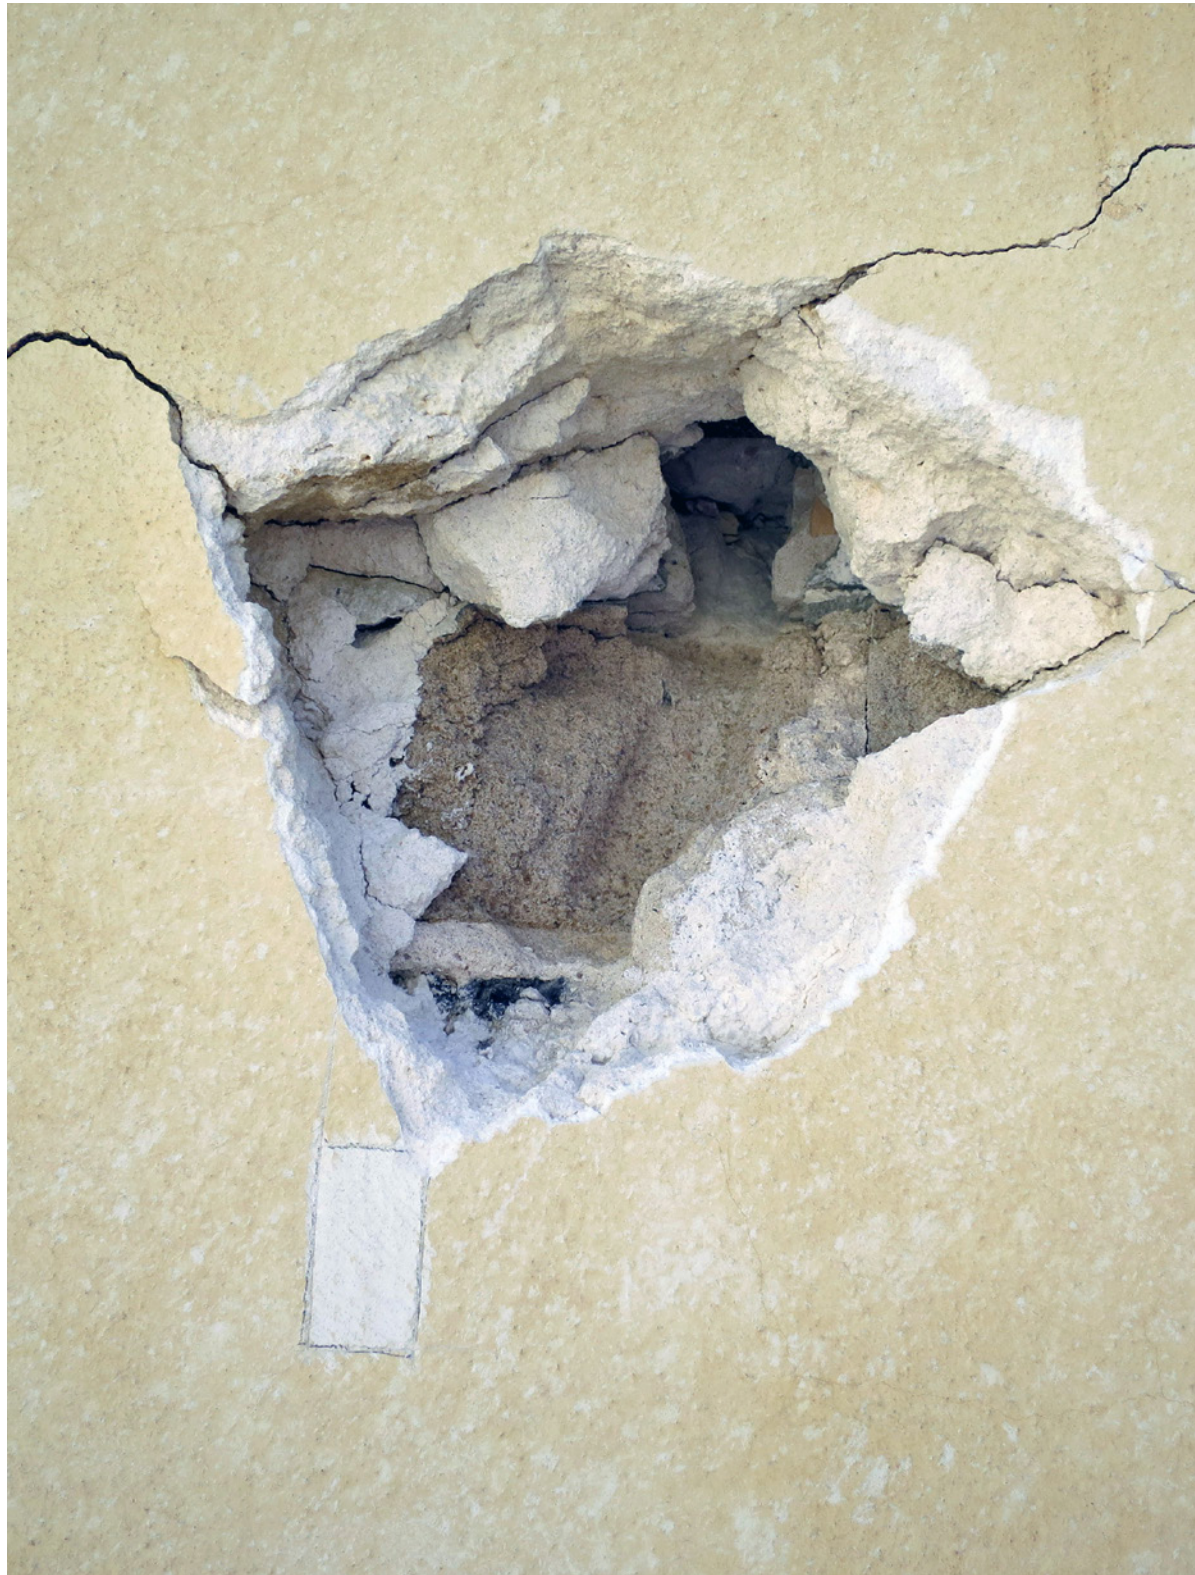
Fig. 35 Crack in the plaster where the wall material changes (bricks/concrete), roof zone of the staircase, 2016
