Final report of the Grantee

Milan, December 23rd, 2020

This publication is made possible with support from the Getty Foundation through its Keeping It Modern initiative

Scientific Coordinator Prof. DAVIDE DEL CURTO Politecnico di Milano, Department of Architecture and Urban Studies

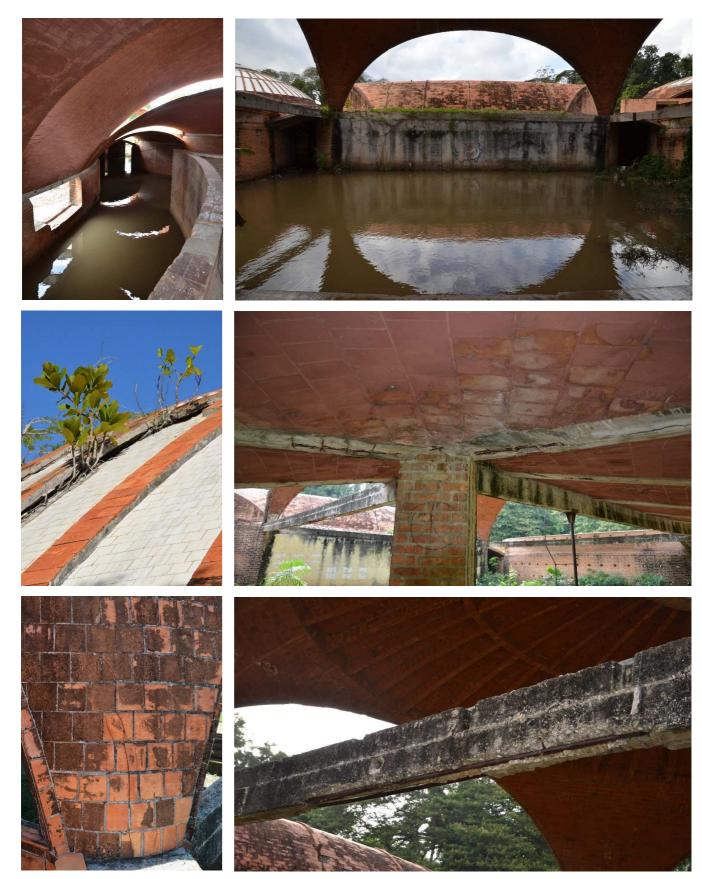
Figure 30 - Main deterioration phenomena detected (2019-2020).

While the Choreography Theater appears well preserved and does not display particular structural failure signs, a few more issues were detected within the Dance Pavilions. The pendentives display several crack paths, and the concrete tie-rods connecting them at their bases are inflected and lost consistent portions of concrete cover (Figure 30 - bottom).

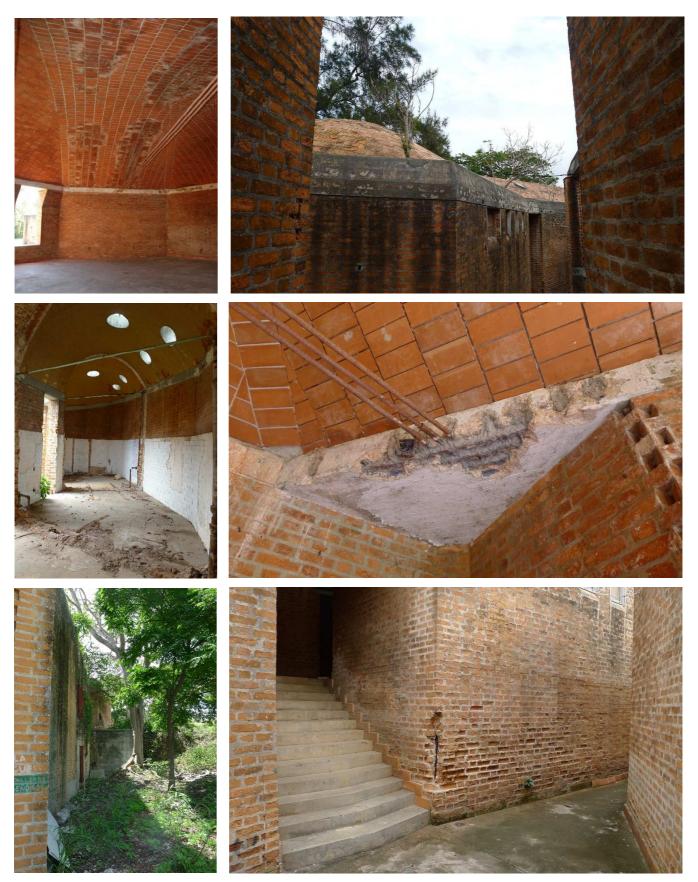
Figure 54 - Main deterioration phenomena detected (2019-2020).

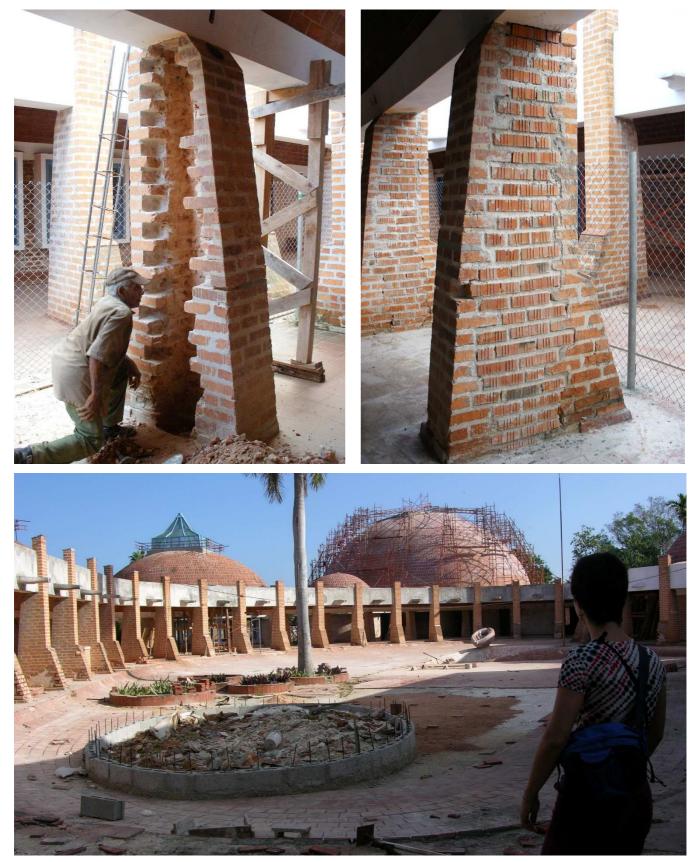
Figure 74 - Restoration occurred between 2000 and 2005. On the top: insertion of a concrete core to strengthen the pillars.

The bricks employed to repair walls after the construction of the reinforced concrete buttresses have suffered severe deterioration due to their faulty composition. The renewal of the skylights has partially modified the domes' original shape as a new profile has been inserted where the clearstory touches the roof. This element, employed to prevent water infiltrations, has proven inefficient, and it has caused further damage to the lower structures.

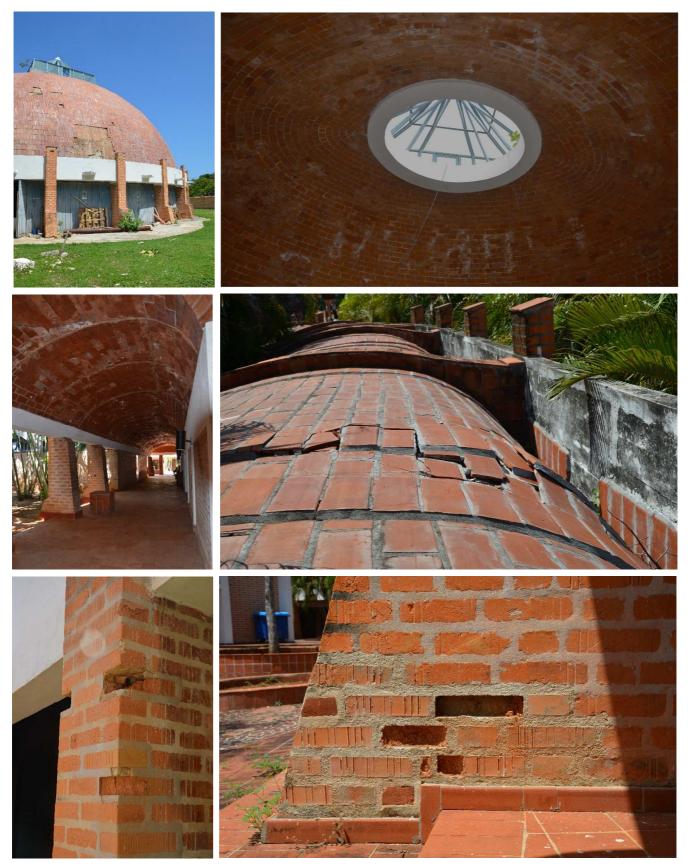
Figure 76 - Main criticalities detected (2019-2020).

The aforementioned problems, regarding the school's roofing, resulted in consistent water infiltration phenomena highlighted by the diffused presence of humidity stains and efflorescence at the intrados of the domes and vaults (Figure 76 - top).
