# The Hill House

Research & Development Project

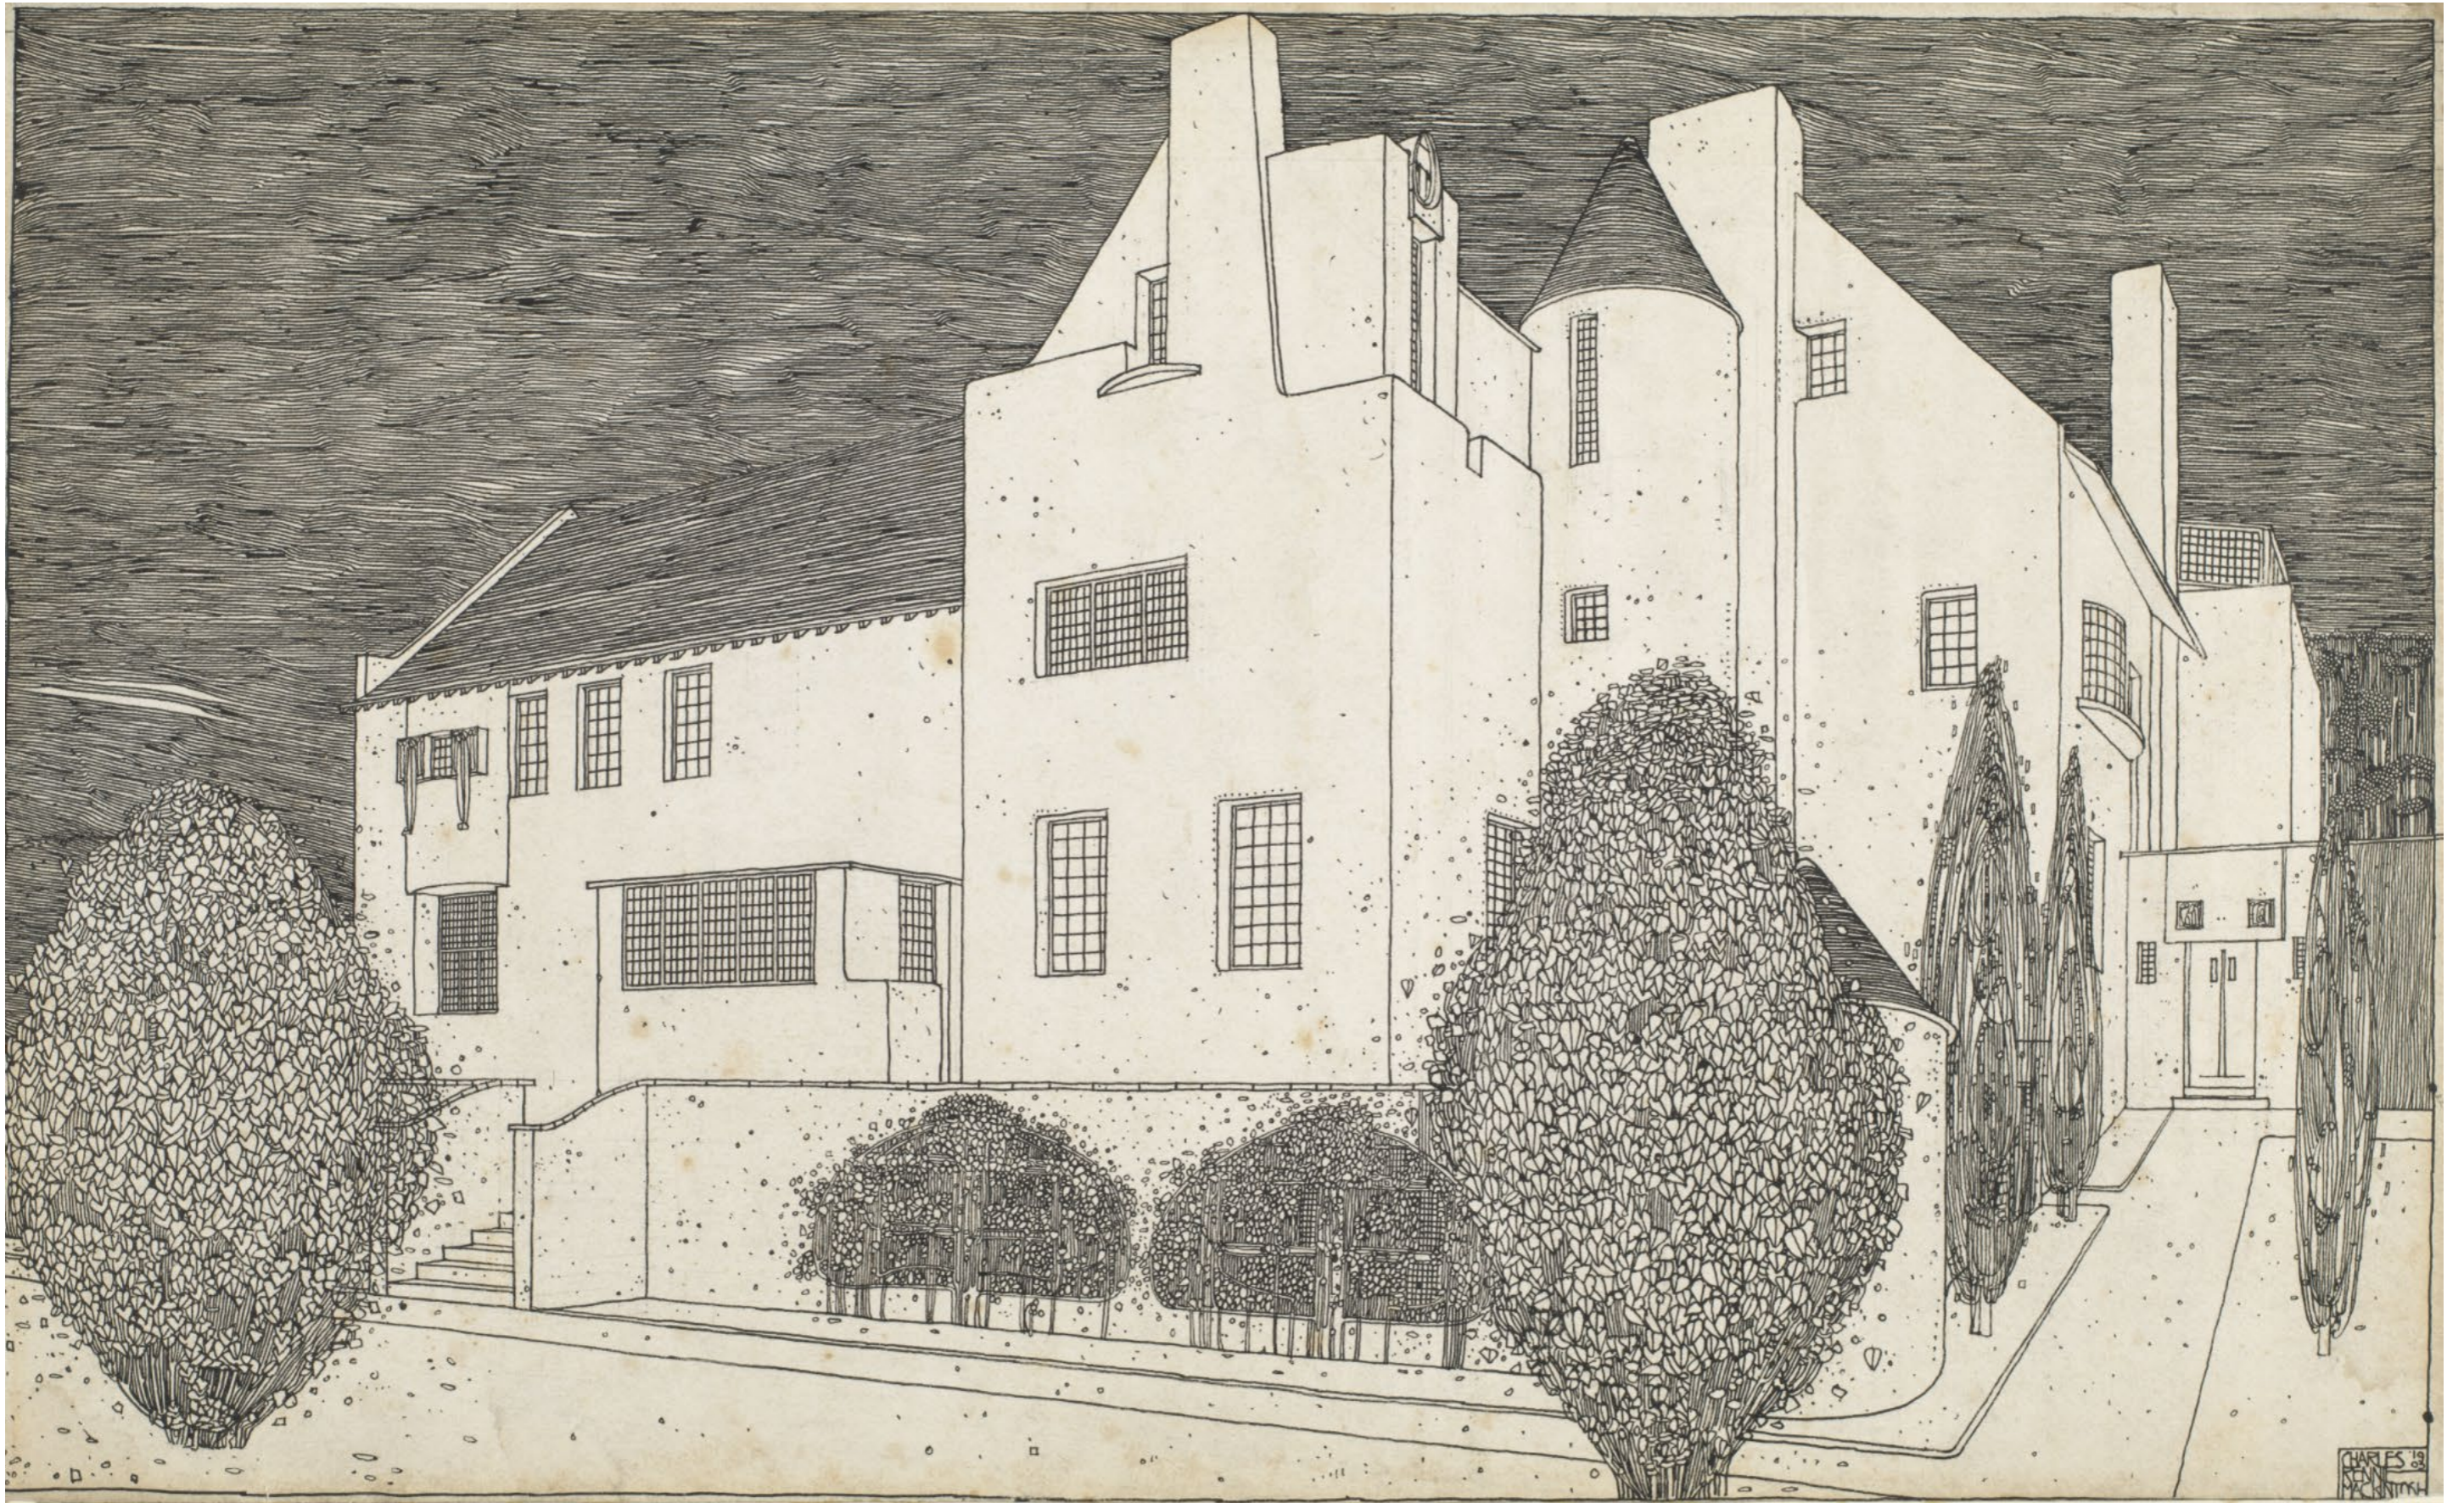
1903 Concept sketch from South East

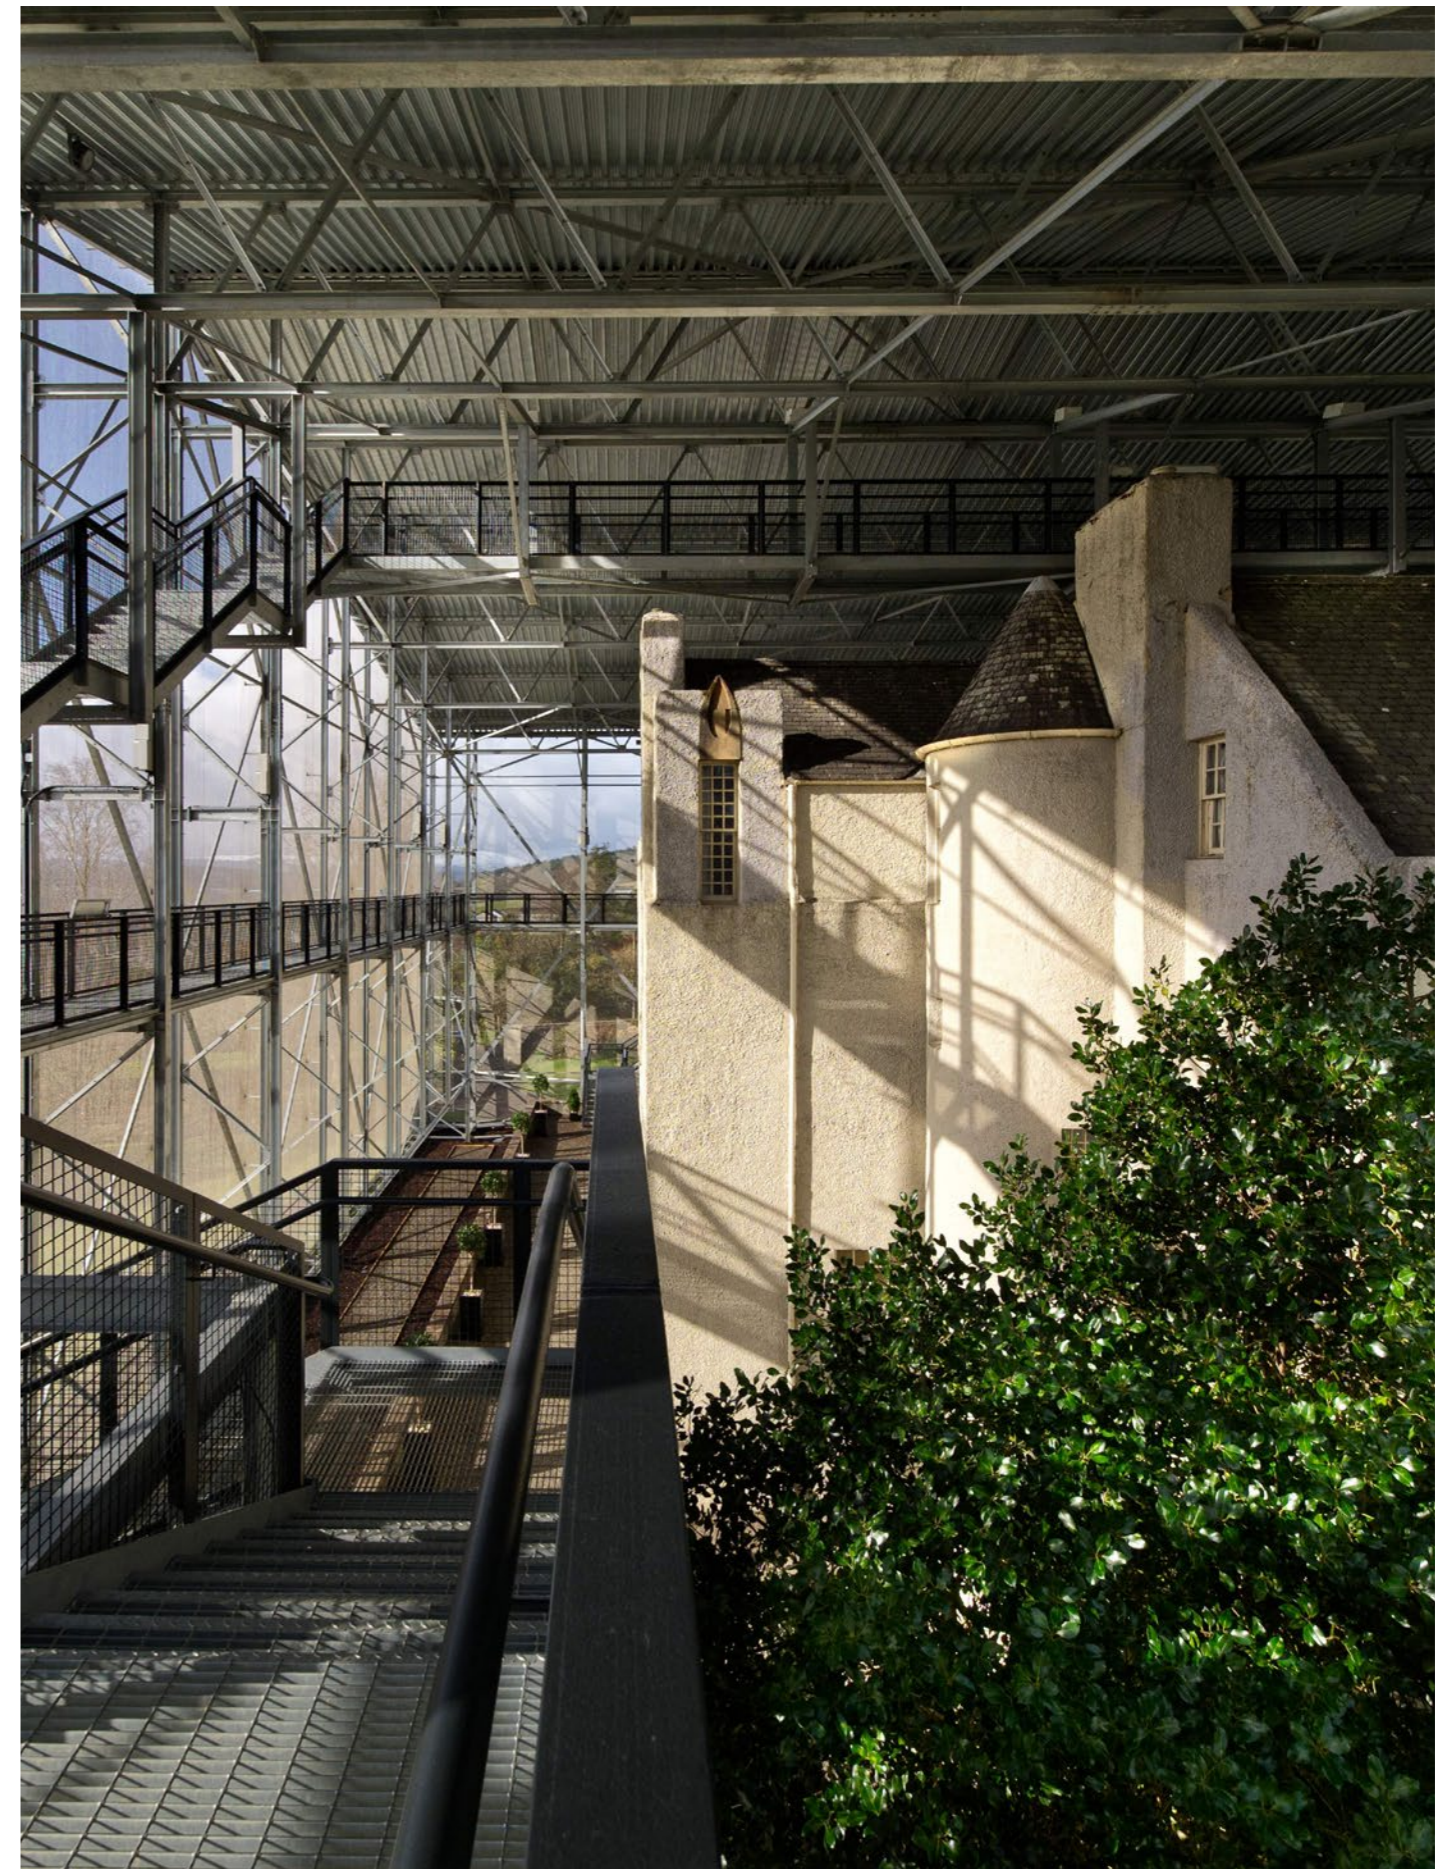
The success of the Box is demonstrated by the evidence of the HES thermographic and moisture content surveys as well as the improvements to the environmental condition of the interiors.

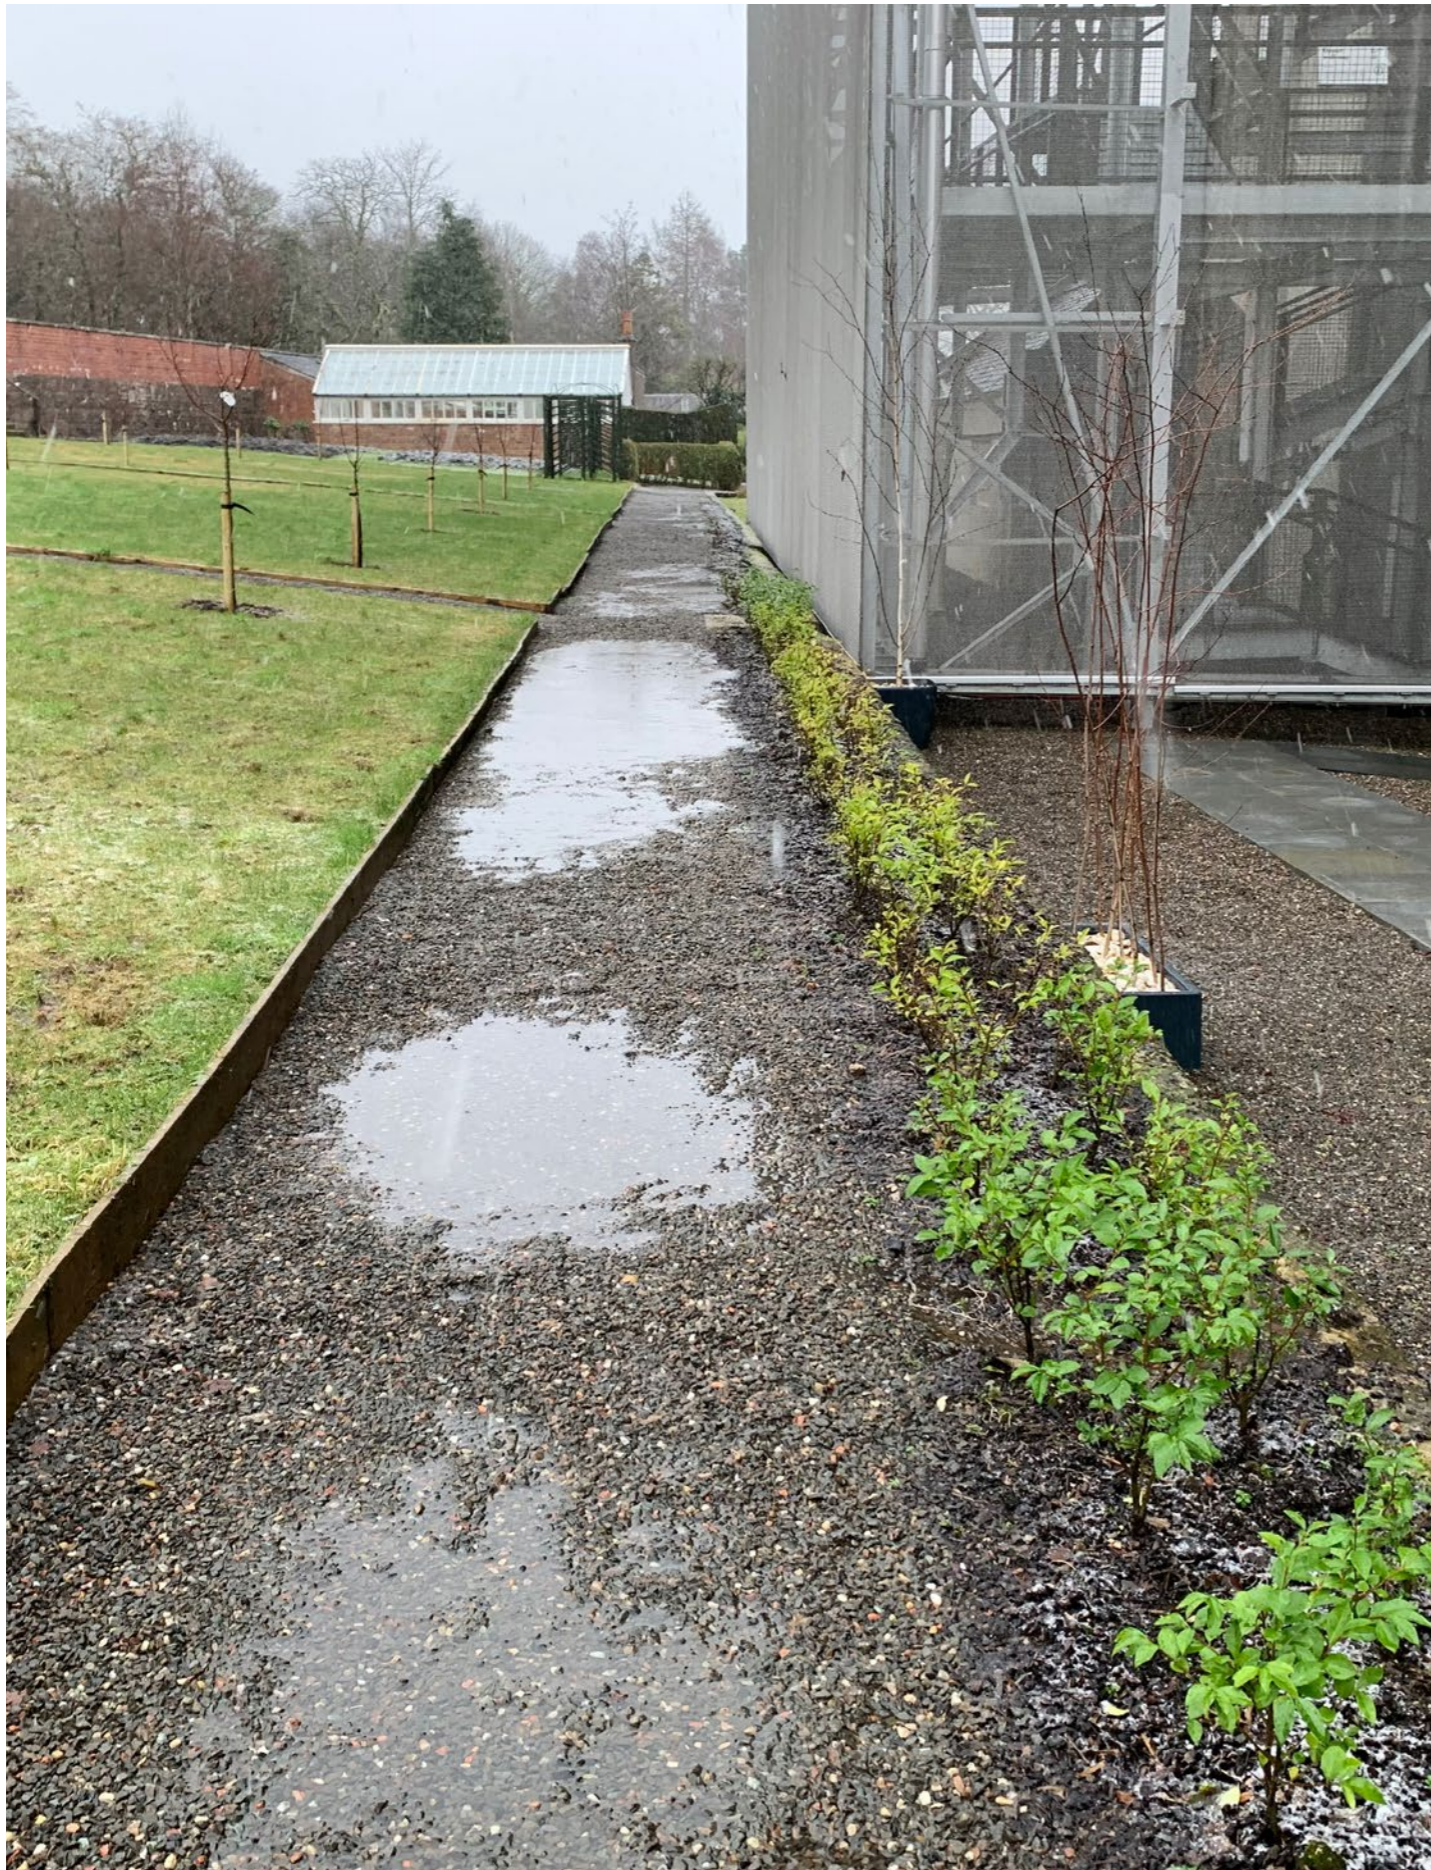
46 Ground water pooling along North Elevation, 2021

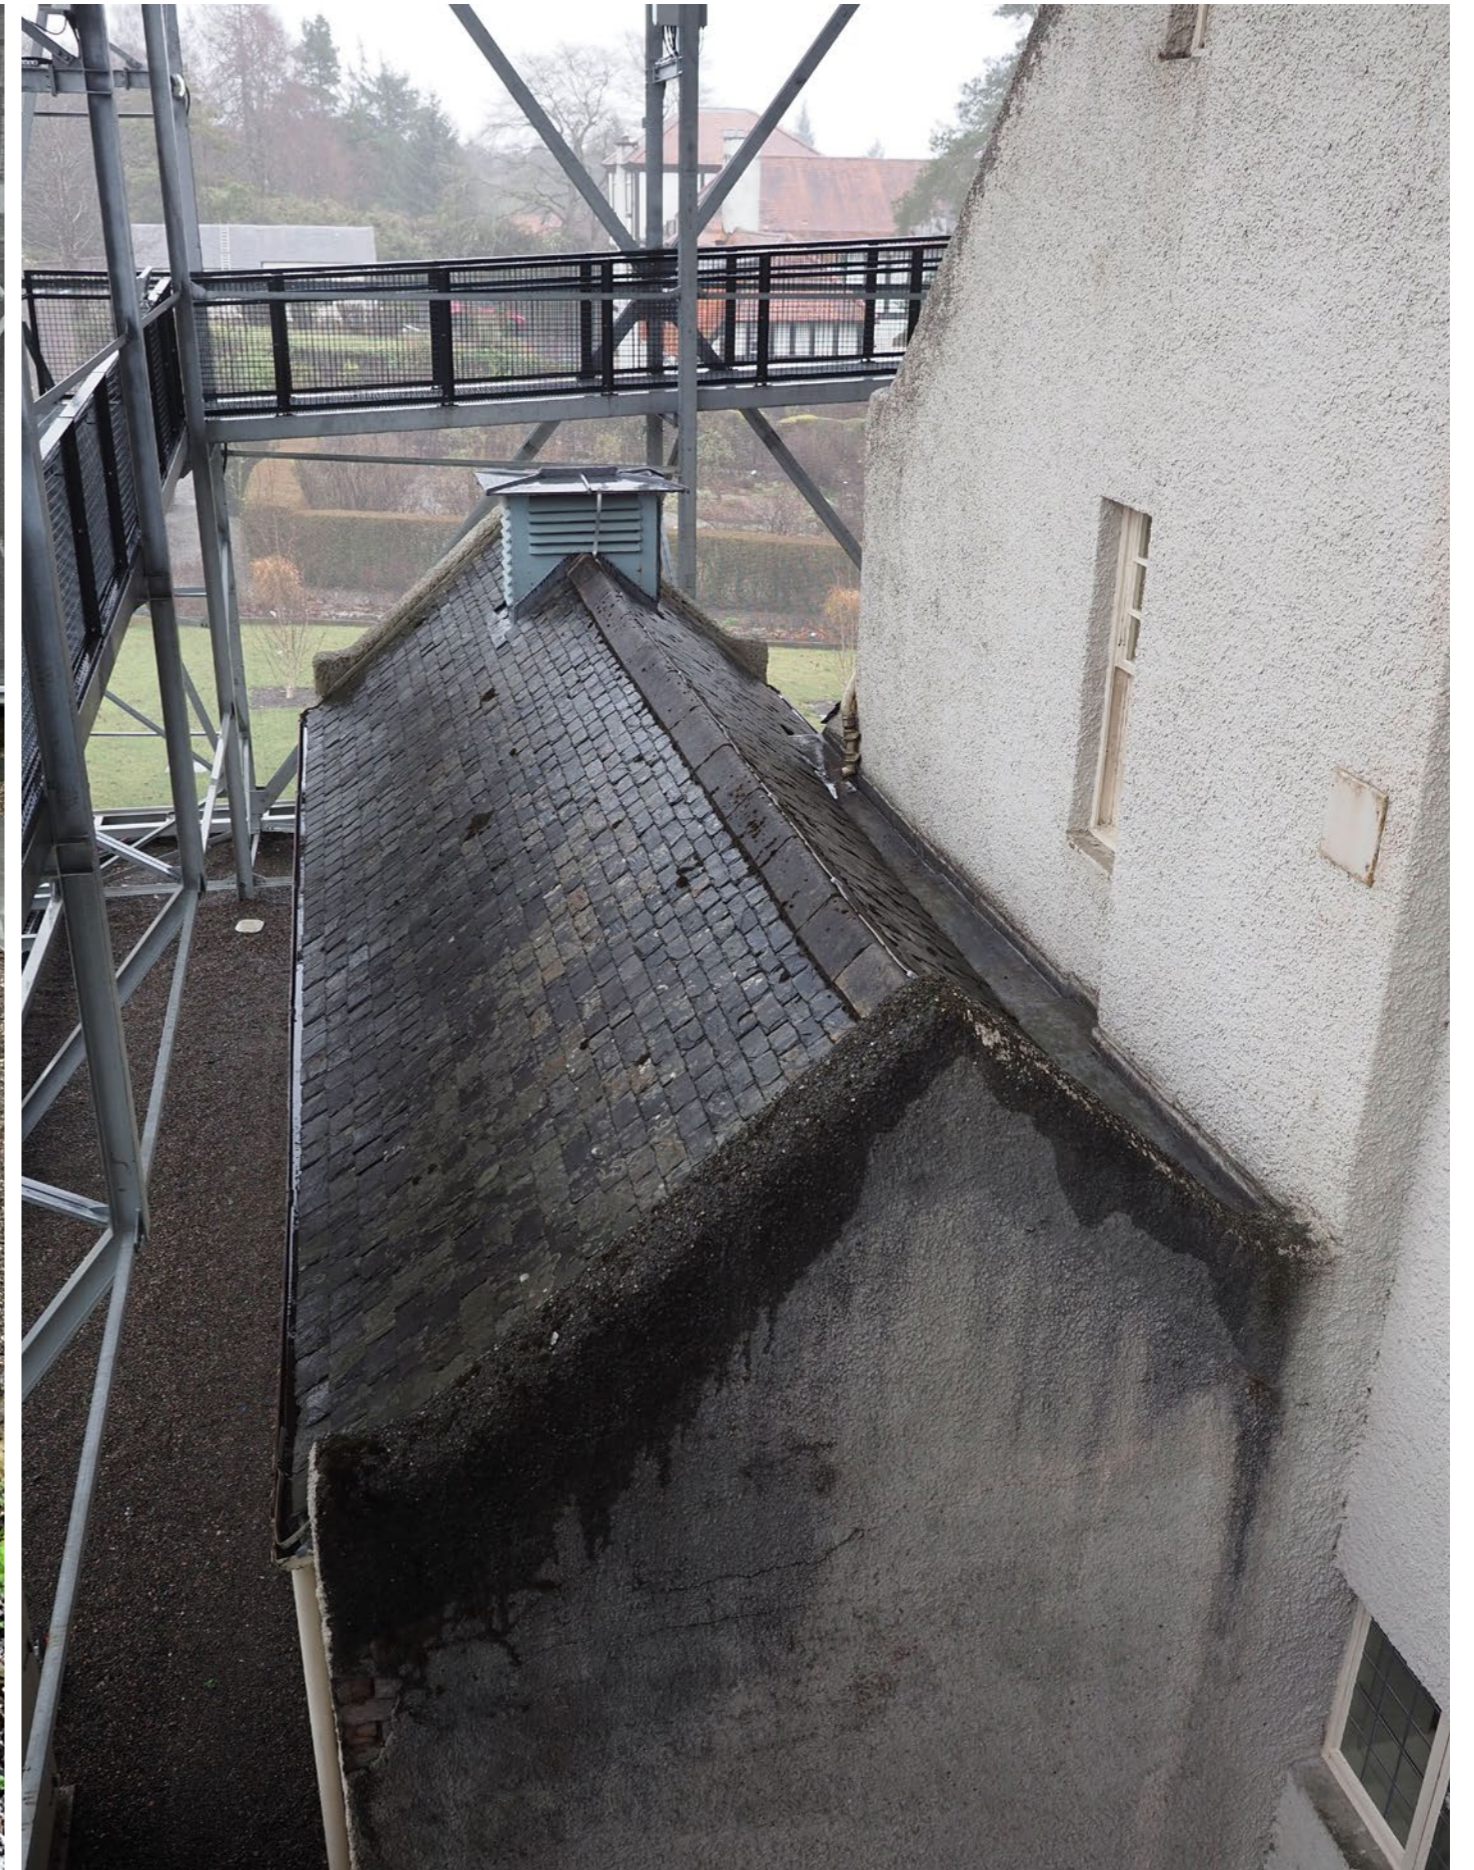
Elements of the building continue to be saturated in bad weather, depending on wind intensity and direction, 2021

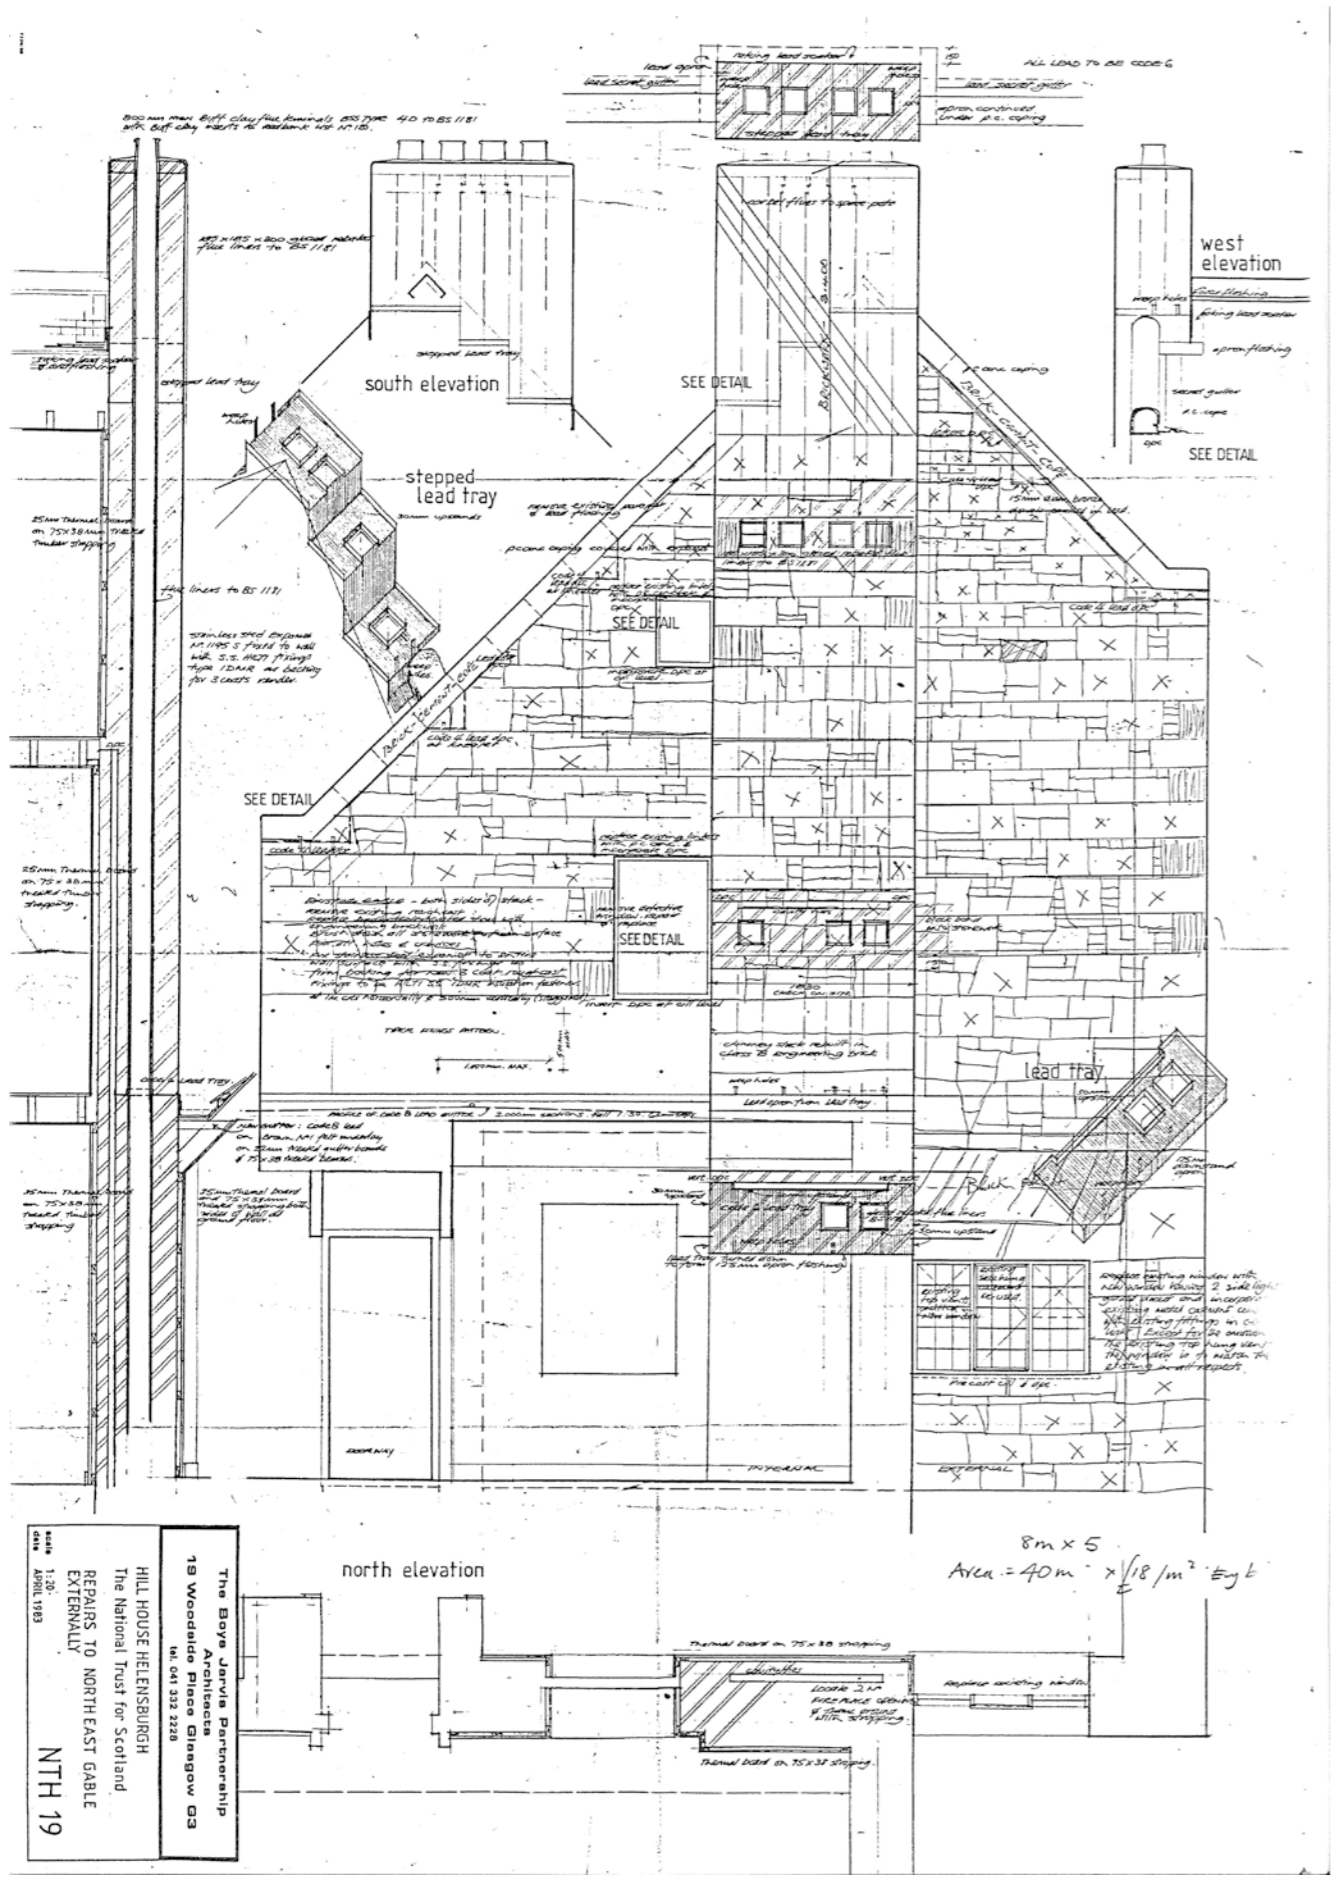
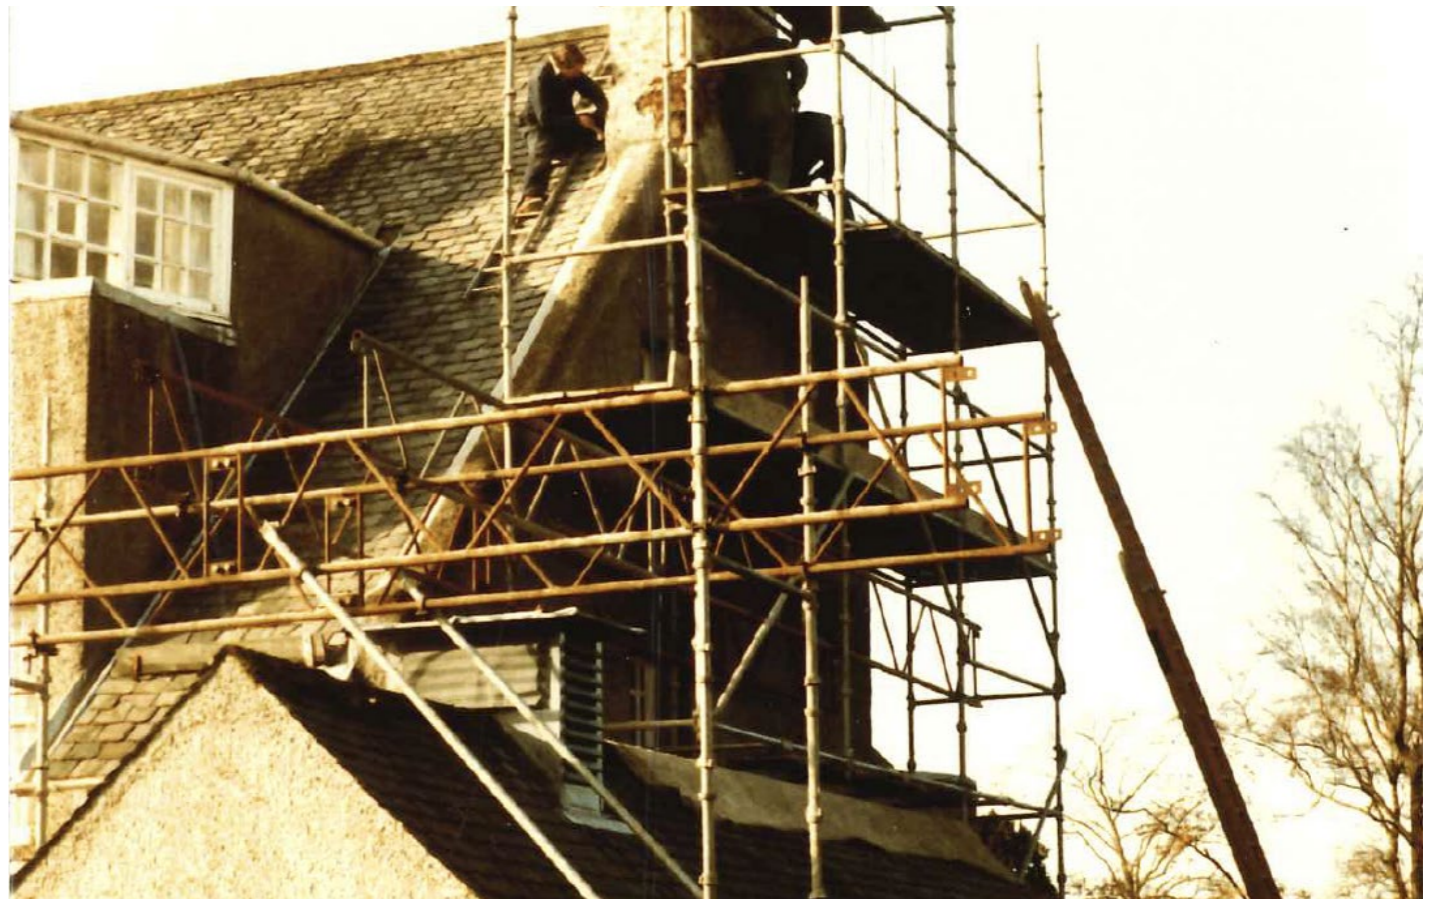
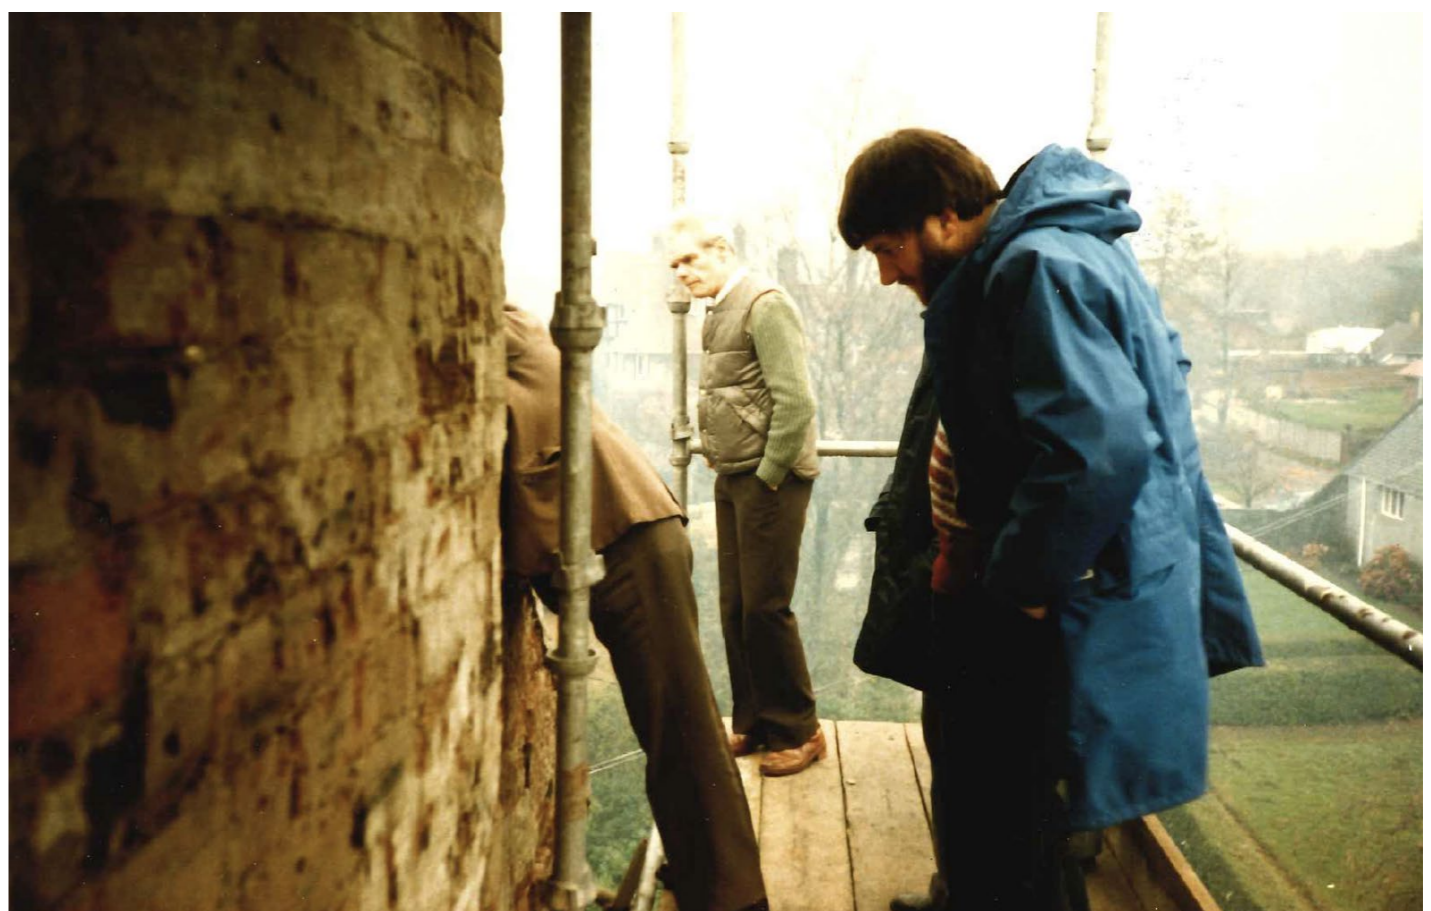
The following elevation analysis drawings are based on documentary evidence uncovered to date and describe the type and extent of underlying wall materials.

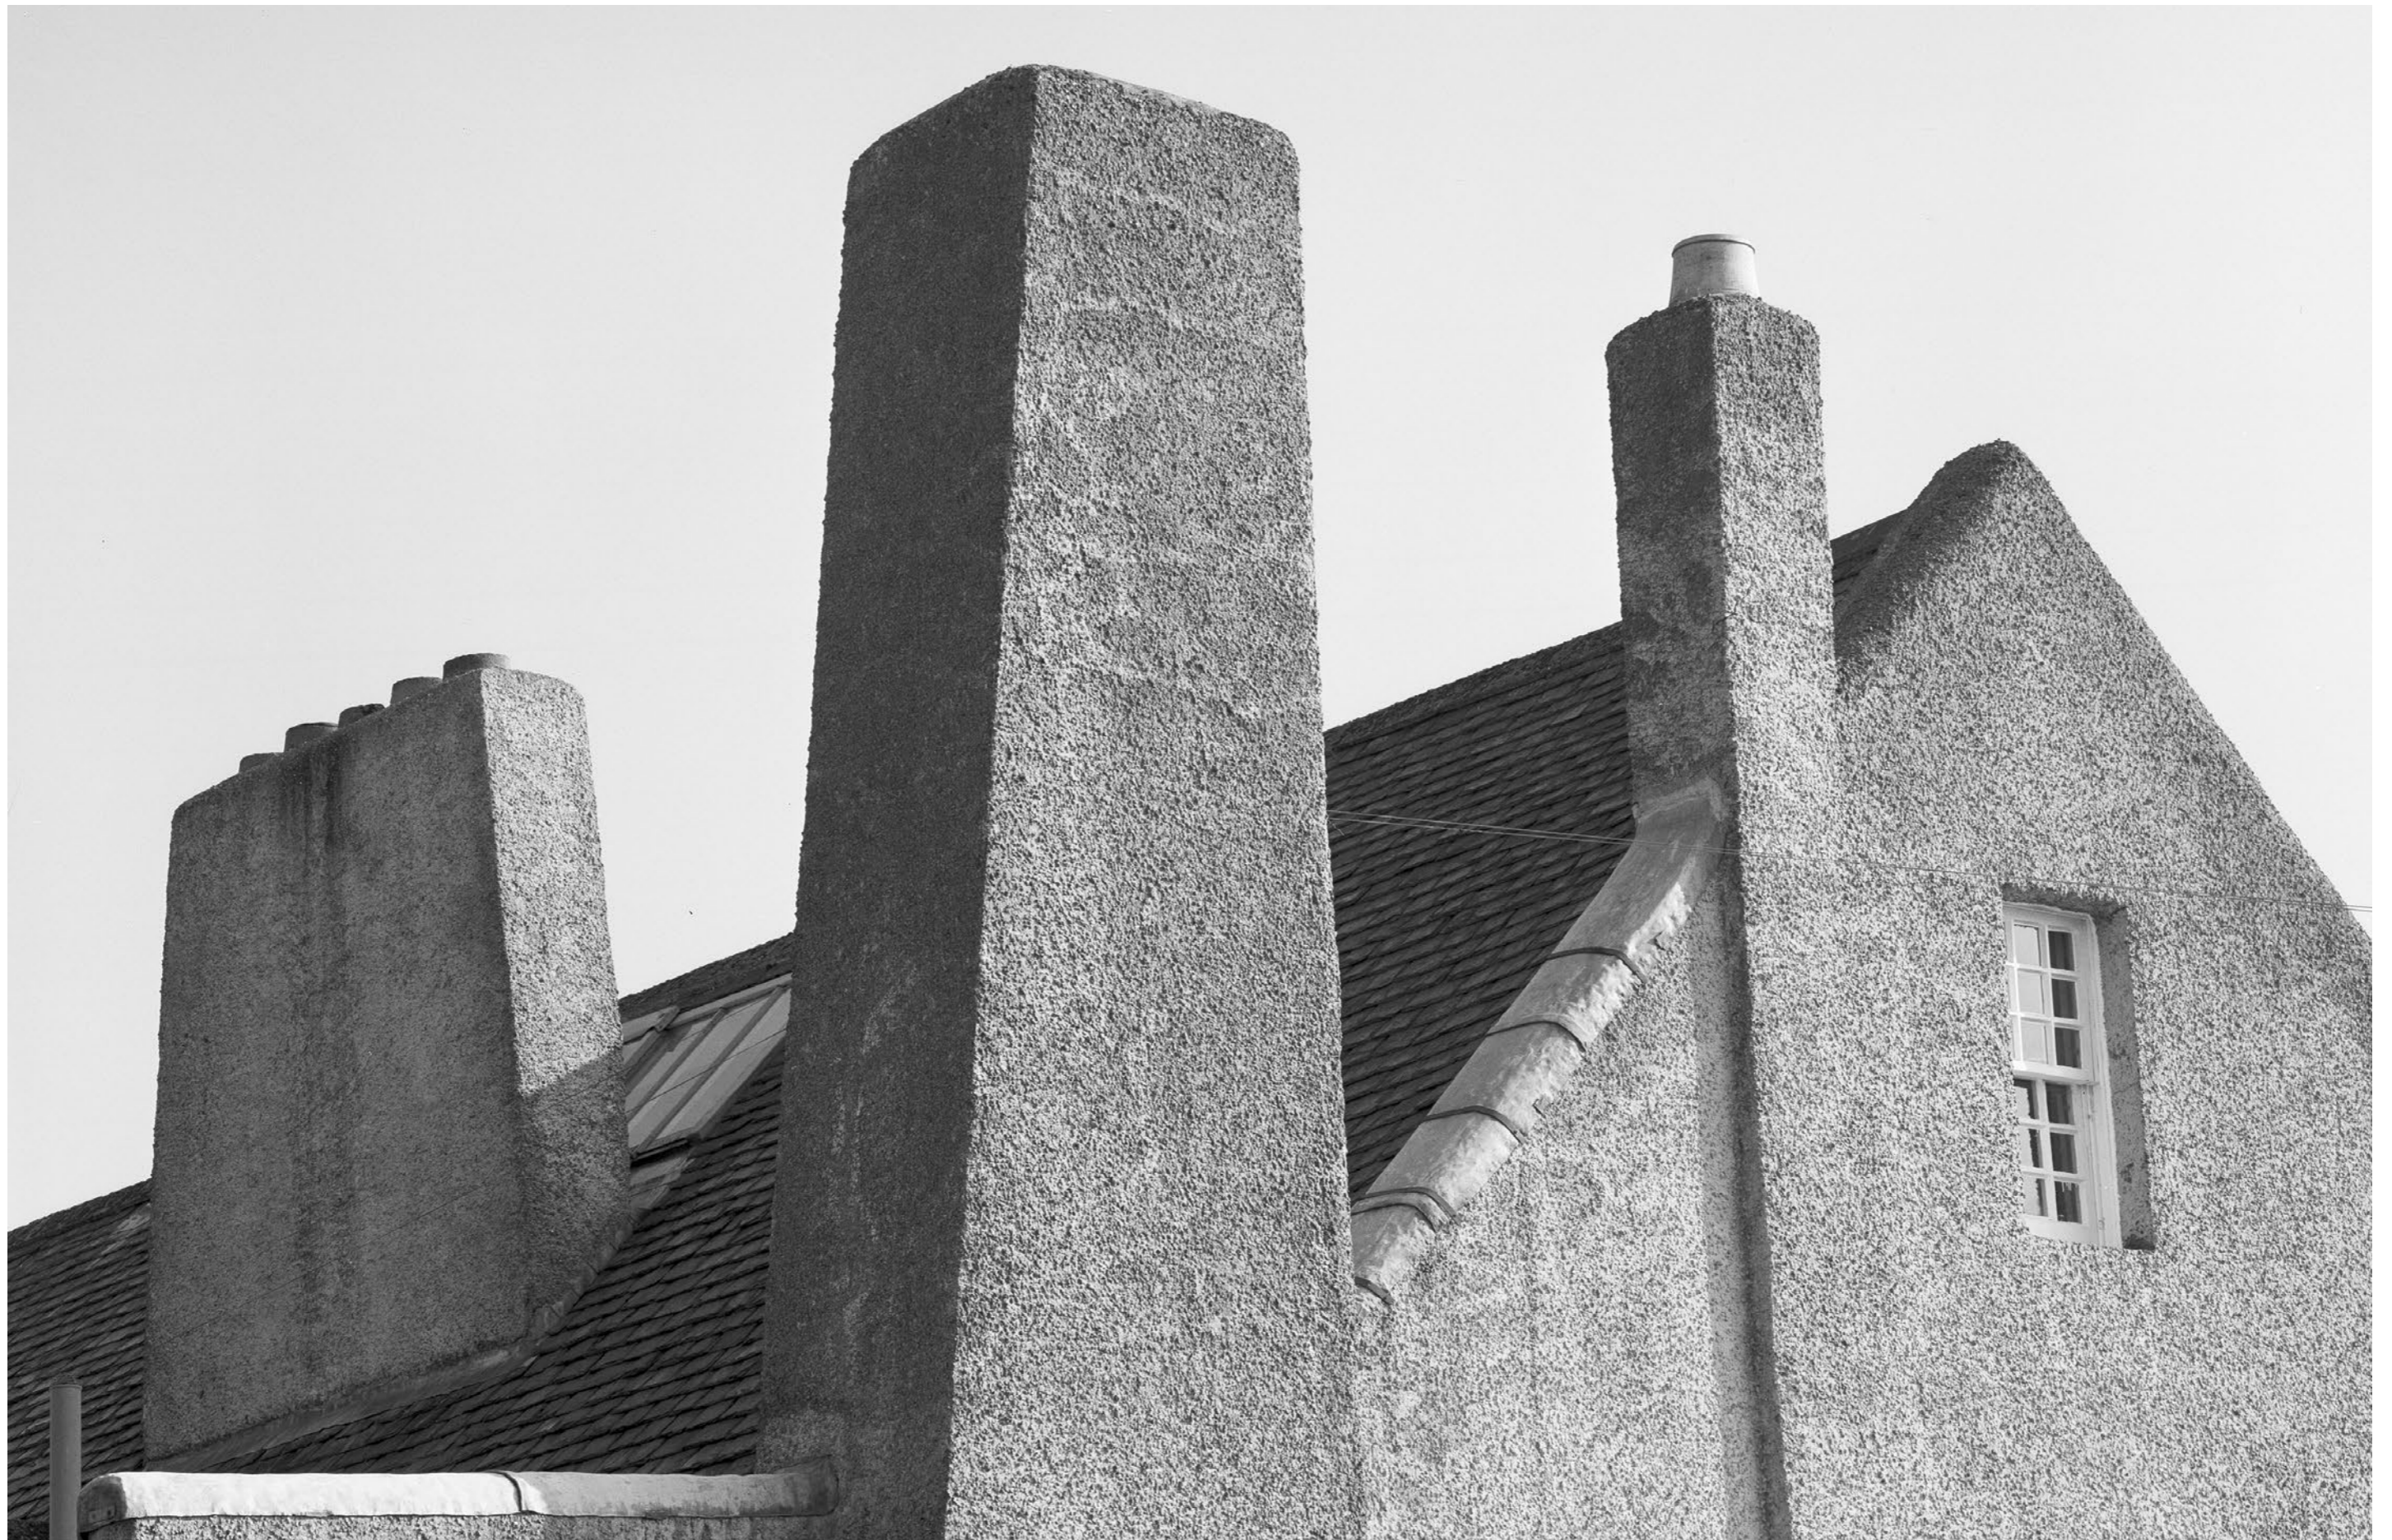
62 RCAHMS 1973 showing Wallhead repair work carried out by Margaret Brodie
