# The Hill House

Research & Development Project

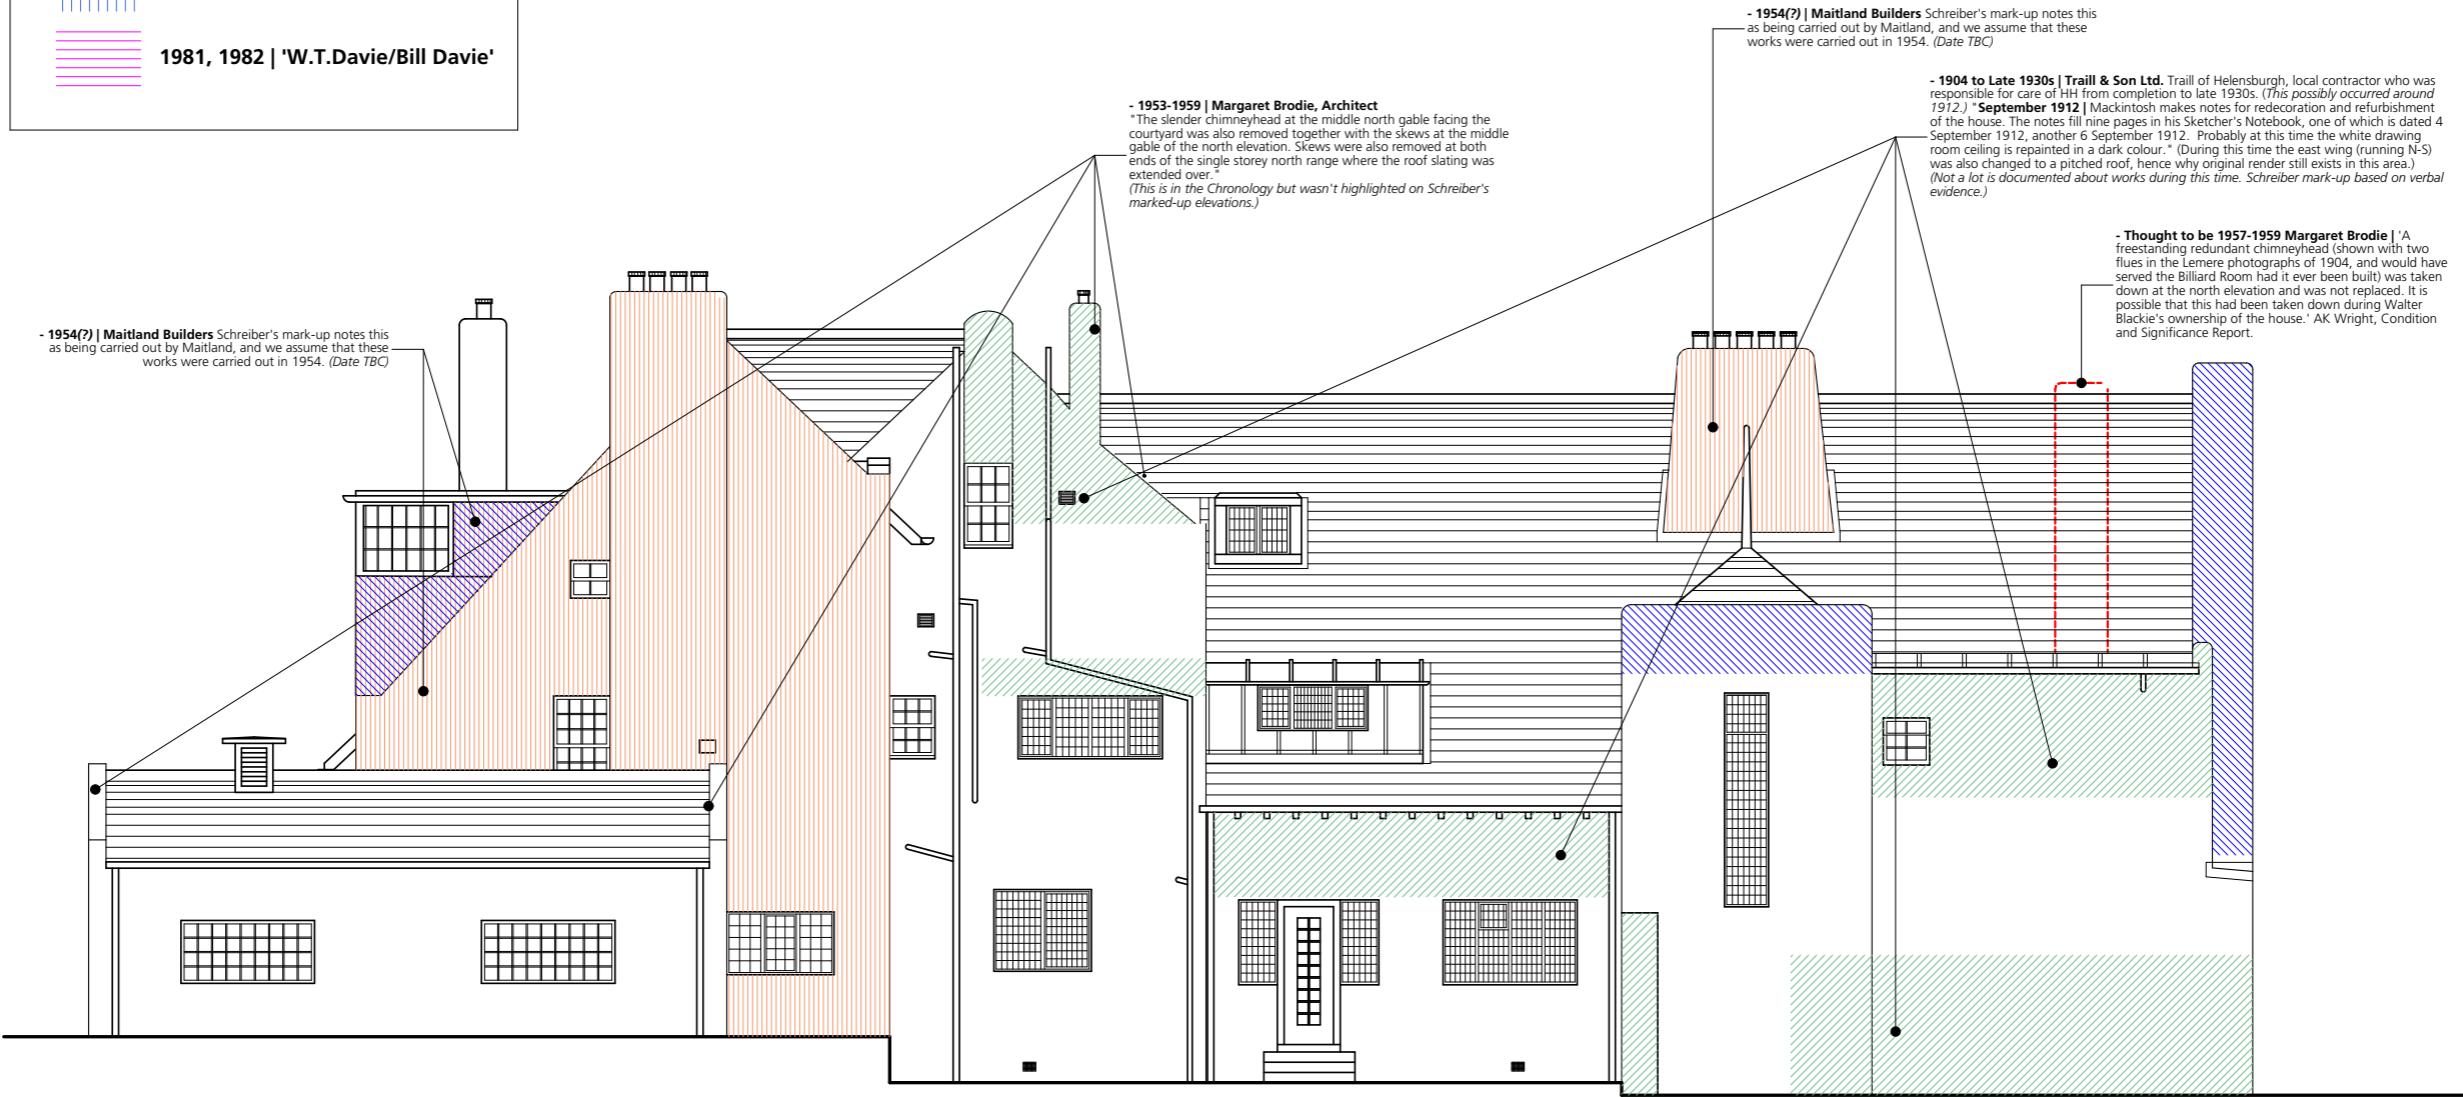
HISTORIC REPAIRS | NORTH ELEVATION  
1:100 @ A3

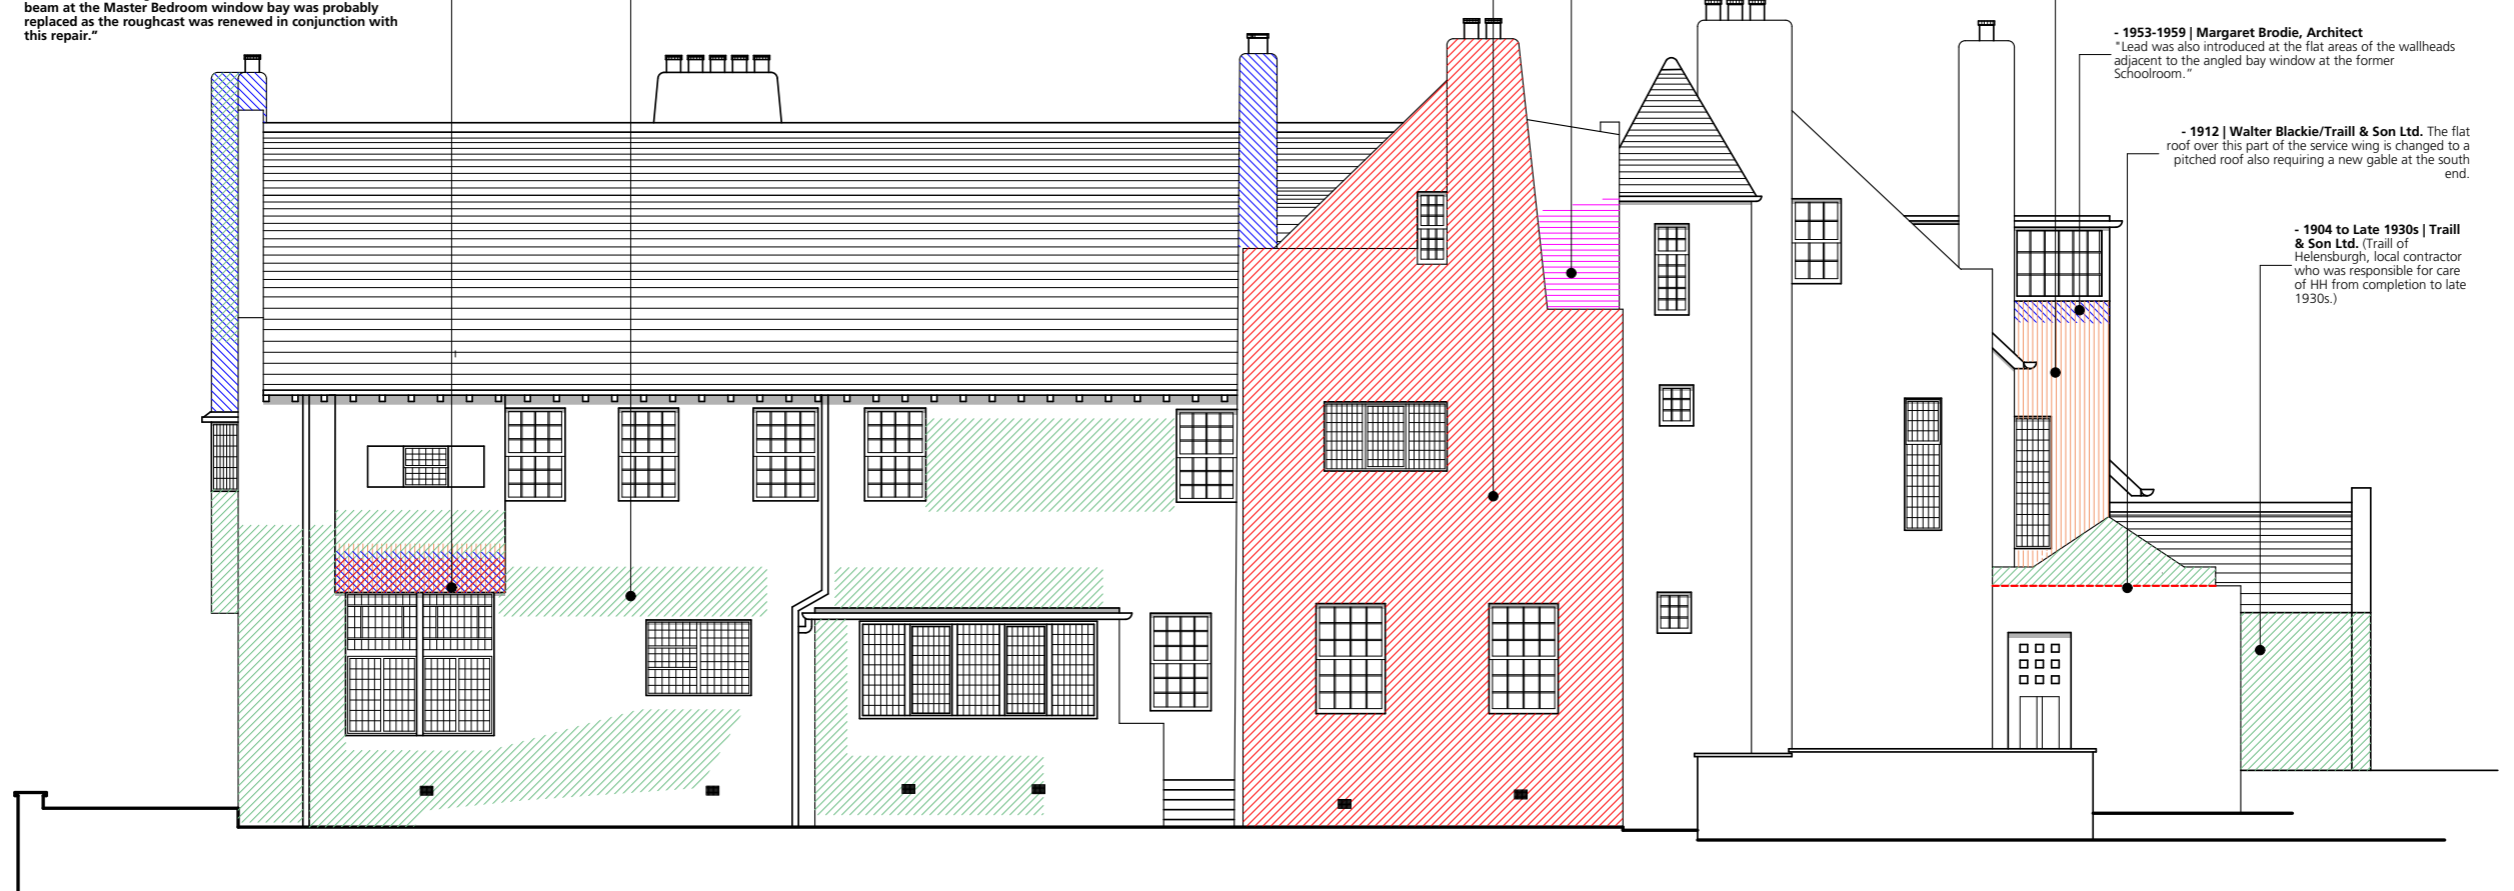
HISTORIC REPAIRS | SOUTH ELEVATION  
 1:100 @ A3

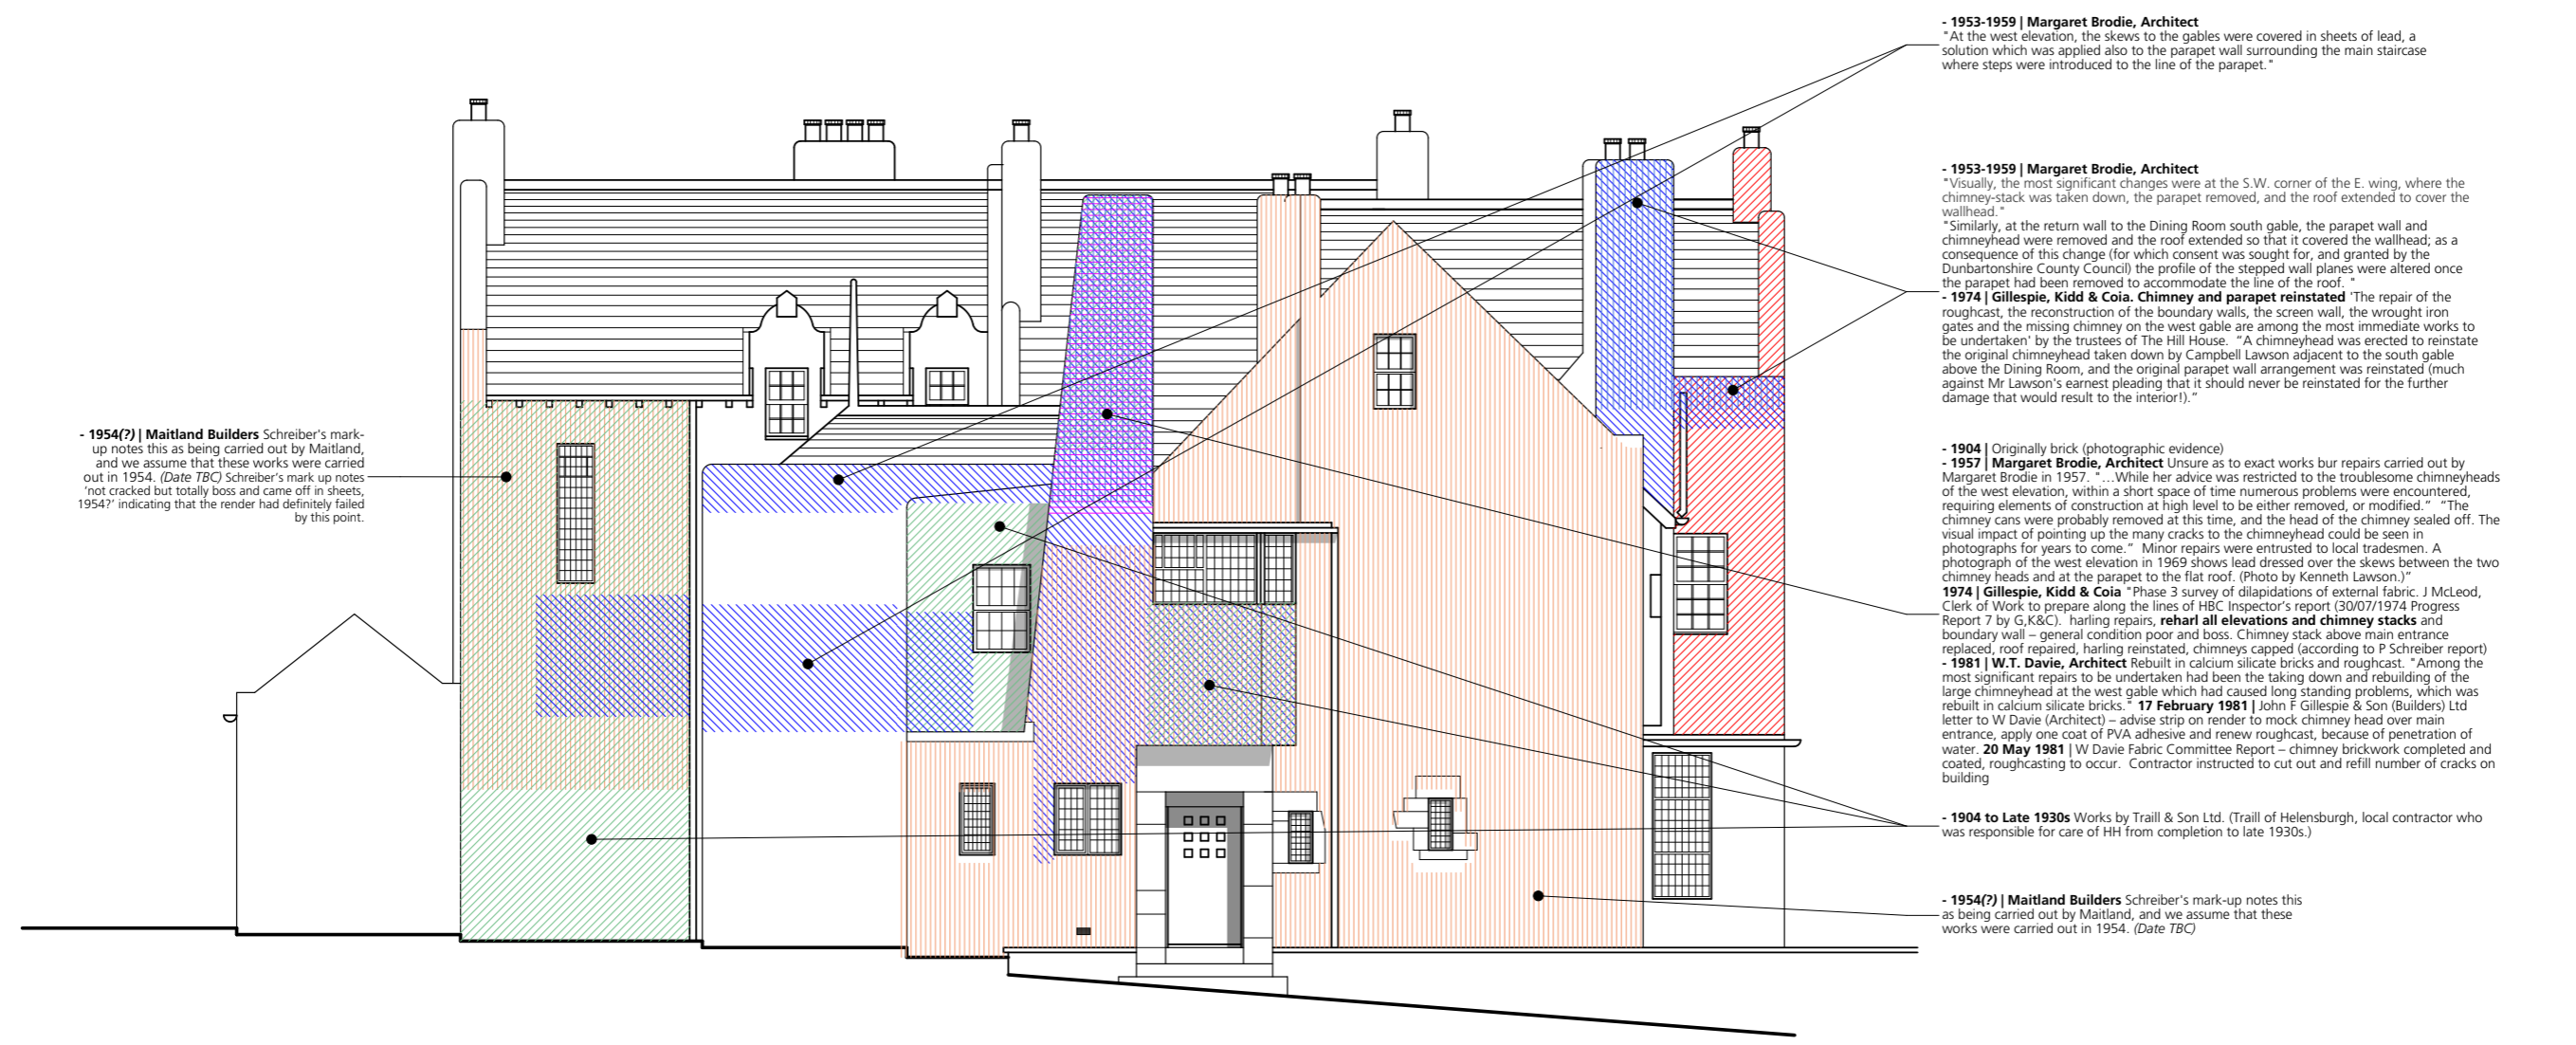
- 1954(?) | Maitland Builders Schreiber's mark-up notes this as being carried out by Maitland, and we assume that these works were carried out in 1954. (Date TBC) Schreiber's mark up notes 'not cracked but totally boss and came off in sheets, 1954?' indicating that the render had definitely failed by this point.

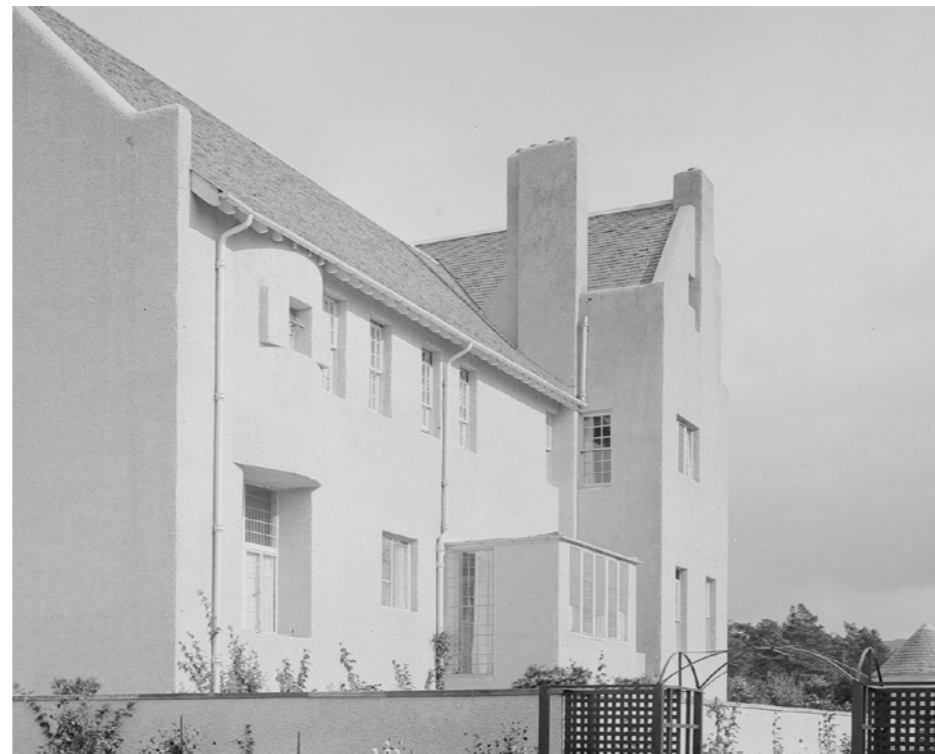
*Bedford Lemere 1905*

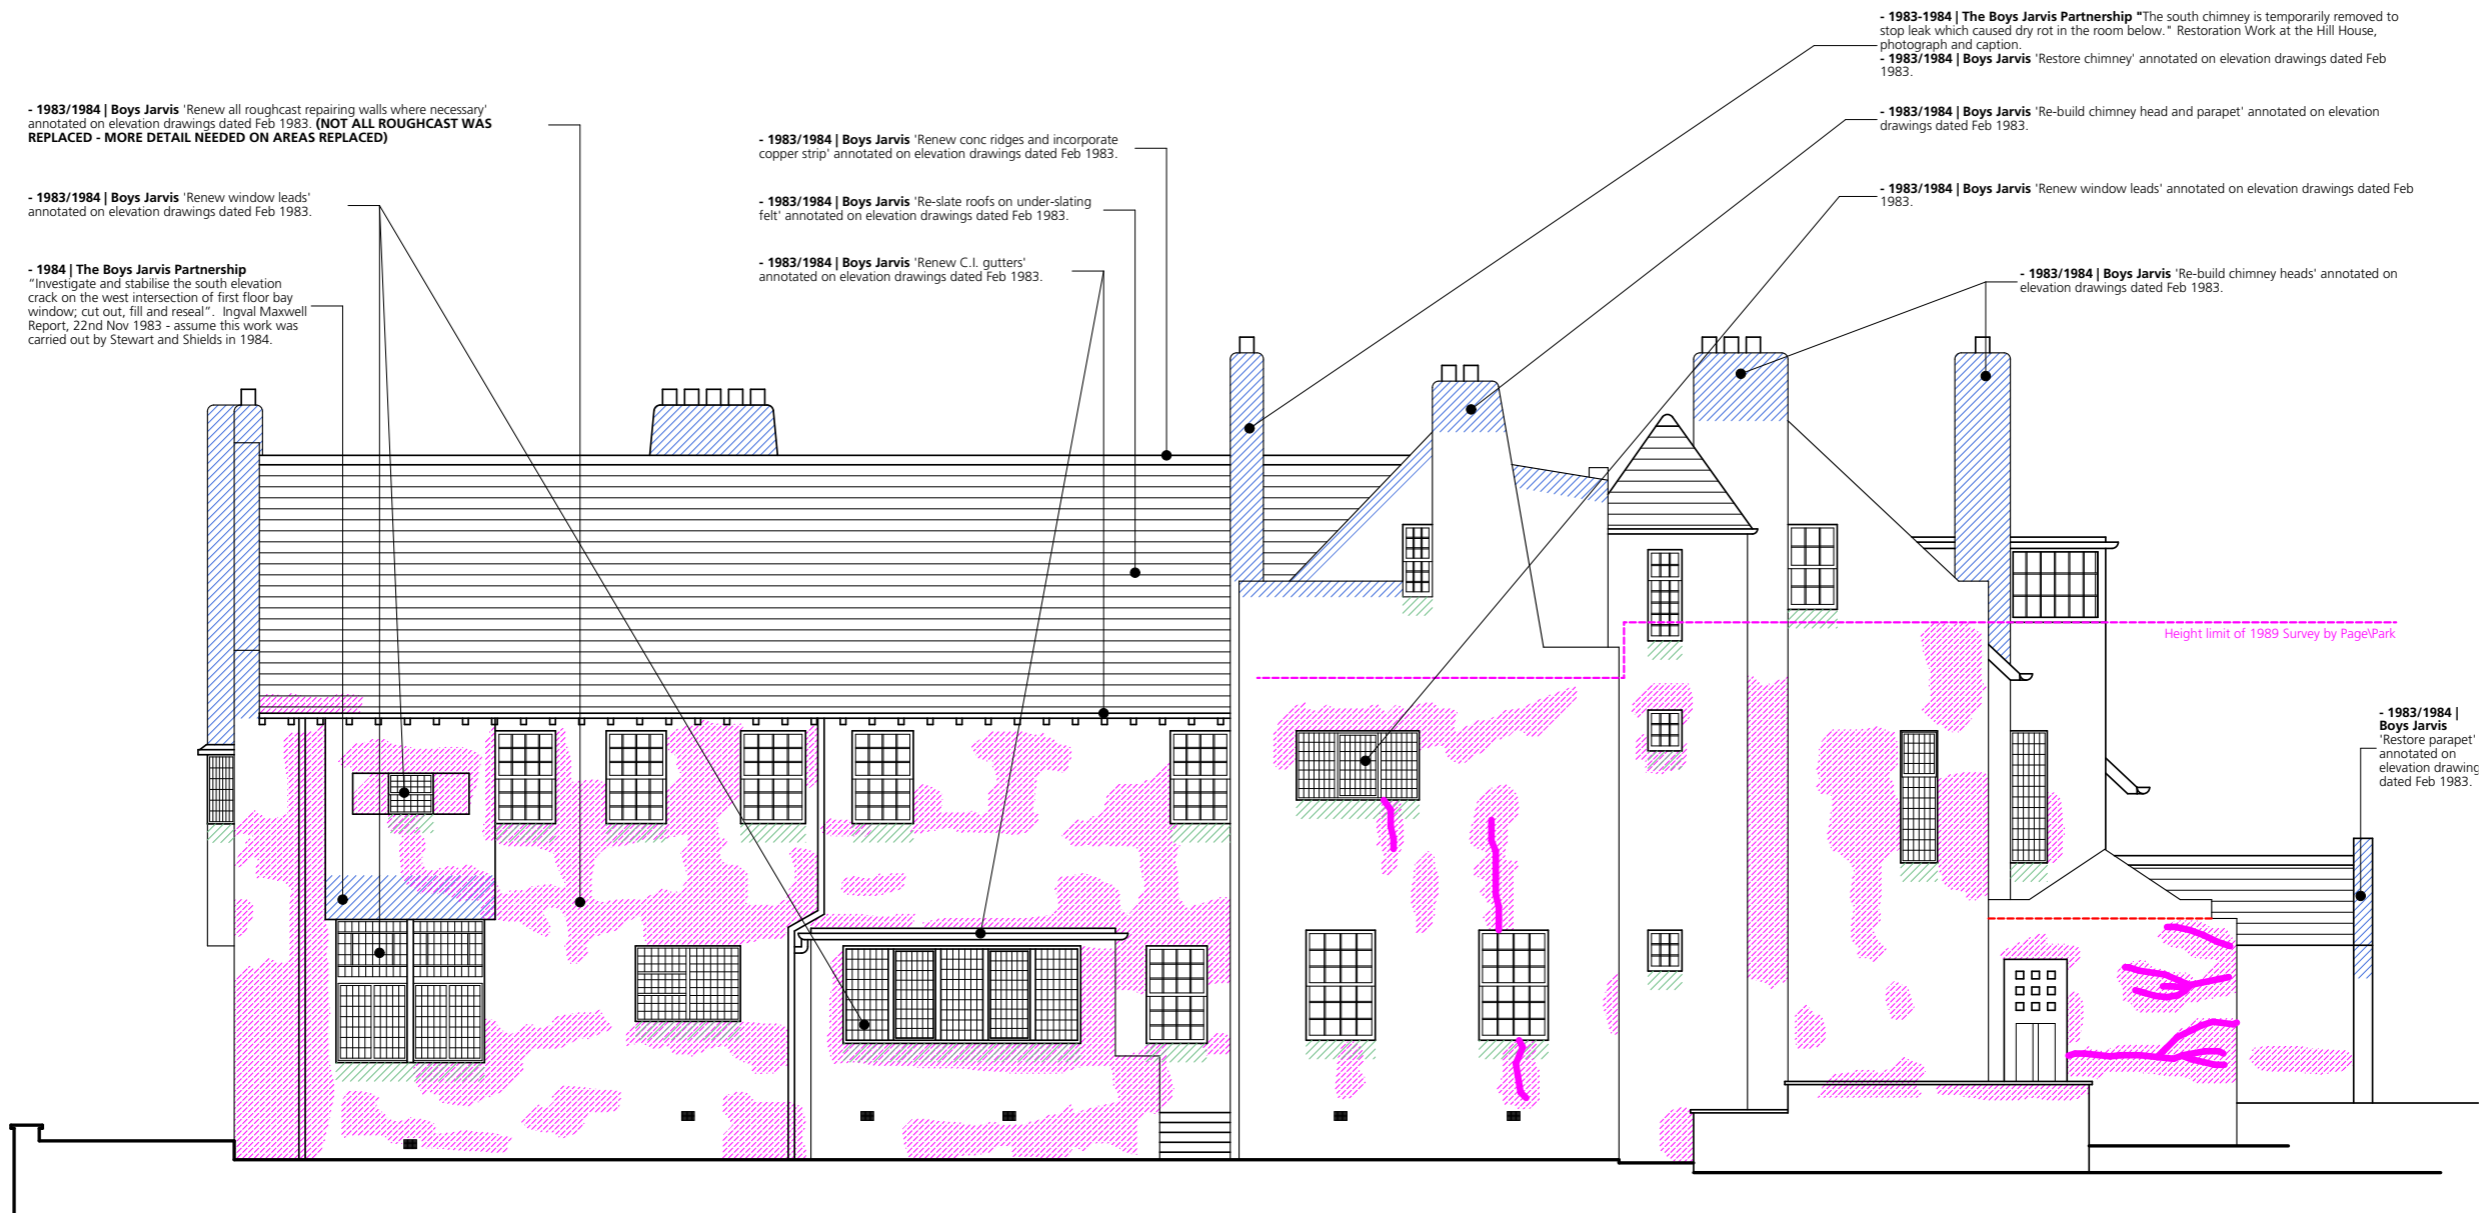
- 1983/1984 | Boys Jarvis 'Renew all roughcast repairing walls where necessary' annotated on elevation drawings dated Feb 1983. (NOT ALL ROUGHCAST WAS REPLACED - MORE DETAIL NEEDED ON AREAS REPLACED)

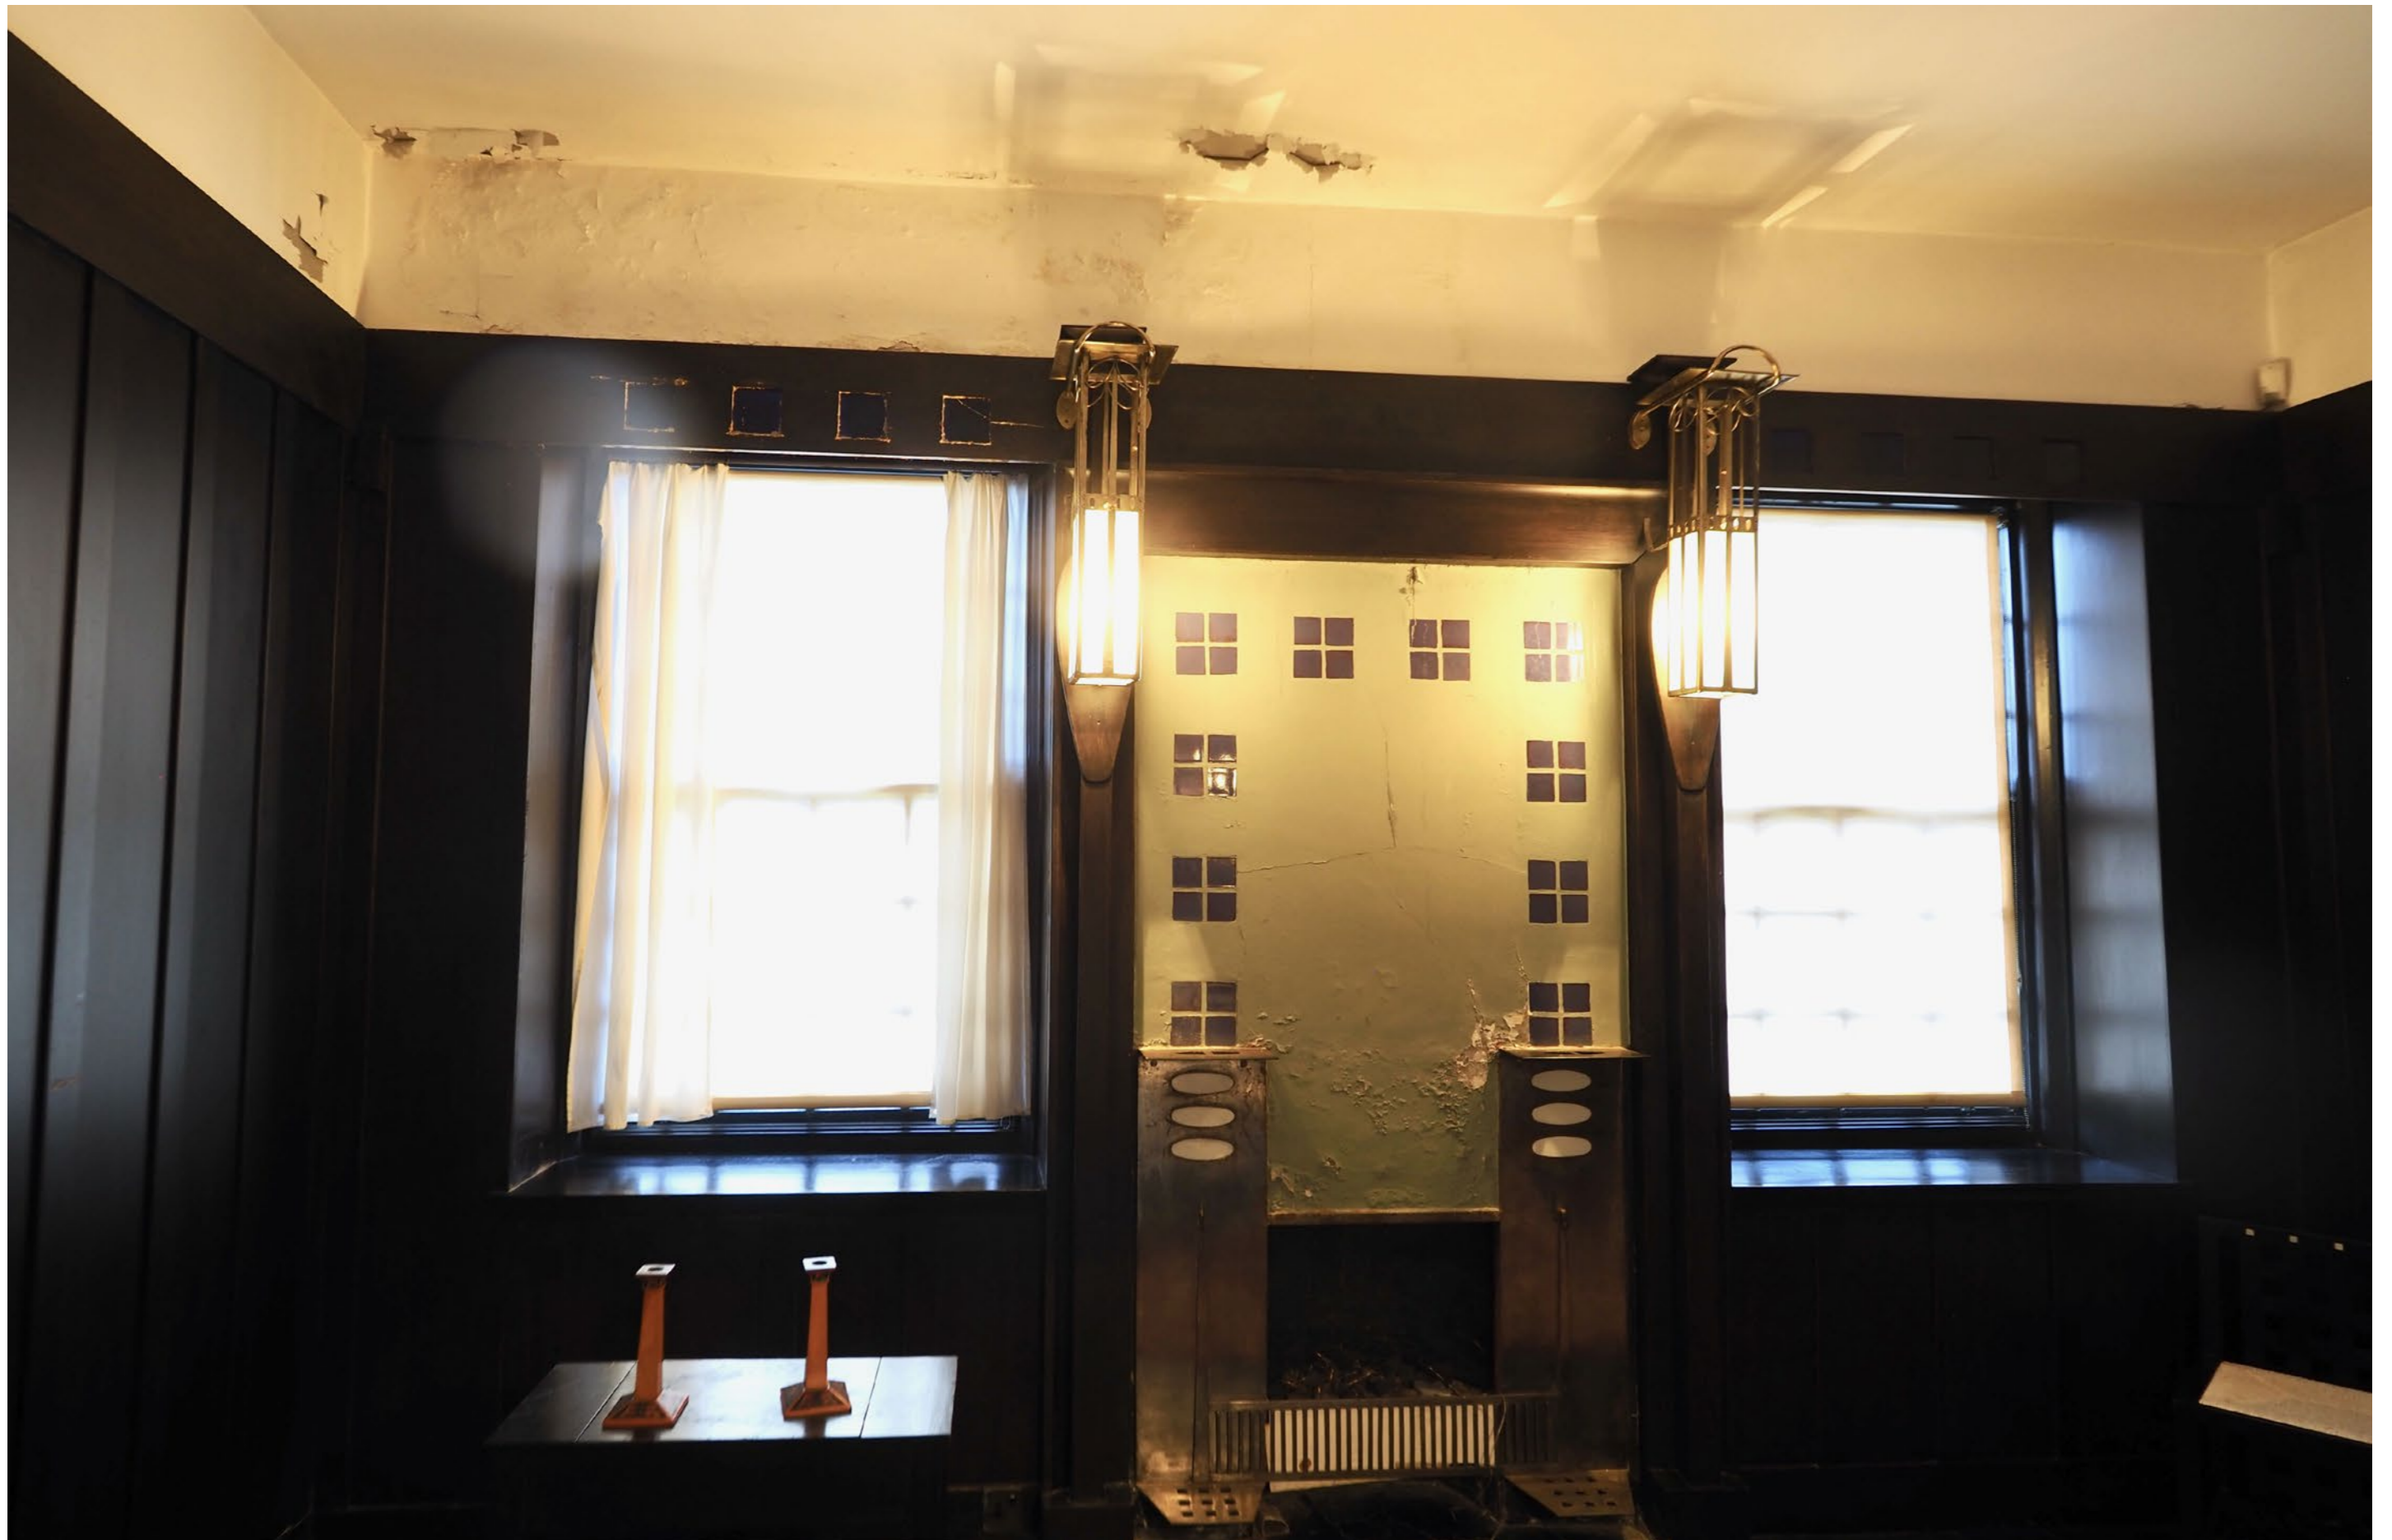
92 Dining Room showing water ingress through external wall and possible wet bridges in fabric at first floor level as well as chimney flue

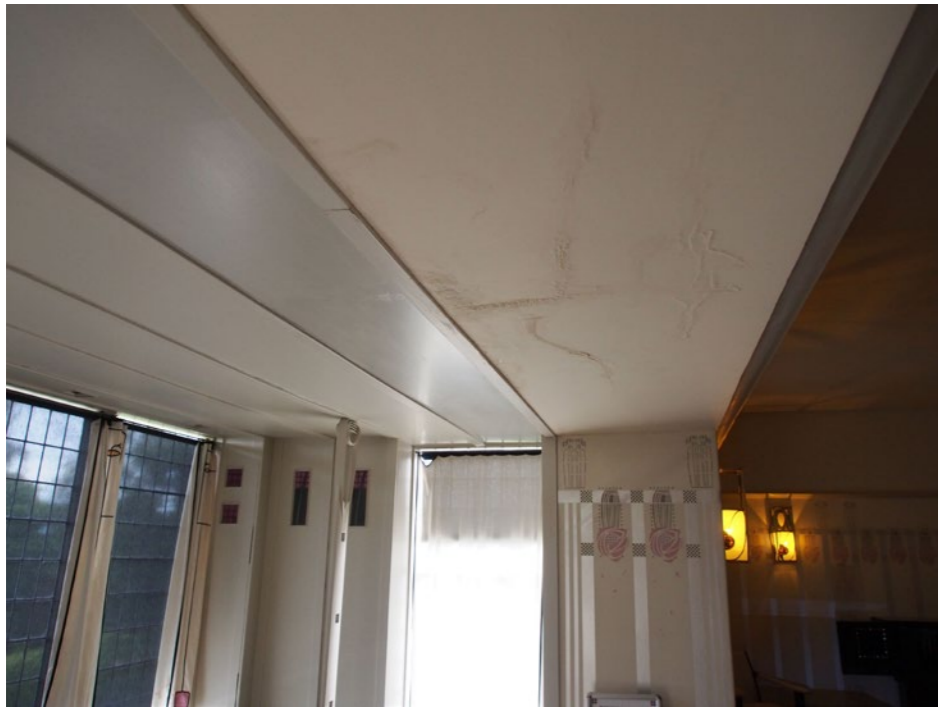
Water ingress and staining above Bay Window of Drawing Room

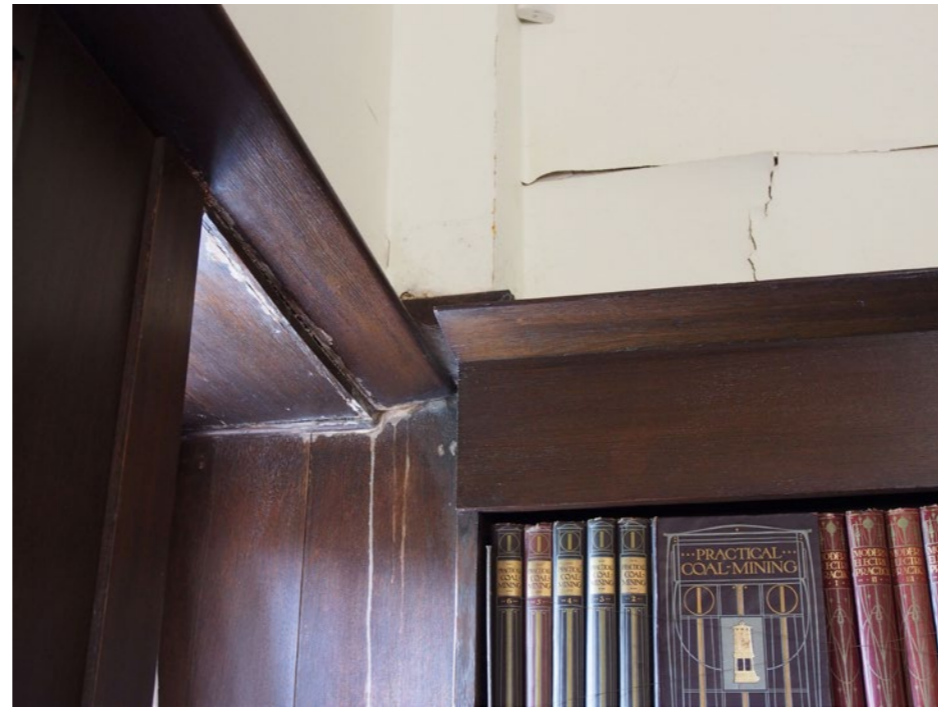
Water ingress and Damage in Library

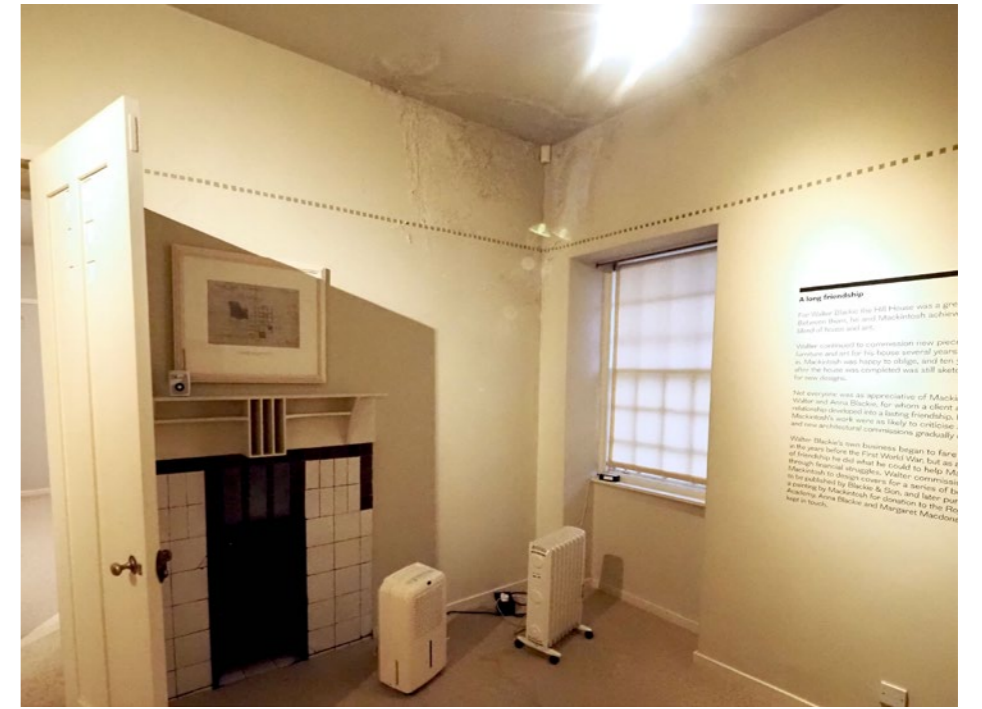
Water ingress and damage, including rot, in Guest Bedroom Dressing Room

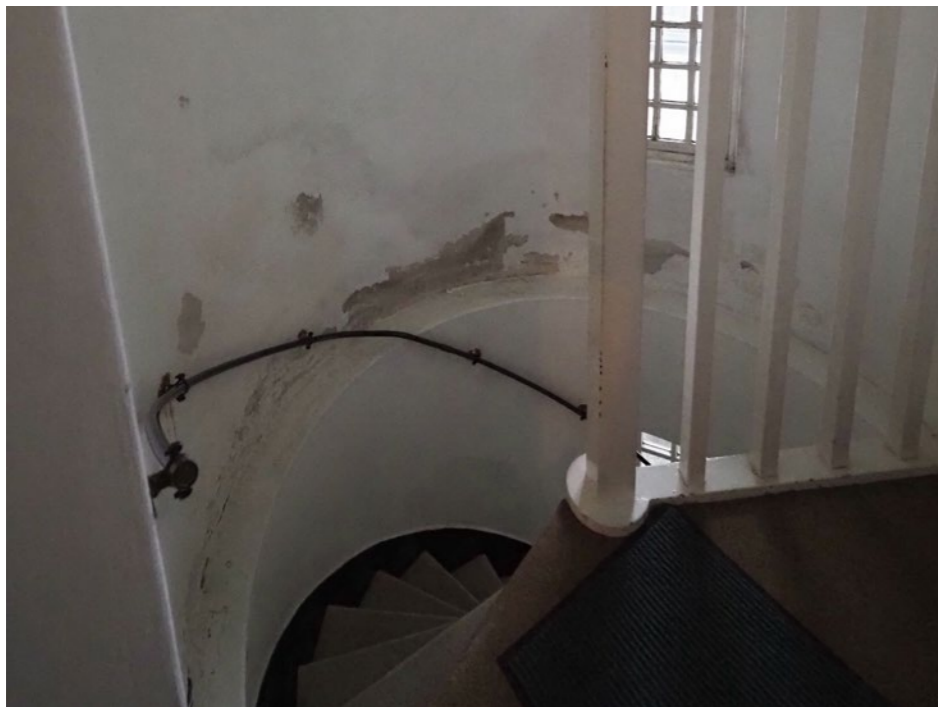
Water ingress and staining in stair tower

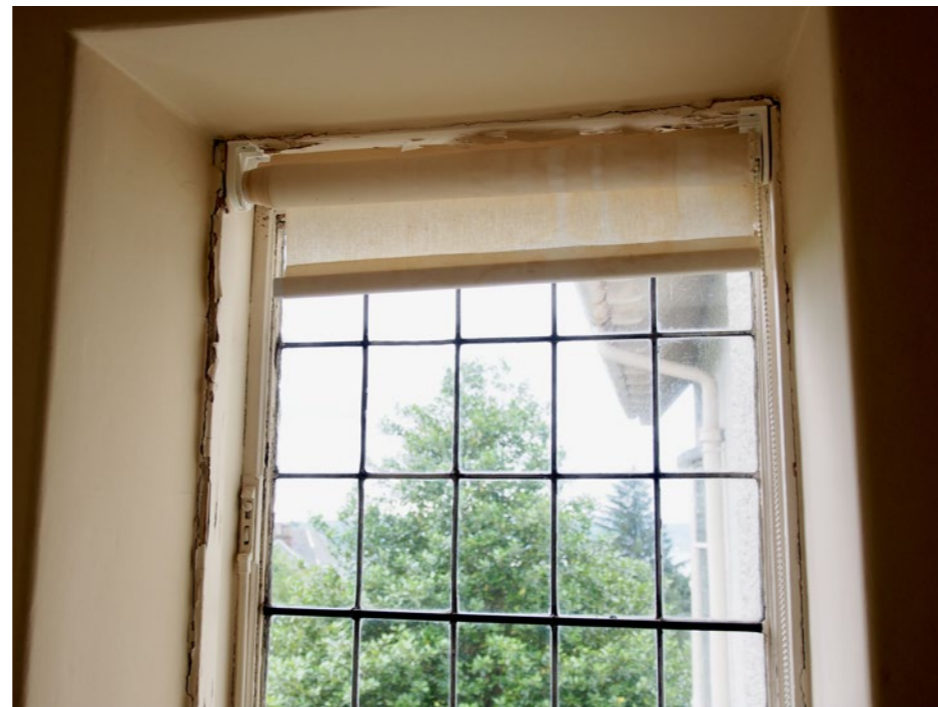
Water ingress and damage around windows

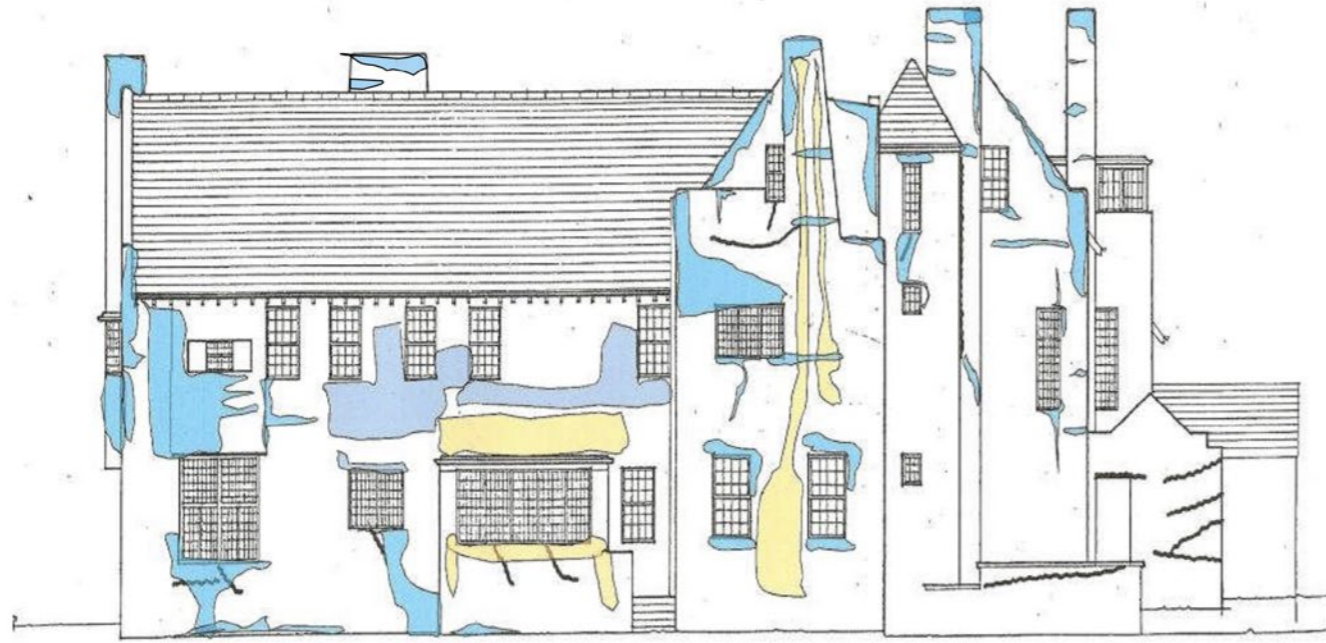
A future repair strategy must have the retention of the Significance and Authenticity of The Hill House at its heart. The unintended impacts of past repair strategies must also be understood in order not to repeat them. The surveys carried out by HES, co-ordinated with visual survey work, should be used to assess the effectiveness of past repairs and identify areas for further intrusive survey work that will develop our understanding of the condition of the brick, stone and mortar substrates underlying the roughcast.

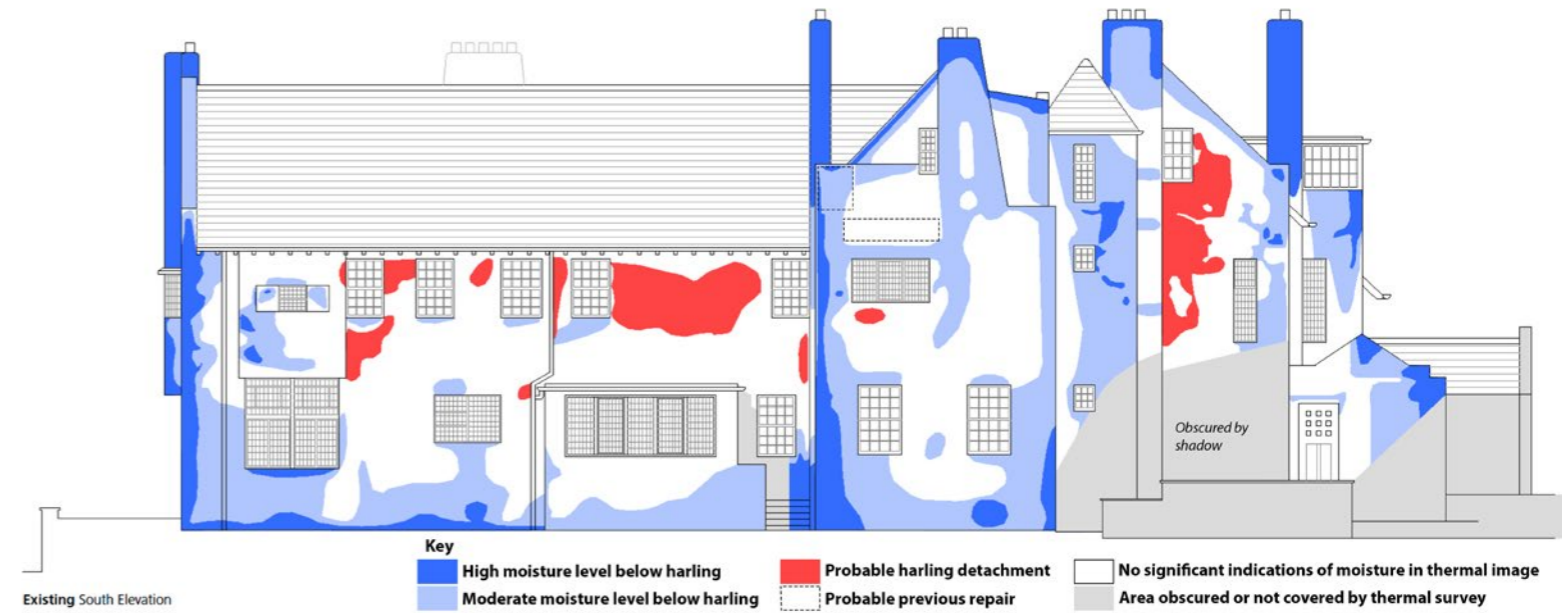
HES Moisture Survey 2019

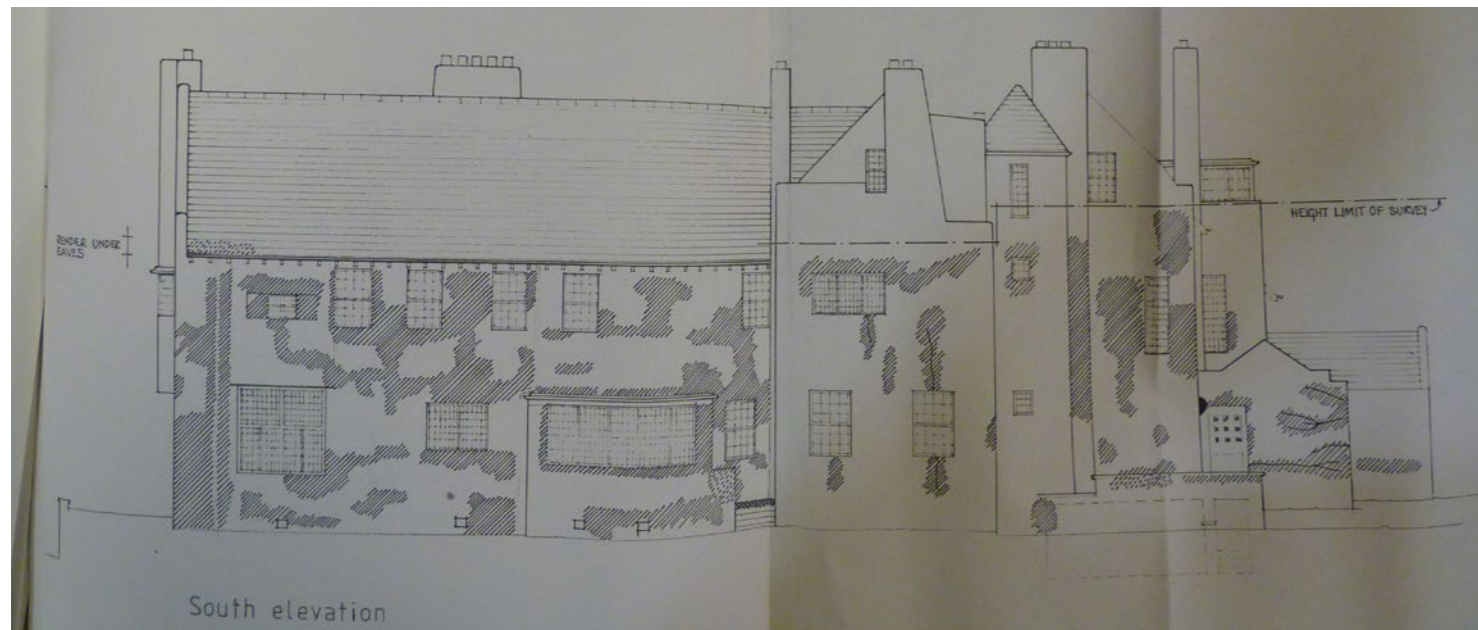
Page and Park Render Survey c1989

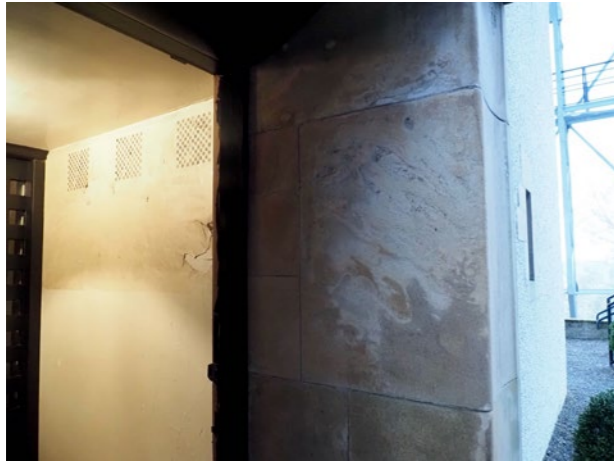
*Stonework around entrance showing signs of delamination and efflorescence as a result of being saturated*

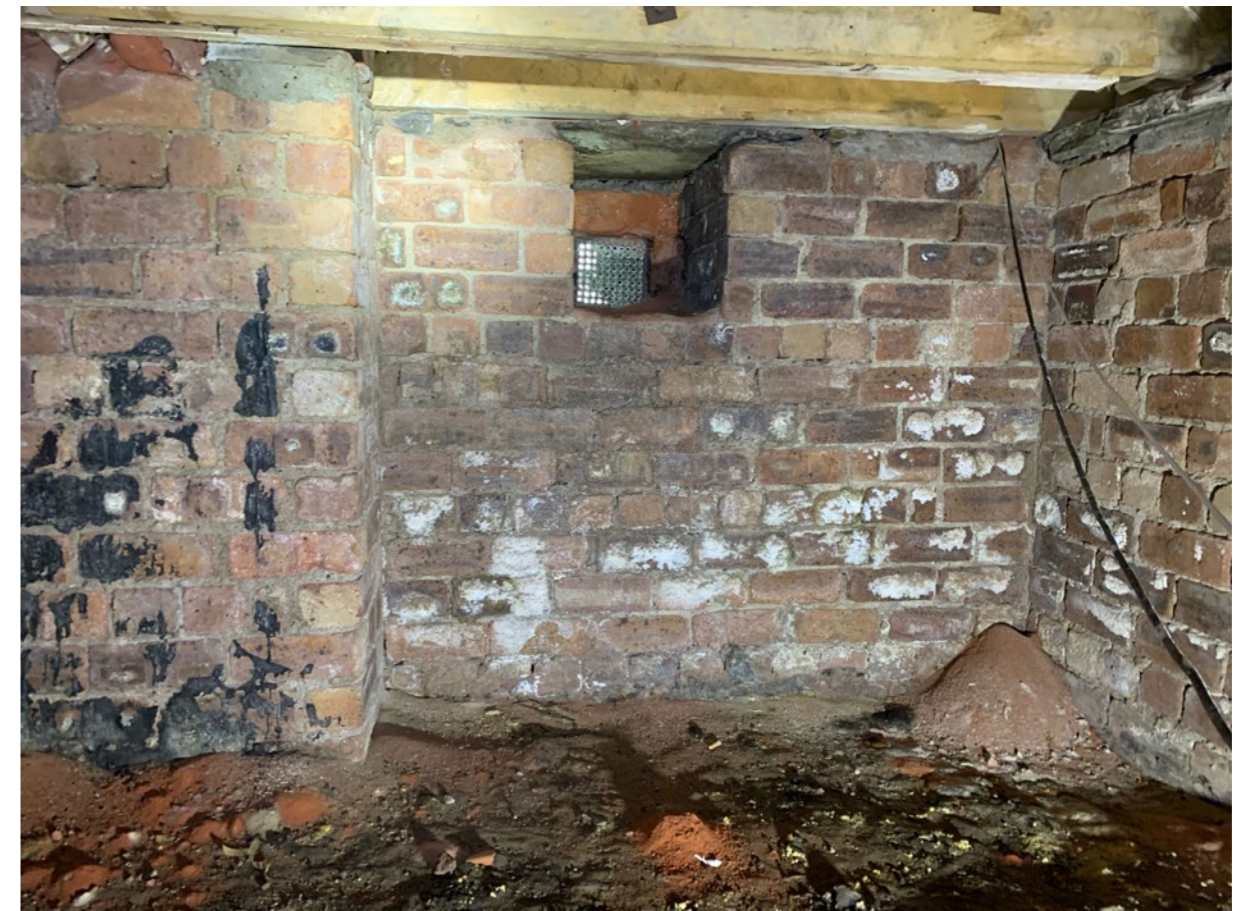
*Solum showing piles of decomposed stone and brick from the external walls. Crumbling brick and stone behind internal wall finishes is likely to be forming wet bridges*
