# The Hill House

Research & Development Project

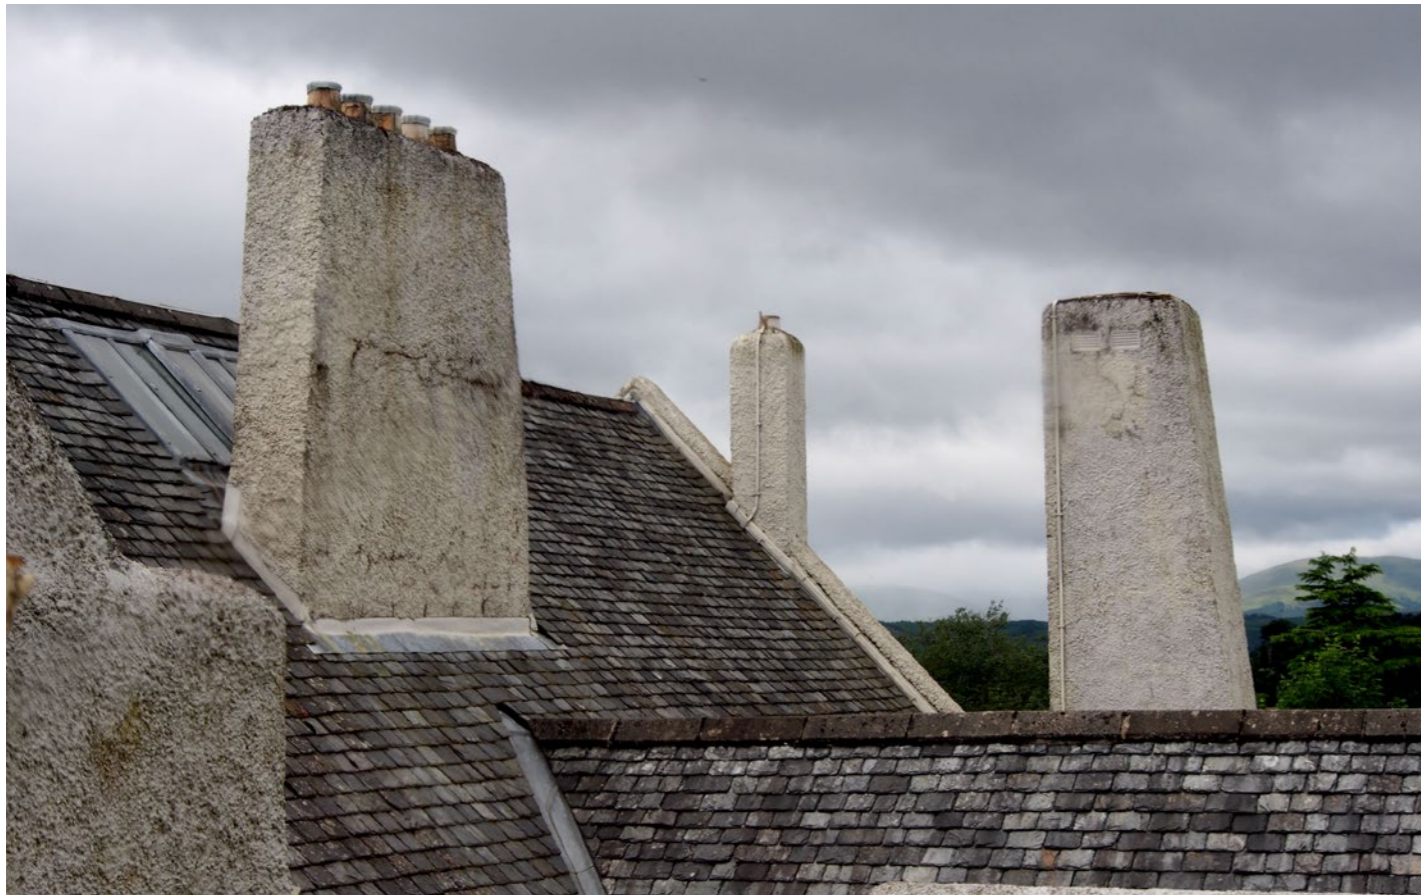
*Roughcast on chimneys is cracked generally*

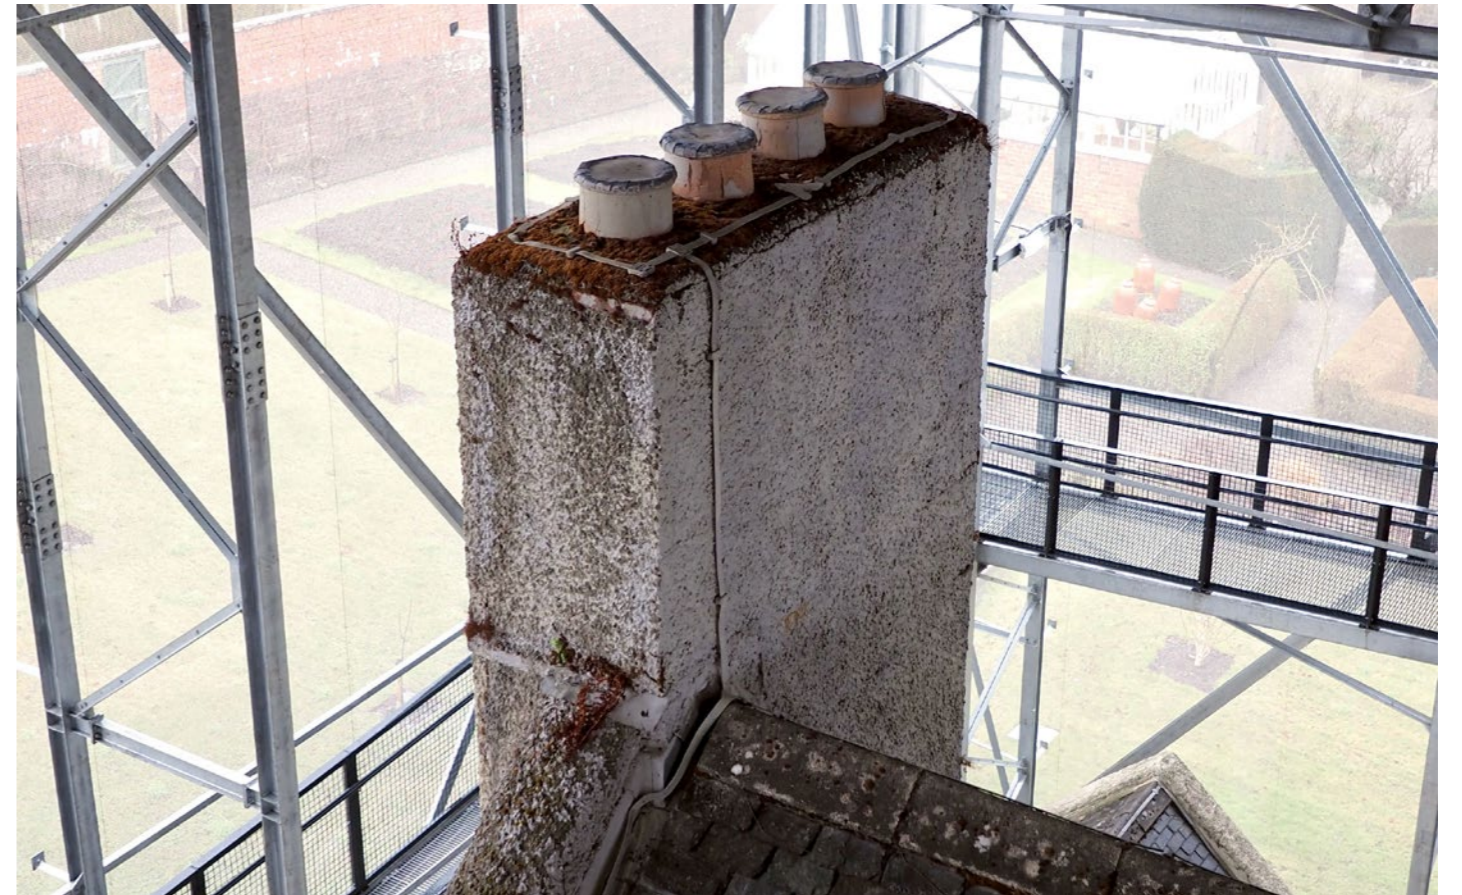
*Moss growth and capped flues*

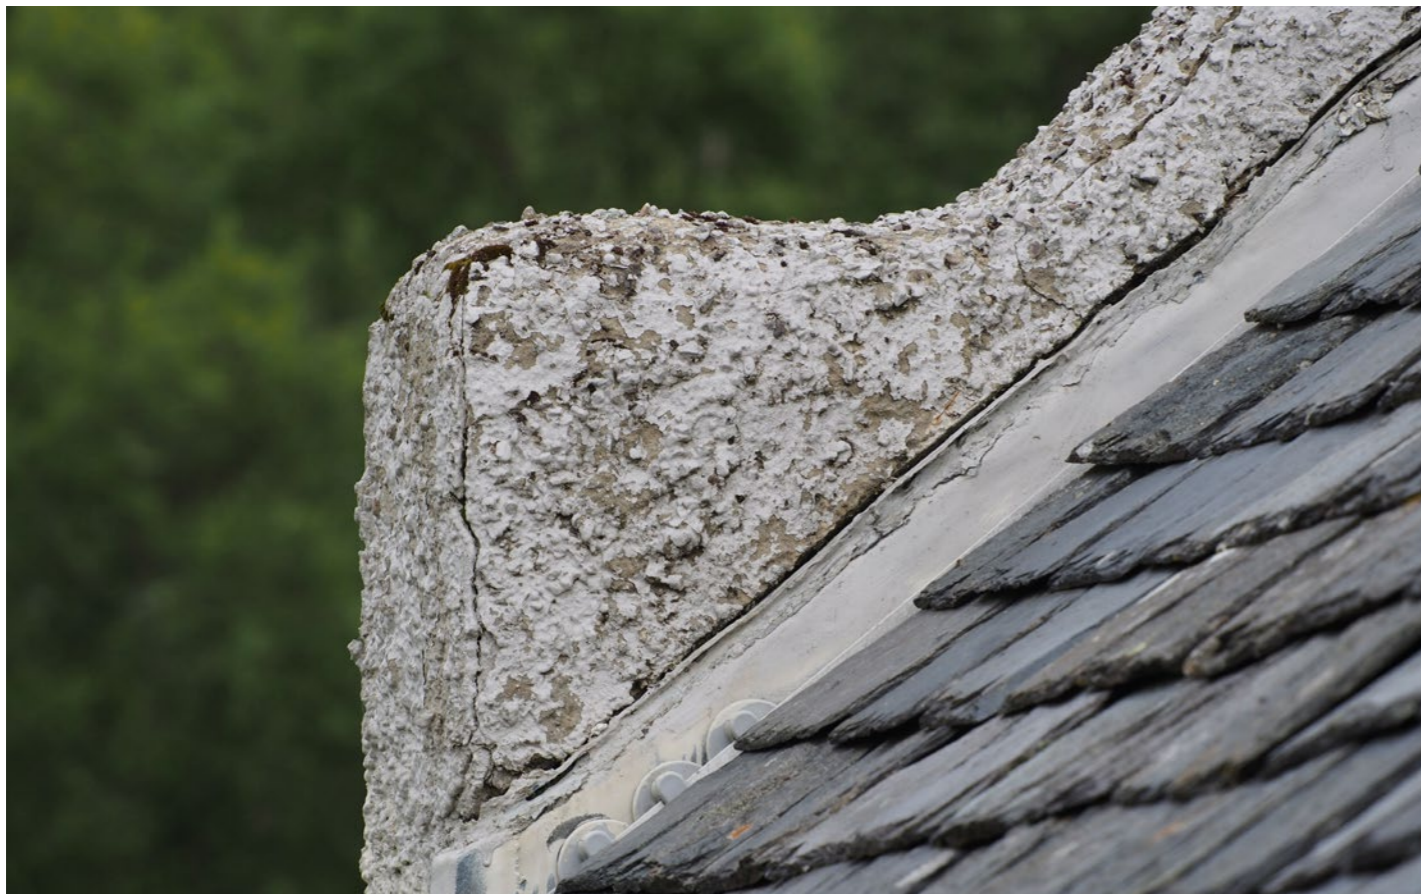
*Cracked wallhead weathering and flashings*

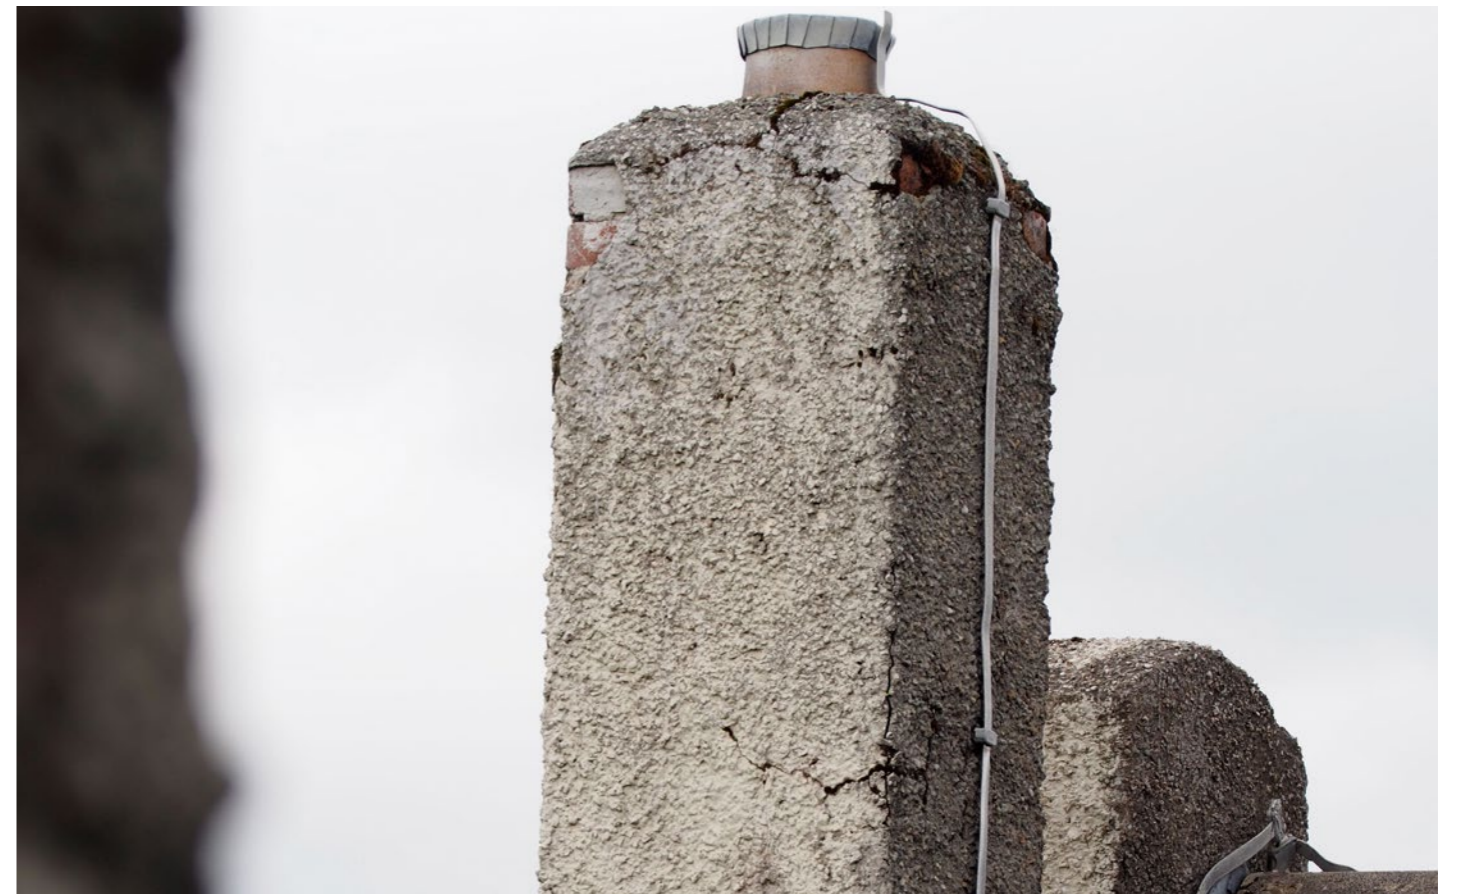
*Chimney roughcast spalling*

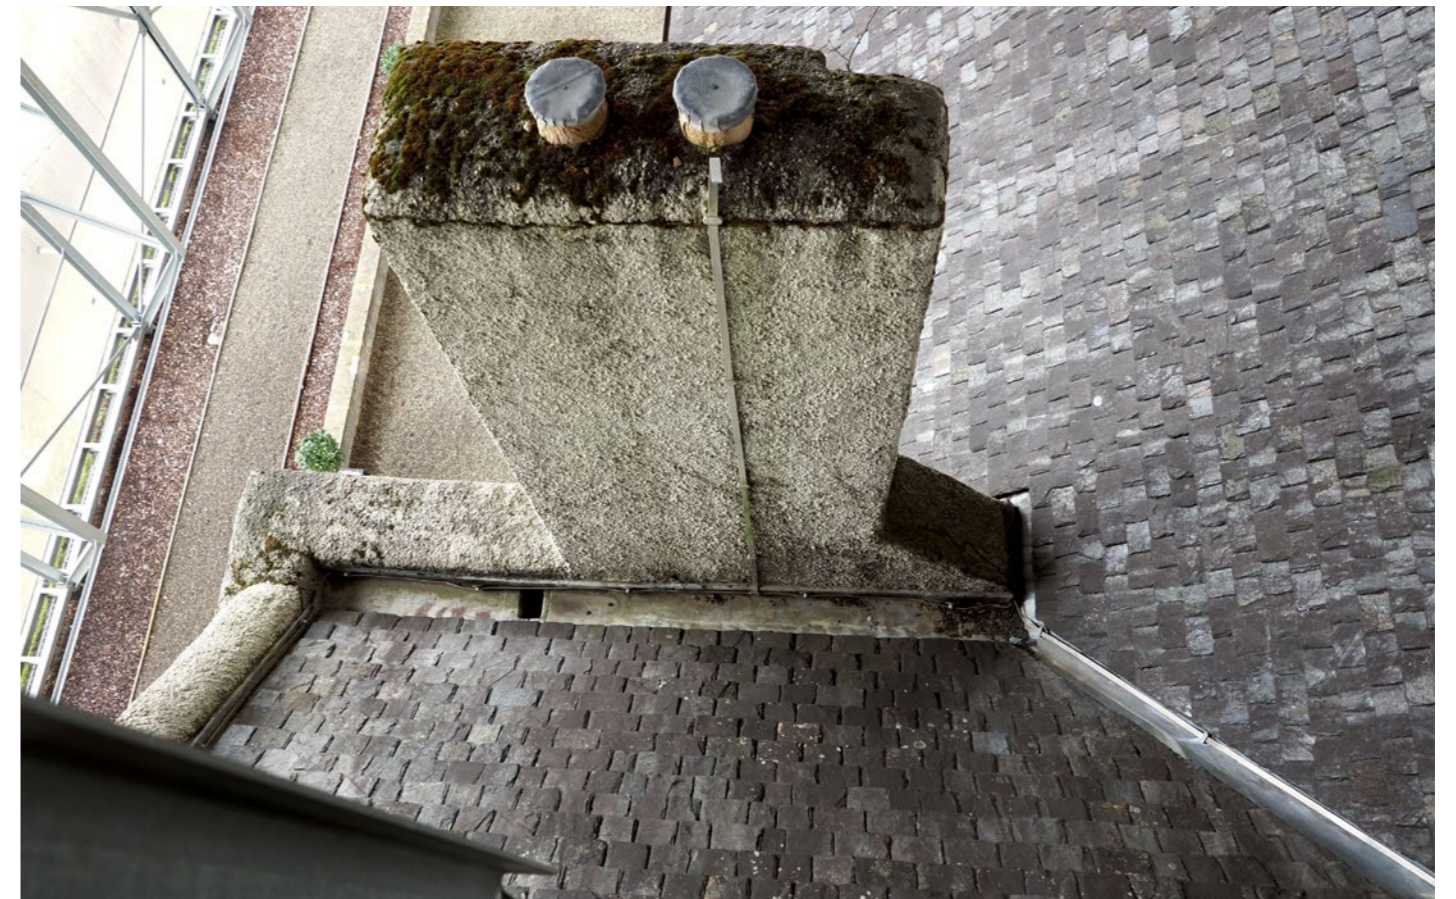
*The Box should allow chimney caps should be removed to improve ventilation and drying out of fabric*

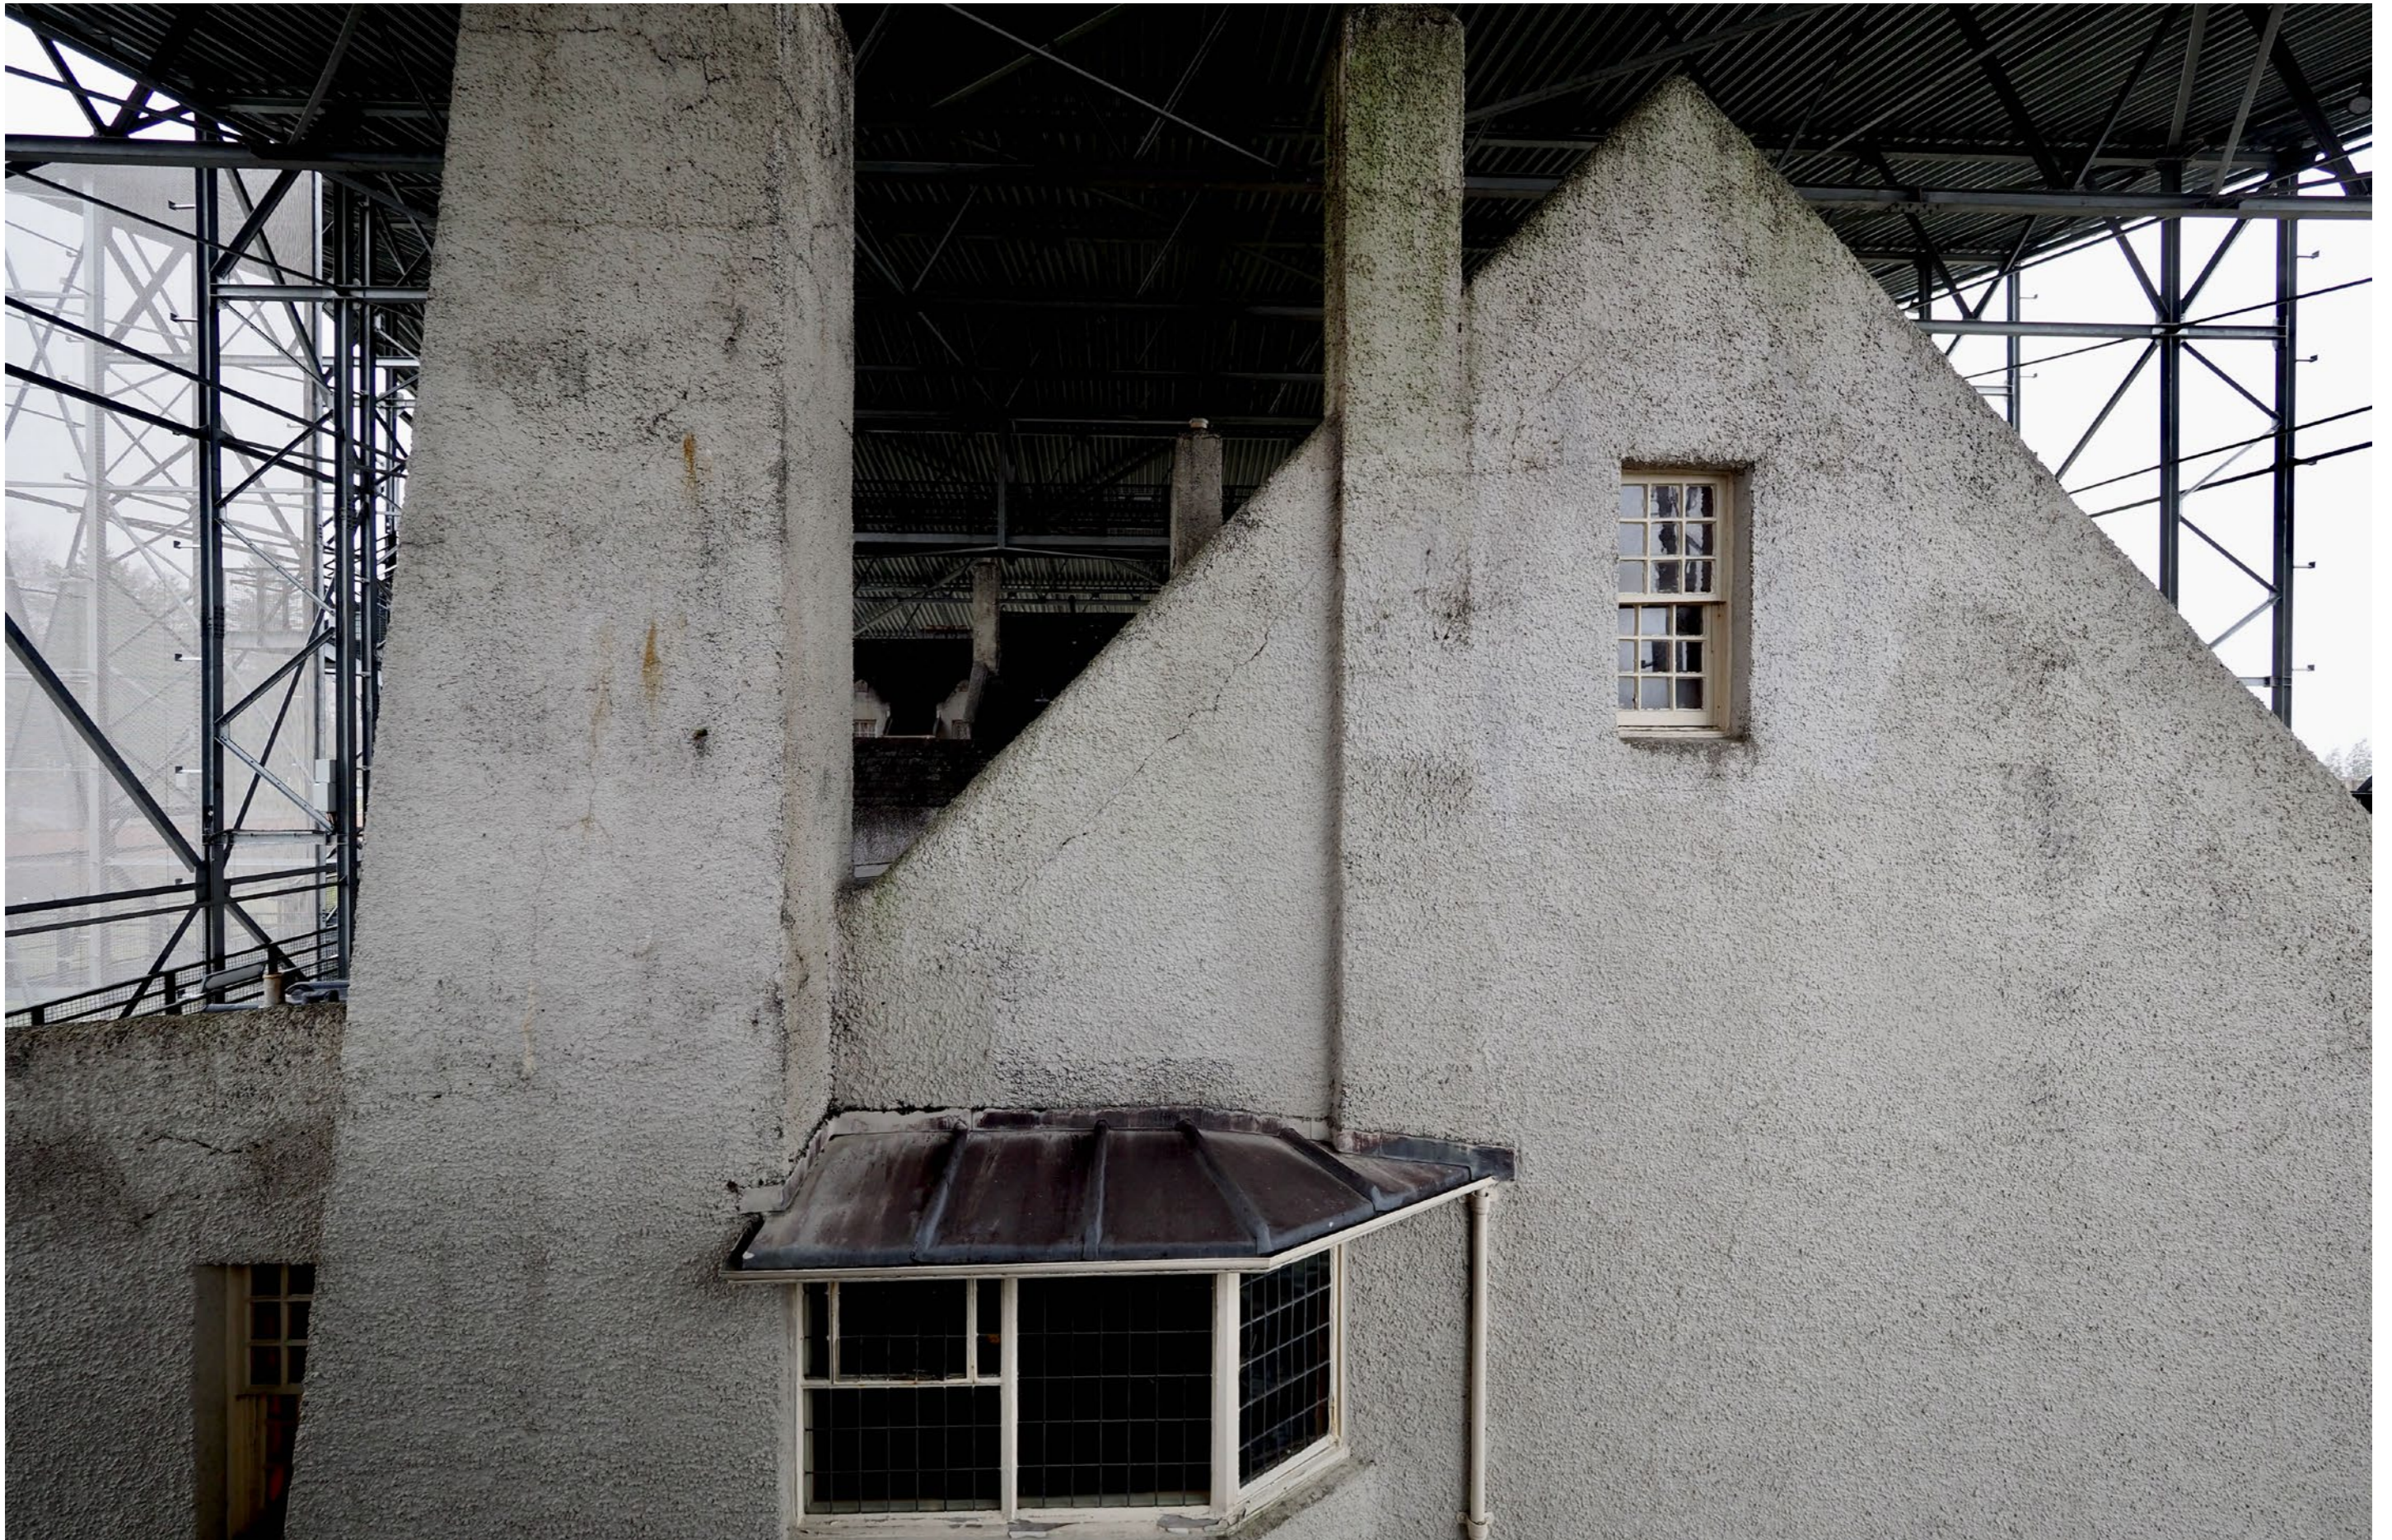
*Dryness within Box and build up of dirt are highlighting cracked roughcast and other defects*

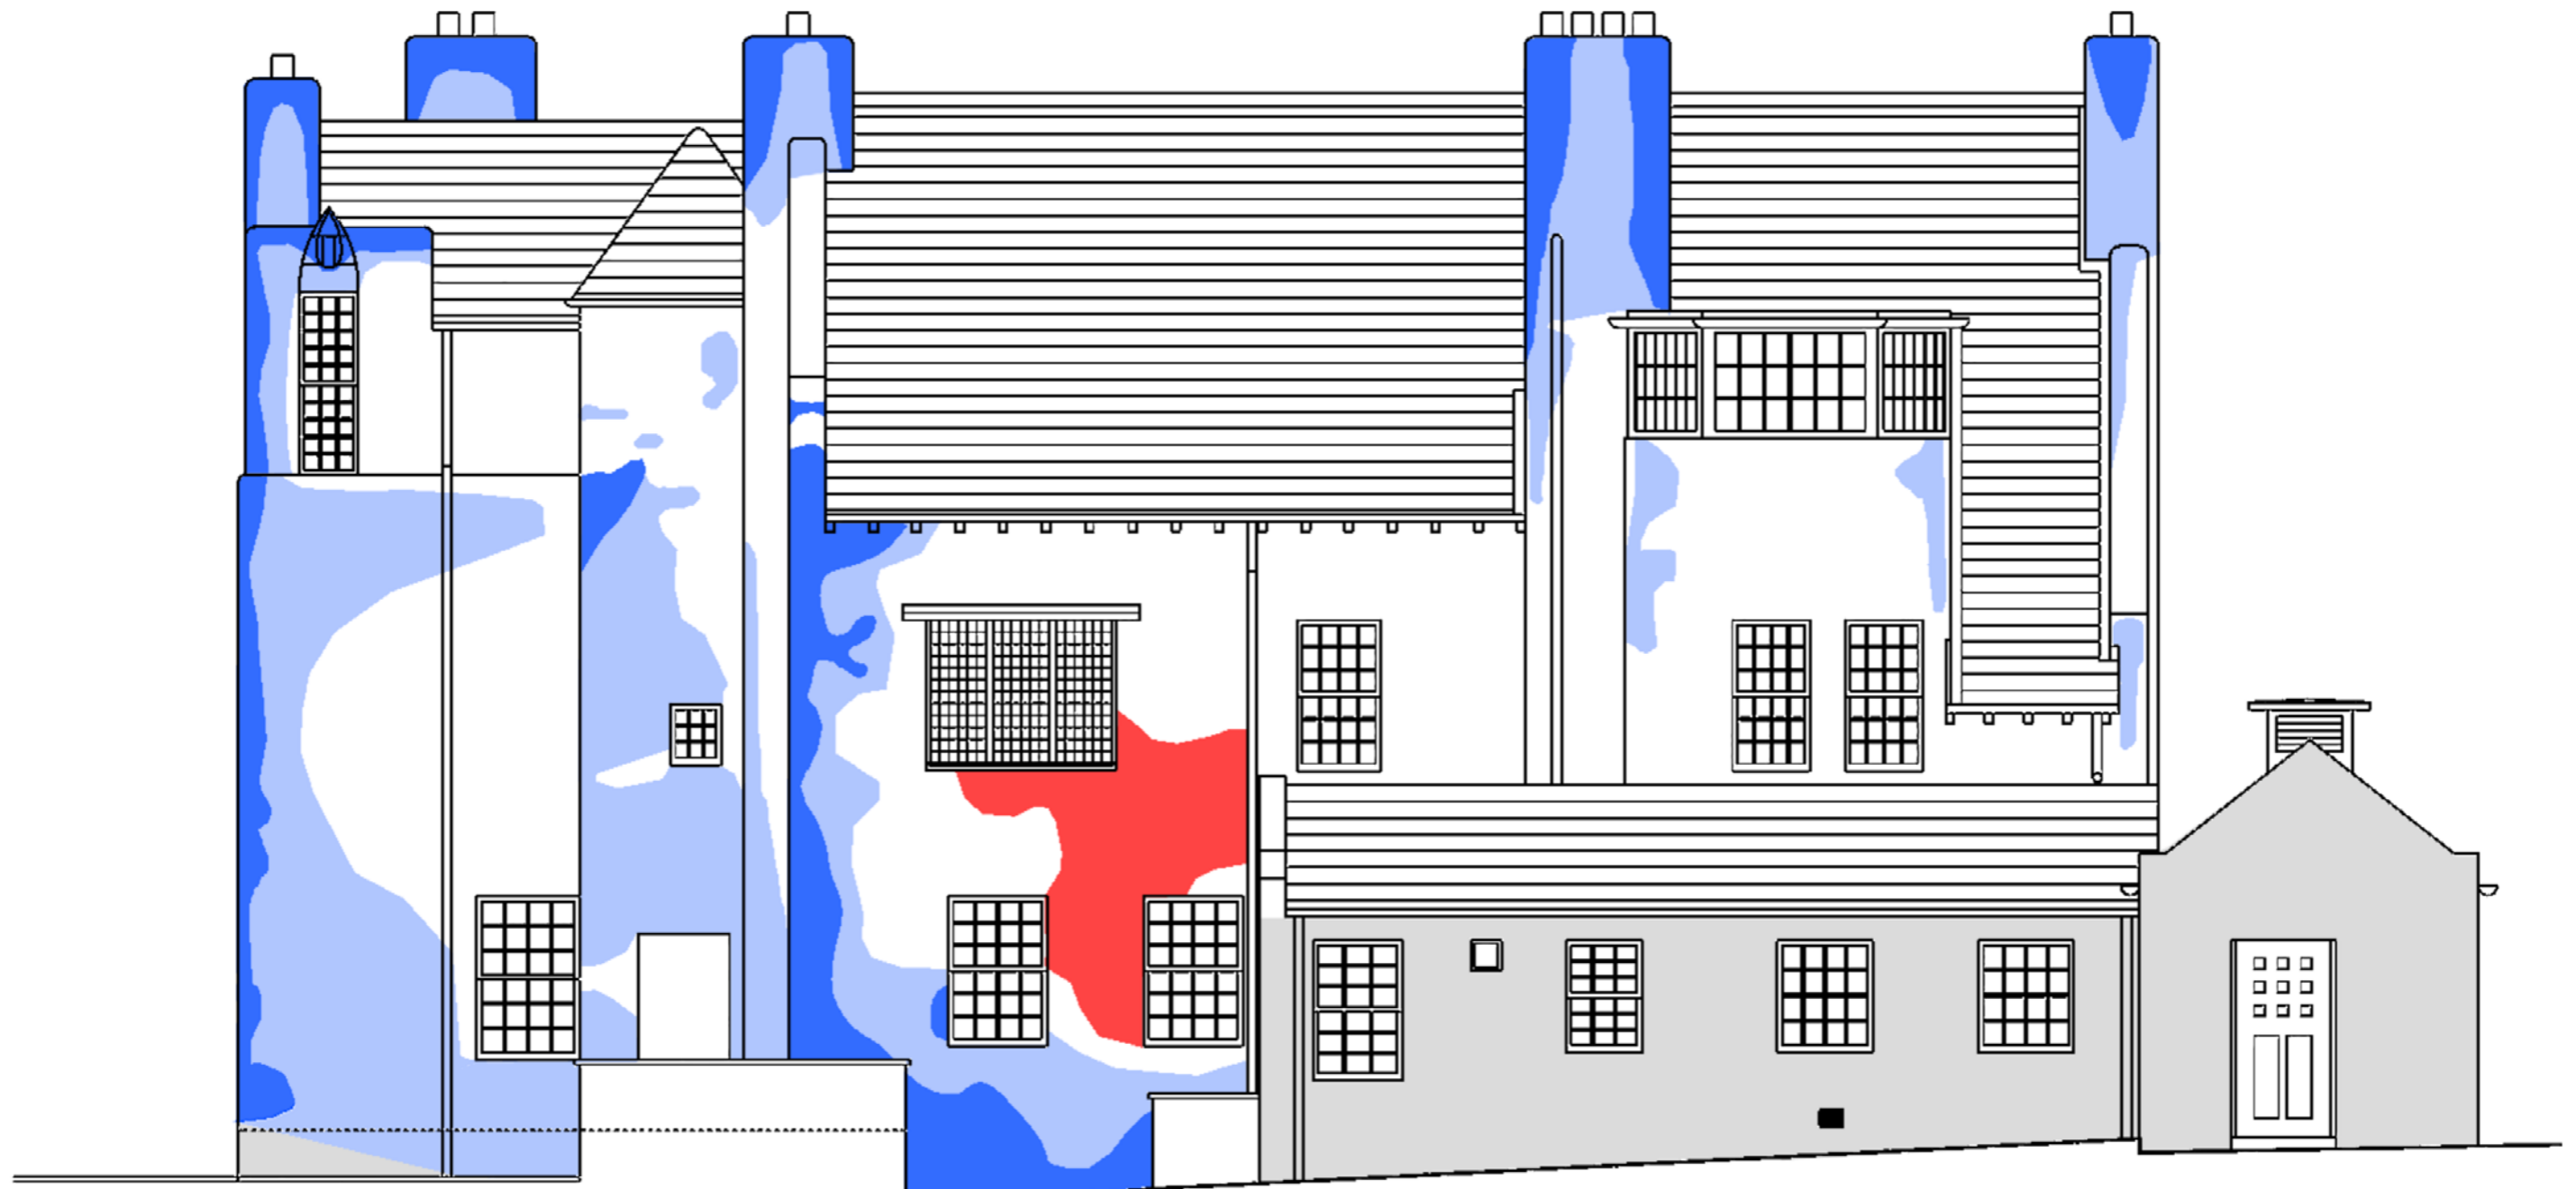
**Existing** East Elevation

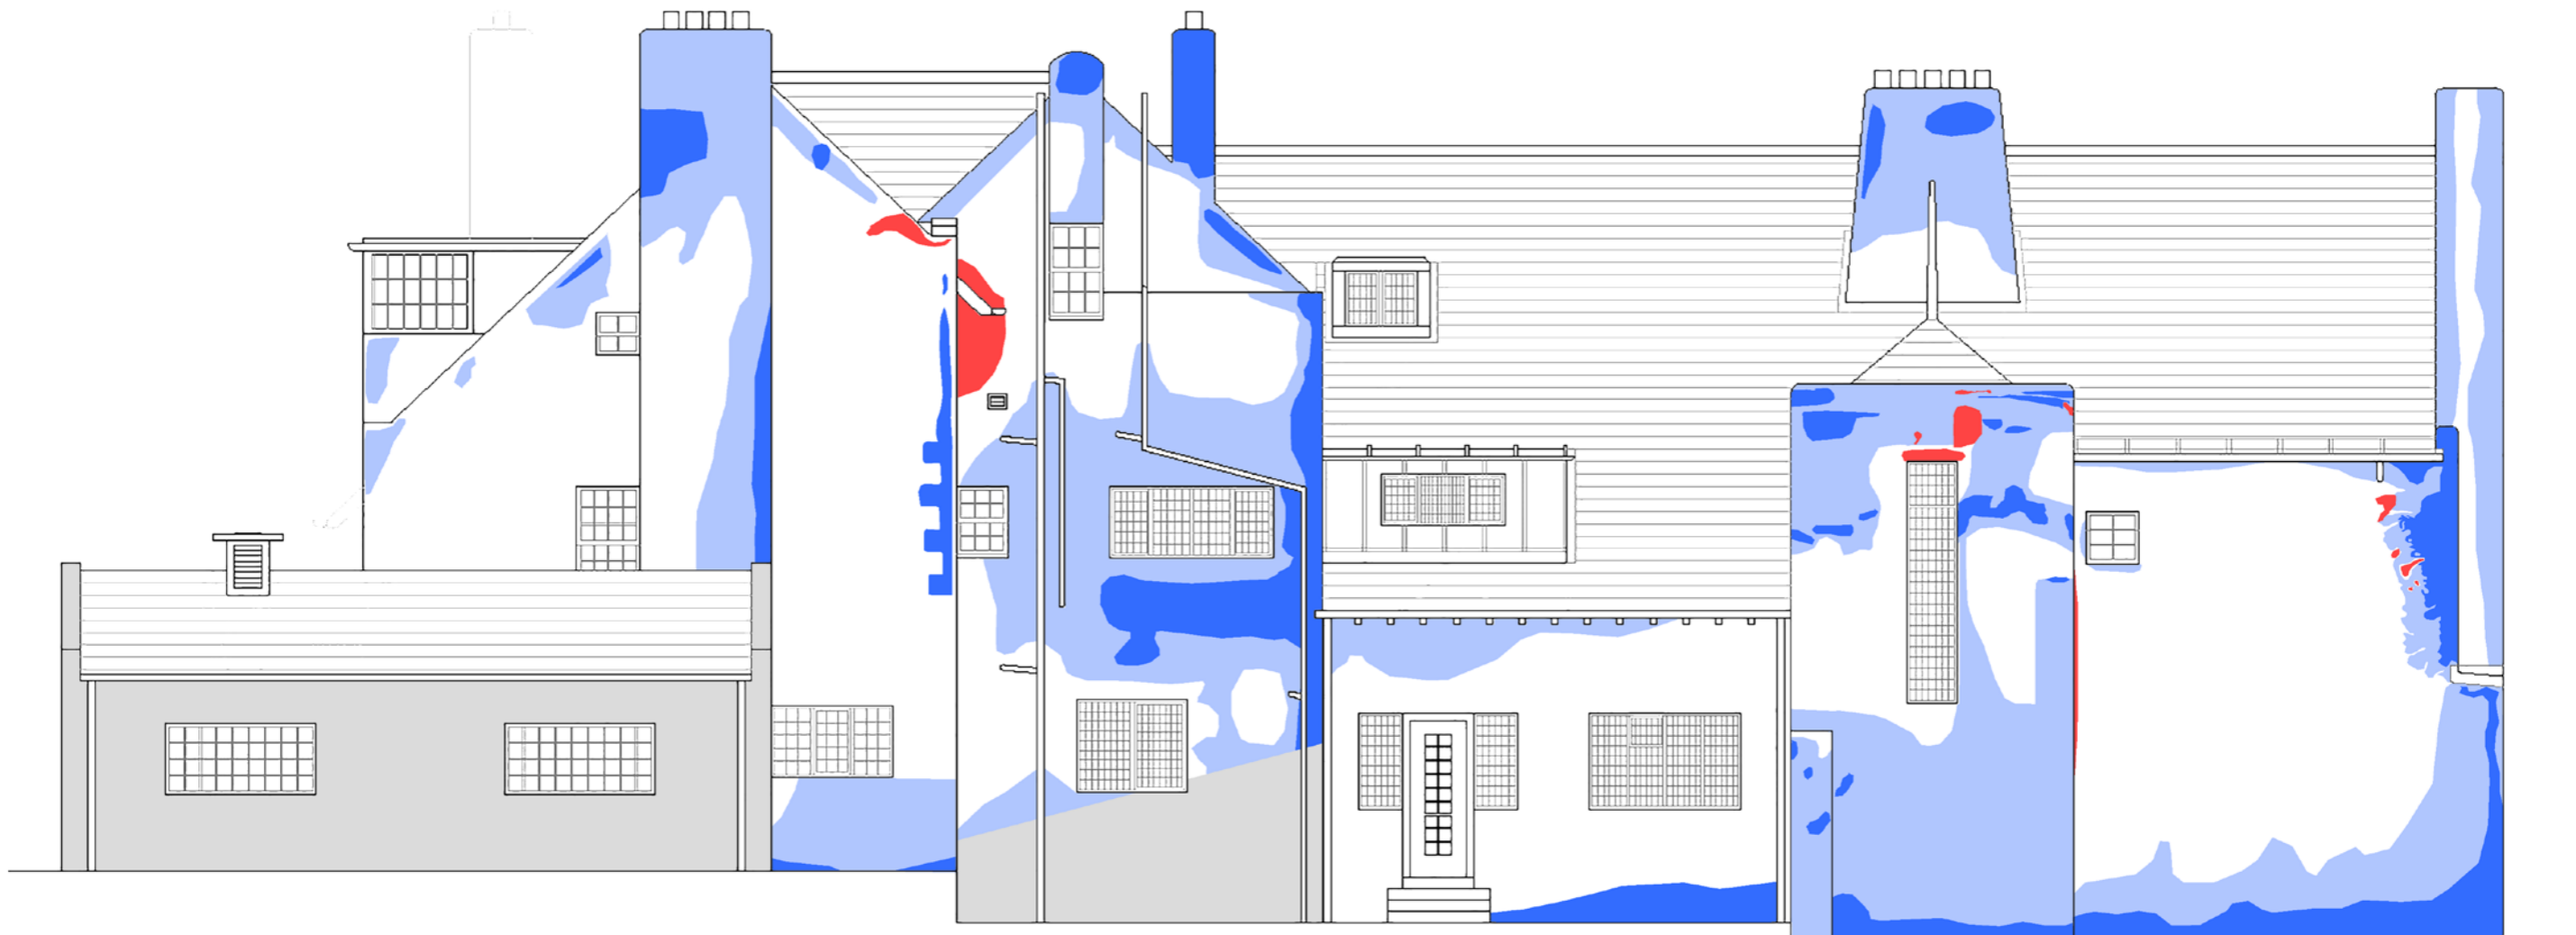
Existing North Elevation

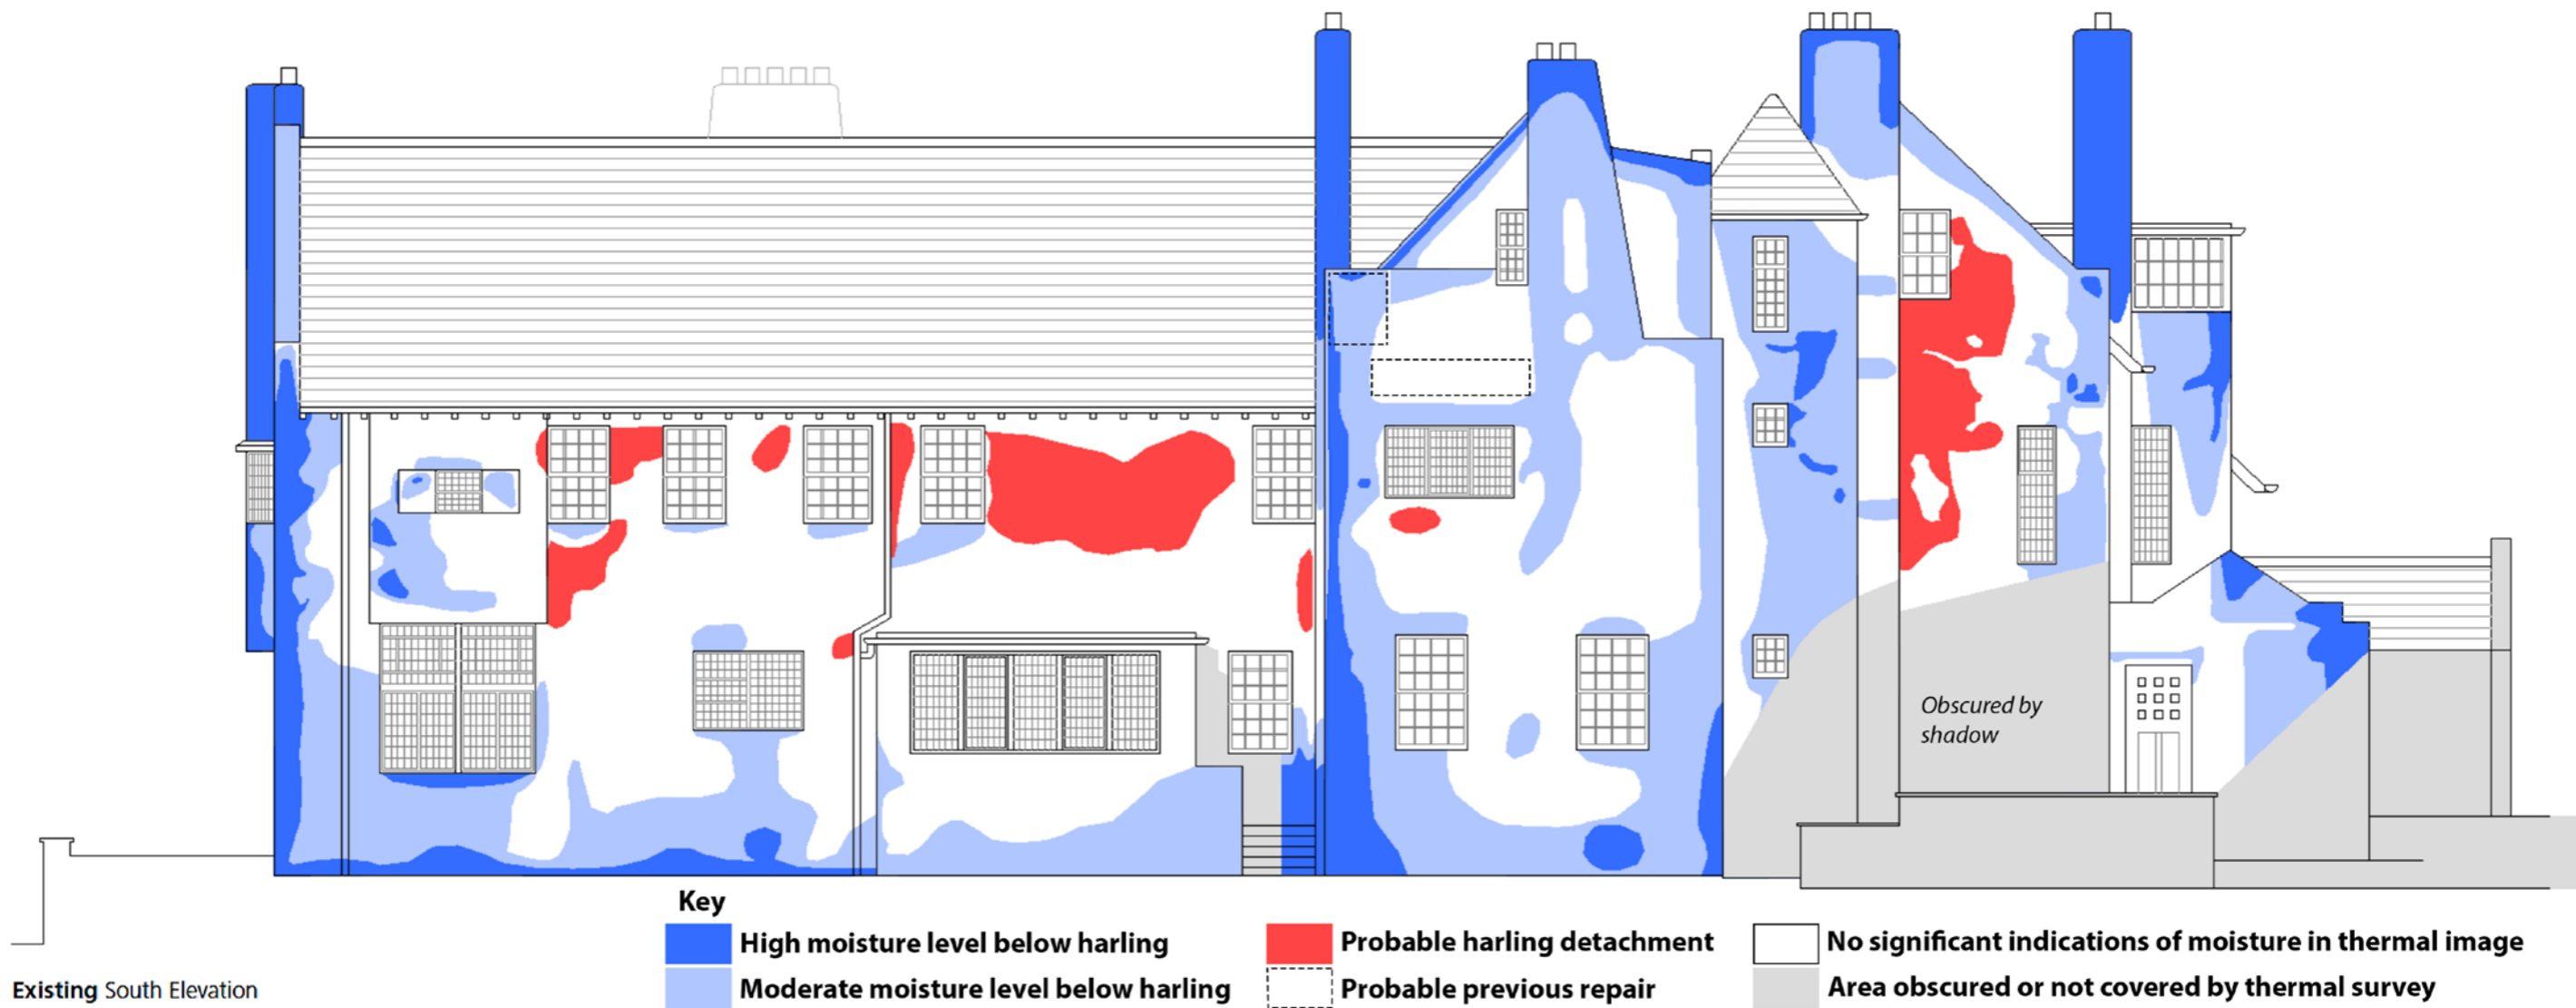
- Key**
- High moisture level below harling
  - Moderate moisture level below harling
  - Probable harling detachment
  - Probable previous repair
  - Area obscured or not covered by thermal survey
  - No significant indications of moisture in thermal image

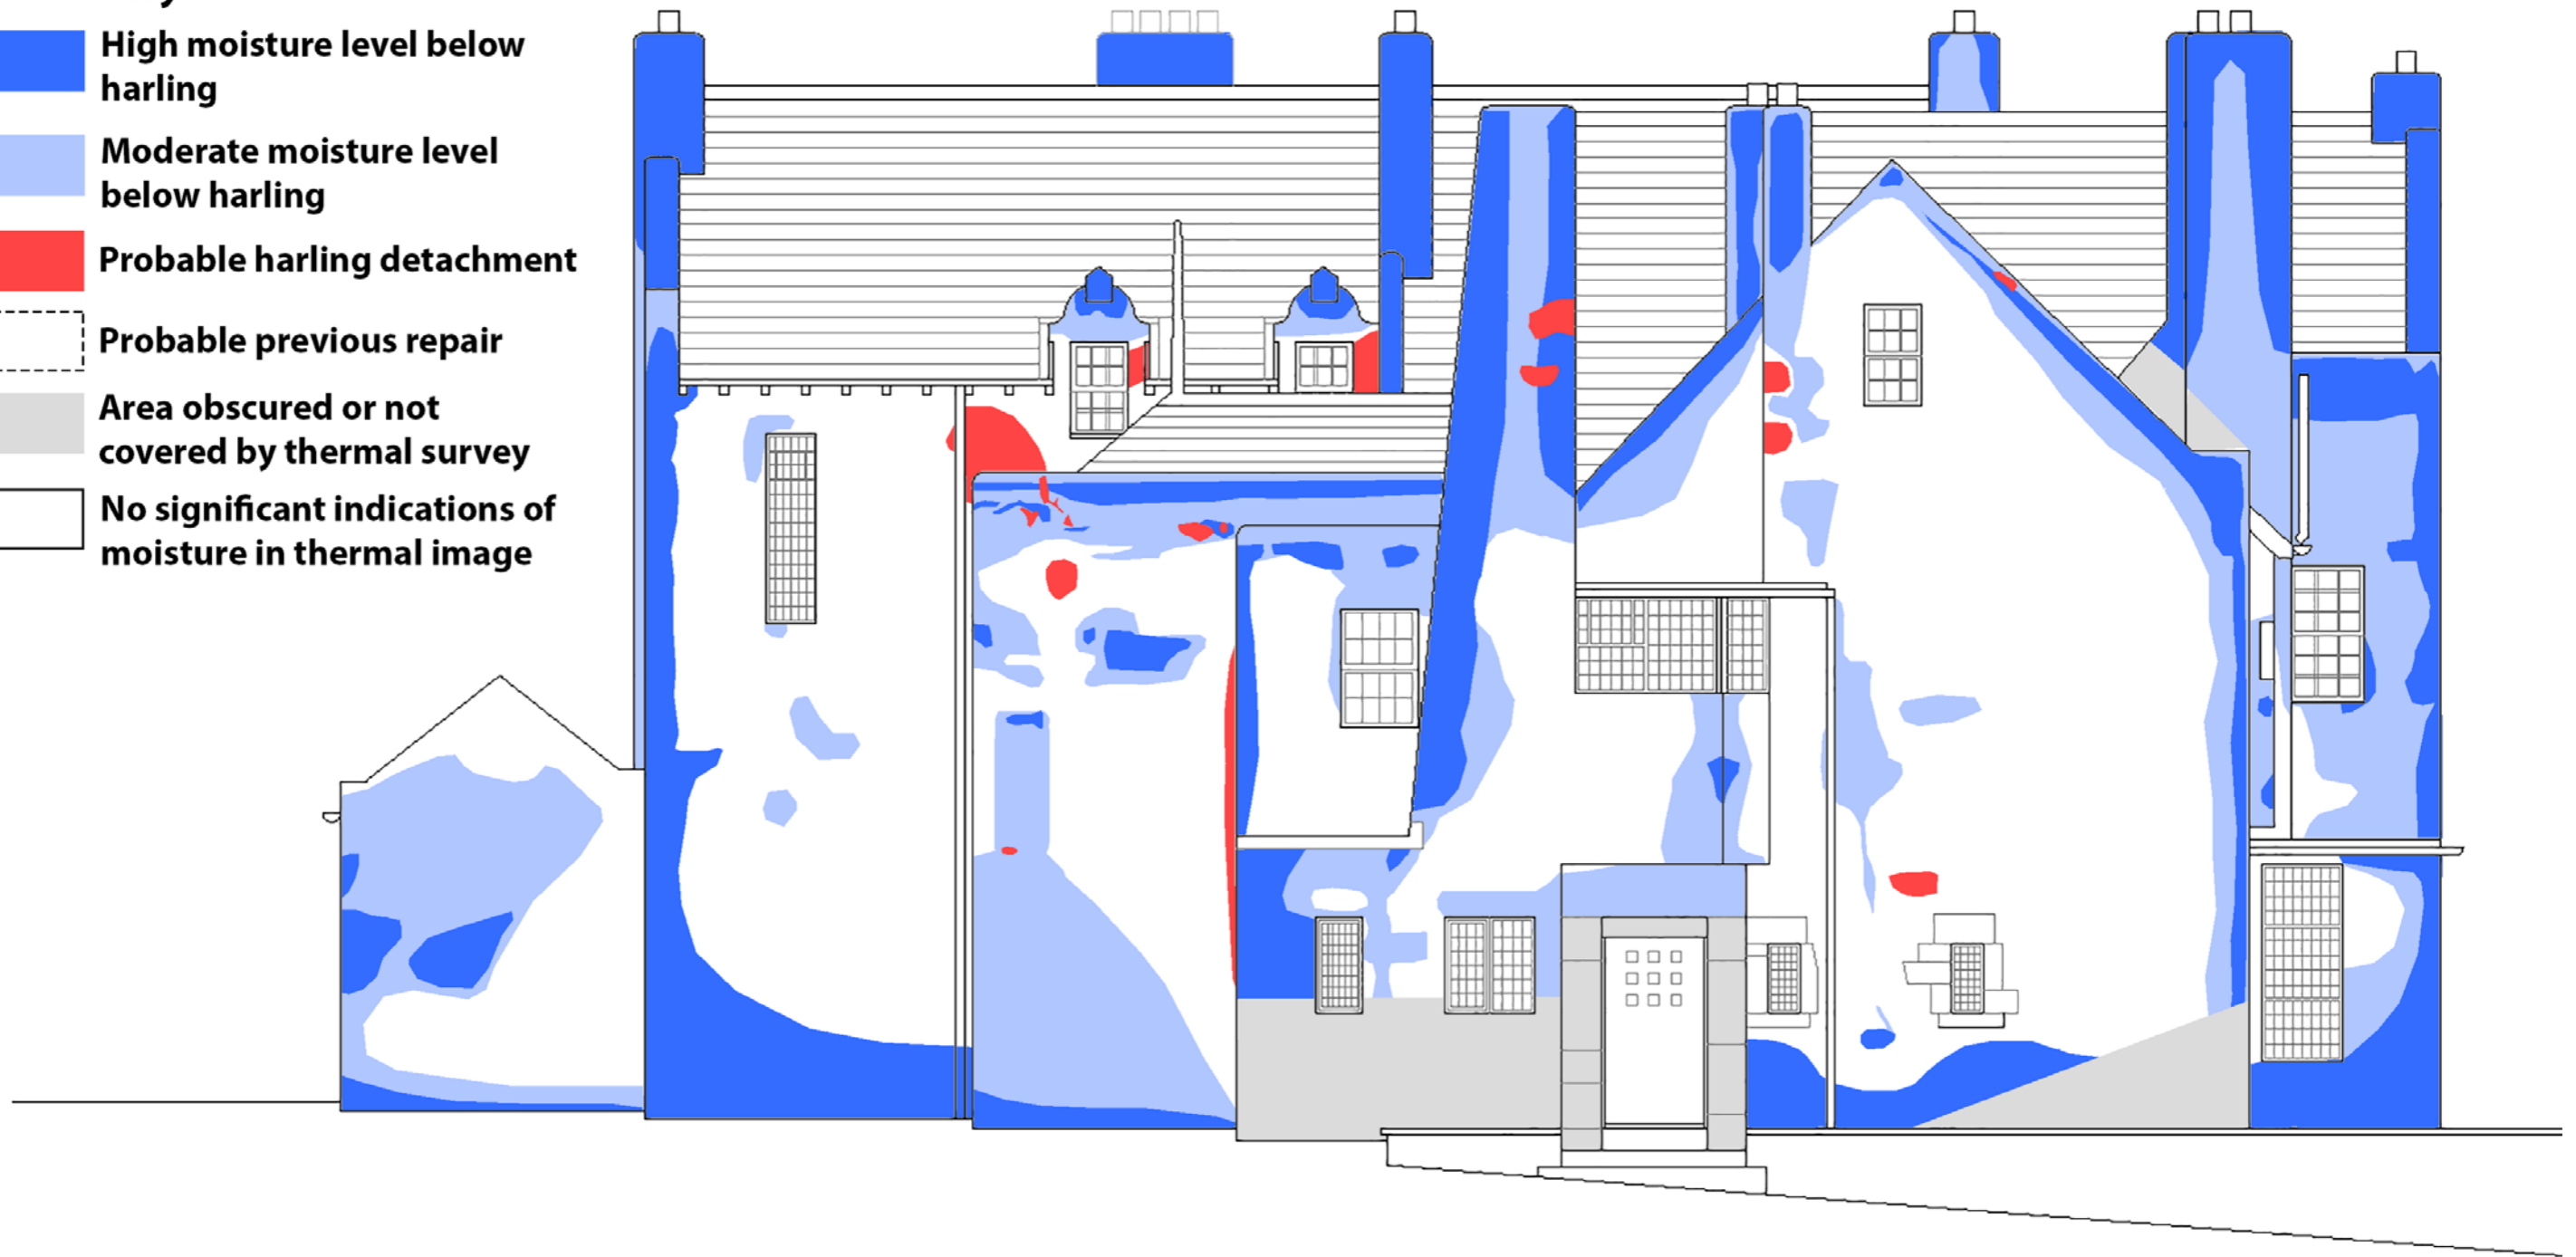
**Existing** West Elevation

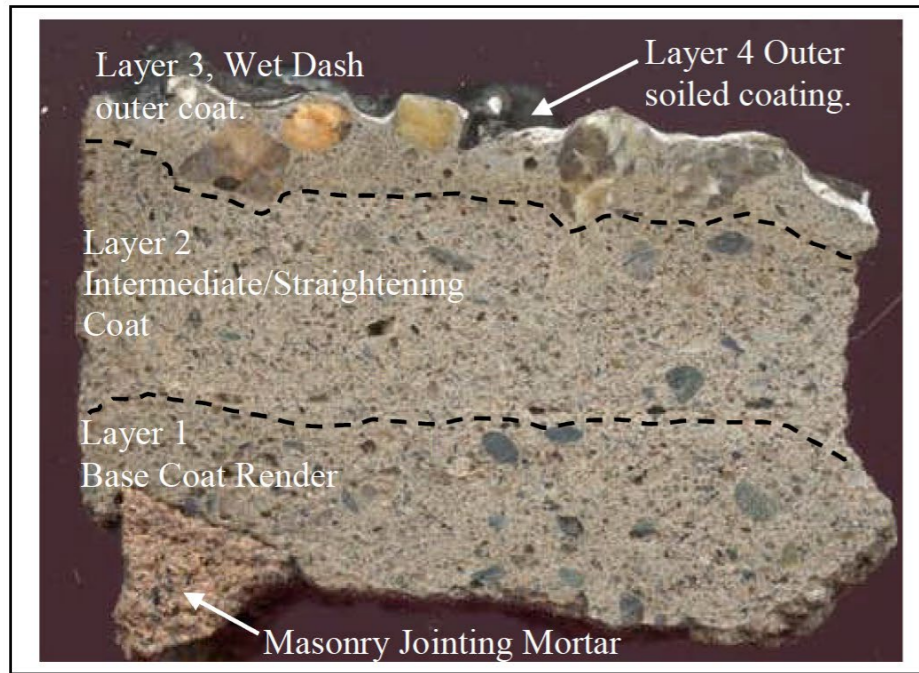
## *Conservation Strategy*
