# The Hill House

Research & Development Project

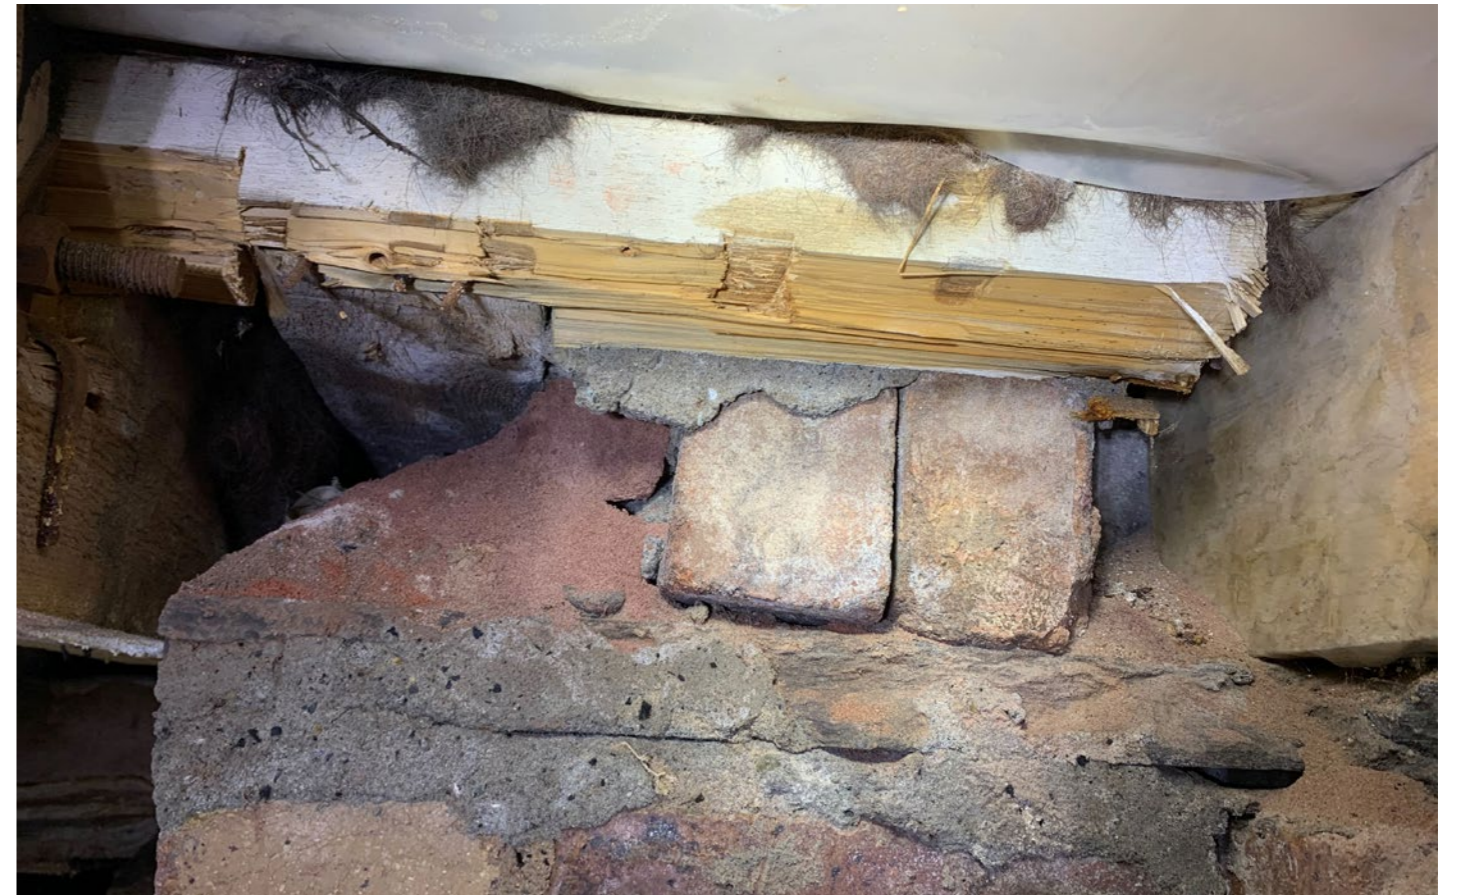
*Powdered brick and stone at base of external walls in solum, 2021*

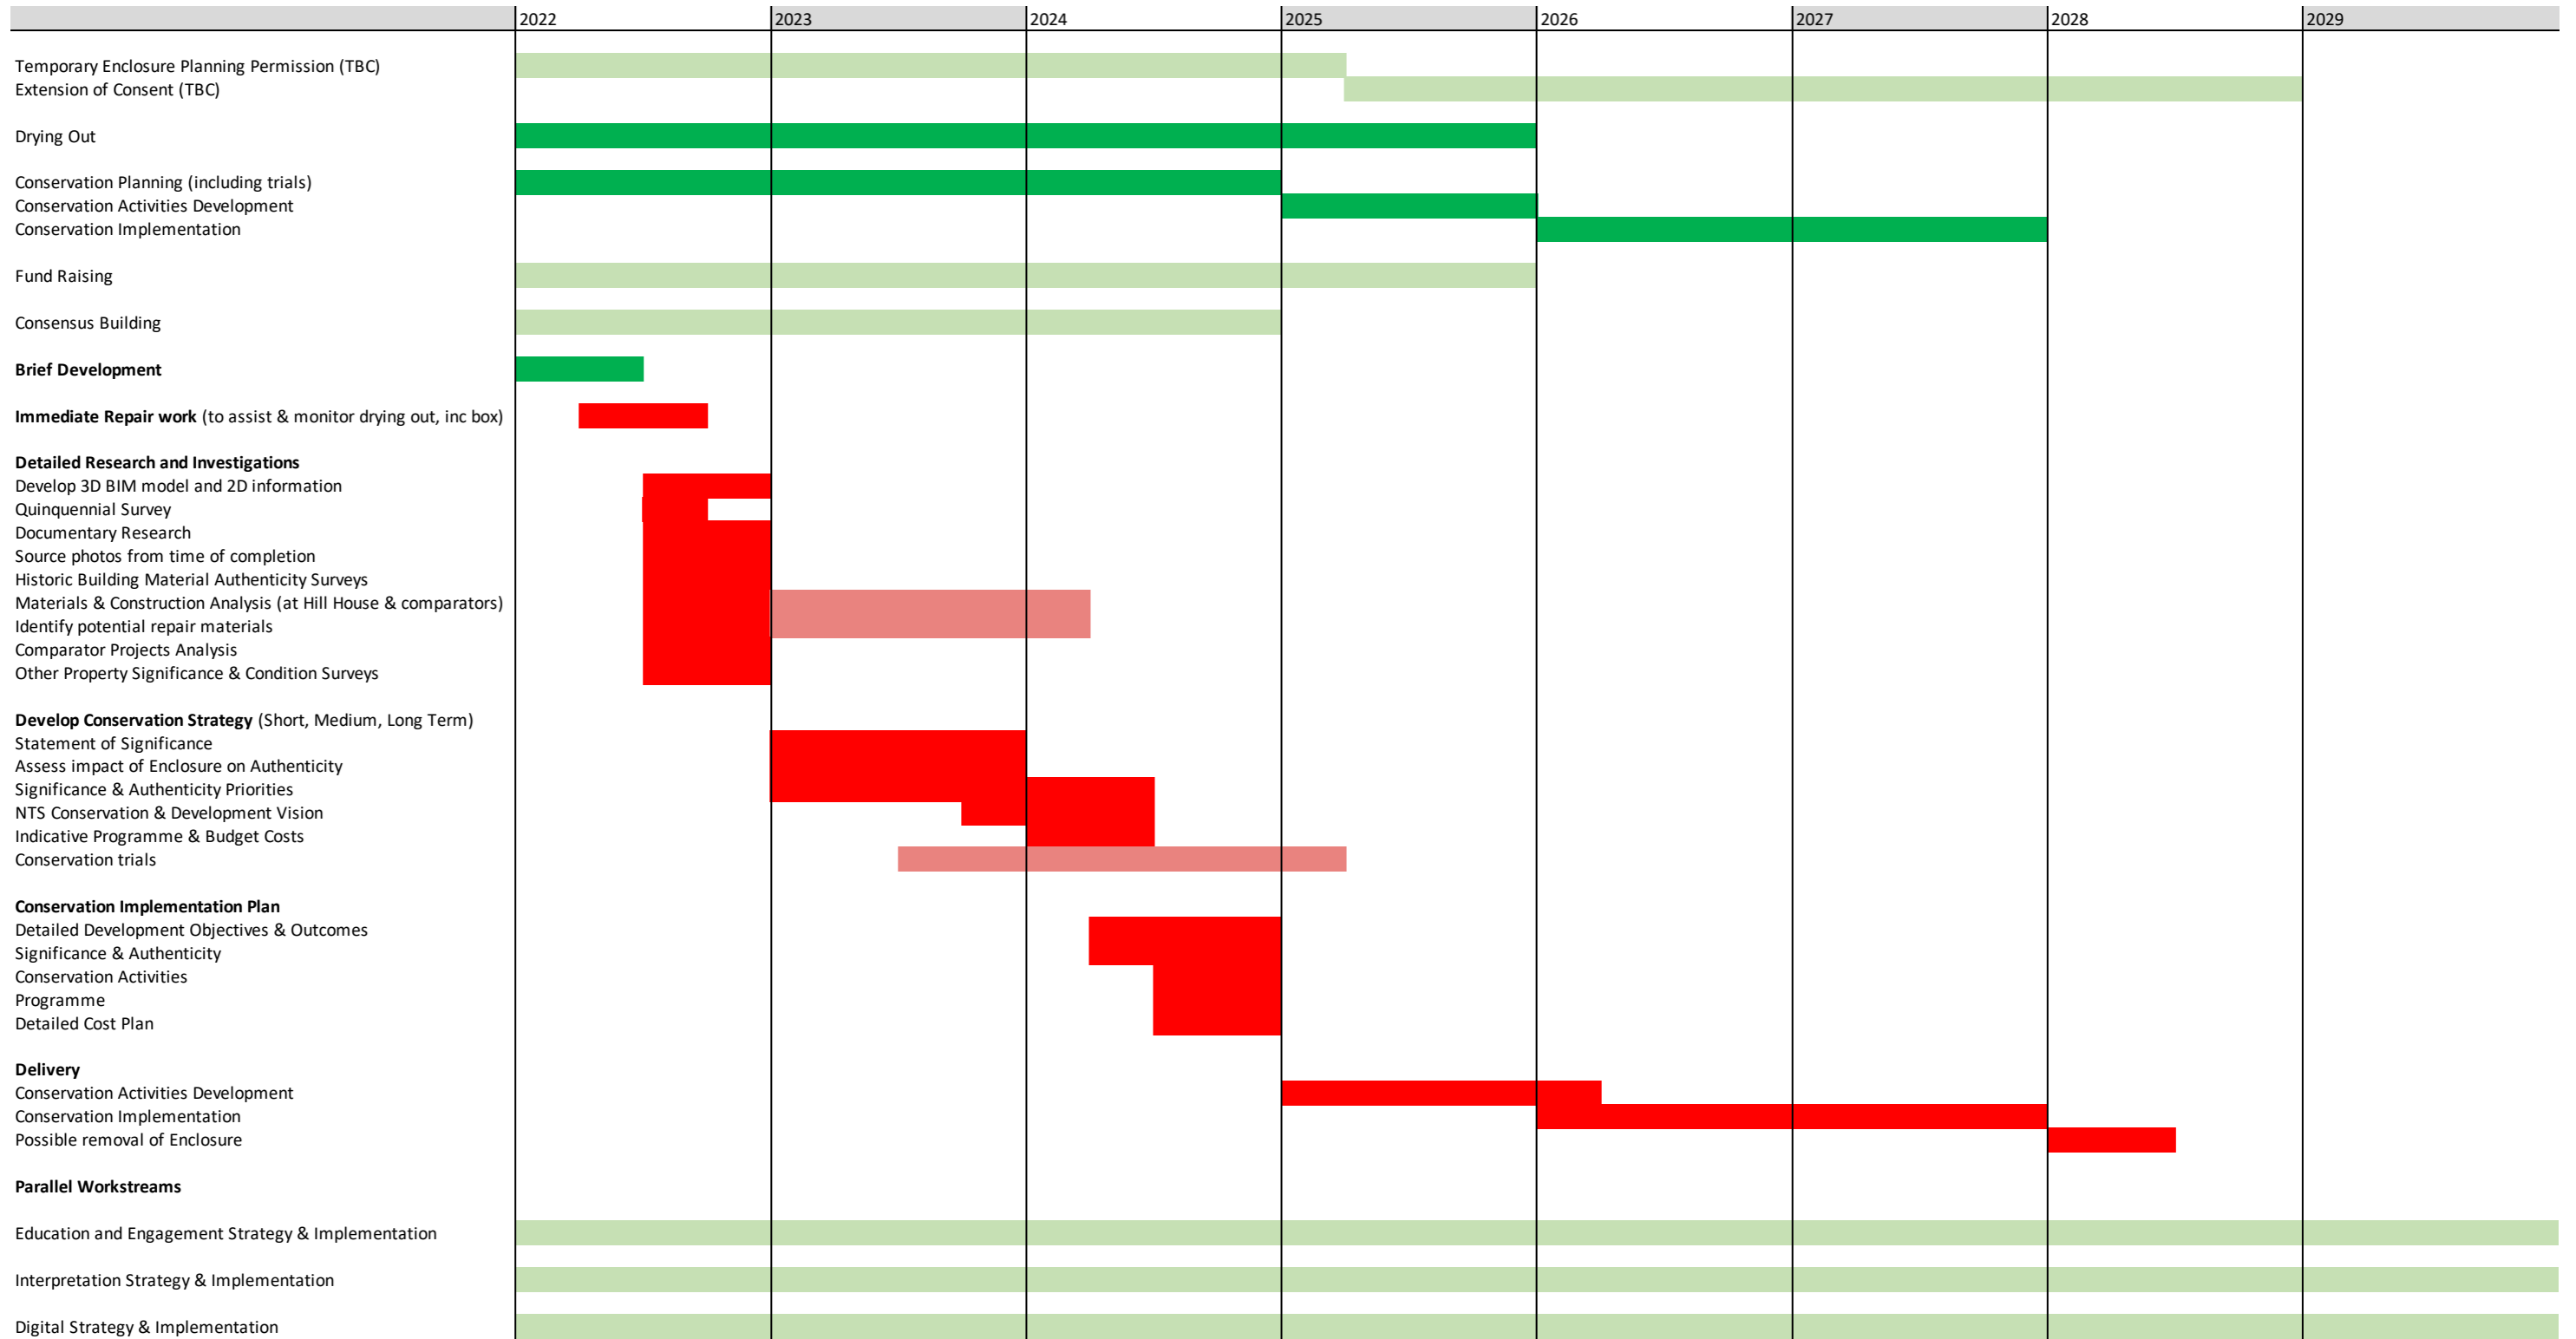
INDICATIVE HIGH LEVEL CONSERVATION RESEARCH, DEVELOPMENT & IMPLEMENTATION PROGRAMME
