A MODERN MASTERPIECE IN UGANDA

UGANDA NATIONAL MUSEUM  
CONSERVATION MANAGEMENT PLAN

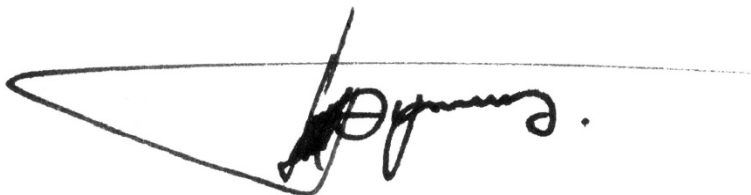
A handwritten signature in black ink, appearing to read 'Tom R. Butime', with a large, sweeping flourish extending to the left.

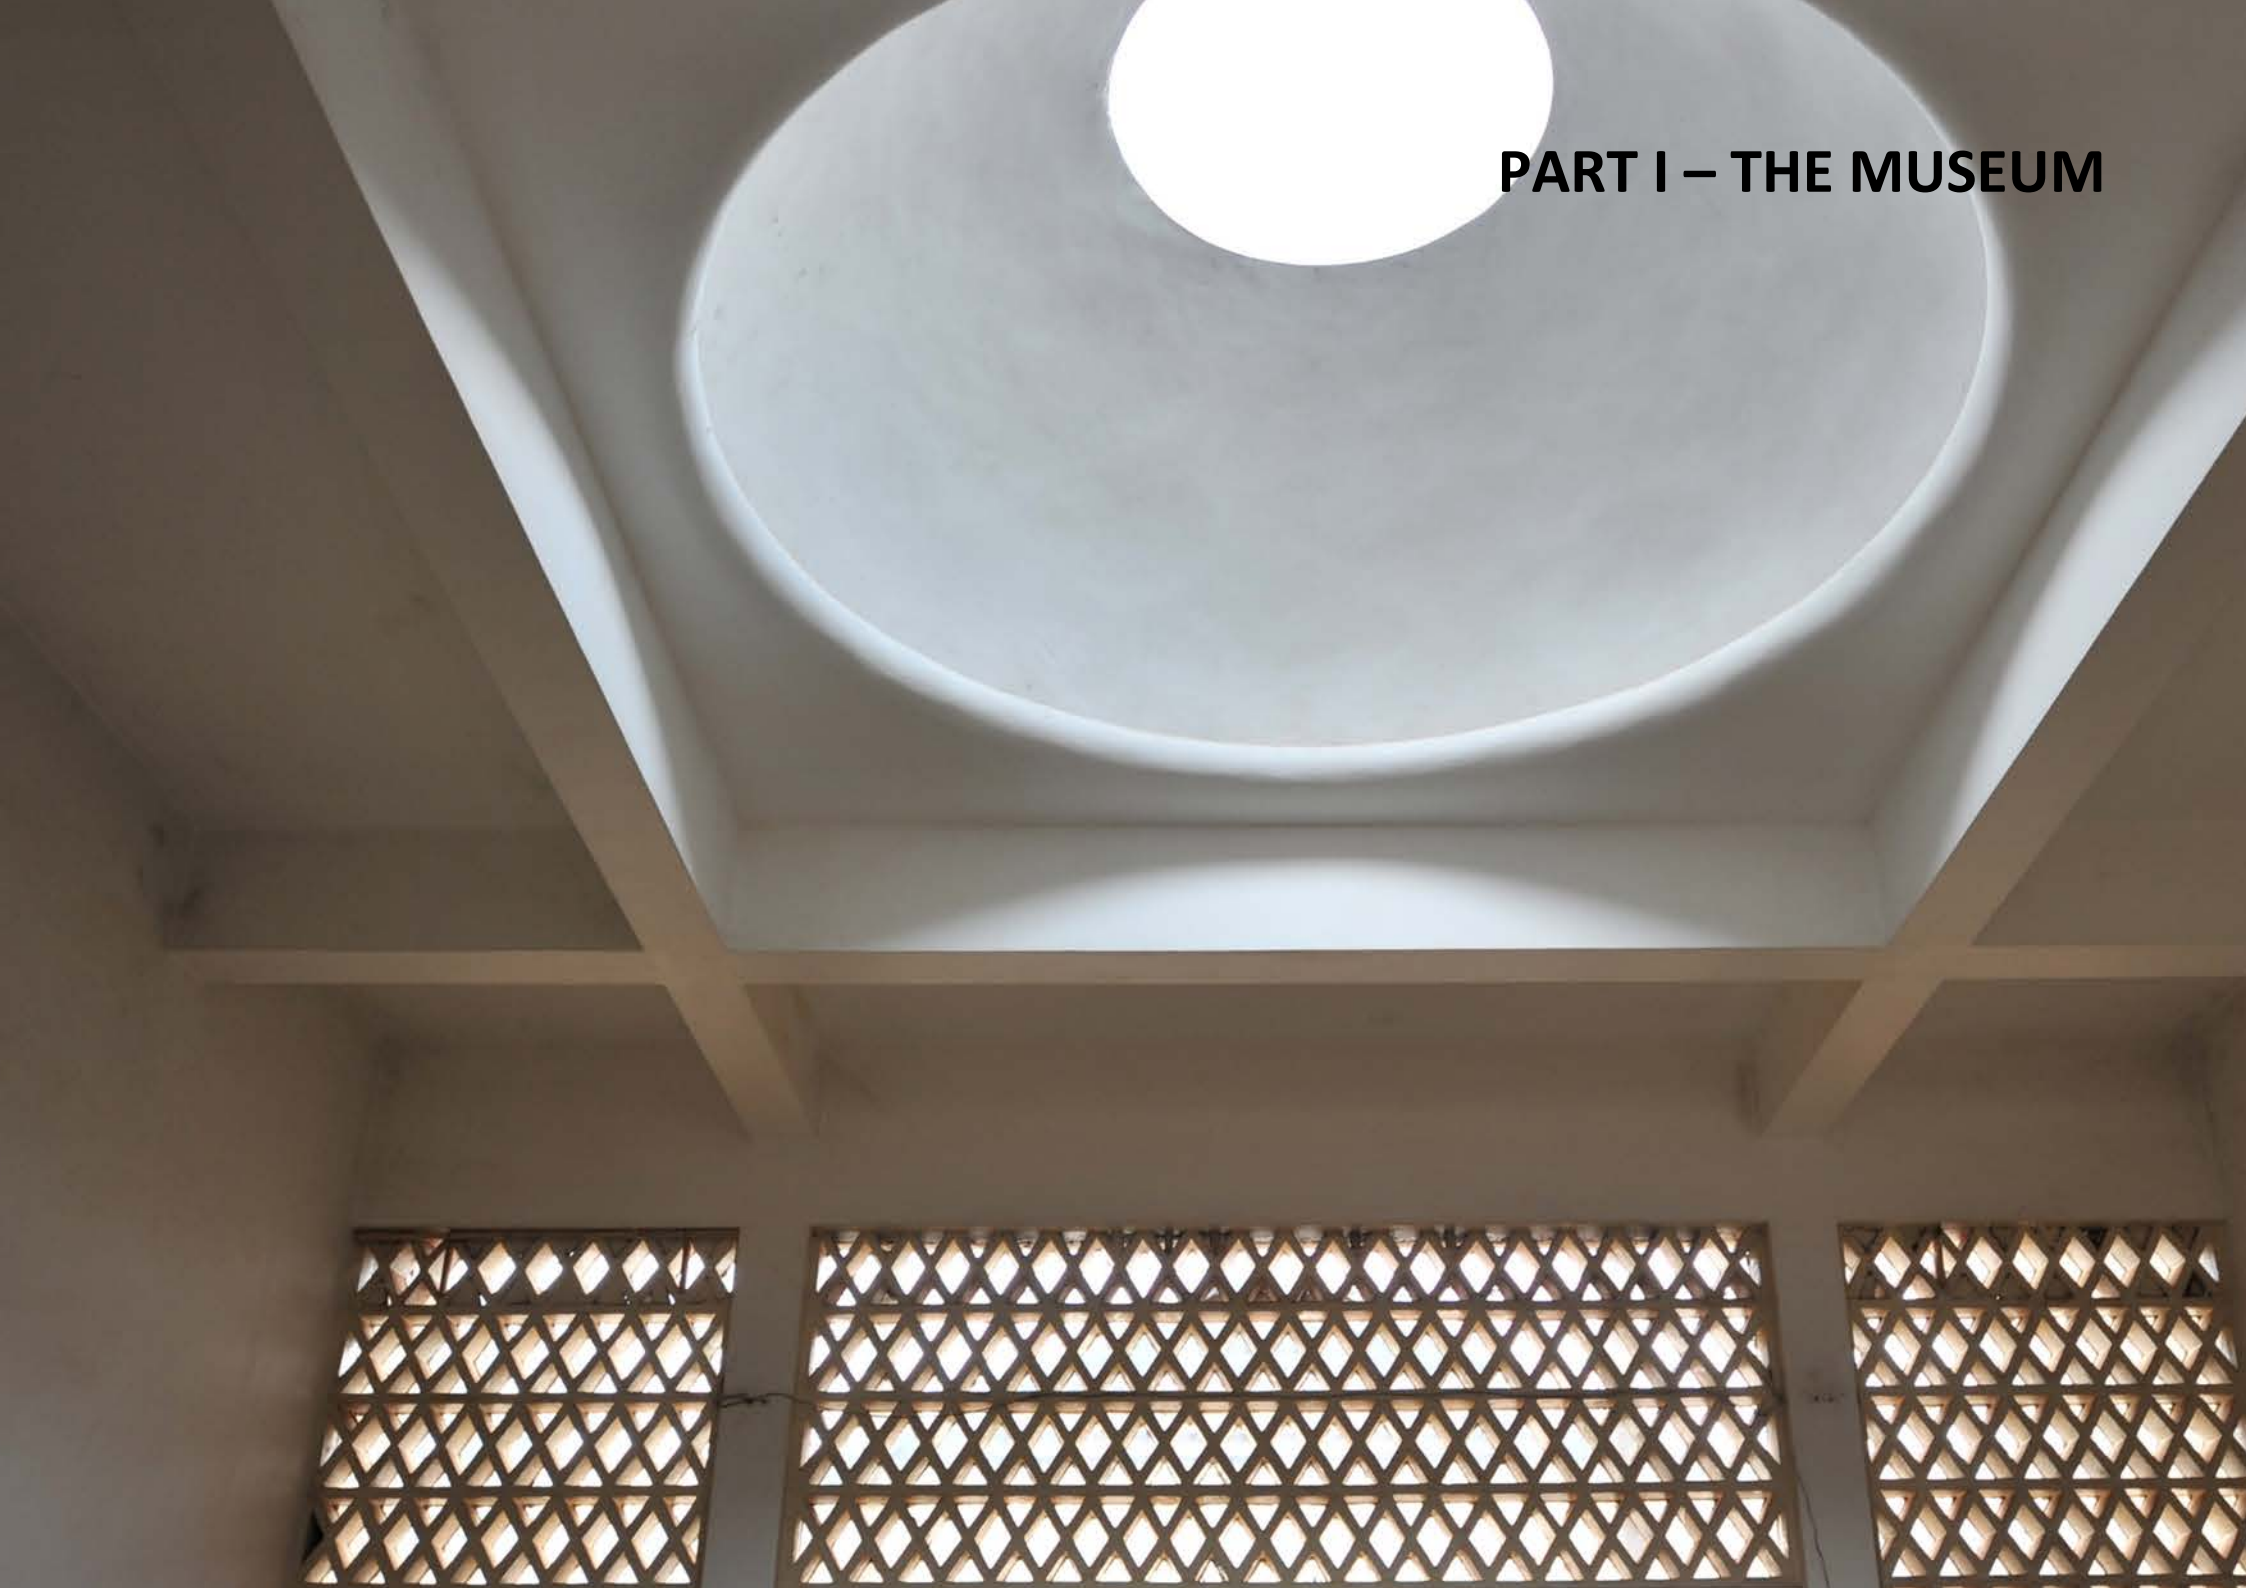
“The national museum is a national treasure. It preserves and presents the diversity of cultural expressions from most of Uganda's ethnic groups as represented by the different vernacular architectural designs of the cultural village behind the national museum. This has inspired many Ugandans to preserve and promote their cultures.”

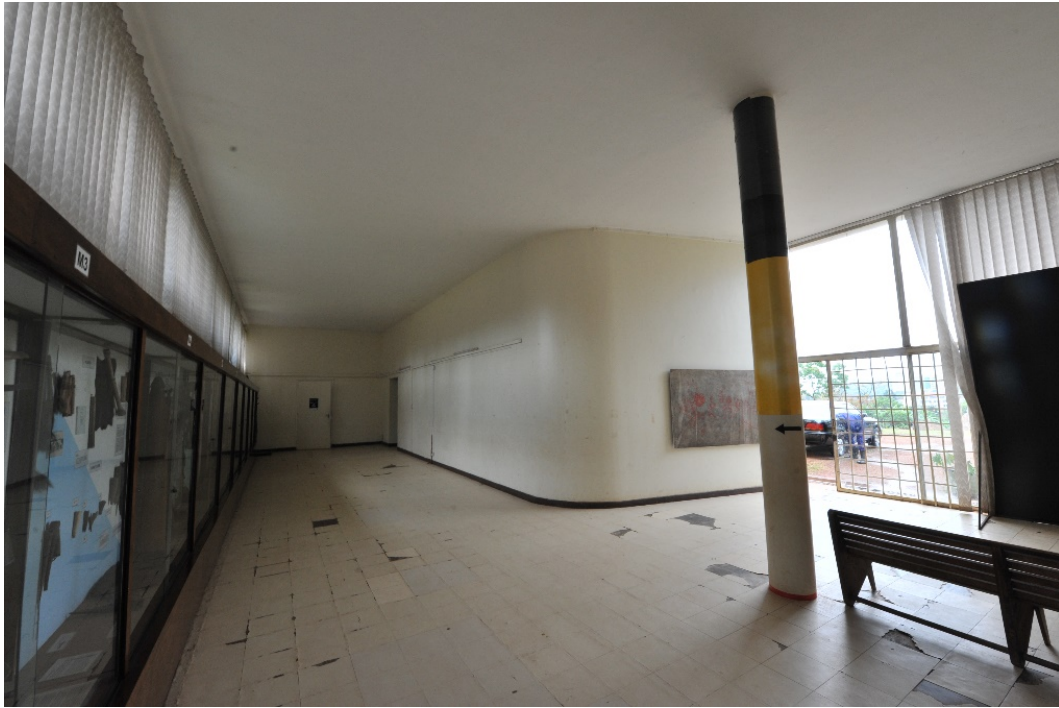
*Figure 4 – The music gallery and rear entrance to the gardens beyond (Eppich, 2018)*

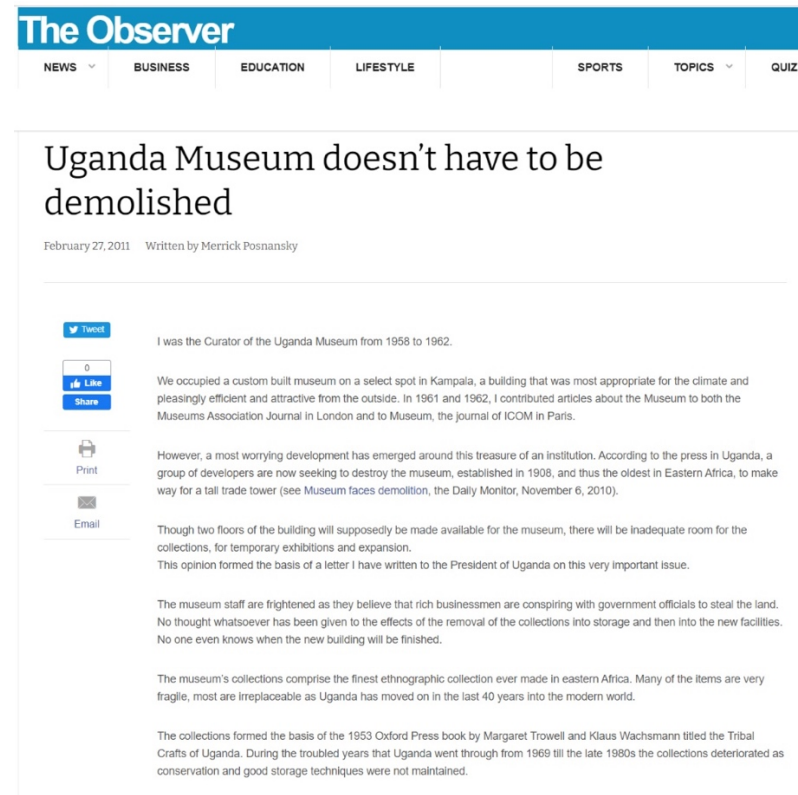
Figure 9 – In 2010, the Uganda National Museum was threatened with demolition (The Observer, 2020)

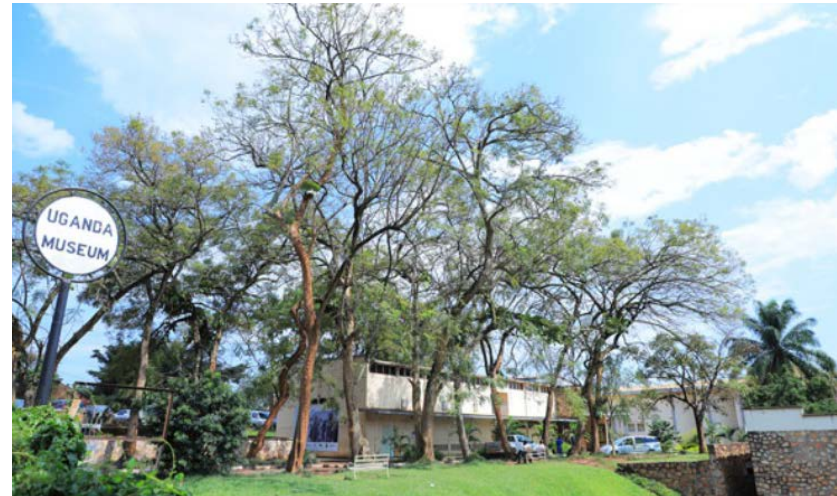
Figure 10 – The Getty Foundation grant made national press and has resulted in increased visitation to the museum (Daily Monitor, 2020). This series of outreach to the press has served to introduce the public to conservation and Conservation Management Planning.

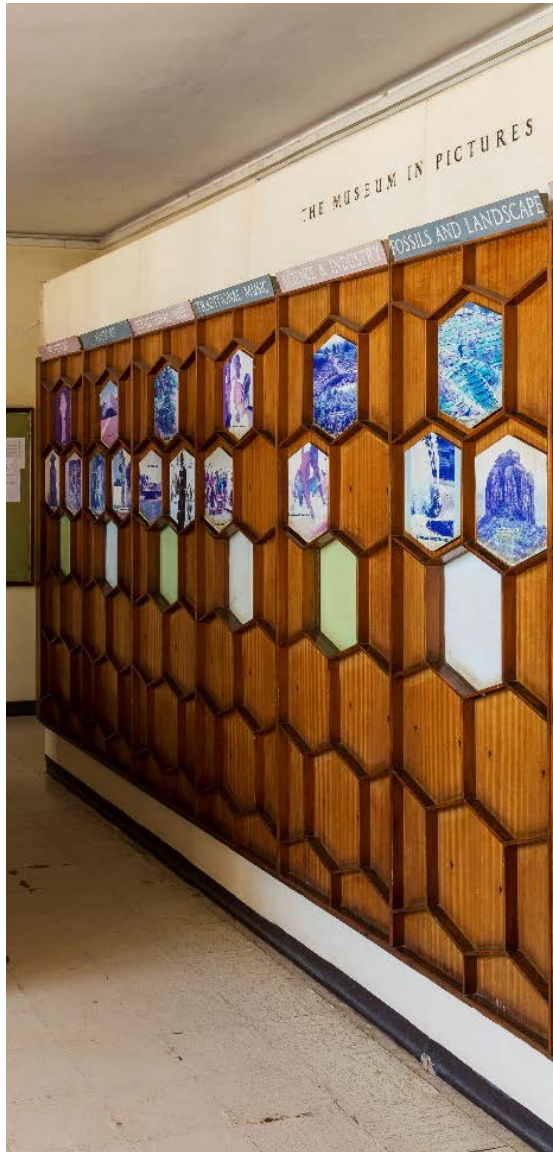
Figure 11 – The unique entry display (Oskar Proctor, 2018)

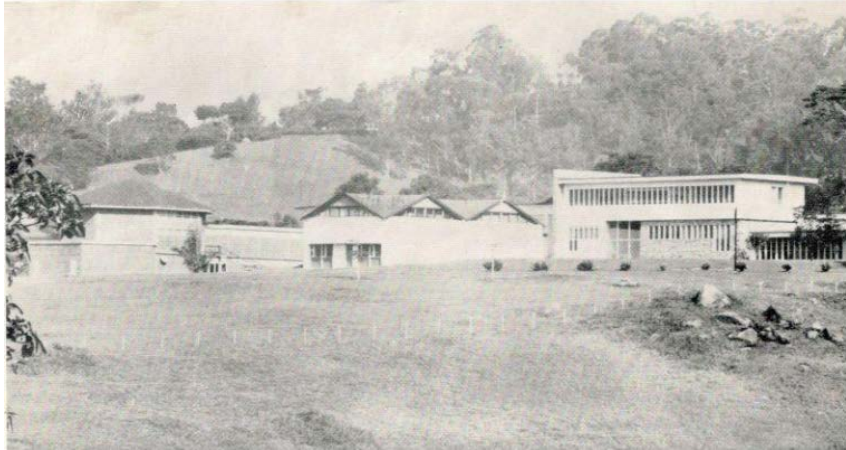
Figure 27 – Photo of the museum building in 1966 (Uganda National Museum archive)

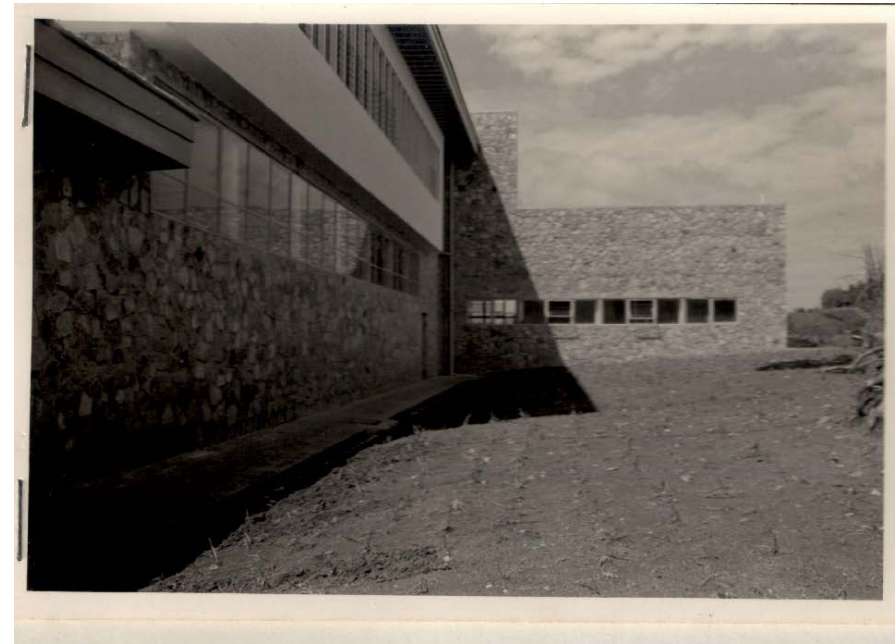
*Figure 32 – Early photograph of the museum from the north, date and author unknown (Uganda National Museum archive)*

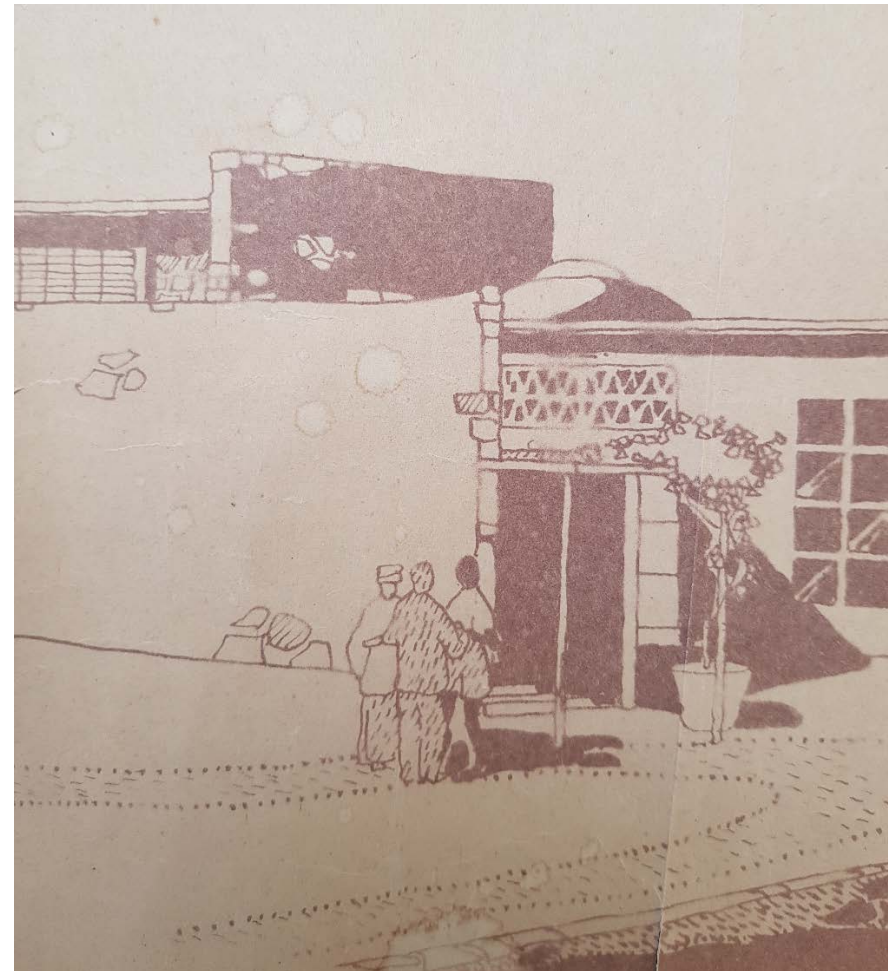
Figure 33 – Sketch of the entrance to the Uganda Museum attributed to Ernst May (Uganda National Museum archives) May believed in the “city as a social space that should provide good living conditions for all its inhabitants”

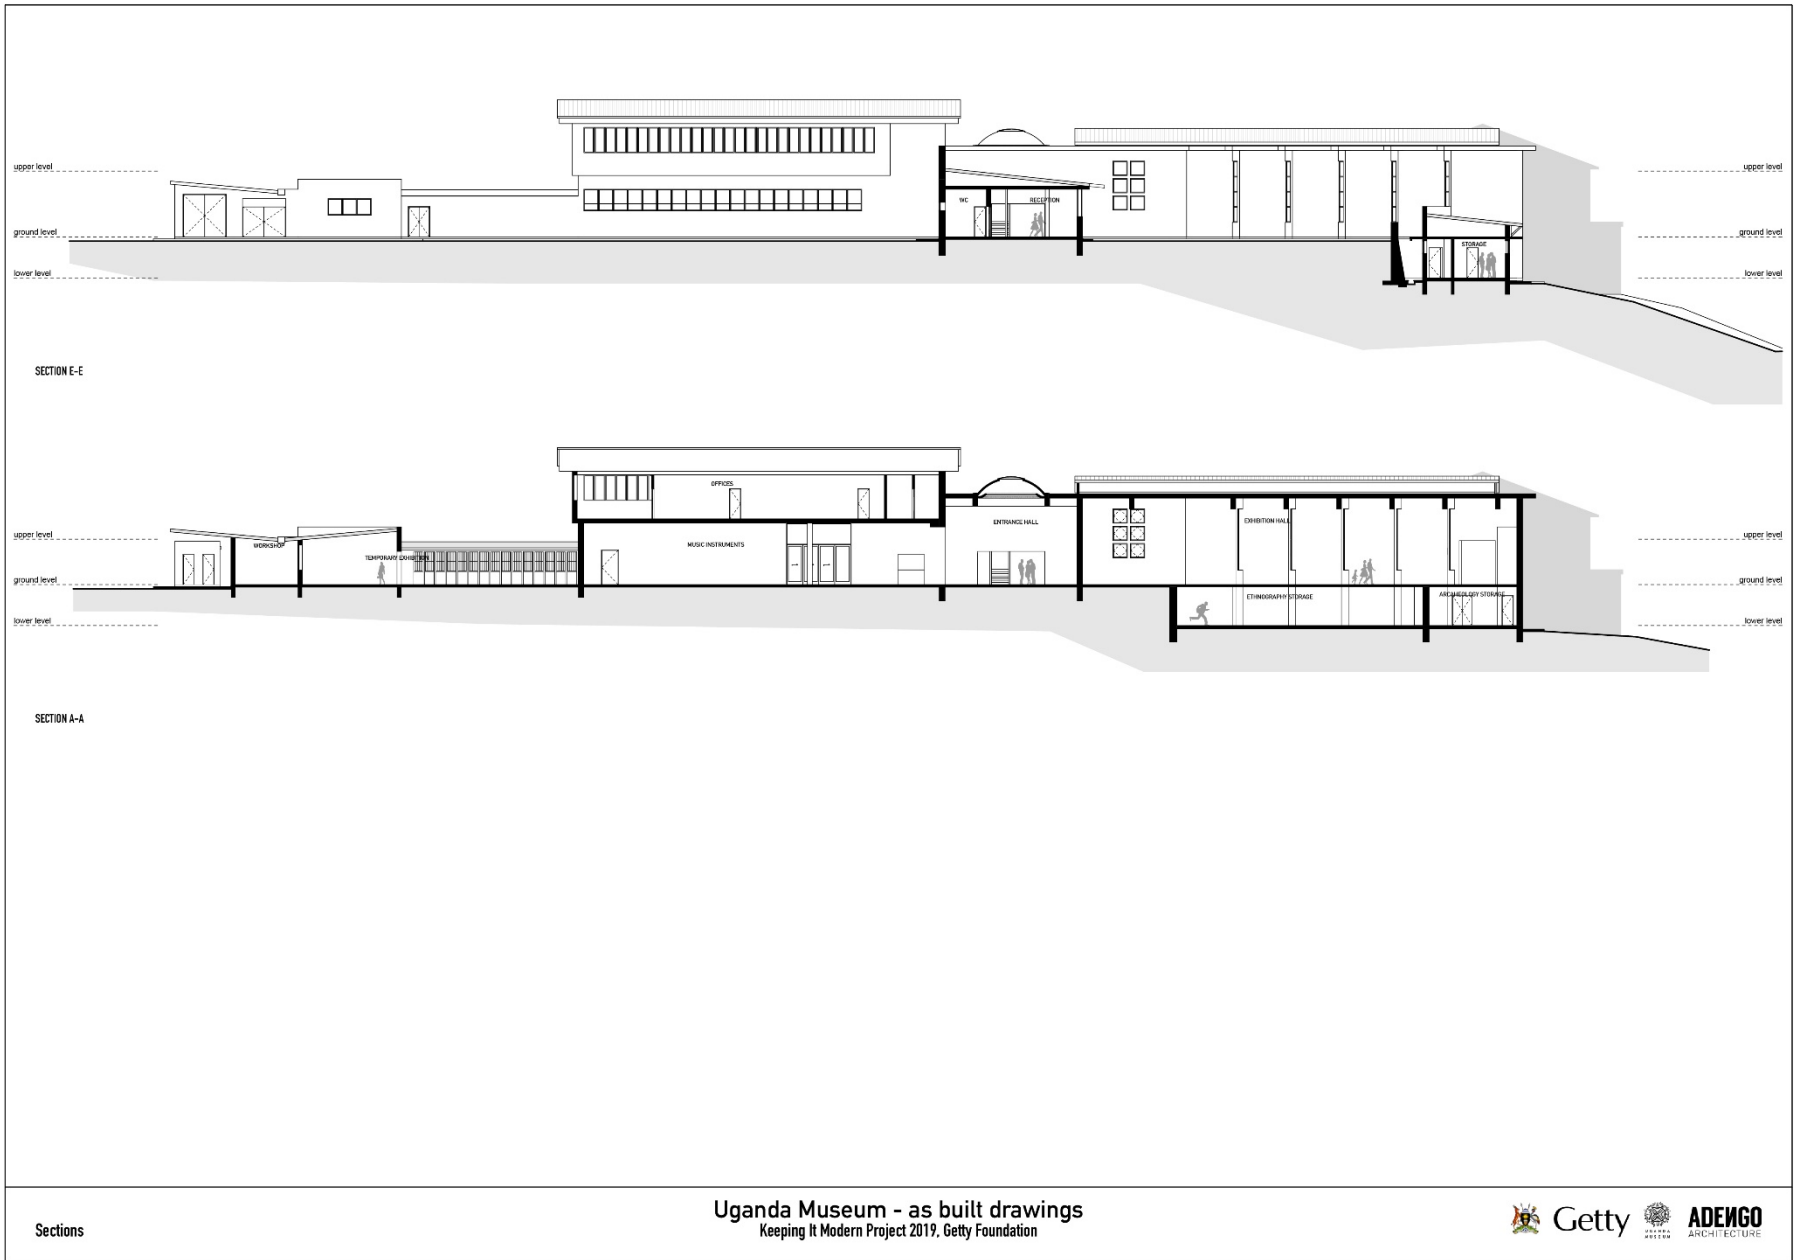
Uganda Museum - as built drawings  
 Keeping It Modern Project 2019, Getty Foundation

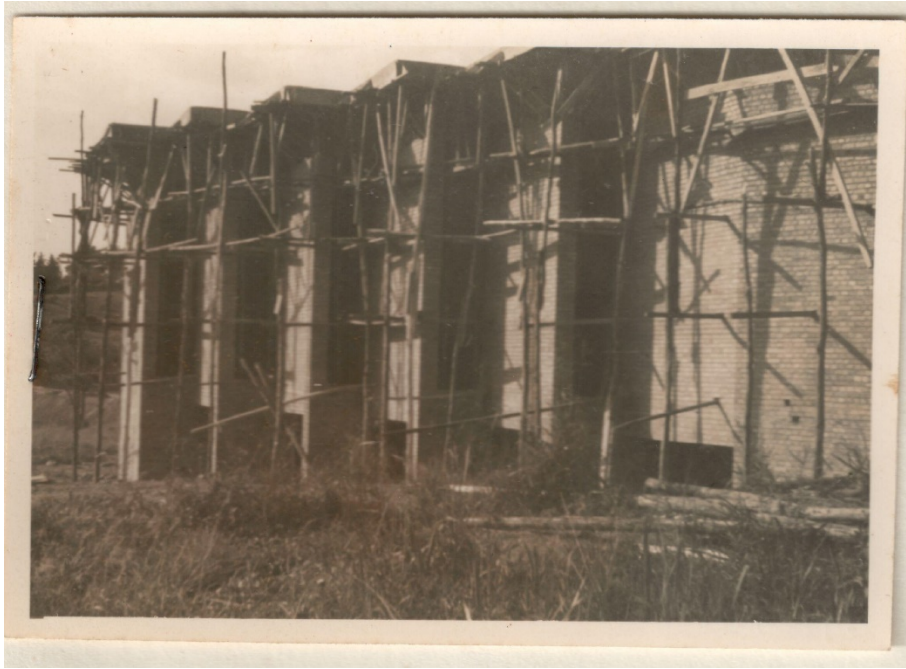
Figure 34 – Uganda National Museum under construction, 1952, Ernst May (Uganda National Museum archive)

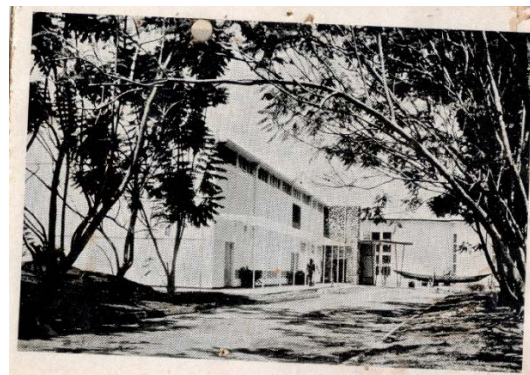
Figure 39 – View with the newly built Education Wing, mid-1960s, author unknown (Uganda National Museum Archives)

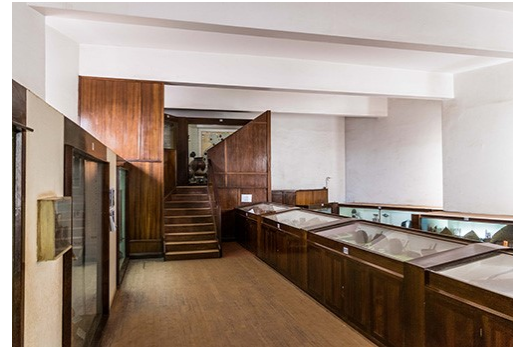
*Figure 43 – the wooden museum display cases are integral to the original design and must be retained and conserved (Adengo, 2020)*

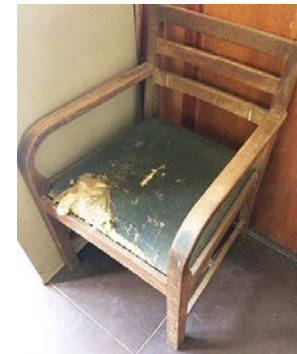
*Figure 44 – Many original furnishings remain but are at risk given their intensive use, current condition, and ease of replacement (Adengo, 2020)*

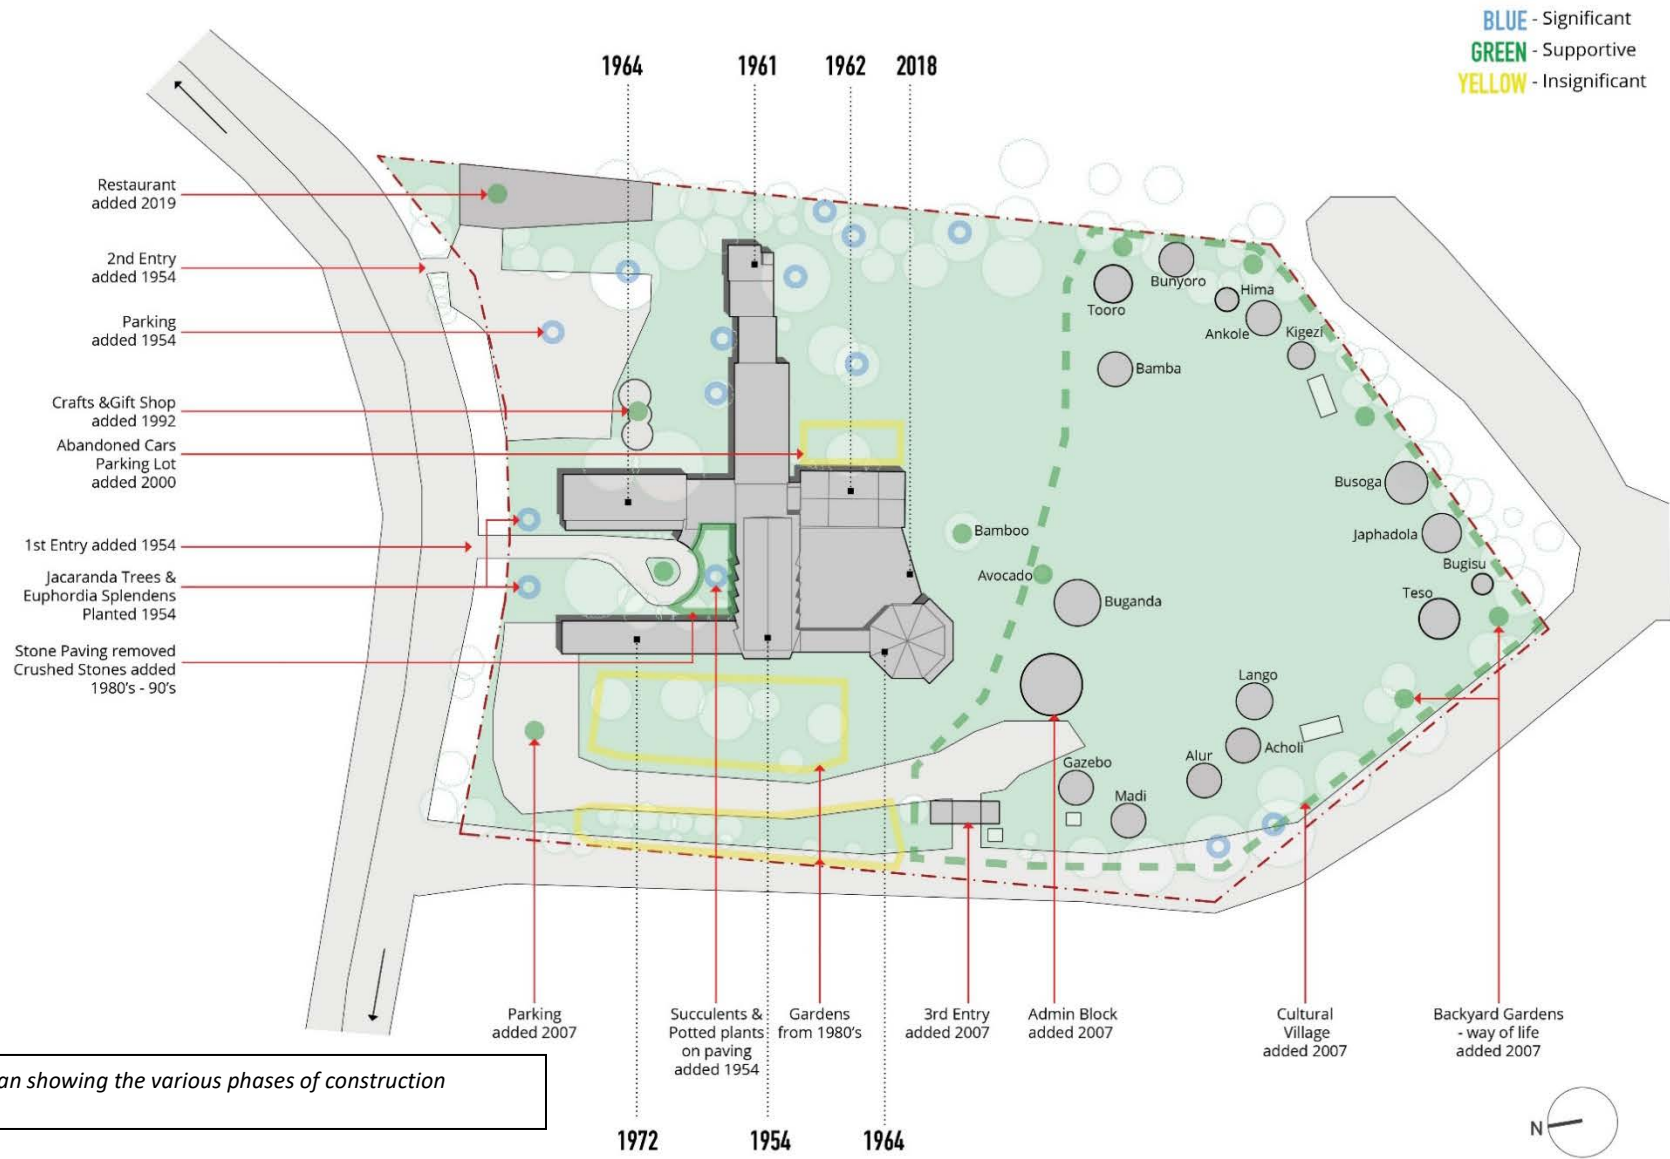
Figure 59 – Site plan showing the various phases of construction

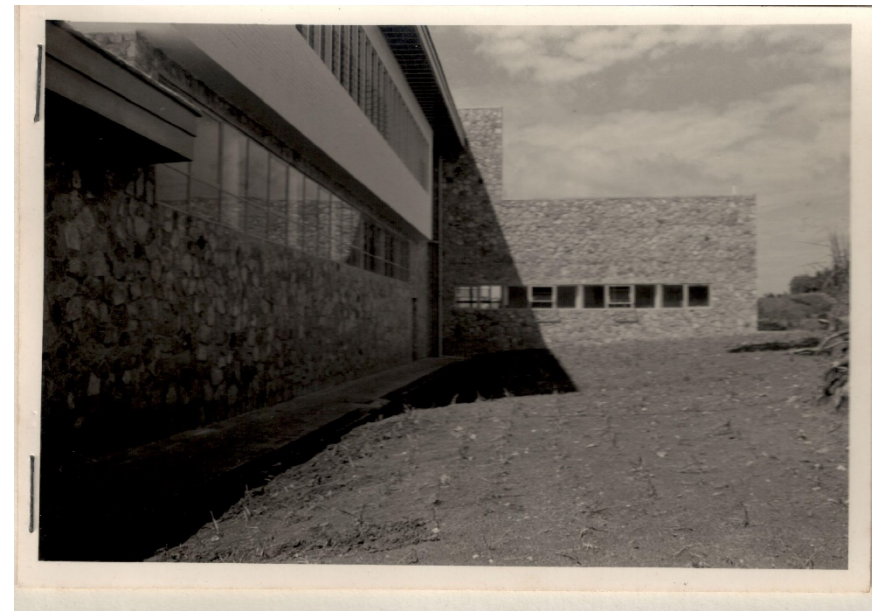
*Figure 63 – An image showing the northern elevation from the 1950 or 1960 before the northern extension (Uganda National Museum archive)*

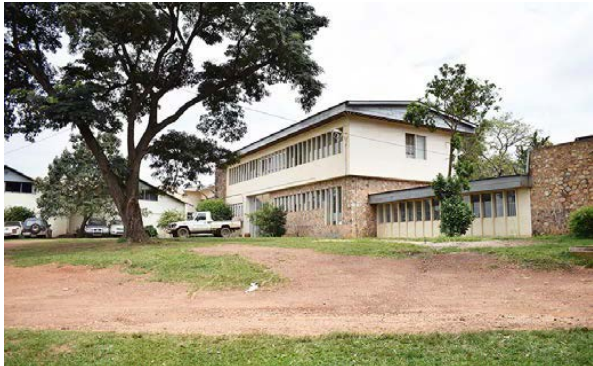
*Figure 64 – Soil erosion at the front of the museum by the stores*

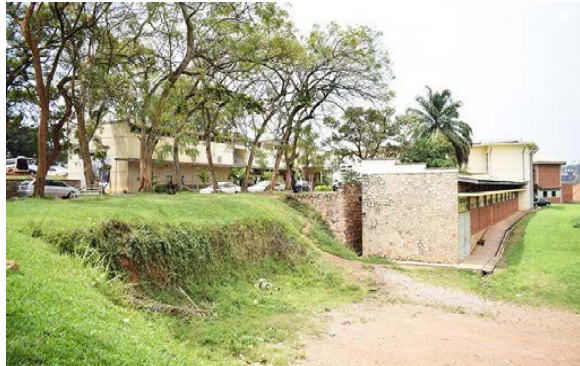
*Figure 65 – Erosion and vehicular damage at the rear of the museum*

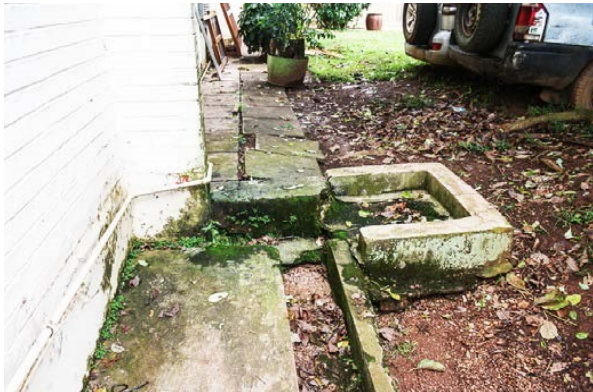
*Figure 66 – missing drainage covers and growth of mold*

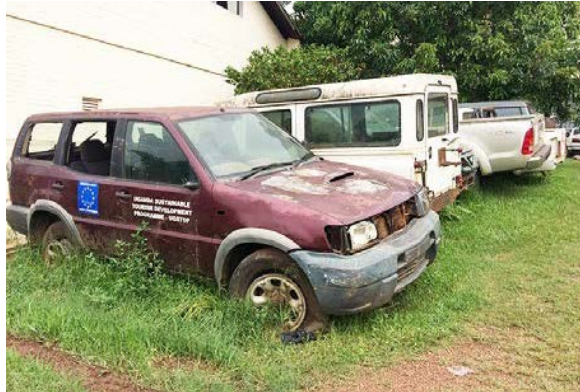
*Figure 67 – stored vehicles are unsightly*

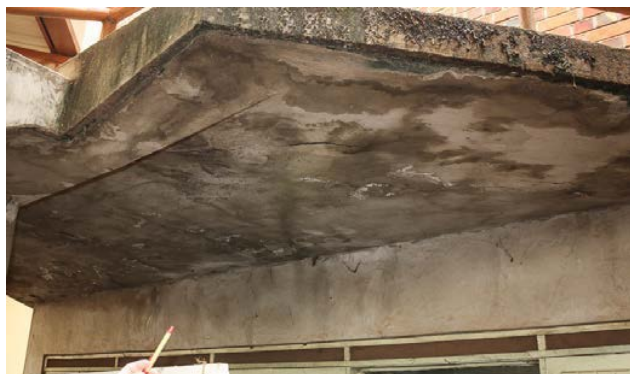
Figure 68 – Soil erosion at the front of the museum by the stores

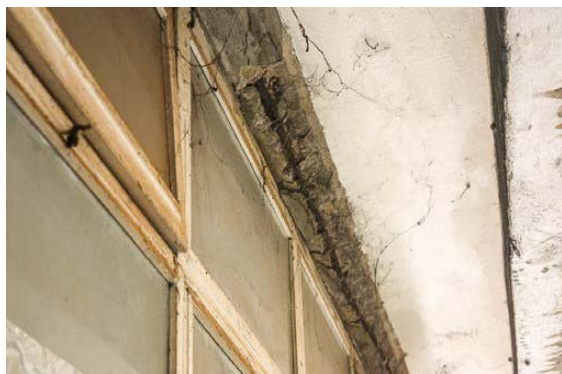
Figure 69 – Damage to concrete with the corrosion of steel reinforcing

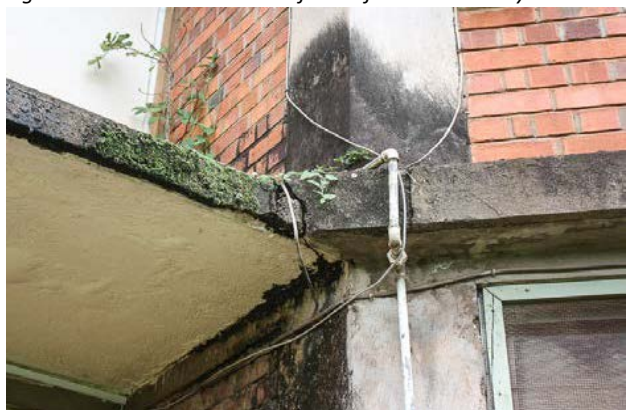
Figure 70 – Inadequate drainage has led to concrete saturation

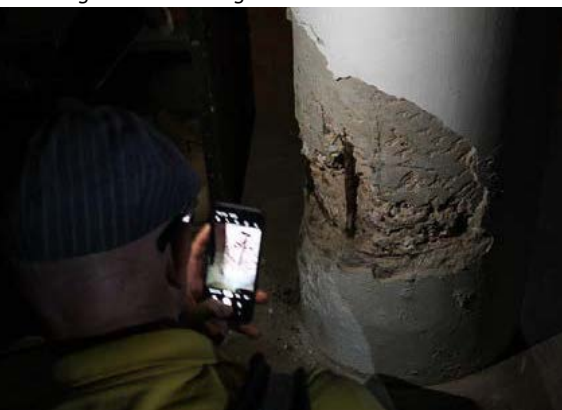
Figure 71 – Destructive concrete tests in the basement

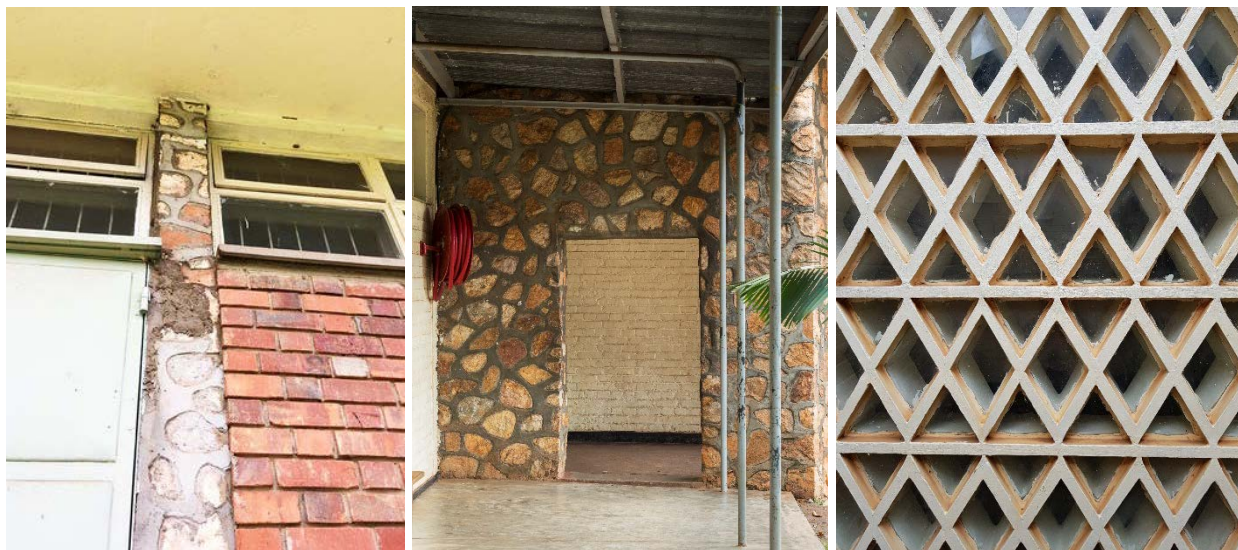
*Figure 72 –the masonry of the museum includes stone, fired brick, and concrete block*

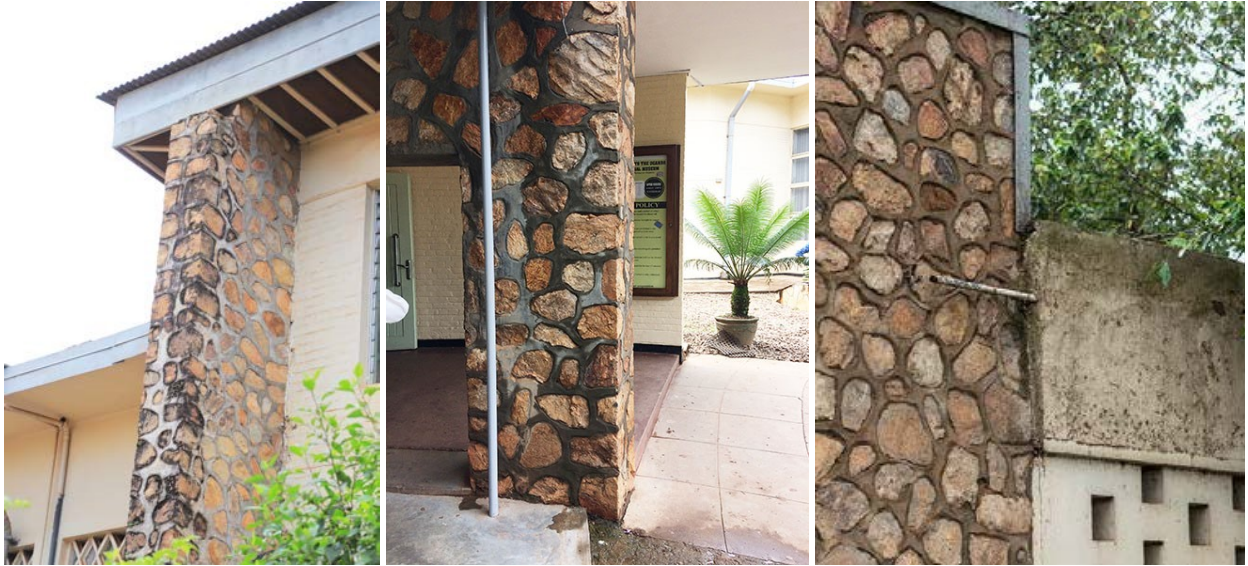
Figure 75 –a variety of issues with the masonry, including water damage, microbiological growth, inappropriate treatment, and poor flashing details

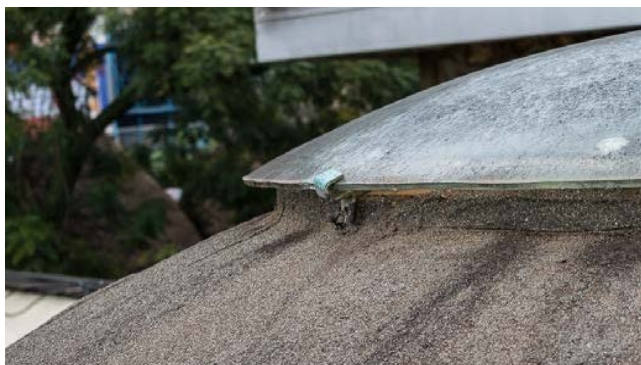
*Figure 76 –various metal clips have corroded and failed*

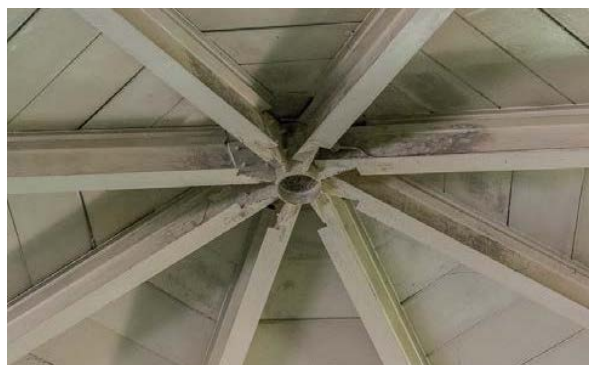
*Figure 77 –the metal structure of the South Pavilion is acceptable*

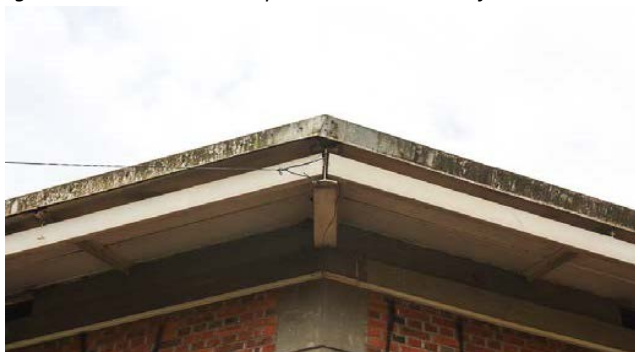
*Figure 78 –flashings, clips, and other elements are failing*

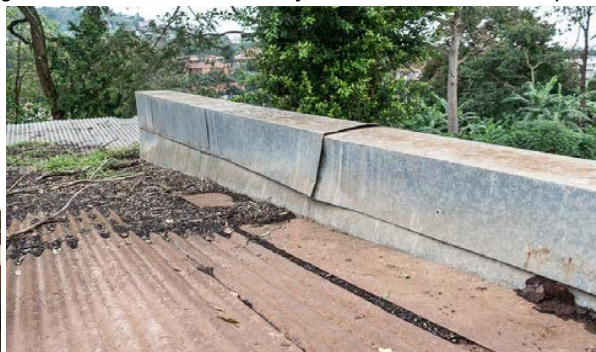
*Figure 79 - metal roofs and flashings are also failing*

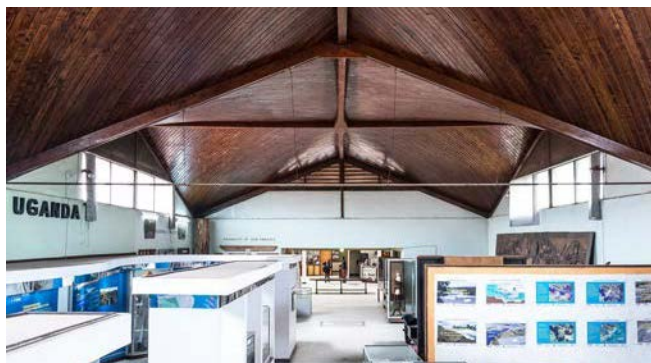
*Figure 80 –the wood structure of the Industrial Pavilion*

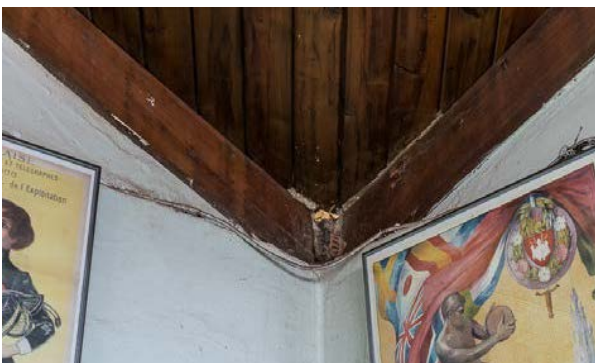
*Figure 81 – Insect infestation and water damage*

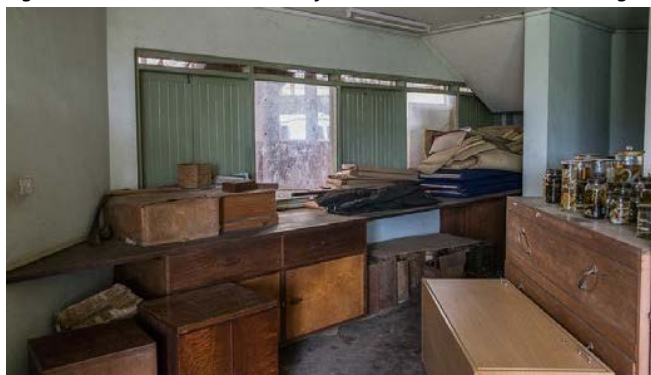
*Figure 82 –cabinets in non-public areas require maintenance*

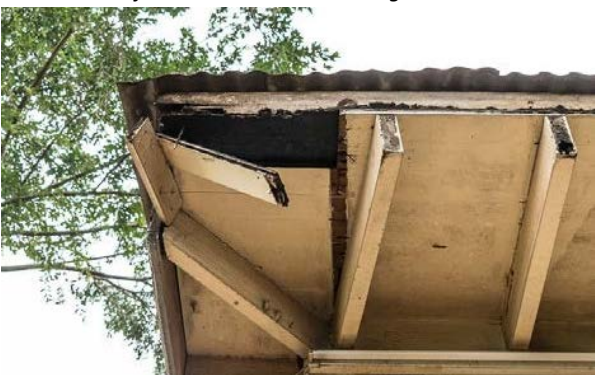
*Figure 83 –wooded soffit has failed near the Office Extension*

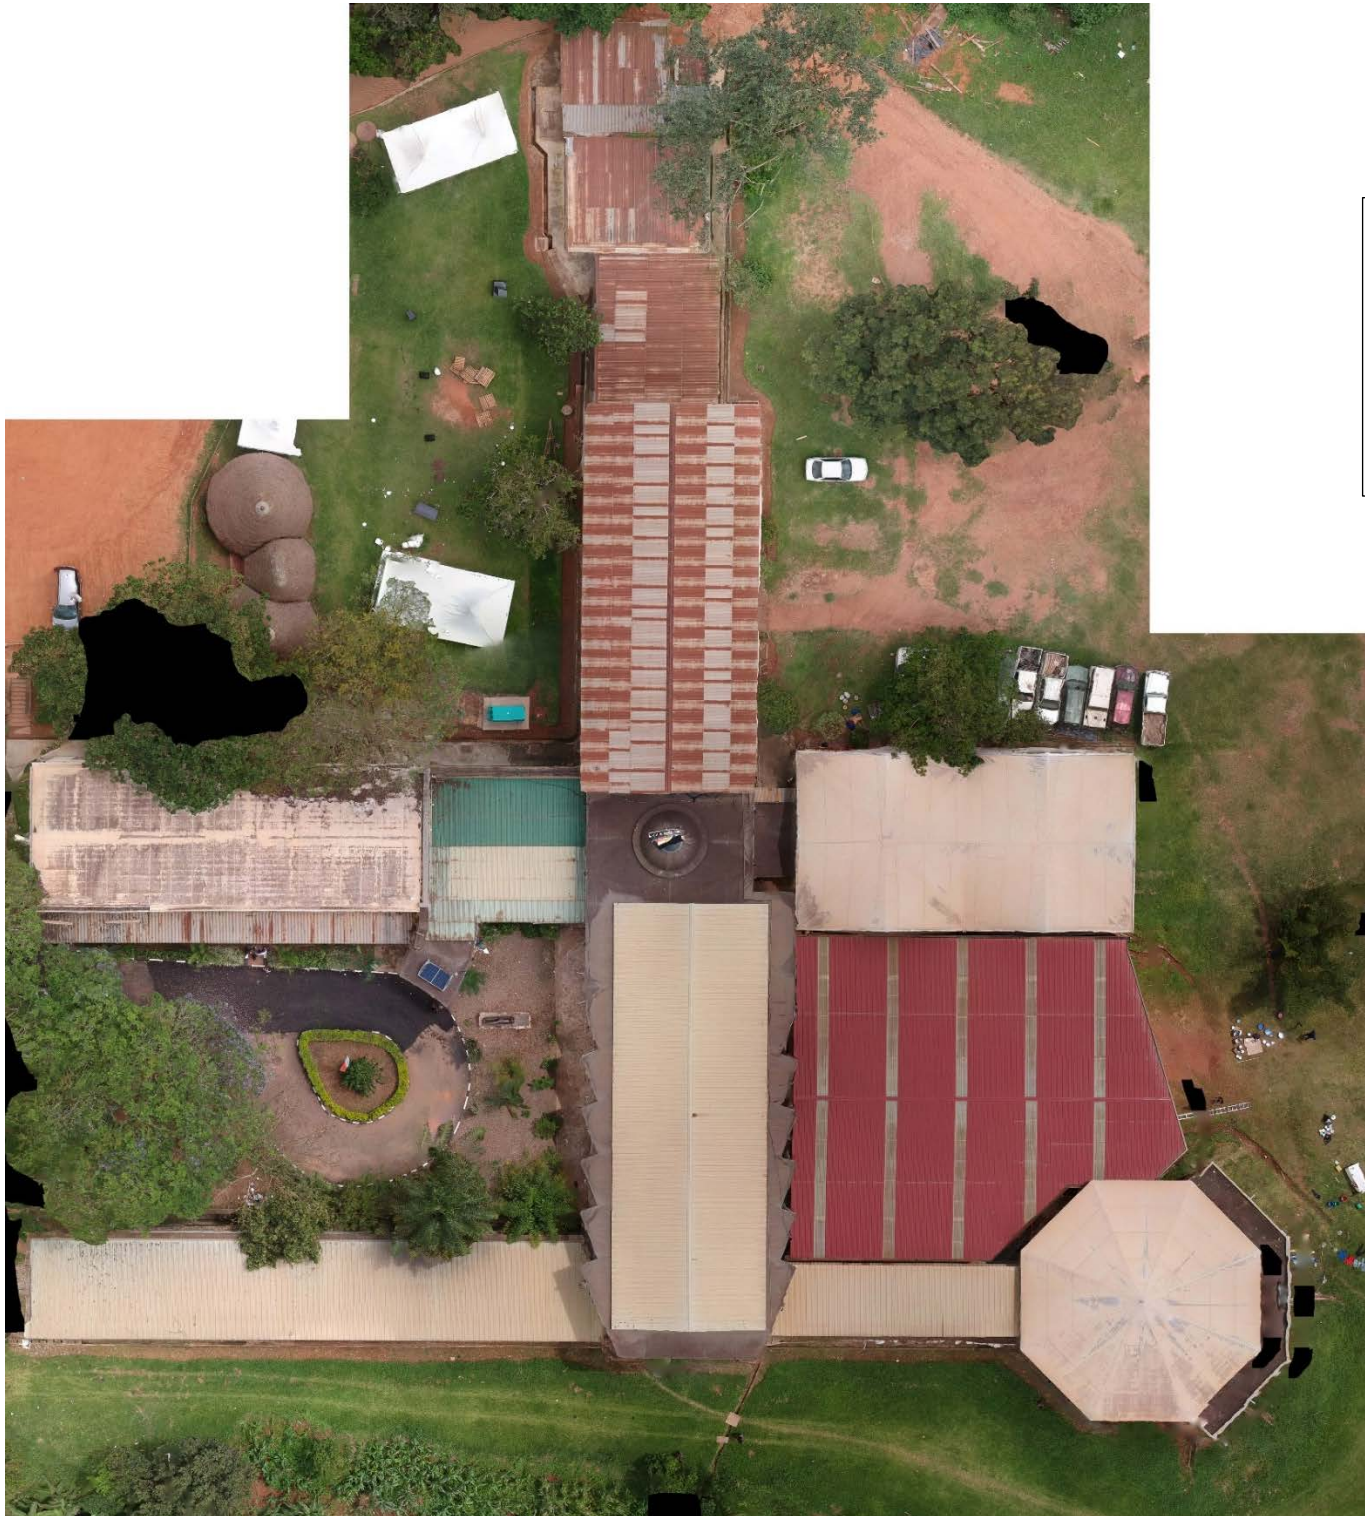
*Figure 84 – Orthophoto of the roof of the museum demonstrates the numerous challenges that exist given the various extensions, materials, and levels.*

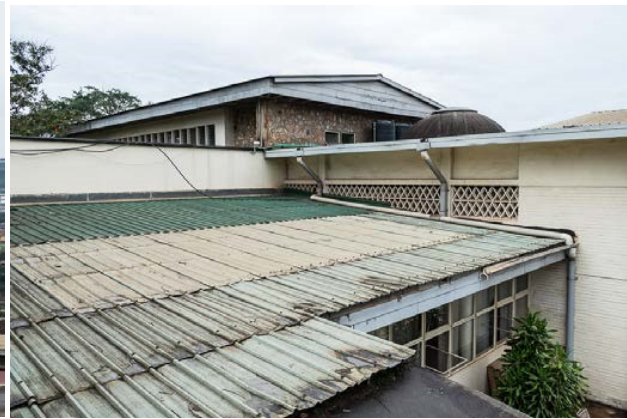
*Figure 88 –The ad hoc repairs over the oldest part of the building at the entry*

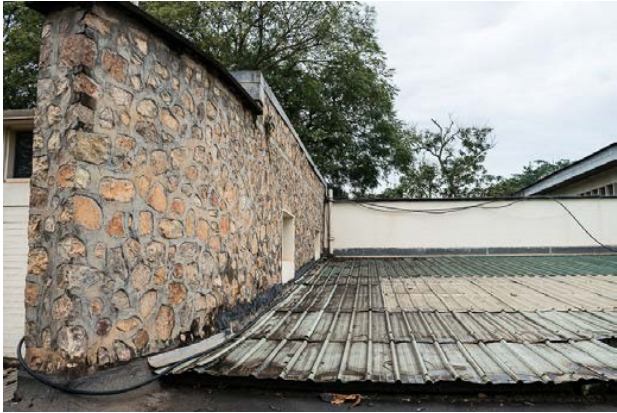
Figure 89 –the failure of flashings between building components

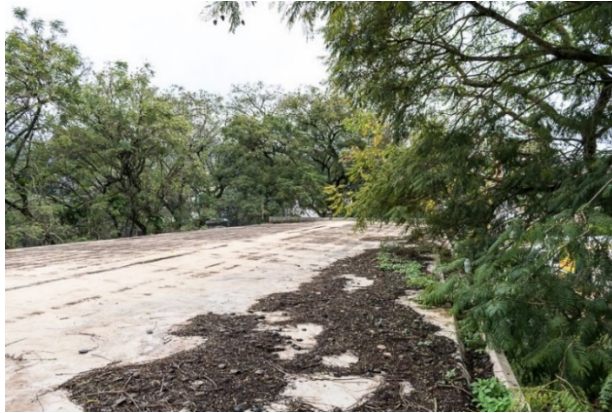
Figure 90 –trees and lack of maintenance contribute to roof failure

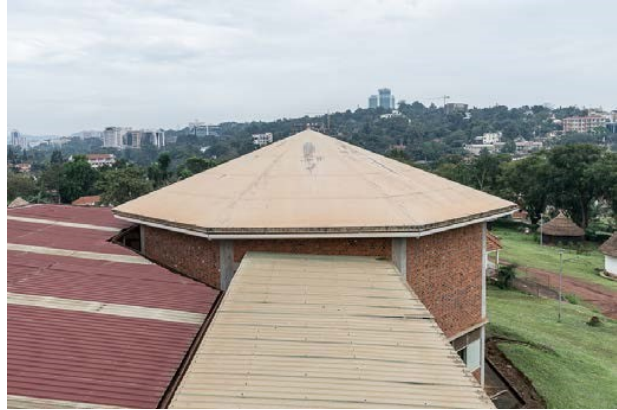
Figure 91 –the sloped metal roof connecting the Natural History
