A MODERN MASTERPIECE IN UGANDA

UGANDA NATIONAL MUSEUM  
CONSERVATION MANAGEMENT PLAN

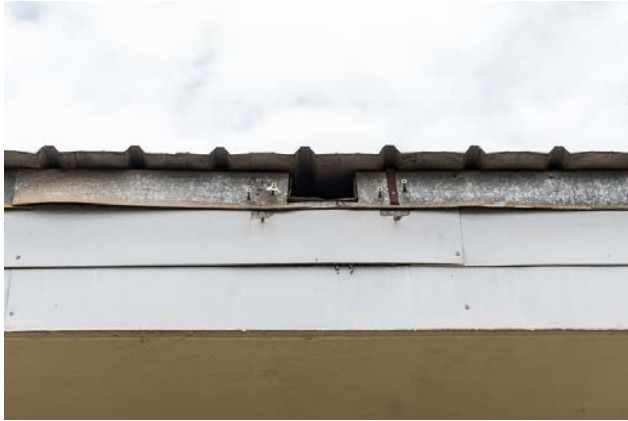
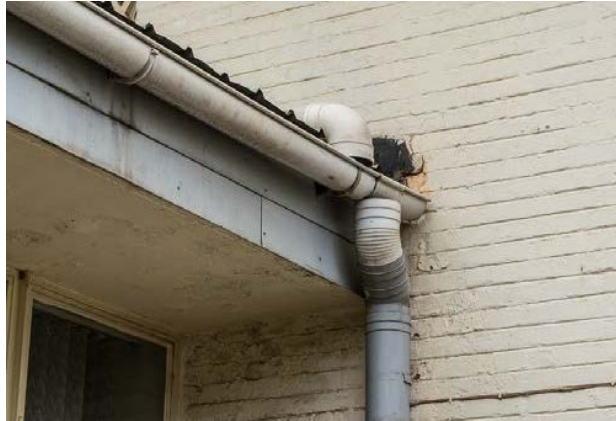
*Figure 93 and Figure 94 –various issues with the drainage system, flashings, ad hoc repairs, lack of maintenance*

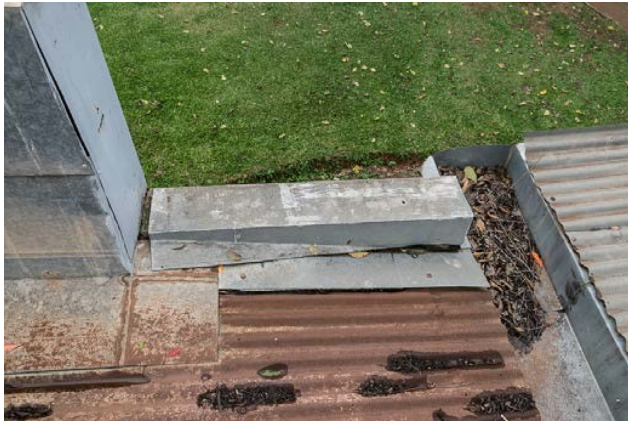
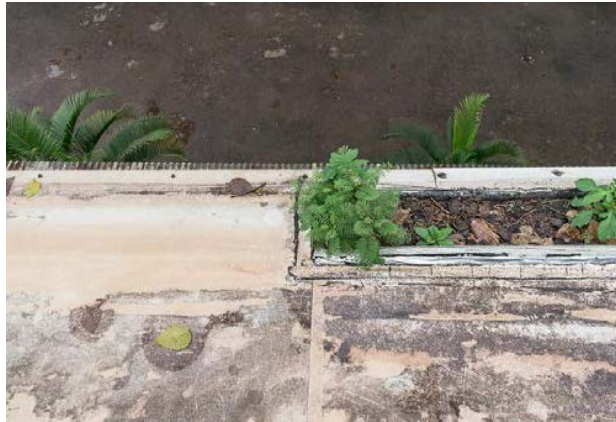
*Figure 95 and Figure 96 –various issues with the drainage system, flashings, ad hoc repairs, lack of maintenance*

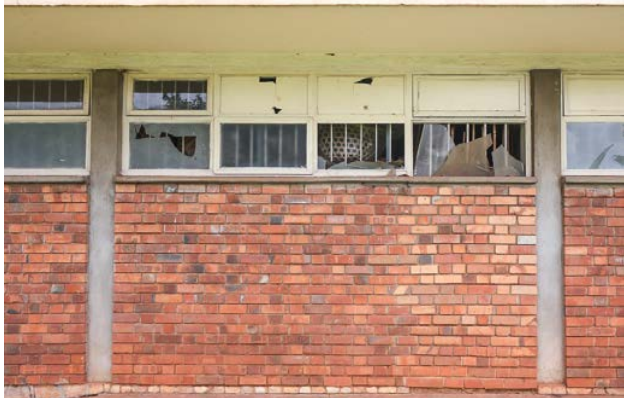
Figure 97 – Broken glass in the store area

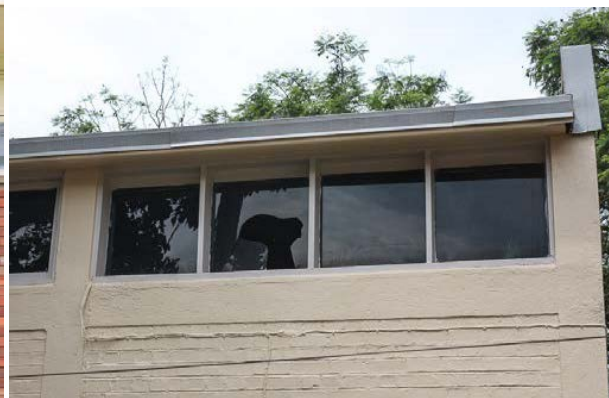
Figure 98 additional broken glass in the north wing

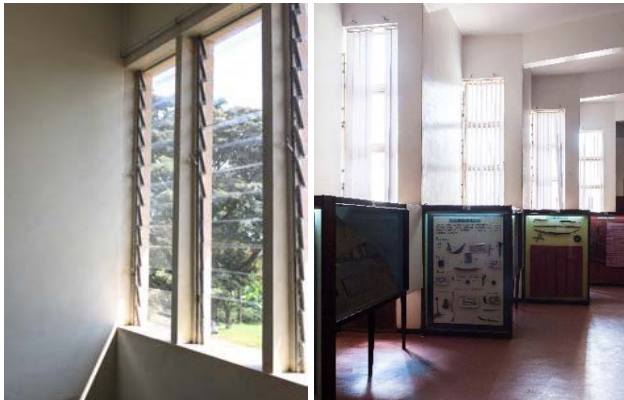
Figure 99 left, jalouse windows inoperable, right casement window require maintenance

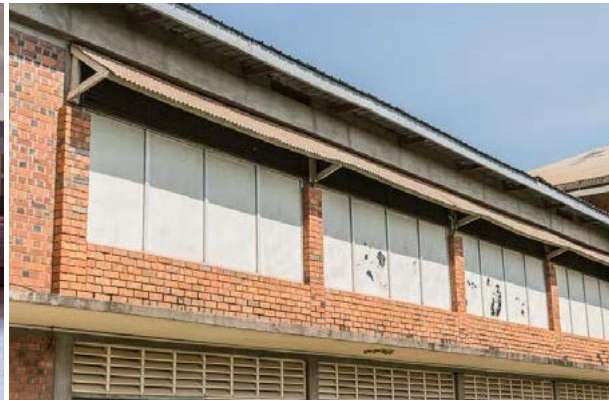
Figure 100 – glass covered to prevent light, west connection

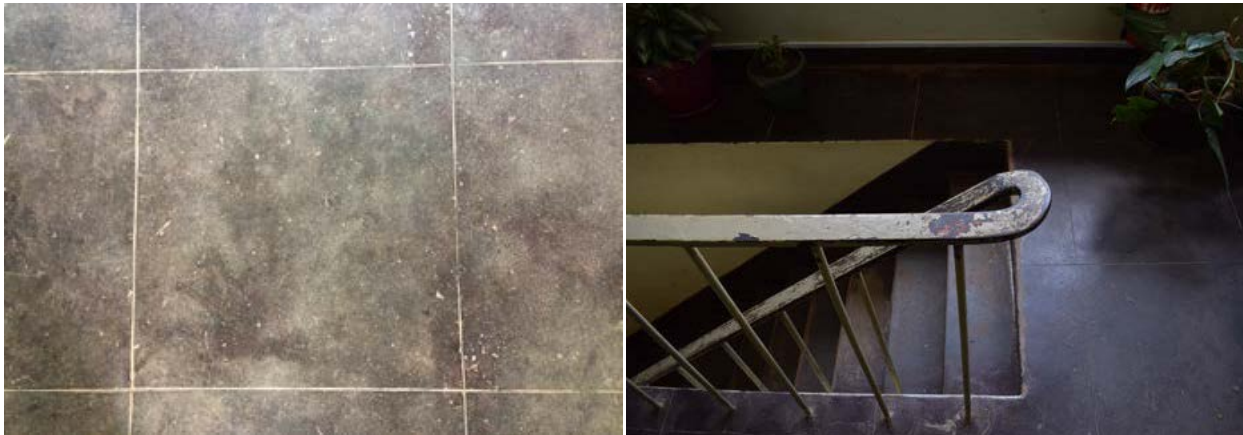
*Figure 101 left, the original concrete scored floor, Figure 102 right, the elegant cast concrete steps without adornment*

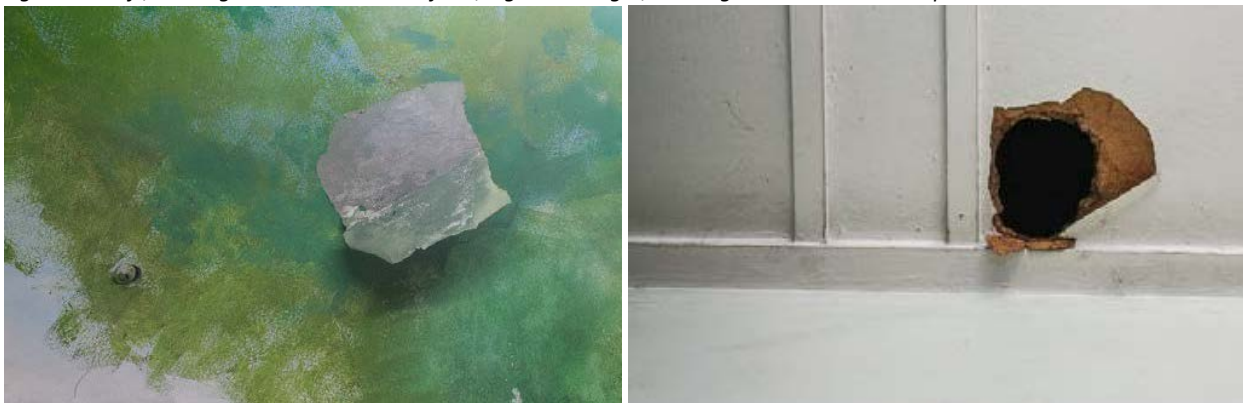
*Figure 103 left, peeling paint at the mural in the Natural History Gallery Figure 104 left, holes in ceiling boards in the office*

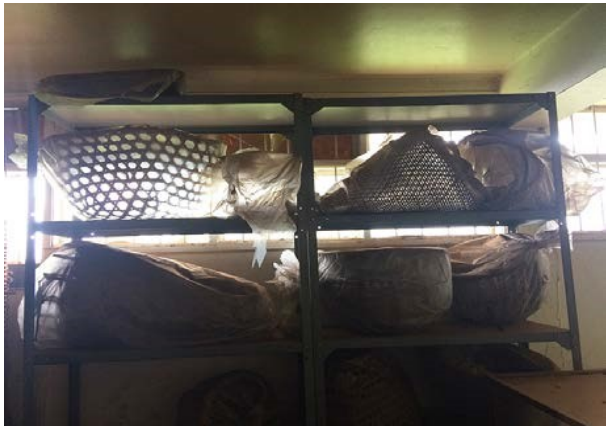
Figure 105 –shelves in the museum storage facilities various

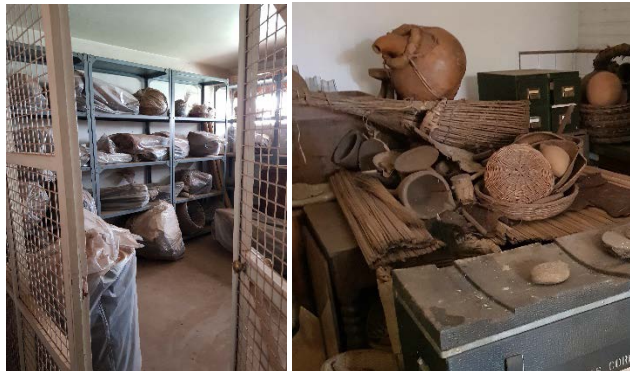
Figure 108 – The museum requires a renewed conservation laboratory

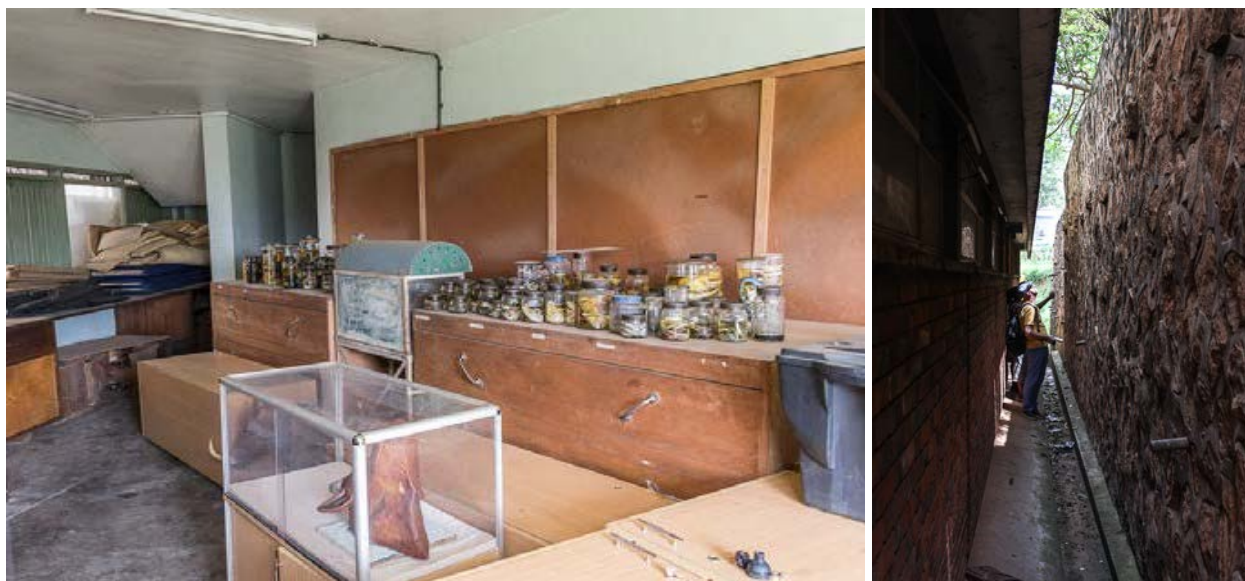
*Figure 109 – The museum requires a renewed conservation laboratory Figure 110 –small hidden space between the retaining wall stores is a security risk*

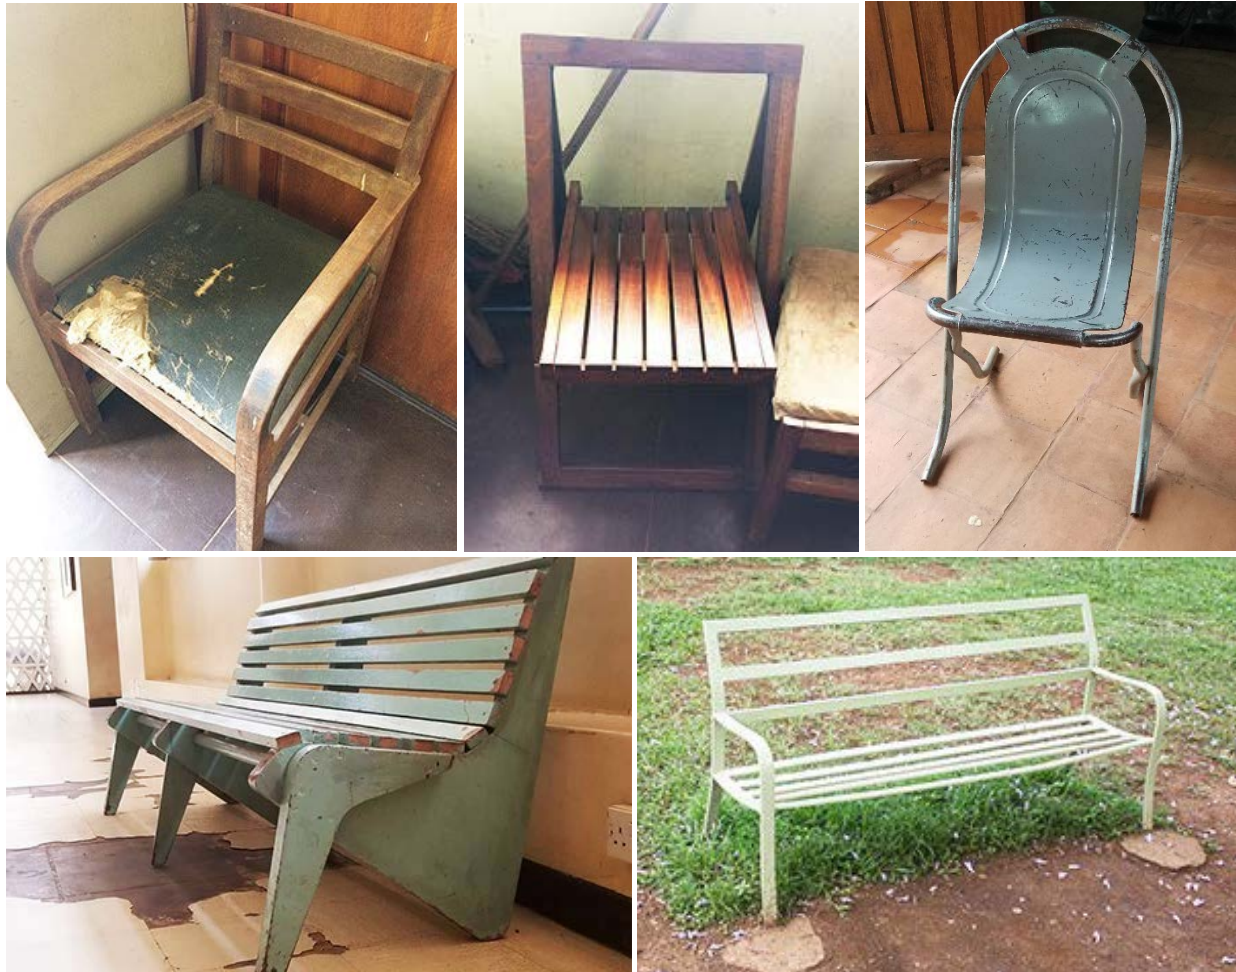
*Figure 111 – from upper left clockwise, original armchair, folding wooden chair, metal office chair, public wood bench, garden bench*

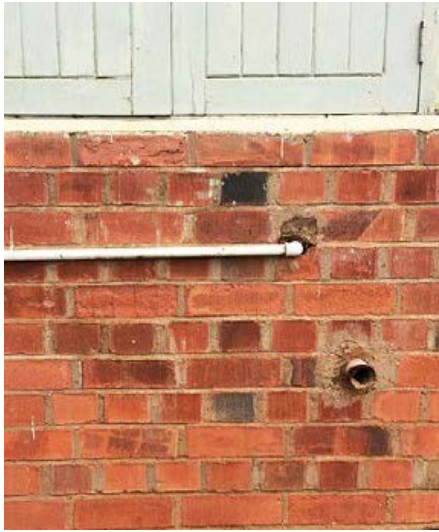
Figure 118 –ad hoc plumbing repairs

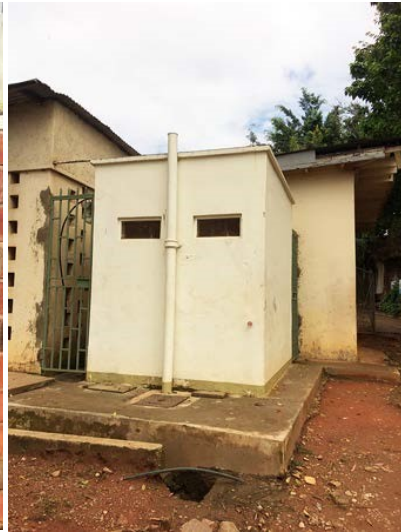
Figure 119 –exterior toilets

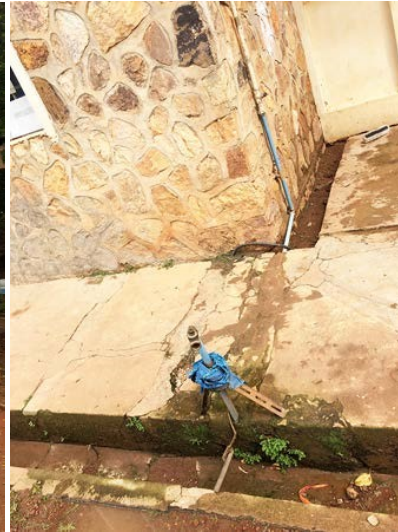
Figure 120 –leaking exterior plumbing

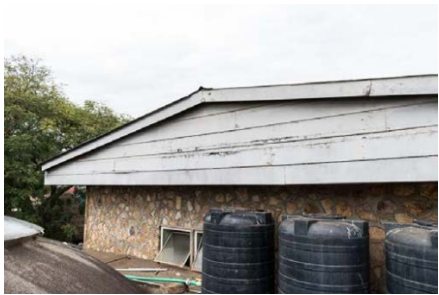
Figure 121 – Plastic water tanks on roof

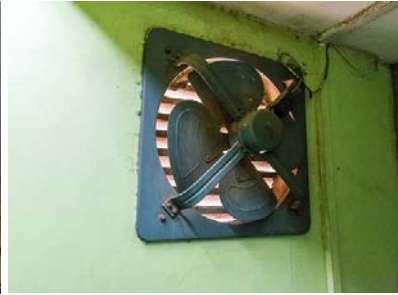
Figure 123 – ventilation fans inoperable

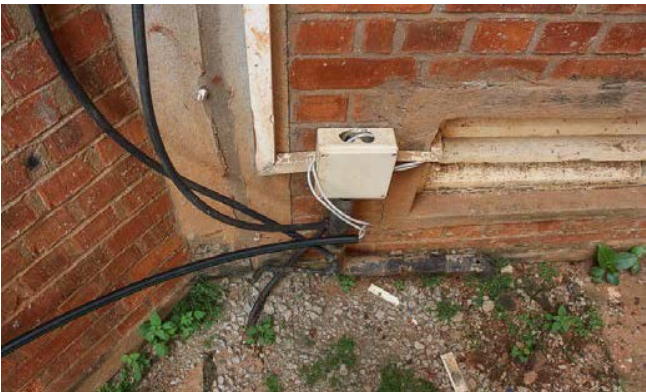
*Figure 124 – Exposed electrical at the building exterior*

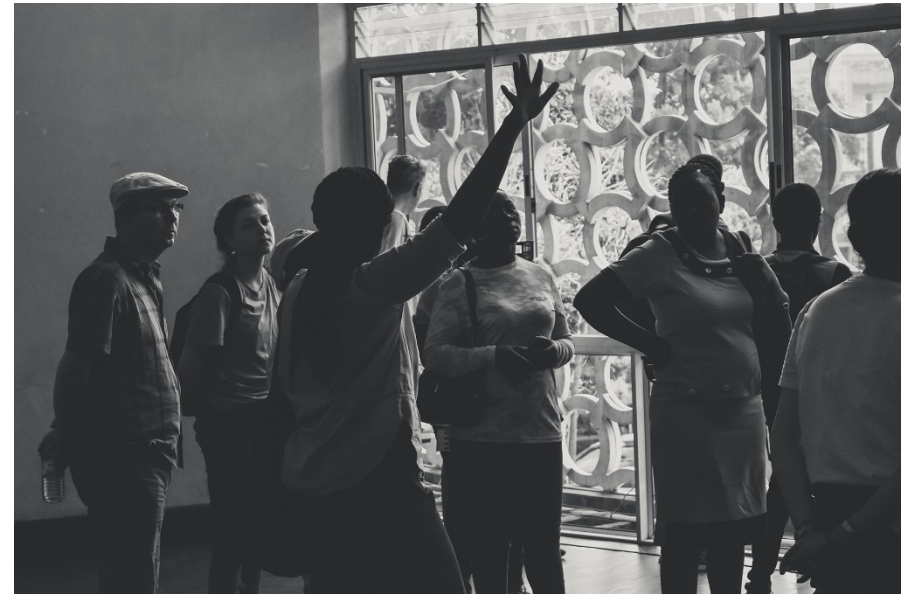
*Figure 129 – The International included a two-day walking tour of the most important modern buildings in Kampala (Adengo Architecture, 2020)*

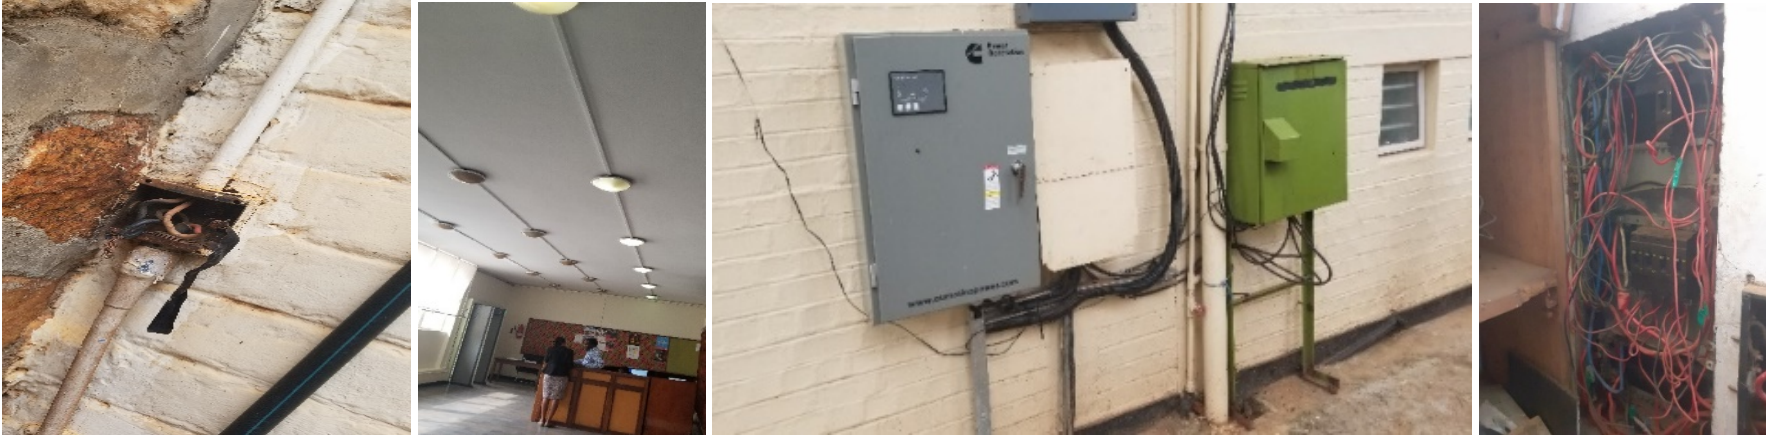
*Figure 130 – Exposed socket outlets, Figure 131 – Faulty lighting fittings, Figure 132 – Unsheltered switch gear Figure 133, Exposed connections in the consumer units*

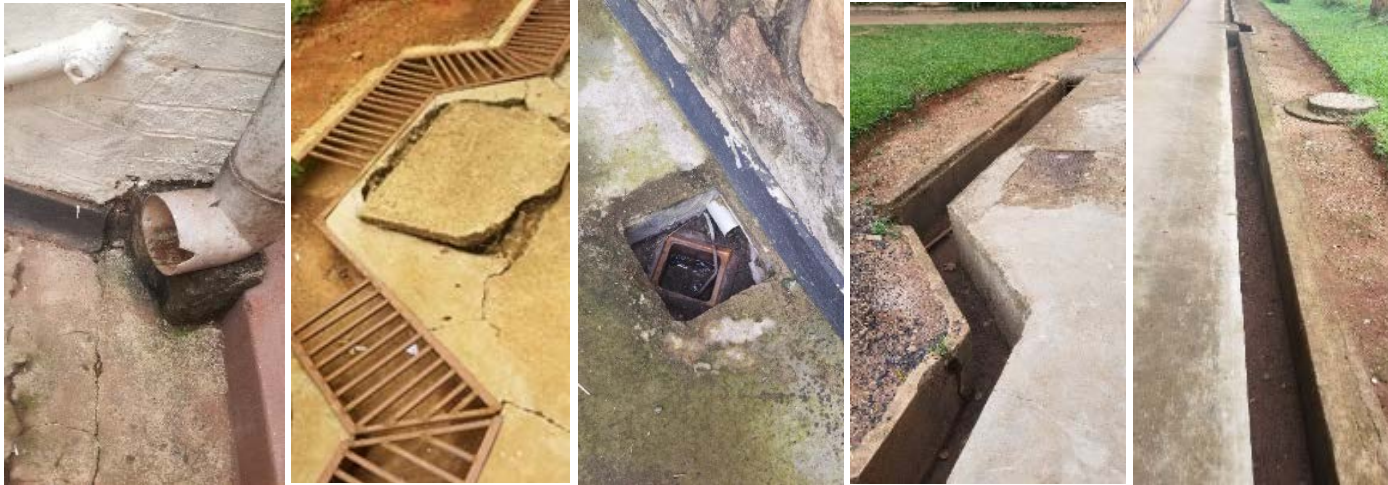
*Figure 134 – Leaking drainage pipes, Figure 135 – Incomplete pipe network, Figure 136 defective covers Figure 137, Open drainage channels*

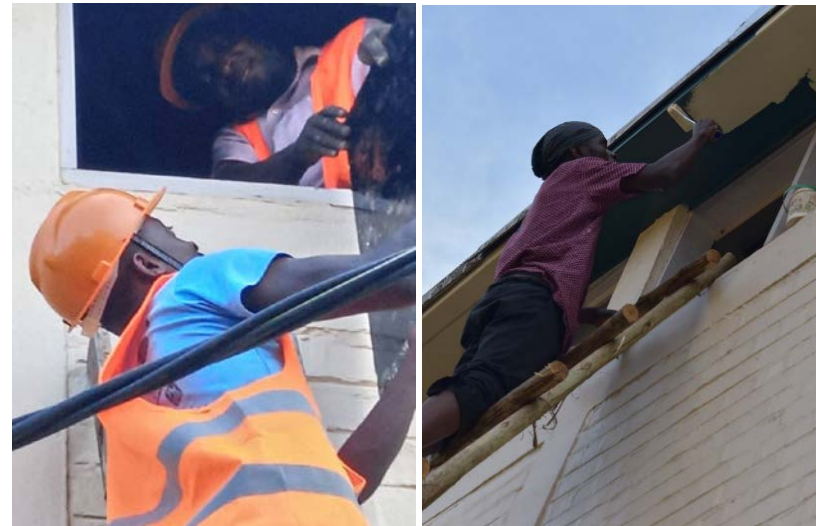
Figure 138 – left, repair of broken glass at the museum store roof, Right, painting of the eave of the Education Hall with the approved paint color (Denis, 2021)

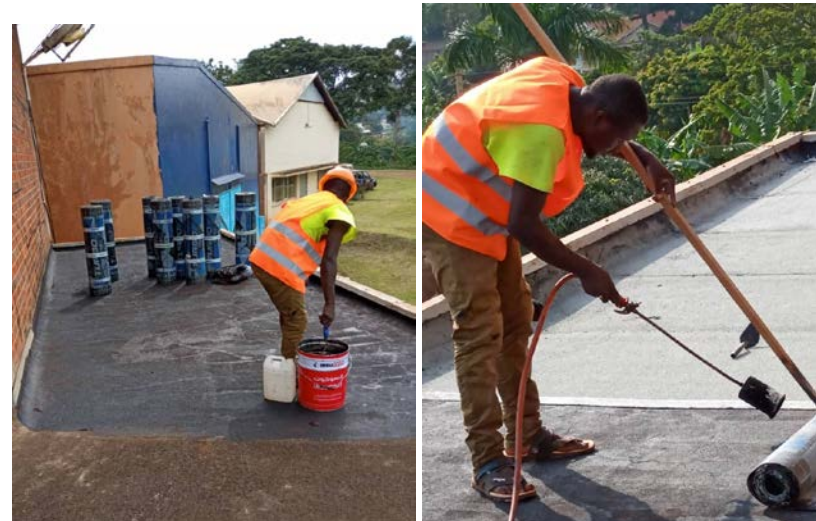
Figure 139 – Left and right roof repairs at the library wing and over the diorama (Denis, 2021)

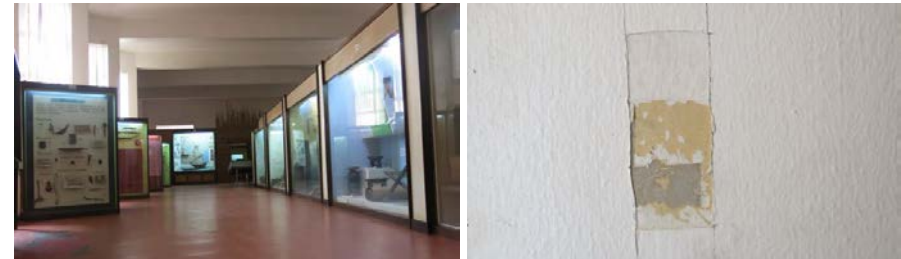
Figure 140 – Ethnography Gallery paint analysis

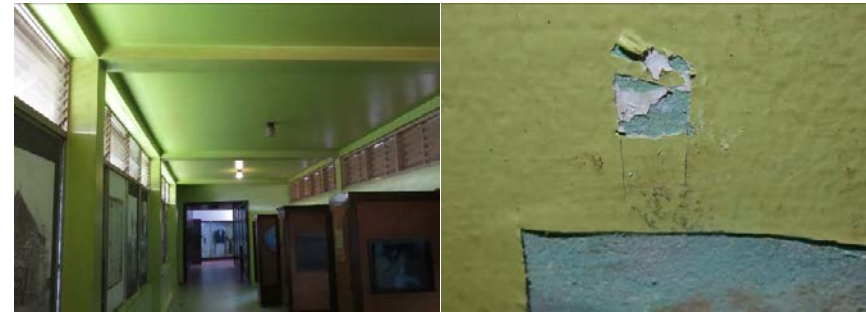
*Figure 141 – Natural History Gallery and its original color on the right revealed after removing outer surface layers.*

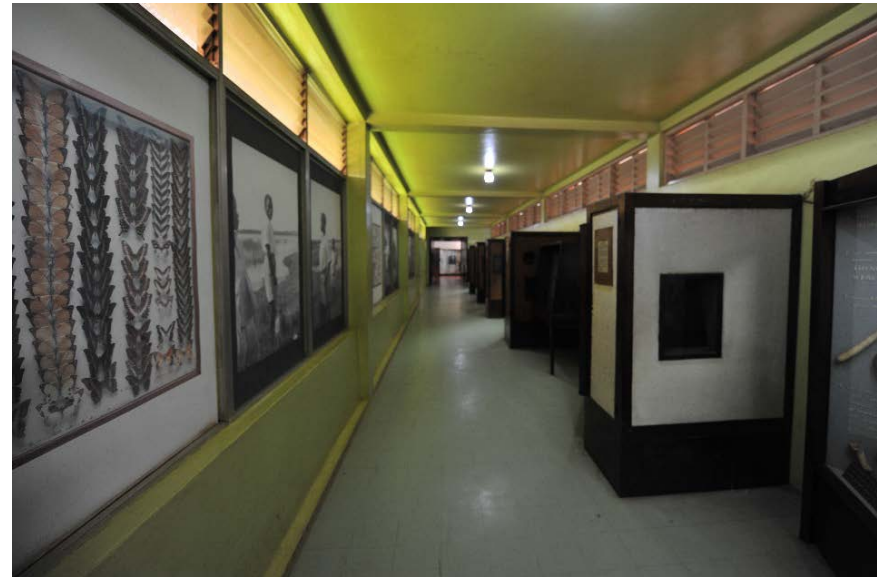
*Figure 142 – the colorful corridor connecting the rear gallery. While useful as an exhibition and transition space, in the afternoons it becomes an oven due to its thin wall construction and western orientation (Eppich, 2019)*

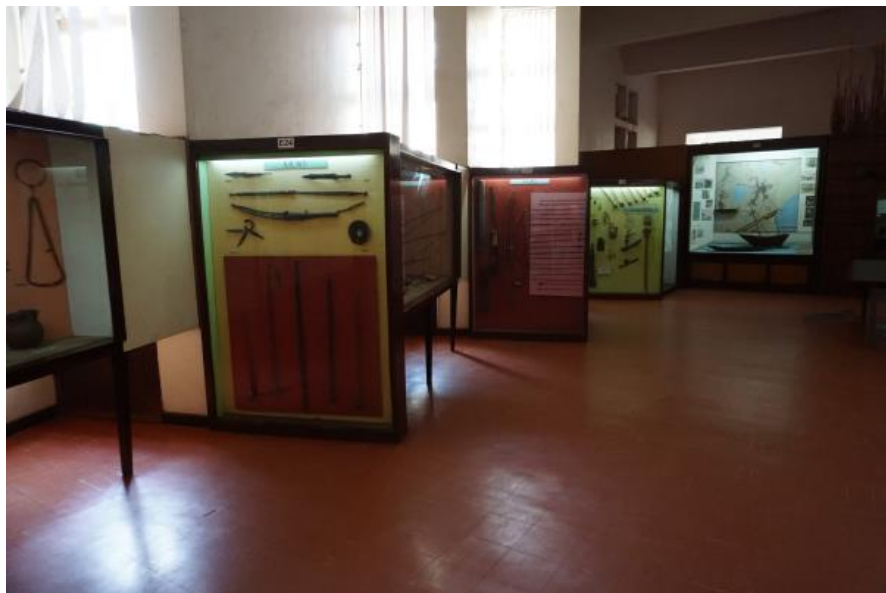
Figure 143 – the collection is overwhelmingly made up of fragile organic objects.

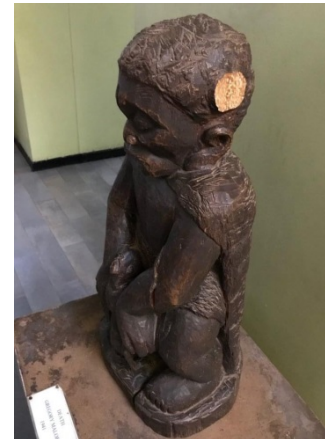
Figure 145 – During installation of a temporary exhibition the Walumbe statue was bumped into and fell off its pedestal. Both horns broke off.

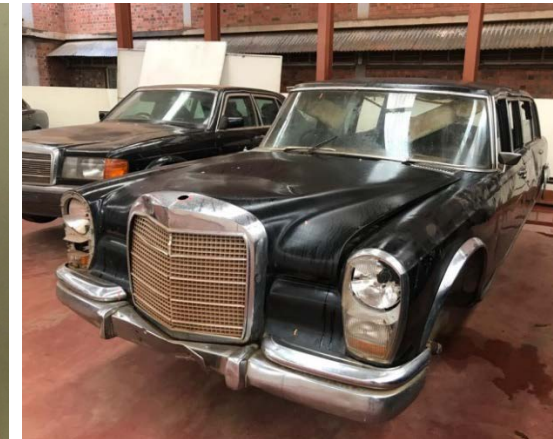
Figure 146 – During a maintenance activity one of the front lights of Iddi Amin's Mercedes Benz in the transport gallery broke.

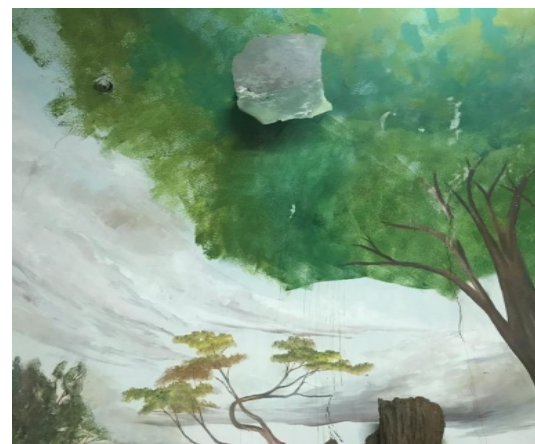
Figure 148 – Cover Cracked and stained ceilings in the diorama section at the Museum. Evident also is the delamination of paint layers.

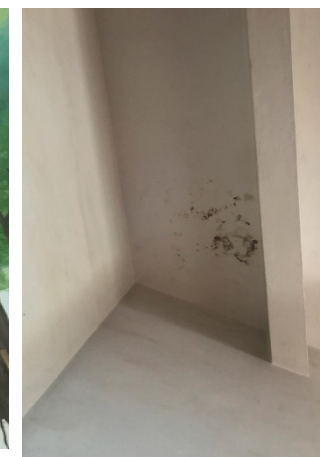
Figure 149 – Stained ceiling in the ethnography section due to leaking roof

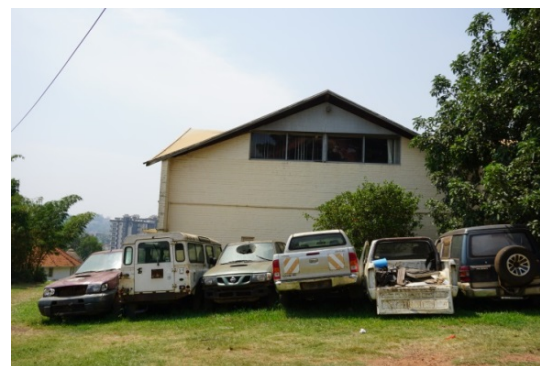
Figure 150 – The old unused vehicles placed near the building façade will increase the risk of fire arson

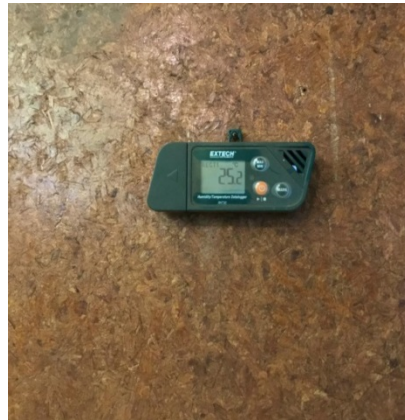
Figure 153 – During a measuring campaign, an RH/T-Data logger was stolen. Although this is not the collection, it shows that visitors might take anything within reach.

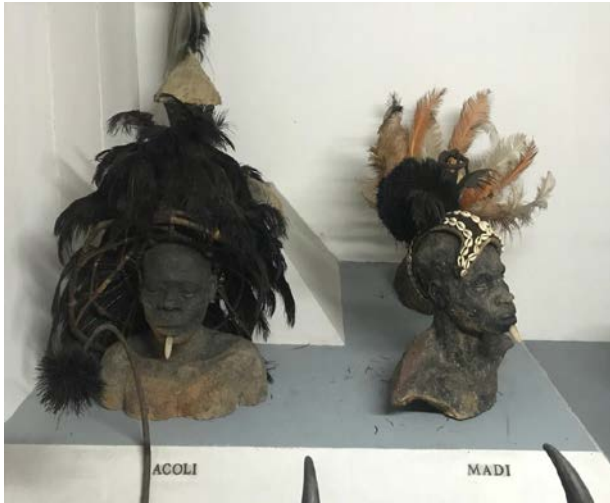
Figure 154 – Falling off of feathers and peeling off of skin from artifacts by carpet beetle larvae in the headgear showcase.

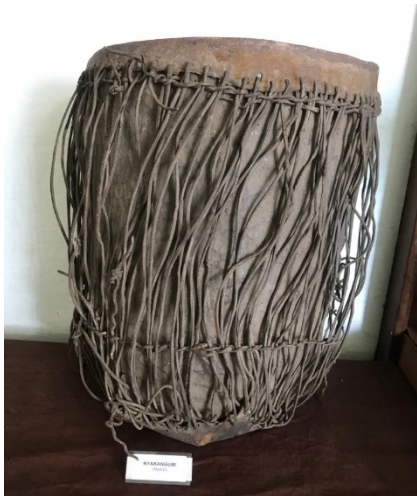
Figure 155 – Nyakangubi (Nyoro) drum affected by wood borers.

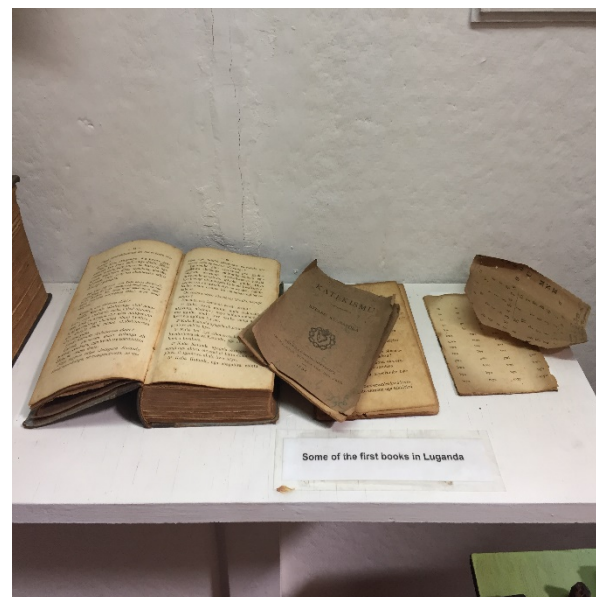
Figure 157 – Browning of paper due to prolonged exposure to ultraviolet radiation.

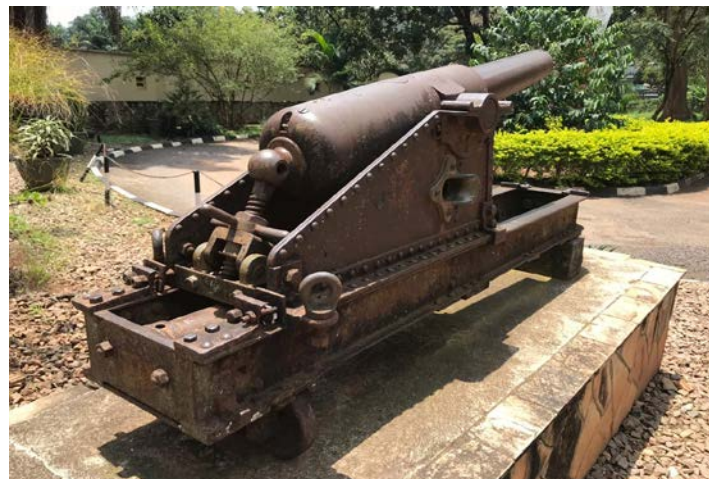
Figure 158 –Damage caused by external contamination on the WWI French Canon.

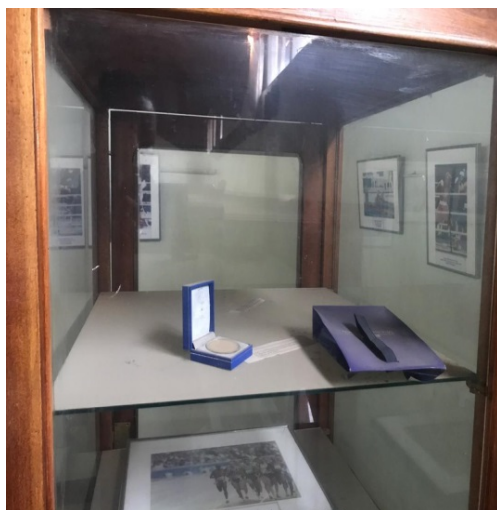
Figure 159 –Poorly fitted showcase affected by dust.

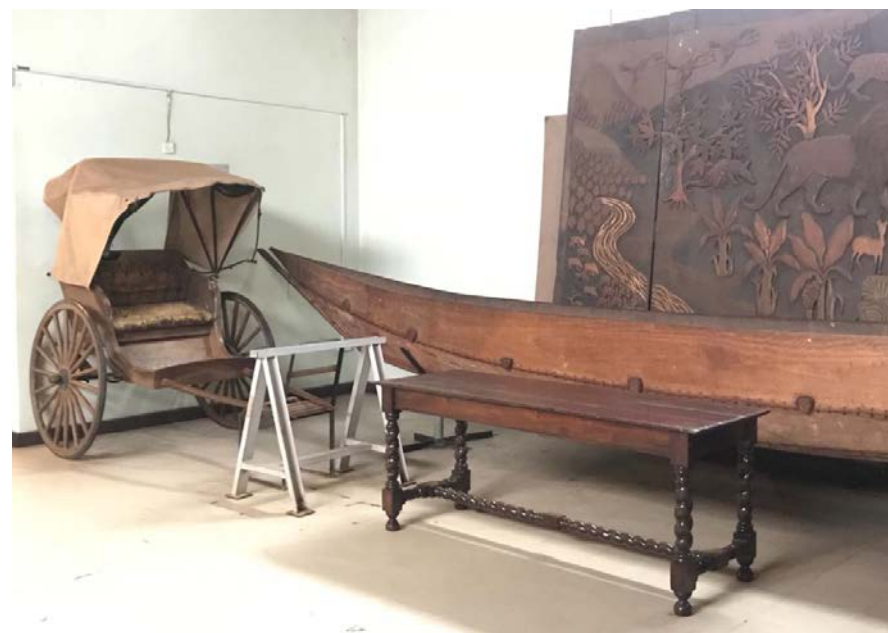
Figure 160 – A collection of artifacts with no labels or information in the science and industry section. Little is known about provenance, use, history, maker, etc.

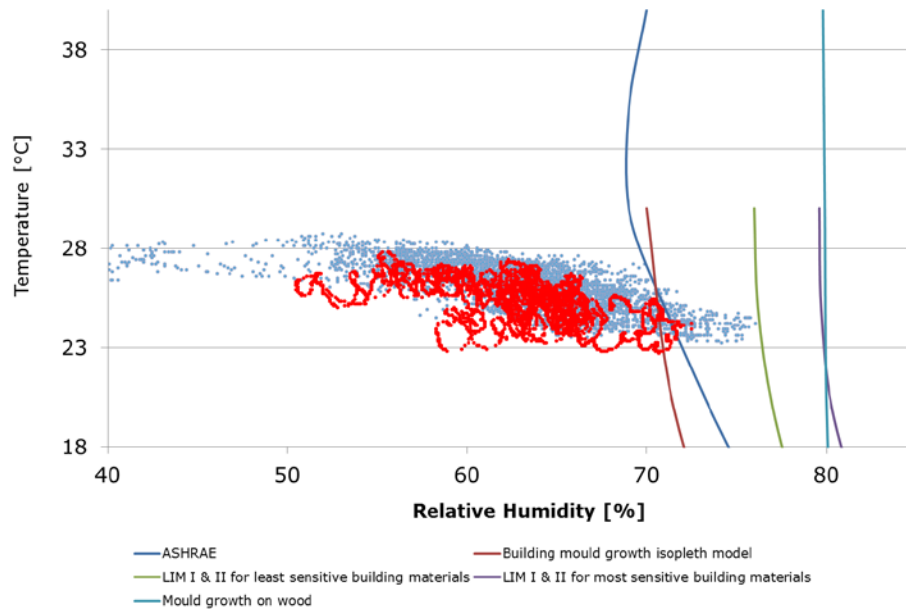
It can be readily seen that the climate in the gallery, see the blue dots in the figure, crosses the lines of known mold growth. The climate in the display case is slightly drier and only briefly enters the zone of biological decay. The risk of mold in the gallery and display case should be considered significant. Steps should be taken to prevent extensive mold growth, e.g., by regular inspection of organic objects.

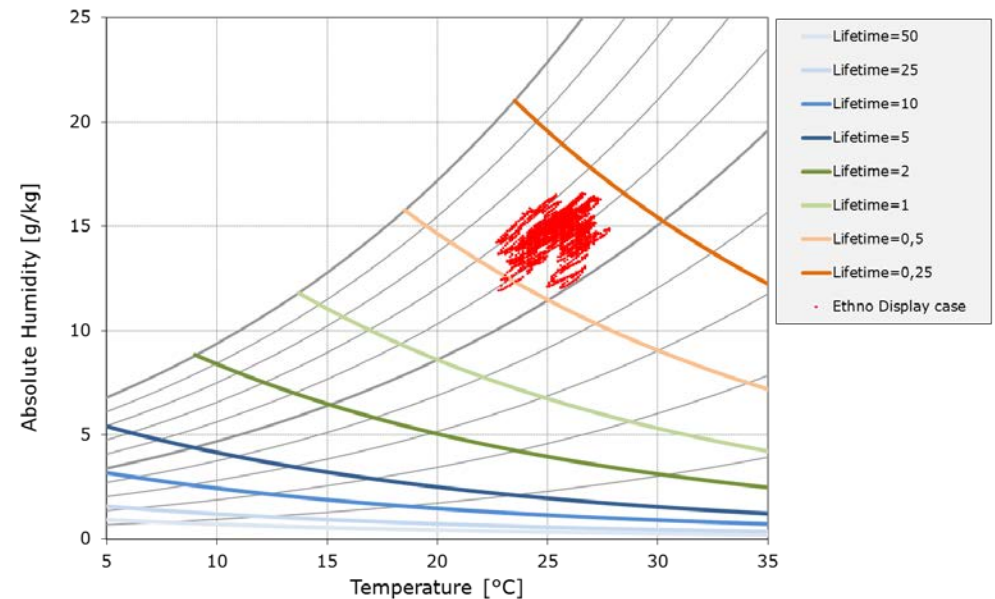
The climate in the display case in the ethnographic gallery is warmer and more humid than the classic museum environment (50%/20° C); this results in a higher rate of chemical decay for chemically unstable materials.

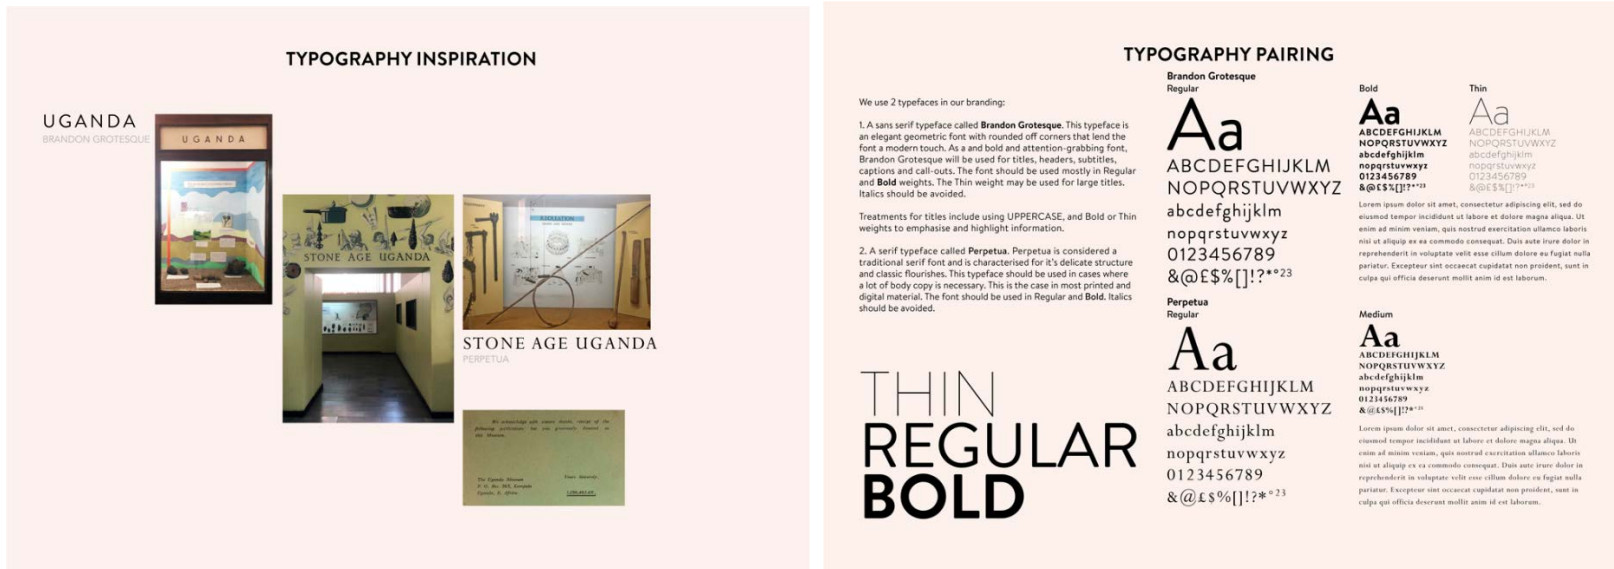
Figure 163 –Typography Inspiration and pairing

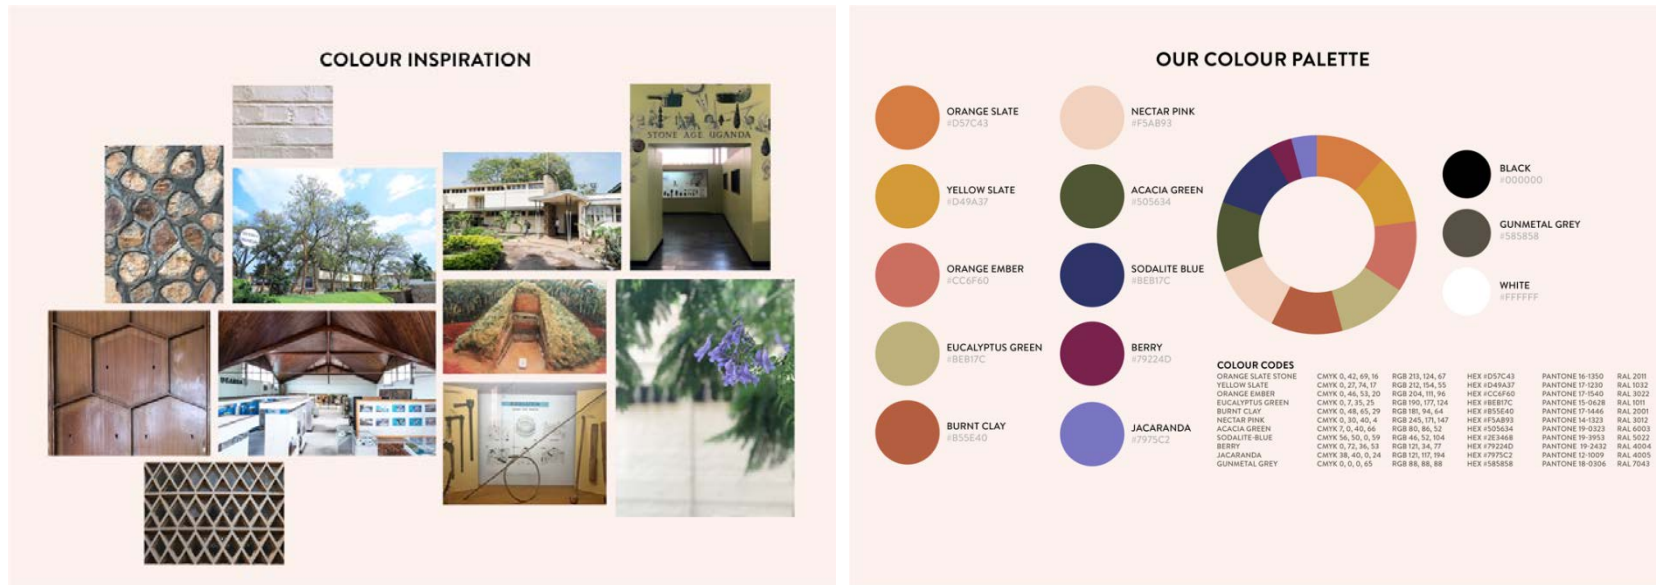
Figure 164 –Color palette

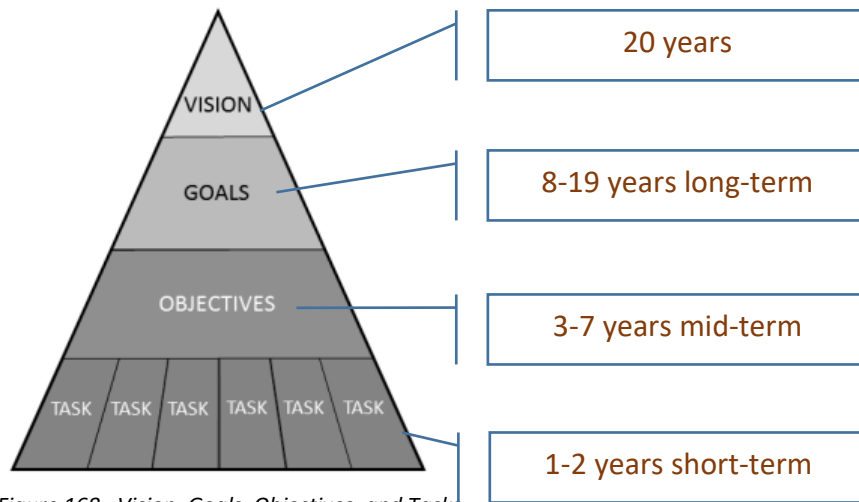
Figure 168 –Vision, Goals, Objectives, and Tasks

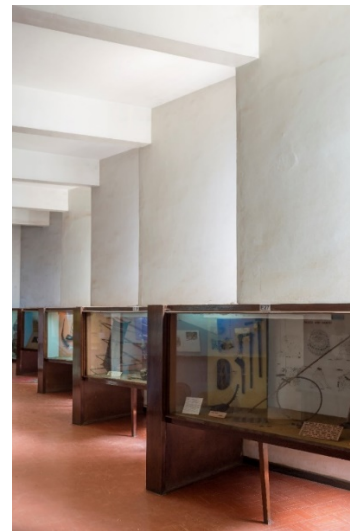
Figure 170 –Physical interventions will conserve this special place (Proctor, 2018)
