UNITY TEMPLE -- FINAL OUTCOMES REPORT

Project Location:	Oak Park, Illinois
Work Completed:	Restoration Master Plan, testing for new geothermal heating system, art glass window study, south roof repairs. Full \$25 restoration project including complete exterior, interior and all building systems.
Date Completed:	Master Plan: 2006; South Roof Repairs: 2010; Million Restoration project: 2015-2017.
Client:	Unity Temple Restoration Foundation
Client Contact:	Mr. Brad White Associate Director Alphawood Foundation PO Box 146340

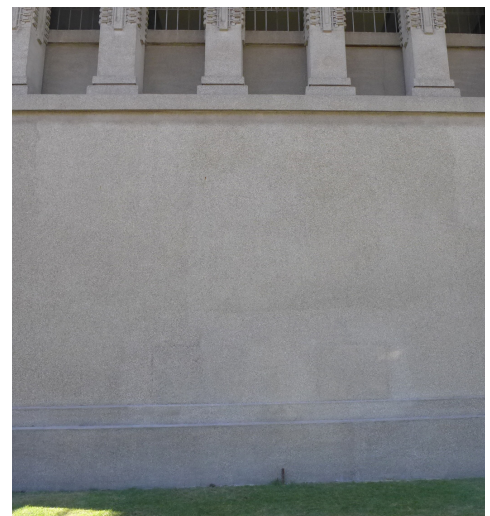
Figure 4. Halos around repaired shotcrete were resolved with modification in the facade cleaning treatment. (Harboe Architects)

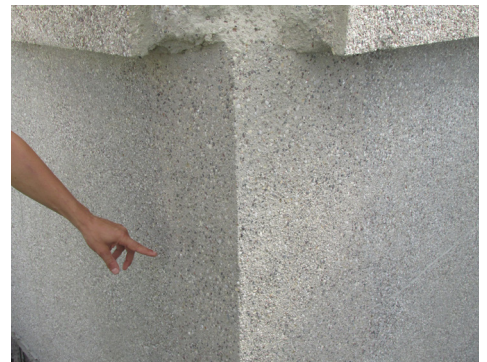
Figure 6. *Shotcrete at corner with two different colors of 1974 shotcrete. Our new patch matched the material on the right but not the left. The mix on the right was accepted for local shotcrete repairs.* (Harboe Architects)

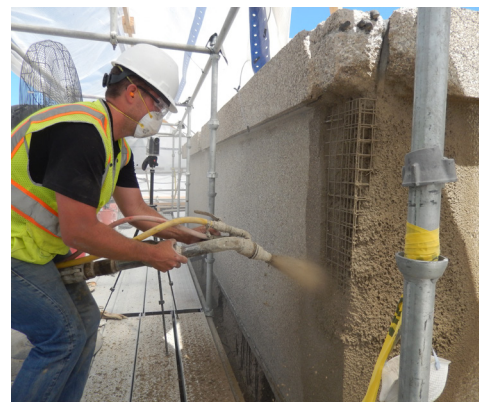
Figure 7. *The shotcrete patch was cut-out and re-patched with a mix design that worked for both colors of existing shotcrete.* (Harboe Architects)

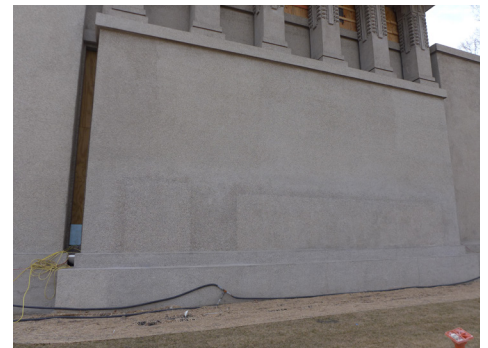
Figure 9. Rejected shotcrete patches at the north elevation. (Harboe Architects)

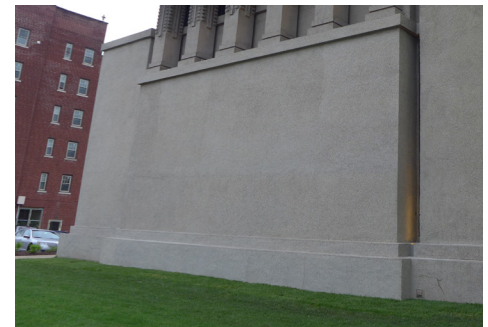
Figure 10. Rejected shotcrete patches at the north elevation were cut-out and are re-patched with a revised mix to provide a closer match. (Harboe Architects)

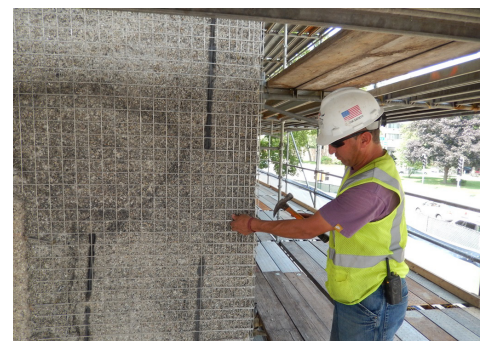
The previous 1970's shotcrete treatment did not include any mesh reinforcement to control shrinkage. During initial repair mock-ups a couple shrinkage issues became apparent.

Figure 11. Installation of mesh reinforcement to control shrinkage. (Harboe Architects)

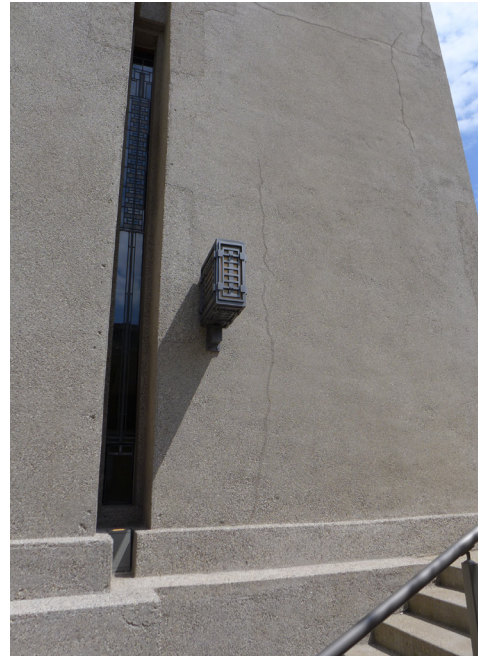
The repair of cracks in existing shotcrete in a way that allowed them to visually disappear proved to be very challenging. Cracks in shotcrete that were sound were ground out and repaired with urethane sealant. Existing shotcrete was crushed and impregnated into the surface of the fresh sealant to help blend the repairs into the adjacent shotcrete. The approach of impregnating urethane sealant with crushed existing shotcrete and aggregate to visually match the appearance of the adjacent shotcrete was difficult to consistently achieve on a large scale. The success of these repairs was dependent on the artistry of the tradesmen doing the work. Repairs that were performed from scaffolding with close-up access often appeared to be good matches, but once the scaffolding was removed and the repairs could be viewed from afar and in different lighting conditions the repairs contrasted with the color of the surrounding existing shotcrete. In addition, some of the successful crack repairs were in close proximity to areas of shotcrete repairs that required additional aggregate exposure once the scaffolding was removed. In these instances, the crack repairs were damaged during the adjacent abrasive aggregate exposure. Much like some shotcrete patches, a number of crack repairs had to be cut out and redone to achieve an acceptable match. In addition, due to the different absorption rate of the shotcrete and the urethane sealant, the appearance of the crack repairs varies with the weather. Repairs that are good matches when the facades are dry become contrasting in visual appearance after a rain storm or in high humidity.

Figure 12. *Rejected crack repair. (Harboe Architects)*

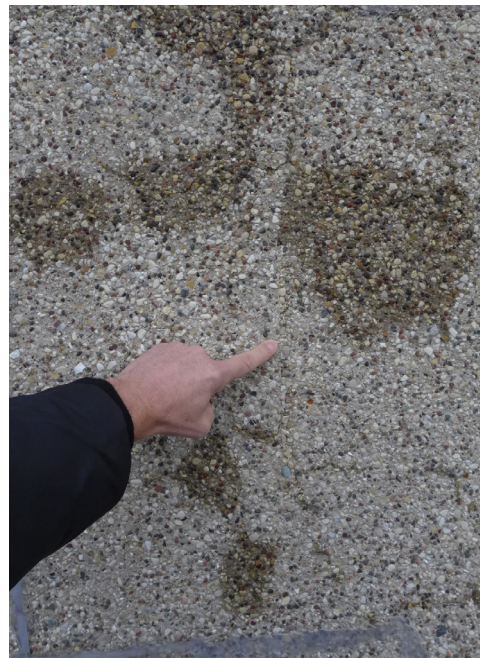
Figure 13 *The rejected crack repairs were cut-out and the cracks were re-patched to more closely match the approved mock-up sample. (Harboe Architects)*
