The future of looking younger: A new face for PMMA. Research into fill materials to repair poly(methyl methacrylate) in contemporary objects and photographs

Laganà, A., J. Langenbacher, R. Rivenc, M. Caro, V. Dion, and T. Learner. 2017. The future of looking younger: A new face for PMMA. Research into fill materials to repair poly(methyl methacrylate) in contemporary objects and photographs. In *ICOM-CC 18th Triennial Conference Preprints, Copenhagen, 4–8 September 2017*, ed. J. Bridgland, art. 0906. Paris: International Council of Museums.

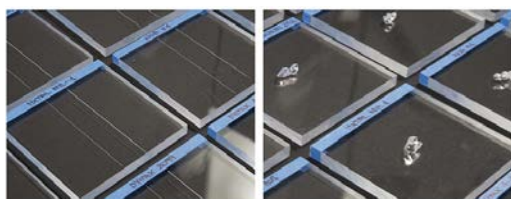
Figure 1. Damaged test sample

Treatment tests were first conducted on samples ($6.5 \times 6.5 \times 0.5$ mm) sawed from commercially purchased clear cast PMMA sheets, as well as extruded. Superficial and deeper scratches (width of 0.2–0.5 mm) were simulated with sharp metal points, while hammers and chisels were used to recreate chips (Figure 1).

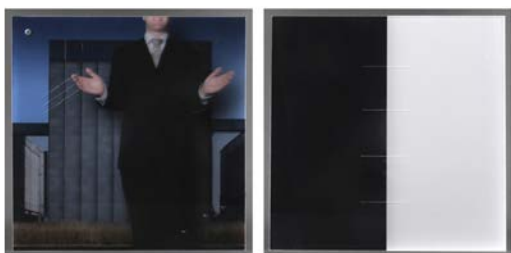
Figure 2. Damaged mock-ups

Fill materials and methods providing the best results were further tested on damaged mock-ups: clear PMMA objects bought at flea markets and face-mounted photographs donated by a photograph conservator. The face-mounted photographs included two kinds of images: a half-black/half-white image and a colored one (Figure 2). These images were selected to evaluate differences in the perception of repairs performed on clear PMMA placed against different colored backgrounds.

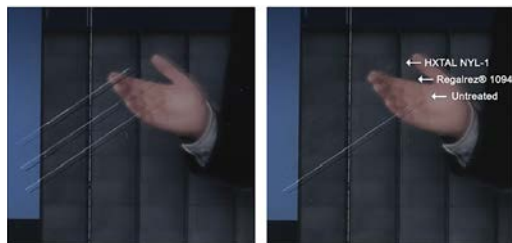
Figure 4. Detail of face-mounted photograph mock-up showing three deep scratches on the PMMA surface interfering with the image underneath (left). The mock-up after scratch-filling (right): upper scratch was treated with HXTAL NYL-1; middle scratch with Regalrez 1094; and lower scratch was left untreated as reference

Based on this assessment, the following materials were selected for further tests on mock-ups and compared. For filling scratches: HXTAL NYL-1, Regalrez 1094 (40%) and Dymax 4-20638; and for filling chips: HXTAL NYL-1, Regalrez 1094, and Paraloid F-10 (both at 40%). Tests on mock-ups showed that HXTAL NYL-1 and Regalrez 1094 are the best options; they were able to restore the transparency on both objects and face-mounted photographs, proved to be easy to apply and posed no issues during curing (Figure 4).

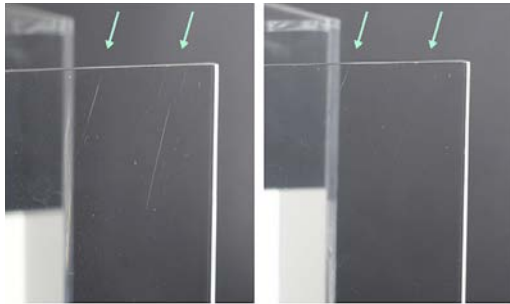
Figure 5. Details of Case 1: the PMMA surface before treatment (left) showing deep scratches interfering with the object's original appearance; after scratch-filling (right) when the transparency was recovered

The three RCE objects showed several scratches on their PMMA surfaces. In Tempelman's and van den Ijssel's works, some deep scratches were particularly interfering with the objects' perception and they could also be mistaken for original incisions. In the van den Ijssel, the additional challenge was to saturate a colored transparent PMMA. Treatment strategies were first discussed with the RCE conservation specialist Ron Kievits. It was decided to treat only the most disturbing scratches, identified by placing the objects on a black background, which also helped to improve the visibility of the damages thus facilitating precise applications. Regalrez 1094 was preferred to HXTAL NYL-1 because, with results almost visually equivalent on scratches, it has the added advantage of being highly reversible. The resin was easily applied with the mini-brush as a paint retouch. One application was sufficient to reduce scratches (Figure 5). Scratch-filling was performed with objects lying flat as well as in an upright position. The mini-brush was able to hold the low-viscosity product; however, when treated in an upright position it was necessary to minimize the amount of resin to avoid dripping. Regalrez 1094 treatments successfully "retouched" the damaged PMMA surfaces, recovering the transparency and permitting the reading of all three objects. Treatments showed also the ability of the resin to re-saturate colored clear PMMA without adding dyes (Figure 6).

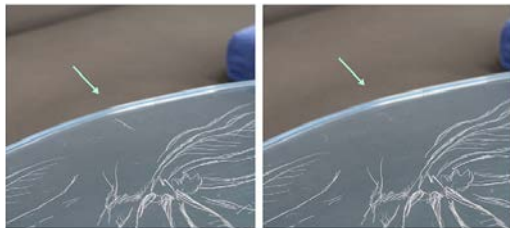
Figure 6. Details of Case 3 showing the ability of the clear resin to re-saturate scratched colored PMMA even without addition of dyes; before scratch-filling (left) and after (right)

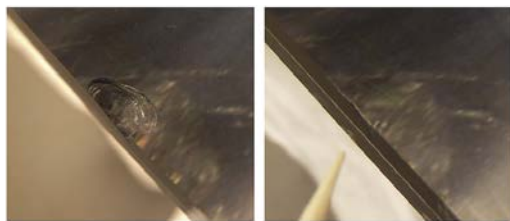
Figure 7. Details of Case 4 before and after chip-filling. © Borzo Gallery

For van Elk's photograph, the face-mount had suffered a serious chip on its edge. The damage was treated with HXTAL NYL-1 because, due to its minimal shrinkage upon curing, it is easier to use on deep chips. Beeswax was temporarily applied along the broken edge to avoid spreading of resin. Epoxy was carefully dripped within the boundaries of the loss until it was completely filled. After curing, no further applications were required. The repair matched the PMMA surface in level and clarity. The photograph completely recovered the lost transparency and visibility of the image underneath (Figure 7).
