Consolidation and Stabilization

Condition, Conservation, and Reinforcement of the Yumen Pass and Hecang Earthen Ruins near Dunhuang

Wang Xudong, Li Zuixiong, and Zhang Lu

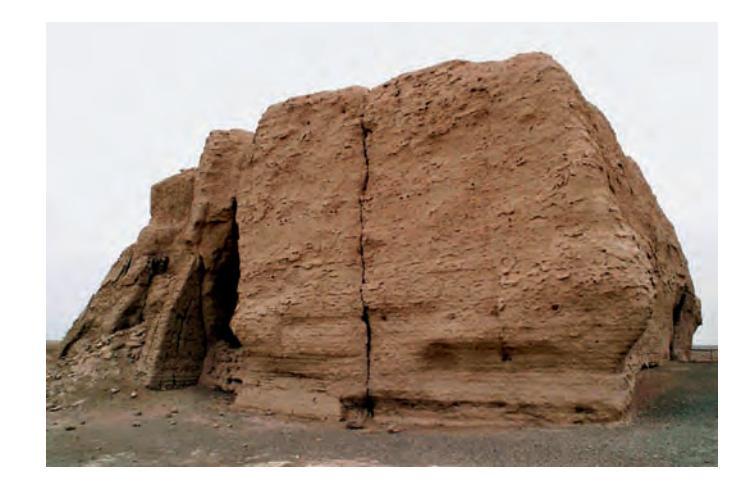
FIGURE 1 Condition of the Yumen Pass before consolidation.

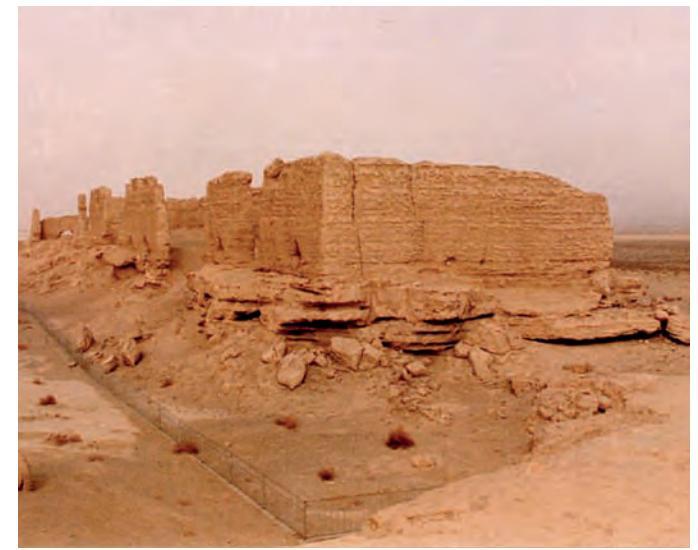
FIGURE 3 Condition of the Hecang Fortress before consolidation.

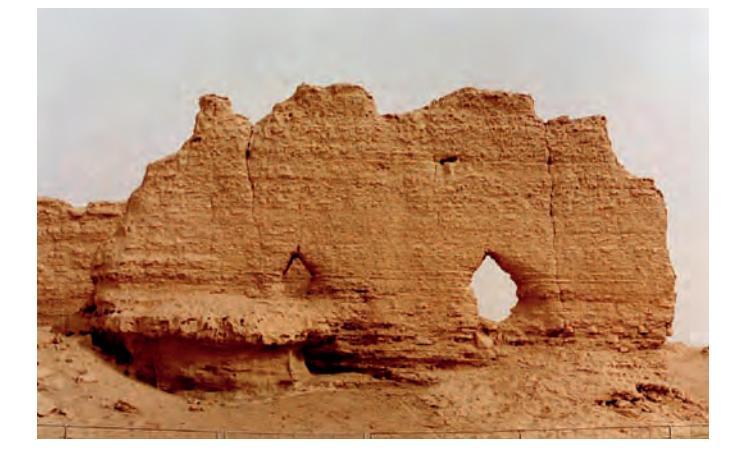
FIGURE 6 Hecang Fortress before consolidation.

Where wall foundations were eroded, the surface was cleaned of friable earth. PS solution was infiltrated into the area to consolidate it; thereafter, adobe bricks with a dry density of no less than 1.75 grams per cubic centimer were laid to support the foundation. Surface treatment was done for visual compatibility. Figures 6 and 7 show an area of the Hecang Fortress before and after reinforcement.

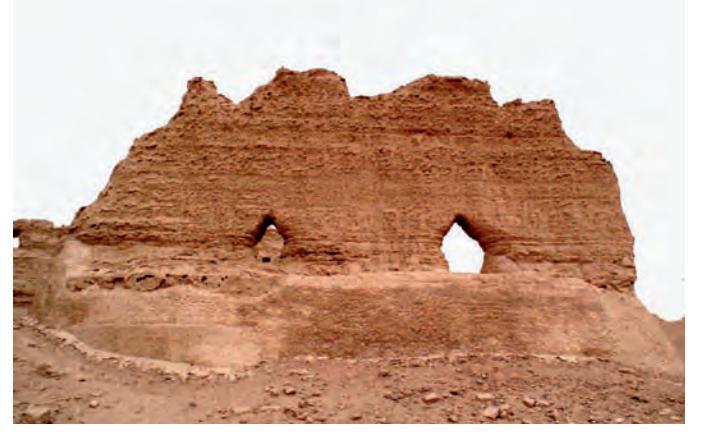
FIGURE 7 Hecang Fortress after consolidation.

Potassium silicate was the primary material for reinforcing the walls and foundations of the Hecang Fortress. After the softened areas were cleaned, three PS solutions of varying concentrations were sprayed on them at intervals of a week to ensure complete infiltration: 2 to 3 percent solution the first time, 5 percent solution the second time, and 7 percent solution the third time. Ten percent PS solution with added earth was applied to the softer and more porous

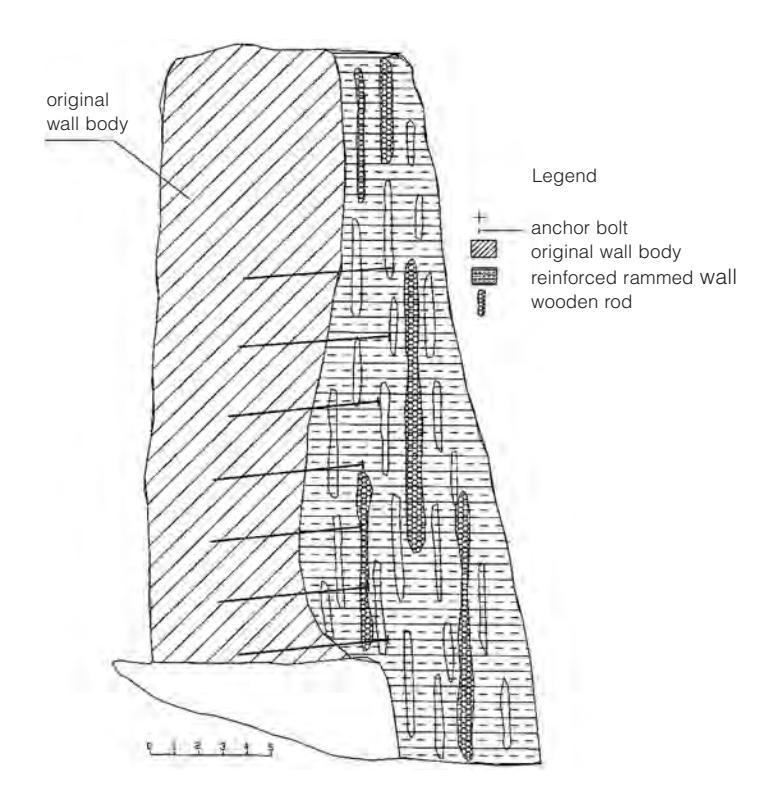
FIGURE 9 Soil mass consolidated with *Achnatherum* stalks on the northern wall.

These techniques were employed in reinforcing the collapsed northern wall of the Yumen Pass. Local earth was also used for making new rammed earth walls. Earth was crushed and soaked before being mixed with lime. This mixed earth was then used for forming new wall. Layers ~18 centimeters thick were laid and rammed manually until reduced to 15 centimeters. Reinforcing iron frames, 300 by 300 millimeters, were placed both horizontally and vertically in the

rammed earth. *Achnatherum* stalks were laid crosswise on each layer to increase the bonding strength of the new wall. PS-tempered clay was used to fill the fissure between the new and old walls (fig. 9).

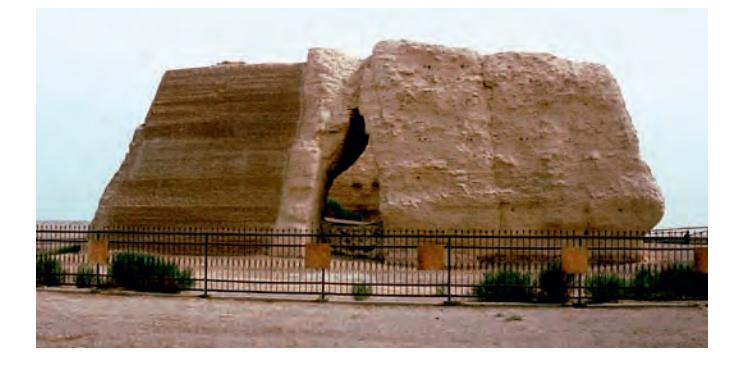
FIGURE 10 Reinforced outer section of the northern wall.

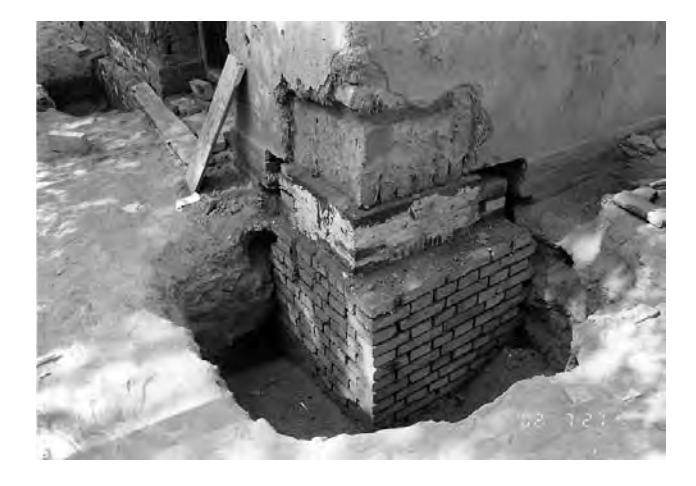
FIGURE 3 Wall stabilization with a brick footing.

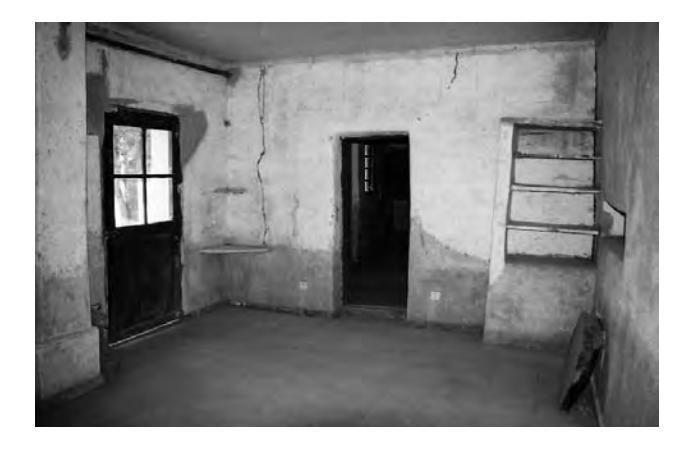
FIGURE 4 Chang Shuhong's residence before restoration.

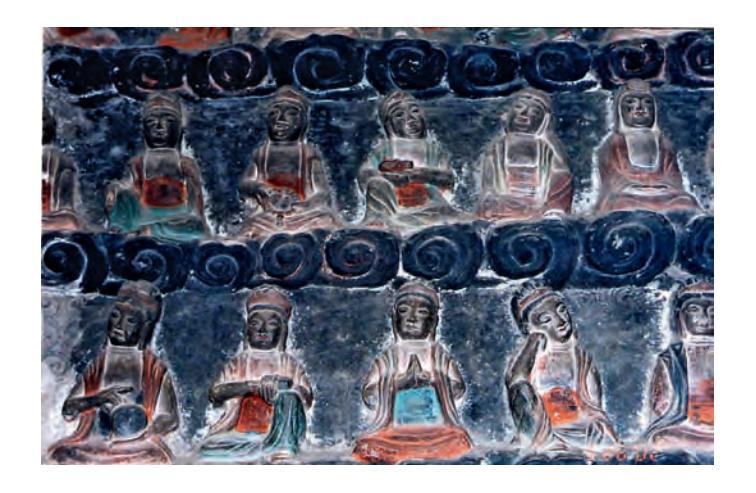
FIGURE 2 Painted figures blackened by deterioration.

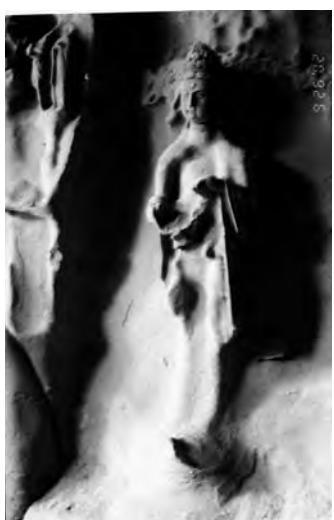
FIGURE 3 Figure eroded by soluble salt and water.

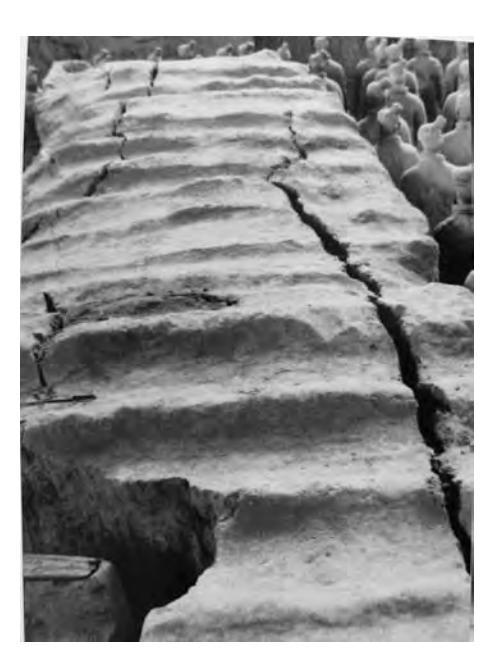
FIGURE 1 Ten-centimeter-wide cracks on the earthen partition wall in pit 1.

In 1988 some parts of a dividing wall were about to collapse. U- and H-shaped steel was used to stabilize ten areas of fissuring (figs. 2, 3). The steel was treated with anticorrosion material, and after installation the supports were further treated to blend visually with the earth.

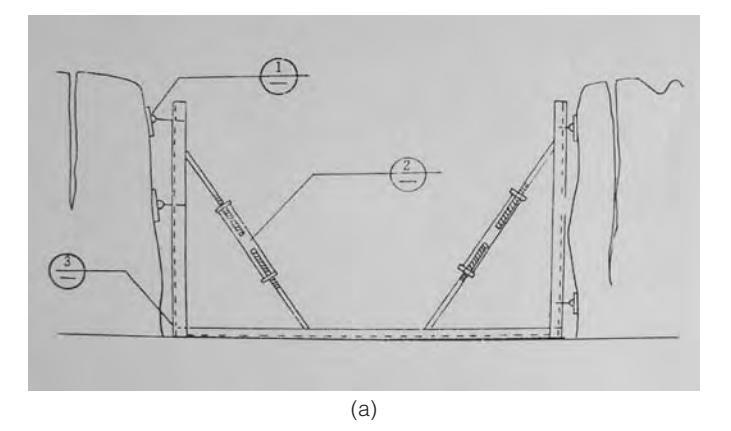
FIGURE 2 U-shaped bracket for reinforcing the earthen partition wall.

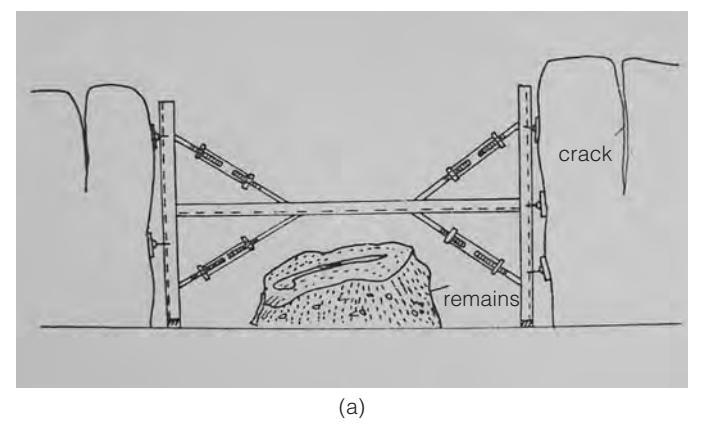
FIGURE 3 H-shaped bracket for reinforcing the earthen partition wall.

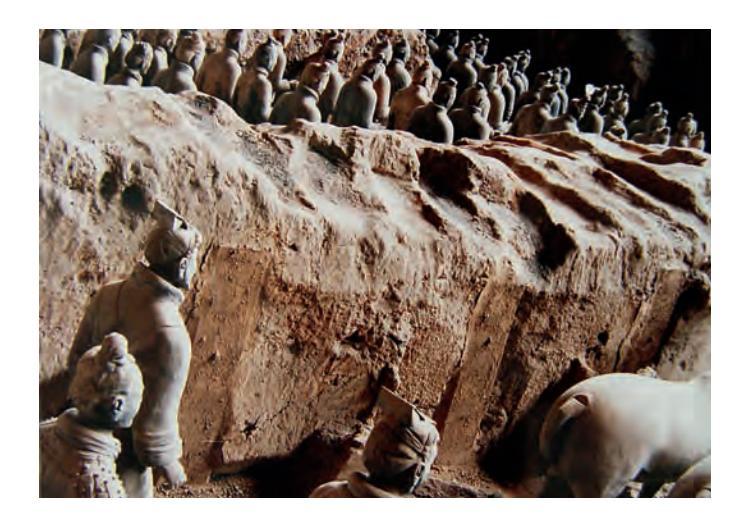
FIGURE 5 Condition of the earthen partition wall after use of steel plates for reinforcing. The imprint of steel plates can be seen on the wall.

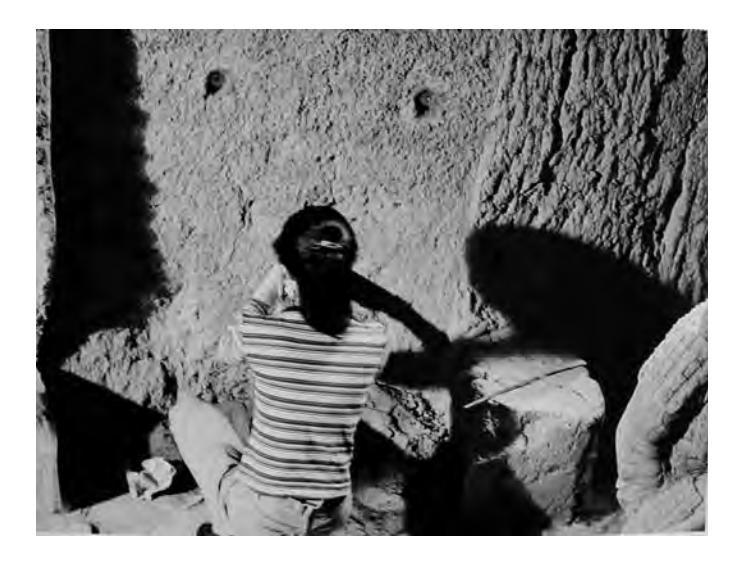
FIGURE 6 Reinforcing with the anchor bolts and grouting method.

Anchor bolts with sand and lime proved most satisfactory. The technique has the advantages of high efficiency, excellent appearance, low cost, and reliability, and it can be used in dry and wet situations. Compared to the other stabilization methods, in general, it is the best way to conserve the Terracotta Army pits.

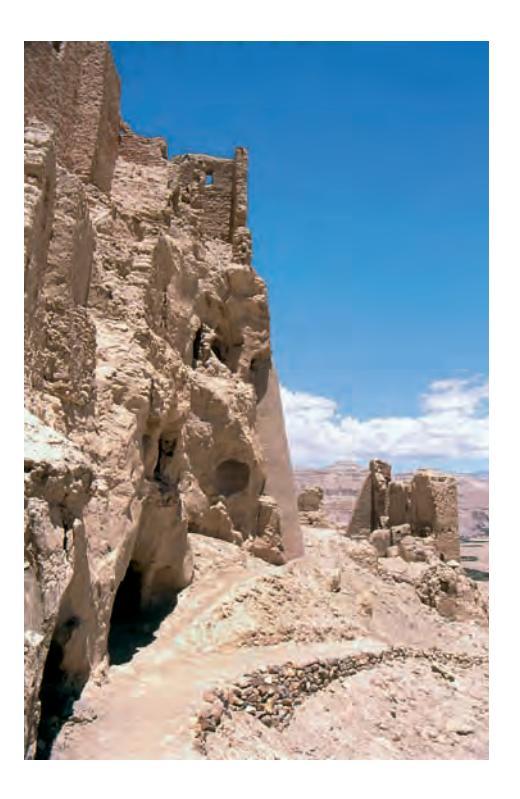
FIGURE 3 Cracking and threatened collapse of earthen architecture.

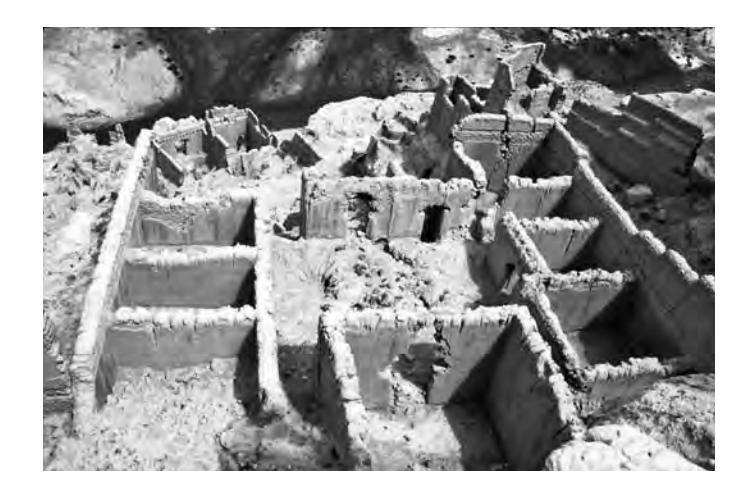
FIGURE 4 Building foundations and the mountainside eroded by rainwater.
